Re: Development at Gynn Lane, Honley for Vivly Homes

Further to your recent planning comments dated July 25 and our meeting with the local residents further site investigation work has been undertaken to determine if there was any existing land drainage associated with the former off site tank/ mill pond on the third party land.

Haigh Huddleston & Associates

Site Photographs

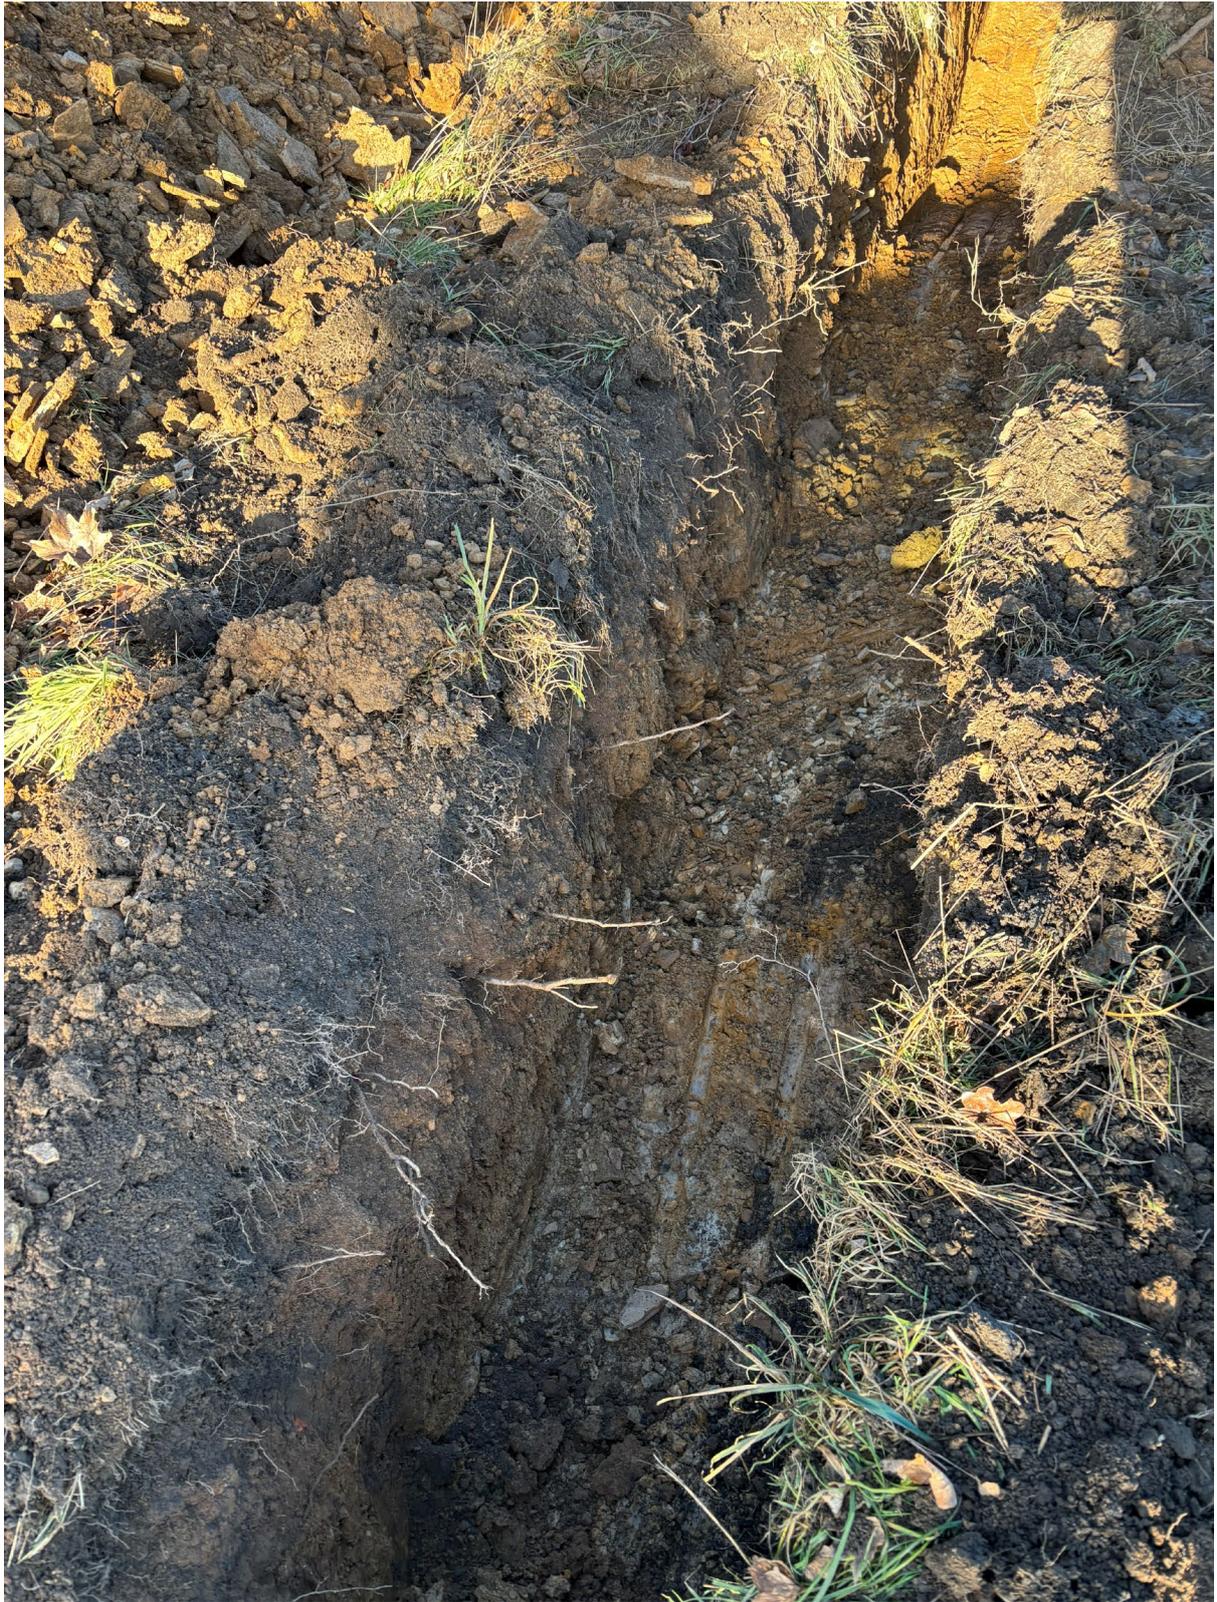
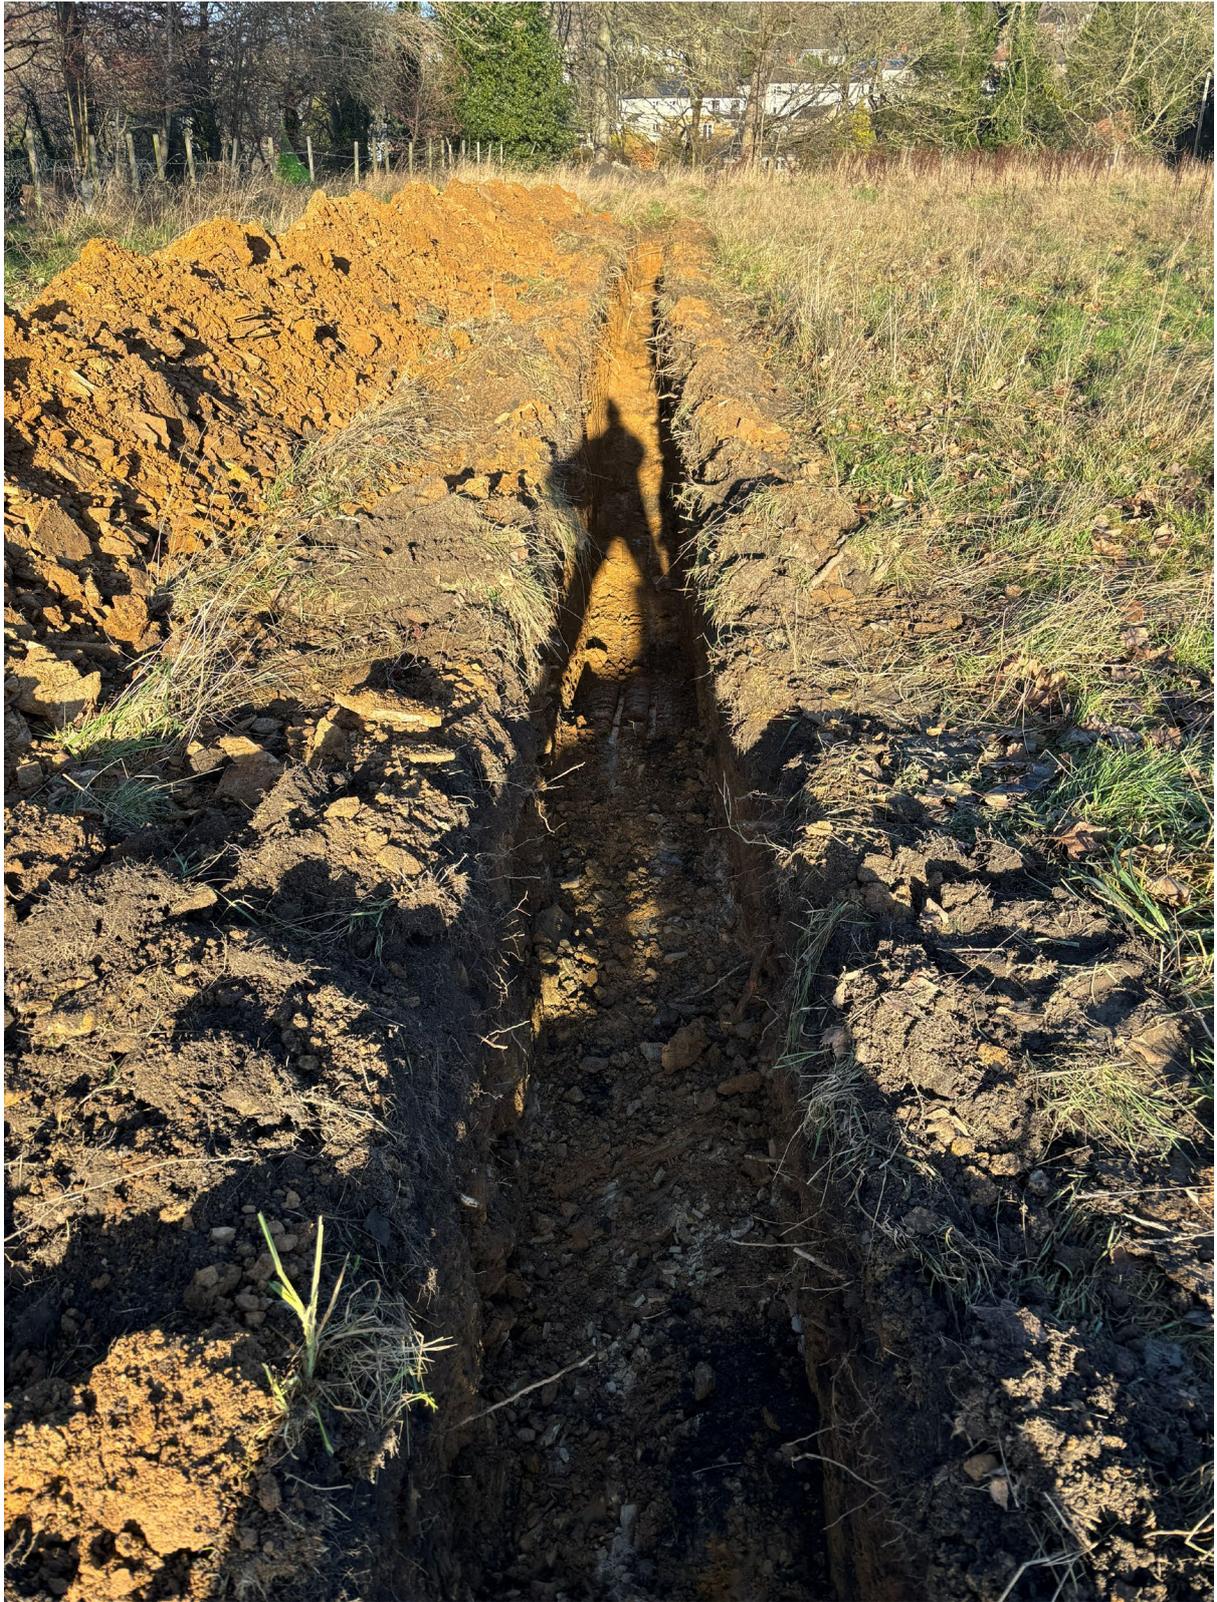
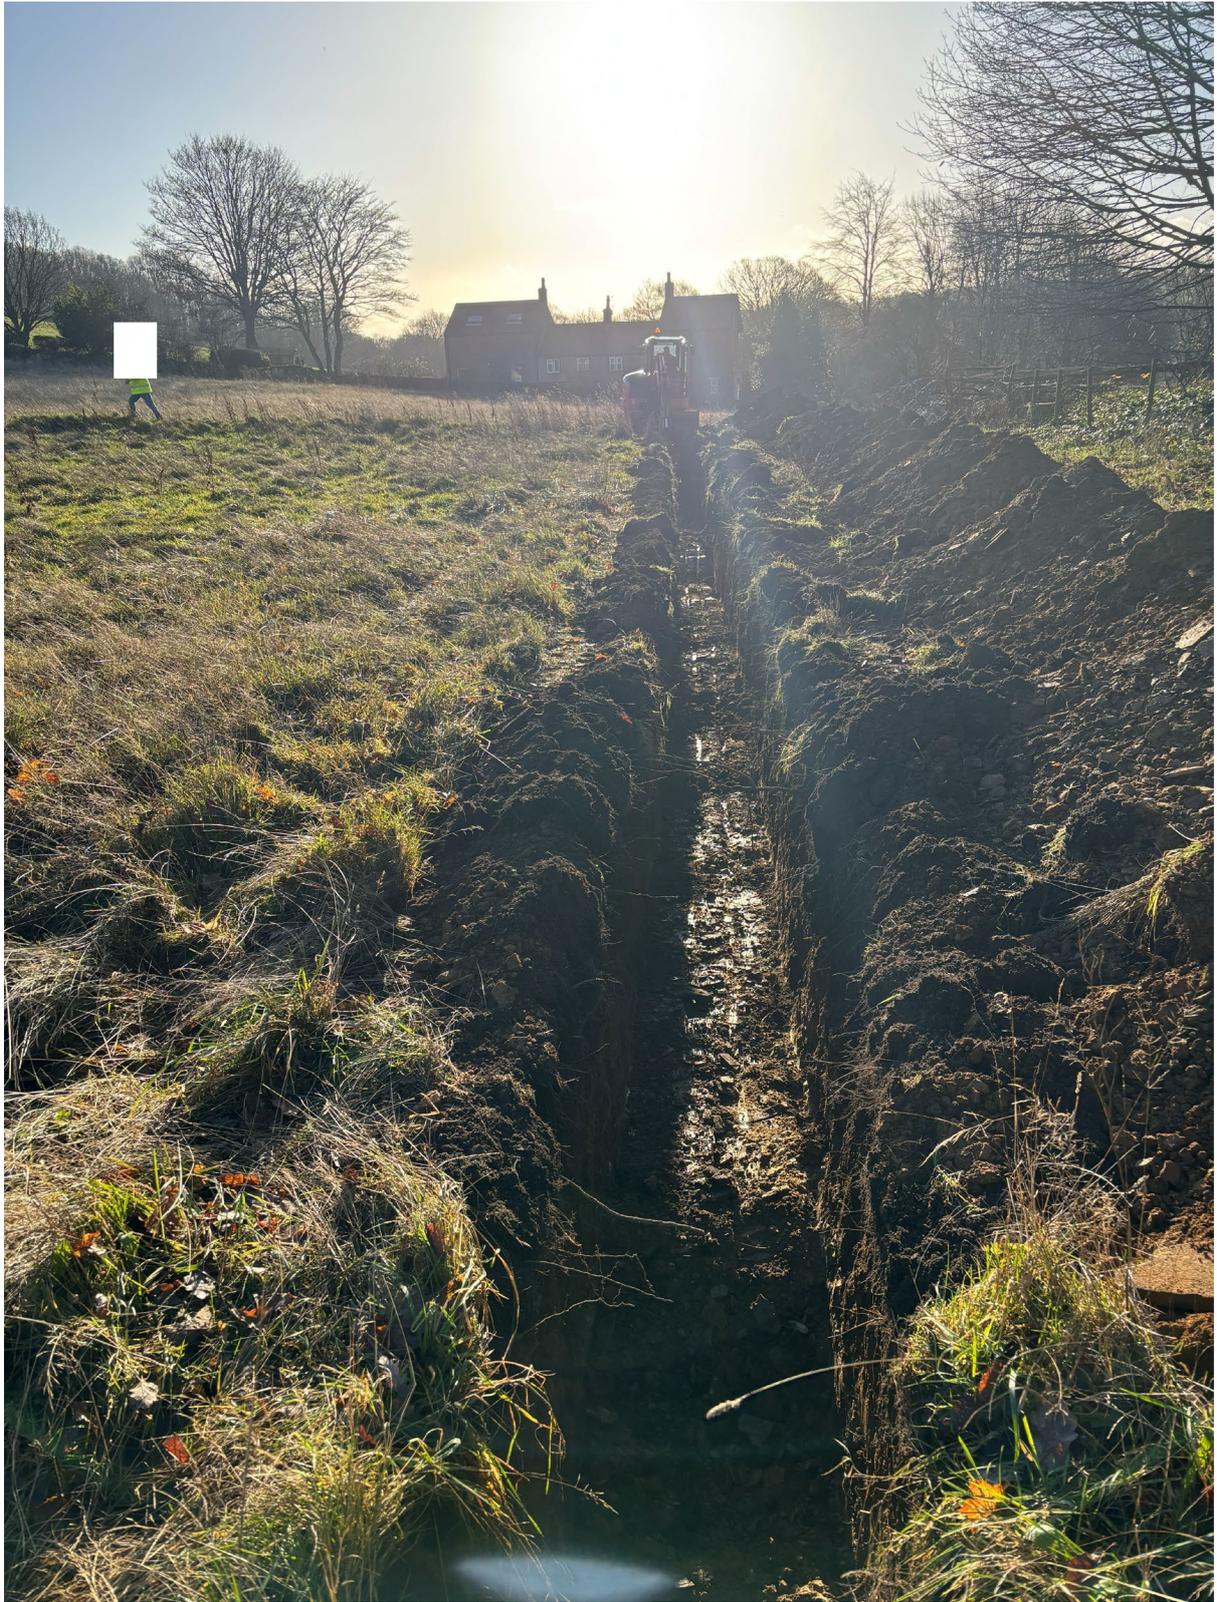
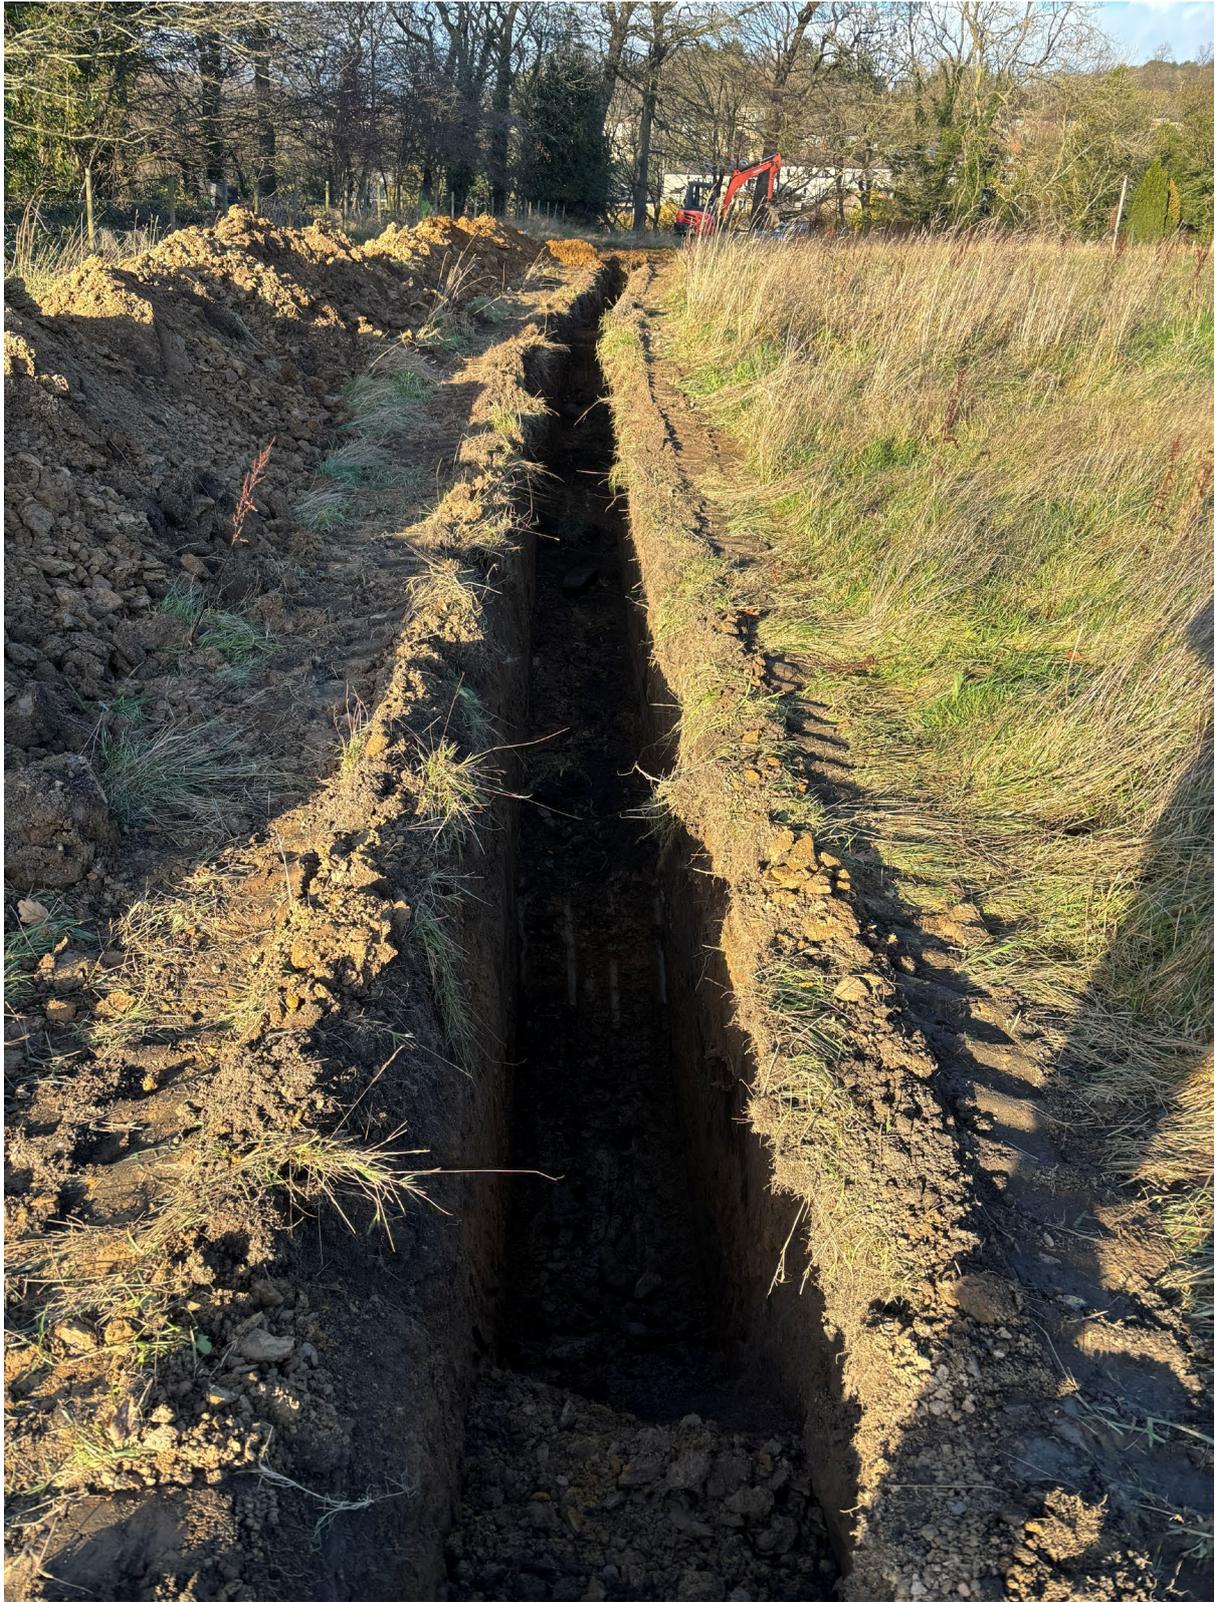
The initial days' work involved the excavation of an extended trial trench along the western site boundary. The trial trench extended for an approximate distance of 47m. The majority of the trial trench encountered shallow sandstone strata at a depth of approximately 1-1.5m. Other than the previously encountered cast iron pipe no other discoloration in the trench sides was observed and the sandstone was intact throughout its entire length. Please note the trial trench extended approximately 15m beyond the return corner where the pond is situated. This was extended to investigate if the line indicated on the historical picture, forwarded to ourselves by the adjacent homeowner, was related to a drainage system. We can confirm that no features were observed, and we would suggest the line on the historical photograph is related to a boundary wall. Site photographs and a location plan are contained in appendix B attached.

Figure 9 Trial Trench

Figure 10 Trial Trench

Figure 11 Trial Trench

Figure 12 Trial Trench

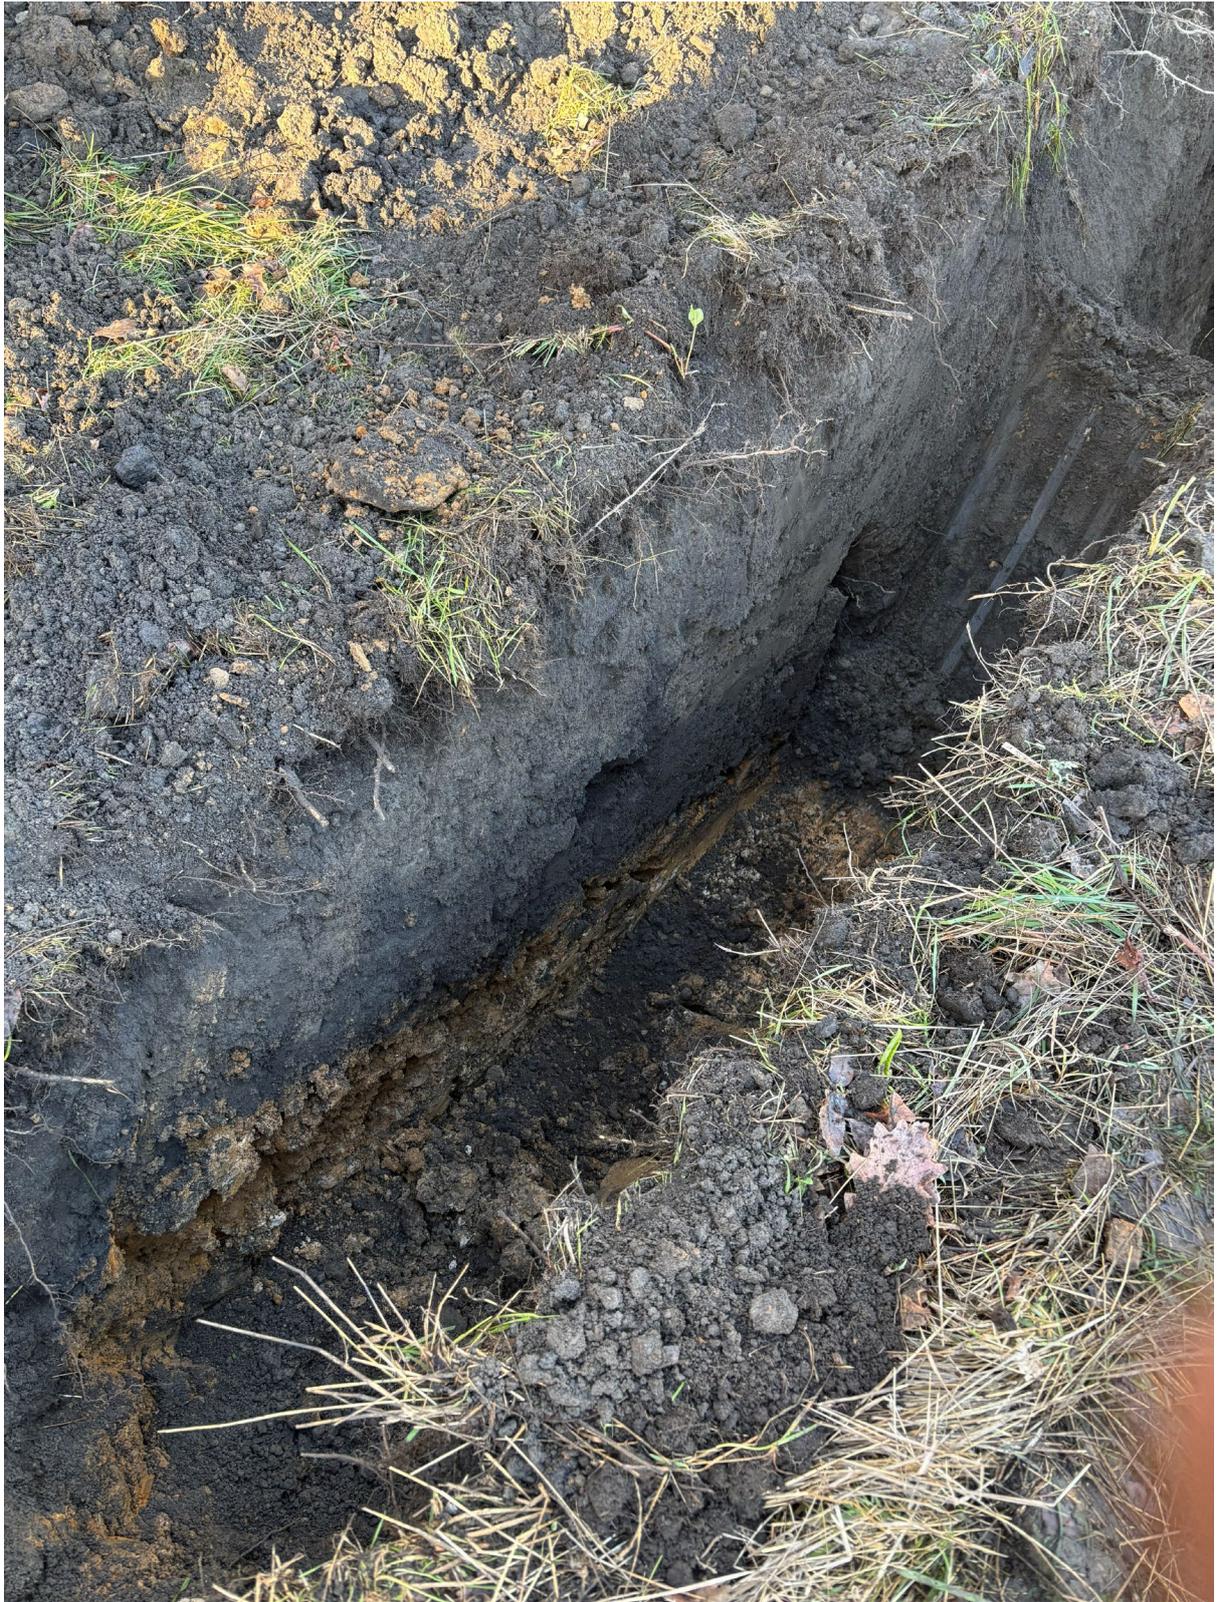
Figure 13 Trench stepping down with made ground

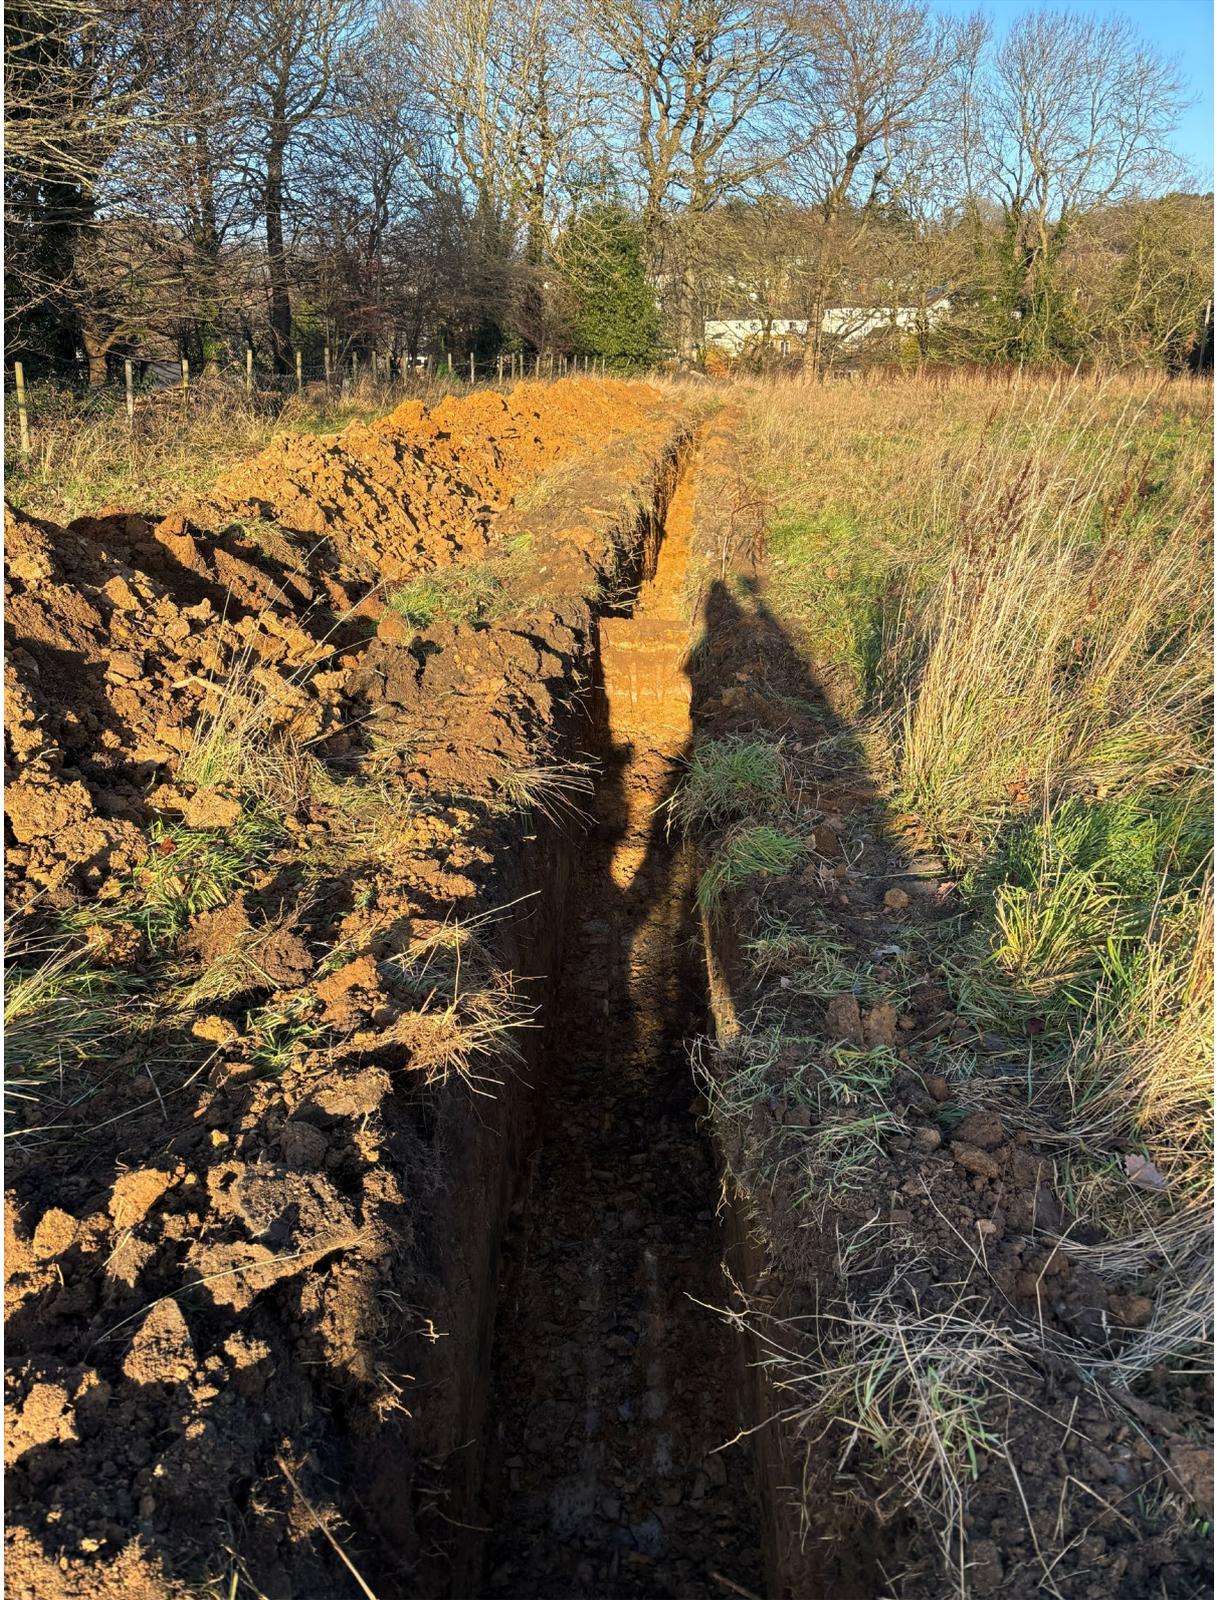
Figure 14 Trail Trench - Pipe crossing

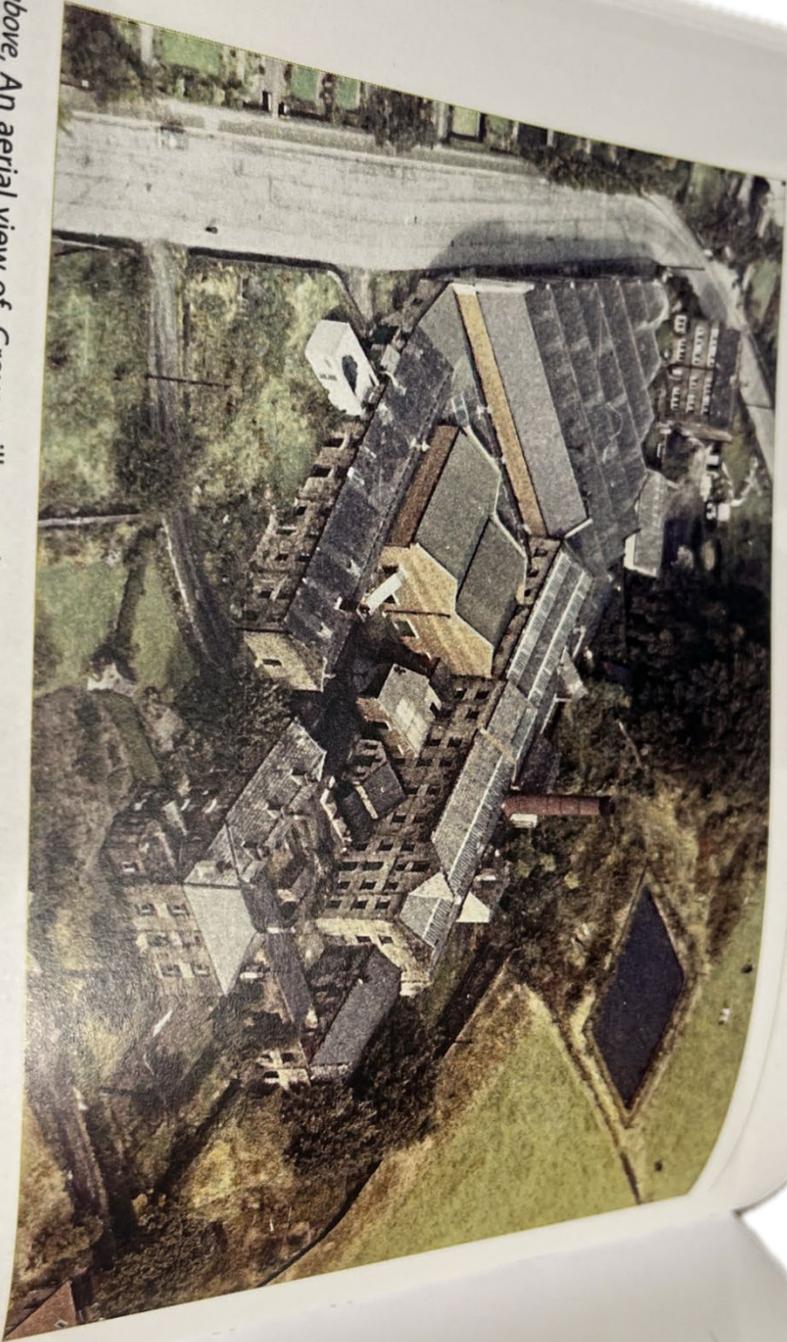
Figure 15 Historical Photo Showing Mill Pond and feature to the south
