**Ref: Shallow Mining Investigation on land off Long Lane, Flockton, Wakefield, West Yorkshire.**

## 1. Introduction

On the instructions of Mr Tom Drake, G&M Consulting Ltd have carried out an intrusive mining investigation on land off Long Lane, Flockton, Wakefield, West Yorkshire. The work was carried out in support of a planning application associated with the development of the site with a building for the stabling of horses; the proposed layout of which is shown on the drawing presented in Attachment A of this report.

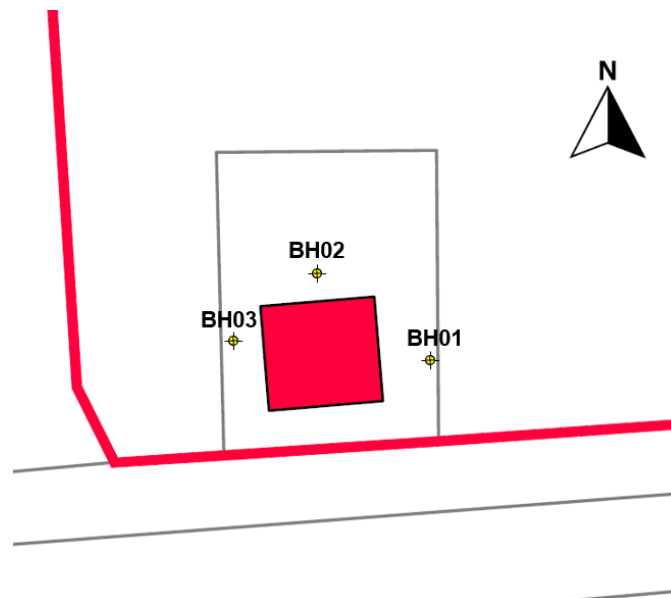
The locations of the exploratory holes are shown below.
