Structural Appraisal Report for Proposed Conversion of Sheds to a Dwelling (Class Q)

Holt Farm, Holt Lane, Holmfirth HD9 3BW

MDL Job Number: 11478

Survey Report

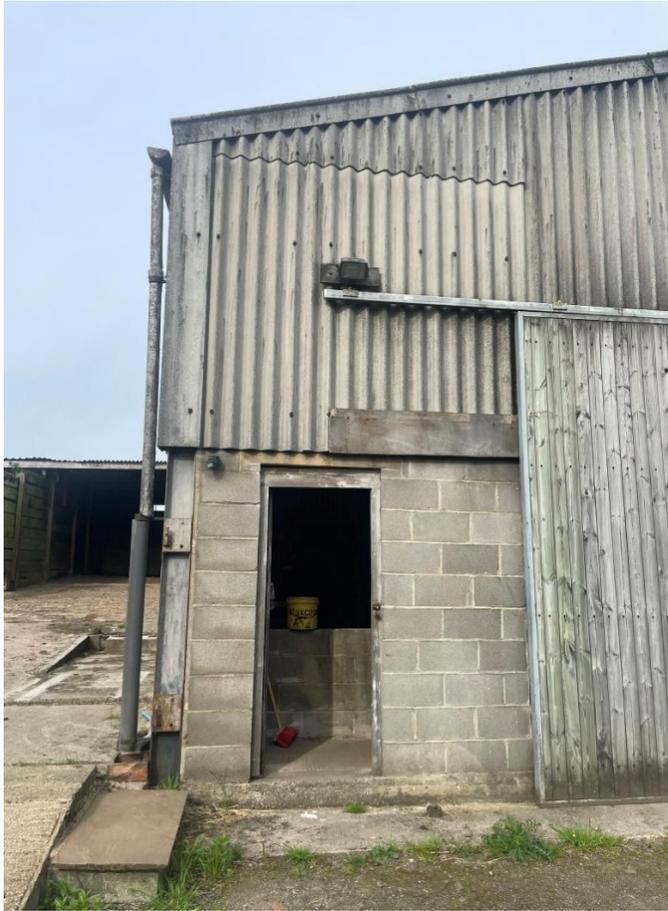
11

There is no cause for concern with the slight cracks on all faces of the block walls, slight horizontal movement cracks noted to the left column around the door aperture of 1-3mm. Generally where there any slight degree of lateral cracks up to 5mm some additional external repointing may be required. **Pic Ref: 11-12 External Ares**
