## PHASE 4 VALIDATION REPORT

## Phase 4: Gap Analysis Assessment & Validation

| Location: | Land off Manchester Road (Area 2)<br>Linthwaite, Huddersfield, West Yorkshire HD7 5QG | |
| Report No. | C4065/25/E/7562 | Report date: June 2025 |

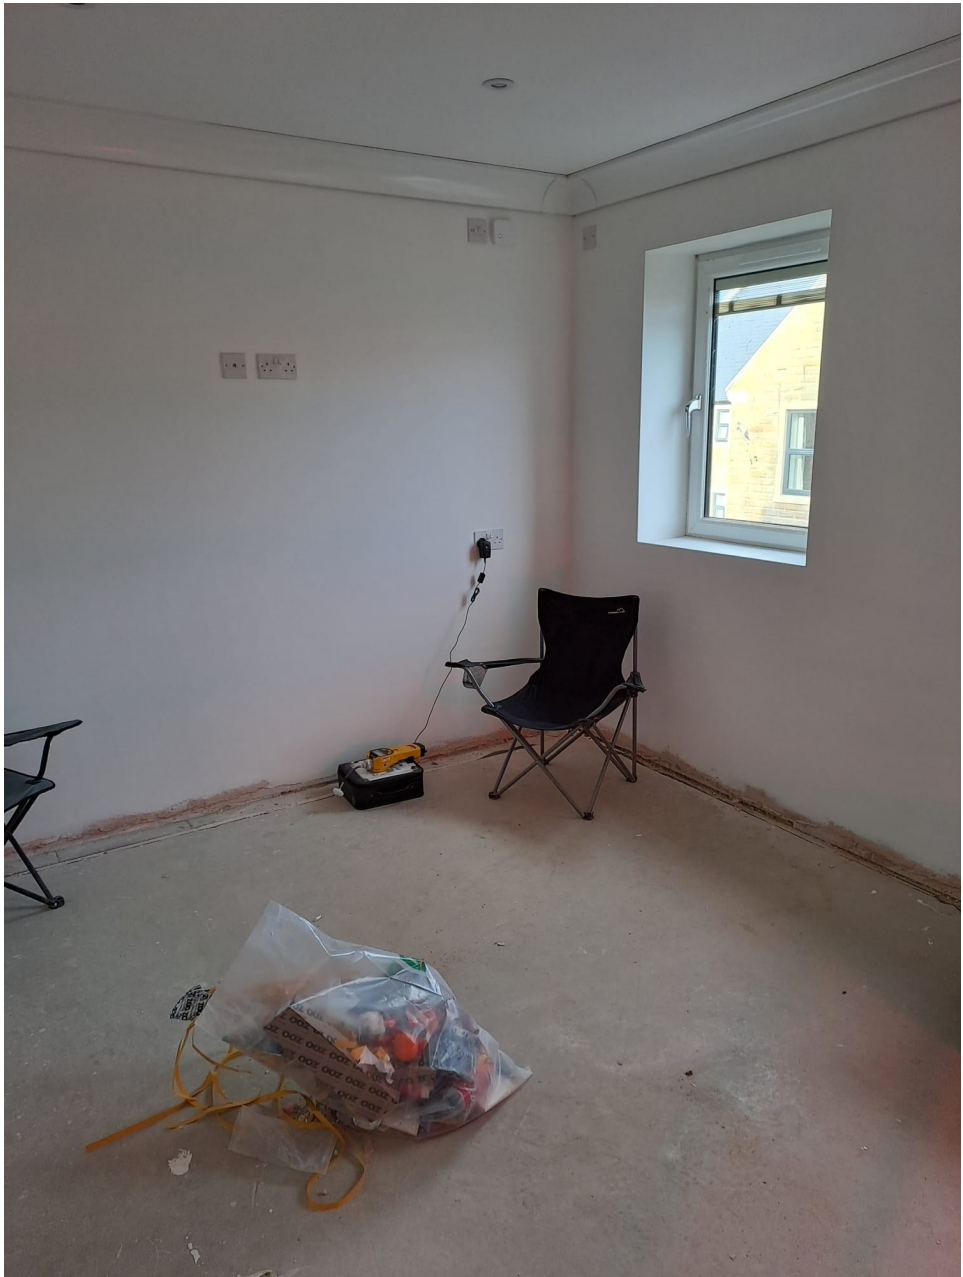
On each occasion, the PID monitor was set to collect readings at 60 second intervals. Throughout the testing period, the VOC reading remained at 0ppm, suggesting that no volatiles are accumulating.

Photo 1 : PID monitor left in Building 1. 5th March 2025.

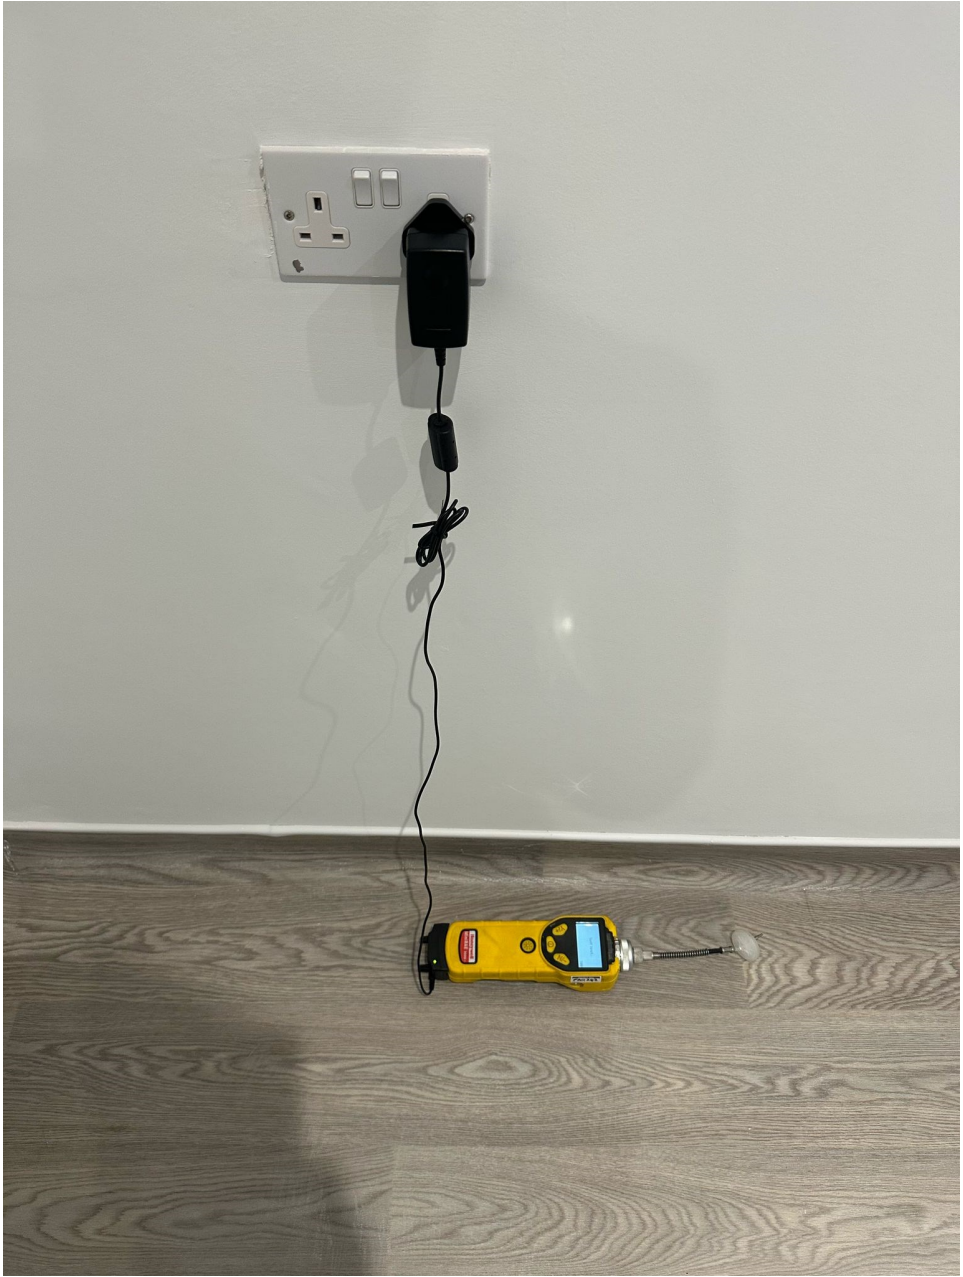
Photo 2 : PID monitor left in Building 2. 10th April 2025.

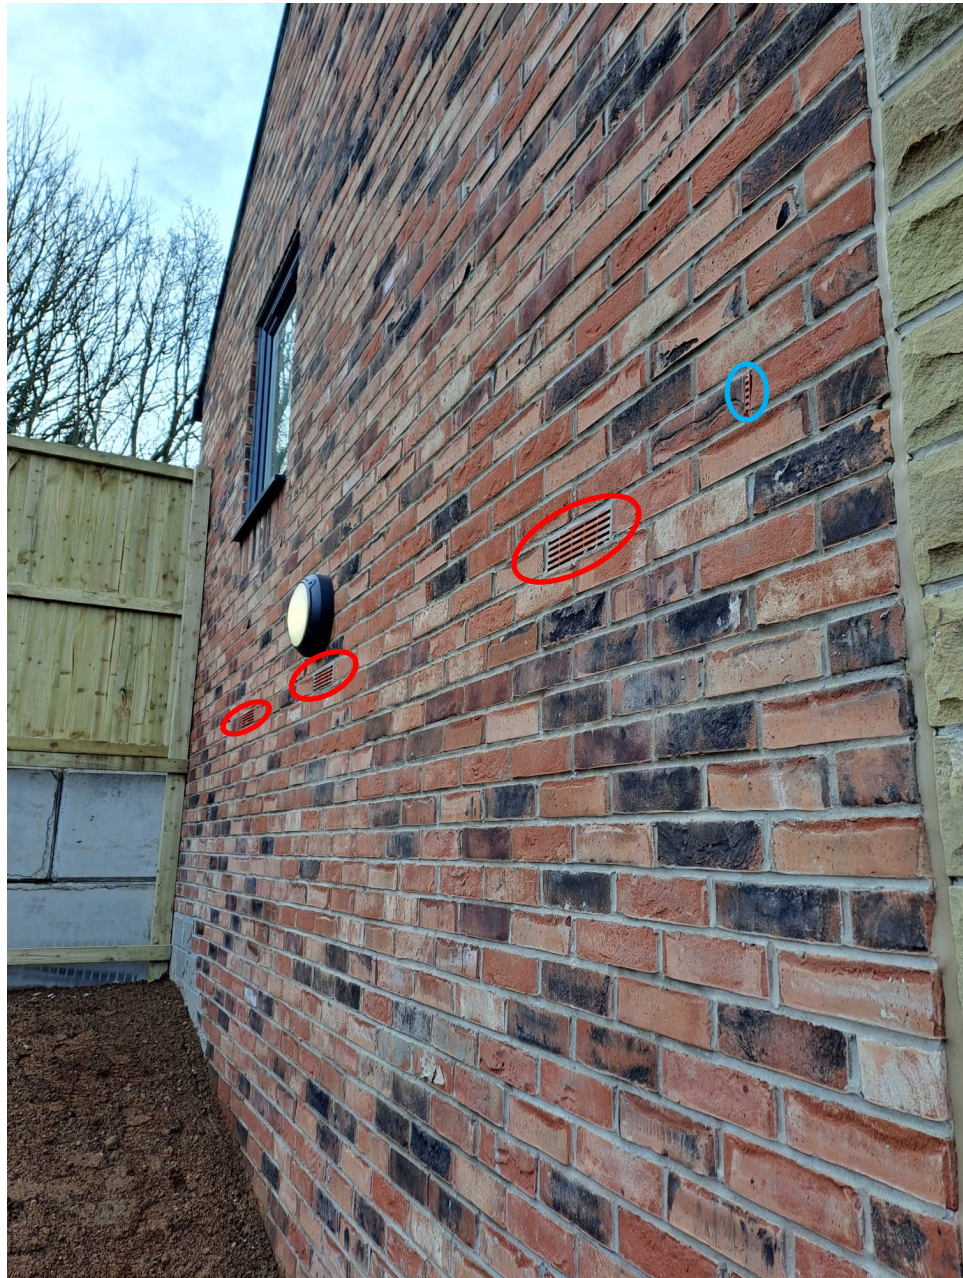
On the basis of the above, it should be noted that all of the readings were zero which implies that the venting system beneath the floors are functioning as they should, or the source has diminished and/or removed.

Photo 3 : Examples of vents on buildings. Air bricks (red) and weep guards (blue).

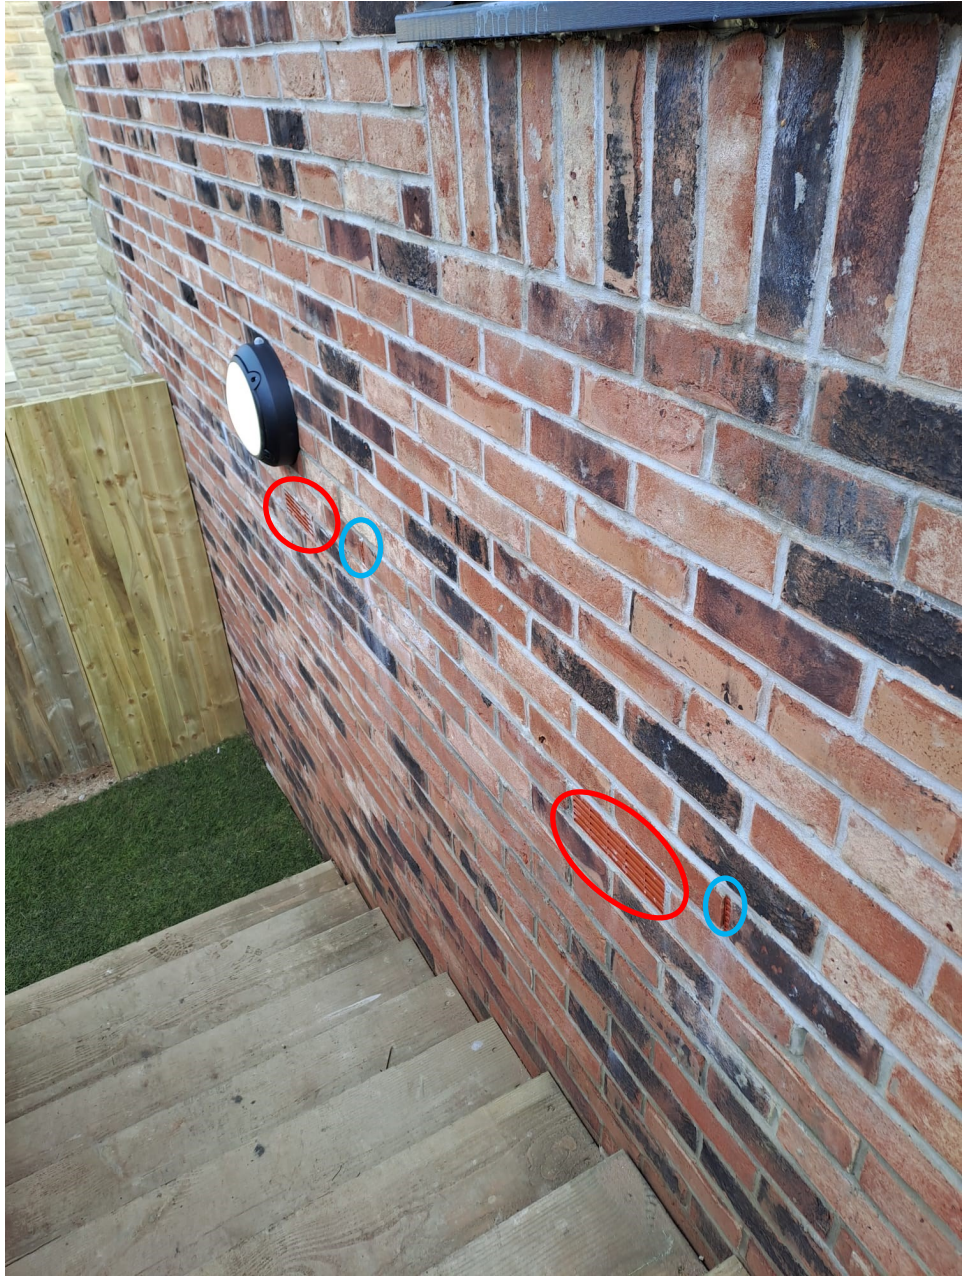
Photo 4 : Examples of vents on buildings. Air bricks (red) and weep guards (blue).

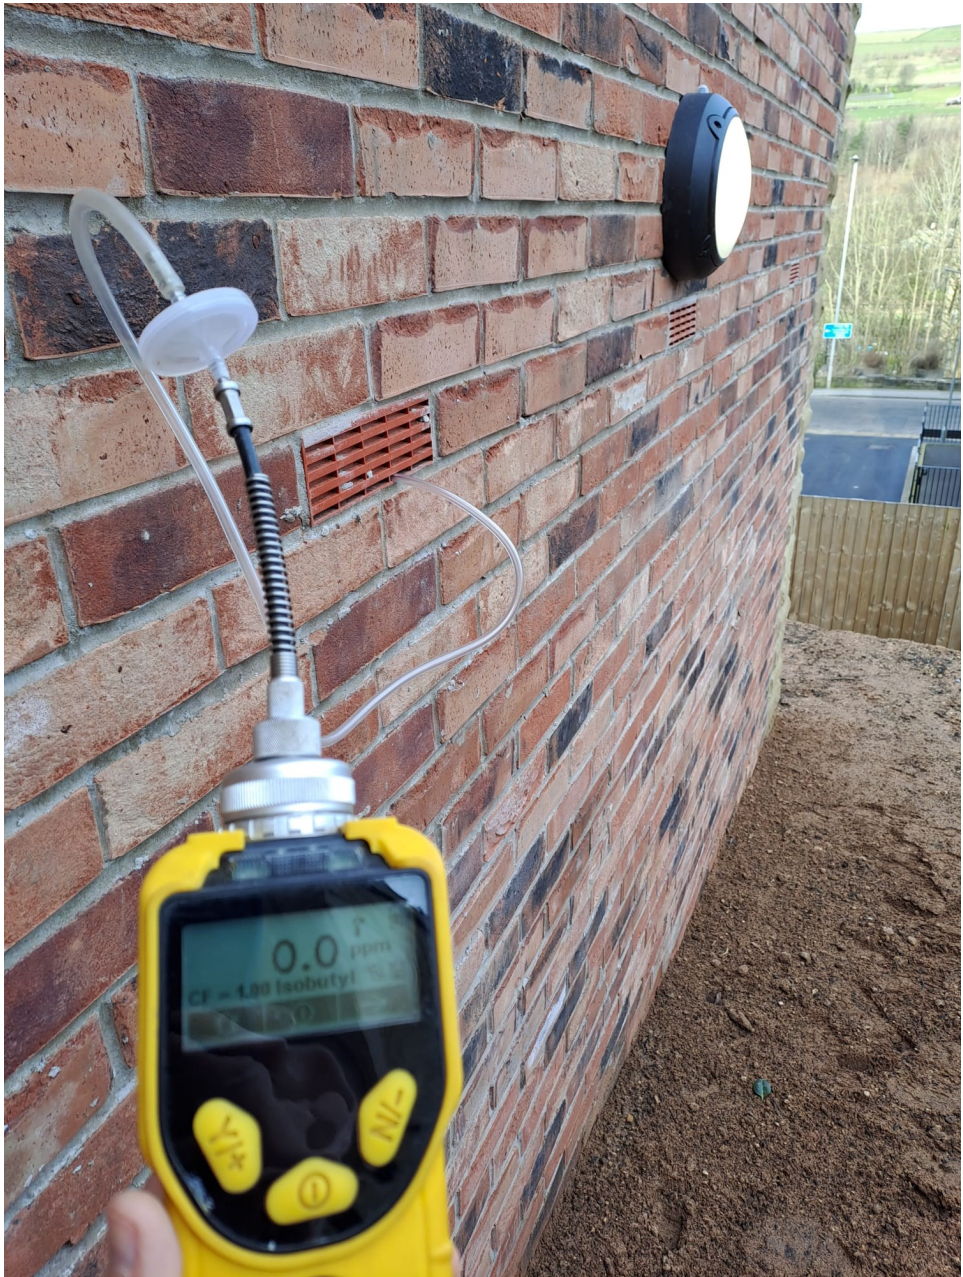
Photo 5 : PID in operation. 05/03/2025

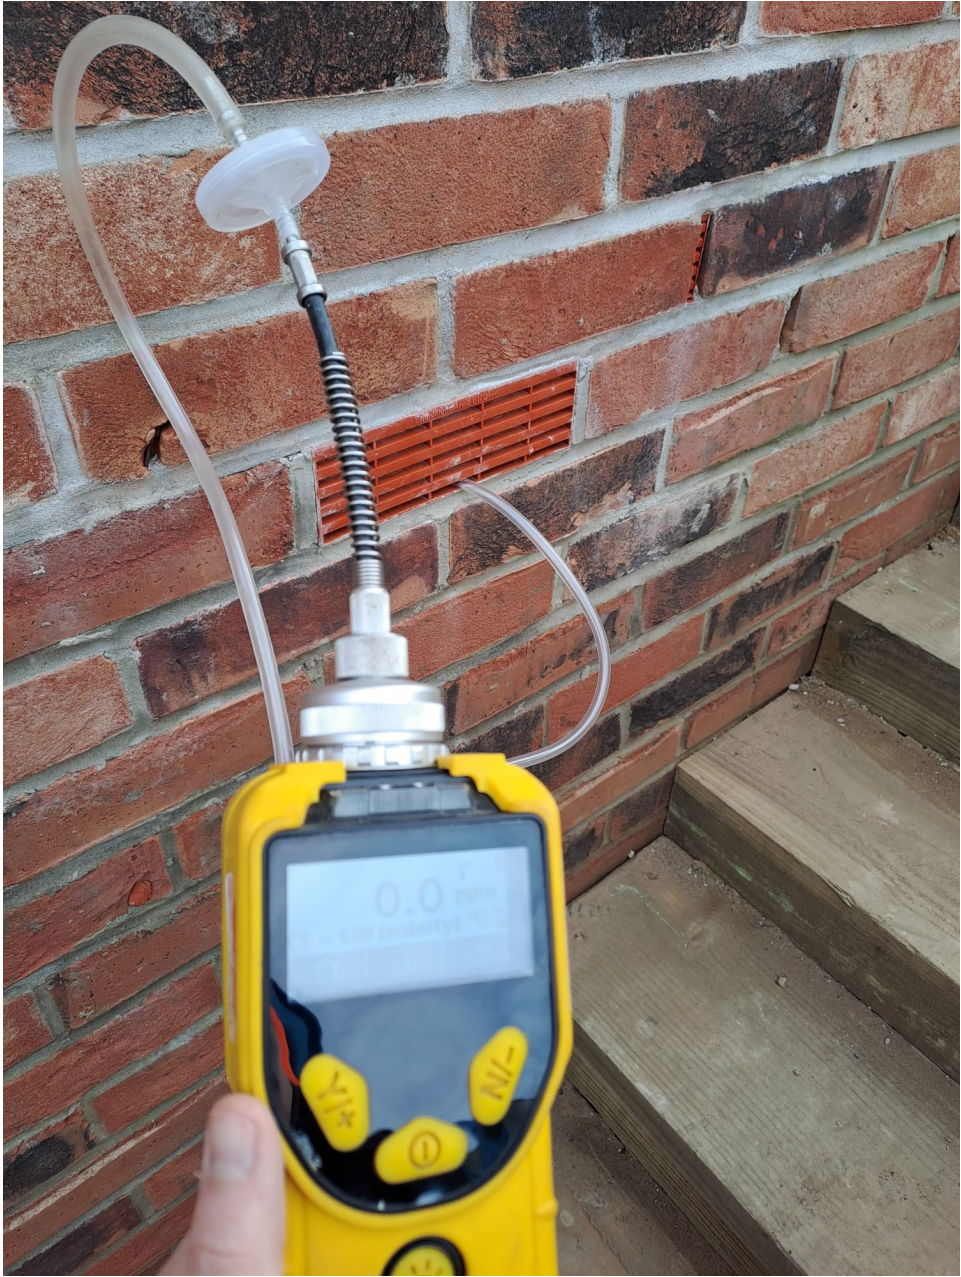
Photo 6 : PID in operation. 05/03/2025

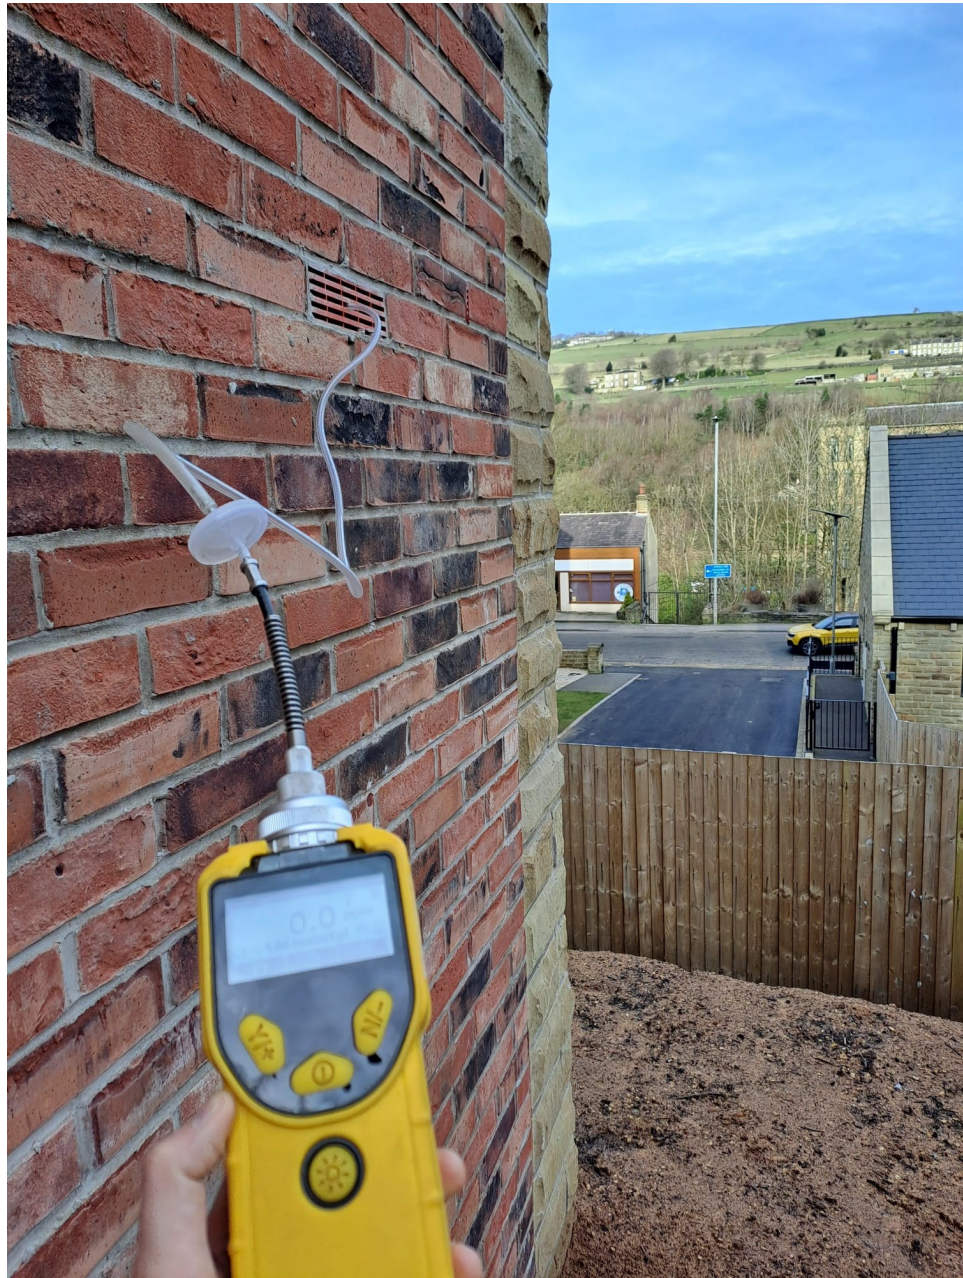
Photo 7 : PID in operation. 05/03/2025
