GeoShield Verification Report 01

PROJECT REFERENCE: GEO104074

PROJECT: Dewsbury Hospital

SPECIFICATION: Verified in accordance CIRIA 735.

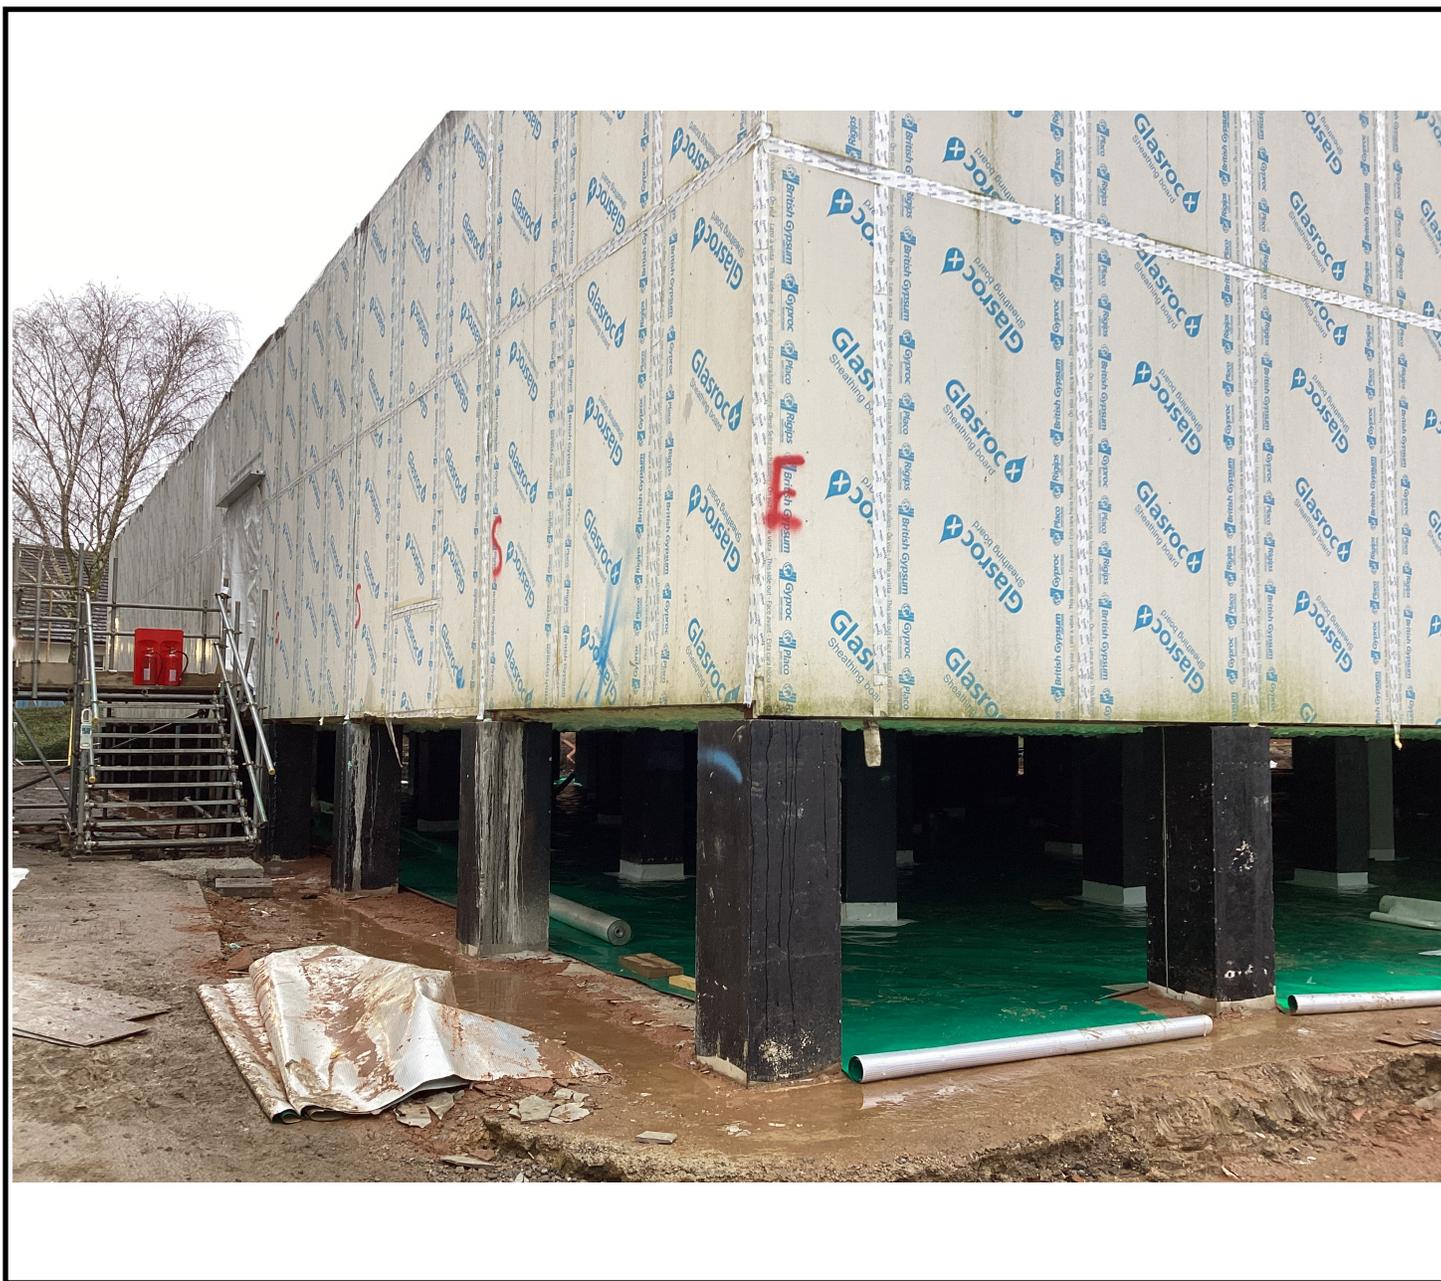
This is a overview of the proposed project where the Proctor GM Super Gas Barrier Membrane is in the process of being installed.

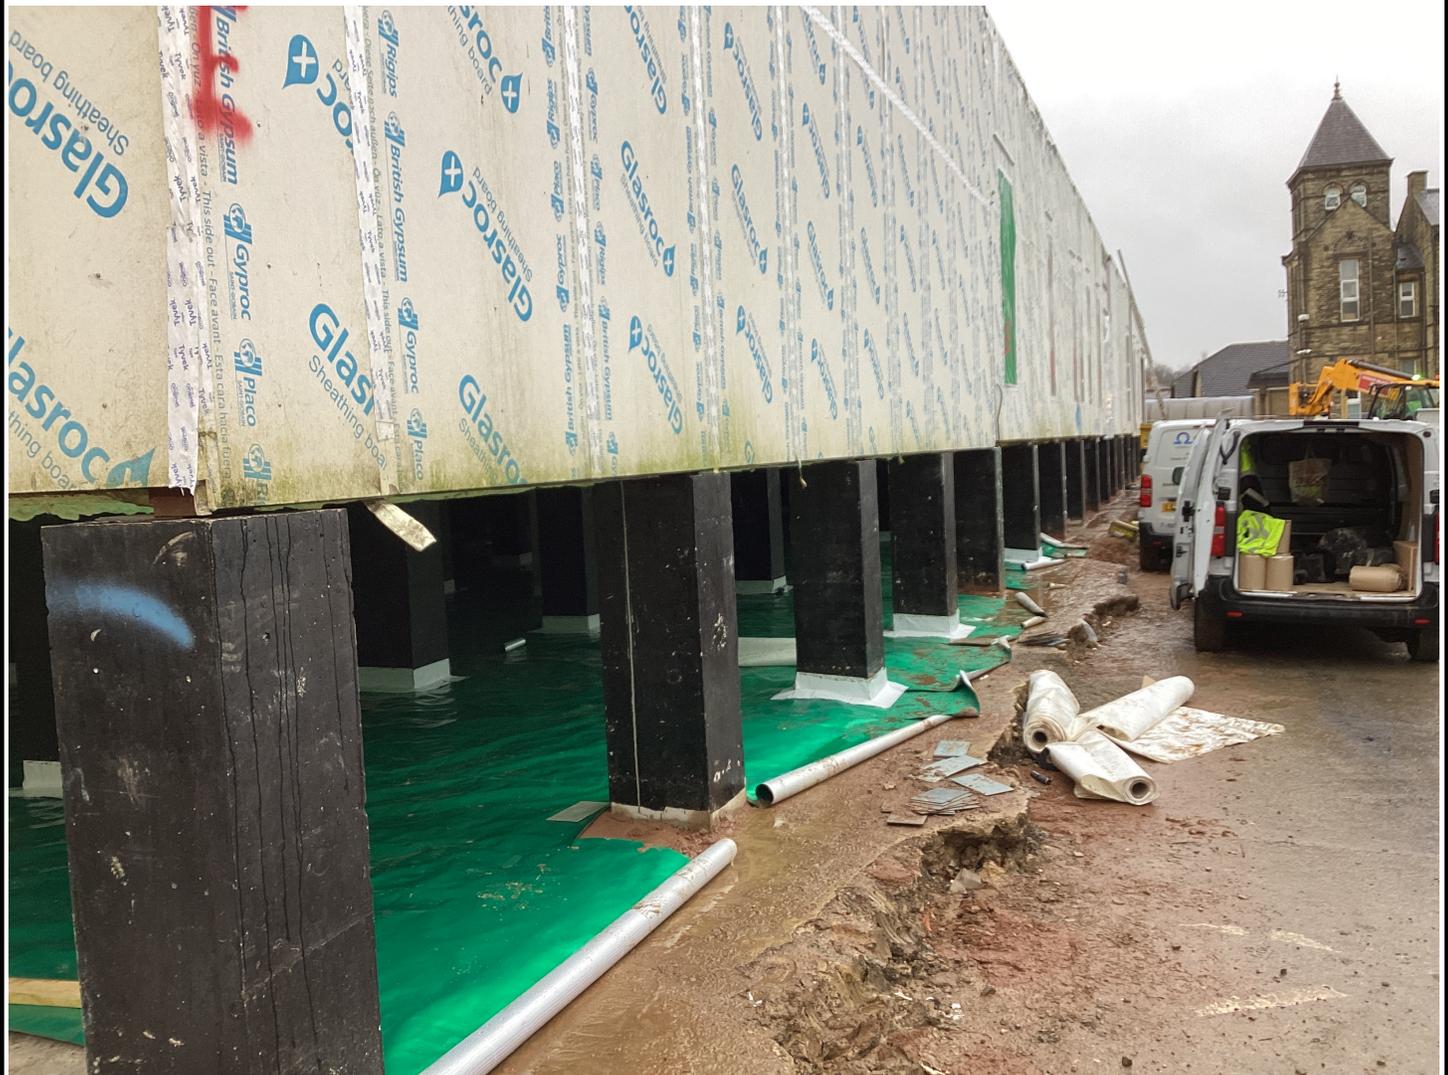
This is a overview of the proposed project where the Proctor GM Super Gas Barrier Membrane is in the process of being installed.

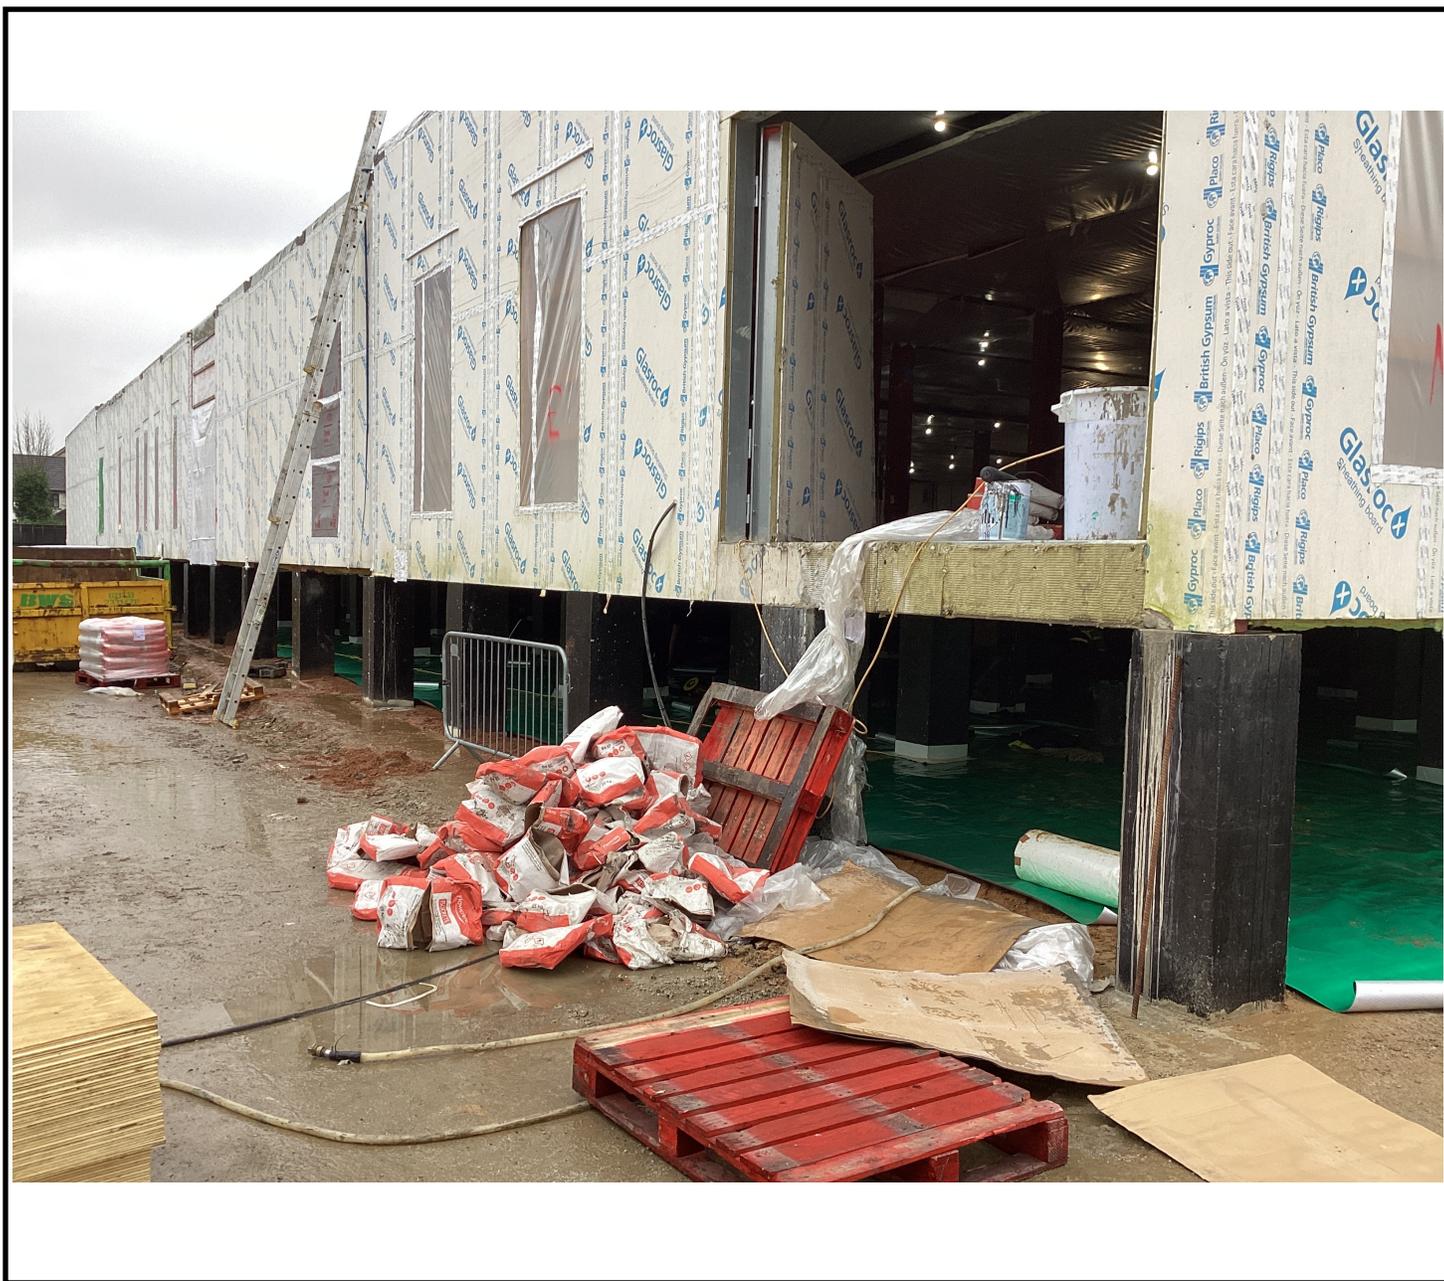
This is a overview of the proposed project where the Proctor GM Super Gas Barrier is in the process of being installed.

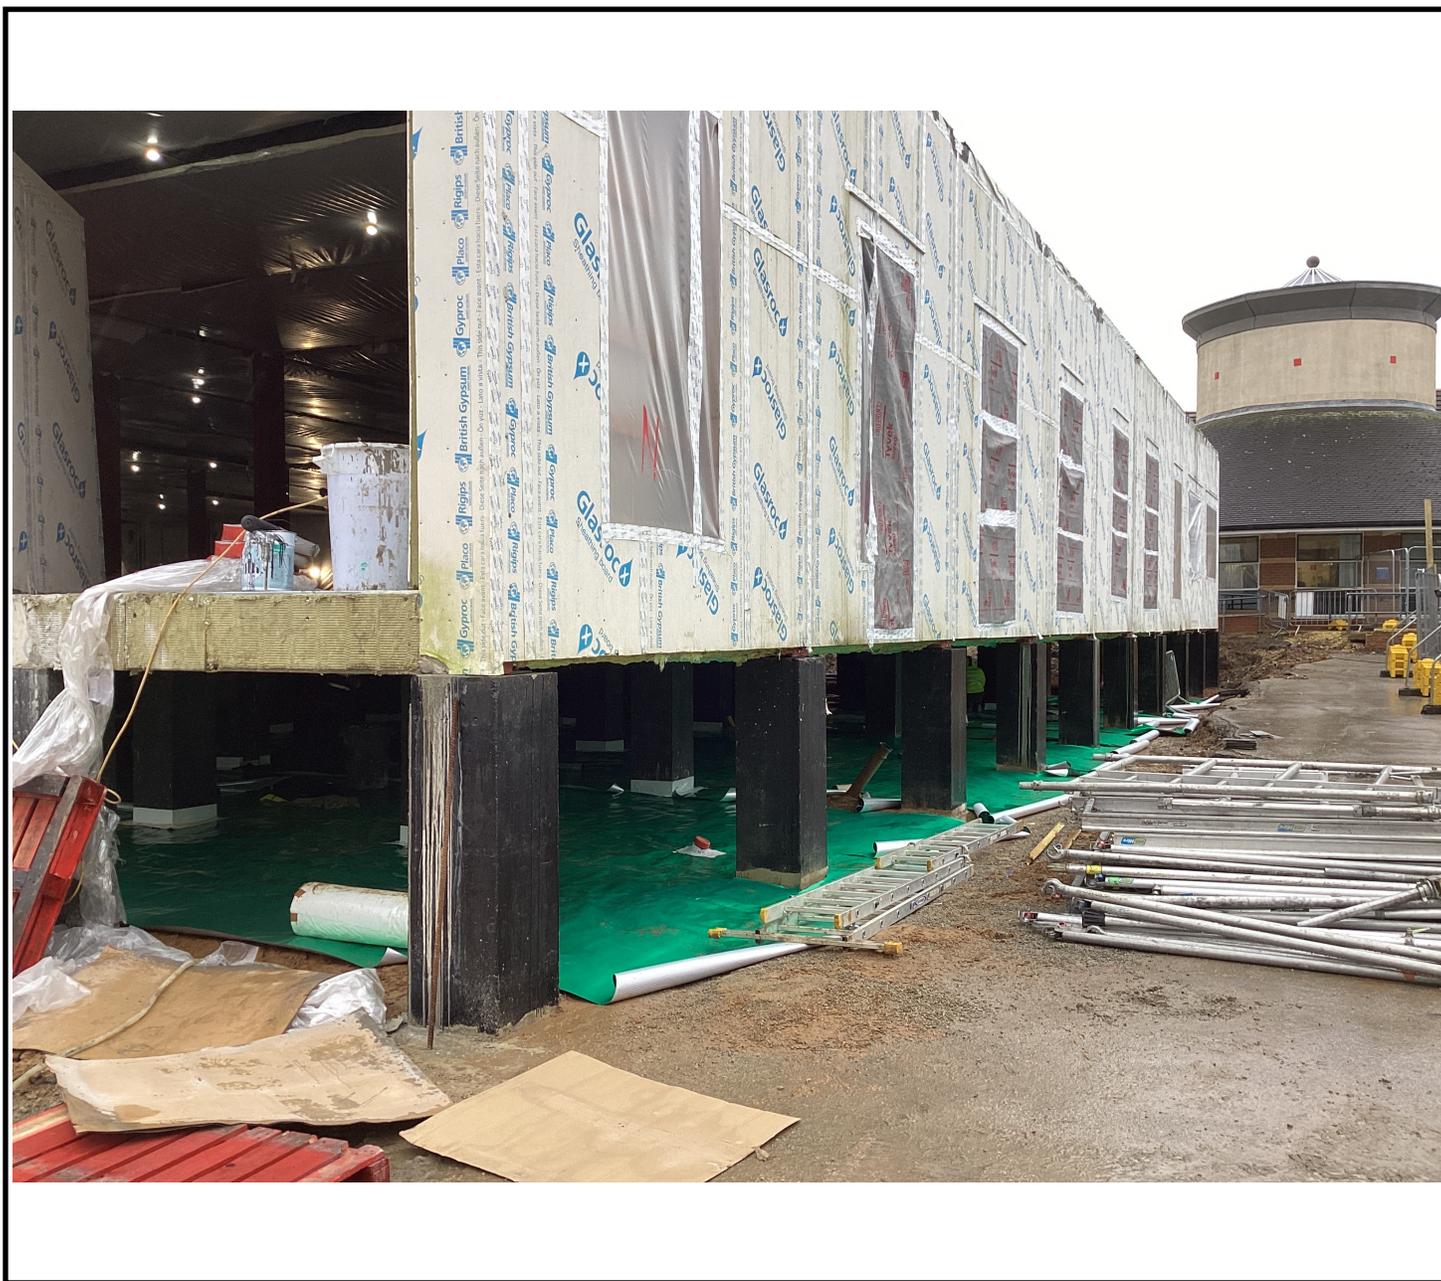
This is a overview of the proposed project where the Proctor GM Super Gas Barrier is in the process of being installed.

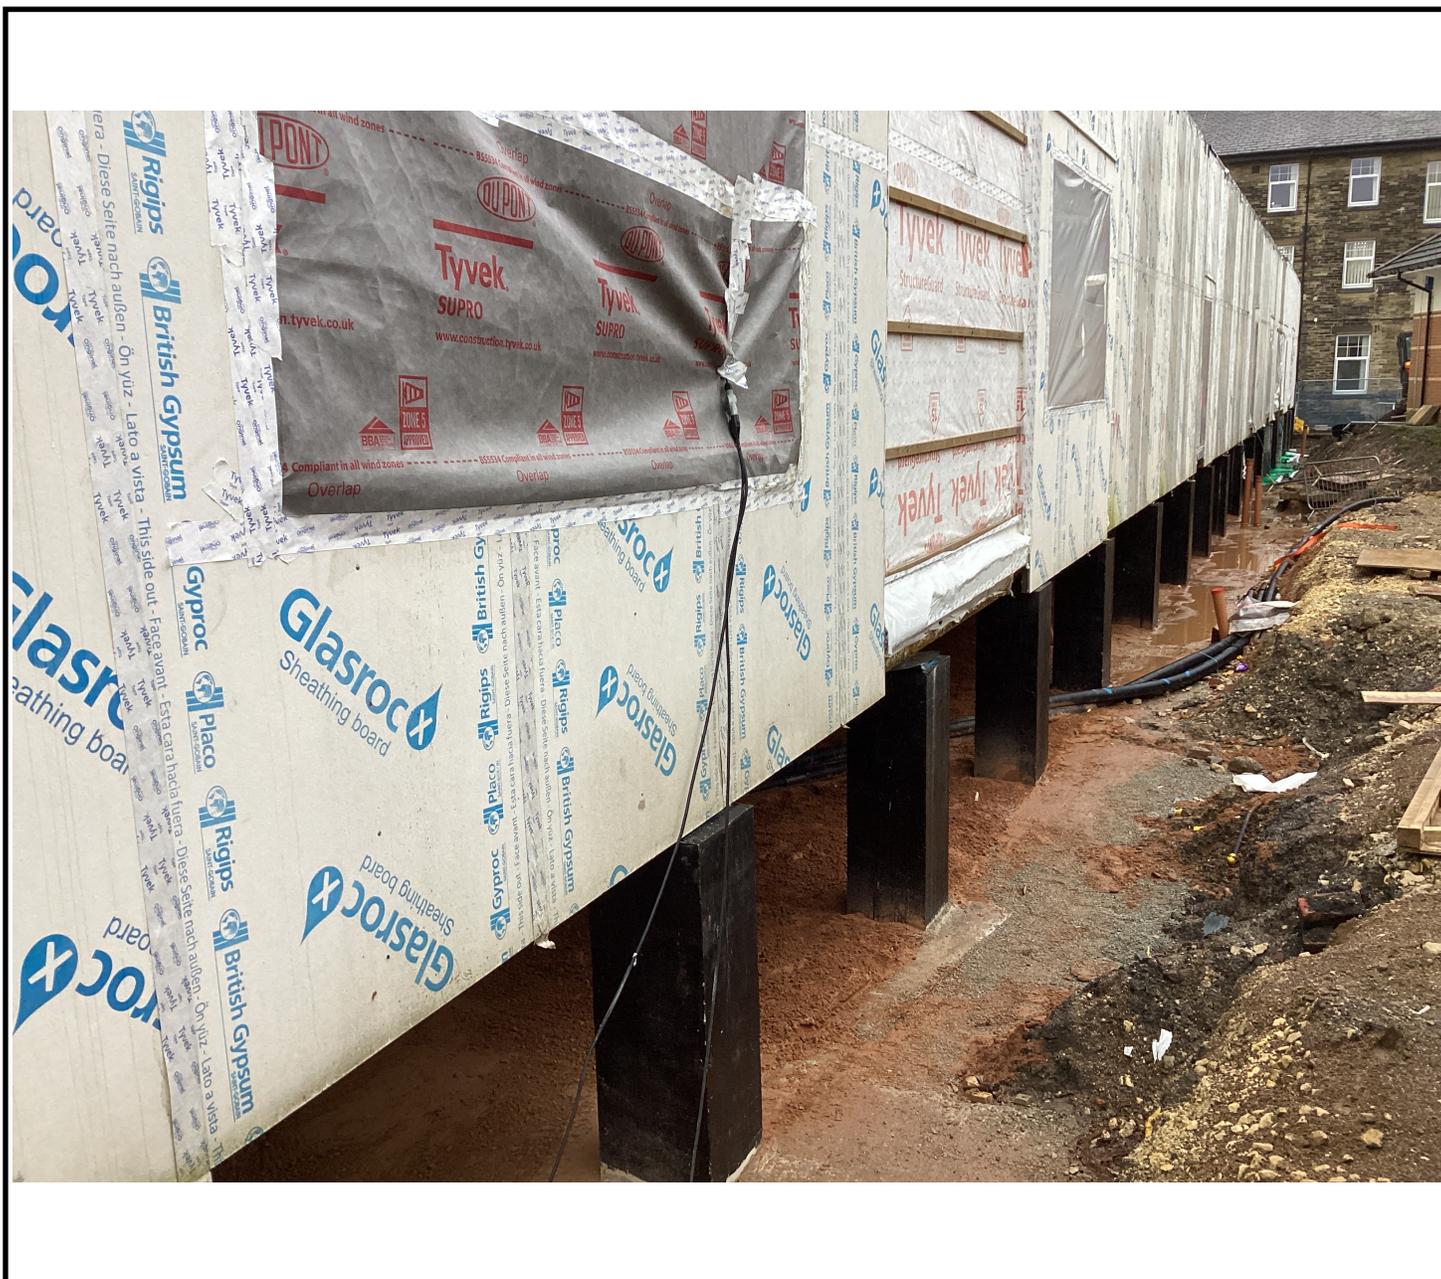
This is a overview of the proposed project where the Proctor GM Super Gas Barrier is in the process of being installed.

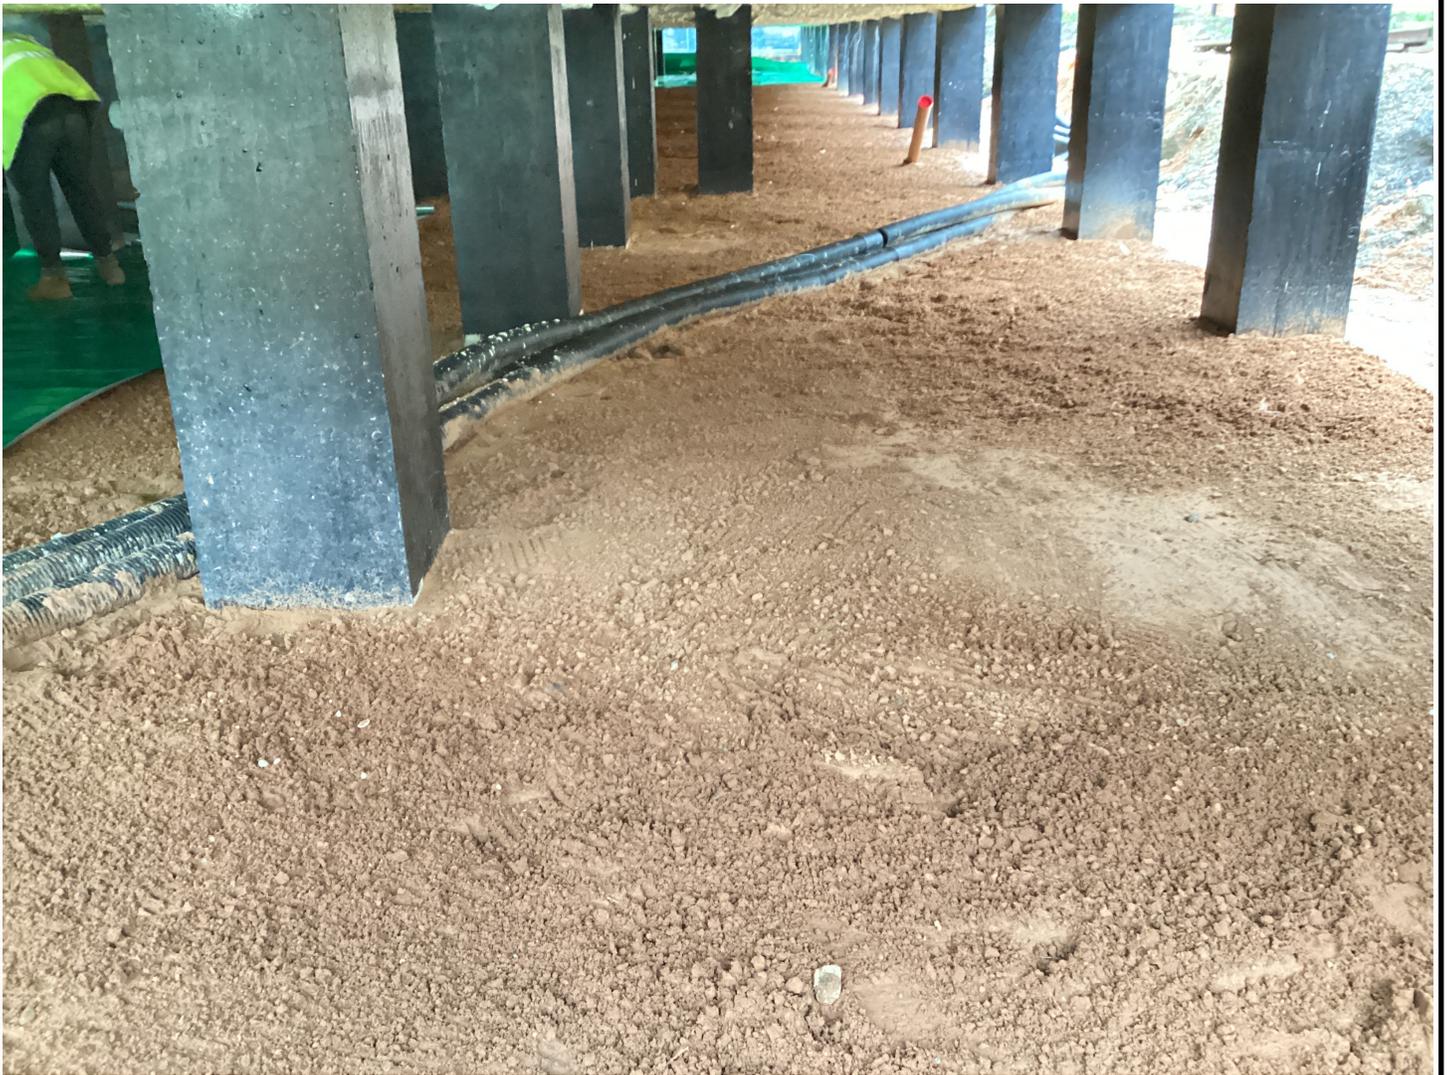
This is an overview of the proposed project where the initial sand blinding has been placed prior to the installation of the Proctor GM Super Gas Barrier.

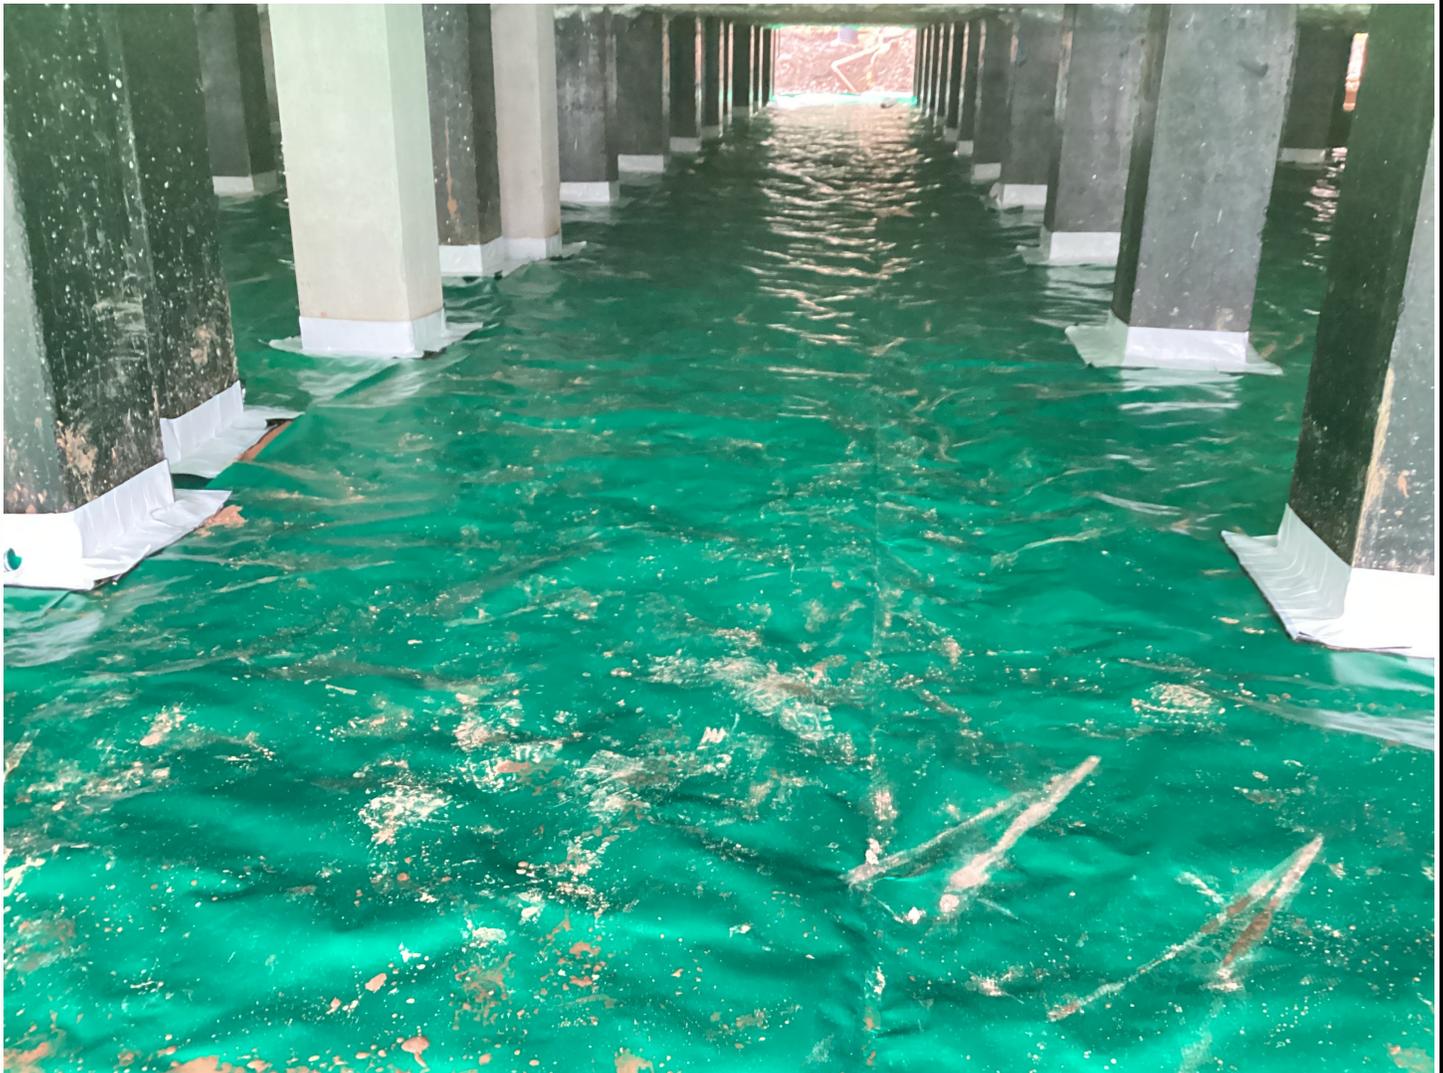
This is an overview of the proposed project where the Proctor GM Super Gas Barrier is in the process of being installed. Please note the restricted access where the average height is approximately 1.5 metres.

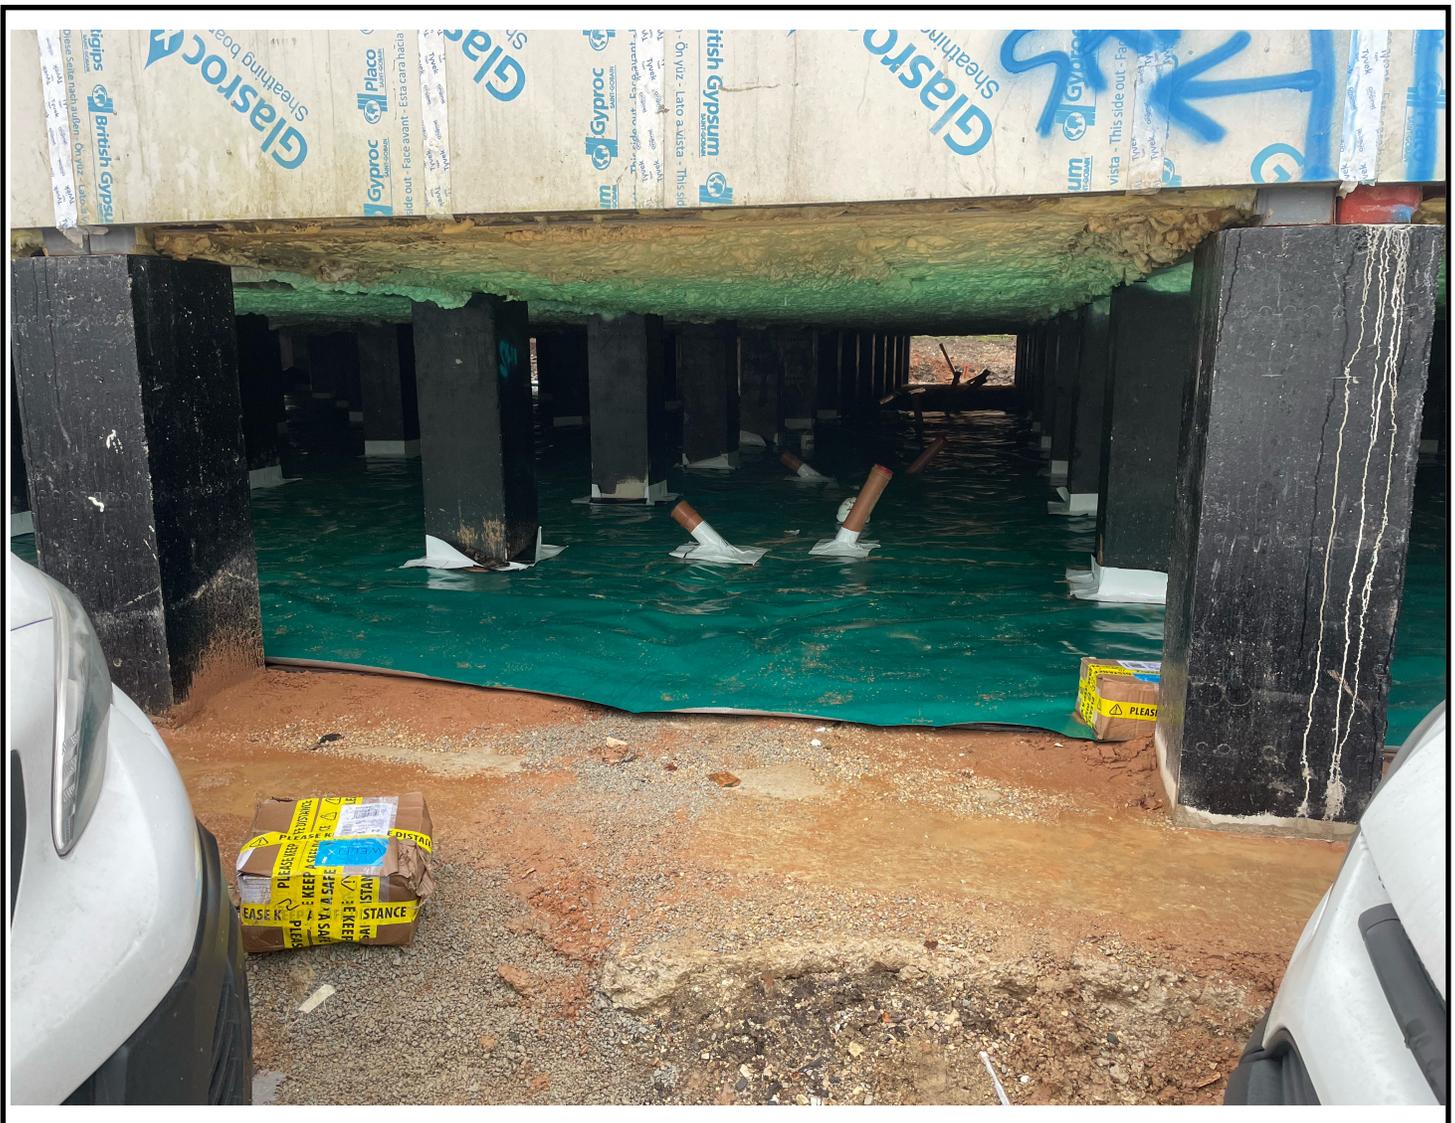
The whole of the verification is deemed restrictive as the average height is approximately 1.5 metres. The area also is relatively dark so additional lighting had to be used during the verification process.

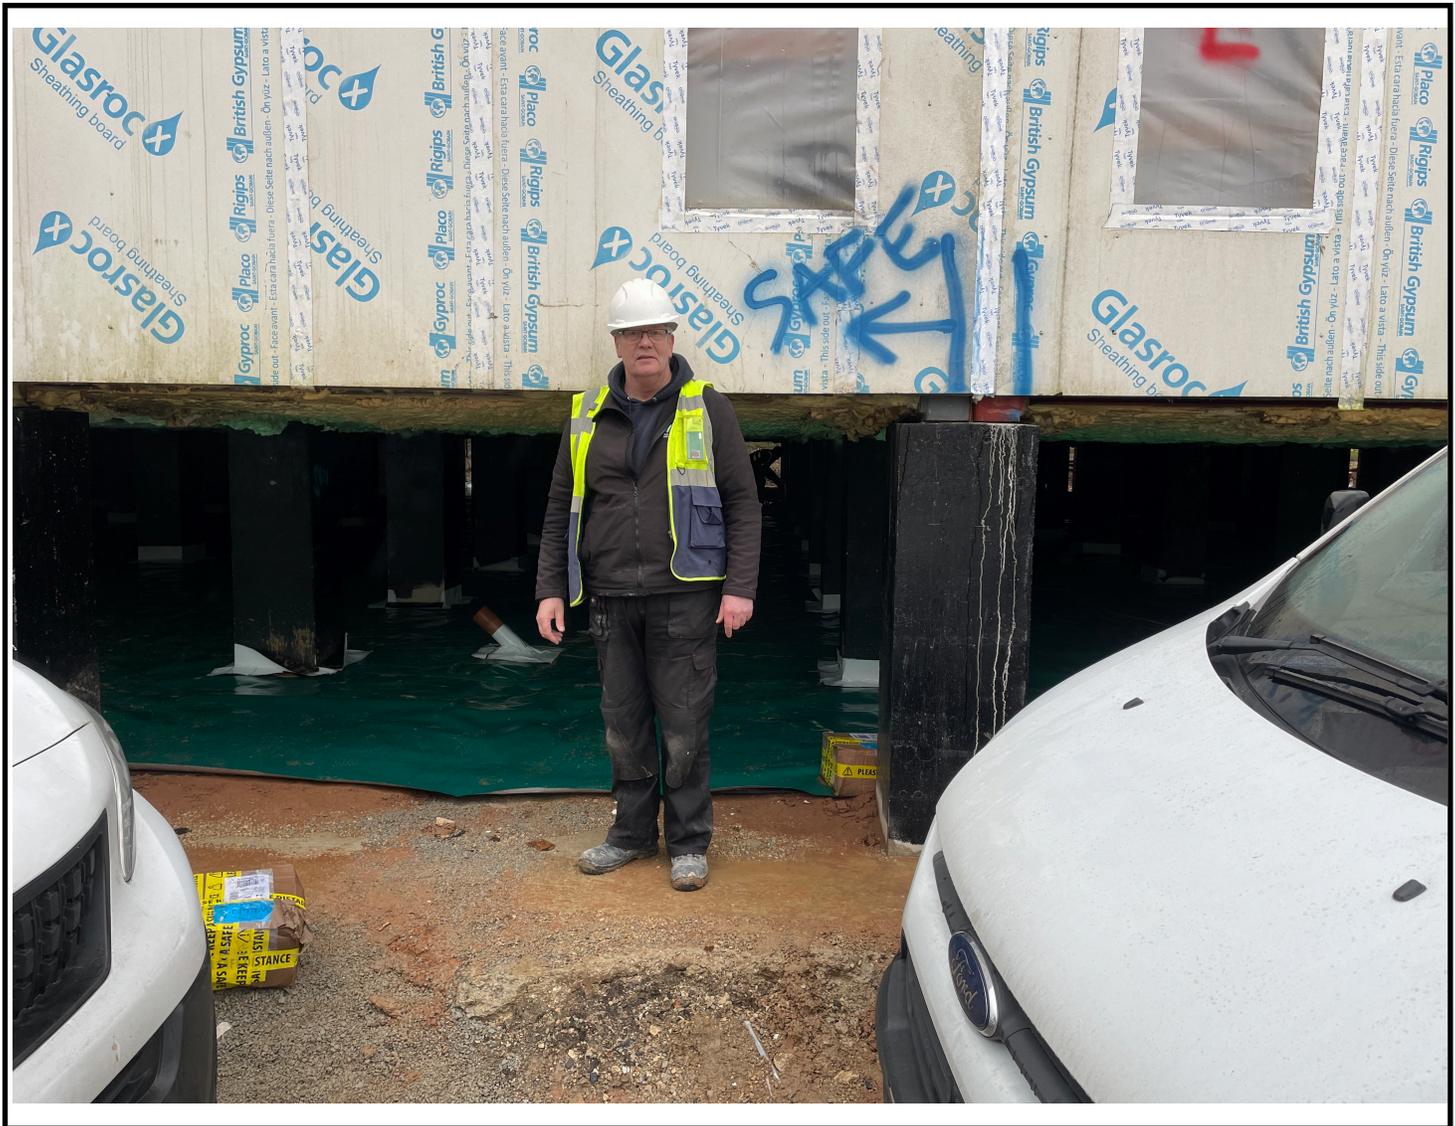
The whole of the verification is deemed restrictive as the average height is approximately 1.5 metres. The area also is relatively dark so additional lighting had to be used during the verification process.

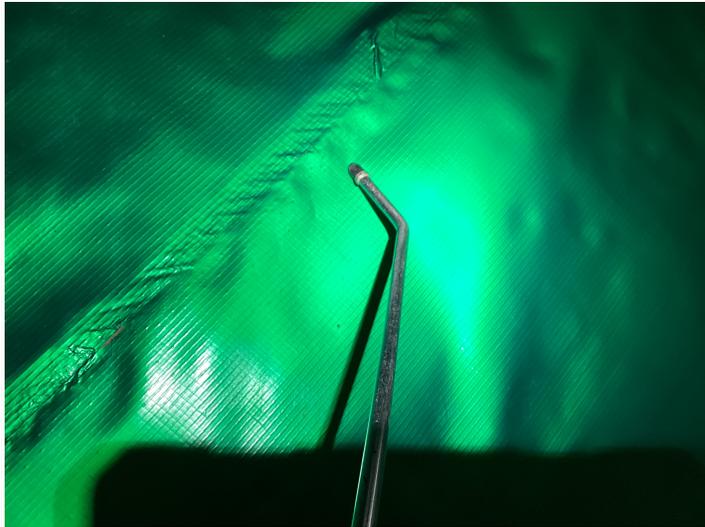
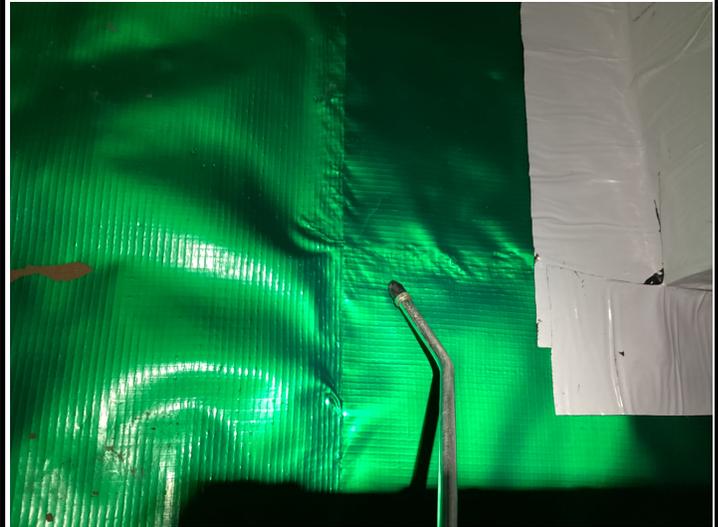
Proctor GM Super Gas Barrier Installation-Lap Joints

The Proctor GM Super Gas Barrier had been installed upon a layer of sand blinding which provided a suitable soft but protective and low risk substrate against potential punctures. The Proctor GM Super Gas Barrier sections had been welded together ensuring the minimum lap of 100mm was maintained throughout.

The images show the Air Lance Integrity Test being undertaken along the edges of the Proctor GM Super Gas Barrier lap joints. The area however was restrictive in height and therefore a head lamp was required to ensure all laps could be identified as well as any damage to the Proctor GM Super Gas Barrier.

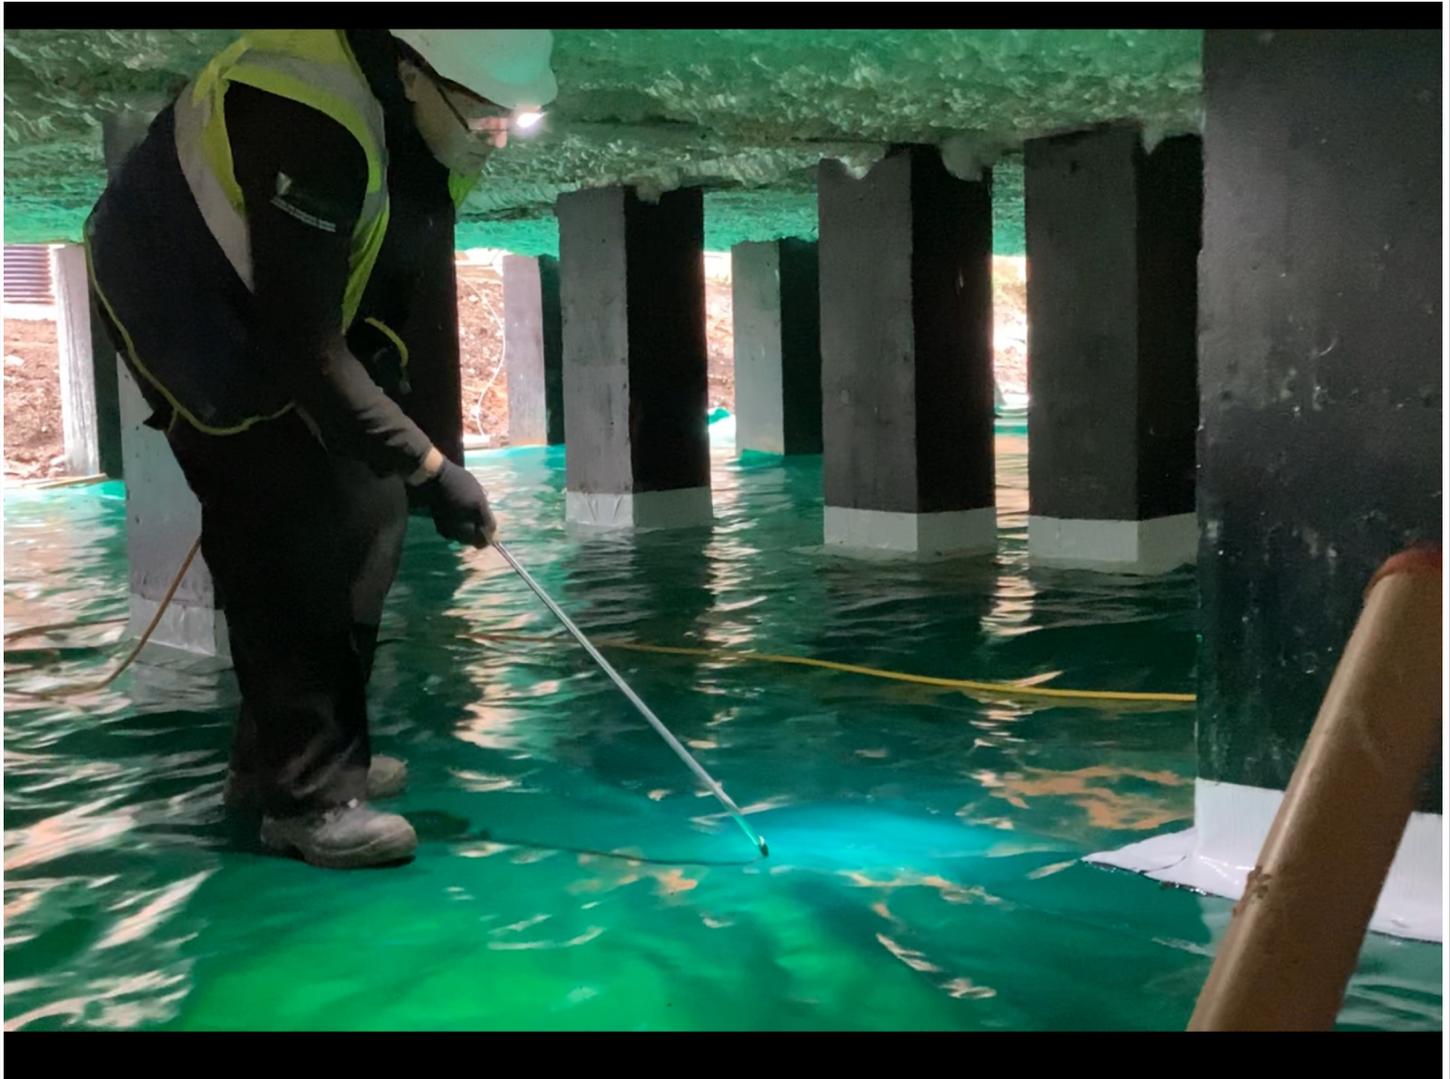
The overview image shows the Air Lance Integrity Test being undertaken along one of the various Proctor GM Super Gas Barrier lap joints. The test involved directing compressed air set at 50psi along the edges of each and every available lap joint at no more than 51mm away. There were no mis-welded lap joints identified.

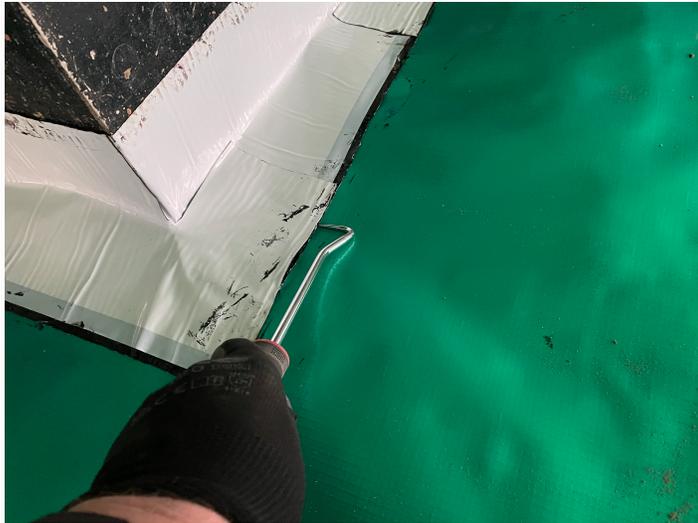
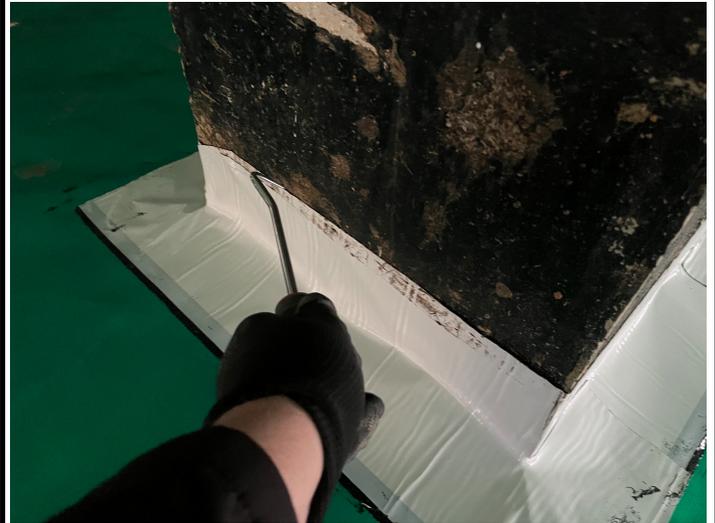
Concrete Column Detailing

The pipe penetrations were all sealed using a variety of Proctor SAGM strips where upon the initial inspection, had been fully bonded to both the column itself and the Proctor GM Super Gas Barrier. The two images show the Mechanical Point Stress Test being undertaken along the edges of

the Proctor SAGM and confirmed there were no potential capillary leaks identified throughout the verification process. It was also noted that there was minimal creasing across the extent of the completed detailing and therefore no potential capillary leaks throughout.

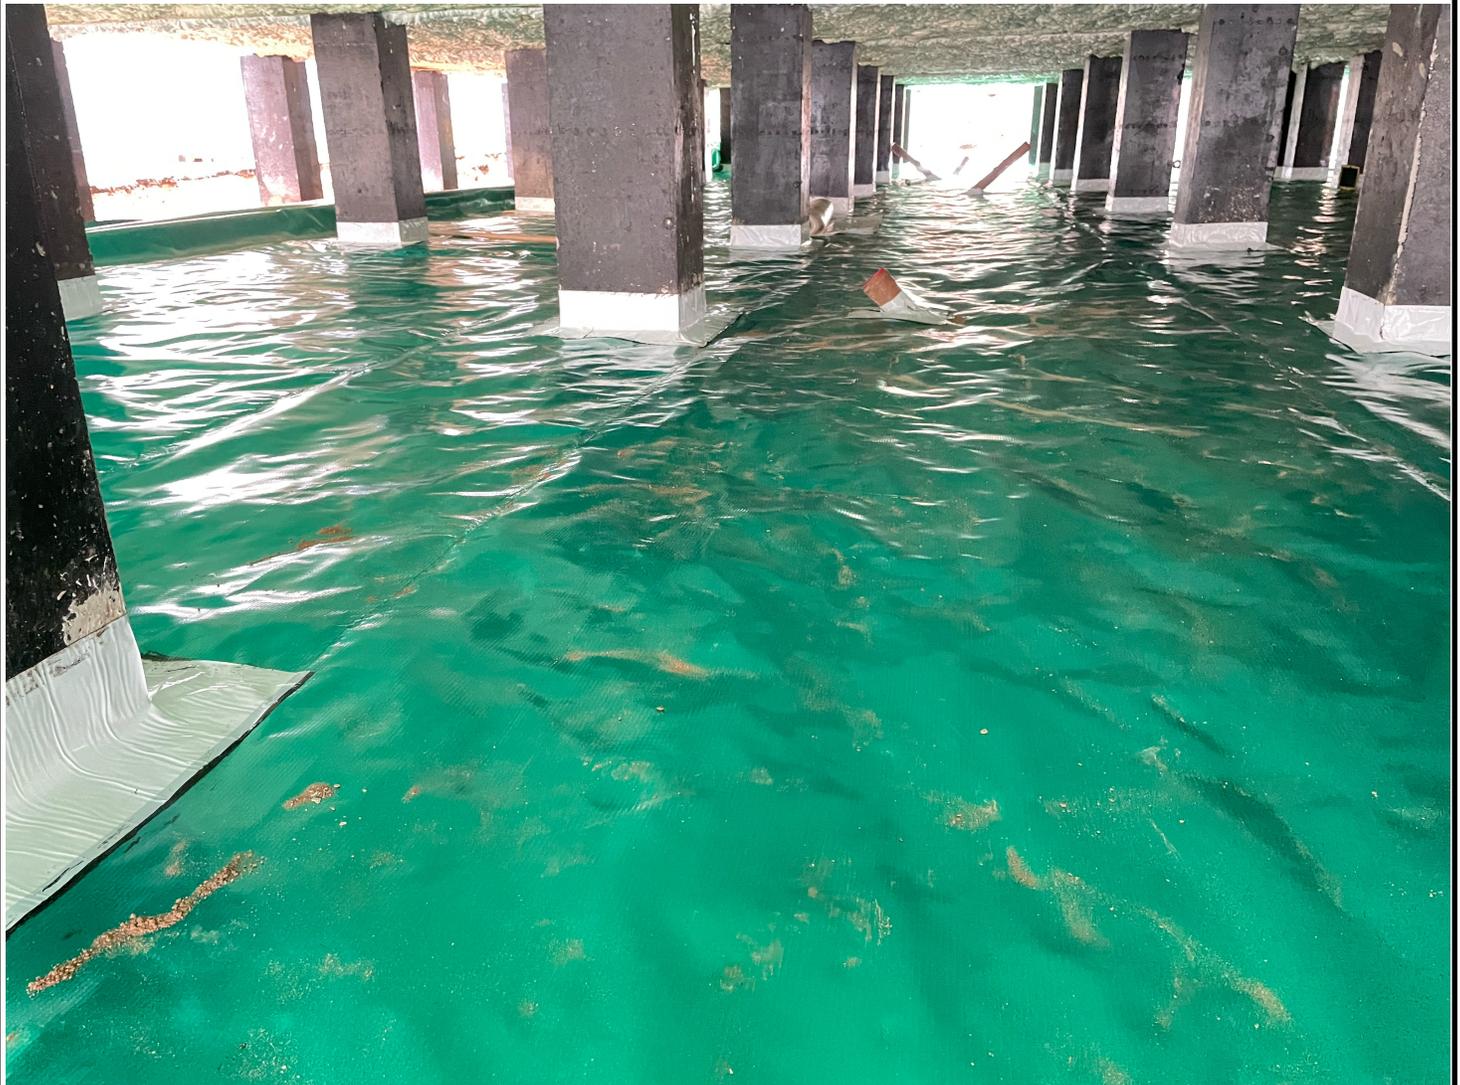
The overview image shows the various column penetrations which were all subjected to both a visual and physical inspection. It was evident that heat was used to activate the bitumen backing and combined with pressure enabled a secure bond with both the column penetration and the Proctor GM Super Gas Barrier identifying no issues.

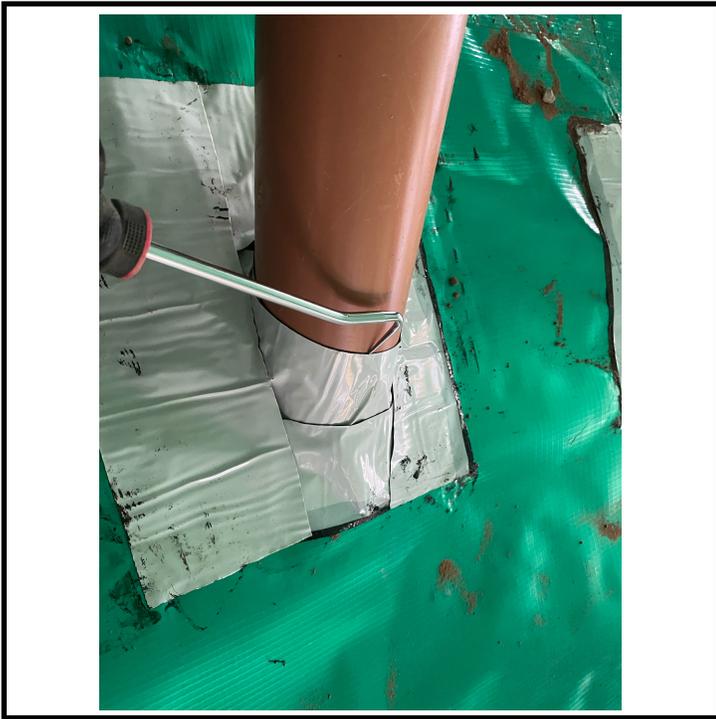
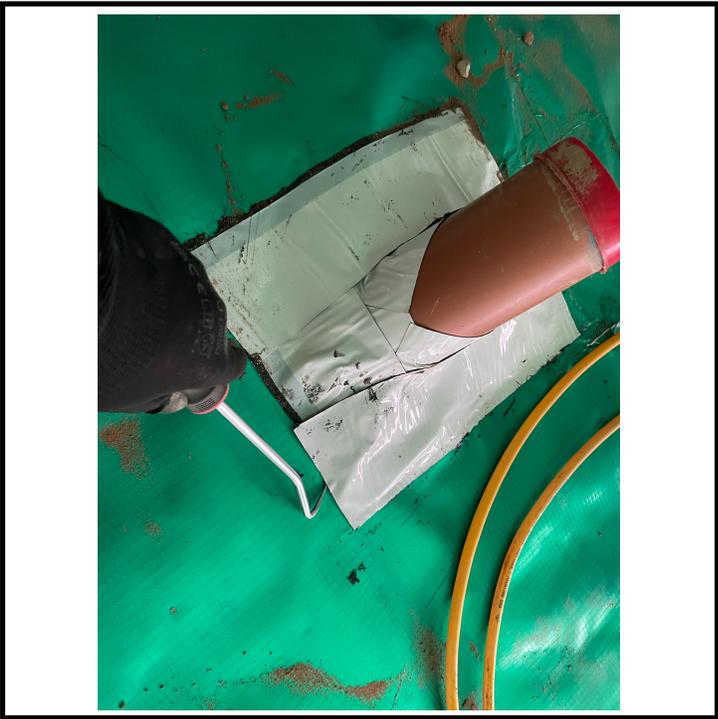
Pipe Penetration Detailing

NOTES:
The various pipe penetrations had all been initially formed around using sections of Proctor GM Super Gas Barrier. The pipes were then reinforced and sealed using strips of Proctor SAGM. The initial inspection included checking generally for any loose Proctor SAGM where it

NOTES:
was noted that all areas of installation had been subjected to both heat and pressure so as to activate the bitumen backing improving the bond with the Proctor GM Super Gas Barrier. The bond was confirmed via the Mechanical Point Stress Test as seen in the images.
