**Structural Appraisal of Buildings B, C, D & G,
Turnbridge Mills, Quay Street,
Huddersfield, HD1 6QT**

RCE6909

Rev	Date	Description	By
-	30-01-25	Initial issue	PR
A	13-03-25	<i>`Comment on possible proposed development of Buildings B & D` section added</i>	PR
B	17-03-25	Minor amendments	PR
C	16-04-25	Minor amendments	PR

21st January 2025

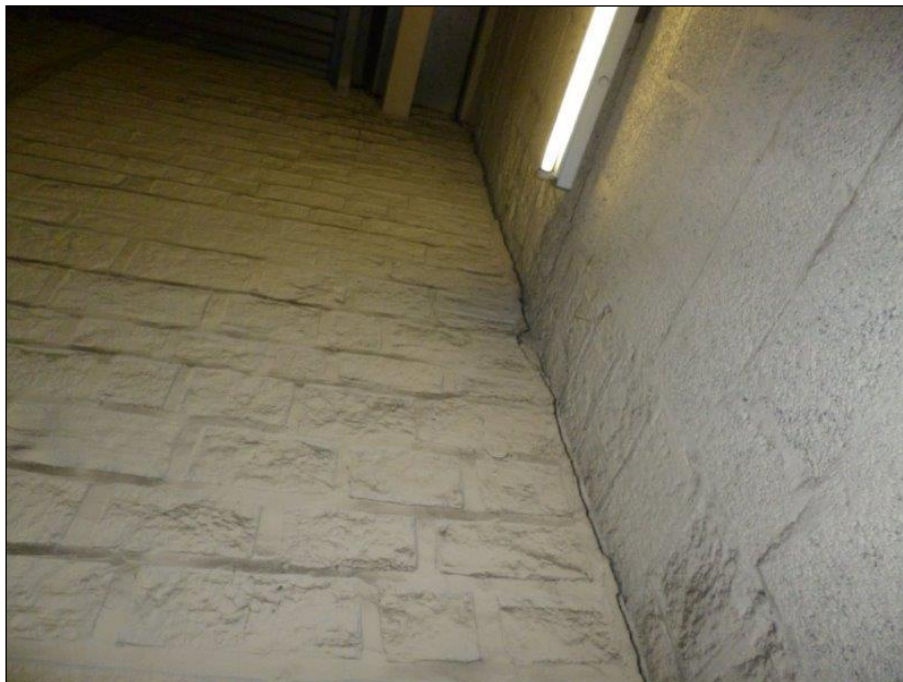
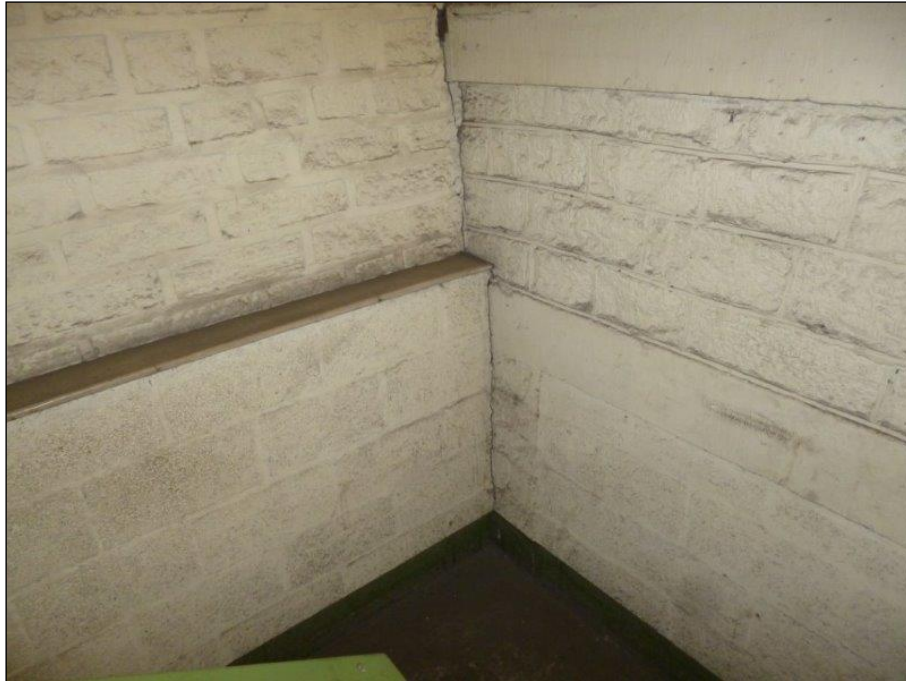
- **Staircase situated between buildings A and B not tied in**

There is a large vertical crack to the interface of the staircase and adjacent mill which demonstrates that the staircase masonry is not tied in. The crack should be pointed using appropriate mortar.

Condition B

The crack should be observed during an annual maintenance programme, and should it appear to change, expert advice should be sought.

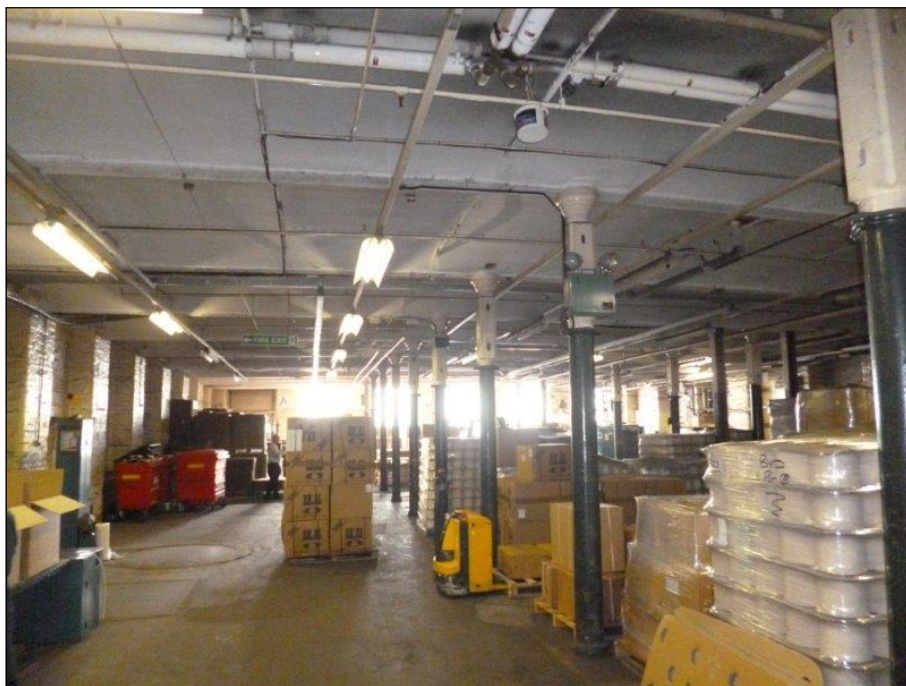
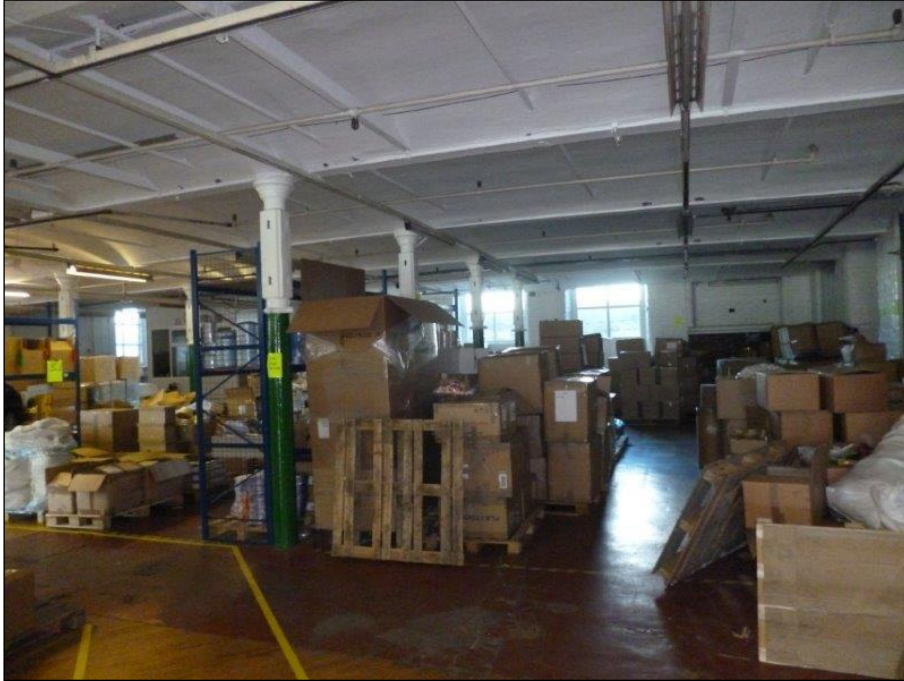
- **Sloping floors**

The outer bays of the mill floor can be seen to be sloping downwards to the perimeter walls (the centre bay is approximately horizontal). The out-of-level floors appears to be a longstanding differential settlement issue where foundations are probably onto different bearing strata (possibly due to the part basement).

Condition A

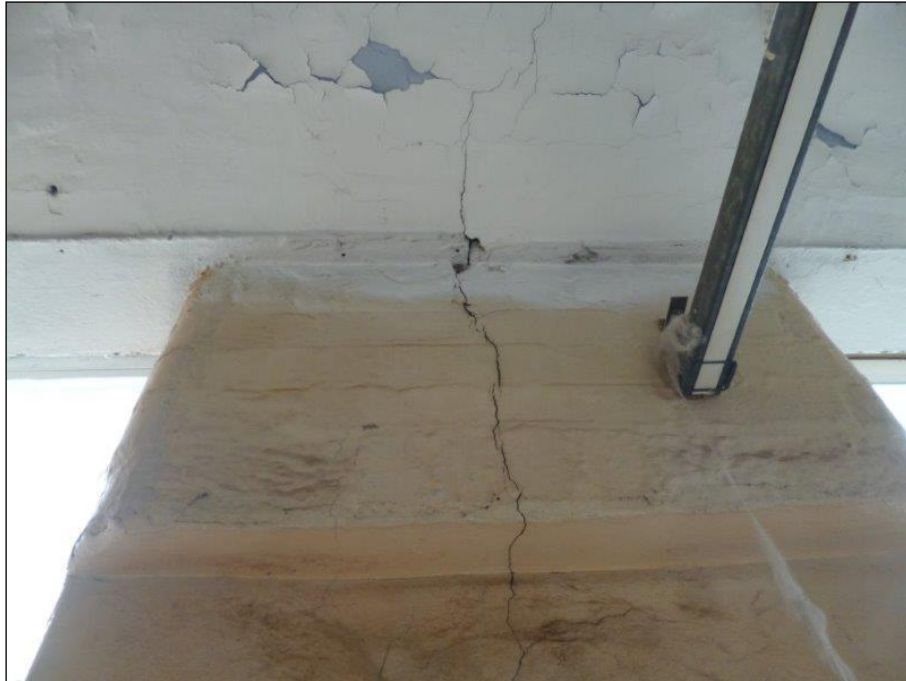
Photograph 6

- **Cracking to east elevation**

To the 2nd floor there is a vertical crack to the centre of one of the masonry piers. The crack is probably due to corrosion of the end of the cast iron beam, but this should be ratified by further inspections.

Condition C

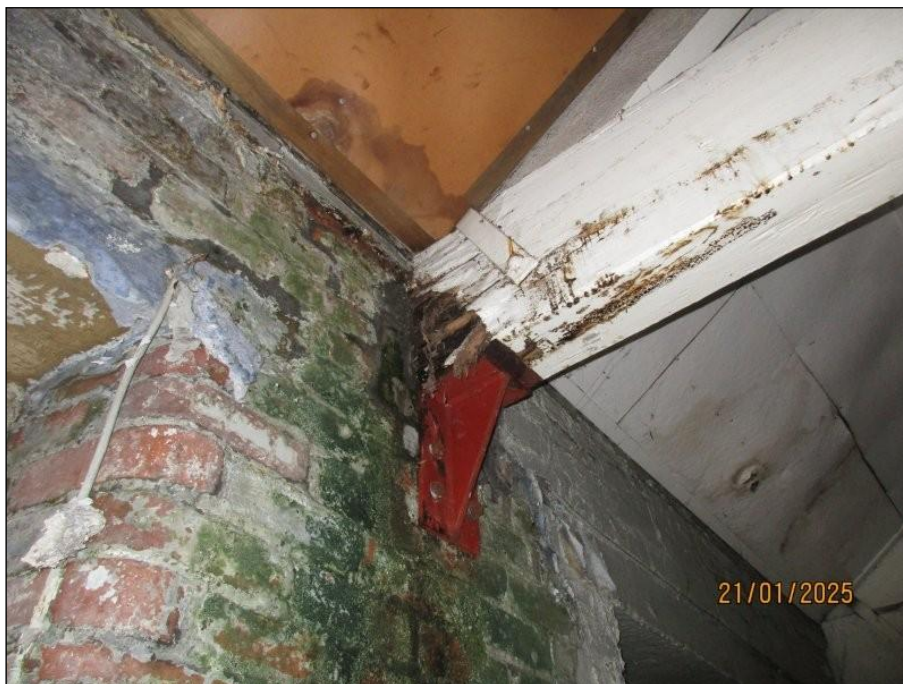
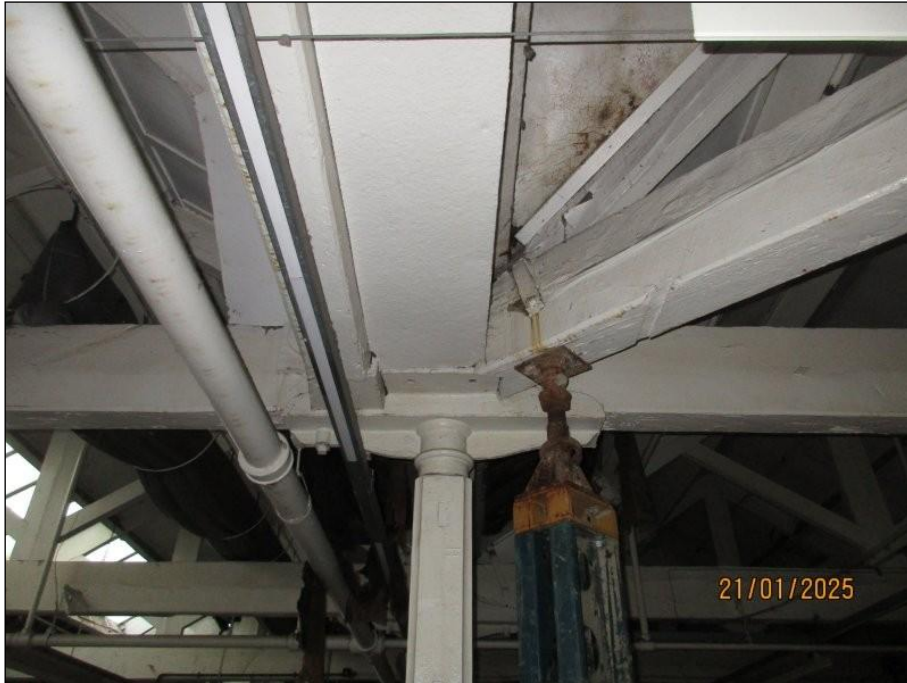
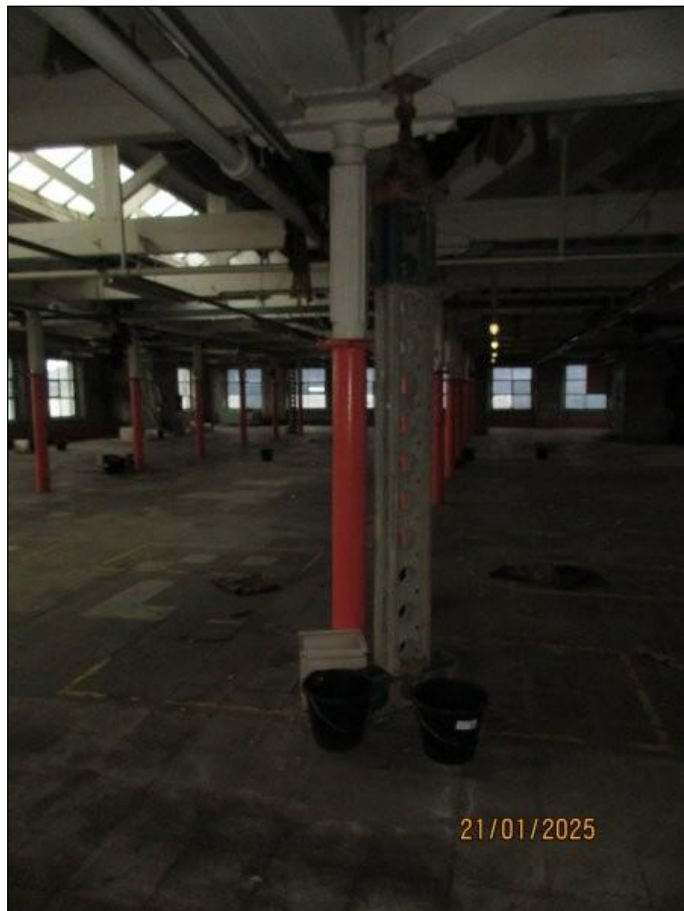
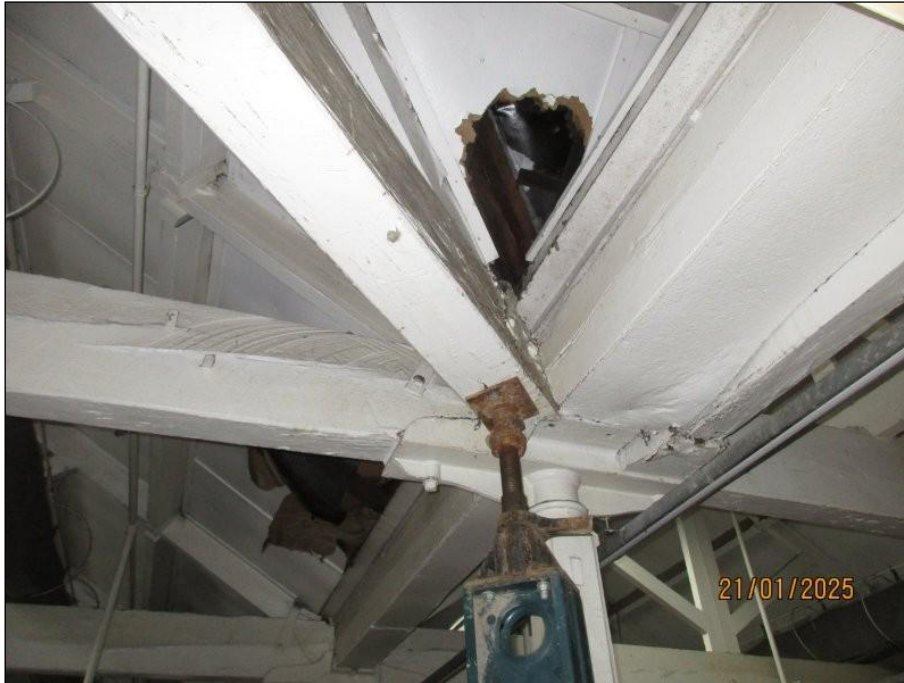
- **Roof structure**

Several repairs have been historically made to the roof. It appears that the gutters have probably not been well maintained, and that water ingress has caused the truss ends to rot. Some of these trusses are now in danger of collapse. Some of the truss ends are currently supported by props.

Condition D

It is recommended that a full timber and damp survey is undertaken by a suitably qualified and experienced specialist to ensure that the extent of the rot is treated. It may be necessary to incorporate additional steel shoes into the structure.

The rainwater goods should be maintained as part of a regular maintenance programme.

Major works to the roof are required. To properly repair the roof, it is estimated that approximately 50% of the roof is removed and replaced.

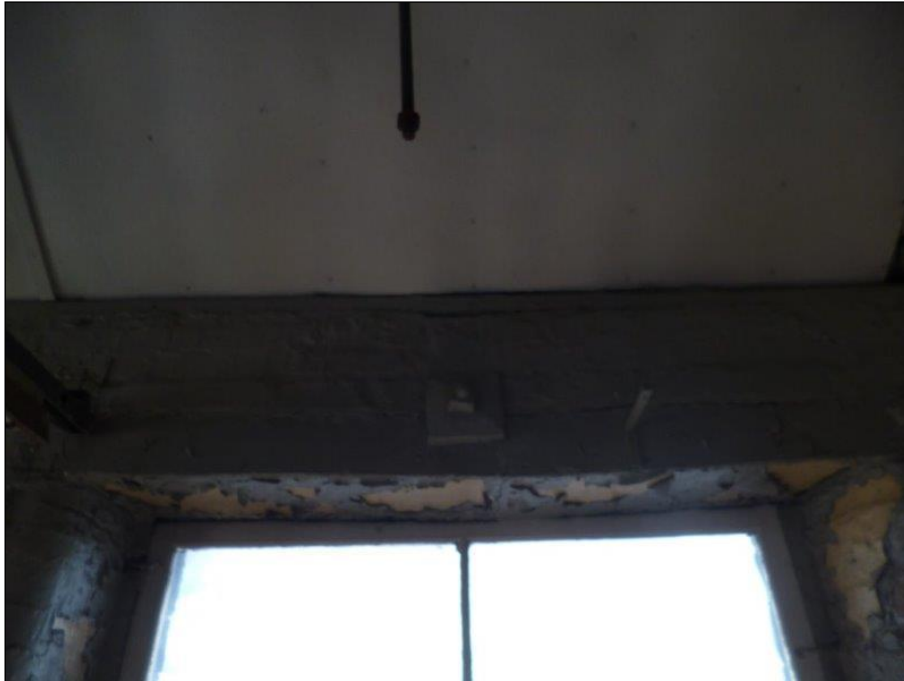
Photograph 14

- **Cracked lintel**

To the fifth floor, there is a cracked lintel. It is imperative that should the window be changed that the lintel is changed prior.

Condition B

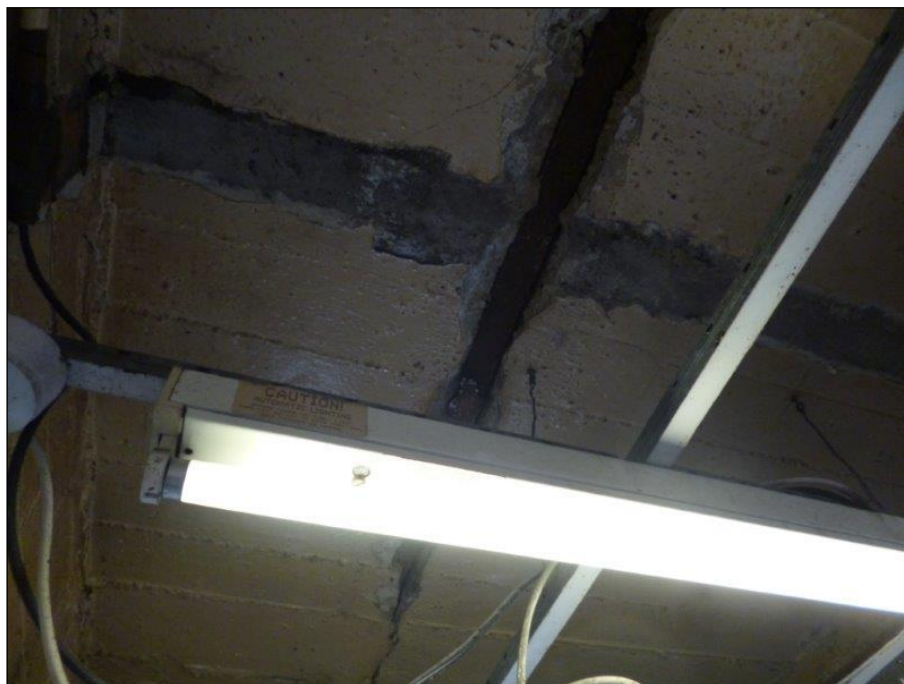
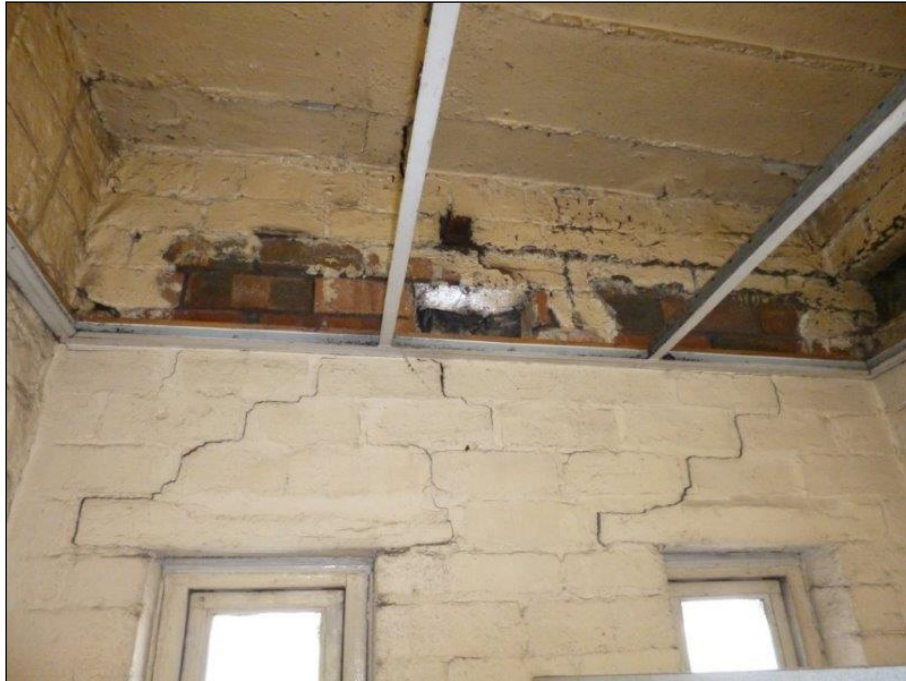
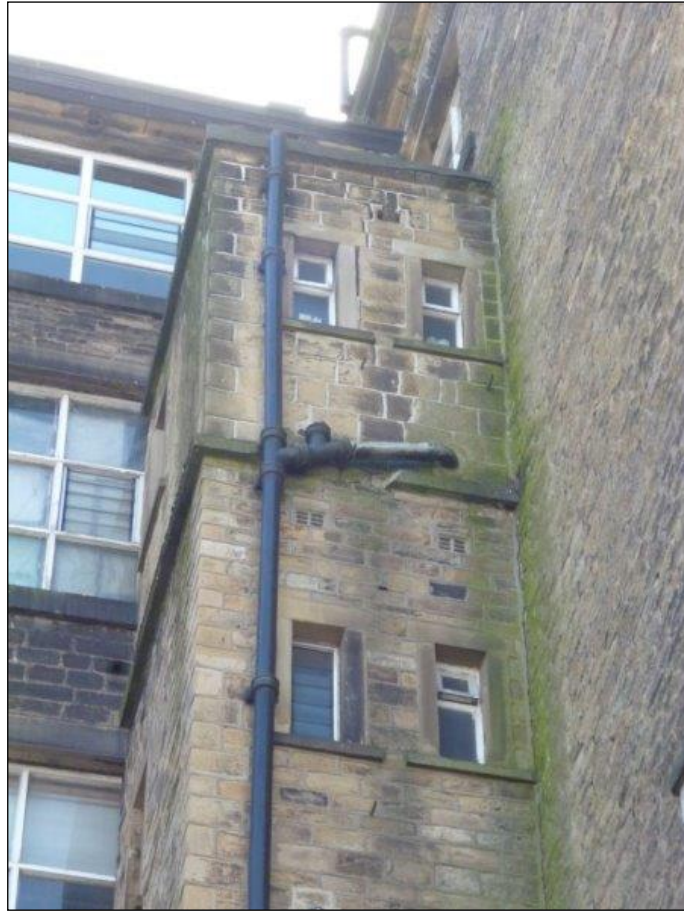
- **West elevation toilet blocks**

The west elevation toilet blocks are in a poor state of structural repair. It appears that water ingress has occurred through the roof and has affected the floors below causing the steel filler beams to corrode. The masonry walls are not tied into the main structure.

Due to the water ingress, the timber lintels appear to be deteriorating. The lintels should be replaced in due course using precast concrete lintels.

Condition B

Provided the water ingress issues have been resolved and the masonry is tied back to the main structure, the main structure should be acceptable.

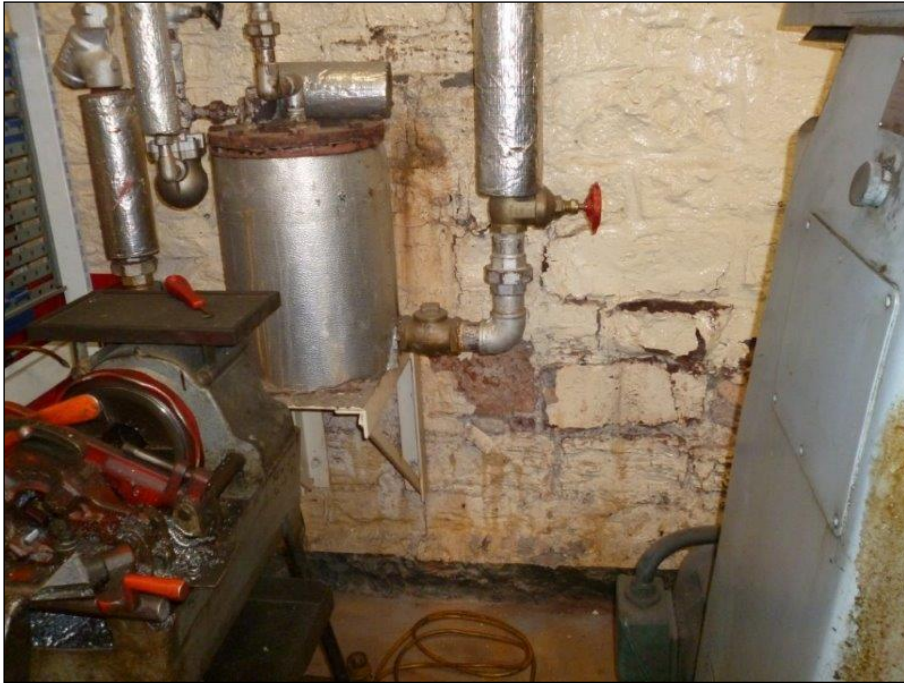
Photograph 35

- **Spalling of masonry**

At low level there are areas of masonry which have spalled. Whether the spalling masonry is due to rising damp, steam or a combination, it is unknown. It is recommended that these areas are rendered in a suitable material to ensure the longevity of the structure.

Condition B

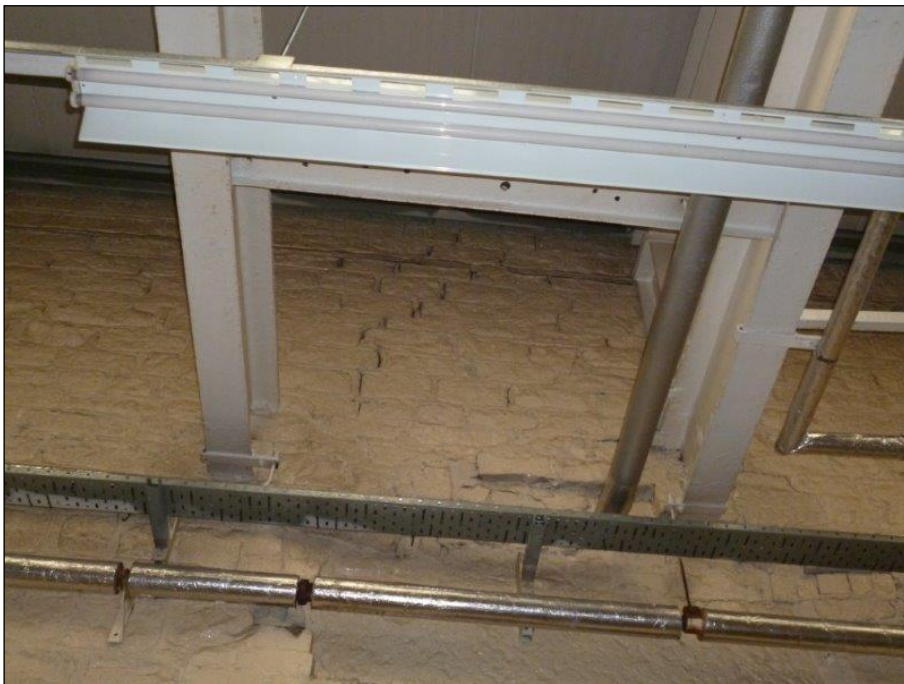
Photograph 36

- **Bulging masonry to adjacent building D**

The masonry wall between buildings C and D has a bulge in the upper sections.

Condition B

It is suggested that the masonry bulge is visually monitored as part of a regular maintenance programme, and should it appear to change, expert advice should be sought.

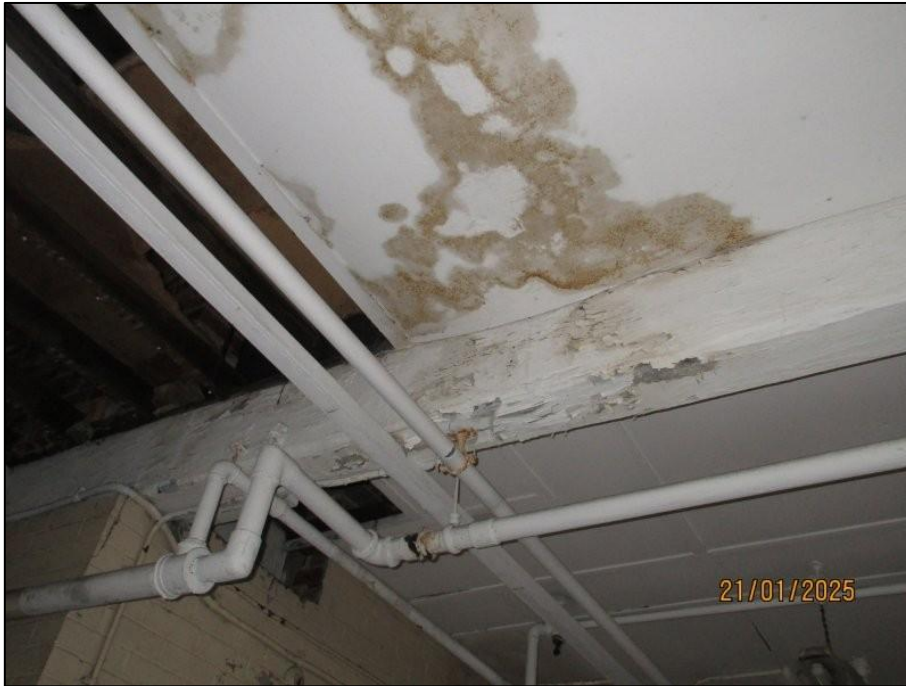
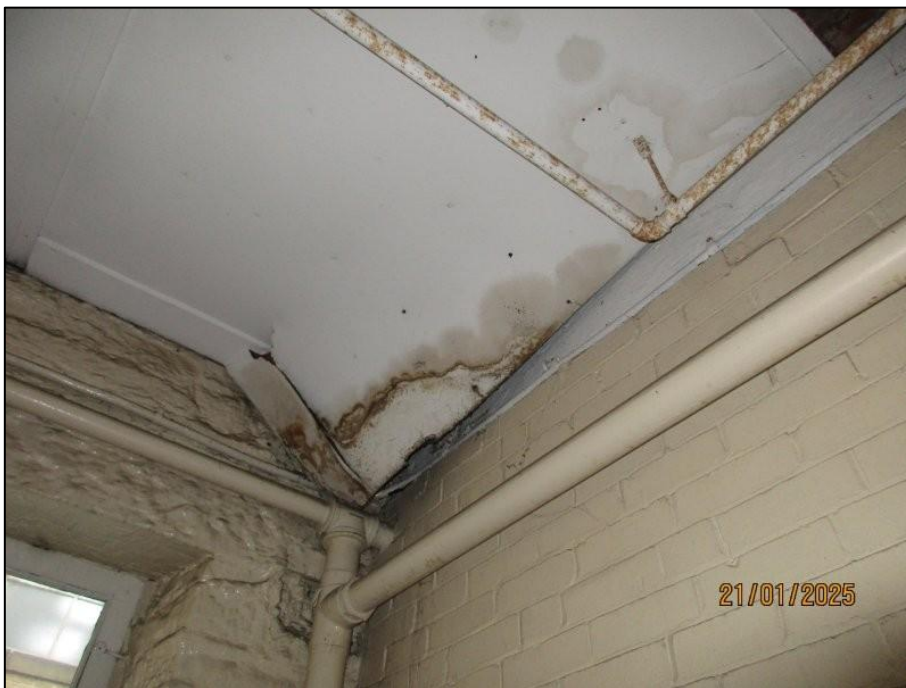
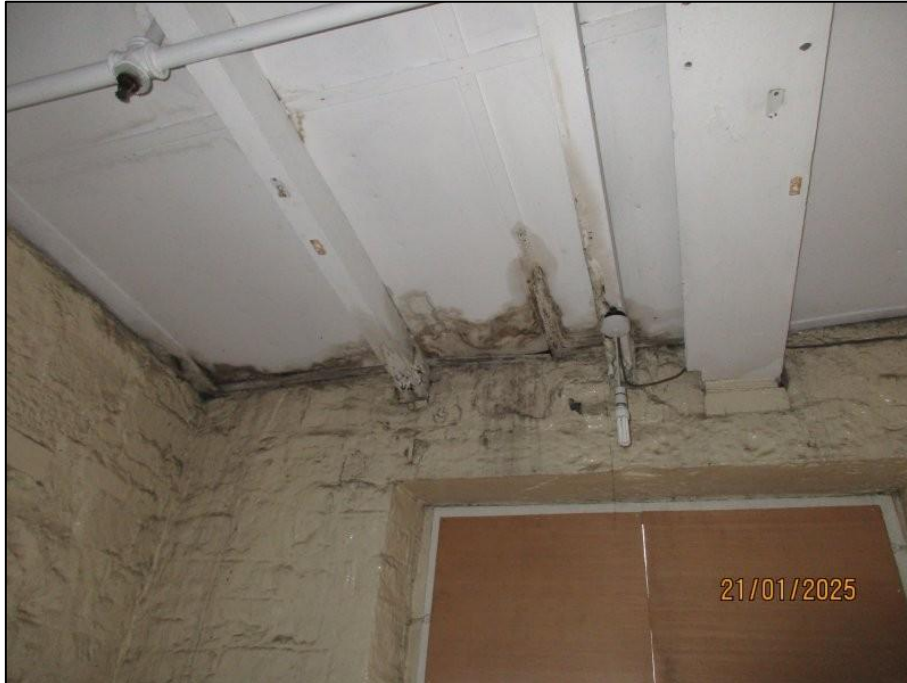
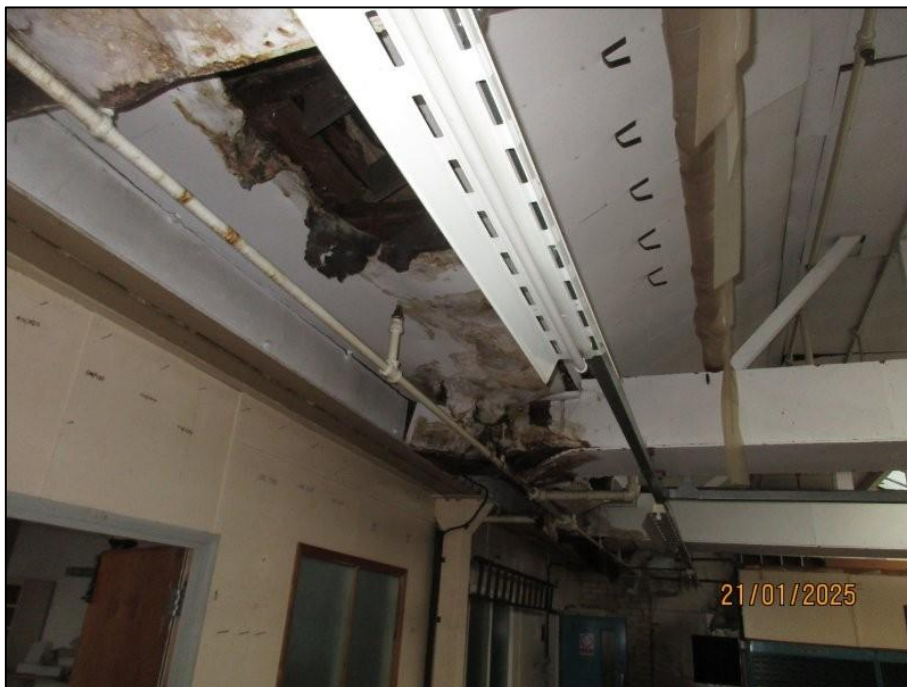
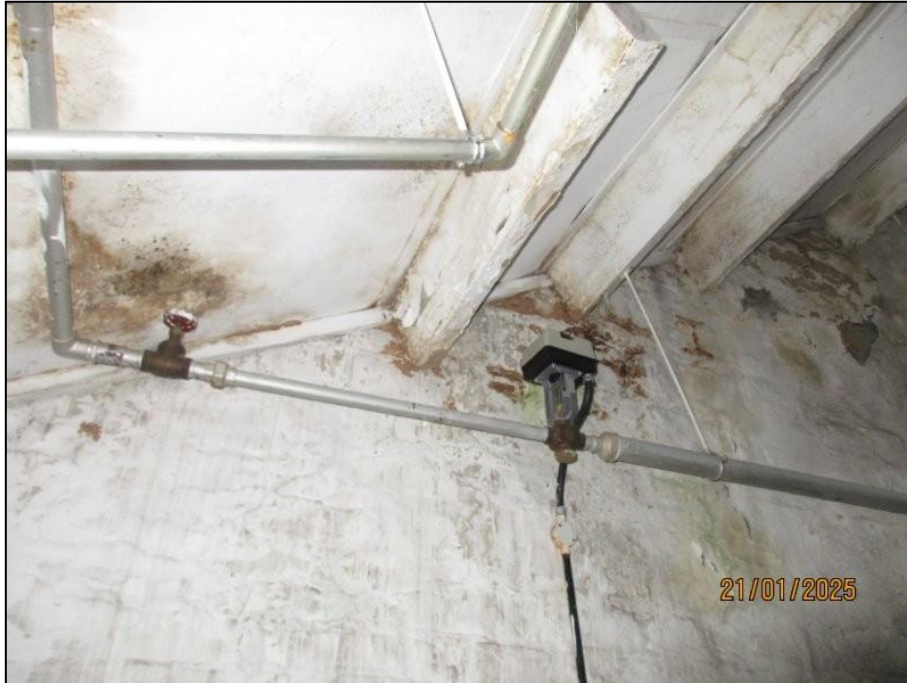
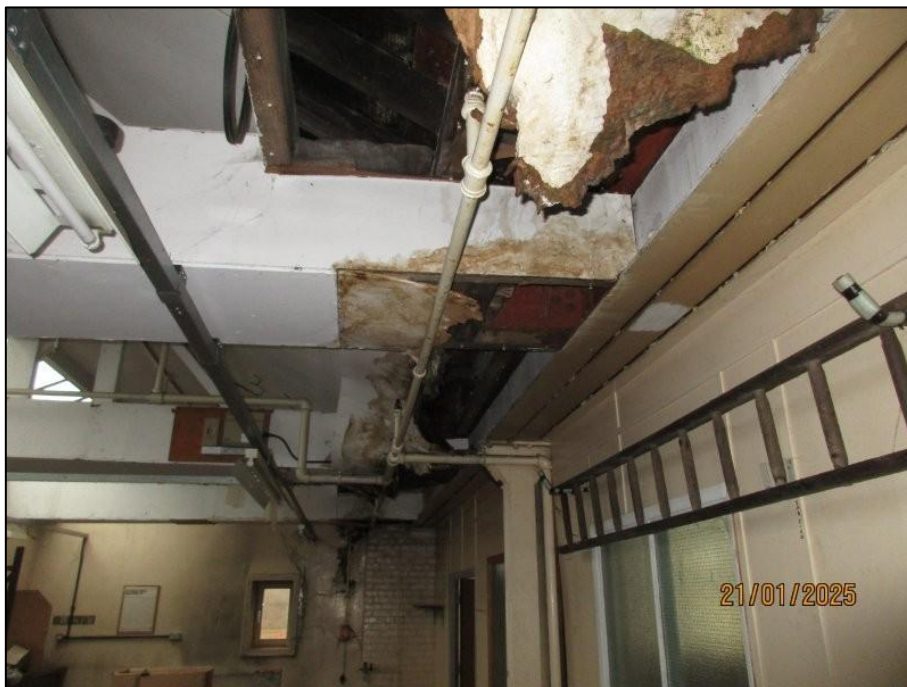
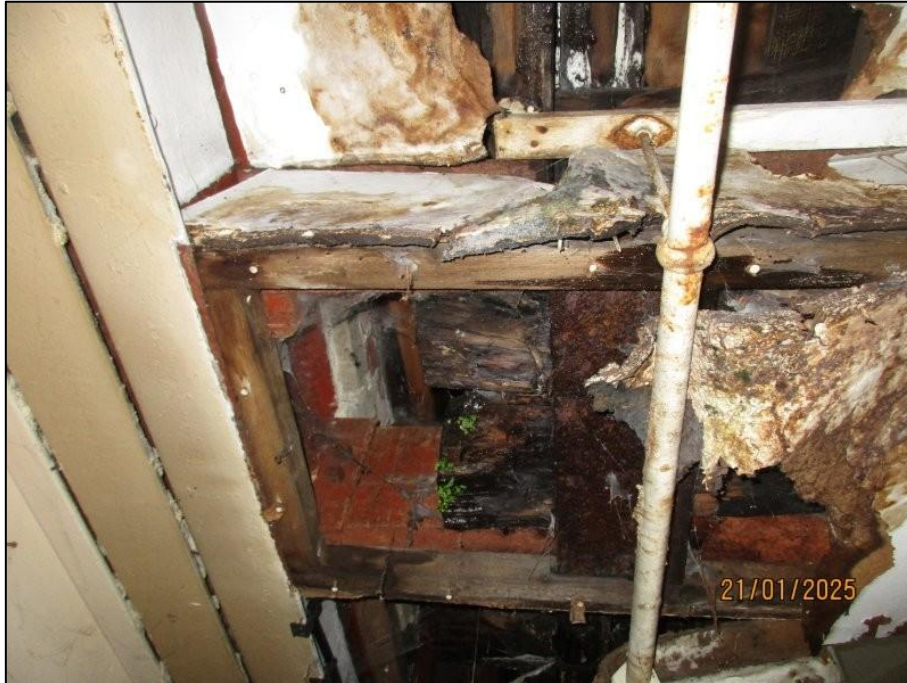
- **Roof structure**

The roof structure to Building D is in a very poor structural state. The roof appears to have been poorly maintained along its valley gutters, and has leaked, causing rot to occur to the timber structure and corrosion to the supporting steelwork.

Remediation works to the roof structure are potentially quite far reaching as the water ingress is affecting steel and timber structural elements two floors lower down.

Condition D

It is recommended that a suitably qualified, experienced and insured timber and dame specialist is employed to determine the extent of the timber damage, at which point the implications can be fully assessed.

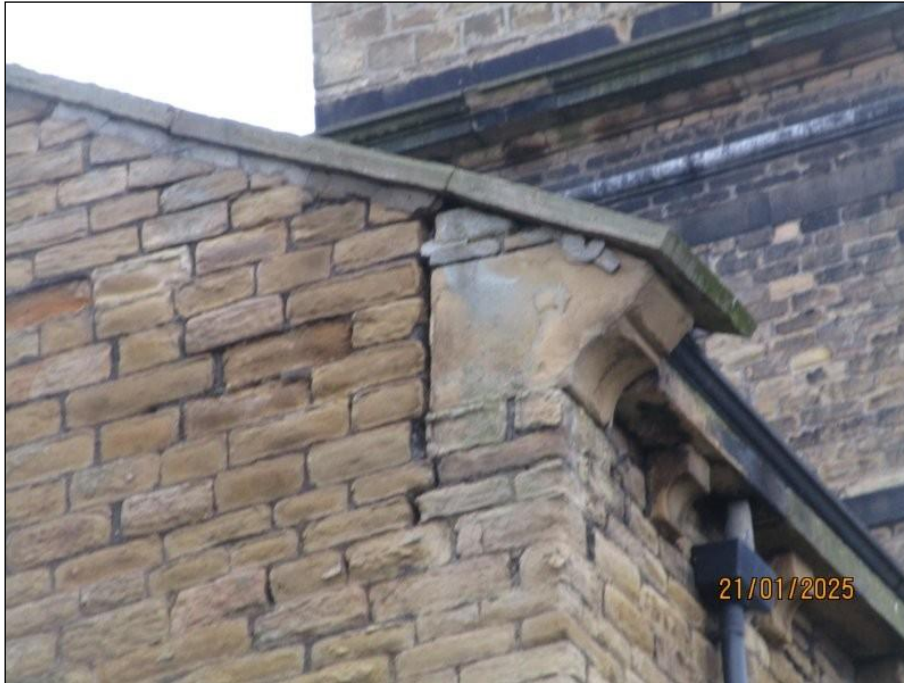
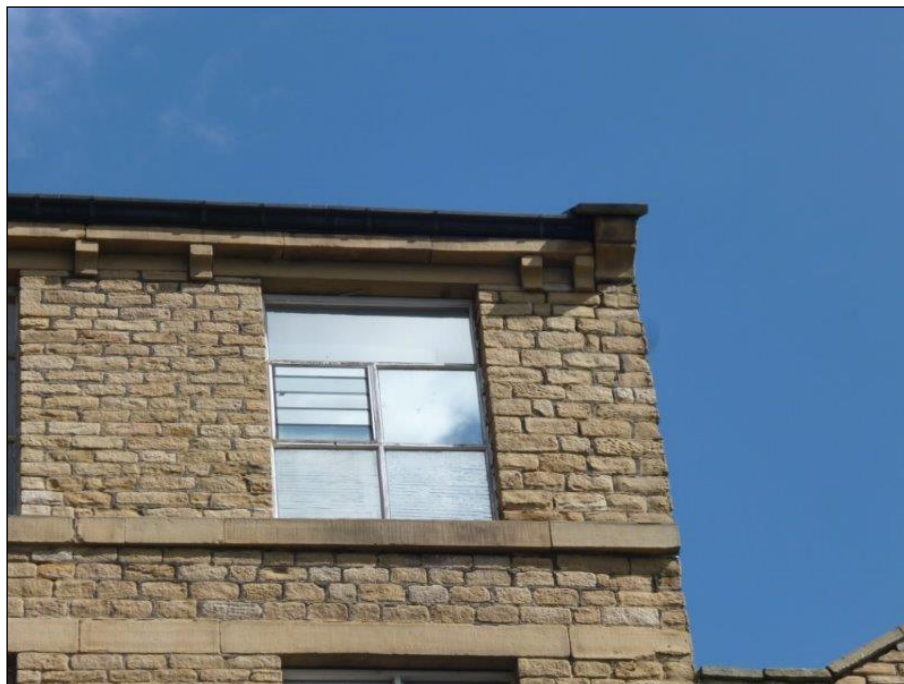
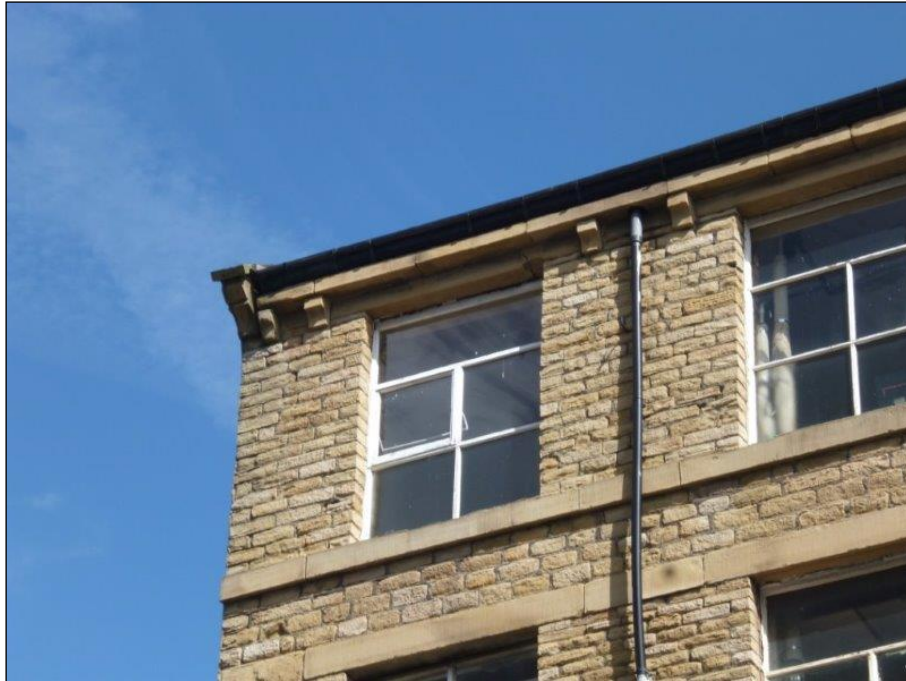
- **Kneeler to south-east corner**

The kneelers to all corners have moved, the kneelers require properly tying back to the main structure.

Condition D

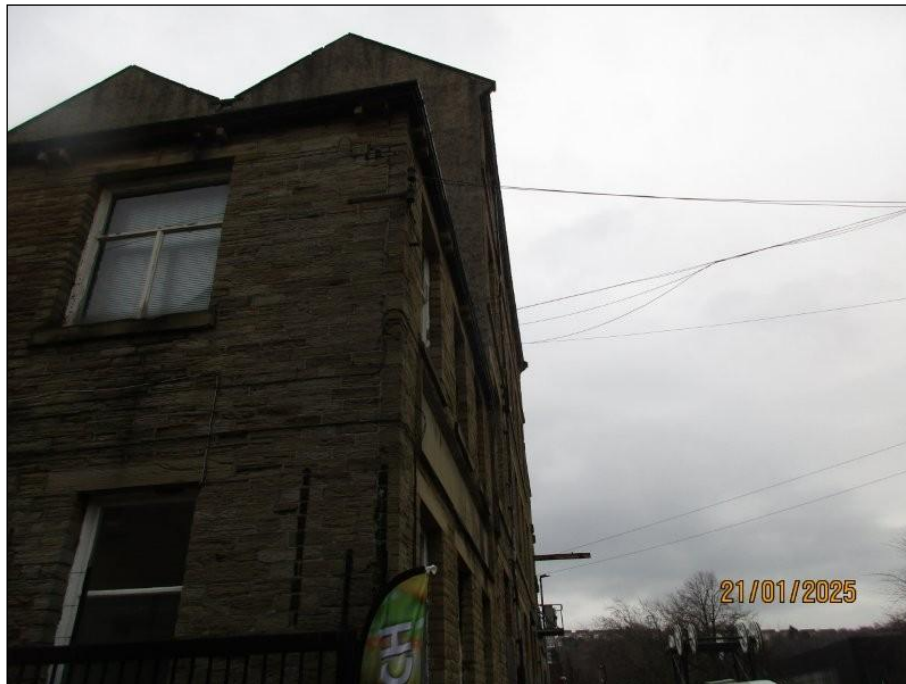
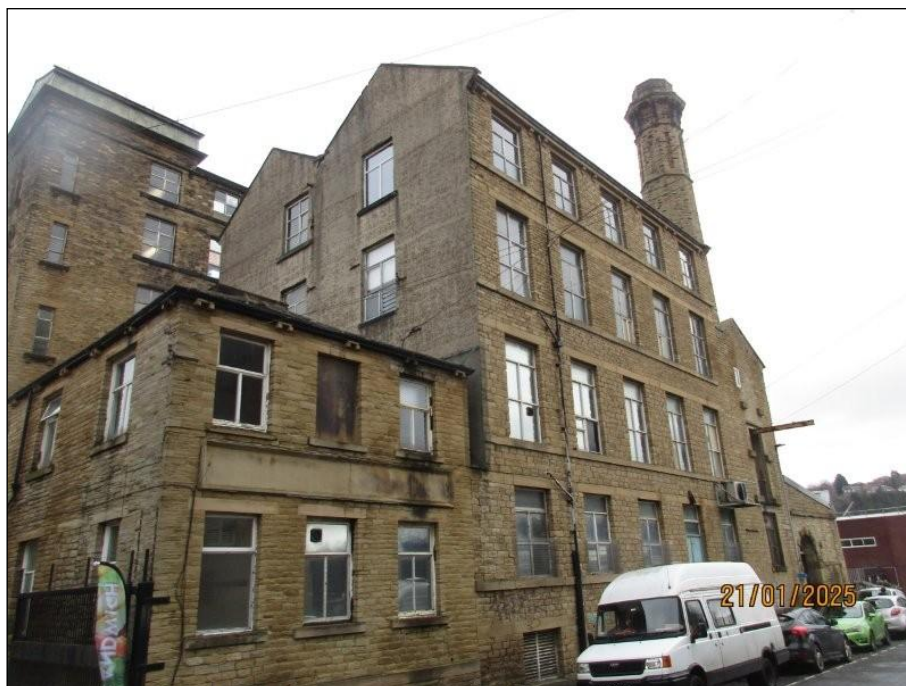
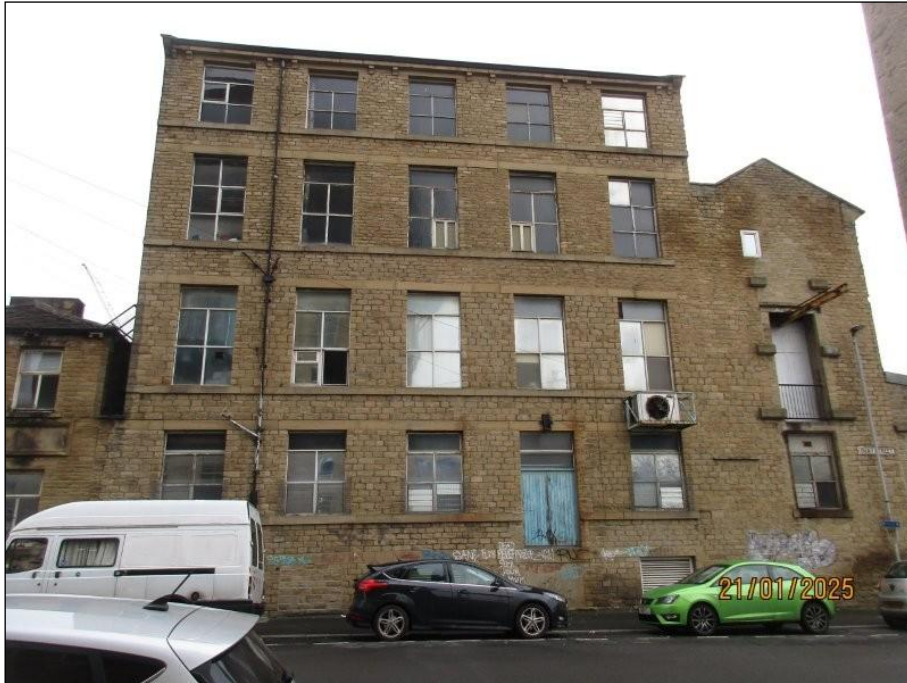
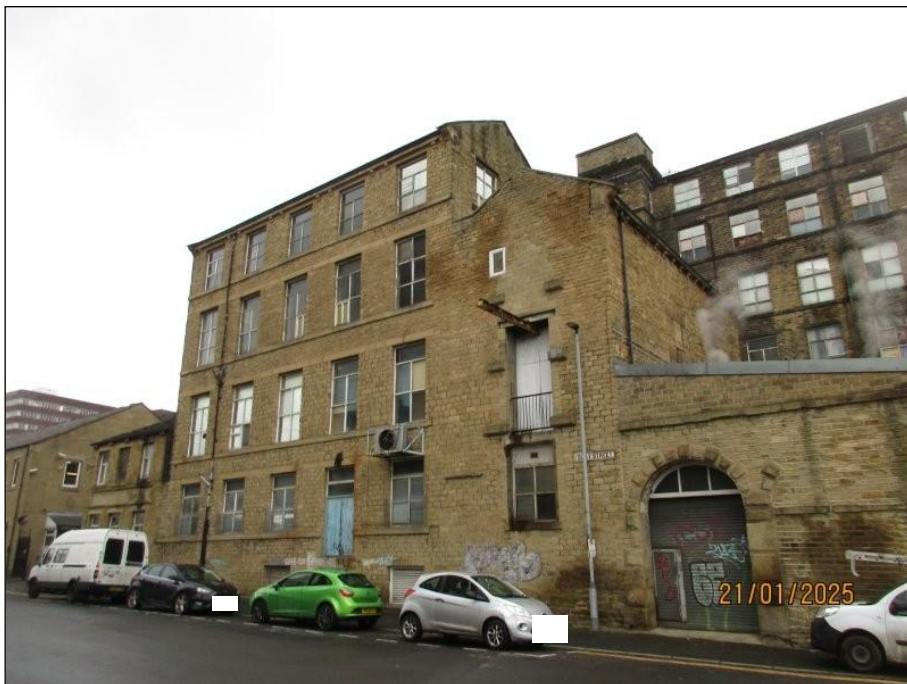
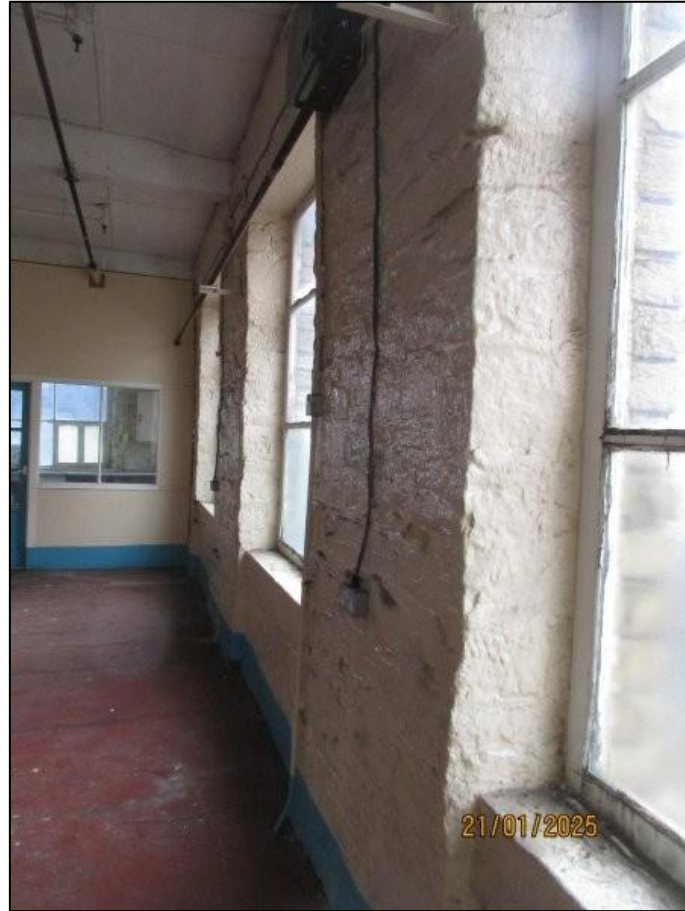
- **South wall**

The south wall is bowing to the uppermost floor. The wall is constructed of stone and appears to be approximately 450mm thick.

The wall seems to have bowed to an eccentricity more than 75mm from its original, plumb location. This is just on the cusp of the 'middle-third rule'.

Condition D

It is recommended that a steelwork supporting system is designed to prevent any further movement to the wall using wind posts resin bolted to the wall, and a wind girder positioned just below the ceiling line. These works should be designed and overseen by a chartered structural engineer.

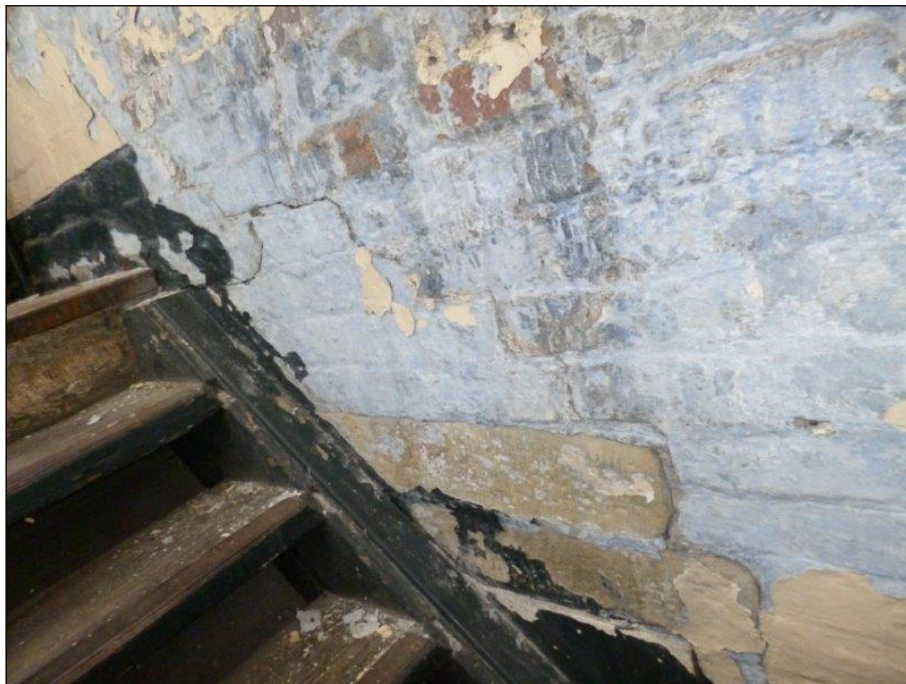
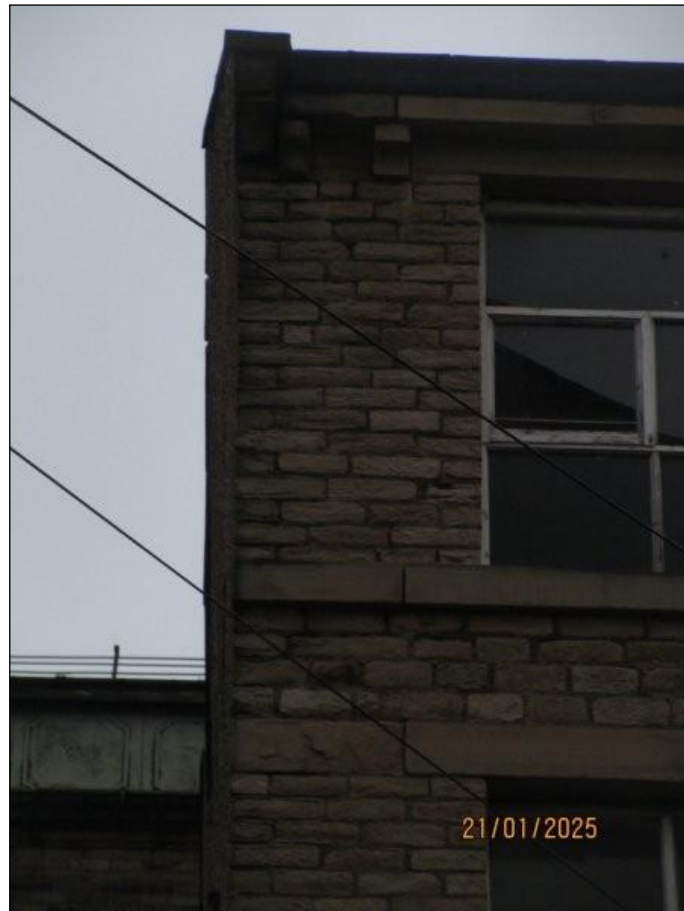
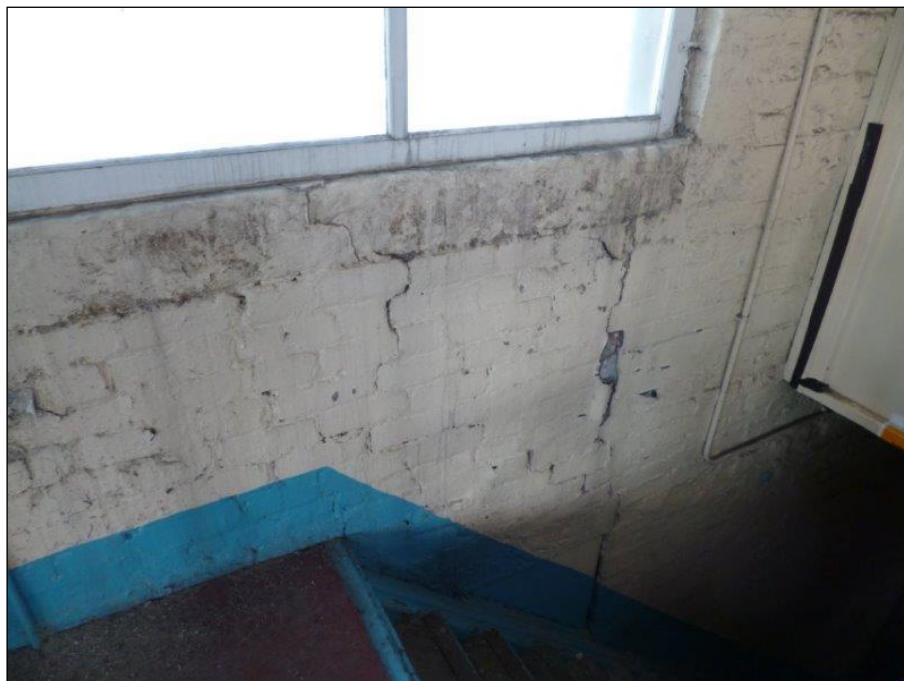
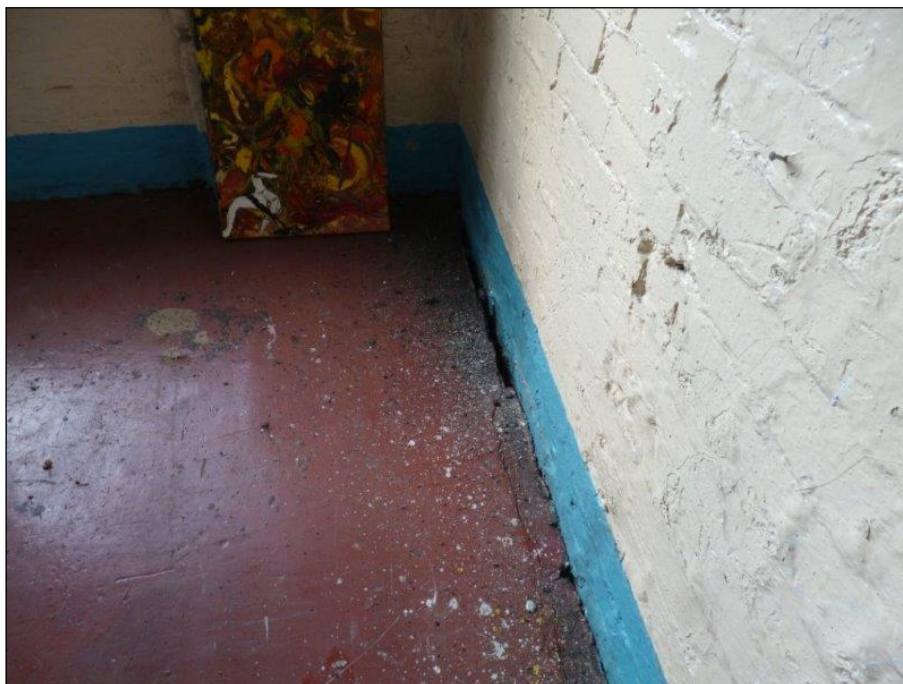
- **Western gable wall**

The west elevation gable wall is bowing and appears to have a significant lack of restraint. The wall is constructed of 9" brick, which seems to indicate that perhaps at some point, the mill structure was to be continued at this wall was initially intended to be temporary.

Unfortunately, the masonry gable wall seems to have bowed to an eccentricity more than 100mm from its original, plumb location. The 'middle-third rule' states that no tension will develop in a wall if the resultant force lies within the middle third of the structural element. This wall has moved such that the 'middle-third rule' has been exceeded and, as such, tensile forces will be developing in the wall for which it is not designed. The western gable wall is becoming structurally unstable.

Condition D

Following a design procedure, it is recommended that the western gable wall is demolished and re-built using appropriate materials, and using a fully qualified, experienced and insured builder.
