**Structural Appraisal of Buildings B, C, D & G,
Turnbridge Mills, Quay Street,
Huddersfield, HD1 6QT**

RCE6909

Rev	Date	Description	By
-	30-01-25	Initial issue	PR
A	13-03-25	<i>`Comment on possible proposed development of Buildings B & D` section added</i>	PR
B	17-03-25	Minor amendments	PR
C	16-04-25	Minor amendments	PR

21st January 2025

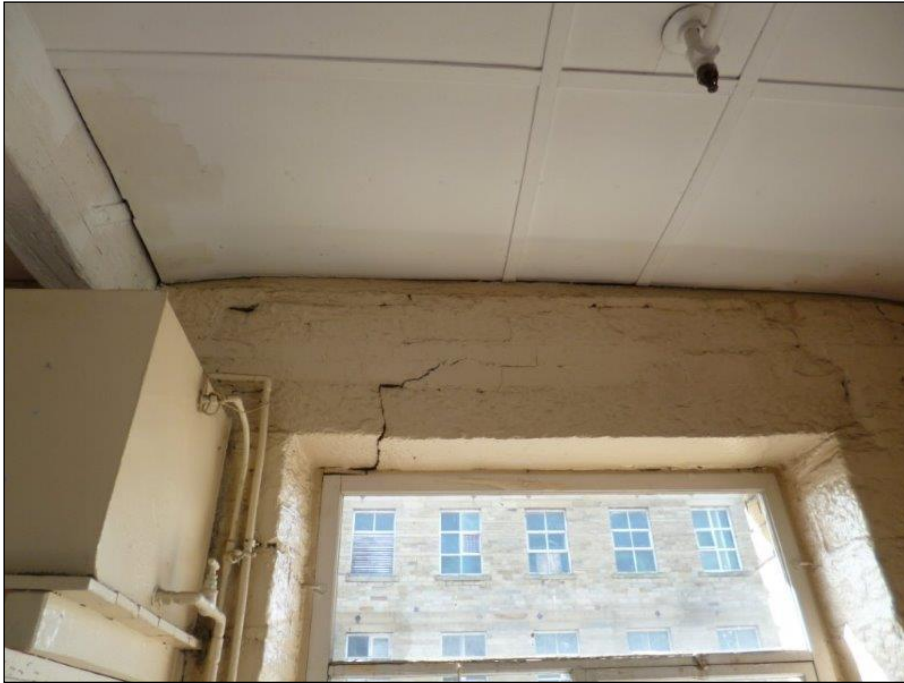
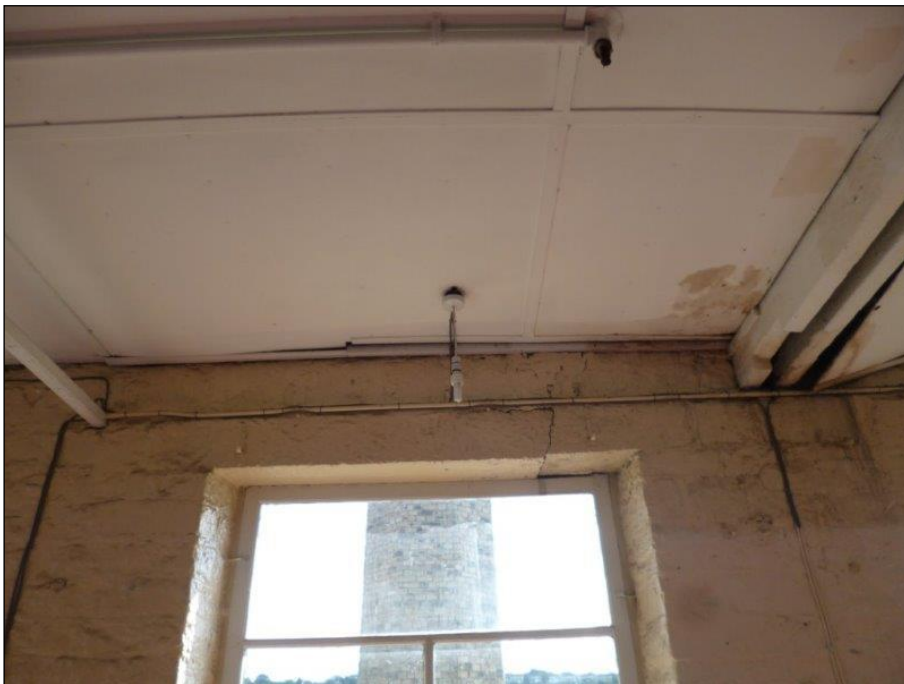
- **Cracked lintels**

There are cracked lintels to various windows throughout the structure. It is imperative that should the window be changed that the lintel is changed prior.

Condition B

- **Screed to timber floors**

The screed to the timber floors has badly cracked. Screed on timber floors never works well.

It is recommended that the screed is removed.

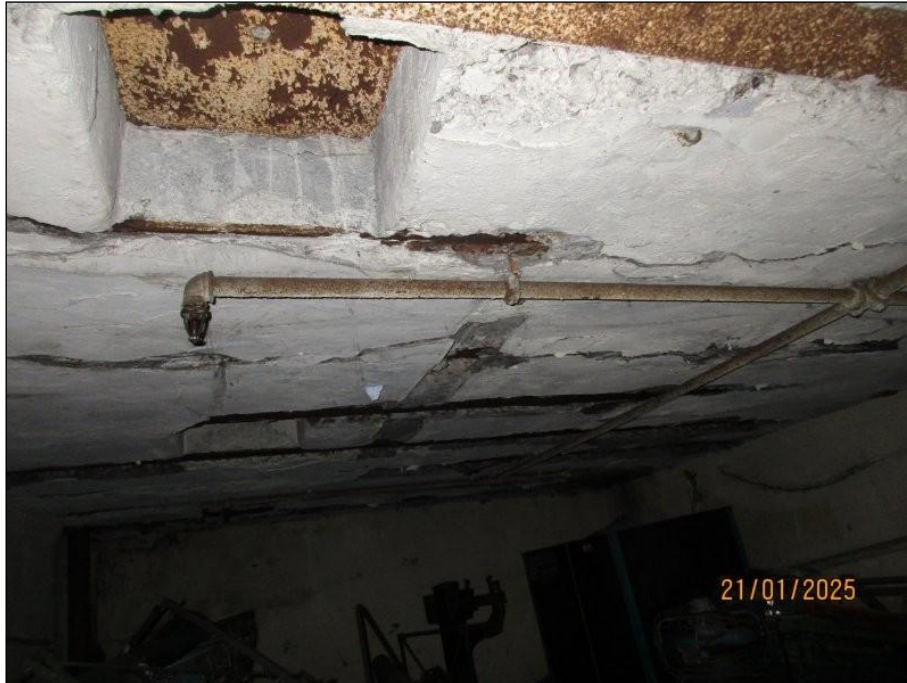
Photograph 65

- **Filler joist floor to west of Building D**

The cellar to Building D seems to extend underneath the access road between the mill buildings. The roof to this section of cellar was probably constructed between 1900 and 1920, judging by the style of construction.

The roof is constructed using steel or cast-iron joists at close spacings, between which a concrete infill has been cast.

The steel or cast-iron joists are heavily corroded and are possibly liable to collapse imminently.

Condition D

It is recommended that the ceiling is propped immediately, with a long-term plan to remove the filler joist roof and to install a new roof or alternatively infill this section of cellar.

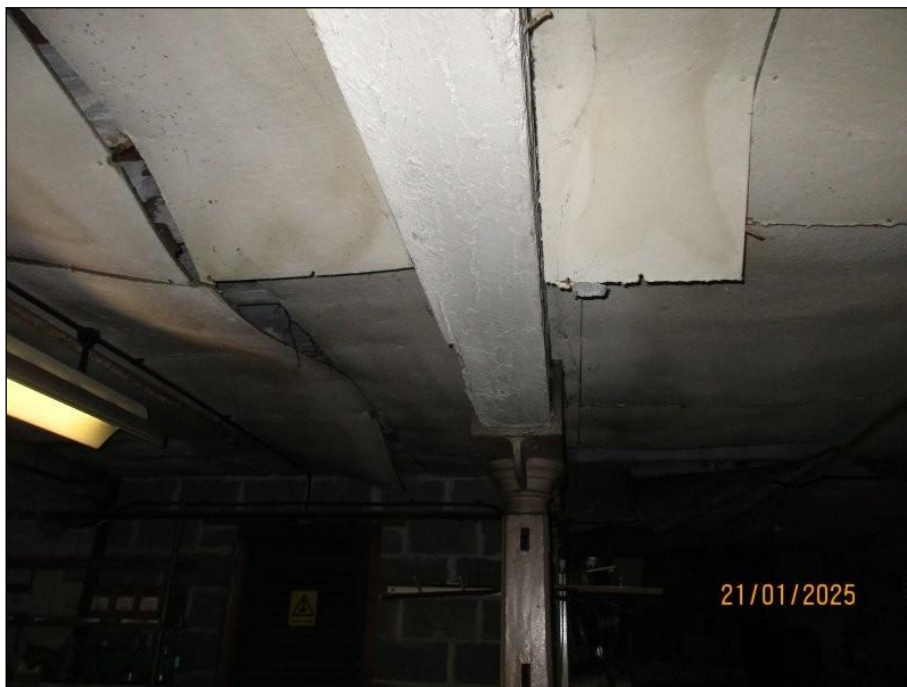
Photograph 66

- **MDF type material to ceiling of ground floor joists**

The soffit of the ground floor timber joists has been covered over with what appears to be an MDF boarding. The boarding is starting to deteriorate from damp and has fallen off in some areas.

The MDF ceiling may constitute a fire hazard, and the floor joists are exposed.

Condition D

It is recommended that the ceiling is removed, and a new, appropriately specified plasterboard ceiling is installed.

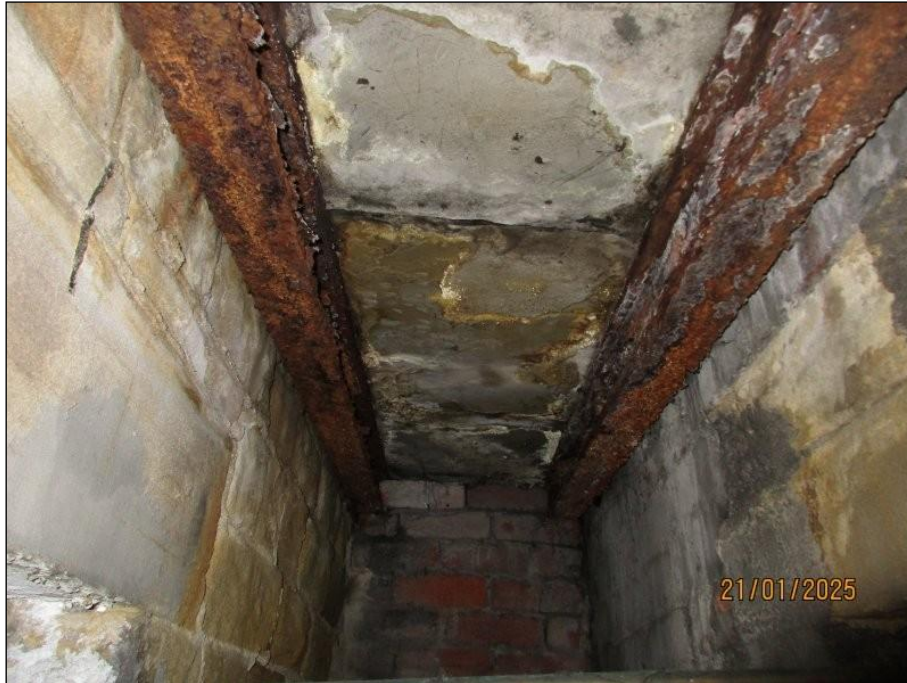
Photograph 67

- **Corroding beams in cellar supporting front gable wall**

In the cellar, there are a pair of steel beams supporting the front gable wall which are badly corroded.

Condition D

It is recommended that they steel beams are removed and replaced on a like-for-like basis by an appropriately insured, experienced and qualified builder.

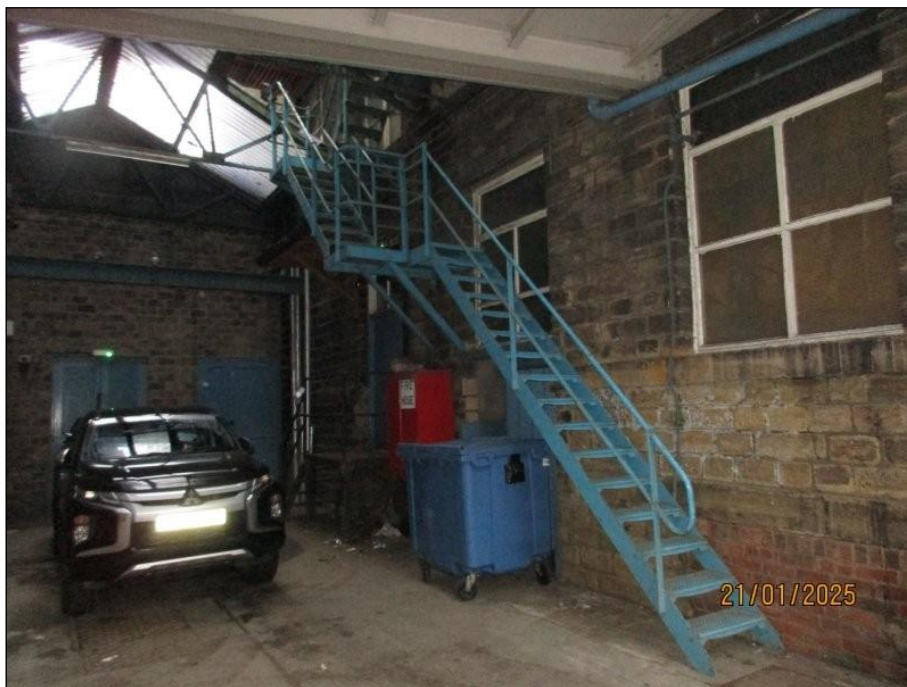
Photograph 68

- **Fire escape**

The fire escape to the north elevation of Building D probably does not comply with the personnel loading that is expected of a modern fire escape, nor is it fire protected.

Condition D

It is recommended that the fire escape is removed and a new fire escape constructed.

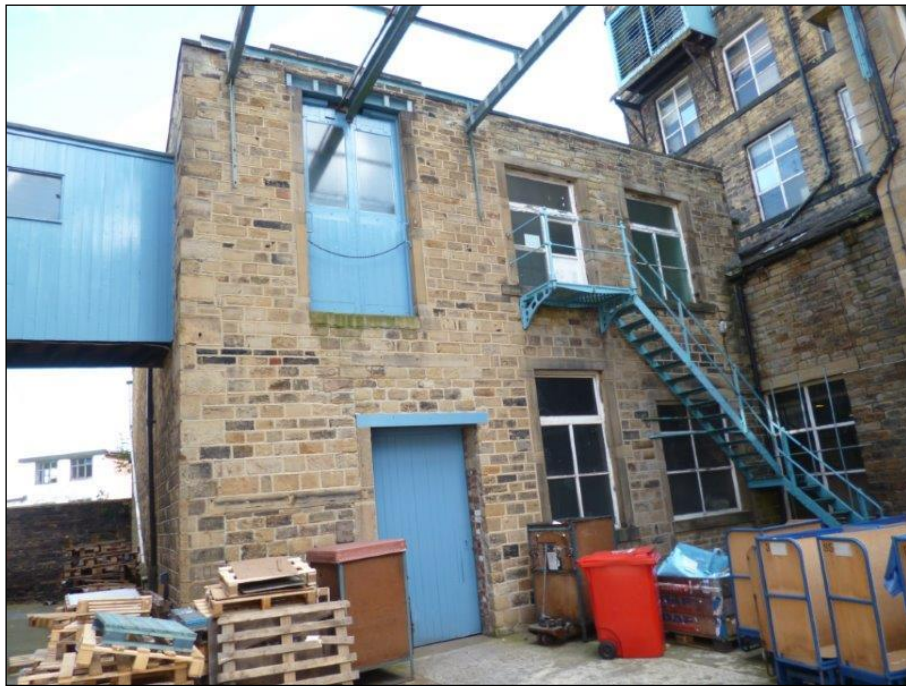
Photograph 69

- **Fire escape structure to first floor**

The fire escape is supported off gallows brackets which have only one level of bolts. The fire escape is clearly not of a strength suitable for the requirements and should be removed and replaced prior to the first floor taking occupancy.

Condition D

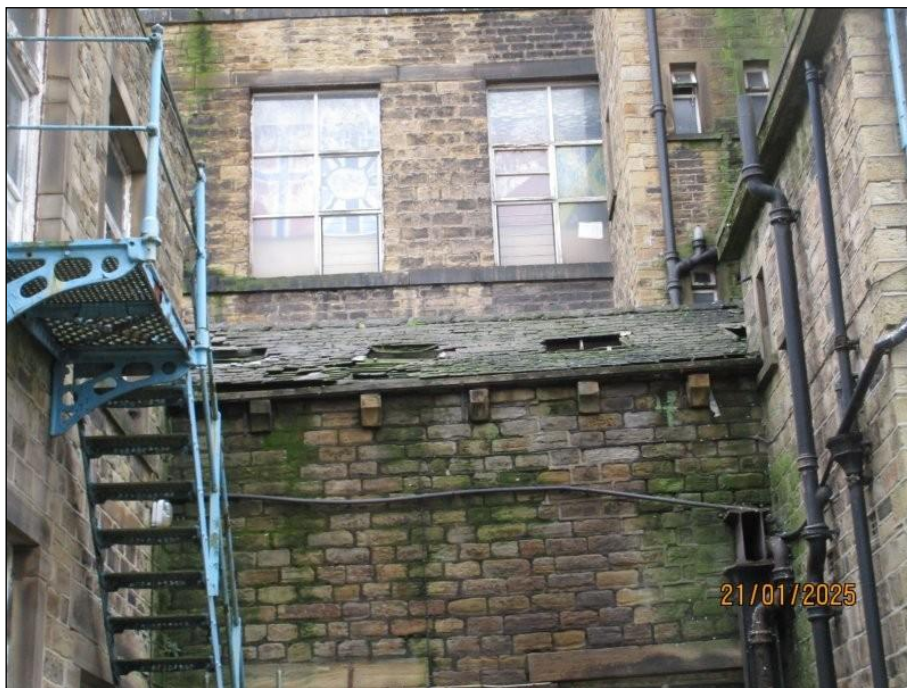
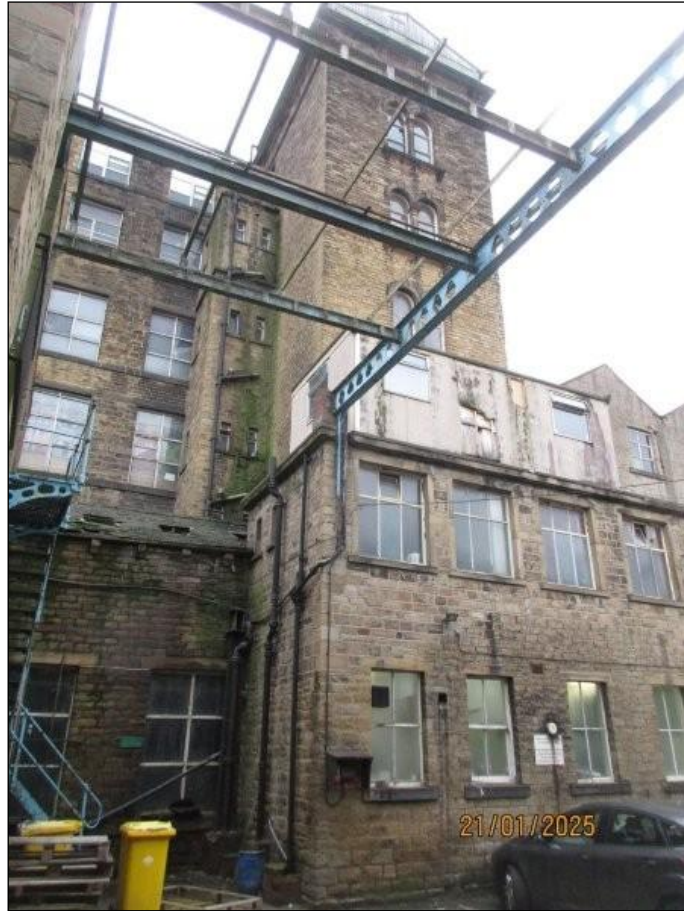
- **Leaking and rotting roof structure**

The roof structure to Building G is badly leaking and is rotting such that it now presents a danger to enter. The danger is further compounded by the pigeons and the commensurate guano present due to the open roof (and presumably other vermin).

Condition D

It is recommended that the roof is completely removed and reinstated.
