**P&A 4872-22/DJO**

**12<sup>th</sup> March 2025**

## **STRUCTURAL INSPECTION – HIGHWAY BOUNDARY WALL**

**Burn Road  
Birchencliffe  
Huddersfield**

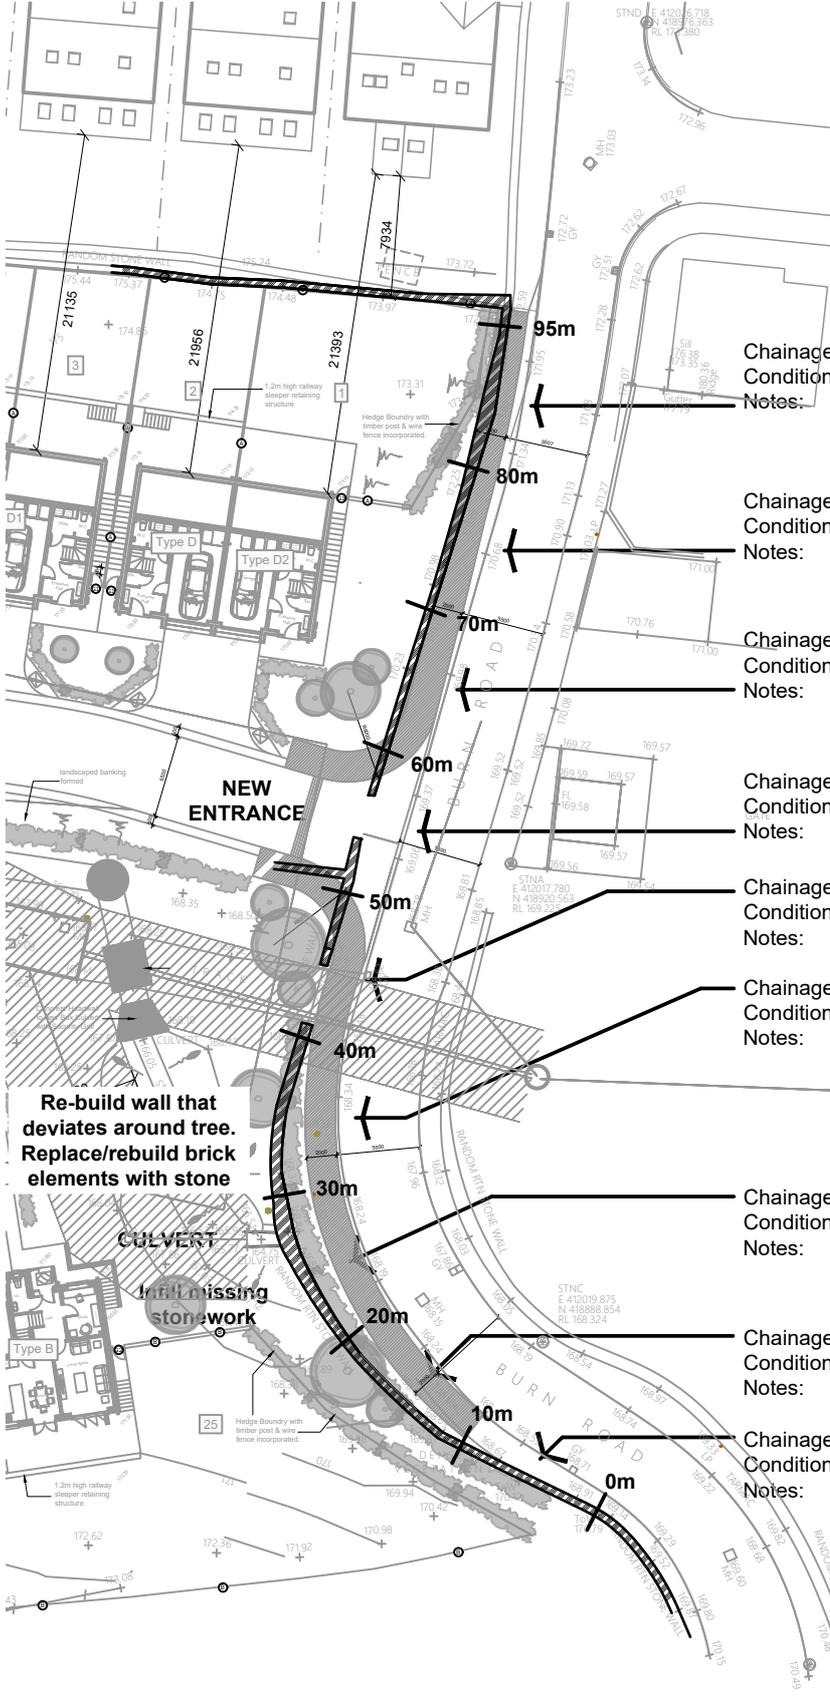
**PLAN ON EXISTING BOUNDARY  
STONE RETAINING WALL (1:500)**

- Chainage: 80m - 95m  
Condition: **POOR** - partial wall collapse  
Notes: Wall removed and ground regraded as part of new development
- Chainage: 70m - 80m  
Condition: Reasonable  
Notes: Wall removed and ground regraded as part of new development

- Chainage: 60m - 70m  
Condition: **POOR**  
Notes: Wall removed as part of new development
- Chainage: 50m - 60m  
Condition: Reasonable  
Notes: Wall removed as part of new development

- Chainage: 40m - 50m  
Condition: Reasonable  
Notes: Wall removed as part of new development
- Chainage: 30m - 40m  
Condition: **POOR**  
Notes: Clear vegetation (including tree embedded into rear of wall to side of culvert), rebuild brickwork elements in stone. Rebuild part of wall that deviates around tree. Provide new stone coping. Consider increase in height for pedestrian barrier

- Chainage: 20m - 30m  
Condition: **POOR** - Coping displaced  
Notes: Clear vegetation, re-set coping. Infill missing stonework to rear of wall. Consider increase in height for for pedestrian barrier

- Chainage: 10m - 20m  
Condition: Reasonable  
Notes: Clear vegetation, re-set coping
- Chainage: 0m - 10m  
Condition: Reasonable  
Notes: Clear vegetation, re-set coping

**Re-build wall that deviates around tree. Replace/rebuild brick elements with stone**

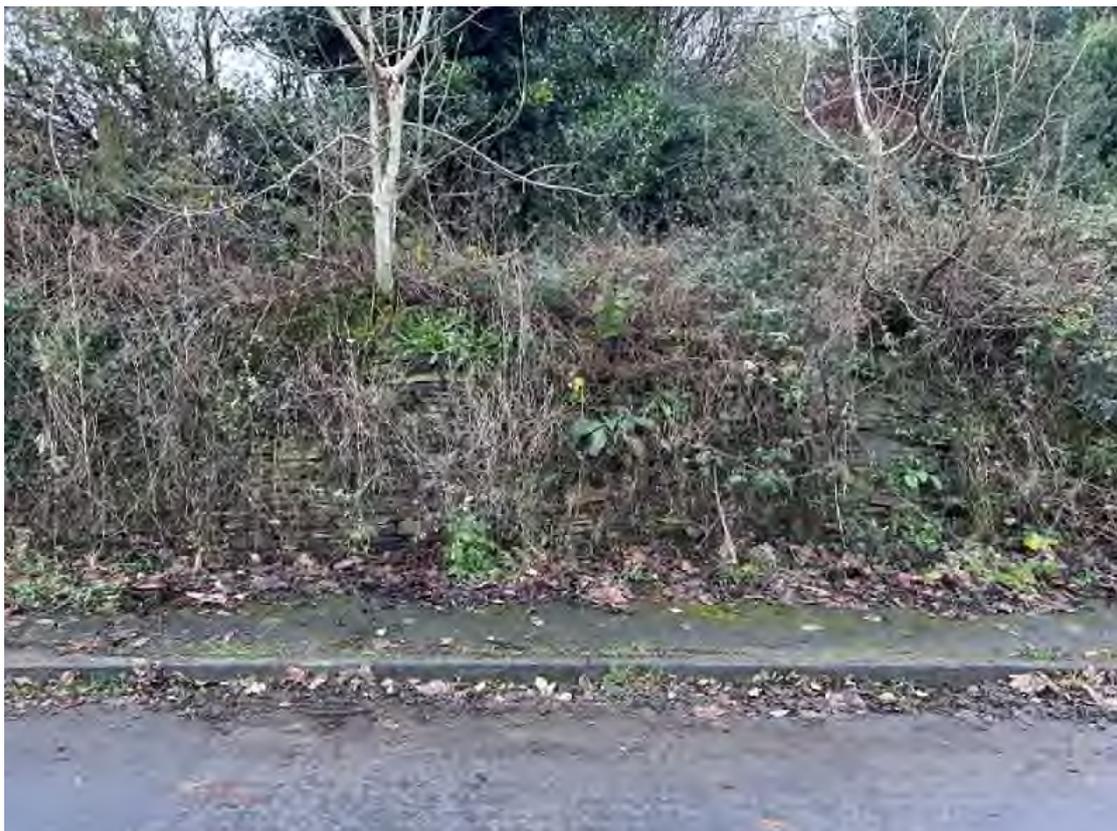
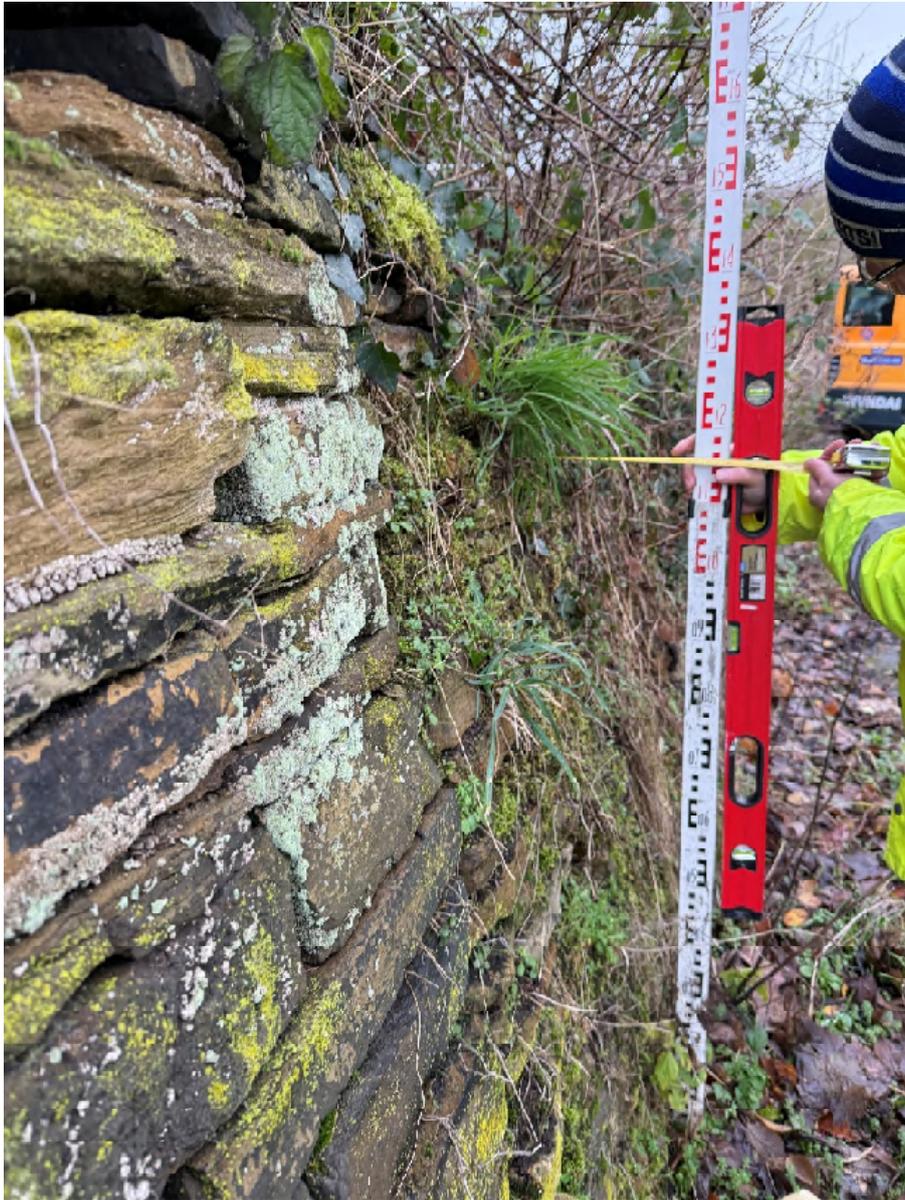
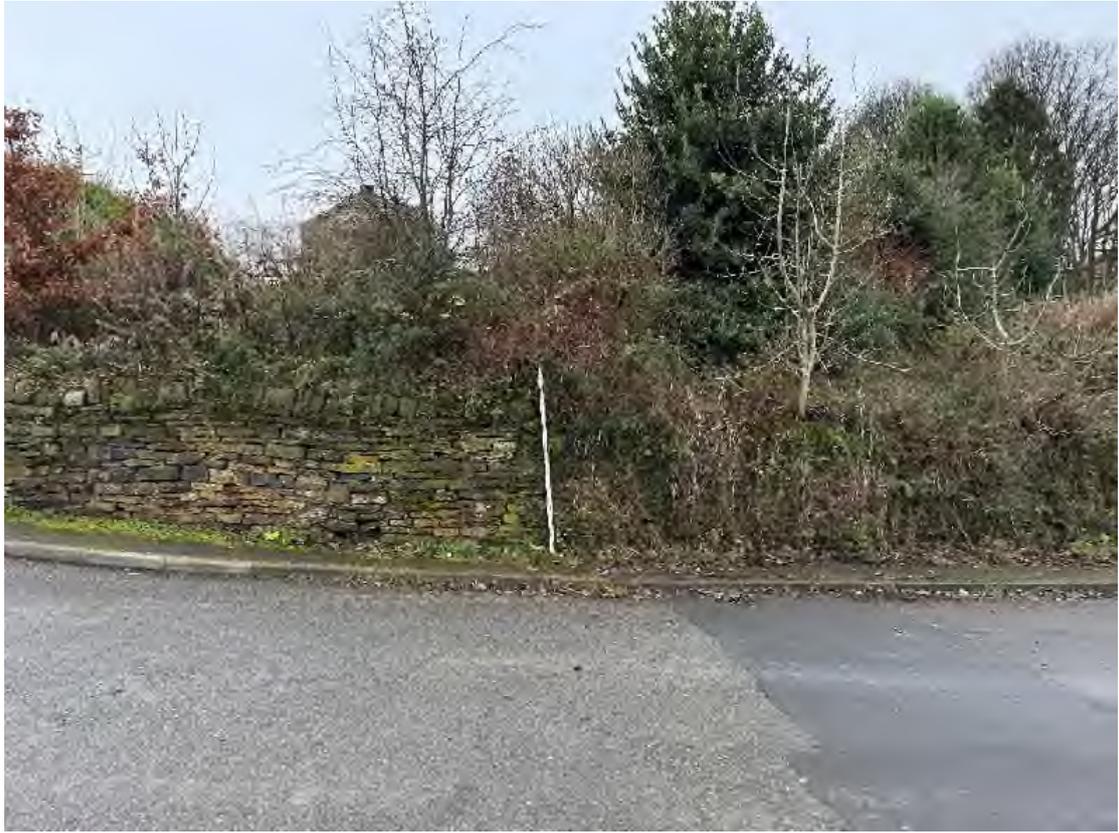
**Approximate Chainage 1m to 10m**

Approximate Chainage	1 to 10m
Height	1.3m
Retaining height	1.1m to rear
Construction	Random stone with vertical stone coping
Verticality	Leans back 180mm over height of wall
Condition	Reasonable
Notes	Self seeded vegetation to front and rear. Clear vegetation, re-set coping

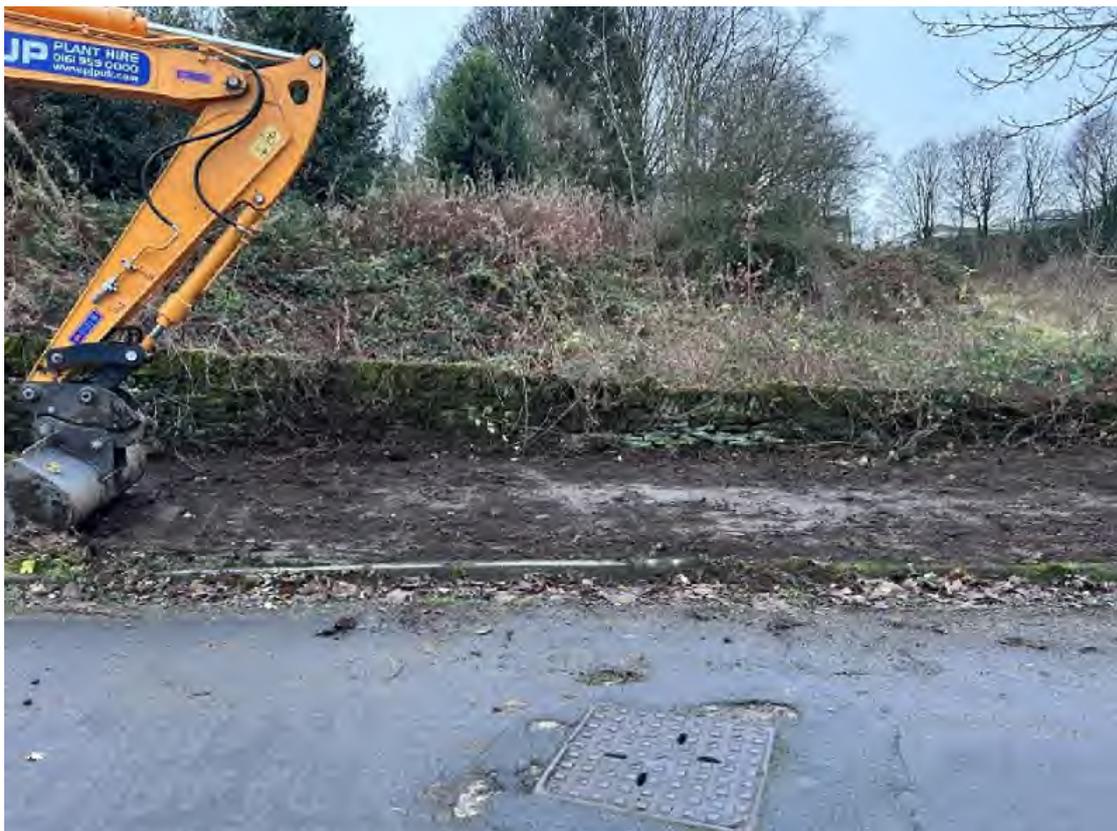
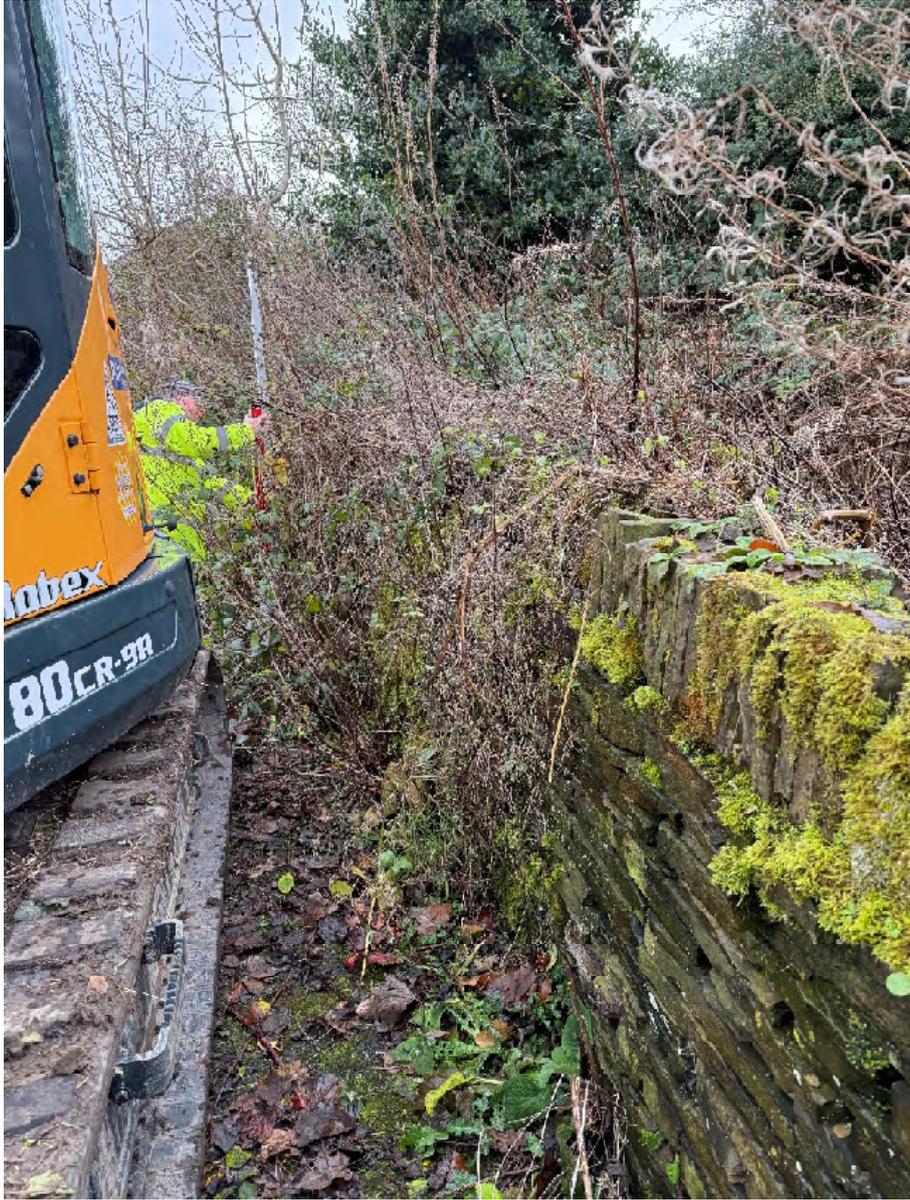
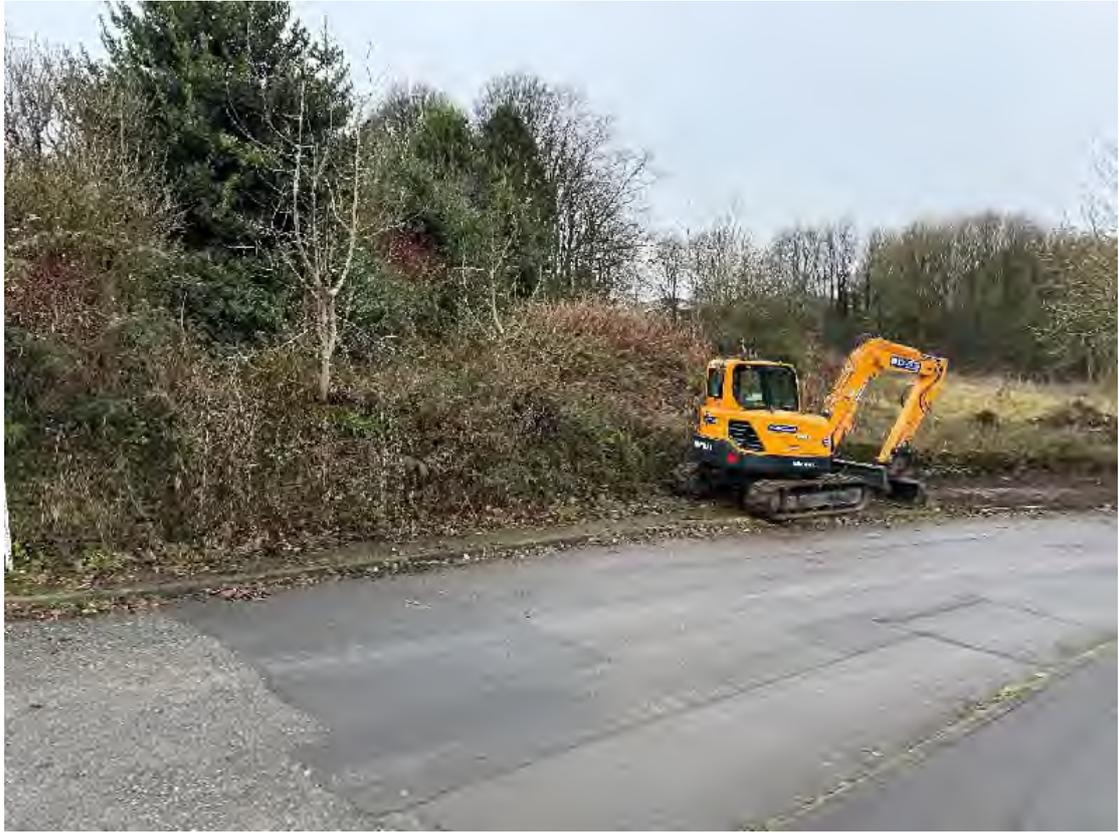
**Approximate Chainage 10m to 20m**

Approximate Chainage	10 to 20m
Height	Varies from 0.95m to 0.50m
Retaining height	0.90m to rear
Construction	Random stone with vertical stone coping
Verticality	Leans back 20mm over height of wall
Condition	Reasonable
Notes	Self seeded vegetation to front and rear. Clear vegetation, re-set coping

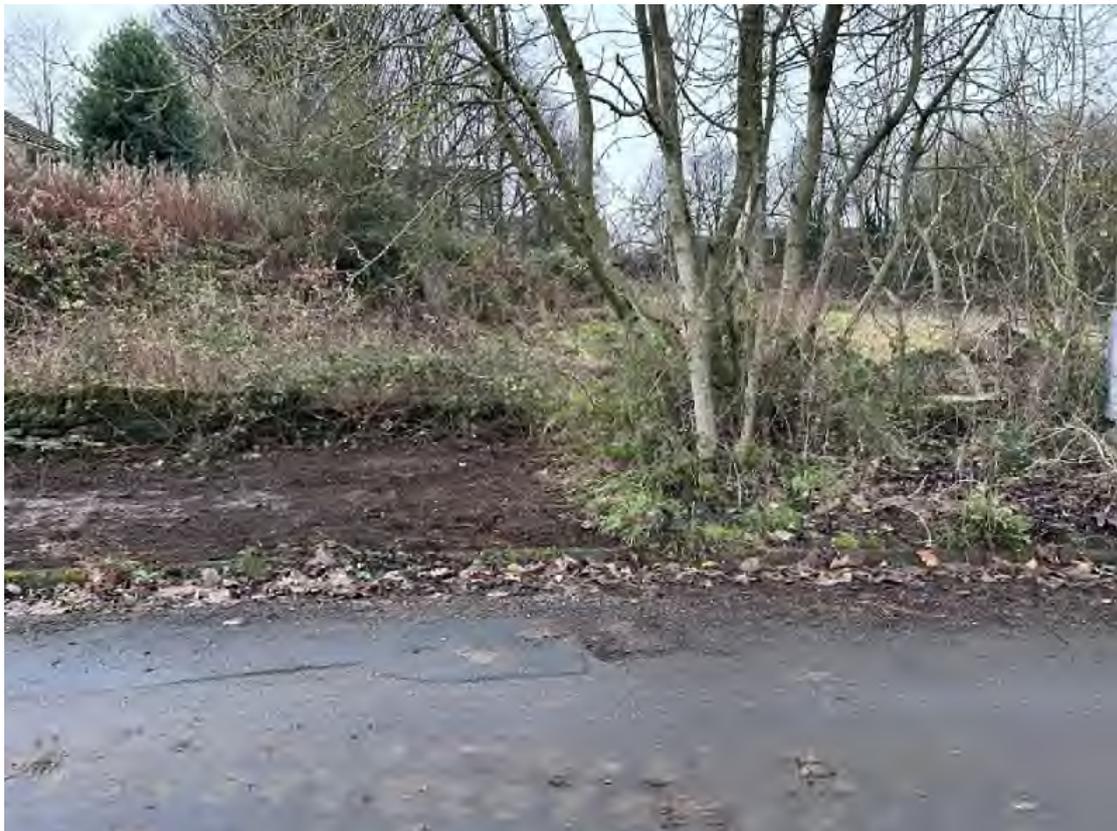
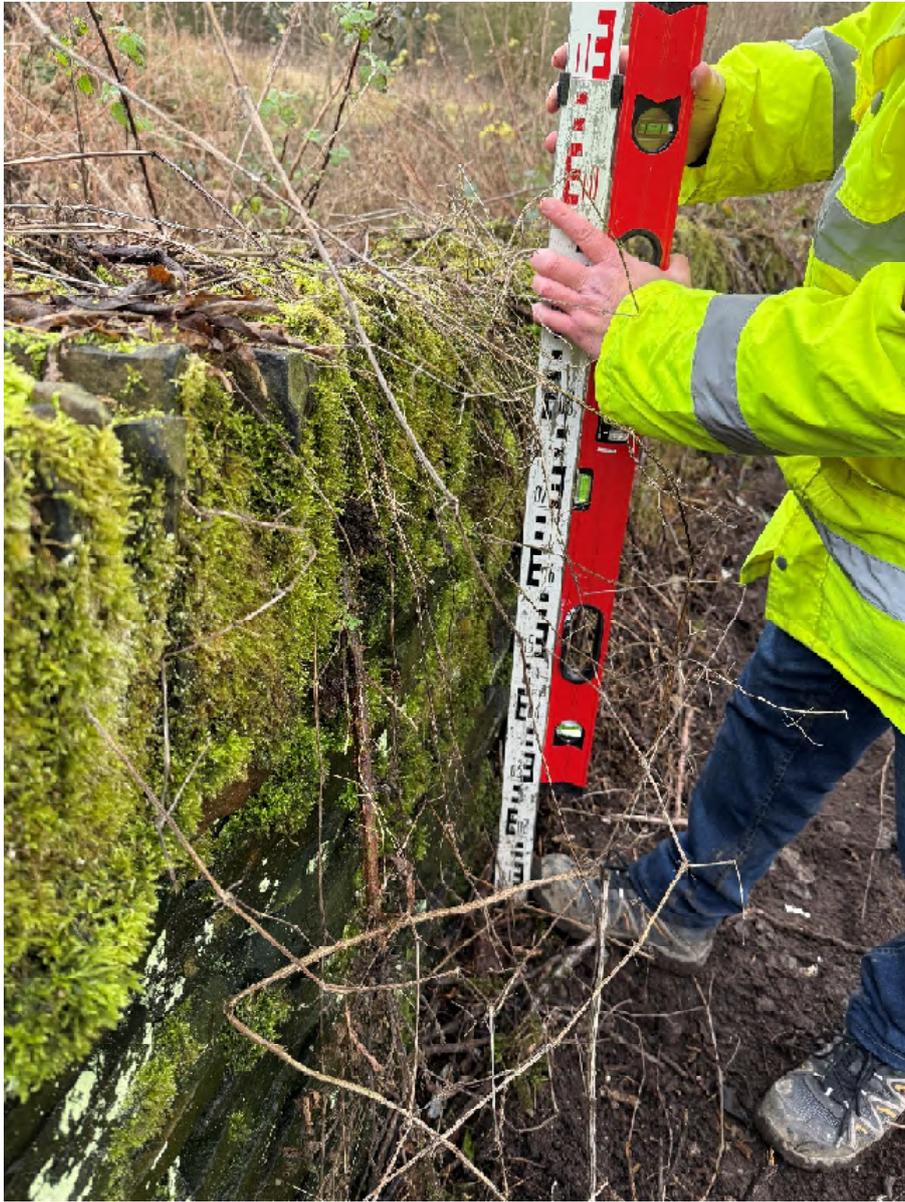
**Approximate Chainage 20m to 30m**

In the location of the culvert the wall is only 500mm high at footpath level. In our opinion the wall is not high enough to act as a pedestrian barrier to prevent pedestrians falling from height into the culvert below.

Approximate Chainage	20 to 30m
Height	0.50m
Retaining height	0.90m to 2.4m to pavement (down to culvert)
Construction	Random stone with vertical stone coping
Verticality	Leans back 20mm over height of wall
Condition	Poor, coping displaced
Notes	Self seeded vegetation to front and rear. Clear vegetation re-set coping. Infill any missing stonework to rear of wall.  Consider increase in height for pedestrian barrier to 1100mm

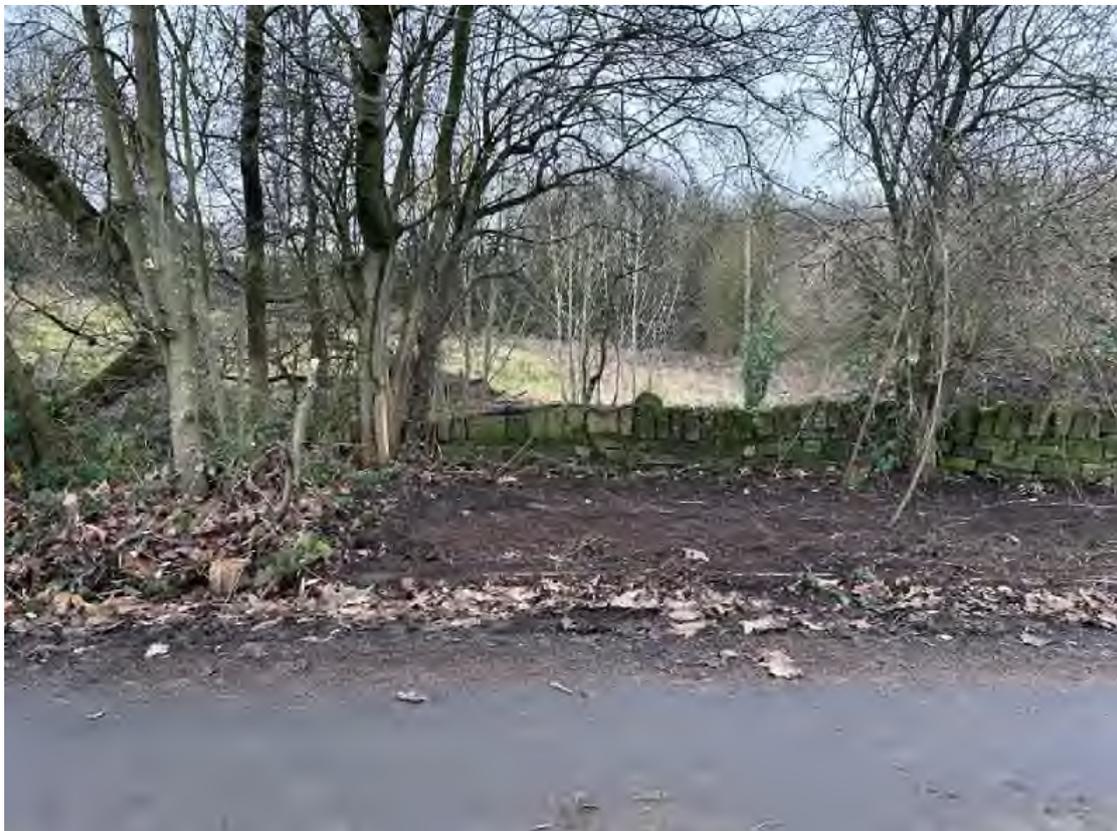
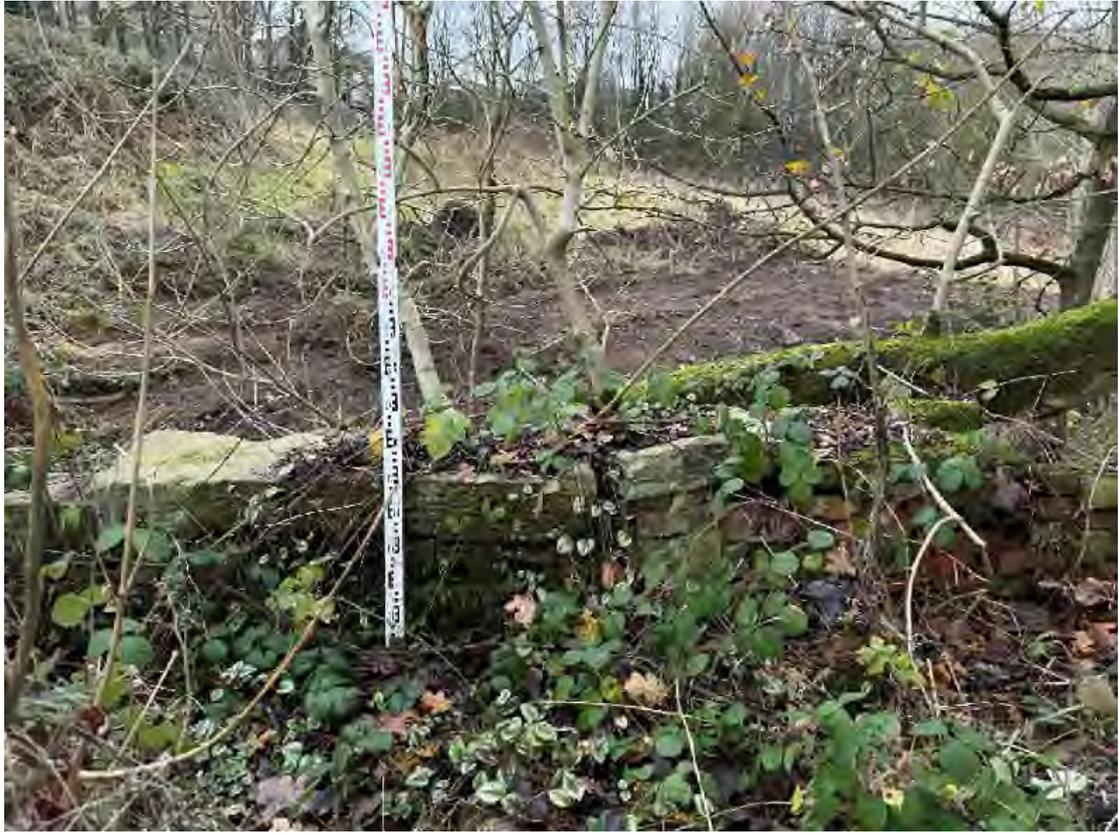
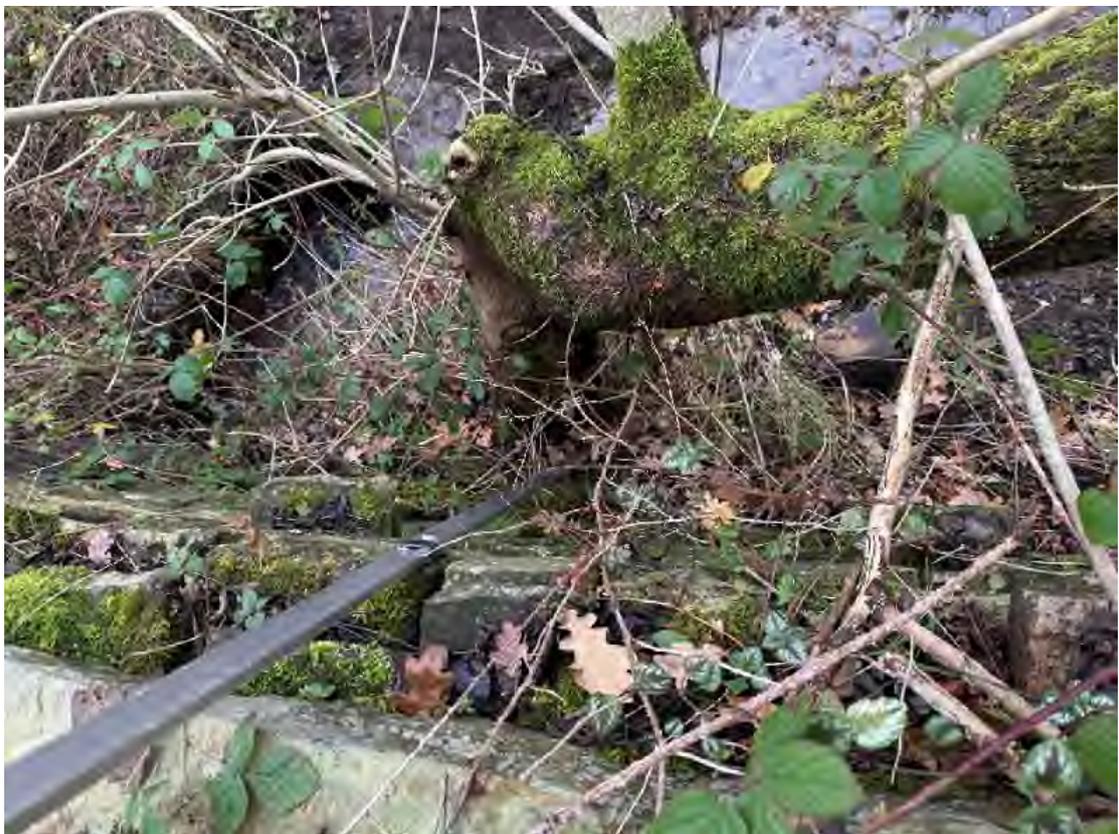
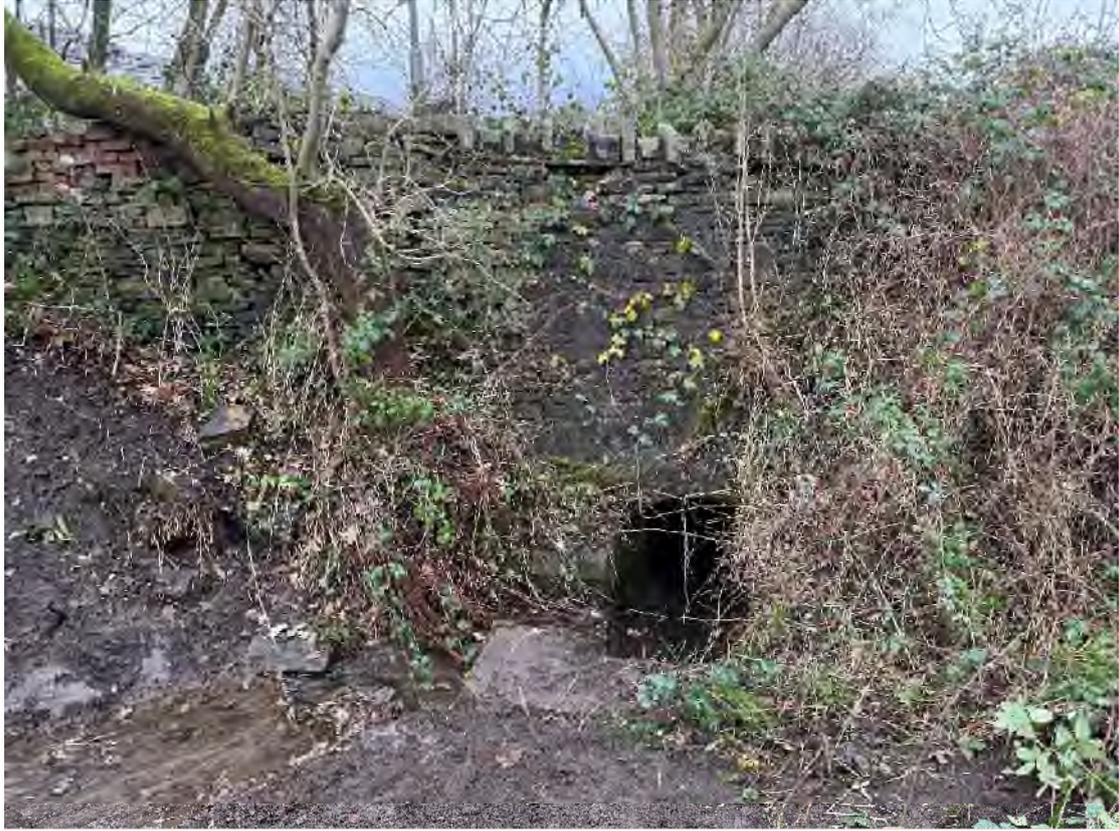
**Approximate Chainage 30m to 40m**

Approximate Chainage	30 to 40m
Height	0.5m to 0.6m
Retaining height	2.4m to 0.1m to pavement (up from culvert)
Construction	Coursed stone with vertical stone coping. Small section of random brickwork. No coping
Verticality	Leans back (unable to measure due to vegetation)
Condition	Poor
Notes	Self seeded vegetation to front and rear. Clear vegetation (including tree embedded into rear of wall to side of culvert), rebuild brickwork elements in stone. Rebuild part of wall that deviates around tree. Provide new stone coping.  Consider increase in height for pedestrian barrier to 1100mm

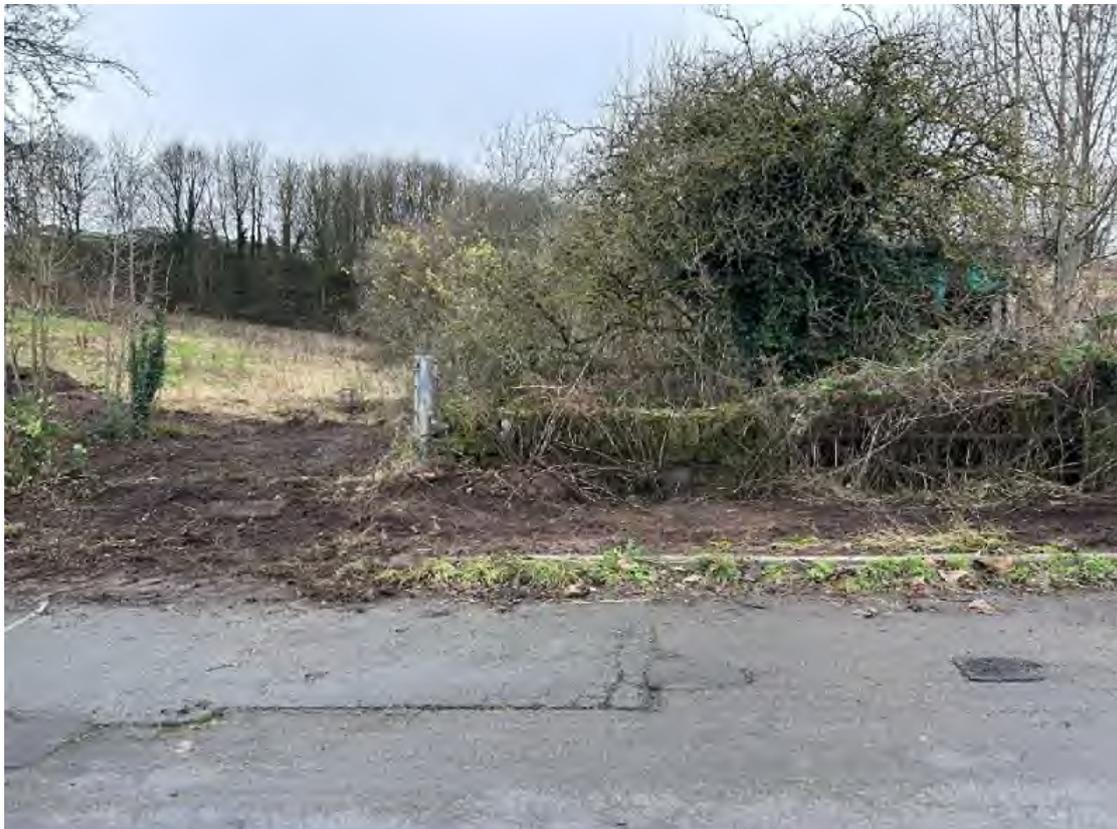
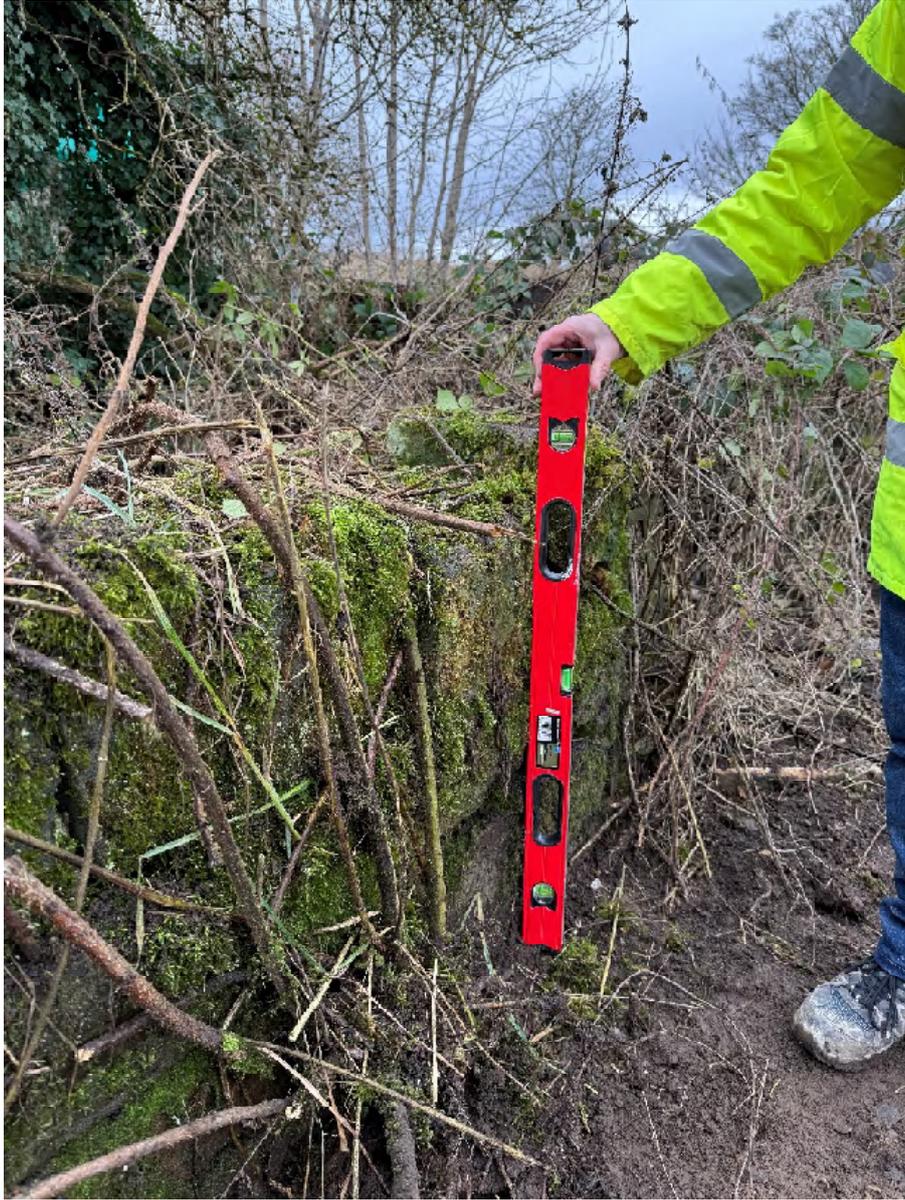
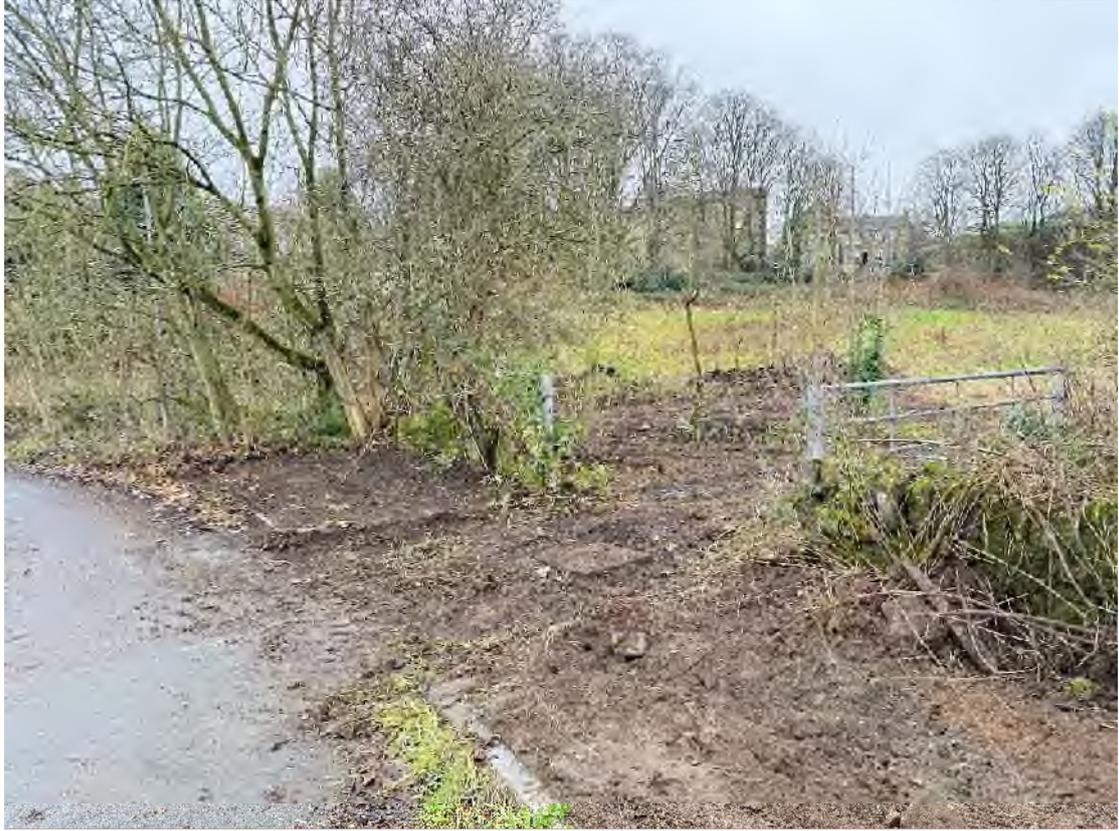
**Approximate Chainage 40m to 50m**

Approximate Chainage	40 to 50m
Height	0.80m
Retaining height	0.60m
Construction	Coursed stone with vertical stone coping. Galvanised steel gate
Verticality	Relatively plumb
Condition	Reasonable
Notes	Self seeded vegetation to front and rear. Clear vegetation.  Wall to be taken down to form new entrance to development.

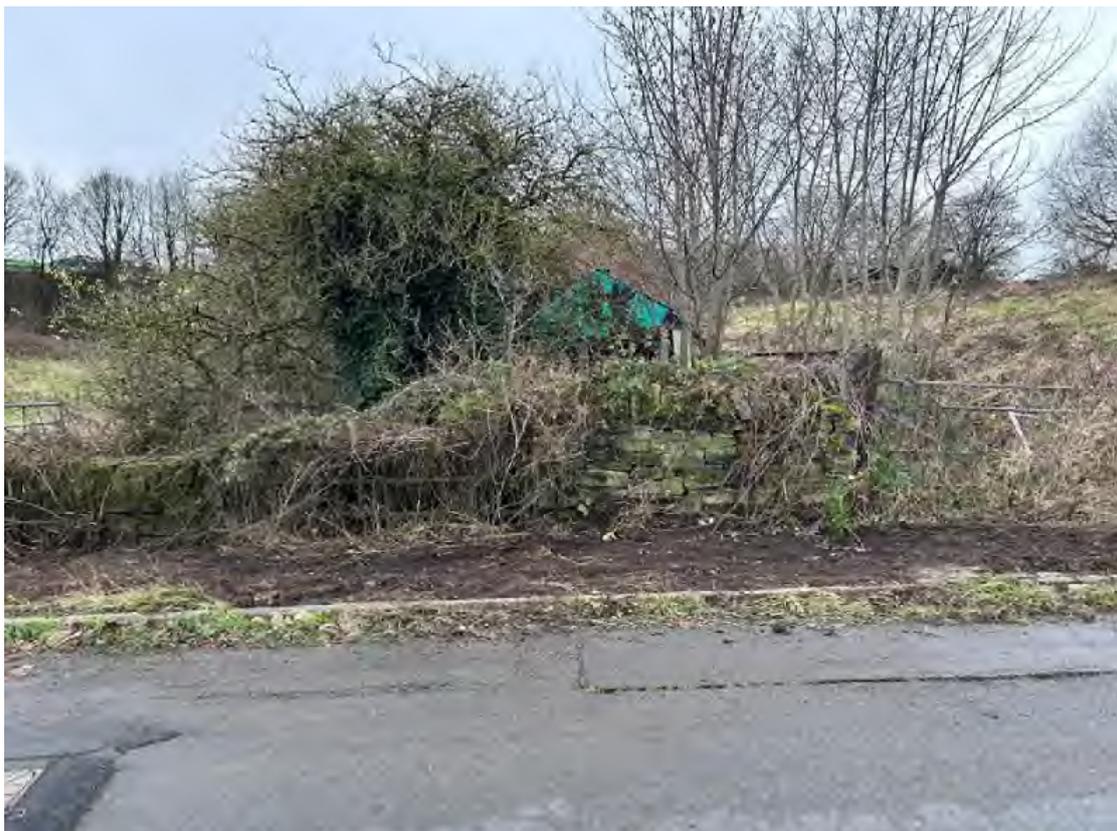
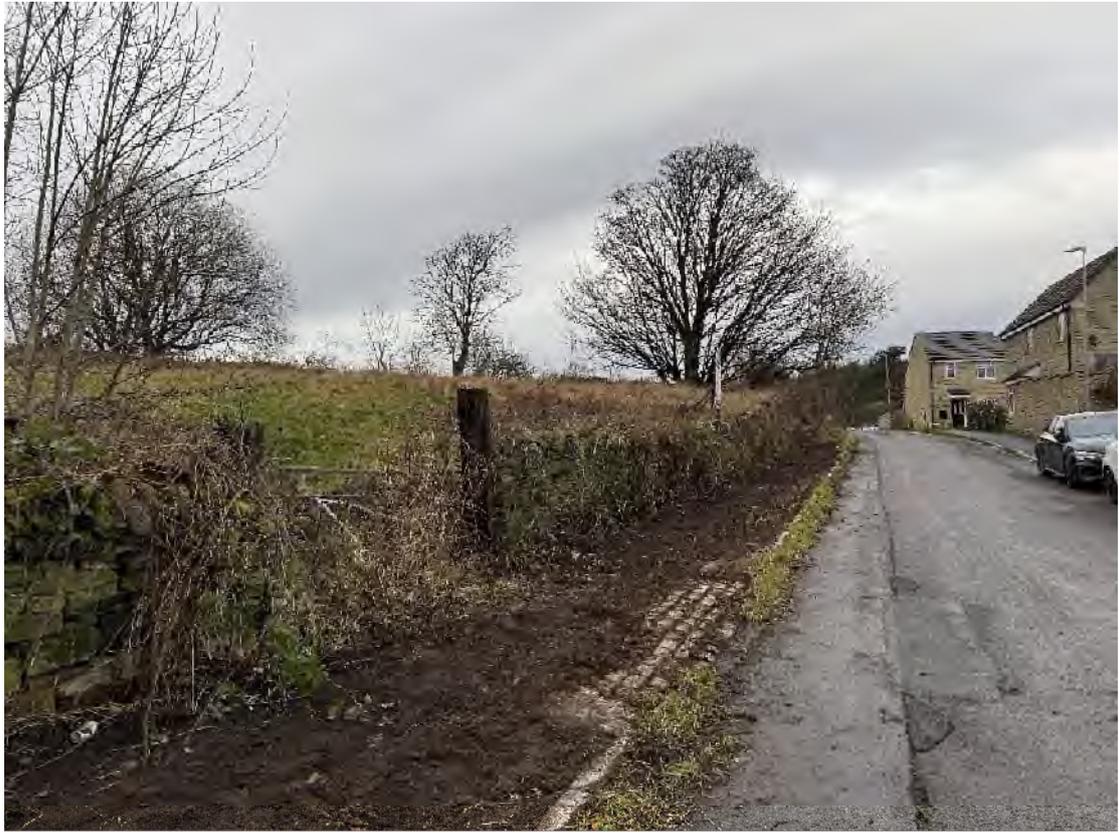
**Approximate Chainage 50m to 60m**

Approximate Chainage	50 to 60m
Height	1.4m
Retaining height	0.2m
Construction	Random stone with vertical stone coping
Verticality	Leans back 30mm over height of wall
Condition	Reasonable
Notes	Self seeded vegetation to front and rear. Clear vegetation.  Wall to be taken down to form new entrance to development.

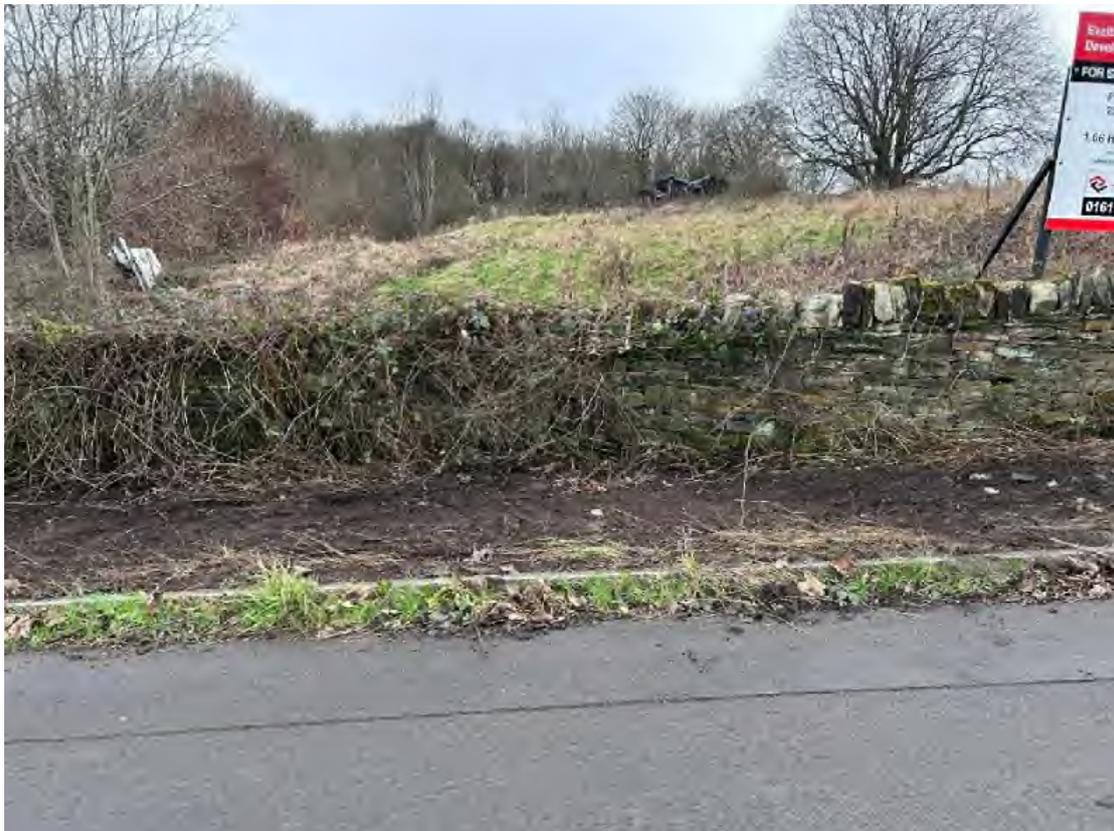
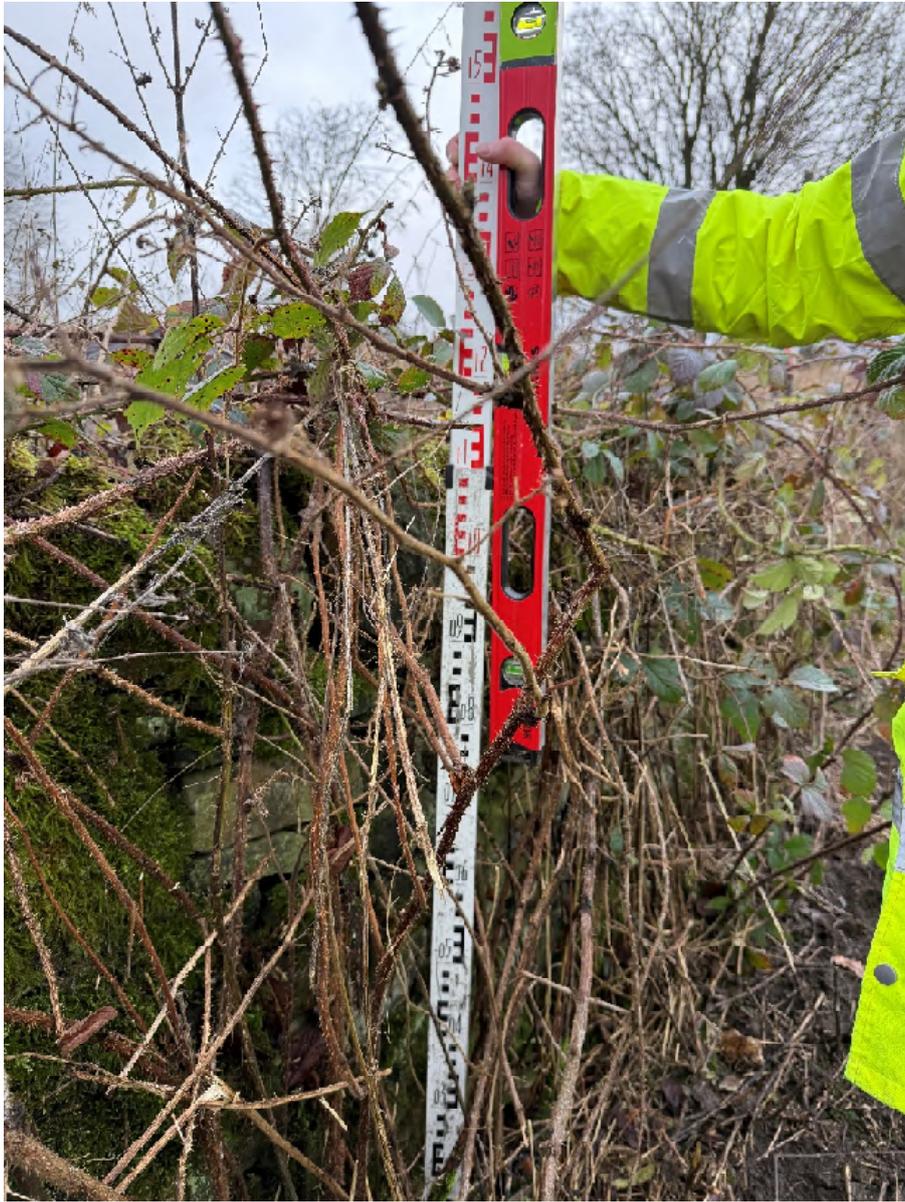
**Approximate Chainage 60m to 70m**

Approximate Chainage	60 to 70m
Height	1.25m
Retaining height	0.25m to rear
Construction	450mm thick course random stone with vertical stone coping
Verticality	Leans back 30mm over height of wall. Bows out to centre
Condition	Poor
Notes	Self seeded vegetation to front and rear. Clear vegetation.  Wall to be taken down and ground to be reprofiled as part of redevelopment.

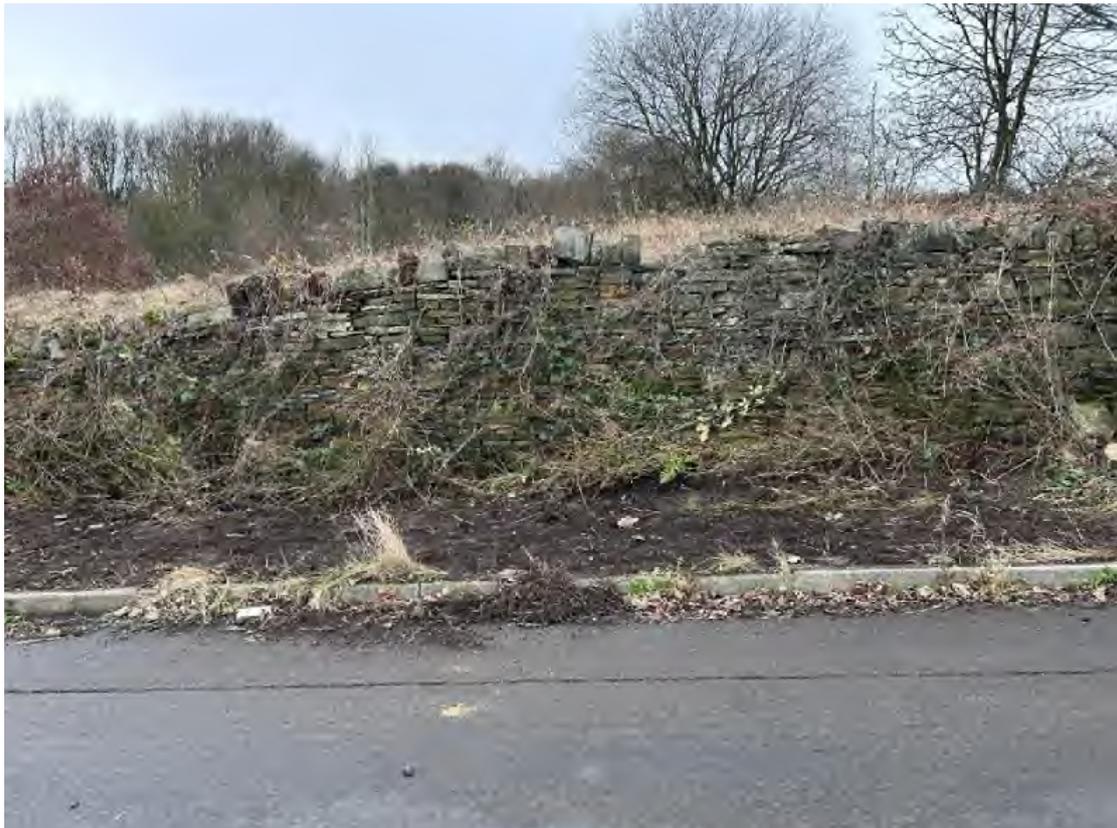
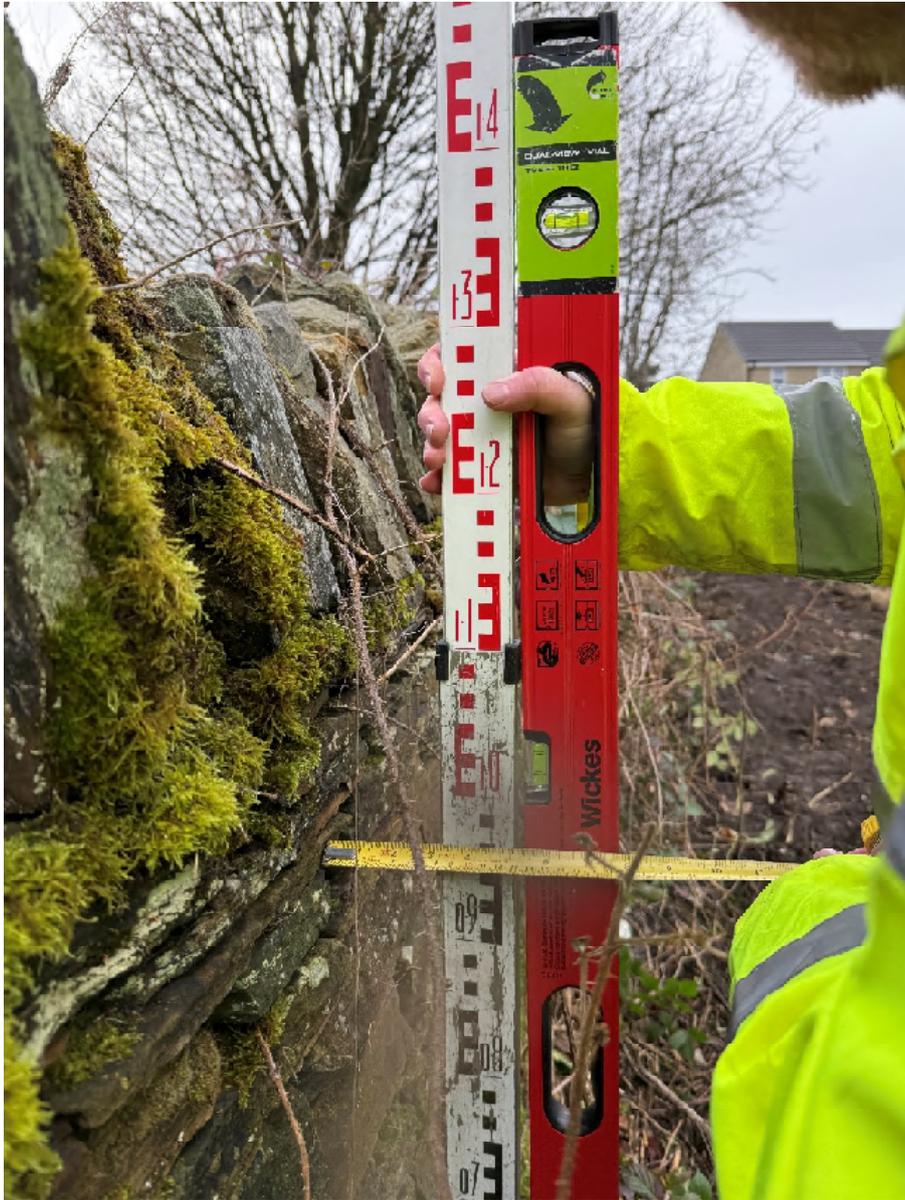
**Approximate Chainage 70m to 80m**

Approximate Chainage	70 to 80m
Height	1.5m
Retaining height	0.7m to rear
Construction	Coursed random stone with vertical stone coping
Verticality	Leans back 85mm over height of wall
Condition	Reasonable
Notes	Self seeded vegetation to front and rear. Clear vegetation.  Wall to be taken down and ground to be reprofiled as part of redevelopment.
