**P&A 4872-22/DJO**

**12<sup>th</sup> March 2025**

## **STRUCTURAL INSPECTION – HIGHWAY BOUNDARY WALL**

**Burn Road  
Birchencliffe  
Huddersfield**

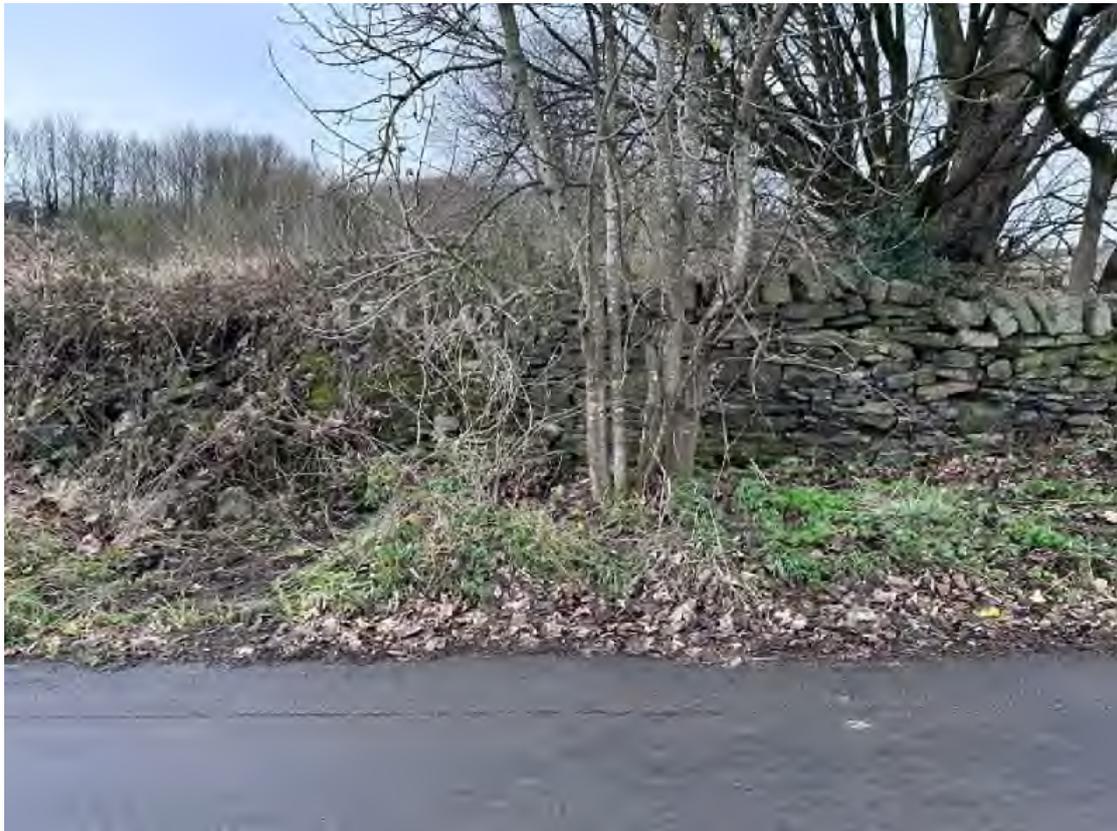
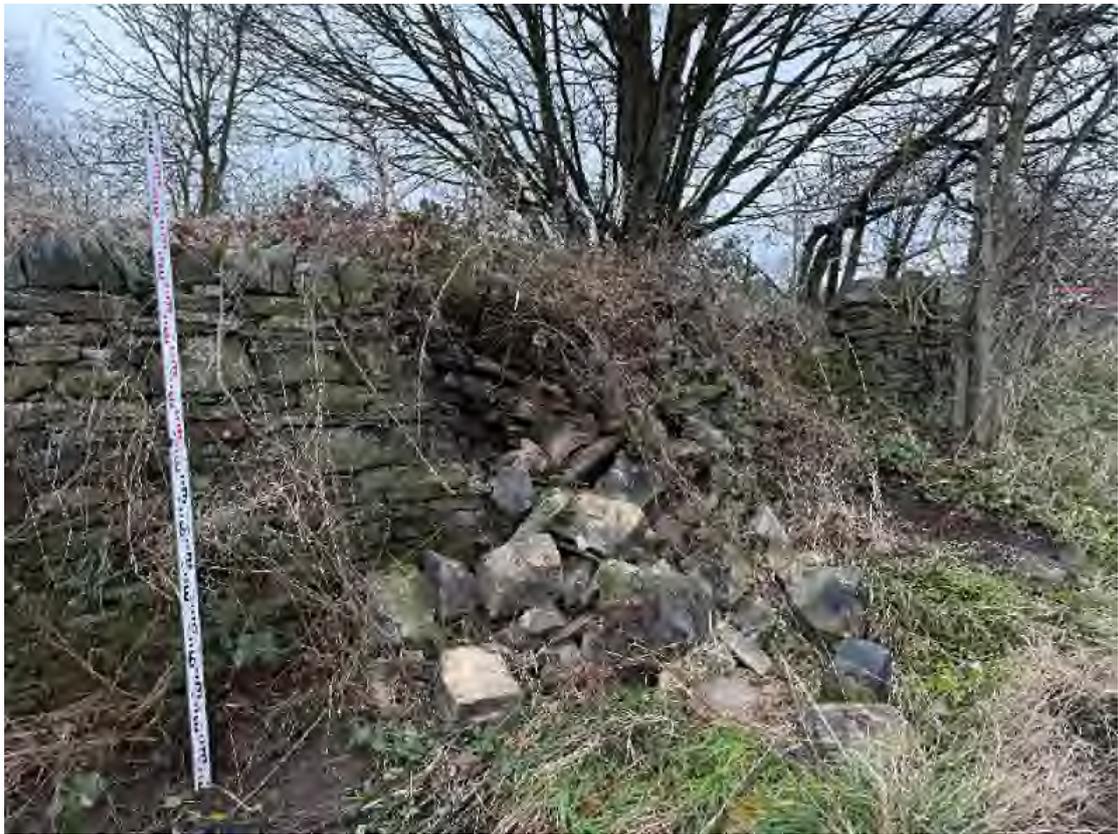
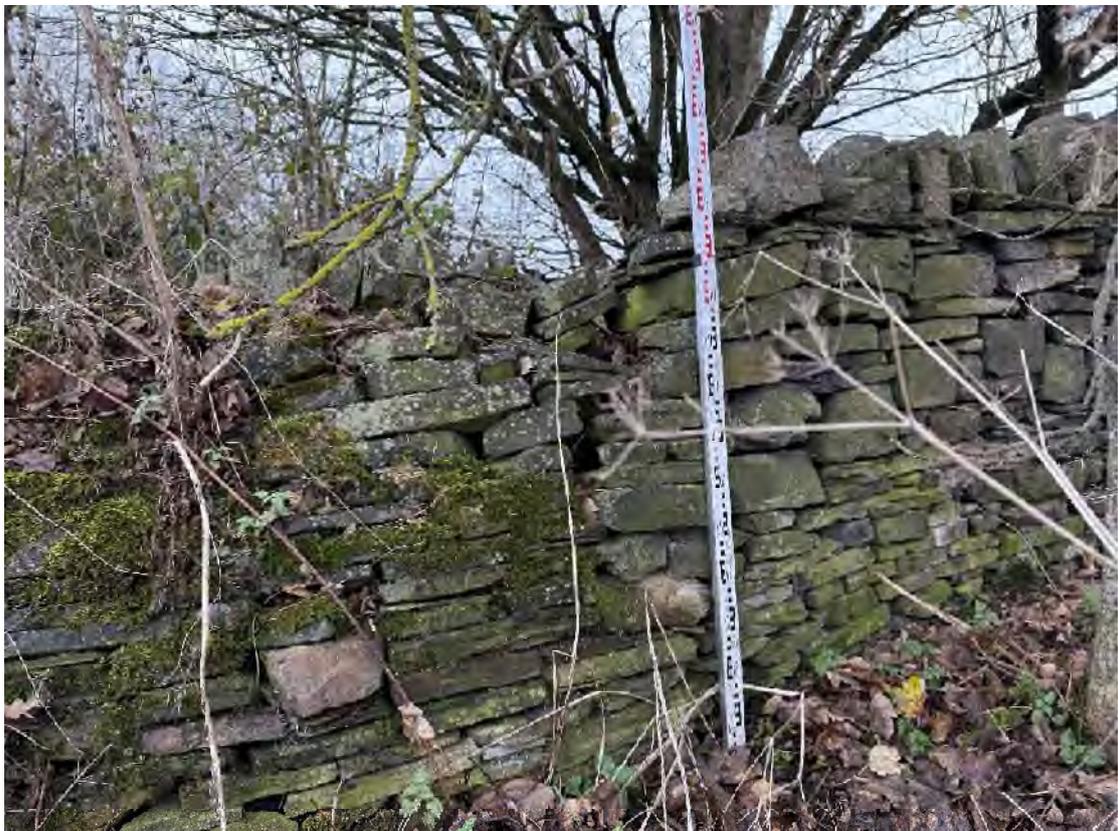
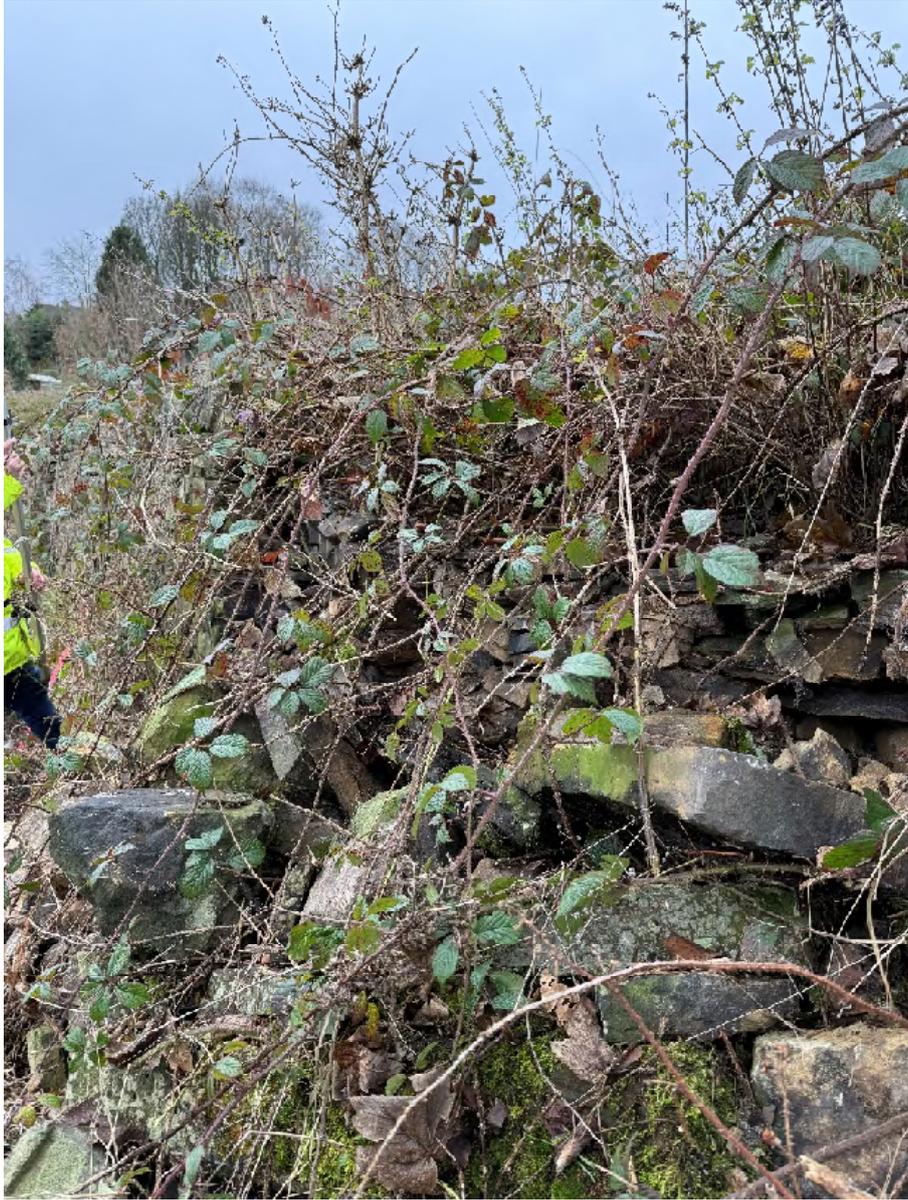
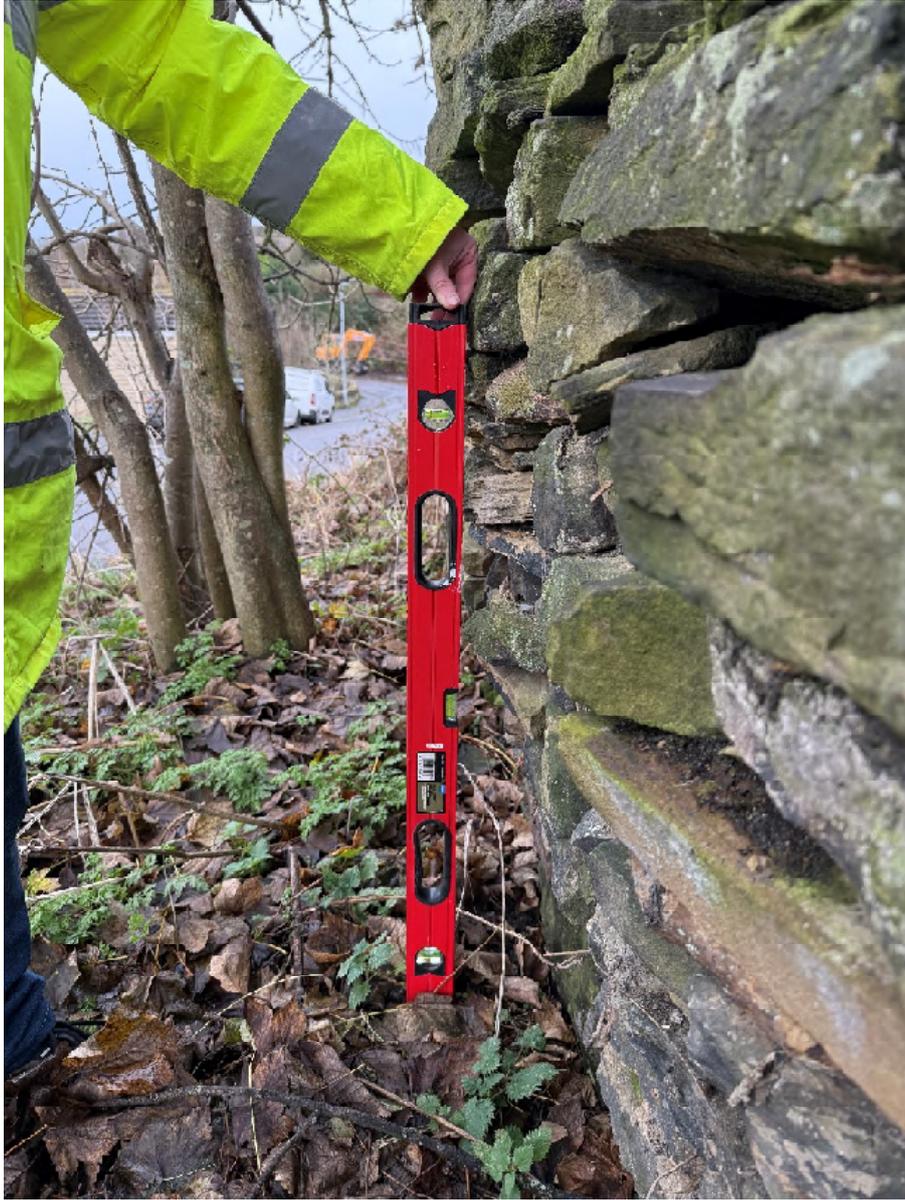
**Approximate Chainage 80m to 95m**

Approximate Chainage	80 to 95m
Height	1.8m to 1.4m
Retaining height	1.1m to 0.7m
Construction	450mm thick coursed random stone with vertical stone coping
Verticality	Leans forward between 150 & 240mm over height of wall. Partial collapse in centre of section
Condition	Poor
Notes	Self seeded vegetation to front and rear. Clear vegetation.  Wall to be taken down and ground to be reprofiled as part of redevelopment.
