**NorthWest
DrainServices**

Inspection Report

Project Name: Burn Rd 290125
Start Date: 29/01/2025
Client: Wiggett Construction Ltd
449 Middleton Road
Chadderton

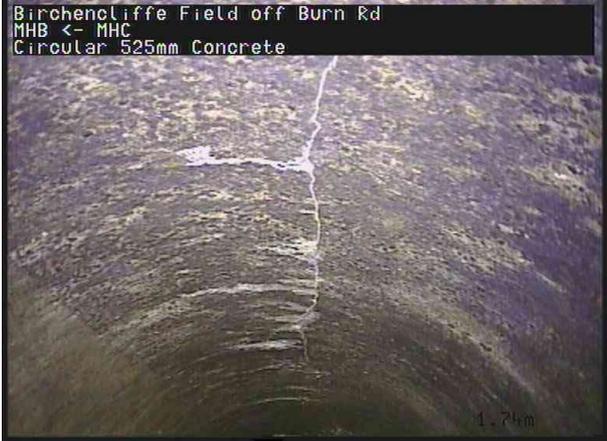
<table><tr> <td style="width: 10%;">0.00</td> <td style="width: 10%;">MH</td> <td style="width: 40%;">Start node, manhole, reference: MHC</td> <td style="width: 10%;">00:00:00</td> <td colspan="4"></td> </tr><tr> <td style="color: red;">1.74</td> <td style="color: red;">S01</td> <td style="color: red;">CLJ</td> <td style="color: red;">Crack, longitudinal at joint at 12 o'clock, start</td> <td style="color: red;">00:00:21</td> <td style="color: red;">MHBX_49 02609f-fe3 d-402d-93</td> <td colspan="2"></td> </tr></table>

MHBX_4902609f-fe3d-402d-9372-55a3a2014abb_20250129_120554_963.jpg, 00:00:21, 1.74 m
Crack, longitudinal at joint at 12 o'clock, start

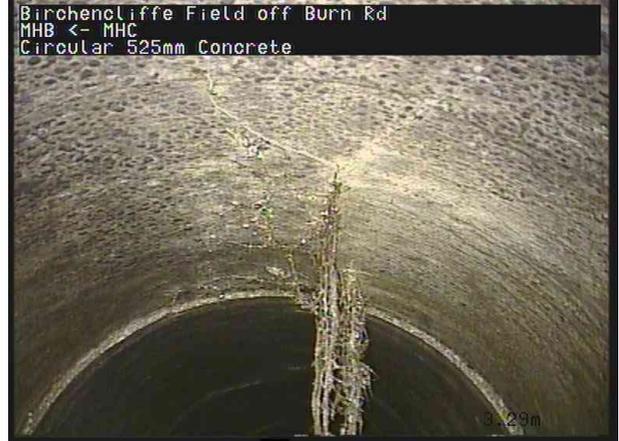
<table><tr> <td style="width: 10%;">0.00</td> <td style="width: 10%;">MH</td> <td style="width: 40%;">Start node, manhole, reference: MHC</td> <td style="width: 10%;">00:00:00</td> <td colspan="4"></td> </tr><tr> <td style="color: red;">3.29</td> <td style="color: red;">FLJ</td> <td style="color: red;">Fracture, longitudinal at joint at 12 o'clock</td> <td style="color: red;">00:00:43</td> <td style="color: red;">MHBX_5a e691b6-bb 29-40d4-b</td> <td colspan="2" style="color: red;">3 / 2</td> </tr></table>

MHBX_5ae691b6-bb29-40d4-b5ba-6857814673c3_20250129_120624_743.jpg, 00:00:43, 3.29 m
Fracture, longitudinal at joint at 12 o'clock

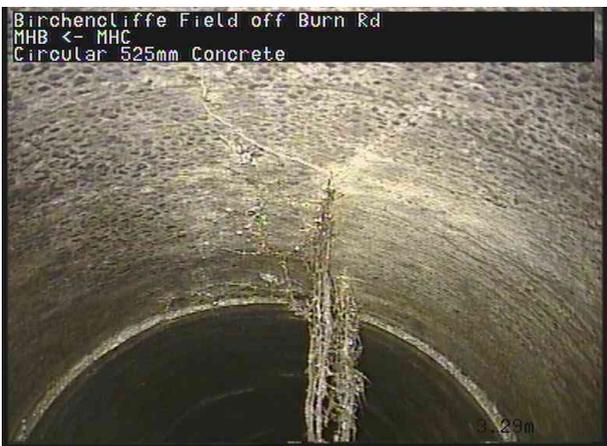
<table><tr> <td style="width: 10%;">0.00</td> <td style="width: 10%;">MH</td> <td style="width: 40%;">Start node, manhole, reference: MHC</td> <td style="width: 10%;">00:00:00</td> <td colspan="4"></td> </tr><tr> <td style="color: green;">3.29</td> <td style="color: green;">RFJ</td> <td style="color: green;">Roots, fine at joint</td> <td style="color: green;">00:00:45</td> <td style="color: green;">MHBX_46 b64558-28 ed-44bd-a</td> <td colspan="2" style="color: green;">2</td> </tr></table>

MHBX_46b64558-28ed-44bd-a651-023e1af7238f_20250129_120625_858.jpg, 00:00:45, 3.29 m
Roots, fine at joint

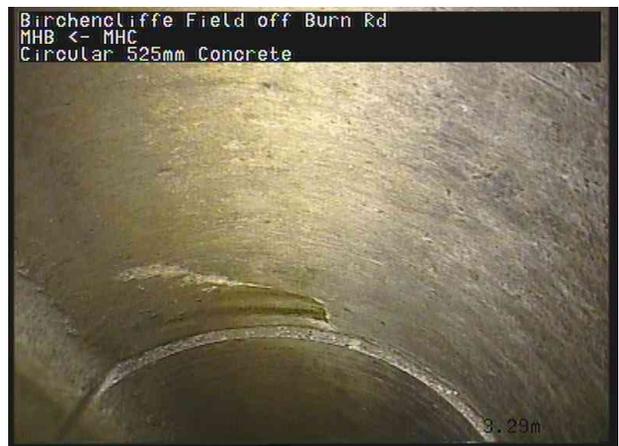
<table><tr> <td style="width: 10%;">0.00</td> <td style="width: 10%;">MH</td> <td style="width: 40%;">Start node, manhole, reference: MHC</td> <td style="width: 10%;">00:00:00</td> <td colspan="4"></td> </tr><tr> <td style="color: red;">3.29</td> <td style="color: red;">FCJ</td> <td style="color: red;">Fracture, circumferential at joint from 7 o'clock to 8 o'clock</td> <td style="color: red;">00:00:54</td> <td style="color: red;">MHBX_fd8 386f7-54df -4000-ad3</td> <td colspan="2" style="color: red;">3 / 2</td> </tr></table>

MHBX_fd8386f7-54df-4000-ad30-053cb1881fe6_20250129_120636_036.jpg, 00:00:54, 3.29 m
Fracture, circumferential at joint from 7 o'clock to 8 o'clock

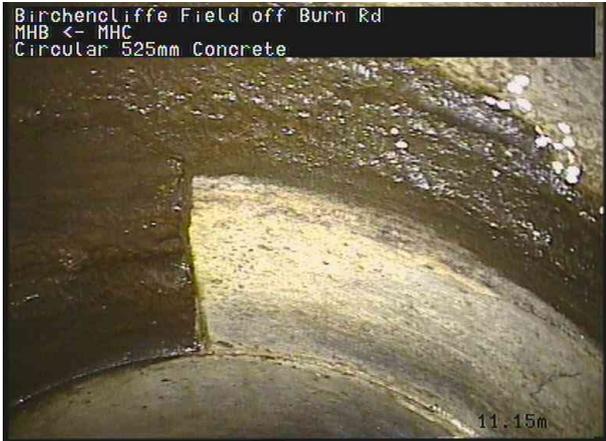
<table><tr> <td style="width: 10%;">0.00</td> <td style="width: 10%;">MH</td> <td style="width: 40%;">Start node, manhole, reference: MHC</td> <td style="width: 10%;">00:00:00</td> <td colspan="4"></td> </tr><tr> <td style="color: red;">11.15</td> <td style="color: red;">FLJ</td> <td style="color: red;">Fracture, longitudinal at joint at 10 o'clock</td> <td style="color: red;">00:01:46</td> <td style="color: red;">MHBX_02 d508dd-4f 11-45eb-9</td> <td colspan="2" style="color: red;">3 / 2</td> </tr></table>

MHBX_02d508dd-4f11-45eb-9911-8205e1384e13_20250129_120732_536.jpg, 00:01:46, 11.15 m
Fracture, longitudinal at joint at 10 o'clock

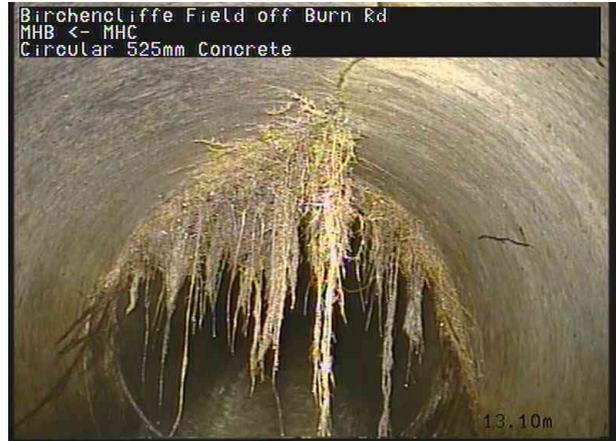
<table><tr> <td style="width: 10%;">0.00</td> <td style="width: 10%;">MH</td> <td style="width: 40%;">Start node, manhole, reference: MHC</td> <td style="width: 10%;">00:00:00</td> <td colspan="4"></td> </tr><tr> <td style="color: green;">13.10</td> <td style="color: green;">RMJ</td> <td style="color: green;">Roots, mass at joint, 10% cross-sectional area loss</td> <td style="color: green;">00:02:02</td> <td style="color: green;">MHBX_15 6a6ace-ce ed-4cd4-8</td> <td colspan="2" style="color: green;">3</td> </tr></table>

MHBX_156a6ace-ceed-4cd4-84e7-cd8e9dfab62b_20250129_120754_011.jpg, 00:02:02, 13.10 m
Roots, mass at joint, 10% cross-sectional area loss

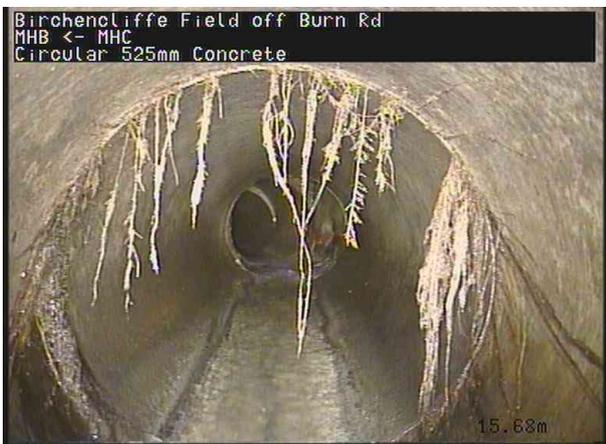
<table><tr> <td style="width: 10%;">0.00</td> <td style="width: 10%;">MH</td> <td style="width: 40%;">Start node, manhole, reference: MHC</td> <td style="width: 10%;">00:00:00</td> <td colspan="4"></td> </tr><tr> <td style="color: green;">15.68</td> <td style="color: green;">RFJ</td> <td style="color: green;">Roots, fine at joint</td> <td style="color: green;">00:02:27</td> <td style="color: green;">MHBX_24 0d1130-87 82-46b3-b</td> <td colspan="2" style="color: green;">2</td> </tr></table>

MHBX_240d1130-8782-46b3-b970-54563cebf36f_20250129_120820_170.jpg, 00:02:27, 15.68 m
Roots, fine at joint

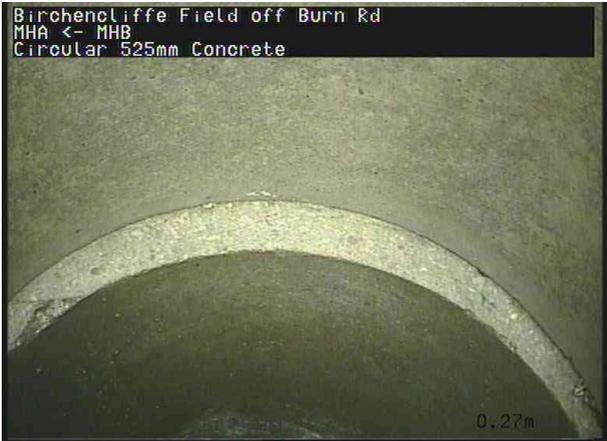
<table><tr> <td style="width: 10%;">0.00</td> <td style="width: 10%;">MH</td> <td style="width: 40%;">Start node, manhole, reference: MHB</td> <td style="width: 10%;">00:00:00</td> <td></td> <td></td> </tr><tr> <td style="color: red;">0.27</td> <td style="color: red;">JDL</td> <td style="color: red;">Joint displaced, large</td> <td style="color: red;">00:00:07</td> <td style="color: red;">MHAX_77 c784c2-de 17-4d7a-9</td> <td style="color: red;">1 / 4</td> </tr></table>

MHAX_77c784c2-de17-4d7a-96d9-b451de4af122_20250129_123353_262.jpg, 00:00:07, 0.27 m
Joint displaced, large

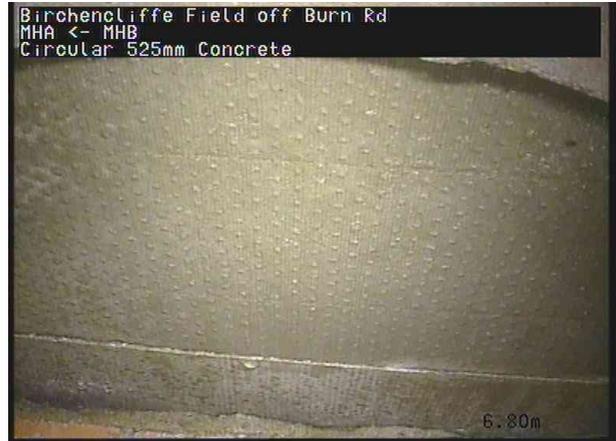
<table><tr> <td style="width: 10%;">0.00</td> <td style="width: 10%;">MH</td> <td style="width: 40%;">Start node, manhole, reference: MHB</td> <td style="width: 10%;">00:00:00</td> <td></td> <td></td> </tr><tr> <td style="color: blue;">7.94</td> <td style="color: blue;">REM</td> <td style="color: blue;">General remark: BURIED CHAMBER</td> <td style="color: blue;">00:01:14</td> <td style="color: blue;">MHAX_e0 ea8e83-07 4e-41ff-a0</td> <td></td> </tr></table>

MHAX_e0ea8e83-074e-41ff-a02e-53461ab5a0f7_20250129_121645_989.jpg, 00:01:14, 7.94 m
General remark, BURIED CHAMBER

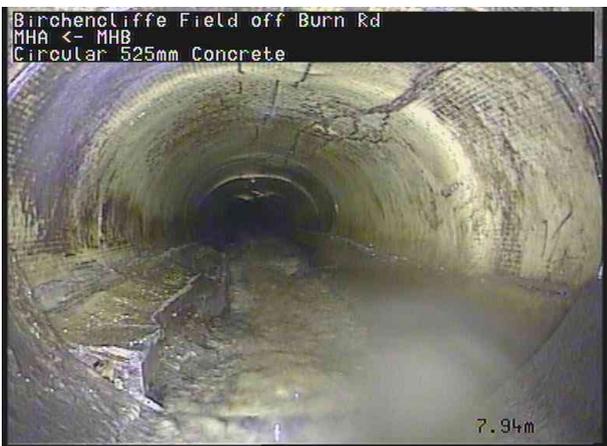
<table><tr> <td style="width: 10%;">0.00</td> <td style="width: 10%;">MH</td> <td style="width: 40%;">Start node, manhole, reference: MHB</td> <td style="width: 10%;">00:00:00</td> <td></td> <td></td> </tr><tr> <td style="color: blue;">7.94</td> <td style="color: blue;">S01</td> <td style="color: blue;">LXEB Defective lining, external bulge at 8 o'clock, start</td> <td style="color: blue;">00:02:00</td> <td style="color: blue;">MHAX_20 aded6e-64 83-4bcf-90</td> <td></td> </tr></table>

MHAX_20aded6e-6483-4bcf-905e-97497a368623_20250129_123712_684.jpg, 00:02:00, 7.94 m
Defective lining, external bulge at 8 o'clock, start

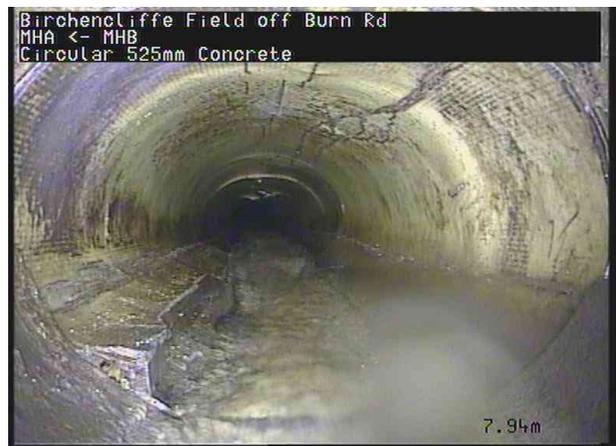
<table><tr> <td style="width: 10%;">0.00</td> <td style="width: 10%;">MH</td> <td style="width: 40%;">Start node, manhole, reference: MHB</td> <td style="width: 10%;">00:00:00</td> <td></td> <td></td> </tr><tr> <td style="color: red;">7.94</td> <td style="color: red;">S02</td> <td style="color: red;">DV Deformed vertically, 20%, start</td> <td style="color: red;">00:02:06</td> <td style="color: red;">MHAX_62 035e76-38 bb-428c-b</td> <td></td> </tr></table>

MHAX_62035e76-38bb-428c-bcb8-4c098ad35ab2_20250129_123724_033.jpg, 00:02:06, 7.94 m
Deformed vertically, 20%, start

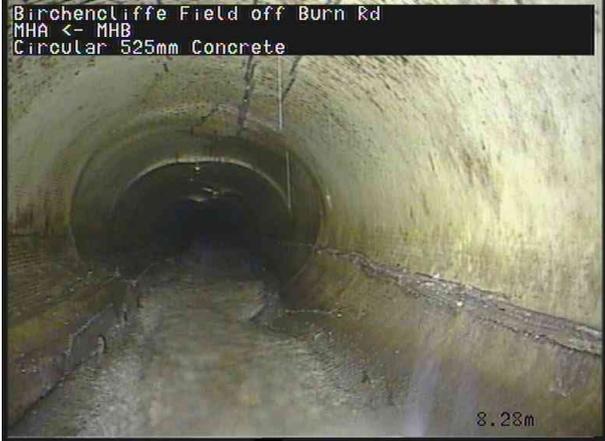
<table><tr> <td style="width: 10%;">0.00</td> <td style="width: 10%;">MH</td> <td style="width: 40%;">Start node, manhole, reference: MHB</td> <td style="width: 10%;">00:00:00</td> <td></td> <td></td> </tr><tr> <td style="color: blue;">8.28</td> <td style="color: blue;">SA</td> <td style="color: blue;">Survey abandoned: DUE TO DEFECTIVE LINER</td> <td style="color: blue;">00:03:22</td> <td style="color: blue;">MHAX_30 988d4e-da bc-4fd3-ab</td> <td></td> </tr></table>

MHAX_30988d4e-dabc-4fd3-ab97-8154044a9564_20250129_123903_044.jpg, 00:03:22, 8.28 m
Survey abandoned, DUE TO DEFECTIVE LINER

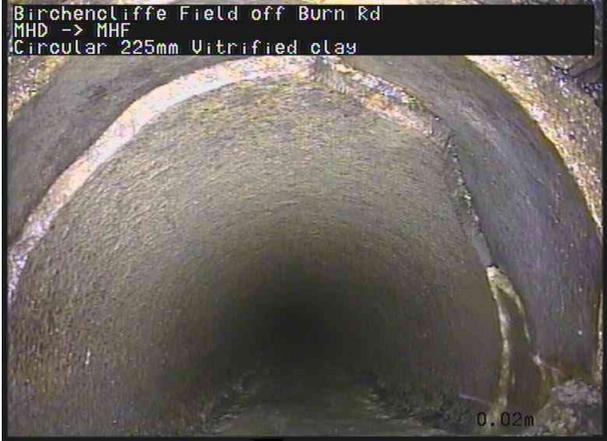
<table><tr> <td style="text-align: right;">0.00</td> <td>MH</td> <td>Start node, manhole, reference: MHD</td> <td>00:00:00</td> <td></td> <td></td> <td></td> </tr><tr> <td style="text-align: right;">0.02</td> <td>B</td> <td>Broken pipe from 7 o'clock to 5 o'clock</td> <td>00:00:04</td> <td>MHDX_07 d47304-f1 1e-4cef-a6</td> <td></td> <td>4</td> </tr></table>

MHDX_07d47304-f11e-4cef-a6ad-3201fbd16c49_20250129_1
25707_564.jpg, 00:00:04, 0.02 m
Broken pipe from 7 o'clock to 5 o'clock

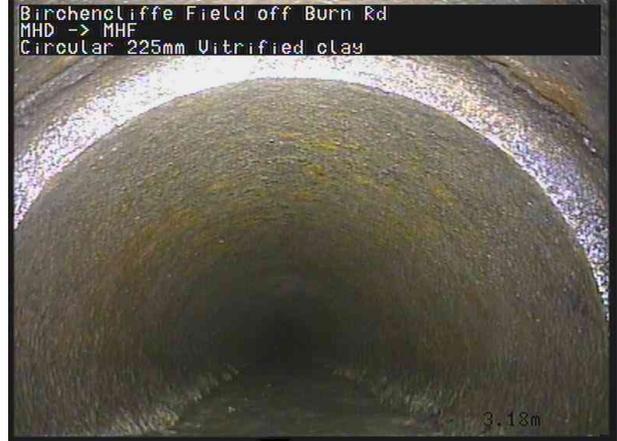
<table><tr> <td style="text-align: right;">0.00</td> <td>MH</td> <td>Start node, manhole, reference: MHD</td> <td>00:00:00</td> <td></td> <td></td> <td></td> </tr><tr> <td style="text-align: right;">3.18</td> <td>JDM</td> <td>Joint displaced, medium</td> <td>00:00:36</td> <td>MHDX_53 ac9ce9-f26 7-4653-a7</td> <td></td> <td>1 / 3</td> </tr></table>

MHDX_53ac9ce9-f267-4653-a7b8-27238d9bccac_20250129_1
125744_860.jpg, 00:00:36, 3.18 m
Joint displaced, medium

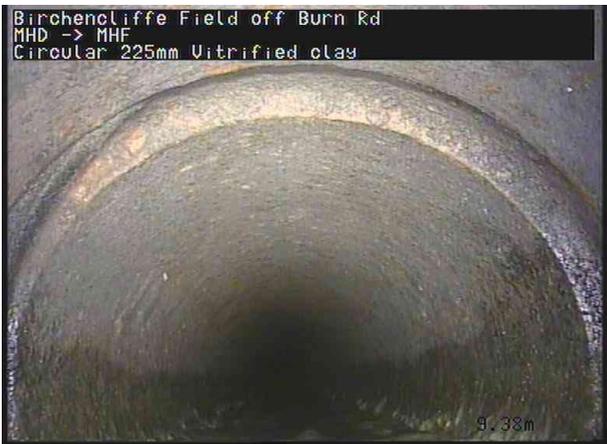
<table><tr> <td style="text-align: right;">0.00</td> <td>MH</td> <td>Start node, manhole, reference: MHD</td> <td>00:00:00</td> <td></td> <td></td> <td></td> </tr><tr> <td style="text-align: right;">9.38</td> <td>JDM</td> <td>Joint displaced, medium</td> <td>00:01:19</td> <td>MHDX_87 d915cf-dc0 7-4ac9-89</td> <td></td> <td>1 / 3</td> </tr></table>

MHDX_87d915cf-dc07-4ac9-8970-d156ab7fe081_20250129_1
25828_940.jpg, 00:01:19, 9.38 m
Joint displaced, medium
