# **SECOND LIMITED** **STRUCTURAL REPORT**

| Project | 13 Well Hill, Honley, HD9 6JF |
| Project Number | 2025/116 |

**Second Limited Structural Conditional Report on chimney and gable  
wall at 13 Well Hill, Honley, HD9 6JF  
as inspected from the top of the scaffolding**

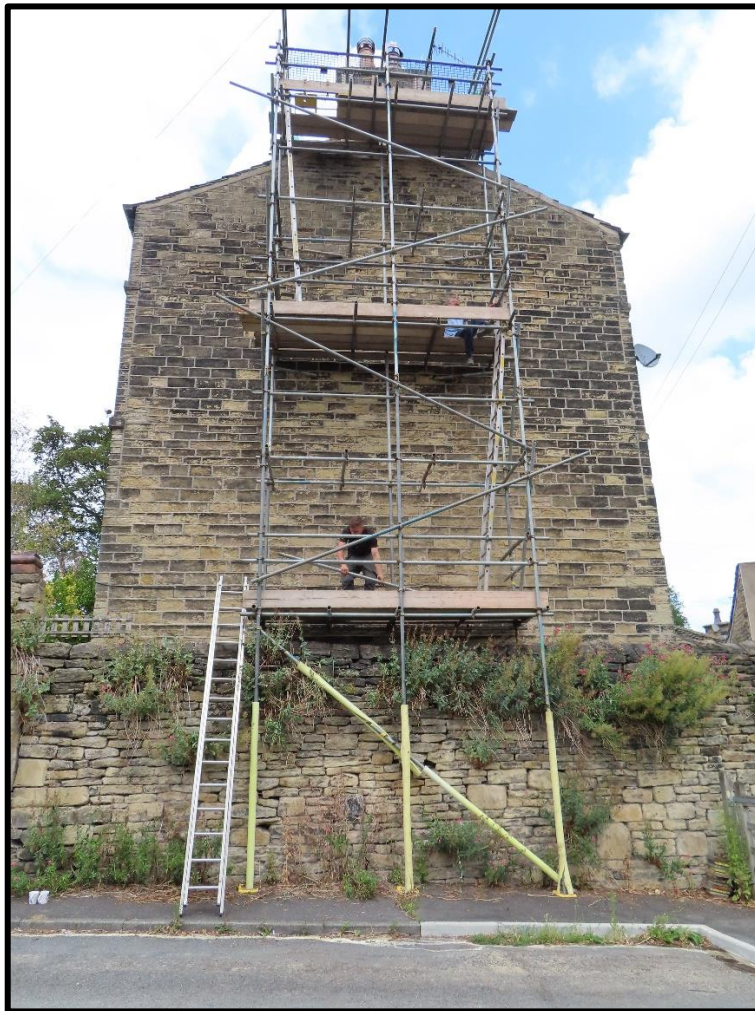
“ Elevation on gable with scaffold adjacent Westcroft Road”

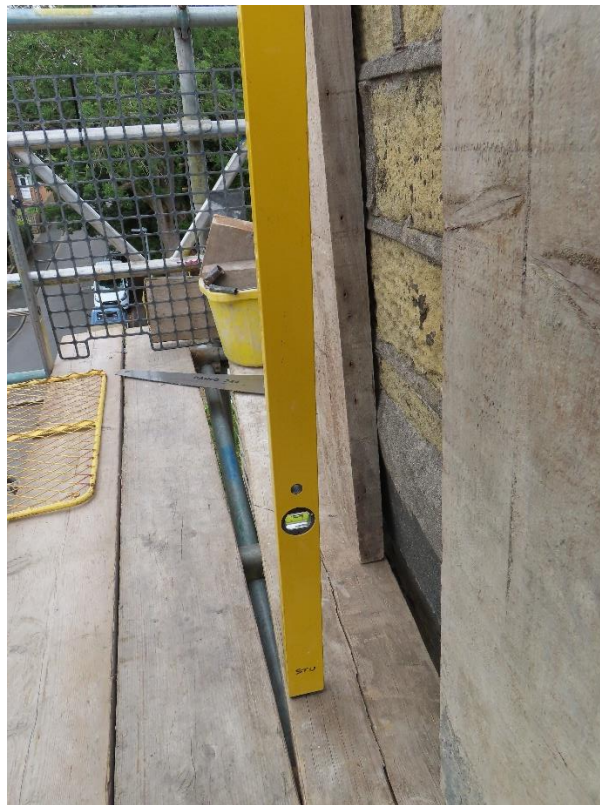
1. The chimney stack has a severe outward lean, which has now been measured as 200mm out of plumb using a 1.8m long builder's spirit level, for the height of the 1.2m height of the stack.

3. As previously stated in our prior report, this severely leaning chimney stack could collapse. Furthermore, the top of the gable wall also has a significant outward lean, which is also dangerous to pedestrians.

Photo 1 – Chimney lean at the top measured as 200mm out of plumb.

1. The chimney stack should be rebuilt identical to the original using the same stonework in a sand-cement mortar mix. The weathered lower course of stone should be replaced with reclaimed stone to match the original. The original chimney pots should be reinstalled. All as previously stated in our initial report.

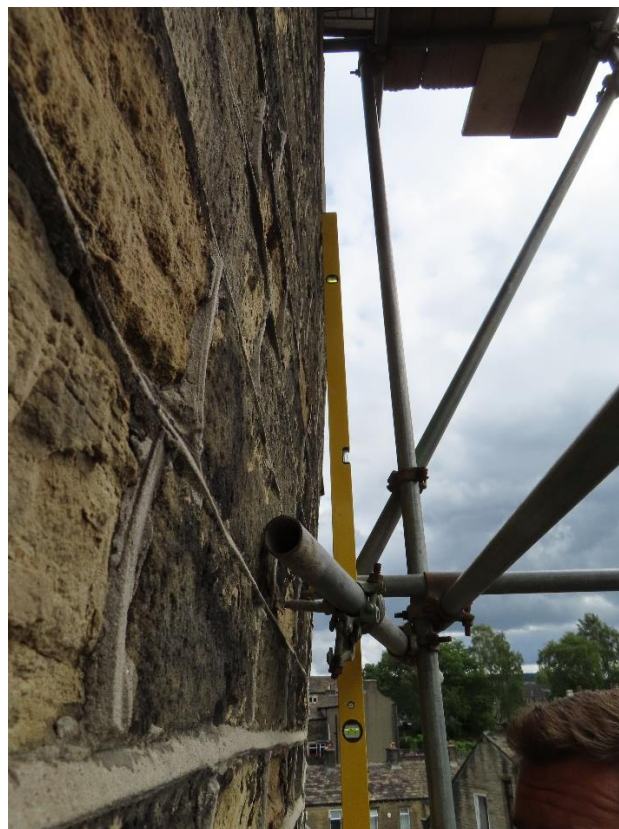
2. The gable wall peak was also significantly out of plumb as now seen from the top of the scaffolding. This outward lean was measured as being 150mm above the level of the projecting front sill stone to the top of the gable wall. The outward lean at the front of the gable was approx. 90mm from the front eaves down to the sill stone level. The front eaves height was measured as being 1.35m high above the sill stone, the gable peak was measured as being 2.75m high.

Photo 2 – Lean to the top of the gable peak measured as being a further 150mm additional to the chimney lean.

2. In addition the gable outer leaf should be taken down and re-built plumb. This would apply for the upper 2.75m from the sill stone level upwards.
3. The outer leaf should be rebuilt incorporating long stainless steel 'L-shaped' straps at 750mm horizontal centres and 450mm staggered vertical centres.

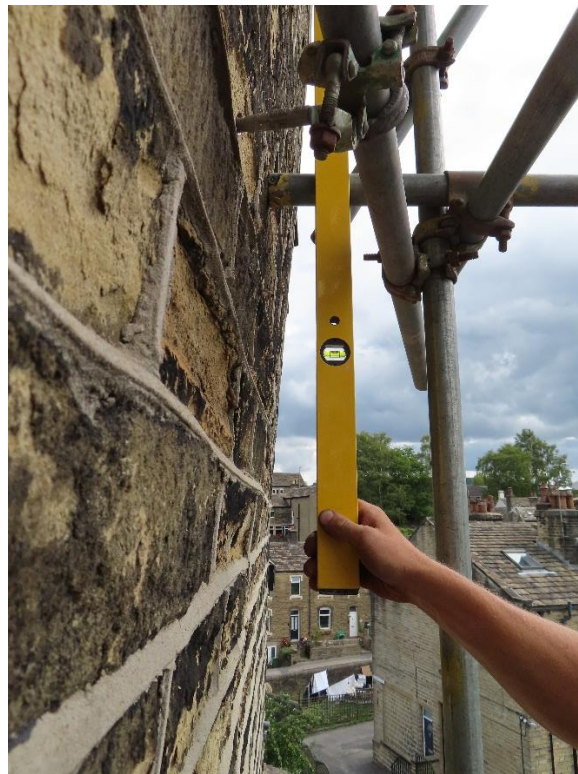
Photo 3 – Top gable lean from front sill stone level upwards. Lean at the front of the gable was measured as 90mm approx. to this 1.35m height above the sill stone level.

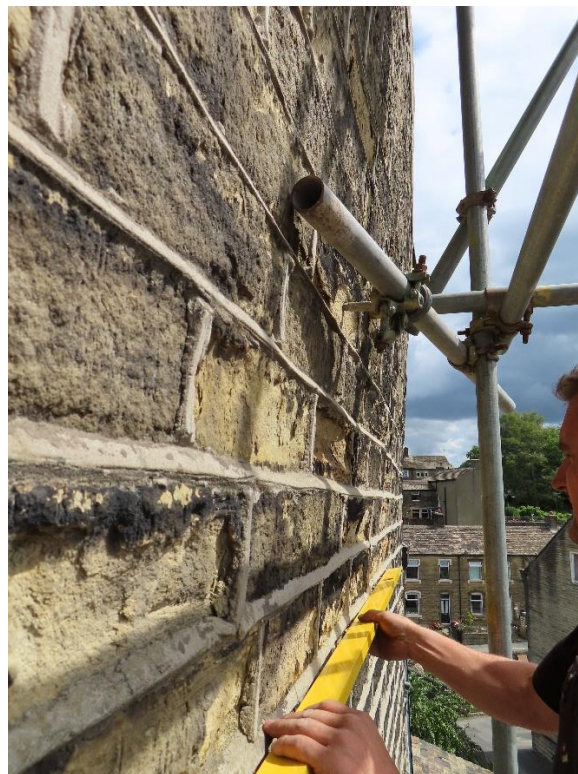
Photo 4 – The builder's spirit level denotes the height to which the outer leaf of the gable wall needs to be taken down and re-built.

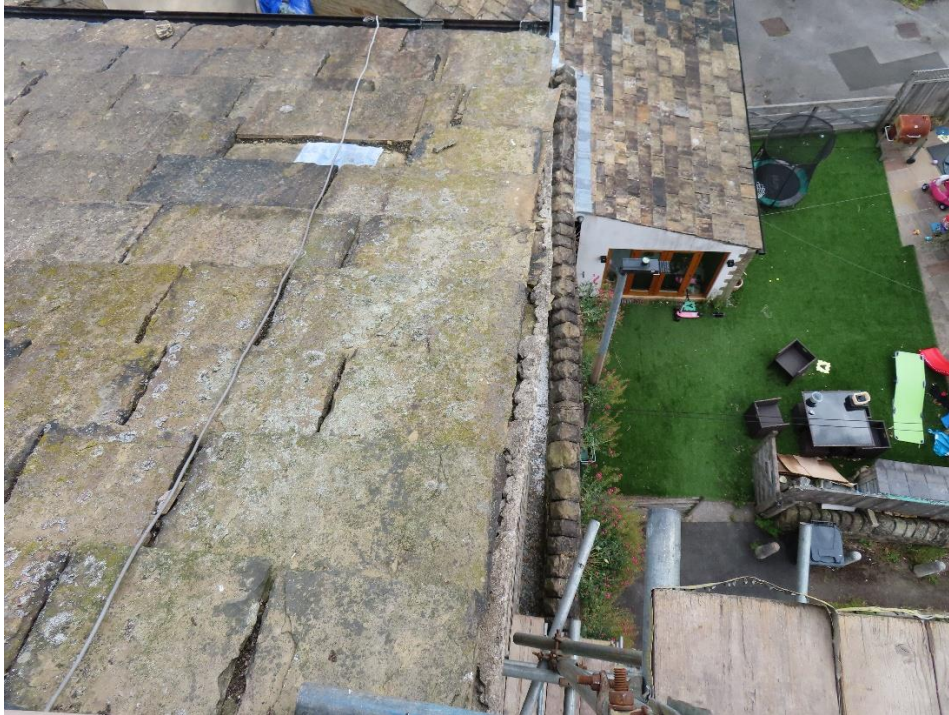
Photo 5 – Exposed top of the stone leaf can be seen as the external leaf of the gable walling has moved out. The stone roof 'slate' finishes are fixed to roof rafters, which are fixed to purlins sat on the inner leaf. Evidence that the inner leaf is moving out far less than the outer leaf stonework.

4. Straps can be installed to the ends of the purlins in the upper portion of the peak and threaded through to the internal small void above the flat ceiling.

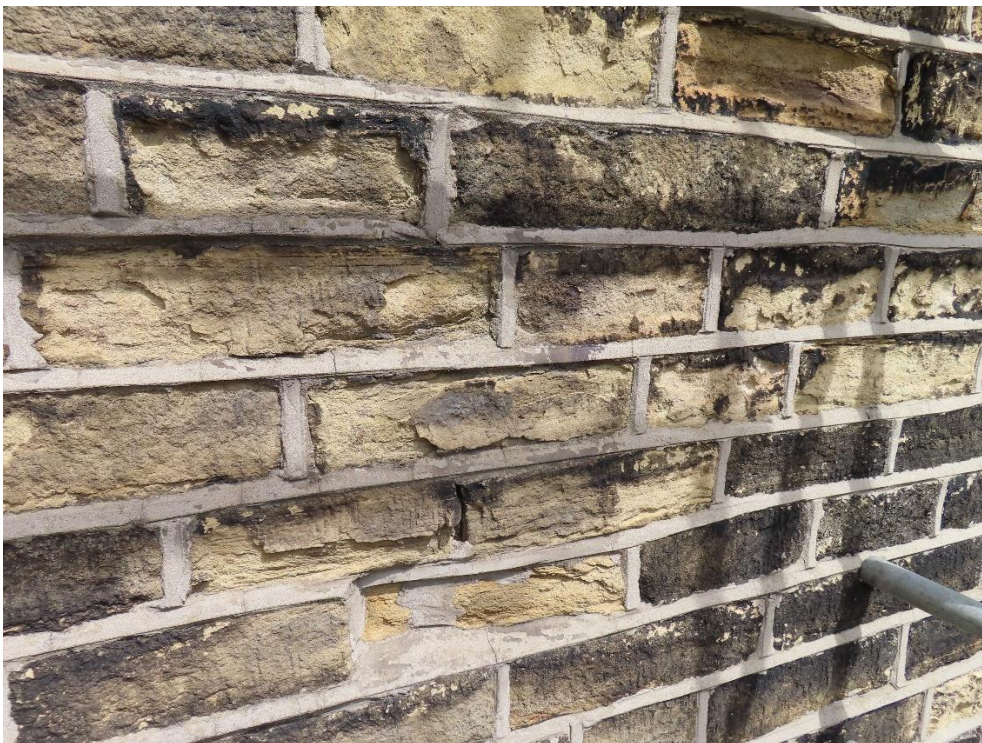
4. Pointing to the outer stonework also has dozens of cracks.
5. In addition to the chimney the outer leaf of the peak of the gable wall will need to be dismantled and re-built. See recommendations below.

Photo 6 – Dozens of tension cracks were seen to the gable pointing as the gable external leaf moves out, increasing the curvature of the external leaf.

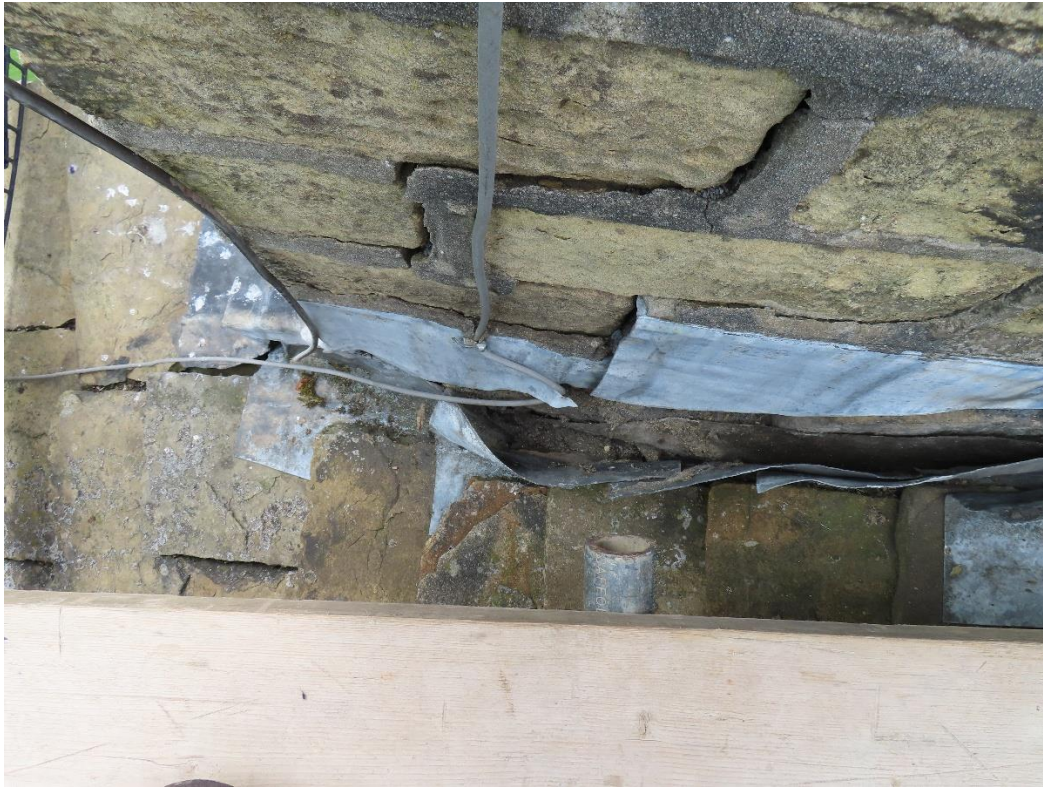
Photo 7 – Massive cracks to the rear of the chimney stack and tearing away of the lead flashings were seen.

8. Lead flashings should be replaced.
9. The Local Authority Listed Buildings Department should be advised before undertaking the additional work.

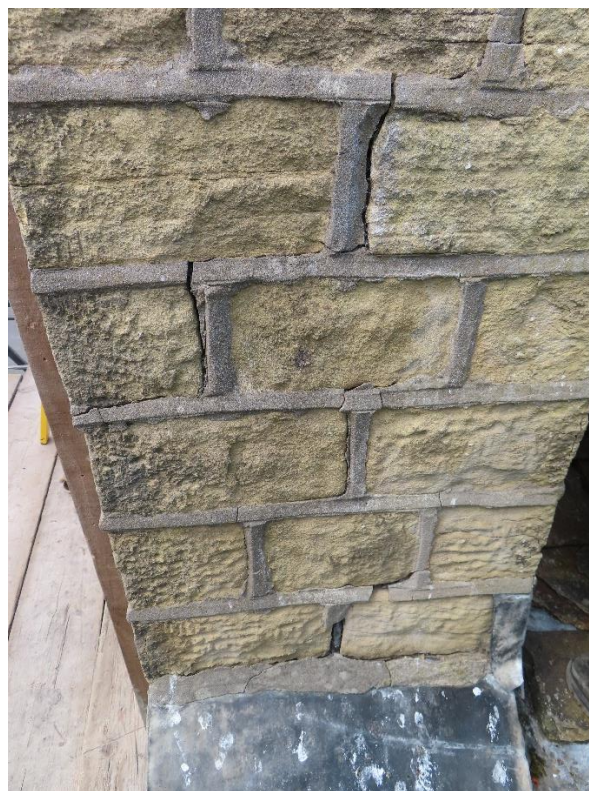
Photo 8 – Cracking was seen on all faces of the chimney stack.
