## **Huddersfield Bus Station**

Intrusive Survey Findings  
HDS-ROS-ZZ-XX-R-S-00500

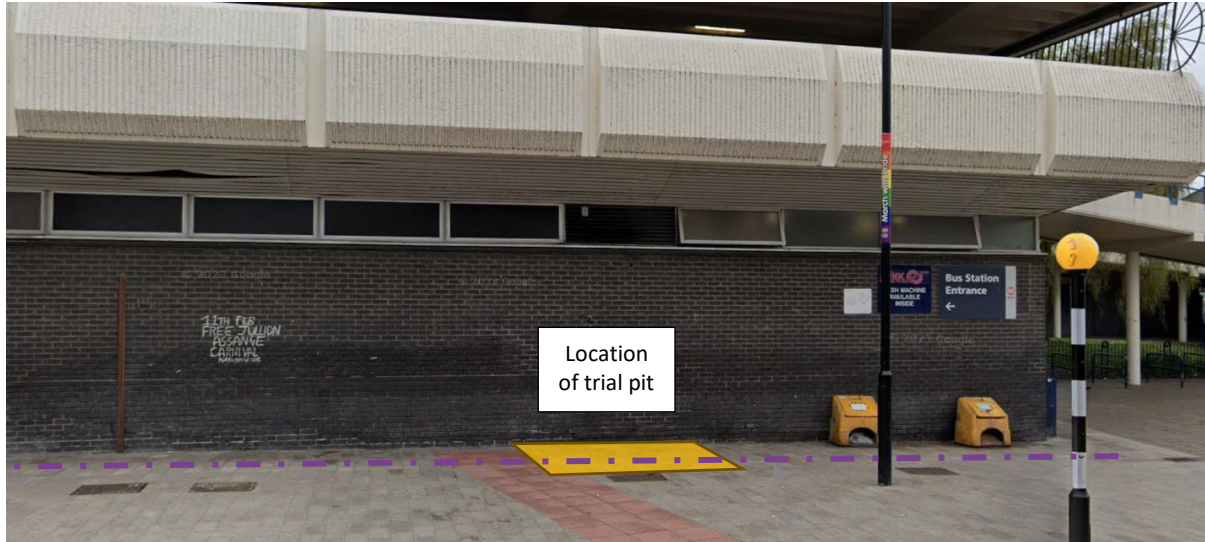
Figure 2: Location of Trial Pit on Upperhead Row

Required to determine existing slab edge and foundations, to inform detail where new drainage to the travel centre passes under the existing external wall, and how new stone cladding will be supported. Locate local to cracking in existing brickwork to determine potential for inadequate footings influencing the brickwork defects.

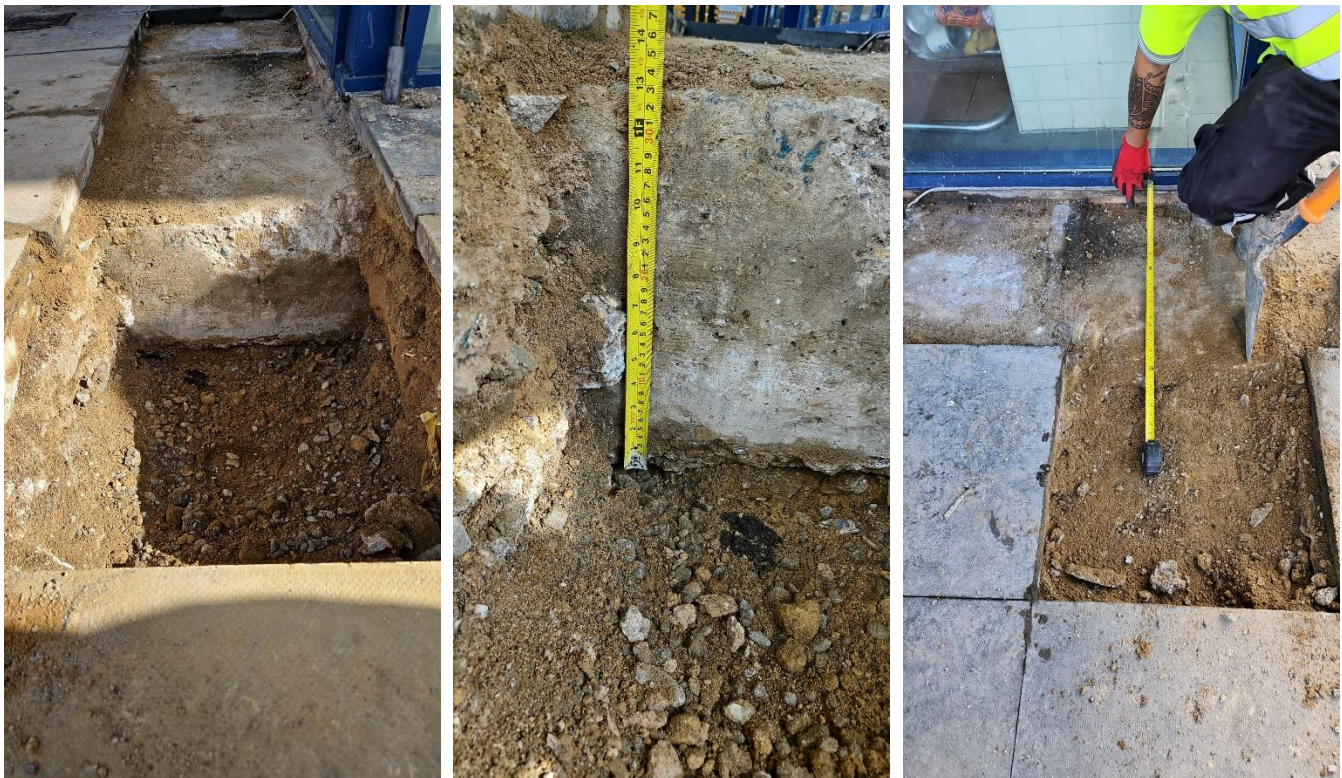
The intrusive investigation has verified the presence of an external slab with a thickness of 300mm, overlaid by approximately 80mm of finishes comprising beading and pavement planks. The slab extends beyond the building's footprint by 400mm along Market Street and 600mm along the Bus DIRO elevation.

The foundations of the primary structural frame were not encountered during the investigation, as initially anticipated. However, it is presumed that these foundations bearing on "firm to stiff brown, light grey, and orange-brown mottled, slightly sandy clay" located approximately 1 meter below the ground surface.

The material identified beneath the slab is classified as "light brown made ground, containing angular gravel-sized fragments with sand."

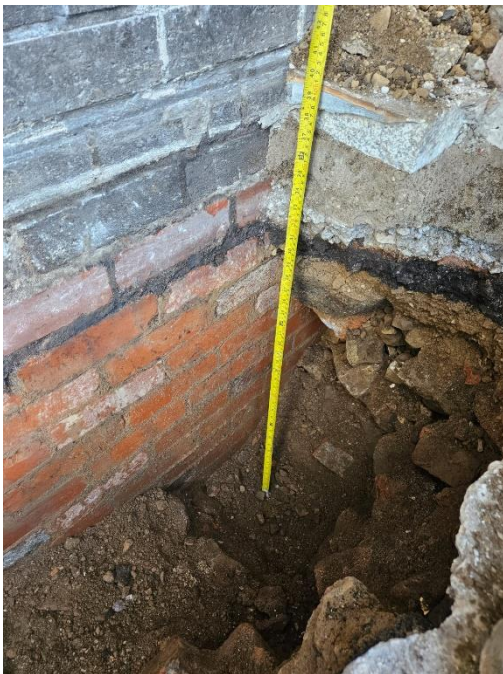
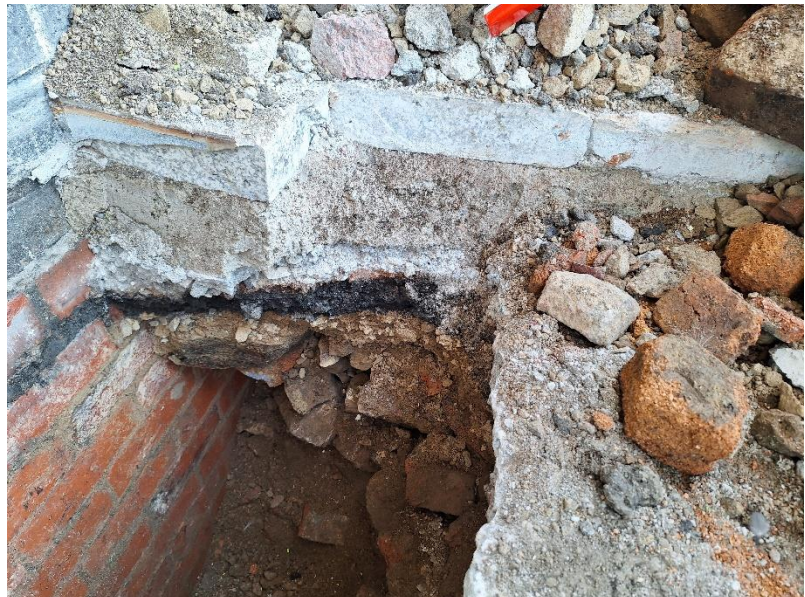
Trial pit excavation confirmed that the brickwork elevation extends to a minimum depth of 1 meter. It is anticipated that the brickwork is supported on a strip foundation bearing on firm to stiff clay, characterized as "firm to stiff brown, light grey, and orange-brown mottled, slightly sandy clay," encountered at approximately 1 meter below ground level.

According to BS 8004:1986, the expected bearing capacity of firm to stiff clay ranges between 100–300 kN/m<sup>2</sup>. Based on these findings and the applied load, the external wall foundation is not considered inadequate.

However, it is noted that no expansion or movement joints are present within 6 meters of the building corner. This does not align with the recommendations outlined in Eurocode 6 or the Brick Development Association (BDA) guide on the design for movement in brickwork.
