ELEVATION RECONSTRUCTION

L.A.C.E. L.A. CONSULTING ENGINEERS LTD 6 Gomersal Lane Bradford BD19 4AE Tel: 07788 313985 Email: Lee@lacetld.co.uk					
PROJECT					
Whitecross Farm, Emley					
DRAWING TITLE					
Elevation Repair					
CLIENT					
Carter Jonas LLP					
STATUS					
Information					
DRAWN	LA	DATE	04/09/2024		
CHECKED	KA	SCALE			
APPROVED	LA	AS SHOWN @ A1			
DRAWING NUMBER	LACE DP 24-074-001			REVISION	-

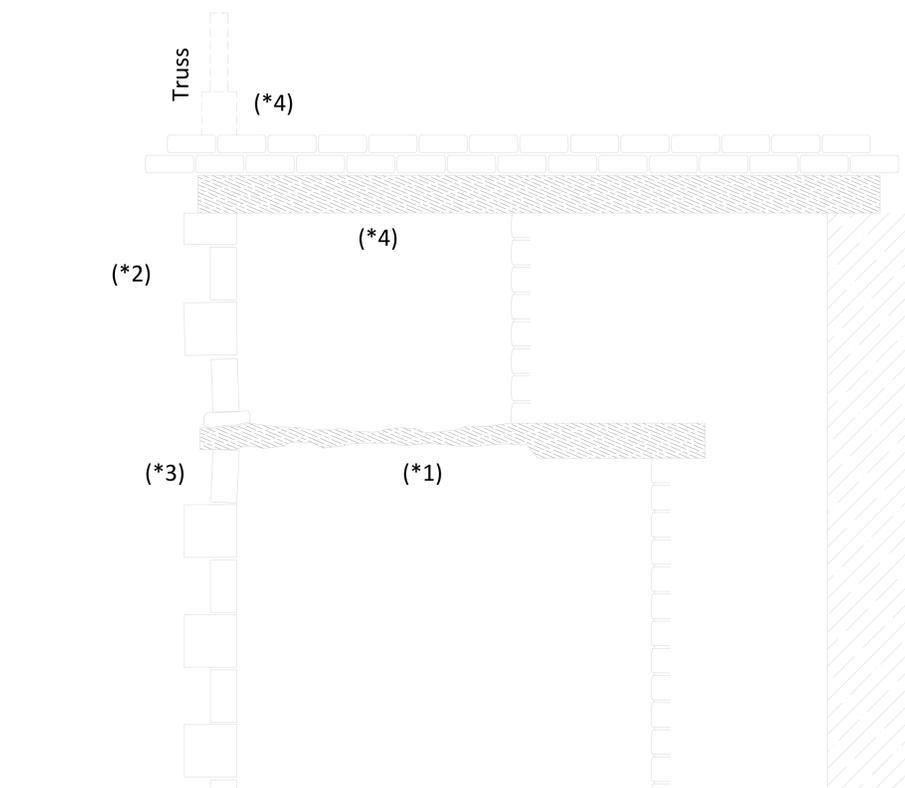
(*1) : Oak lintel to infill stonework has failed following direct exposure to weathering over a period time. Failed lintel to be carefully removed and replaced with a reclaimed 225 x 225 mm oak section with approximately 250 mm bearing each end to match lintel removed. Replacement section to be UV treated for external use. Inner leaf existing oak section to be carefully inspected on full exposure to ensure bearings or section are showing no signs of rot / damage, confirmation photos to be sent to LACE LTD.

(*2) : Stonework to West of historic barn entrance is severely weathered in areas. Areas of weathered masonry to be carefully taken down during reconstruction of elevation/entrance. Rubble fill to wall to be carefully removed with outer leaf of stonework. Elevation to be reinstated during reconstruction with matching reclaimed stonework constructed using lime mortar with through stones and rubble fill to cavity reinstated where present.

(*3) : Stone quoins to West of historic barn entrance have displaced following failure of lintel (*1). Quoins are to be carefully taken down in order during reconstruction, numbered and reinstated in order during reconstruction using lime mortar.

IMPORTANT - Masonry/window opening over oak beams to be reinstated to match historic elevation prior to collapse - tenant to confirm window position and size to contractor. Masonry over to be reinstated as (*2).

(*4) : Existing oak king post truss, timber wall plates and historic barn door lintel to be propped to specialist design and detail to allow for clear working access for repair works and support while masonry is removed and reconstructed. Mabey Hire or similar to be consulted for site inspection and detailed design of propping scheme.
