LACE 25-010-DOC001

White Cross Farm, Emley – Cart Shed Removal

Our inspection was undertaken to provide an opinion on the condition of the South Elevation cart shed with a view to providing an opinion on the reconstruction / demolition of the structure.

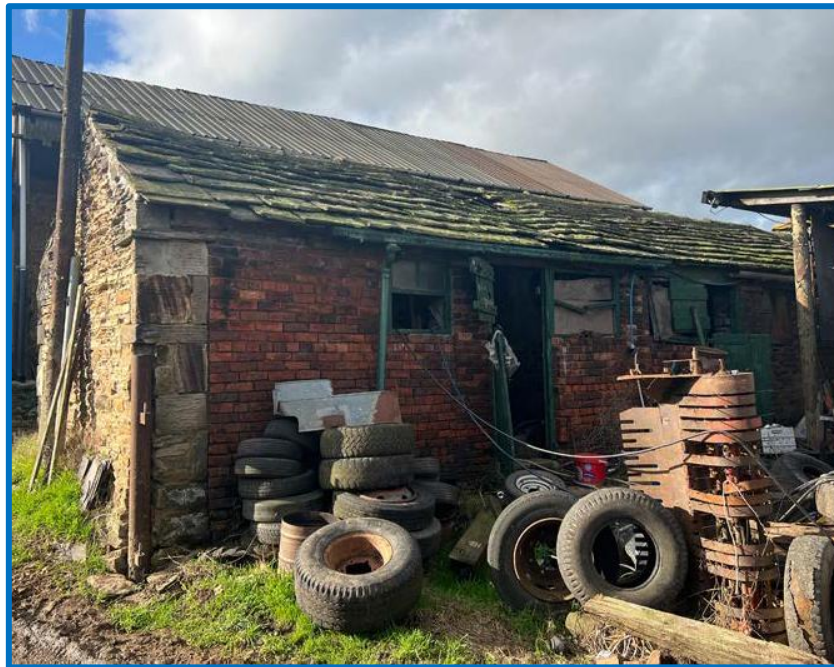
IMAGE 1 – CART SHED EAST FACING ELEVATION

The main structure is a Grade II listed 17th century stone built barn with a stone flag roof covering. The inspected cart shed is constructed from a mix of stone and engineering brick walls with an oak internal roof structure and stone flag roof covering. The Eastern elevation has multiple window/door openings with cast iron supports to the oak wall plate.

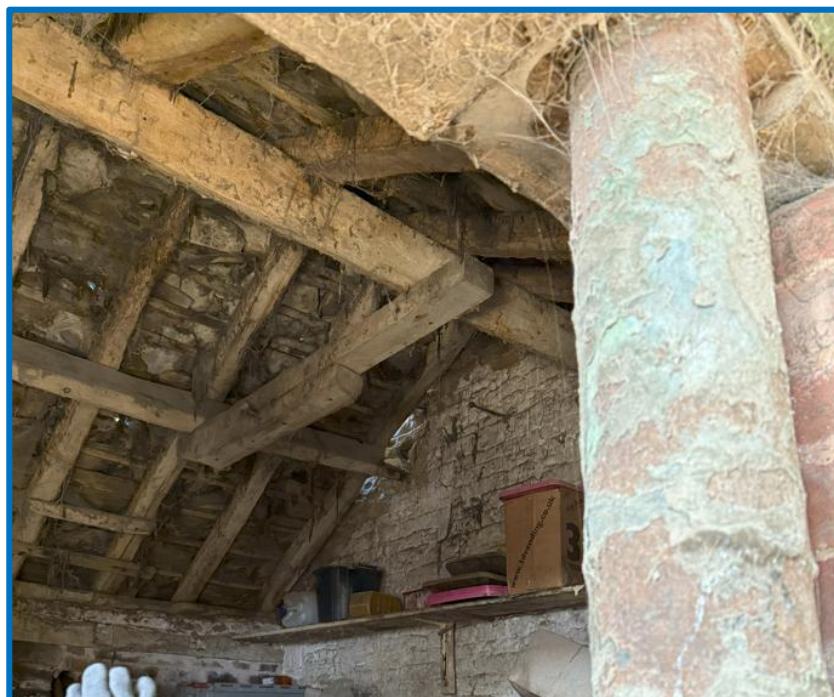
IMAGE 2 – CART SHED PART ROOF STRUCTURE

The removal of the cart shed roof structure would require the purlins to be removed from their bearings into the barn structure. From our visual inspection the purlins have very little bearing into the South facing elevation stonework and the removal of the purlins would have no detrimental structural impact.

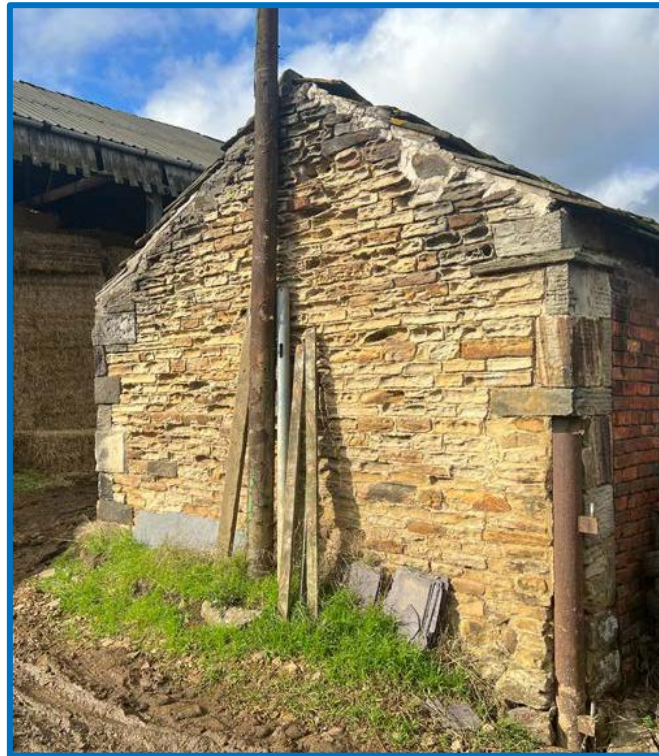
IMAGE 3 – CART SHED SOUTH FACING ELEVATION

- The cart shed is a much later addition to the original 17th century barn structure. The cart shed structure appeared to be simply adjoining the barn structure with no visible tothing or tying.
- The stone flag roof covering to the cart shed is in poor condition with missing covering and no flashing between the cart shed and original barn.
- The roof timbers throughout the cart shed are in very poor condition with loss of section and visible rot where the timbers have been exposed to the elements due to missing roof coverings.
- The cart shed Eastern elevation has had multiple alterations including masonry infill areas and additional openings which have been poorly constructed.
- The Southern elevation of the cart shed is of stone construction and showing significant weather erosion.
