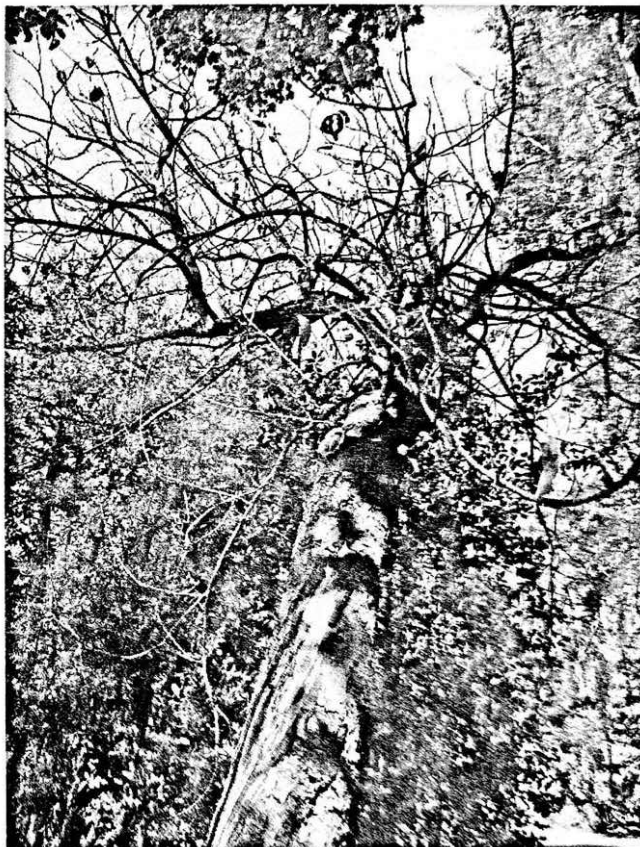
| Moderate Risk Tree | | | |
|---|---|---|---|
| T025 Horse chestnut | | | |

| Moderate Risk Tree | | | |
|---|---|---|---|
| Growing in a group.<br>Growing next to the retaining wall.<br>Woodland tree.<br>Target – the footpath.<br>Target - the road.<br>Tree is dead and has a limited safe life. | | Remove the tree. | |

| Moderate Risk Tree | | | |
|---|---|---|---|
| Priority | 6 months | Next inspection | Not required |

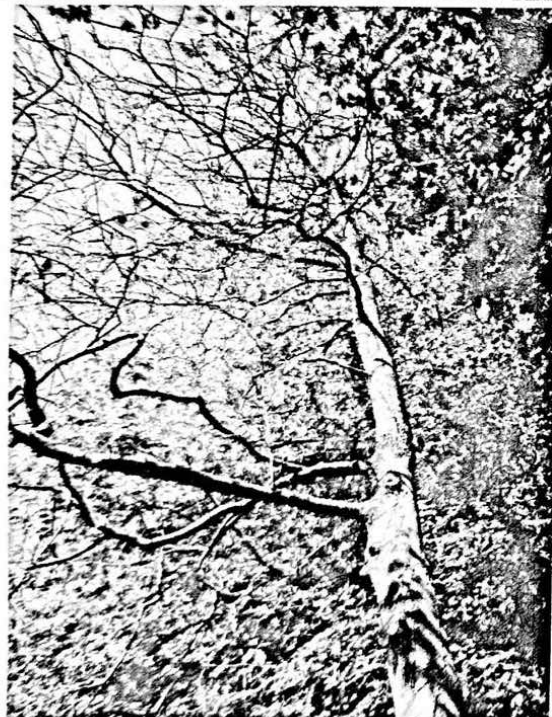
| Moderate Risk Tree | | | |
|---|---|---|---|
| <p>Growing in a group.<br/>Growing next to the retaining wall.<br/>Woodland tree.<br/>Target – the footpath and the road.<br/>Significant dieback of canopy.<br/>Large diameter (&gt;25 mm) deadwood can be seen in the inner and outer canopy.<br/>Dieback in canopy - poor vitality/canopy cover.<br/>Poor vitality cover<br/>Limited safe life.</p> | | <p>Remove the tree.</p> | |

| Moderate Risk Tree | | | |
|---|---|---|---|
| Priority | 3 months | Next inspection | Not required |

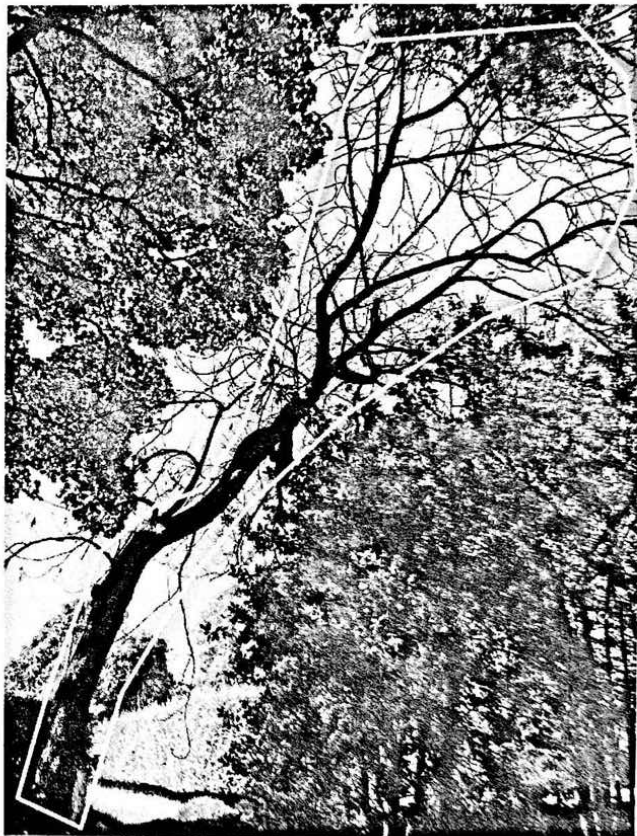
| Moderate Risk Tree | | | |
|---|---|---|---|
| T027 lime | | | |

| Moderate Risk Tree | | | |
|---|---|---|---|
| <p>Growing in a group.<br/>Growing next to retaining wall.<br/>Woodland tree.<br/>Target - the footpath and the road.<br/>Tree is dead and has limited safe life in its location.</p> | | <p>Remove the tree.<br/>T027 is highlighted in yellow.</p> | |

| Moderate Risk Tree | | | |
|---|---|---|---|
| Priority | 3 months | Next inspection | Not required |

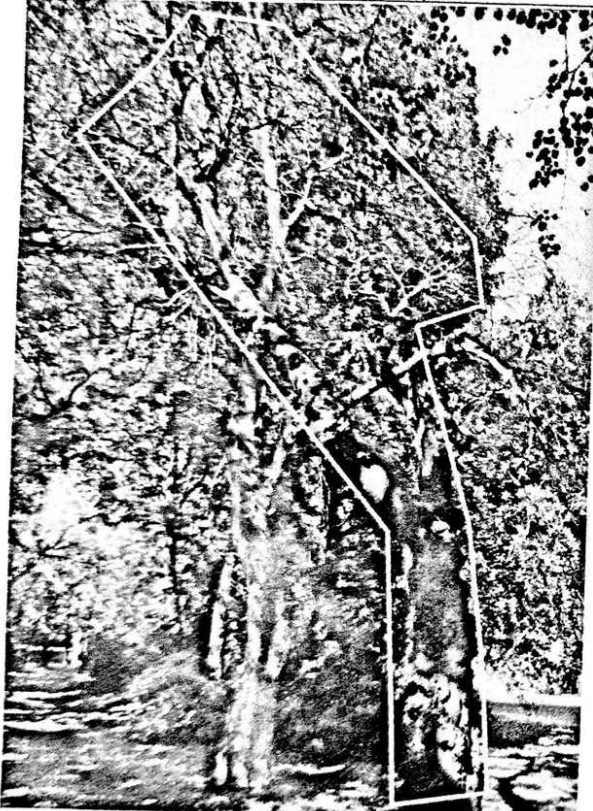
| Moderate Risk Tree | | | |
|---|---|---|---|
| <b>Comments</b><br>Growing in a group.<br>Woodland tree.<br>Target - the driveway<br>Significant dieback of canopy.<br>Large diameter (>25 mm) deadwood can be seen in the inner and outer canopy.<br>Dieback in canopy - poor vitality/canopy cover. | | <b>Recommendations</b><br>Remove the tree.<br>T028 is highlighted in yellow. | |

| Moderate Risk Tree | | | |
|---|---|---|---|
| Priority | 3 months | Next inspection | Not required |

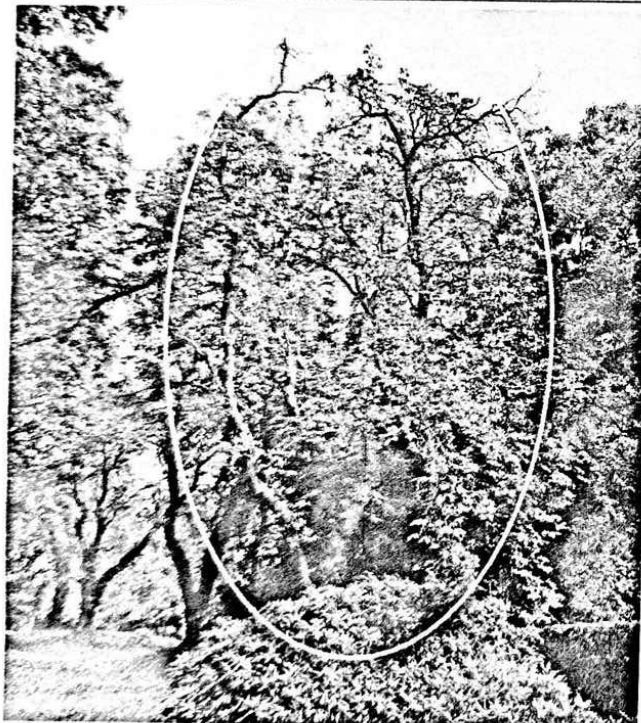
| Minimal/Slight Risk Tree | | | |
|---|---|---|---|
| <b>Comments</b><br>Growing in a group.<br>Target - Driveway.<br>Risk offered to Site Users.<br>Risk offered by expected failure of main stem.<br>Risk offered by expected root plate failure.<br>Cavity within buttress.<br>Decay within buttress.<br>Bark missing on stem.<br>Stem decay visible.<br>Significant dieback of canopy.<br>Wounding from branch failures visible.<br>Armillaria mellea (Honey Fungus). | | <b>Recommendations</b><br>Removal or monolith of T011 and either re-inspect or monolith or removal of T012 due to the state of decline and limited safe life next to drive way and parking area.<br>T011 highlighted in yellow. | |

| Tag No. | Structure | Name | Comments | Failure Score | Target Score | Impact Score | Risk | Recommendations | Priority | Next Inspection |
|---|---|---|---|---|---|---|---|---|---|---|
| T011 | Tree | Horse chestnut | Growing in a group.<br>Target - Driveway.<br>Risk offered to Site Users.<br>Risk offered by expected failure of main stem.<br>Risk offered by expected root plate failure.<br>Cavity within buttress.<br>Decay within buttress.<br>Bark missing on stem.<br>Stem decay visible.<br>Significant dieback of canopy.<br>Wounding from branch failures visible.<br>Armillaria mellea (Honey Fungus). | Likely,<br>Foreseeable | Medium | Large | 3: Slight | Monolith at 5m.<br><i>Not yet!</i> | 6<br>Months | Not required |

| Tag No. | Structure | Name | Comments | Failure Score | Target Score | Impact Score | Risk | Recommendations | Priority | Next Inspection |
|---|---|---|---|---|---|---|---|---|---|---|
| T012 | Tree | Horse chestnut | Growing in a group.<br>Target - Driveway.<br>Risk offered to Site Users.<br>Risk offered by expected failure of main stem.<br>Risk offered by expected root plate failure.<br>Cavity within buttress.<br>Decay within buttress.<br>Bark missing on stem.<br>Stem cavity visible.<br>Significant dieback of canopy.<br>Wounding from branch failures visible.<br>Armillaria mellea (Honey Fungus). | Potentially with time | Medium | Large | 2: Minimal | Reinspect in summer. Or<br>Monolith at 5m. | 6 Months | Next summer |

| Minimal/Slight Risk Tree | | | |
|---|---|---|---|
| Priority | 6 months | Next inspection | Not required |

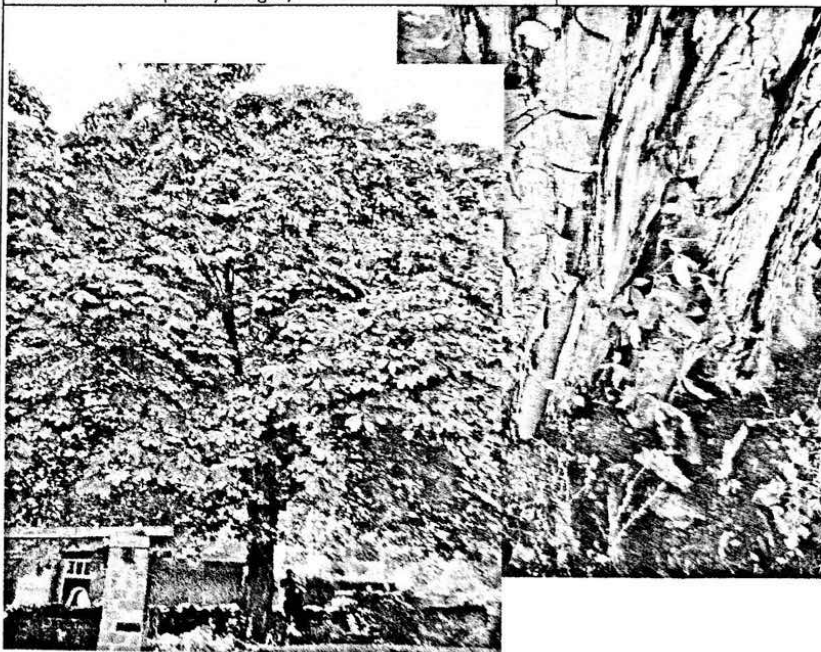
| Slight Risk Tree | | | |
|---|---|---|---|
| <b>Comments</b><br>Tree displays ecological/habitat value.<br>Growing in a group.<br>Growing next to retaining wall.<br>Target – building, Outbuilding.<br>Risk offered to Site Users.<br>Risk offered to Building.<br>Single Stem.<br>Adaptive growth on stem.<br>Bark missing on stem.<br>Stem cavity- unable to inspect.<br>Typical vitality levels for the species/season.<br>Armillaria mellea (Honey Fungus). | | <b>Recommendations</b><br>Further investigation of buttress and stem required.<br>Further investigation using Sonic Tomography required.<br>Further investigation using Electrical Impedance Tomography required. | |

| Tag No. | Structure | Name | Comments | Failure Score | Target Score | Impact Score | Risk | Recommendations | Priority | Next Inspection |
|---|---|---|---|---|---|---|---|---|---|---|
| T030 | Tree | Horse chestnut | Tree displays ecological/habitat value.<br>Growing in a group.<br>Growing next to retaining wall.<br>Target - building.<br>Target - Outbuilding.<br>Risk offered to Site Users.<br>Risk offered to Building.<br>Single Stem.<br>Adaptive growth on stem.<br>Bark missing on stem.<br>Stem cavity- unable to inspect.<br>Typical vitality levels for the species/season.<br>Armillaria mellea (Honey Fungus). | Potentially with<br>time | Very High | Large | 3: Slight | Further investigation of buttress required.<br>Further investigation of stem required.<br>Further investigation using Sonic Tomography required.<br>Further investigation using Electrical Impedance Tomography required.<br><br><i>Honey Fungus</i> | 3<br>Months | 18 Months |

| T030 | Ideally, undertake Tomography of the buttress and lower stem to understand the extent of decay versus sound wood. | Within 3 months |

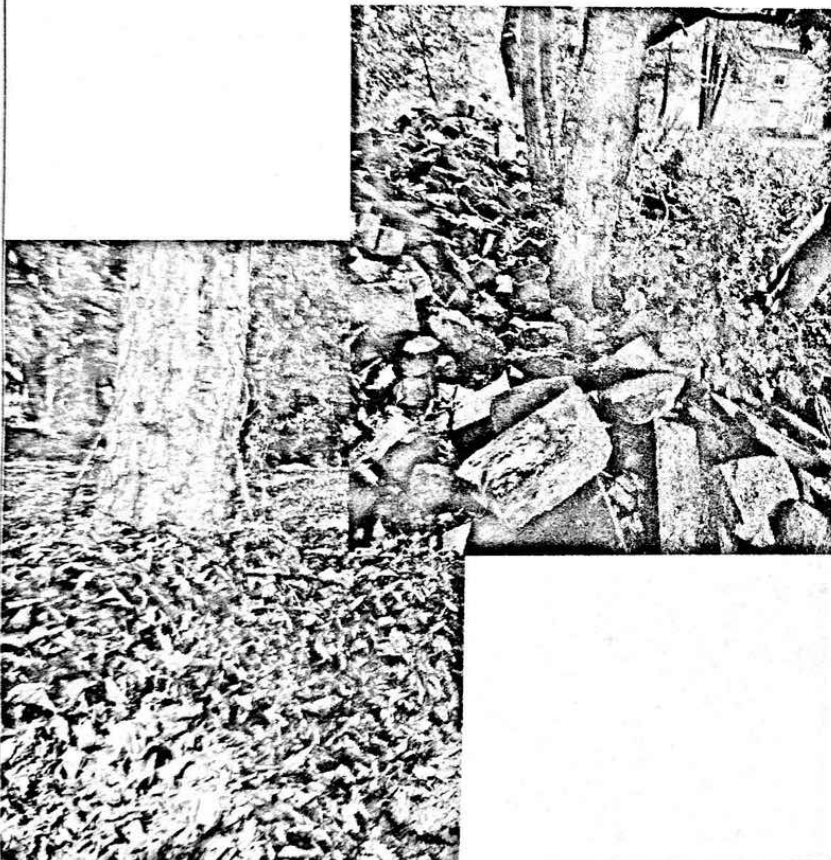
| General notes | | | |
|---|---|---|---|
| Soil level has been raised by the leaves and compost area is and the buttress and lower stem has been buried on a few trees, and the northern side of the site is stone around the root plate area of the trees this is compacting the soil and could create future problems. | | Gently remove the build up material to expose the original soil level. | |

| General notes | | | |
|---|---|---|---|
| Priority | 12 months | Next inspection | 18 months |

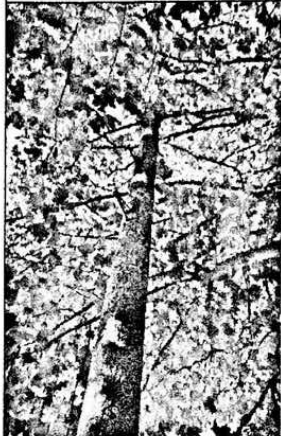
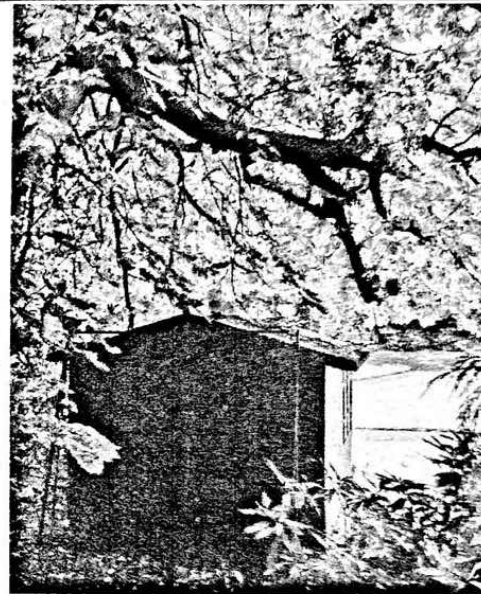
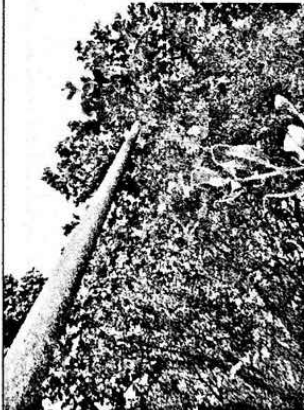
| General notes | | | |
|---|---|---|---|
| Clearance from buildings and utilities/ lamposts | | | |

| General notes | | | |
|---|---|---|---|
| Some trees around the property are getting close to some structures and utilities such as lamposts. | | Prune the trees to make a clearance gap of 0.5-1m | |

| General notes | | | |
|---|---|---|---|
| Priority | 12 months | Next inspection | 18 months |

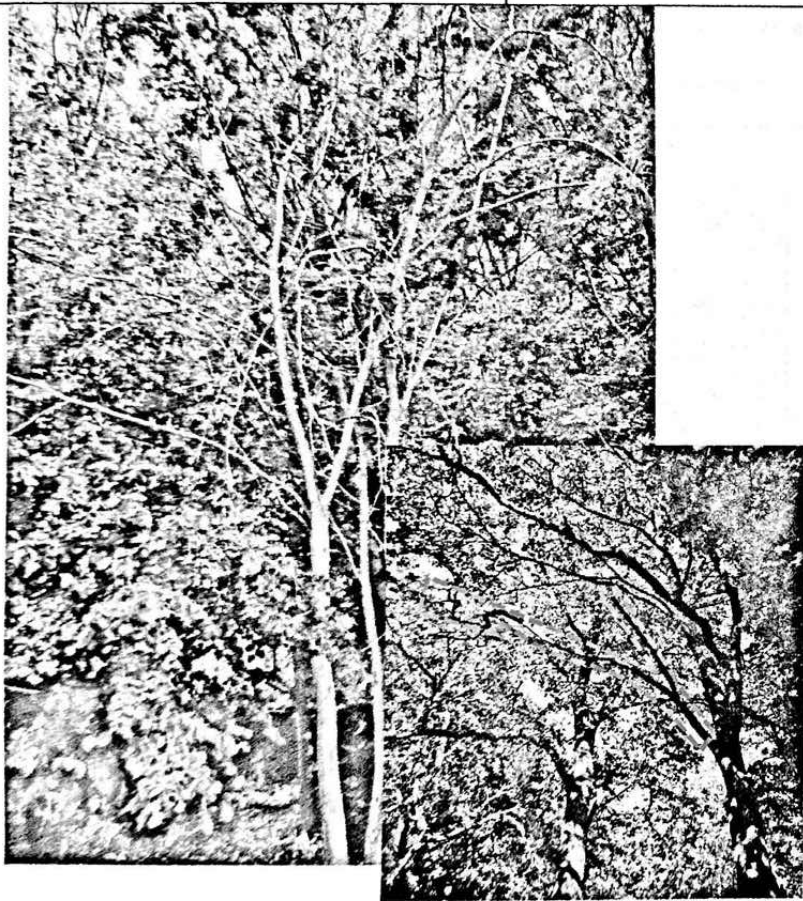
| General notes | | | |
|---|---|---|---|
| Standing deadwood, deadwood in trees | | | |

| General notes | | | |
|---|---|---|---|
| Lots of the trees on site have some dead wood in such as above the whole stretch of driveway, There were a few standing dead trees around the site. | | Some deadwood has been highlighted below in red not far from T028 | |

| General notes | | | |
|---|---|---|---|
| Priority | 12 months | Next inspection | 18 months |

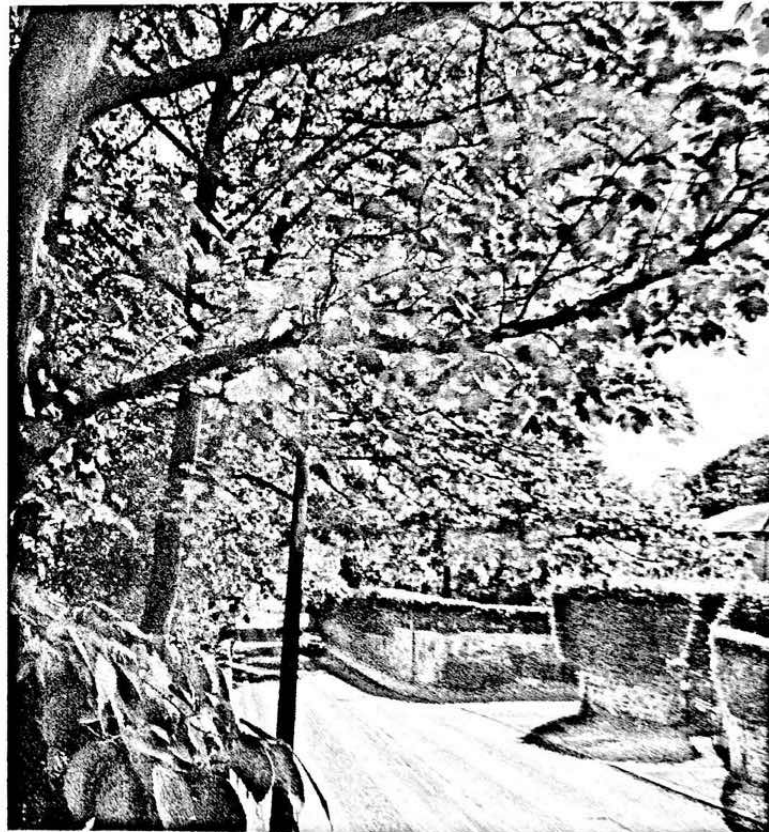
| General notes | | | |
|---|---|---|---|
| Highway Clearance | | | |

| General notes | | | |
|---|---|---|---|
| Some of the trees surrounding the highway are getting quite low in some places and require some pruning. | | Prune the trees to make highway clearance of 5.2m for the highway and 2.5m for footpaths. | |

| General notes | | | |
|---|---|---|---|
| Priority | 12 months | Next inspection | 18 months |

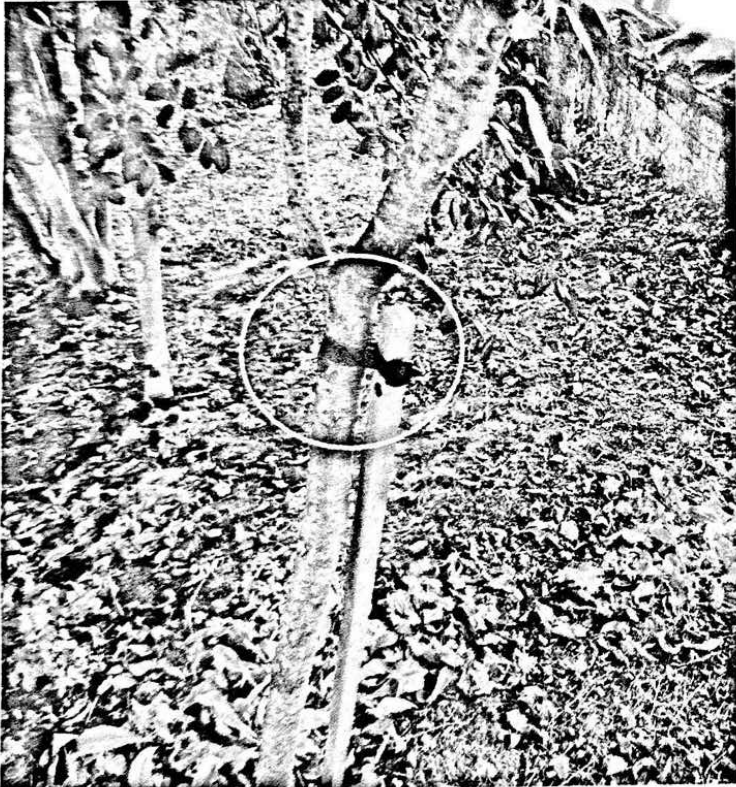
| General notes | | | |
|---|---|---|---|
| <p>Some of the smaller trees still have their stake and ties that were tight on the stem, this could cause future problems and stop the tree from becoming established.</p> <p>Make sure the appropriate species for the light level, soil conditions are chosen.</p> | | <p>Remove the stake and ties when the trees rooting system has become established.</p> <p>Water the trees for the first 3 years after planting in summer time.</p> <p>Loosen or remove stakes/ties if getting too tight.</p> | |

| General notes | | | |
|---|---|---|---|
| Priority | 12 months | Next inspection | 18 months |
