GeoShield Verification Report 1

GEO105226

European Screeding Ltd
New School Building, North Huddersfield Trust
School,
Woodhouse Hall Road,
Huddersfield,
HD2 1DJ

New School Building - Infills

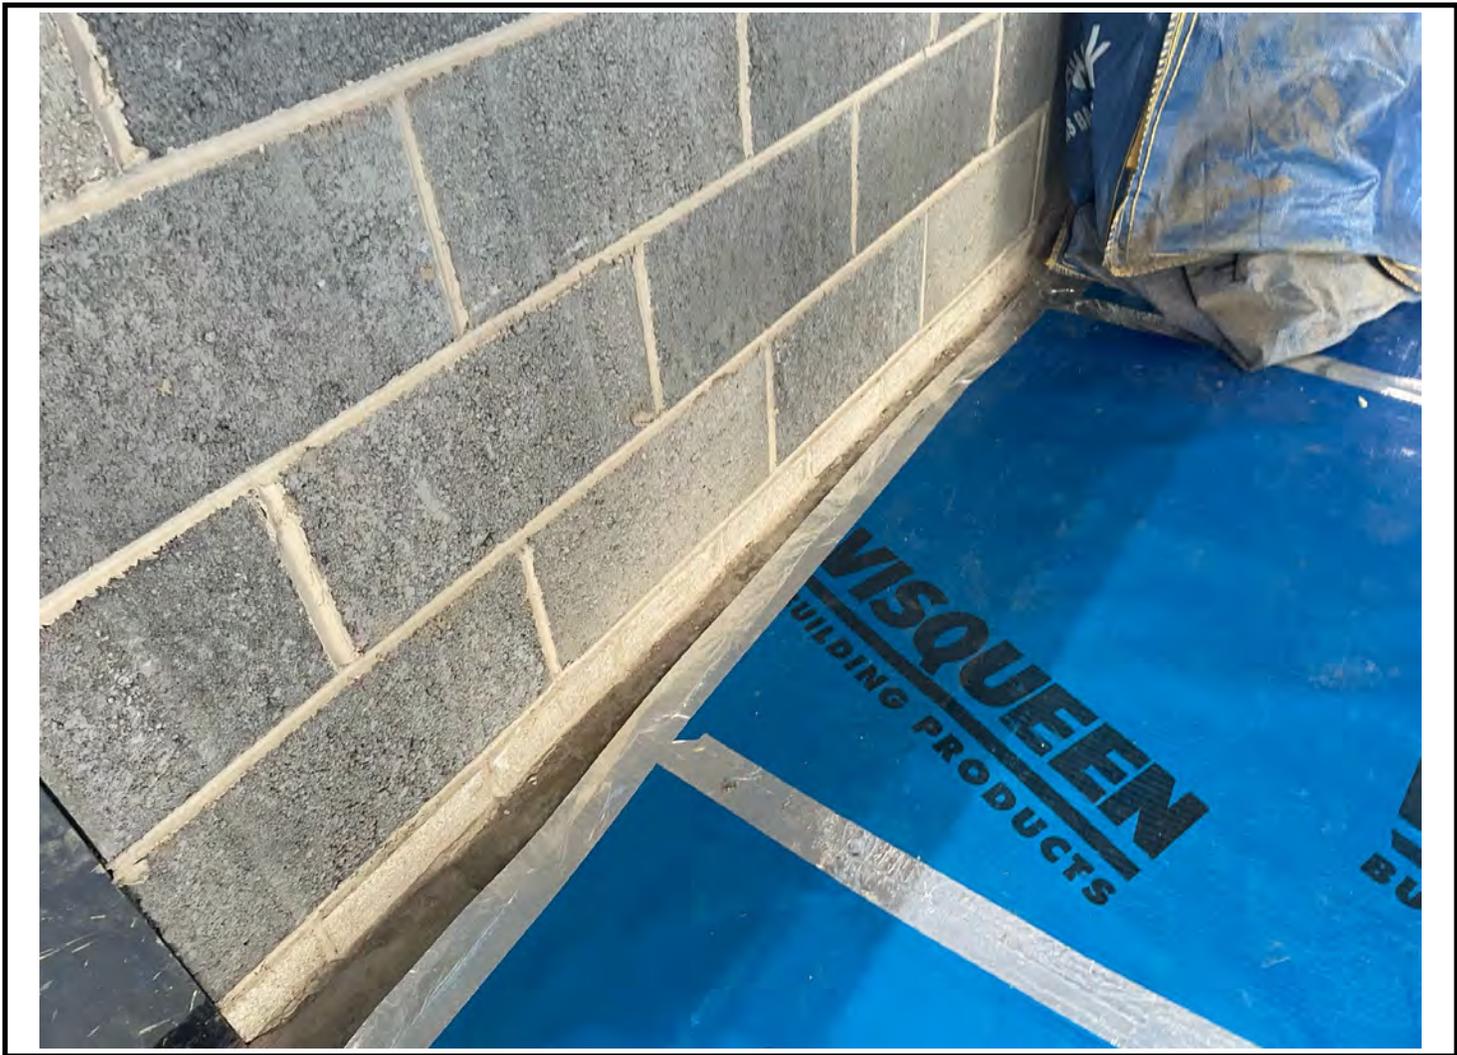
New School Building - Perimeters

The perimeter membrane had already been installed and brickwork built up prior to European Screeding entering site therefore, GeoShield were unable to verify the installation of Visqueen Ultimate DPC to the perimeters.

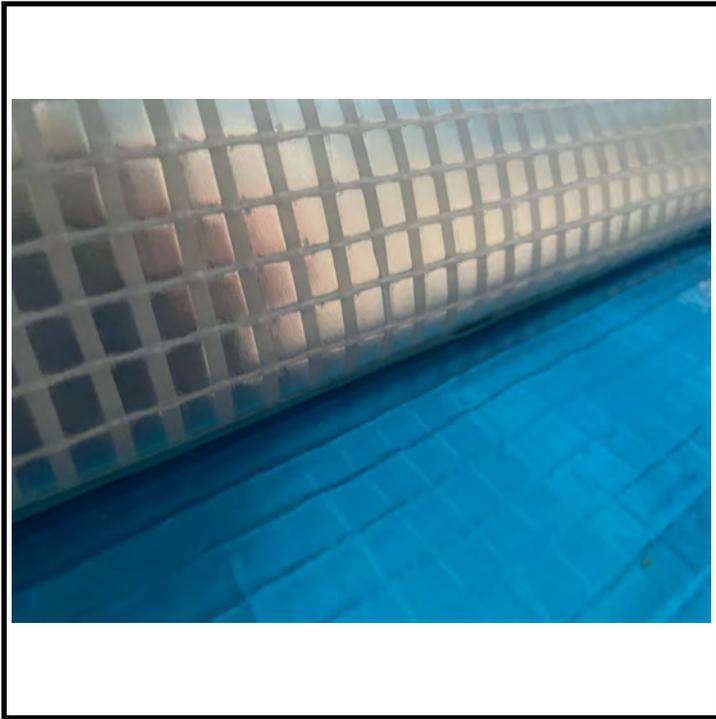
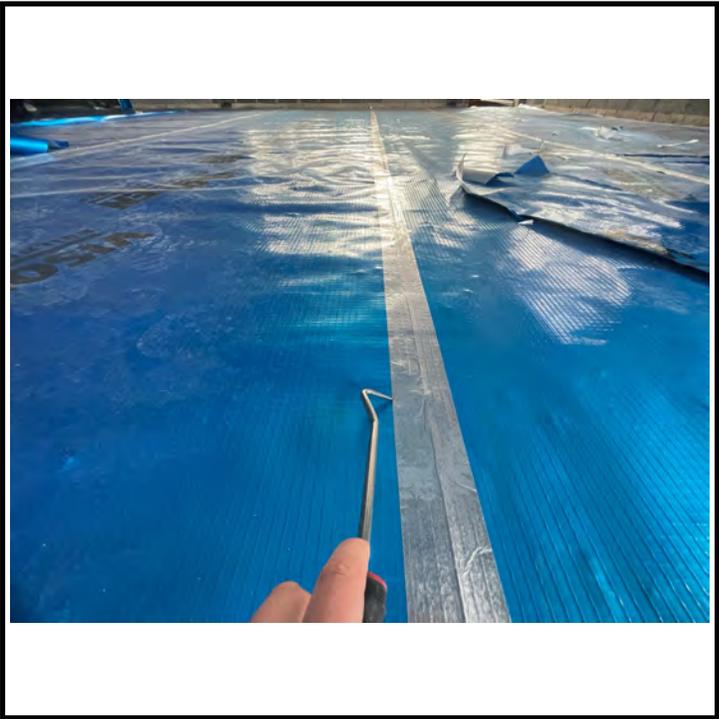
INSPECTION DETAILS: Installation of Visqueen Standard Gas Barrier - Lap Joints

NOTES:
Infills of the Visqueen Standard Gas Barrier have been installed across the footprint of the new school building. All lap joints between the adjacent sheets of Visqueen Standard Gas Barrier have been overlapped a minimum of 150mm, conforming to manufacturer's specifications, and sealed using a dual

NOTES:
taped system consisting of Visqueen Pro Double Sided Butyl Tape beneath the overlaps of the adjacent sheets and over-taped using Visqueen Foil Lap Tape. Thorough visual inspections, supported by mechanical point stress testing were conducted upon all taped overlaps. No faults or defects were identified.

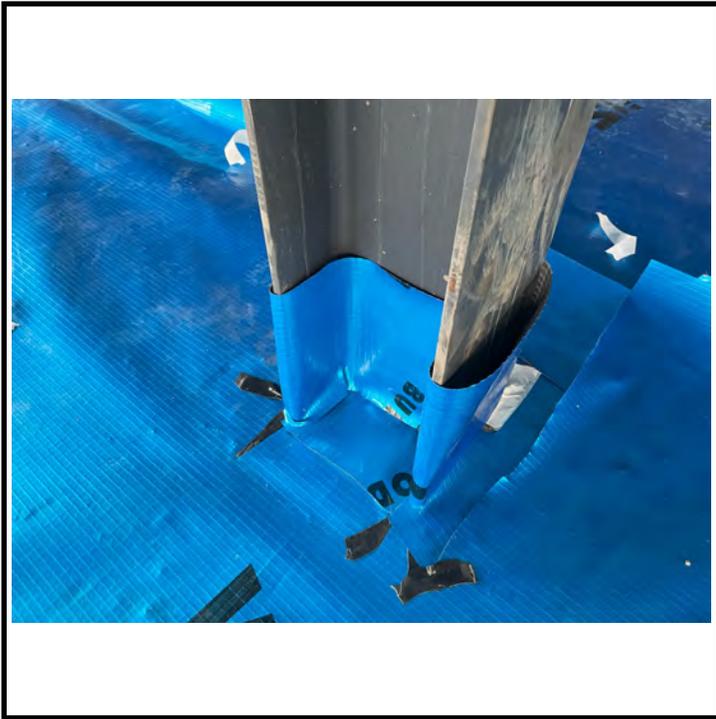
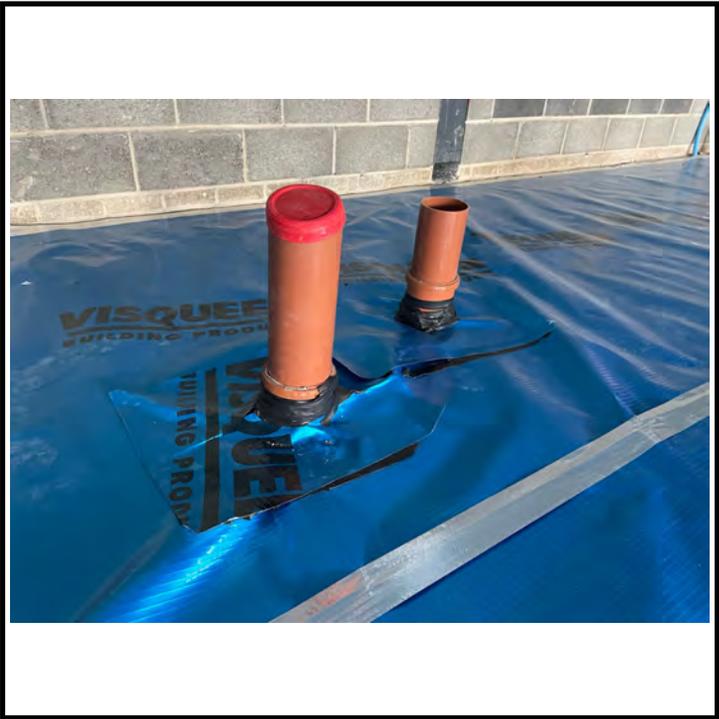
INSPECTION DETAILS: Steel Stanchions & Pipe Penetrations

NOTES:
Throughout the infill installation of the Visqueen Standard Gas Barrier to the referenced area, there were a number of pipe penetrations and steel stanchions that required sealing. The installers have not been supplied with the correct materials and have attempted to seal the details with

NOTES:
Visqueen Standard Gas Barrier, Visqueen Double Sided Butyl Tape and Visqueen Foil Lap Tape, as shown in the above photographs.
These materials are not sufficient to achieve a reliable gas resistant seal.

Outstanding Remediations:
 - Pipe penetrations & stanchions have not been sealed correctly due to the installers not being supplied with the correct materials. All details require sealing with Visqueen GRSAM. This has caused a failed visit. Site management have been advised to seal all details using Visqueen GRSAM. Once complete, a further verification visit will be required prior to sign off being achieved.

GeoShield have advised the site management to acquire Visqueen GRSAM to seal the pipe penetrations and steel stanchions to the correct specification. Once complete, the pipe penetrations and steel stanchions will require verification prior to sign off being achieved.

Date	No.	Remediation Description	Y/N
02/04/2025	001	Stanchions & Pipe Penetrations to be sealed with Visqueen	
		GRSAM prior to infills of the new school building achieving sign off.
