GeoShield Verification Report 2

GEO105226

European Screeding Ltd
New School Building, North Huddersfield Trust
School,
Woodhouse Hall Road,
Huddersfield,
HD2 1DJ

New School Building - Remediations

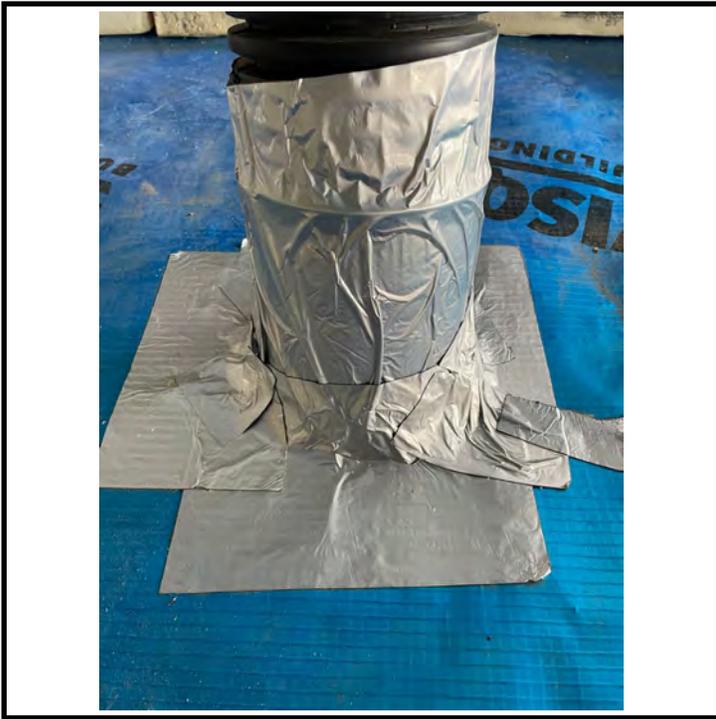
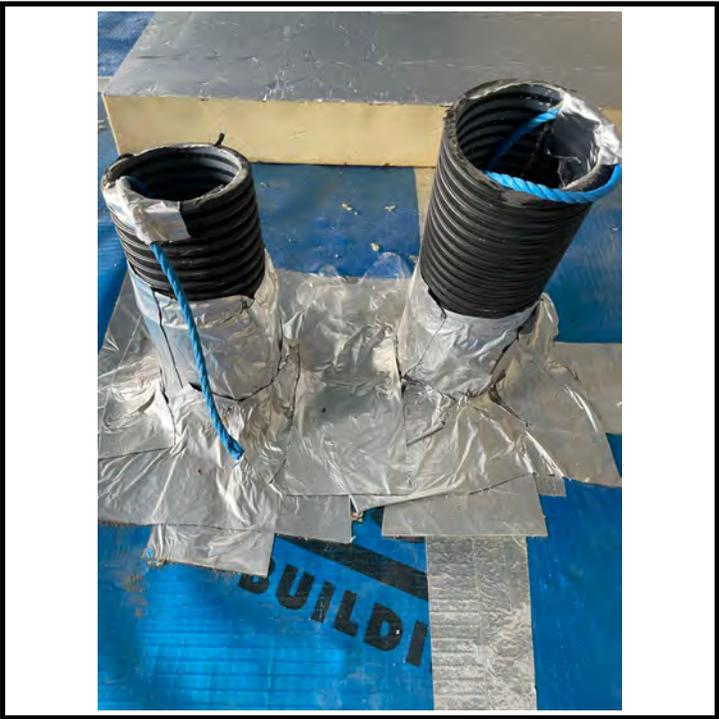
INSPECTION DETAILS: Pipe Penetrations

NOTES:
Following a failed verification inspection during the previous visit, the pipe penetration and steel stanchion detailing has now been completed. GeoShield were appointed to carry out the testing of sealed details. The sealing of the details has been achieved using Visqueen GRSAM, which is gas resistant self adhesive membrane.

NOTES:
The installers have first cut the Visqueen Standard Gas Barrier tight around the base of each pipe penetration to minimise voided areas. Strips of Visqueen GRSAM are heated and rolled into position around the base of the pipe penetrations, onto the Visqueen Standard Gas Barrier. Firm rolled pressure is applied with a silicone

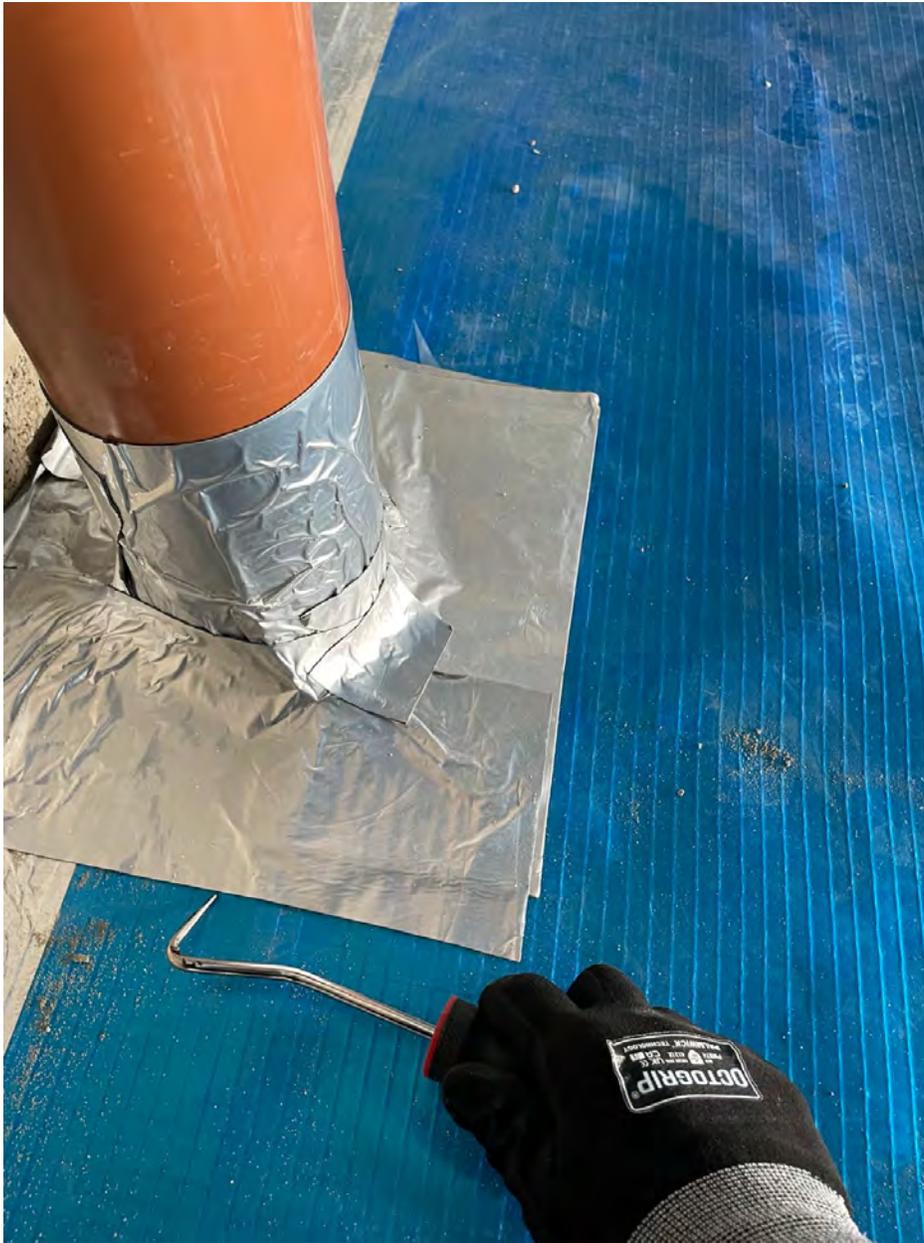
roller to ensure the Visqueen GRSAM had fully bonded and a continuous gas resistant seal has been achieved. Thorough visual inspections, supported by mechanical point stress testing conducted upon the pipe penetrations identified no faults or defects.
Tested and verified in accordance with CIRIA 735.

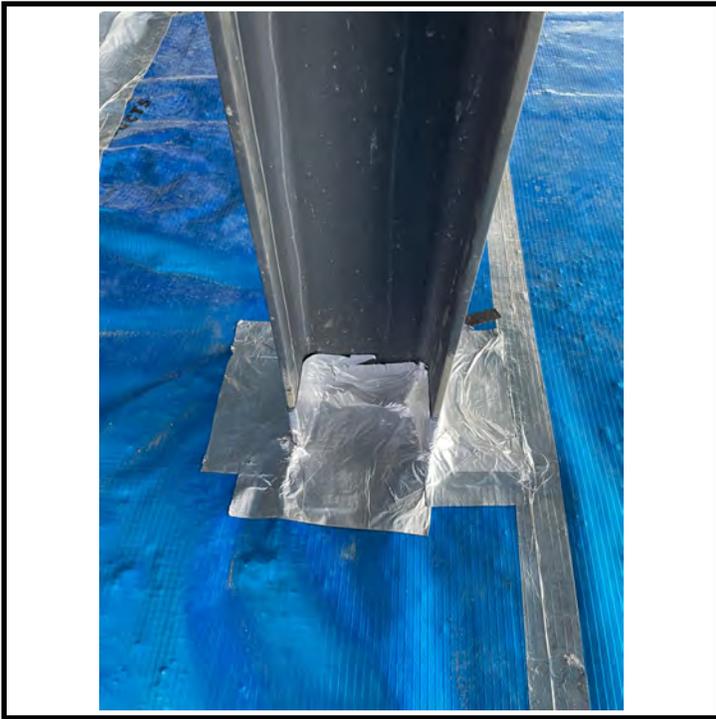
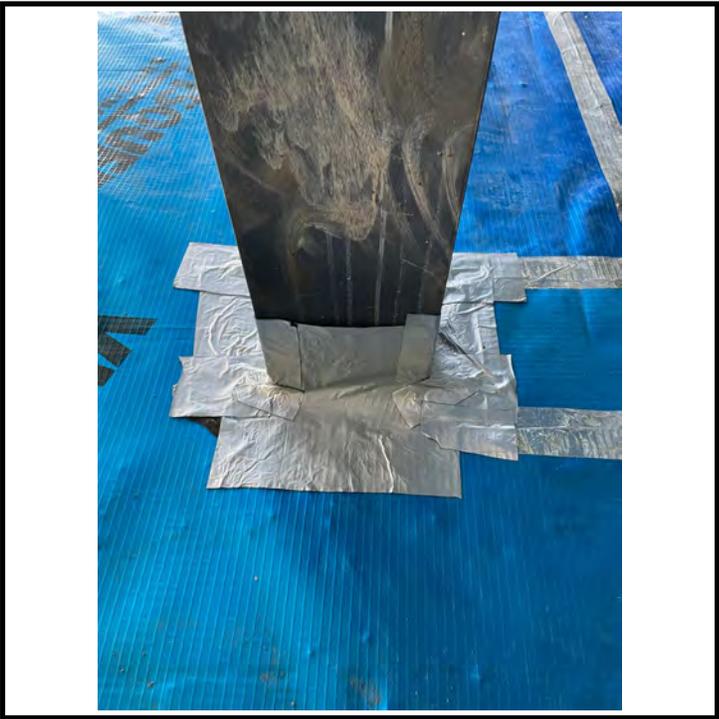
INSPECTION DETAILS: Steel Stanchions

NOTES:
All steel stanchions throughout the building have been sealed in accordance with manufacturer's specifications and design guidelines. Again, this has been achieved using Visqueen GRSAM. The installers have first cut the Visqueen Standard Gas Barrier tight around the concrete base of each steel stanchion to minimise voided areas.

NOTES:
Next, patches of Visqueen GRSAM are placed intricately around the base of the steel stanchion and onto the Visqueen Standard Gas Barrier. Adequate heat and firm rolled pressure are applied to ensure the Visqueen GRSAM has fully bonded.

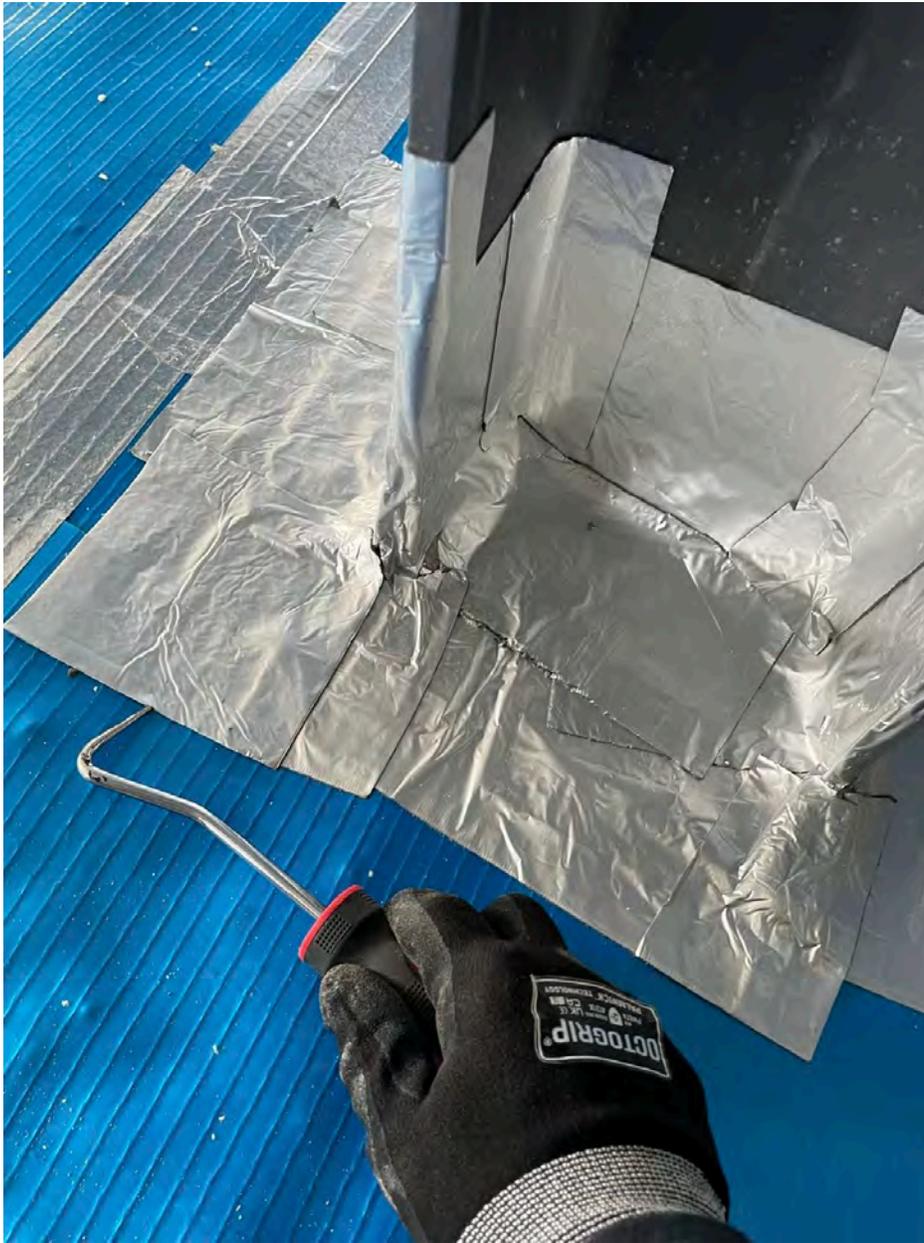
All steel stanchions throughout the referenced area were subjected to thorough visual inspection and mechanical point stress testing, where no faults or defects were identified. All remedial works throughout the proposed new school building have been verified and sign off has been achieved.

Tested and verified in accordance with CIRIA 735.
