Sycamore Maple (Sycamore Rear)

Tree Details and Location

Date Assessed 2025-07-14 11:01 am

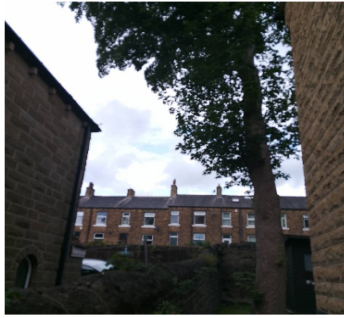
Imbalanced crown. Weighted towards neighbouring properties.

3 nearby trees removed.

Weighted towards property. Partially occluded wound at base.

The highest risk is whole tree failure onto property.

Risk reduction
Tree Management
