# Tree Survey

26 Botham Hall Road  
Milnsbridge  
Huddersfield  
HD3 4RJ

A 'visual tree inspection' was undertaken on Monday 14<sup>th</sup> July 2025 at 26 Botham Hall Road at the request of the owners.

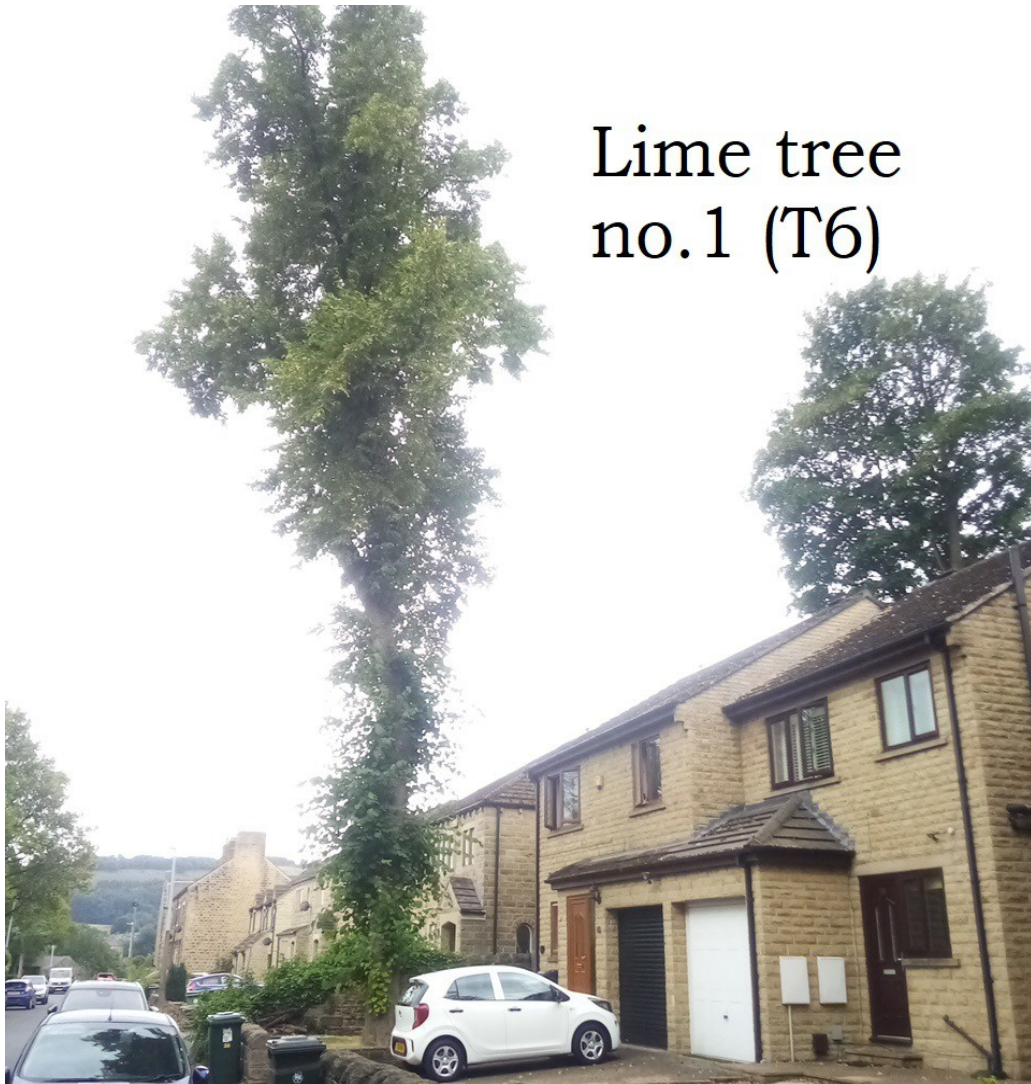
Lime tree  
no.1 (T6)

**Vitality:** In terms of foliage the vitality would appear quite reasonable, however the reported history of branch drop (especially Summer Branch Drop / SBD) would indicate that the tree is stressed, particularly during drought conditions.

**Features / Defects / Observations:** There is slight basal decay on the South – a steel probe was pushed 20 cm below the ground, below the base of the tree.

The tree may be considered to have been excessively crown lifted (approx. to 6 metres height).

The crown is imbalanced with perhaps 2 thirds weighted towards the North.

The Root Protection Area has been severely compromised by the construction works. The driveway is almost next to the trunk/stem on the North side. This looks as if excavations would have been at least 60cm

The tree has a habit of shedding large branches – made worse by the compromised root system.

**Recommendation:** Removal of the tree.

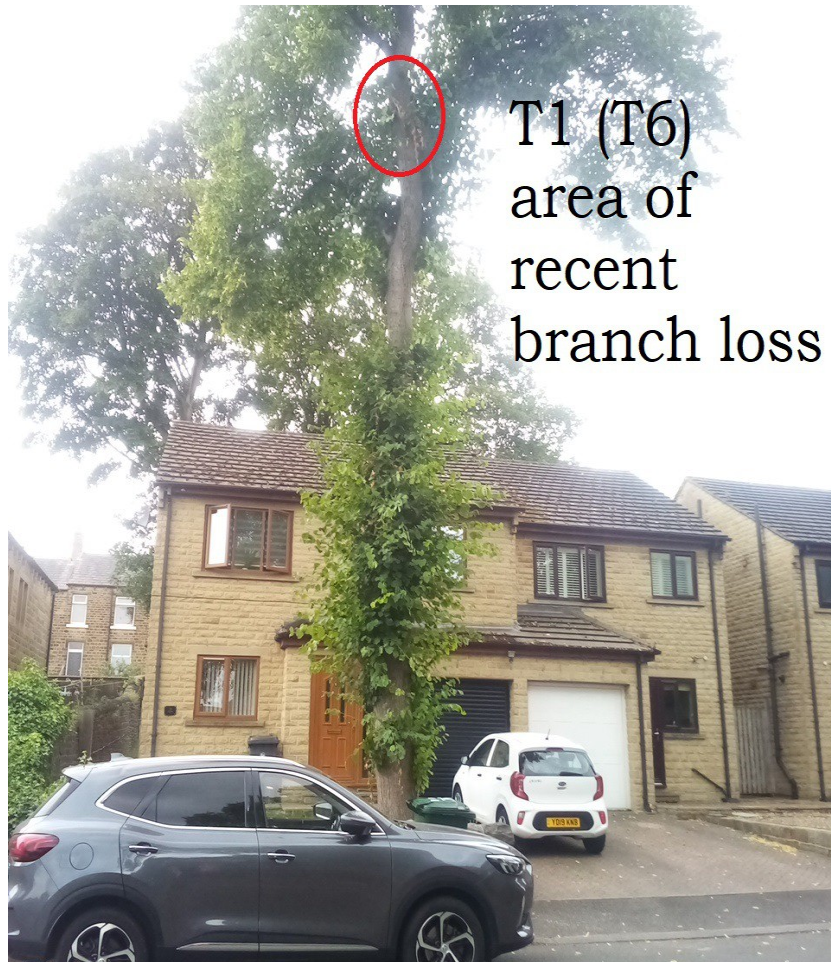
A recent branch failure is evident, with the pieces stacked in the corner of the garden. Diameter was measured as 13cm. The fractured wood appears very brittle and dessicated, despite not having been 'deadwood'.

T1 (T6)  
area of  
recent  
branch loss

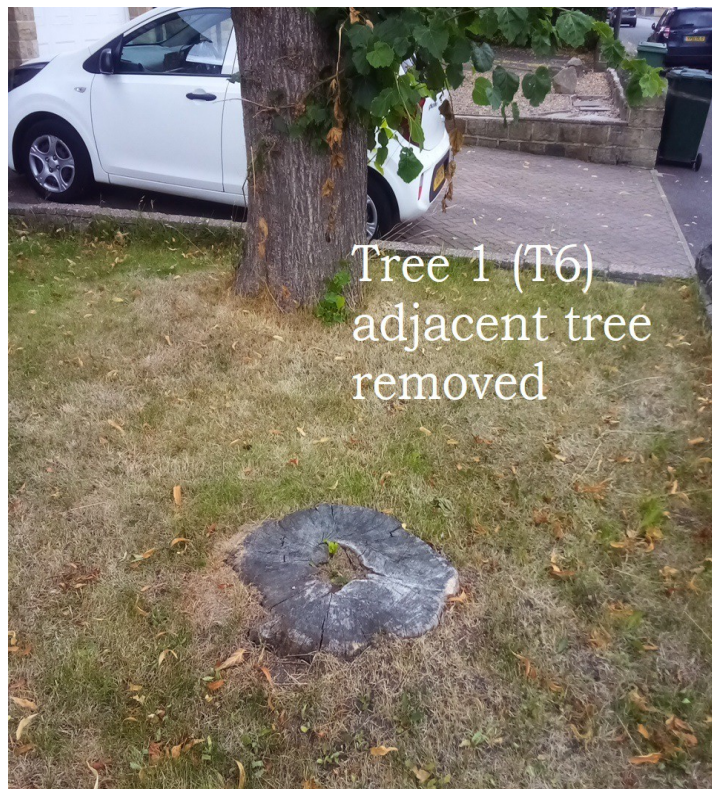
A tree was removed in 2018 (?) - this was in the front garden next to the Lime. This will have exposed the Lime to increased wind loading and potential breakages from storm damage (this is different to SBD).

Tree 1 (T6)  
adjacent tree  
removed

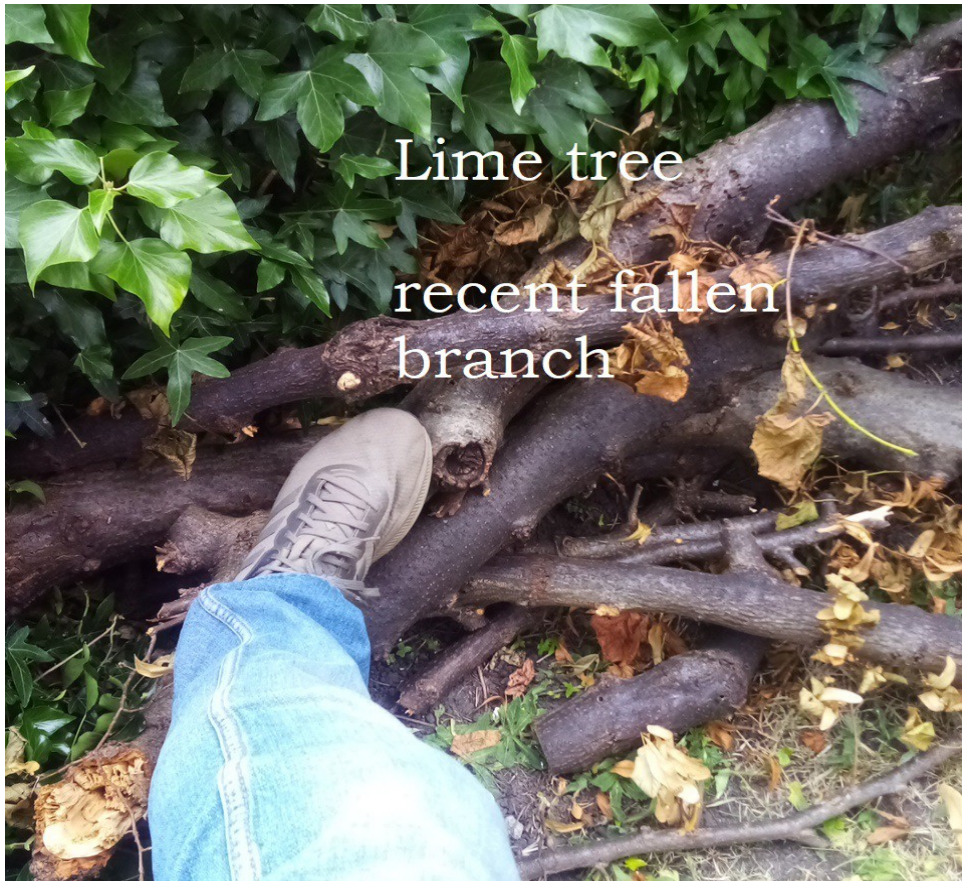
fractured  
branch  
from Lime

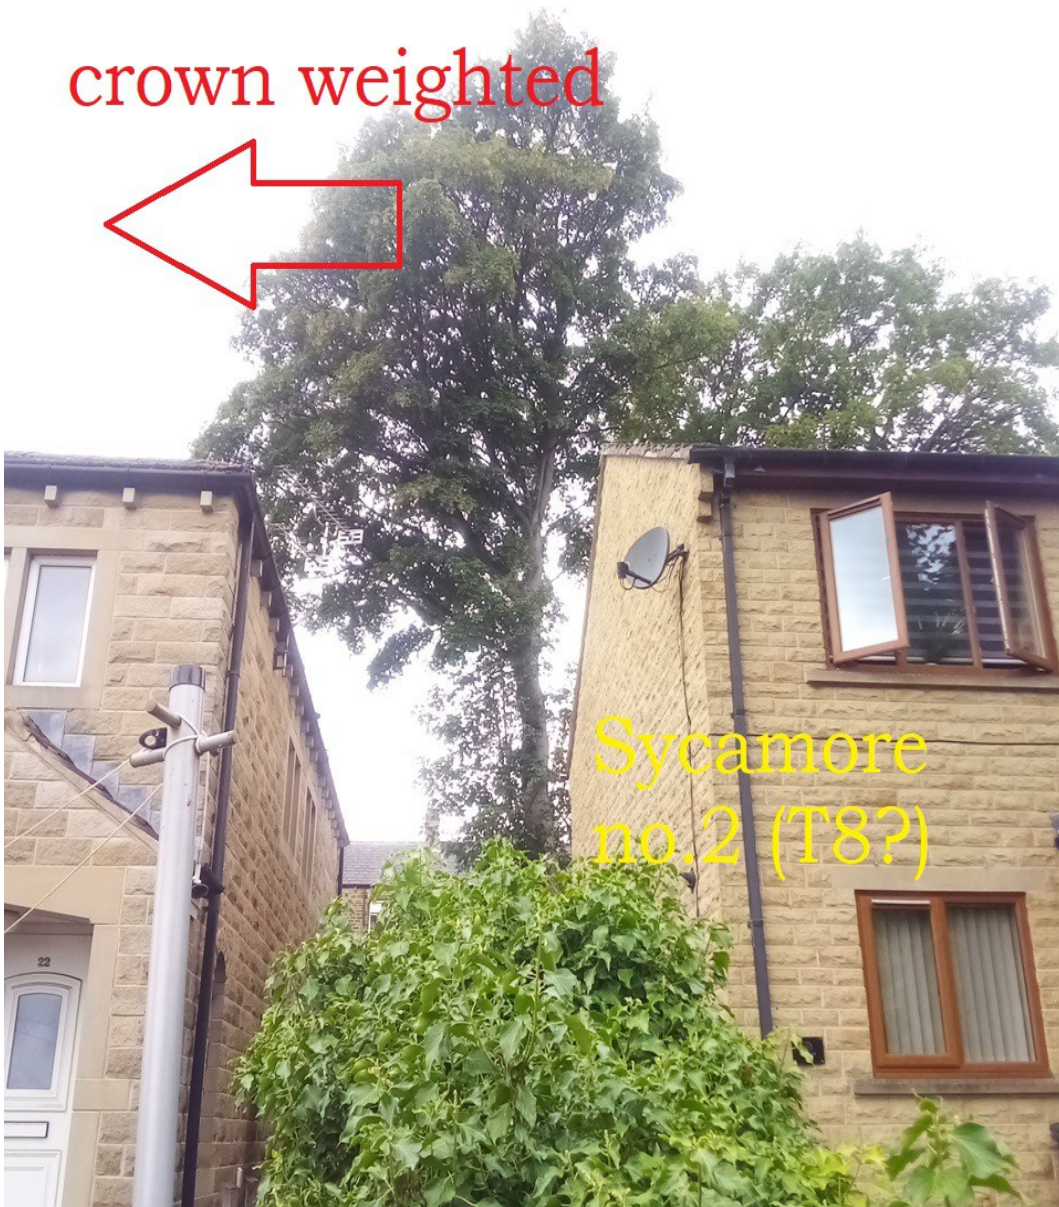
Sycamore  
no.2 (T8?)

**Features / Defects / Observations:** The crown is almost wholly weighted to one side – towards the neighbouring property to the South. The stem / trunk also has a slight lean.

**Summary:** Although in reasonable vigour, the tree is imbalanced and is outgrowing its position. There are concerns that if it structurally fails then considerable damage would likely occur. The partial damage to the root system during construction may yet have a detrimental impact on the overall structural integrity of the tree.

**Recommendation:** Removal of the tree.

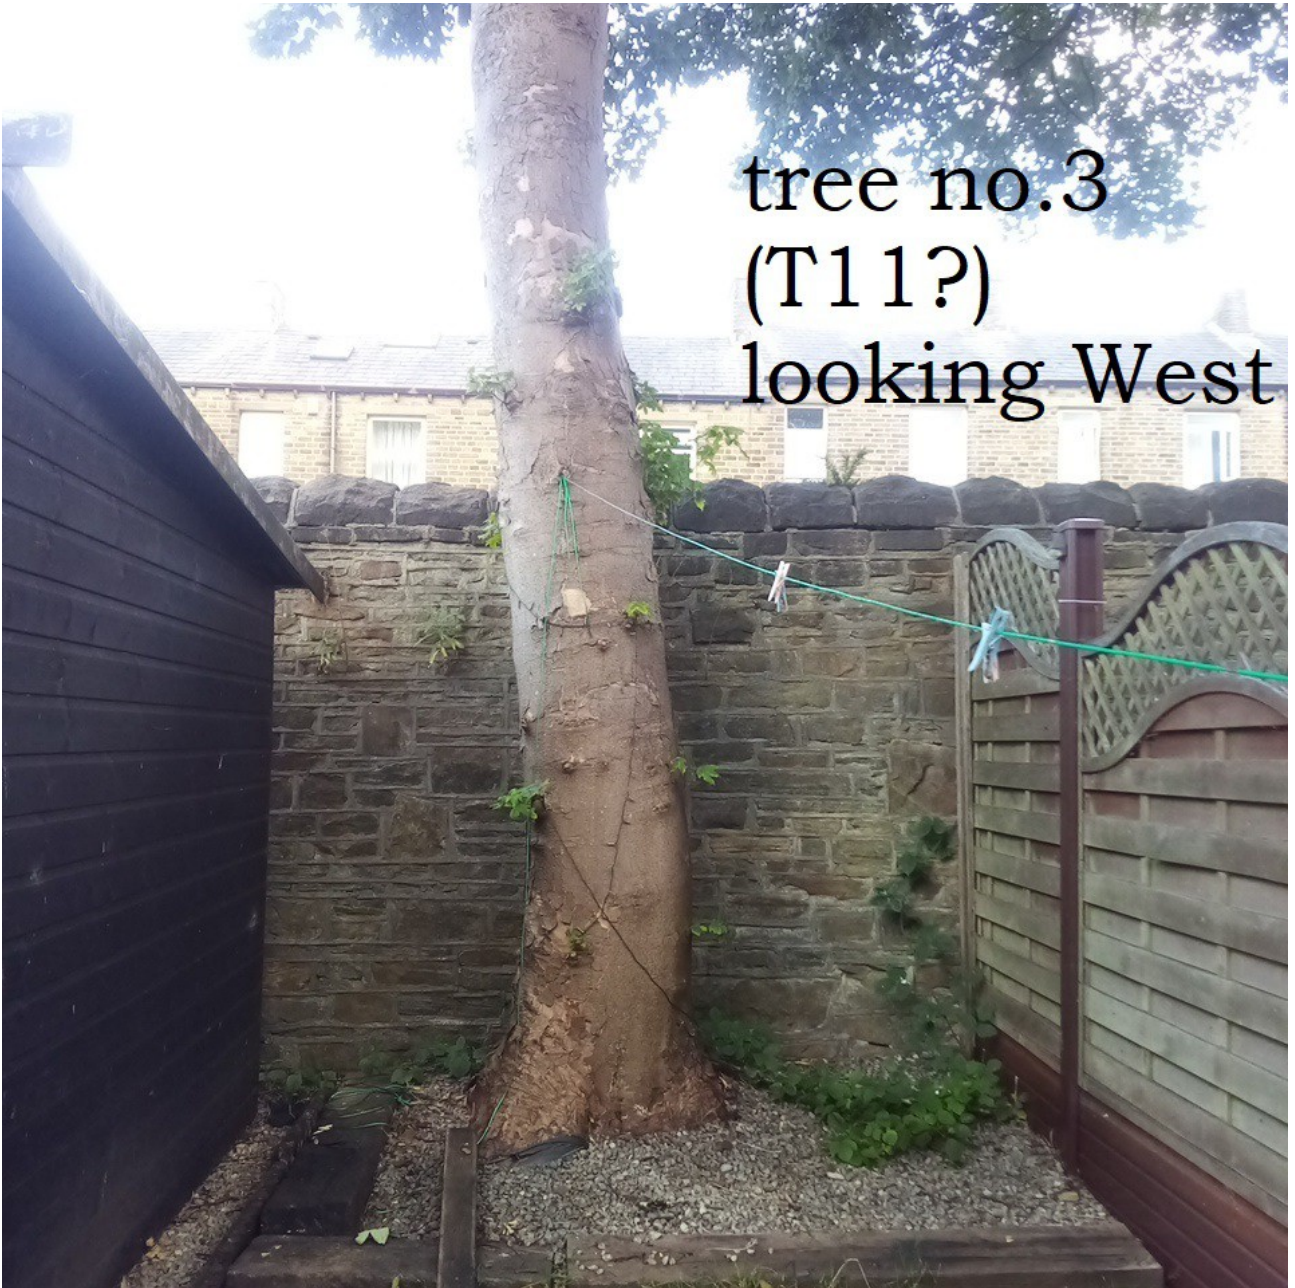
tree no.3  
(T11?)  
looking West

**Features / Defects / Observations:** Crown and stem mainly weighted towards the West – towards driveway / alley.

Large buttress root response growth to opposing weight of crown.

Stem bifurcates with U-shaped fork.

**Recommendation:** Approximately a 3 metre partial crown reduction to balance the crown.

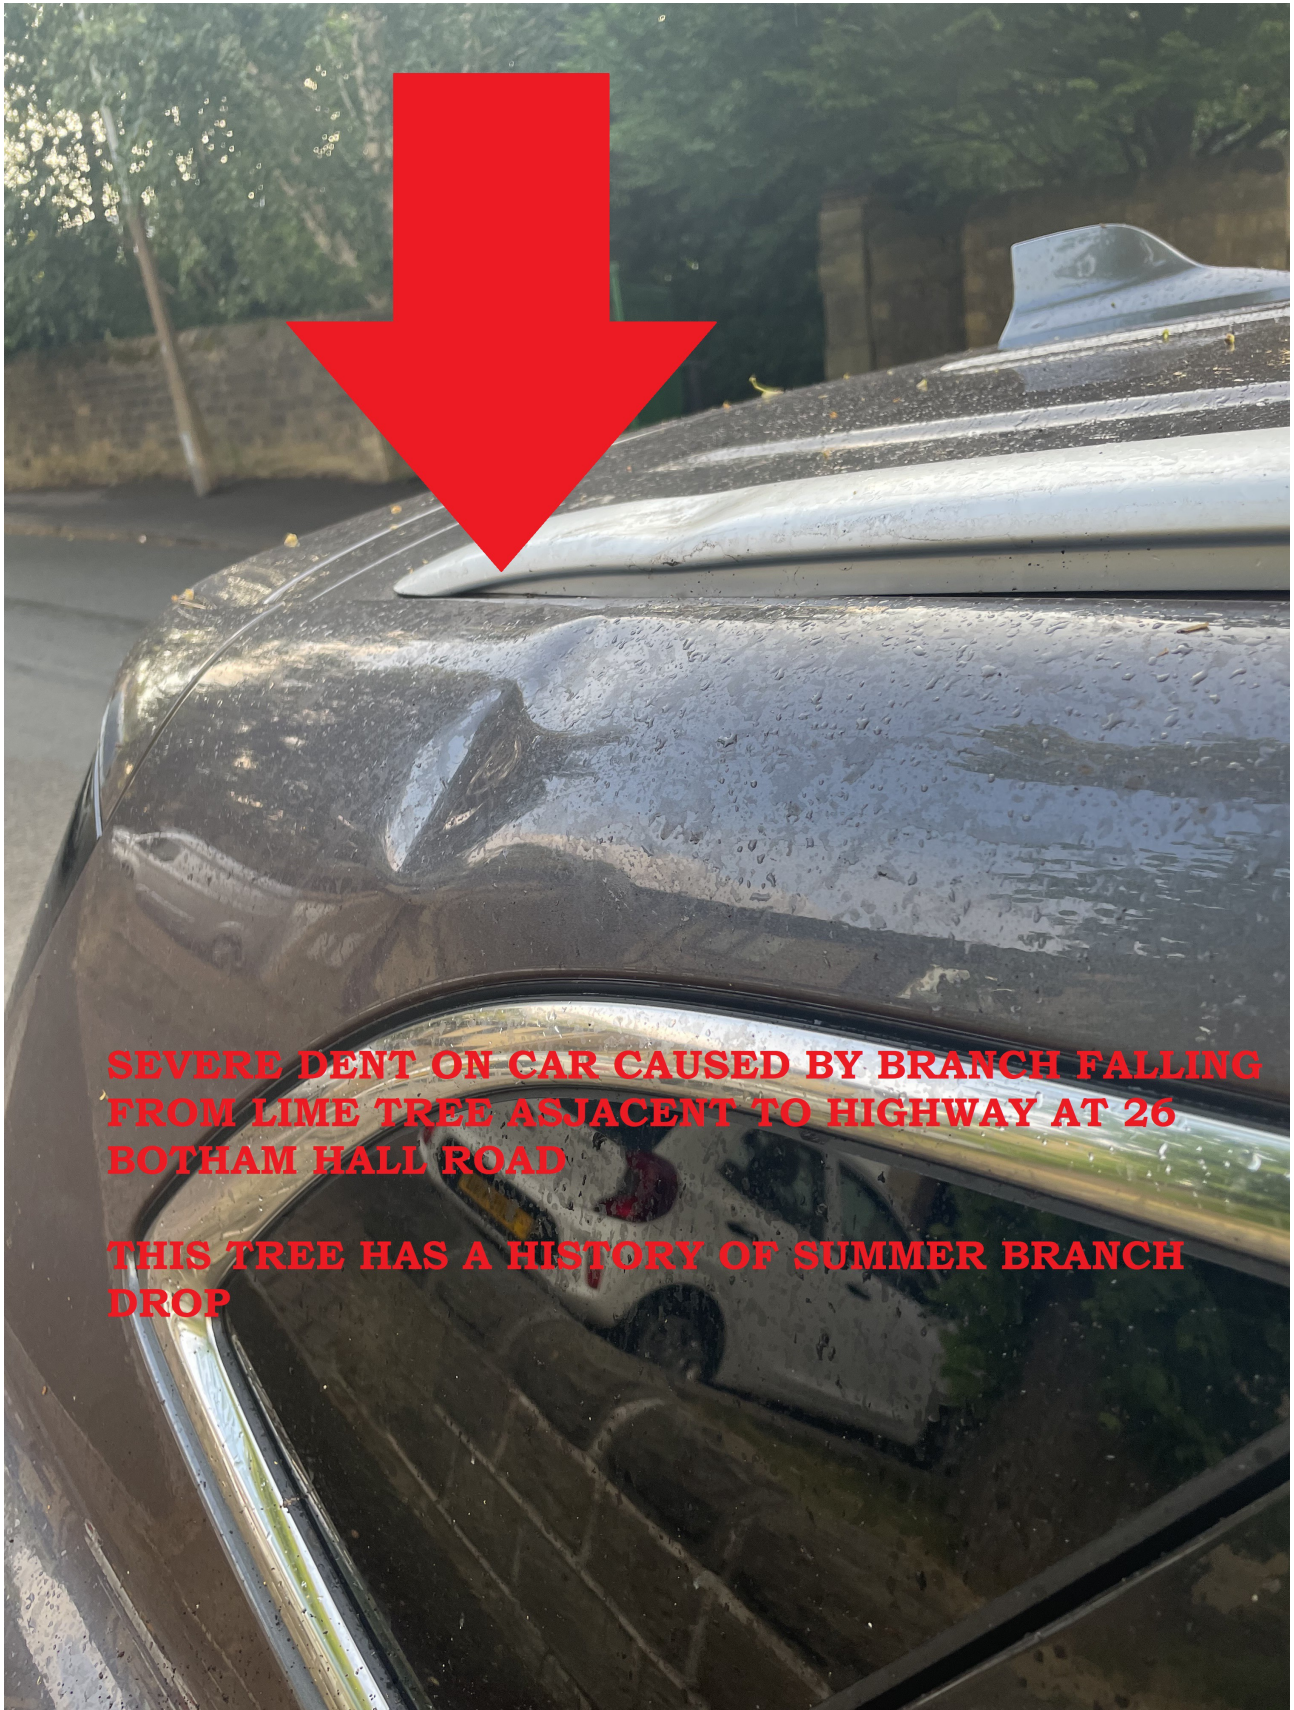
**SEVERE DENT ON CAR CAUSED BY BRANCH FALLING  
FROM LIME TREE ASJACENT TO HIGHWAY AT 26  
BOTHAM HALL ROAD**

**THIS TREE HAS A HISTORY OF SUMMER BRANCH  
DROP**
