## Sycamore Maple (Sycamore 2)

### Tree Details and Location

## Summary

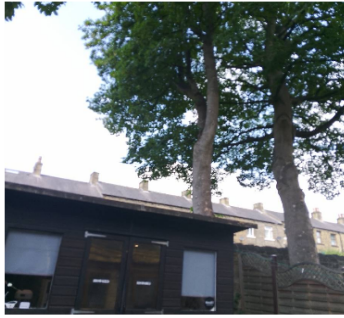
The highest risk is branch failure onto cars, etc.
