# Tree Condition Survey & Management Work Recommendations

SITE: 54 Mount Road, Marsden, HD7 6HP

Ref: NWTC/RG002

**NORTH WEST TREE CONSULTANCY LTD**

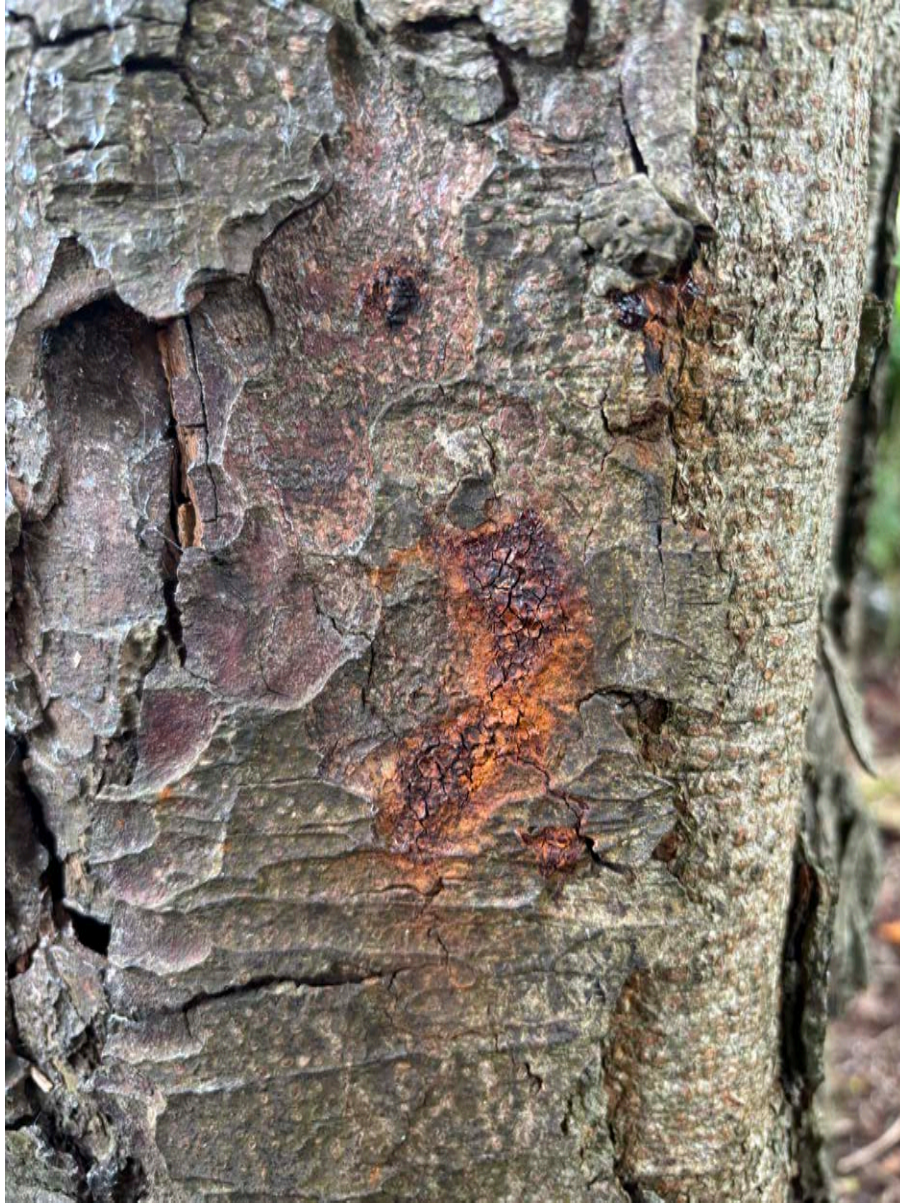
Photograph 2: *Pseudomonas syringae* on lower stem.

| Ref. | Species | Description | Measurements | Survey Notes | Overall Condition | Inspect Period | Recommendations |
|---|---|---|---|---|---|---|---|
| T1 | Horse chestnut<br>( <i>Aesculus hippocastanum</i> ) | Owned by the client.<br>Target # - dwelling.<br>Target # - Pedestrians.<br>Target # - Traffic. | Height (m): 15<br>DBH (mm): 820<br>Life Stage: Mature<br>Life Exp.: < 10 Years | A mature specimen of poor structural condition. Large seams of decay present on main stem and primary ascending stems and lateral limbs. Exudates visible at lower trunk consistent with Pseudomonas syringae. FFB to upper trunk identified as Cerioporus squamosus, approximately 5m from ground level on north stem quadrant. Overall vitality is fair for species. Dead wood present throughout crown with max diameter estimated at <50mm diameter. | Poor | 18 Months | Fell Tree and replace.<br><br>Timescale: 12 months |

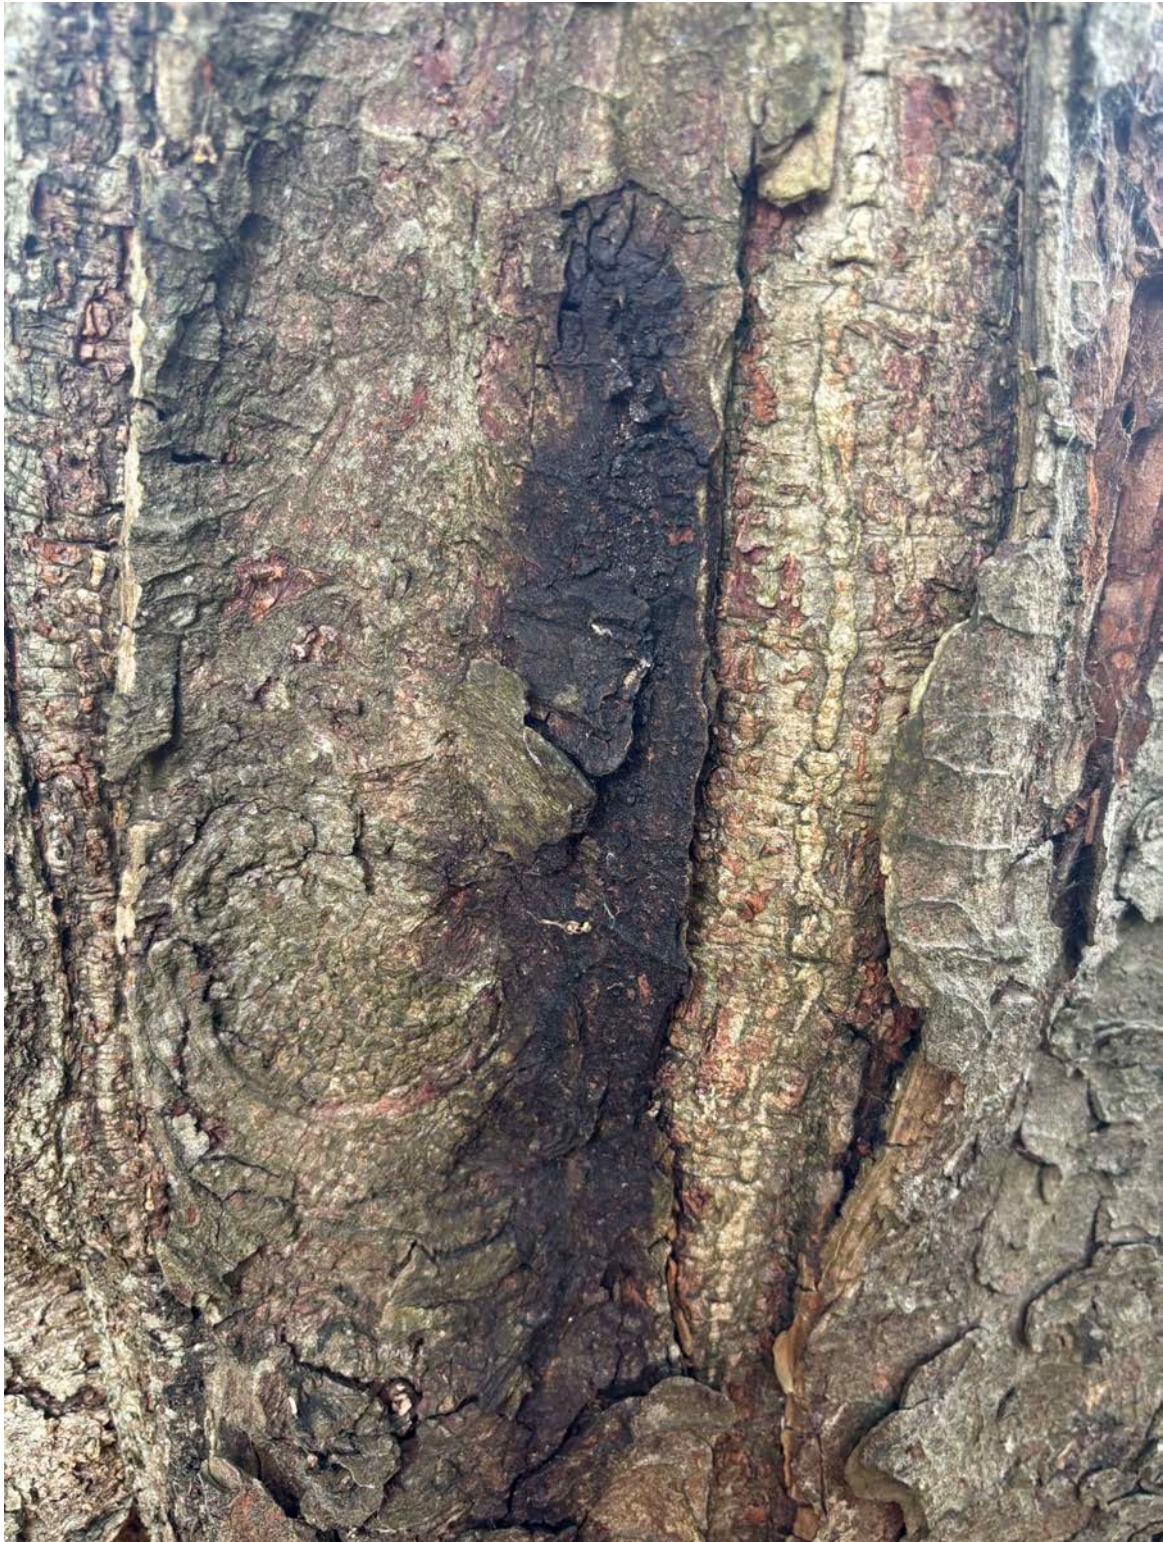
- 4.1.5 The subject tree T1 *Aesculus hippocastanum* is a mature tree which is located to the south east of the property on the garden boundary.
- 4.1.6 The tree is situated on a slightly raised garden bed and overhangs the main Mount Road highway.
- 4.1.7 Large seams of decay are present on both main stem, primary ascending limbs and lateral limbs.
- 4.1.8 The tree has visible signs of *Pseudomonas syringae* located at lesions to the lower stem.
- 4.1.9 The tree has brackets of *Ceriporus squamosus* located to the upper stem along a large seam of decay on the main stem.
- 4.1.10 Overall vitality of the tree is considered fair with normal vitality present for the species and time of year.
- 4.1.11 Some dead wood is visible throughout the entirety of the crown with an estimated maximum diameter of <50mm.

Photograph 3: Seam of decay on main stem with bracket of *Ceriporus squamosus* to upper stem.

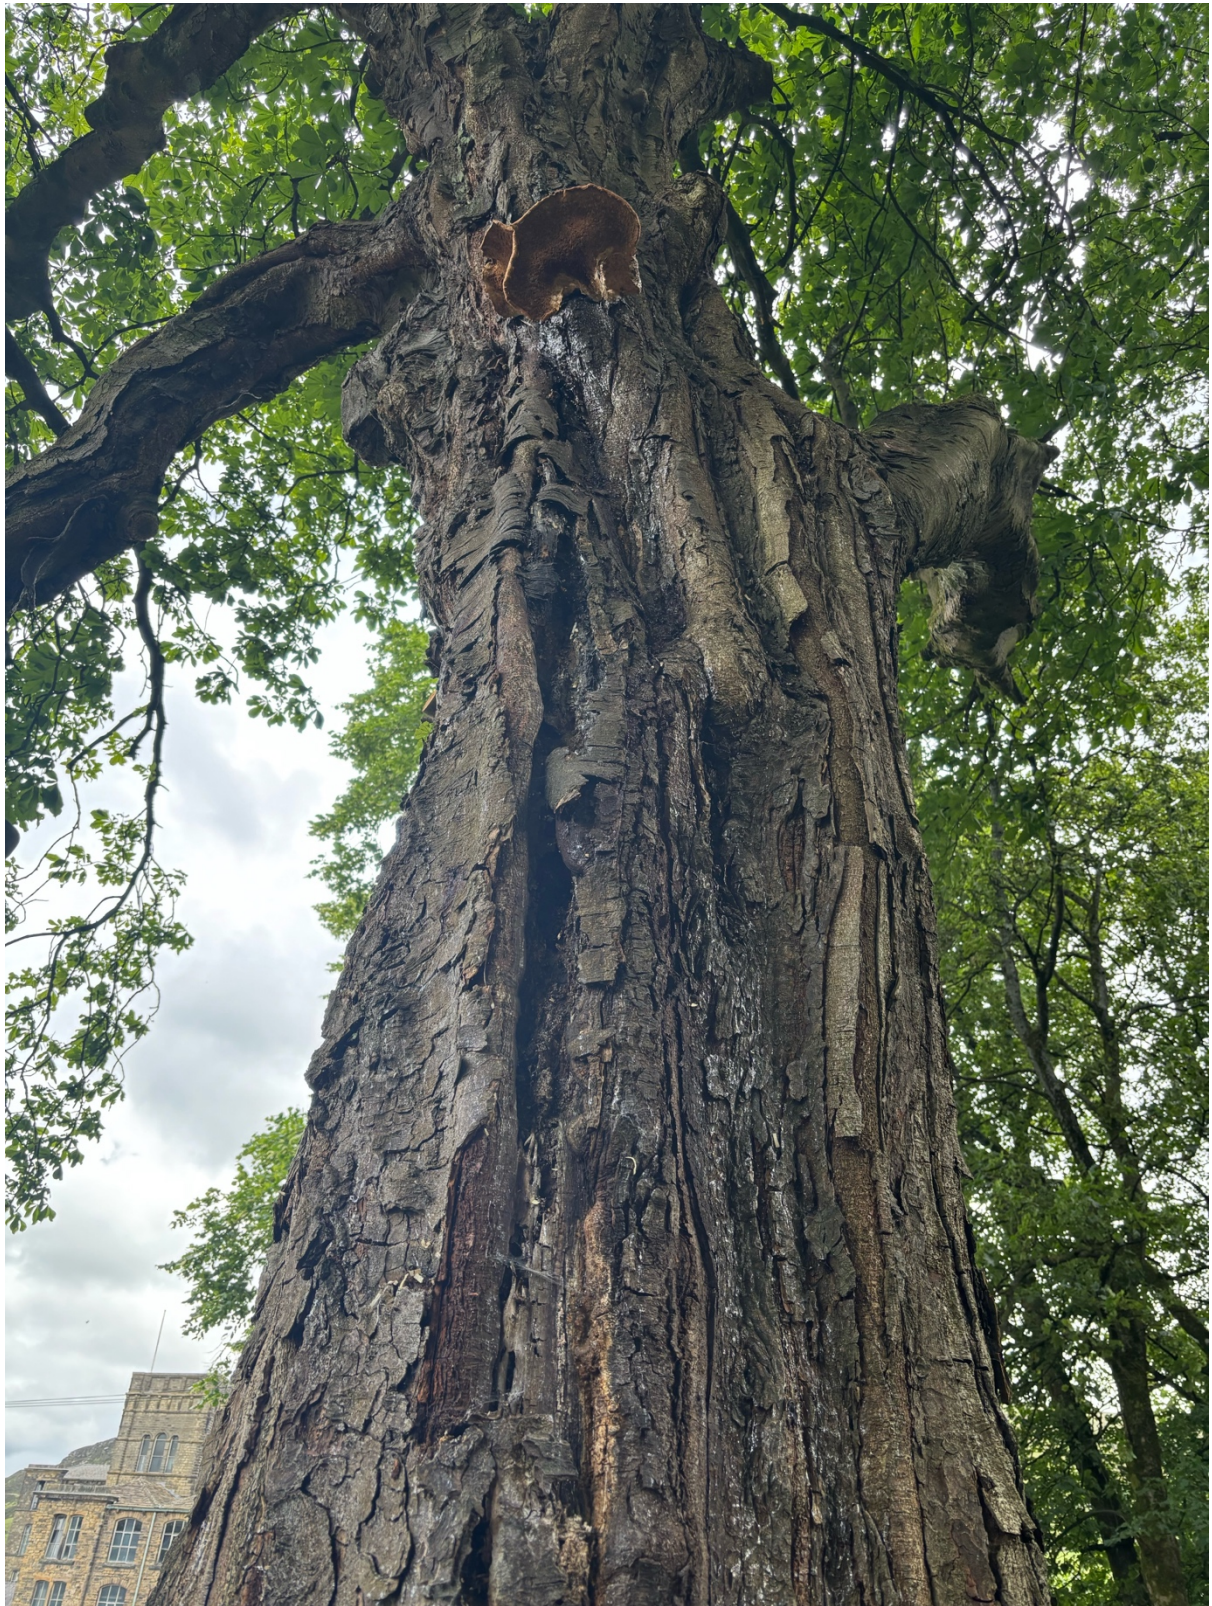
Photograph 4: Seam of decay on main stem with bracket of *Ceriporus squamosus* to upper stem
