STRUCTURAL INSPECTION REPORT

LOCATION:
Dewsbury Library, Dewsbury.

DOCUMENT REF:
25343-SIR-001

REVISION/DATE:
Revision B / 01.10.2025

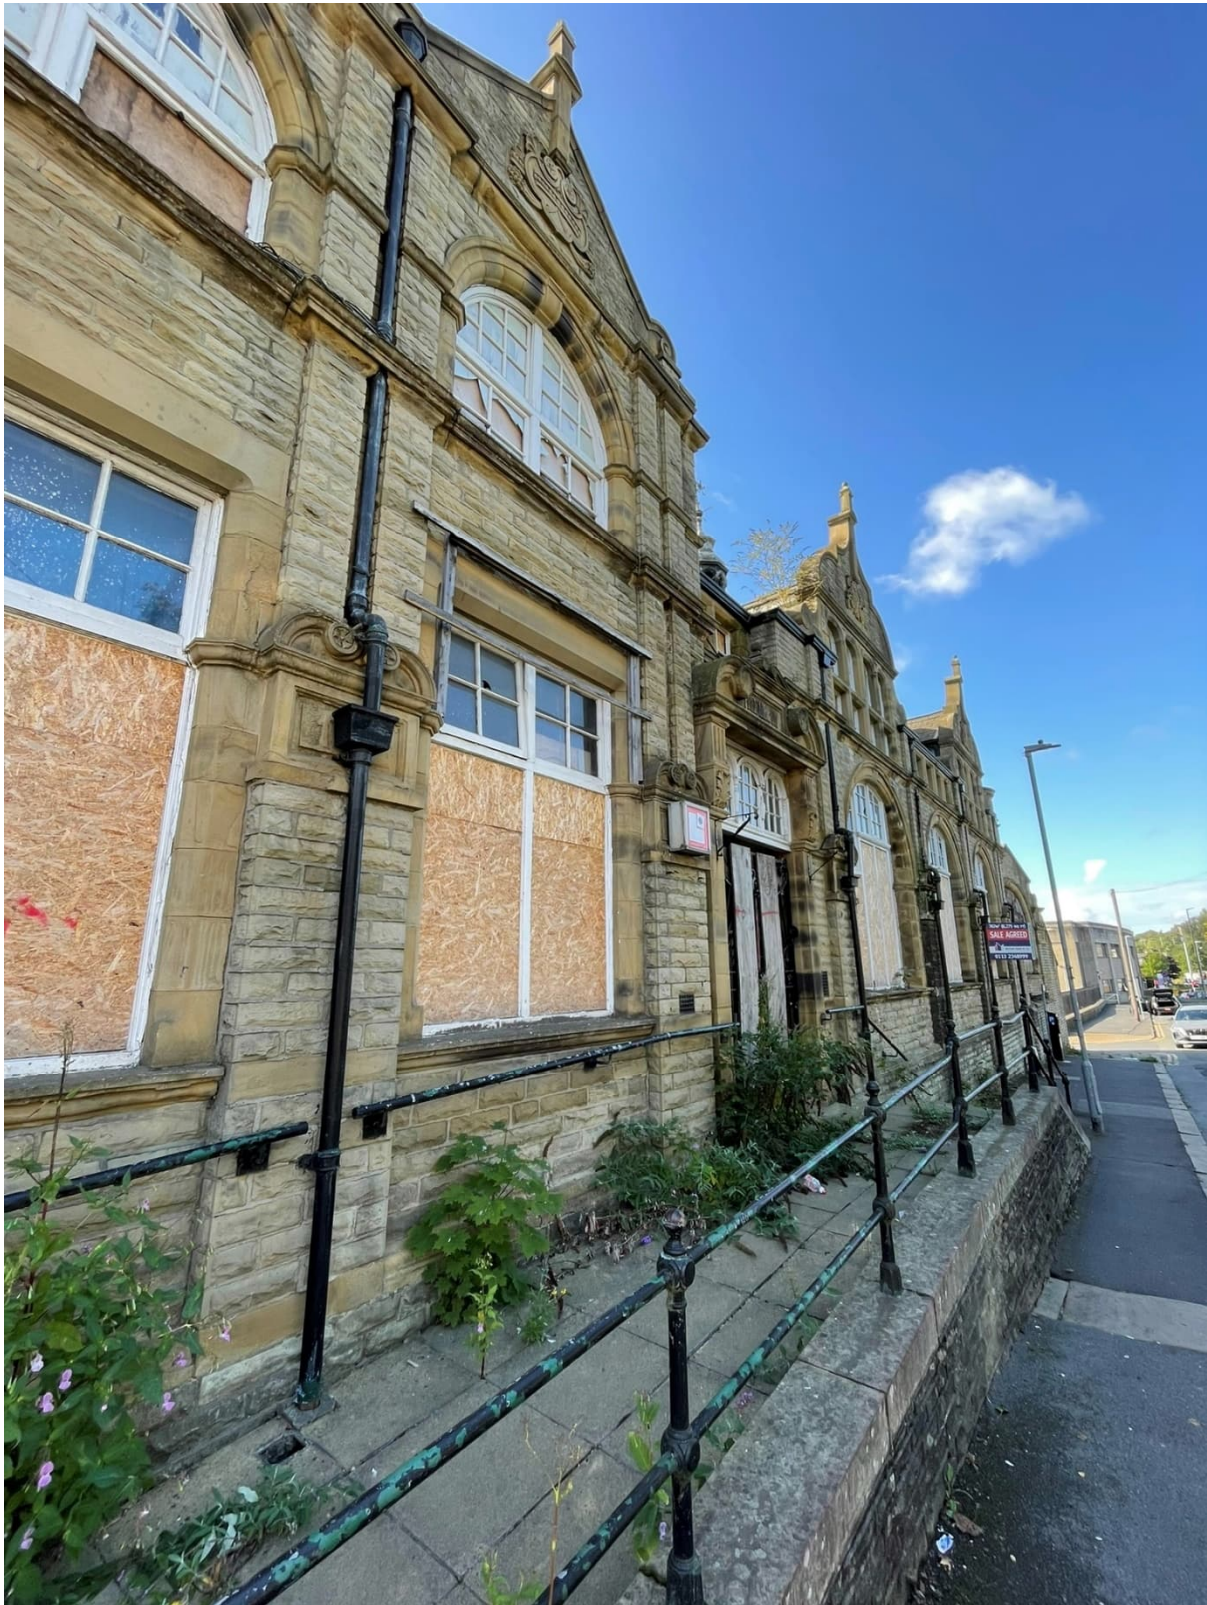
The masonry appeared to look structurally sound, but only the front elevation was accessible due to the site being fenced off, and very overgrown round the side. Therefore, access and further investigation should be carried out the sides and rear of the building. There were some areas where the pointing appears to have dropped out. Also, a large area of the north-east elevation was covered with climbing vegetation. The windows and sills/surrounds are clearly in need of repair.

Front elevation, boarded up windows, weathers sills and missing mortar.

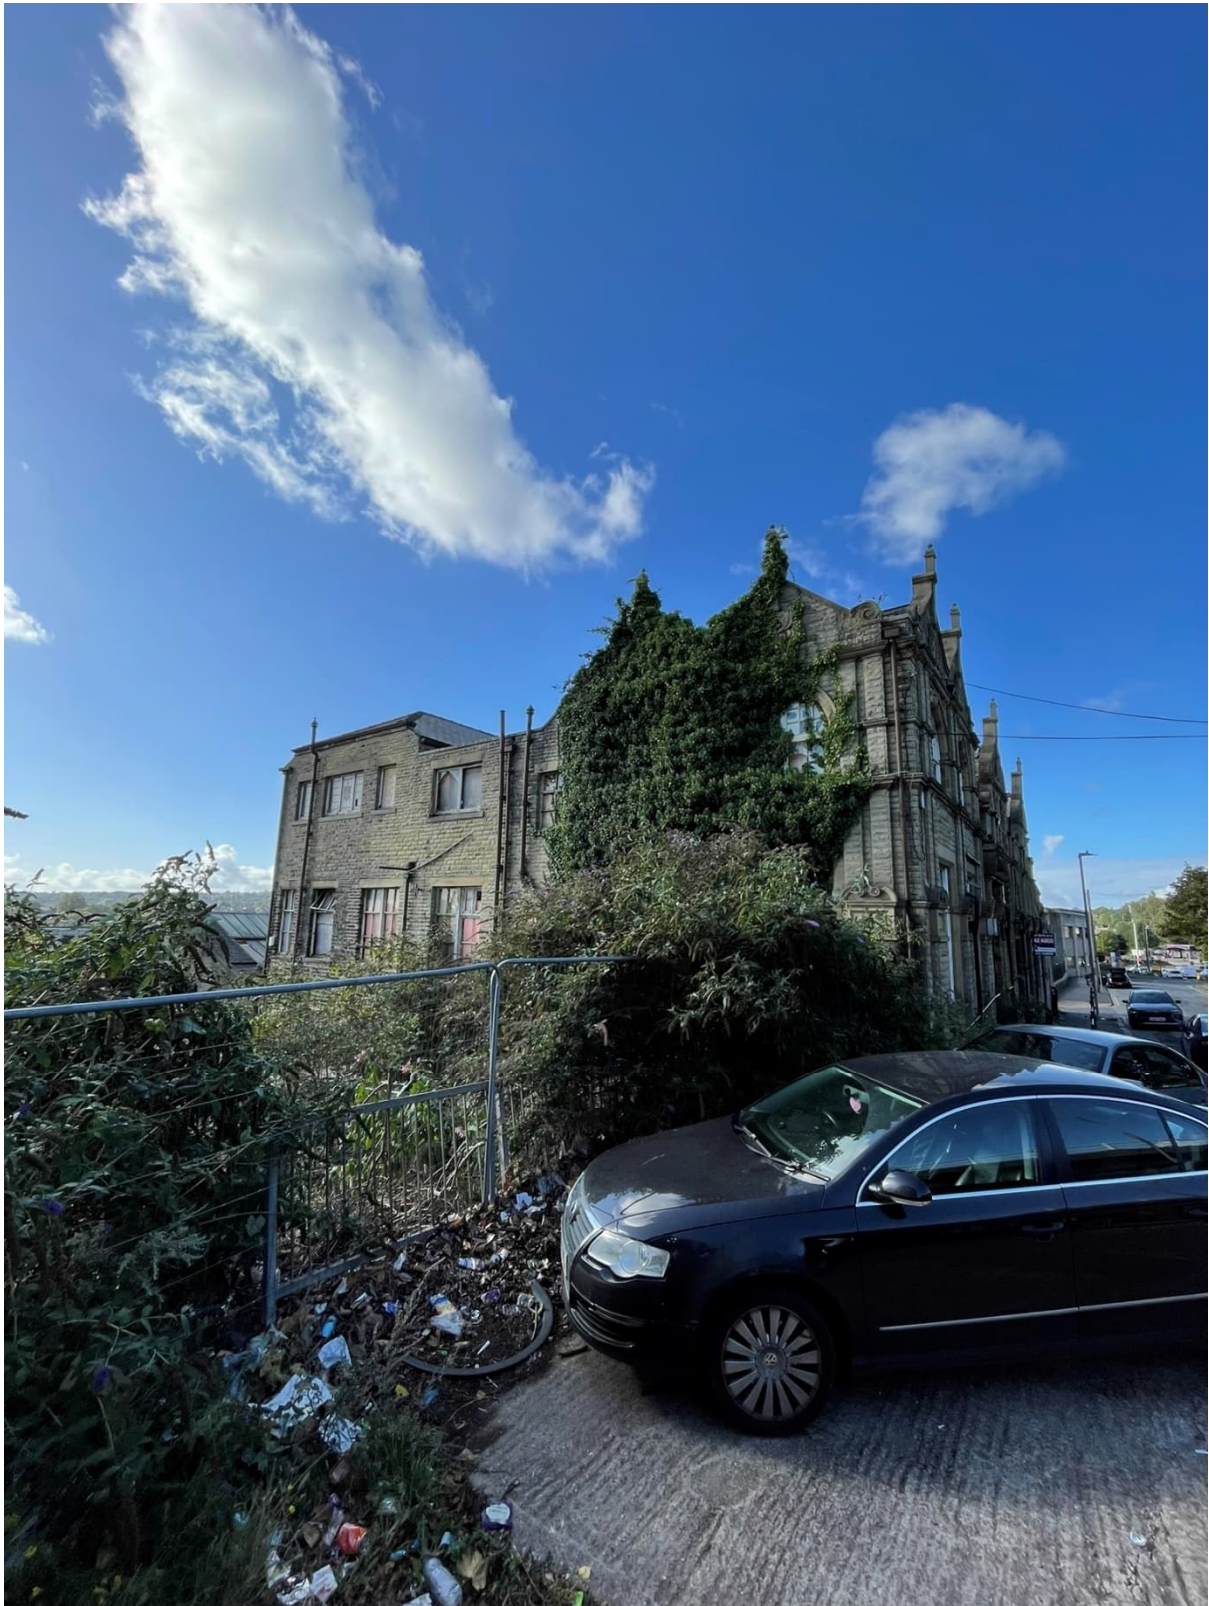
North East elevation, climbing vegetation.

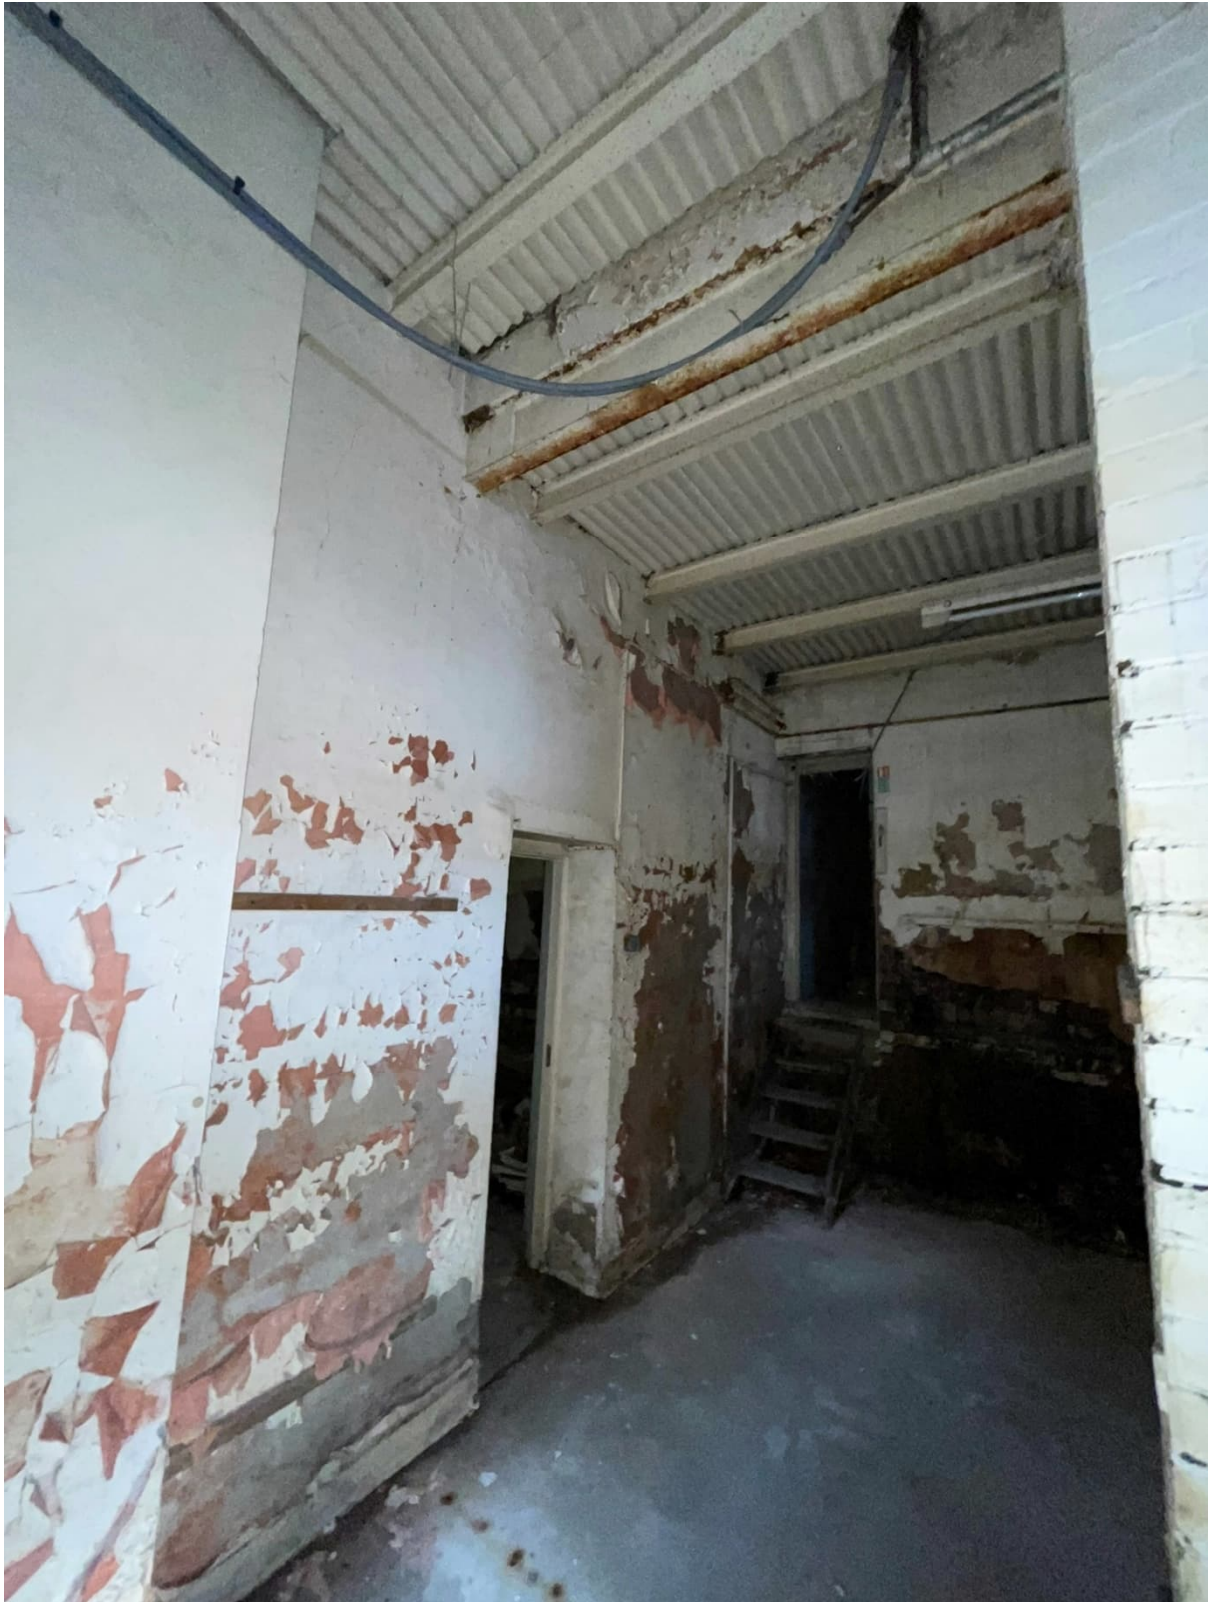
have profiled sheeting (possibly asbestos). This is potentially a permanent formwork. It was not possible to establish the build-up over the sheeting. The suspended floor is supported on a grillage of steel beams. The steel beams are showing signs of corrosion. Likely caused from the damp.

Steelwork gillage and sheeting to underside of suspended ground floor.

- Where steelwork is heavily corroded it is to be replaced.
- Where steelwork has surface corrosion and no loss of section, then they are to be fully exposed, cleaned and prepared for painting.
- Where existing timber members are defective, they are to be replaced.

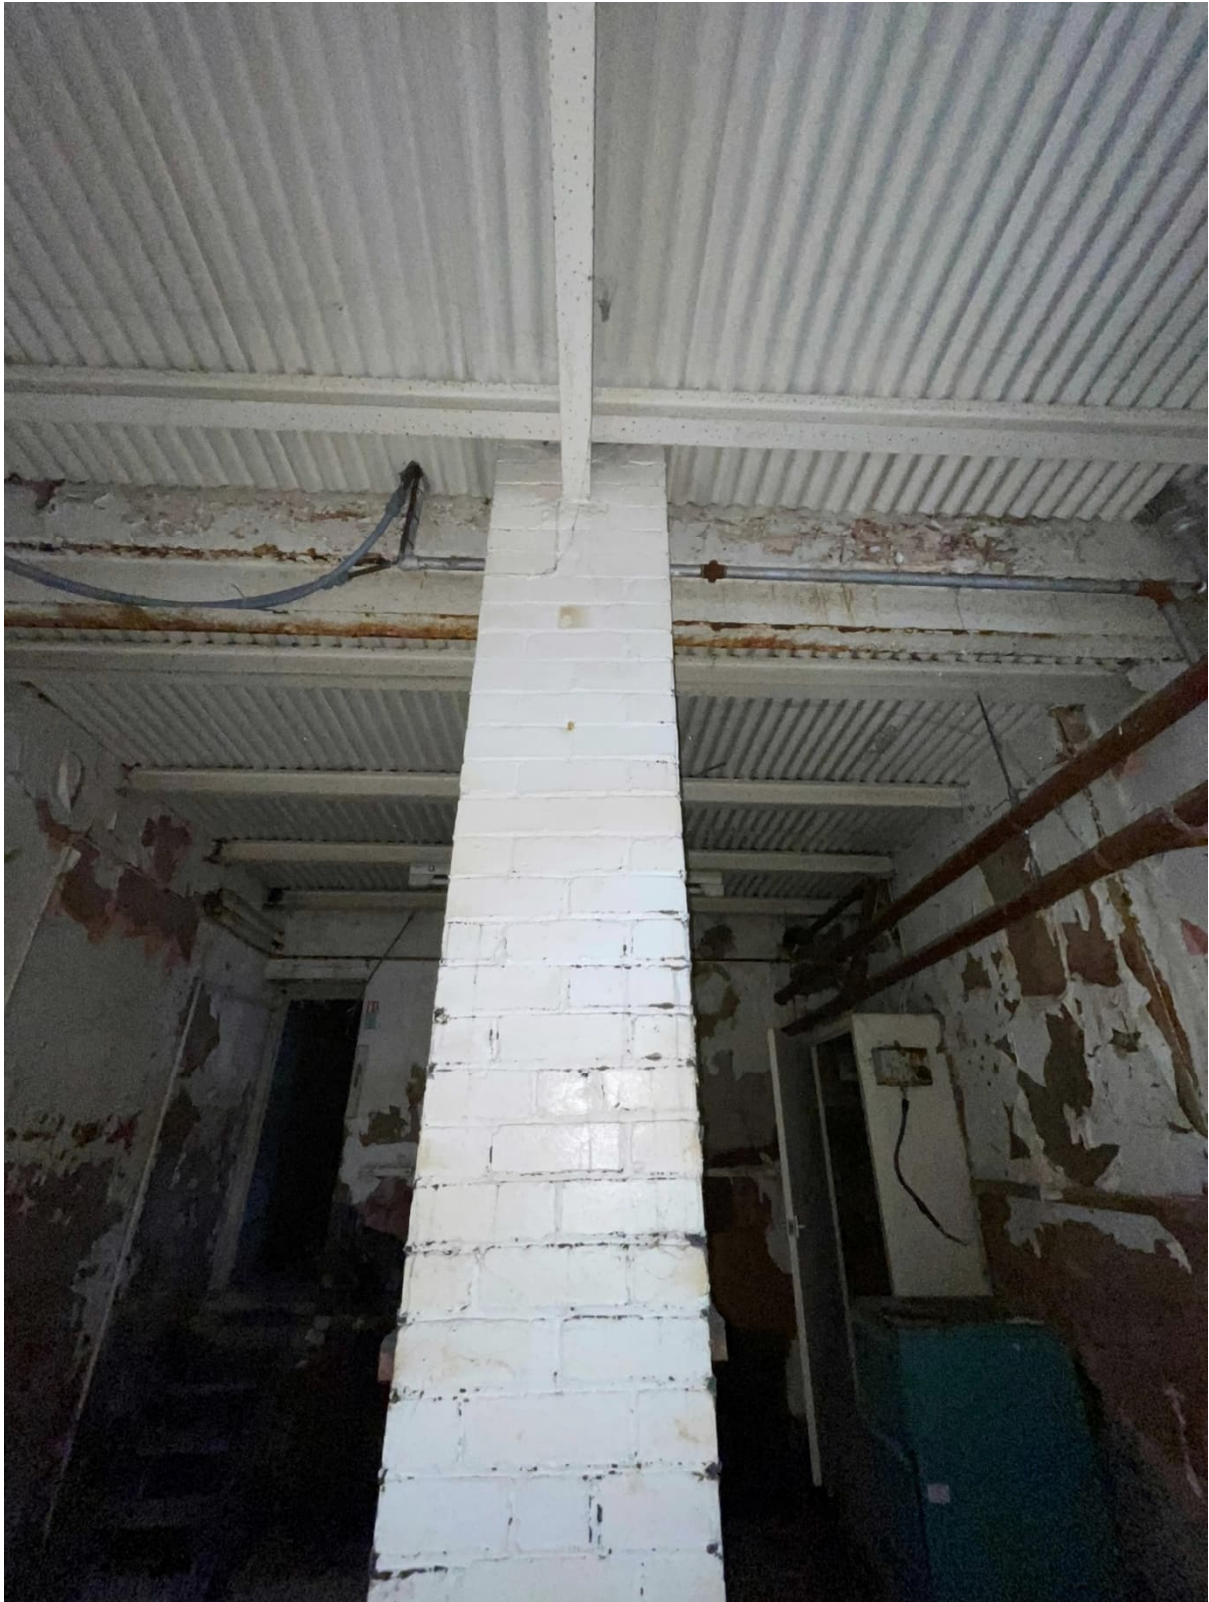
The first room you enter coming down the stairs has a large solid brick pier in the centre. This is carrying steel beams, which in turn are supporting the suspended ground floor. The steel beams are showing signs of corrosion with rust staining likely caused from the damp.

Masonry column supporting steelwork which in turn supports the suspended ground floor.

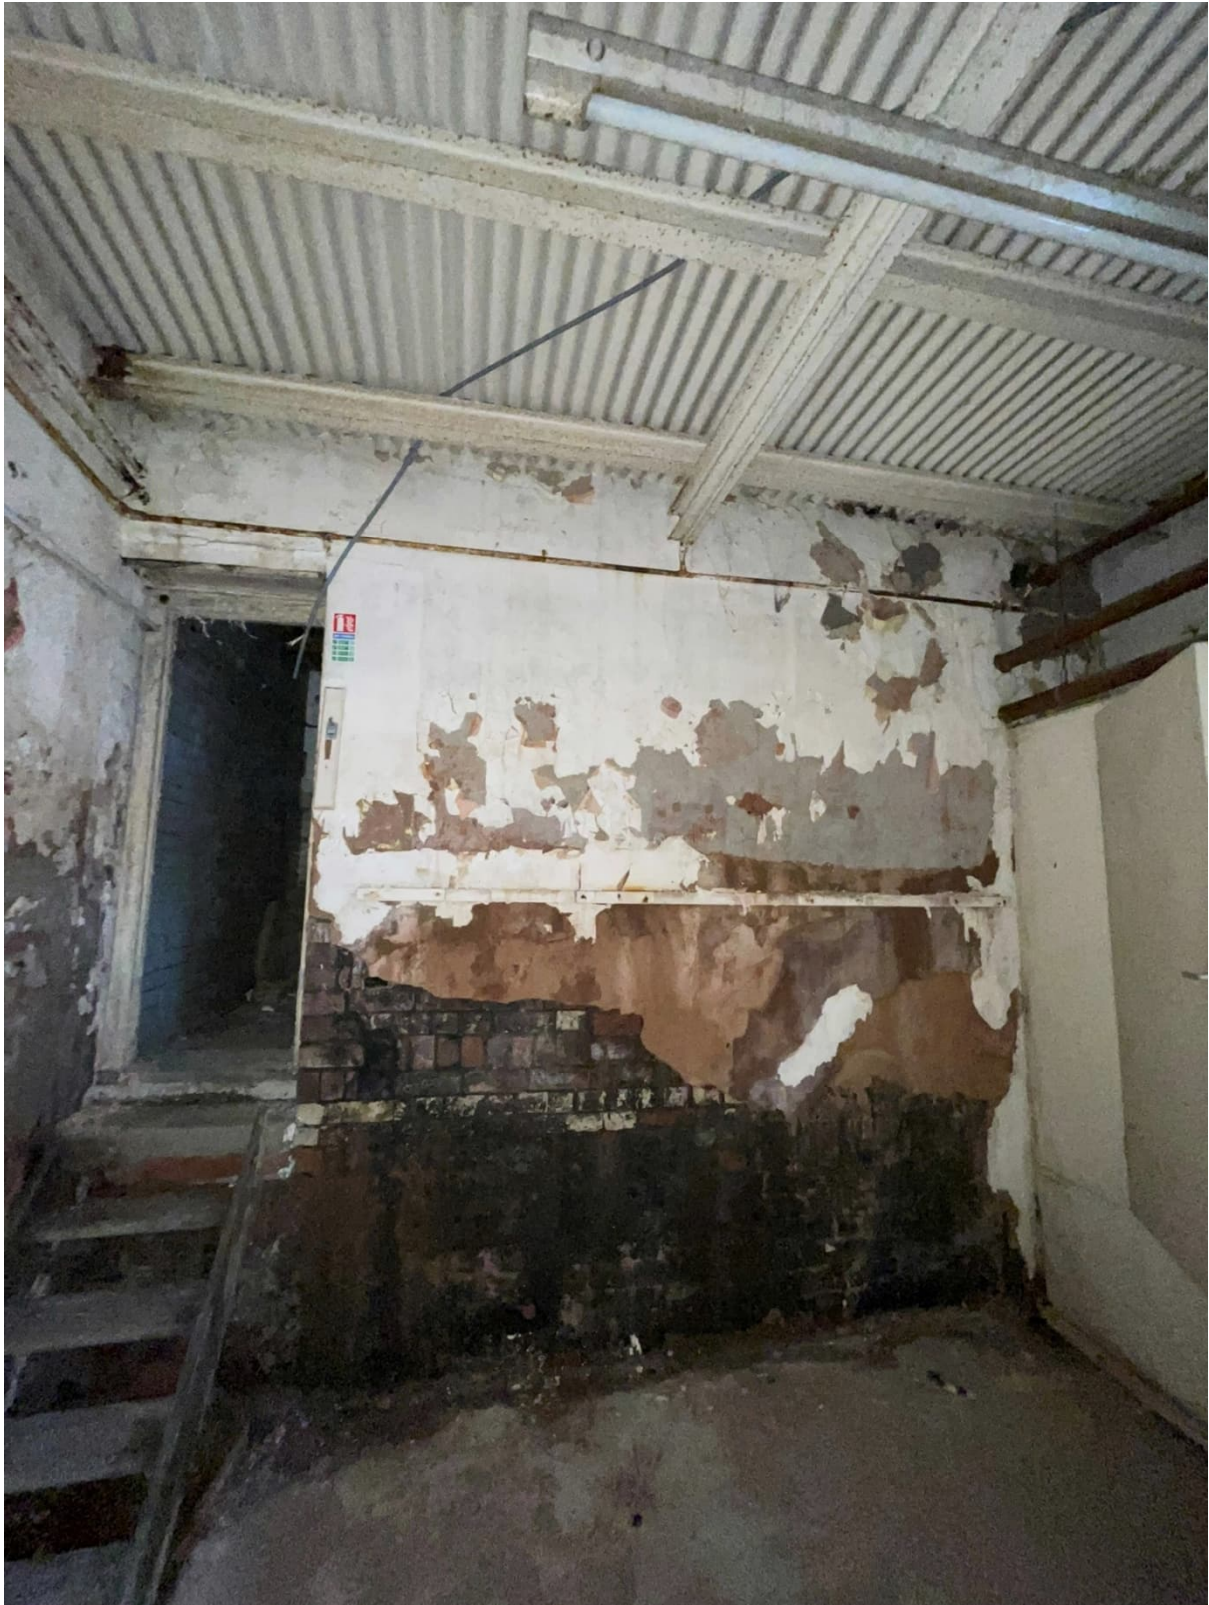
The basement consists of four rooms, three large rooms and one smaller all separated with solid brick walls. The smaller room is at a higher level and still contains plant and ducting. There are clear signs of damp on the walls throughout. The underside of the ground floor appears to

Signs of damp at low level on basement walls.

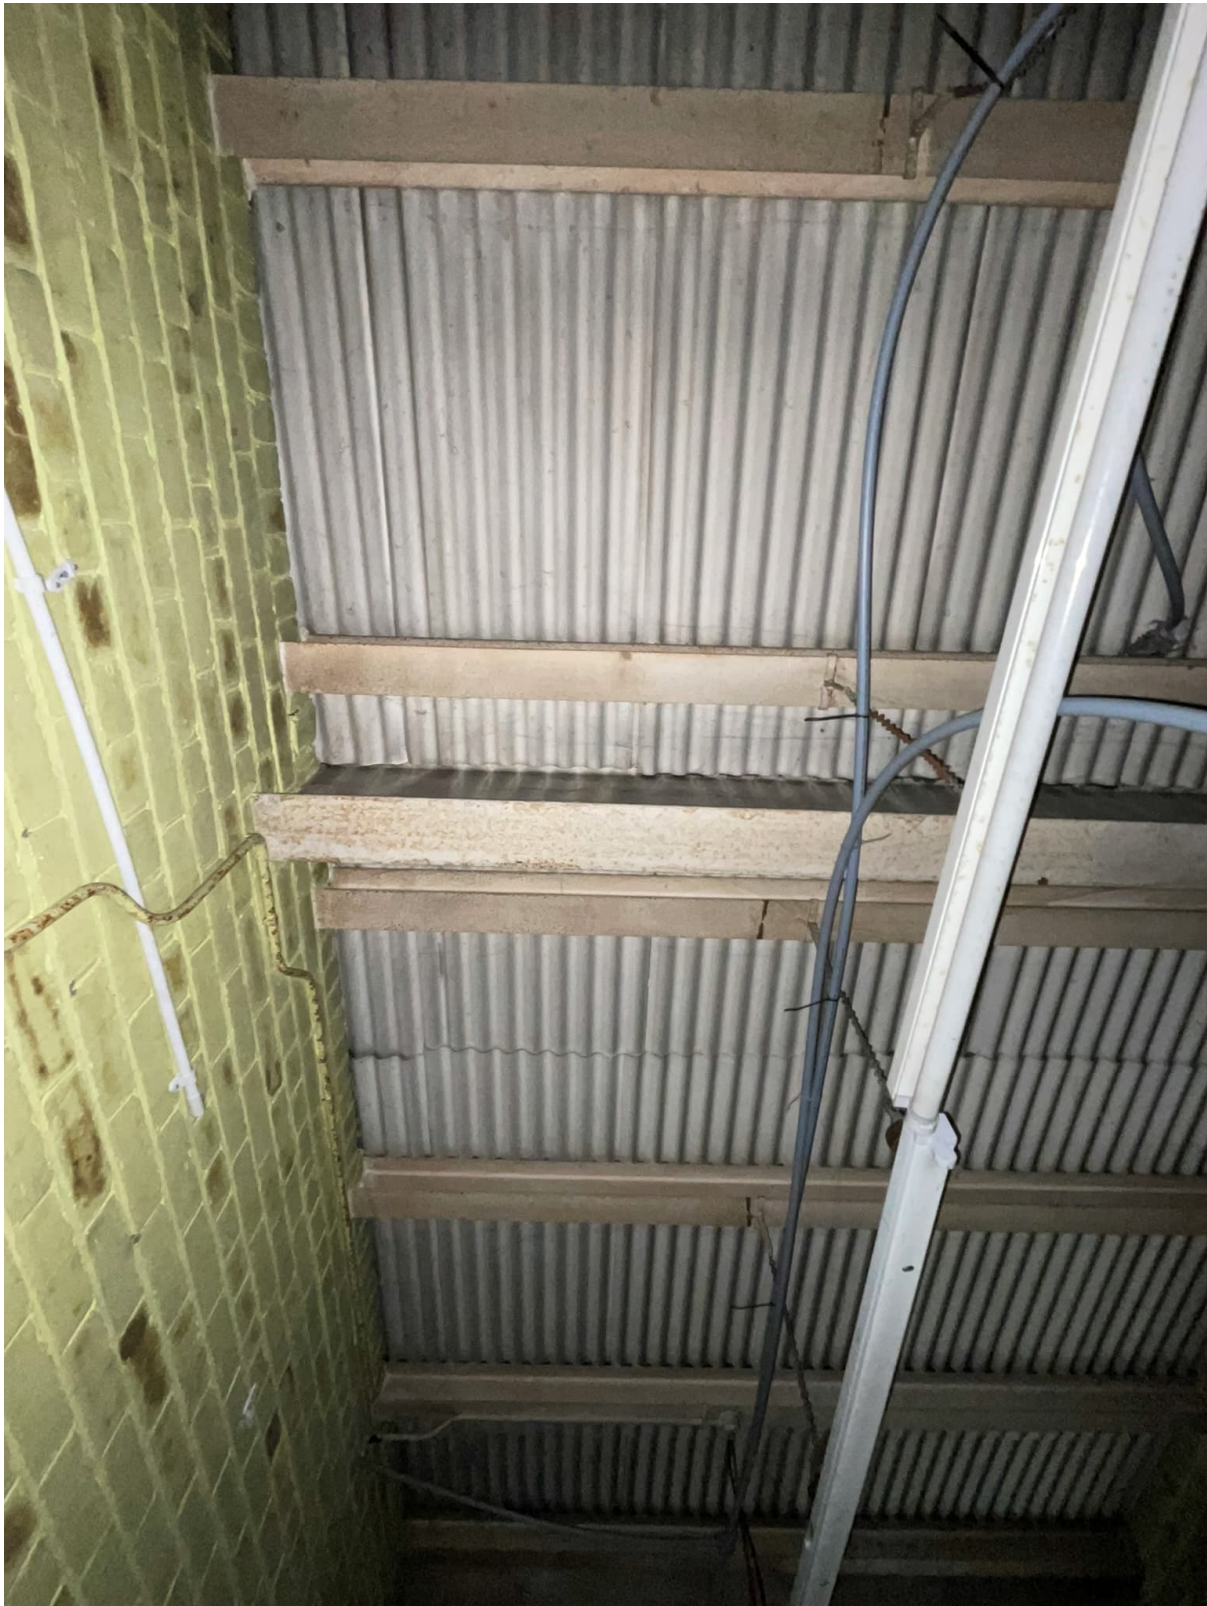
Steelwork grillage & sheeting to underside of ground floor.

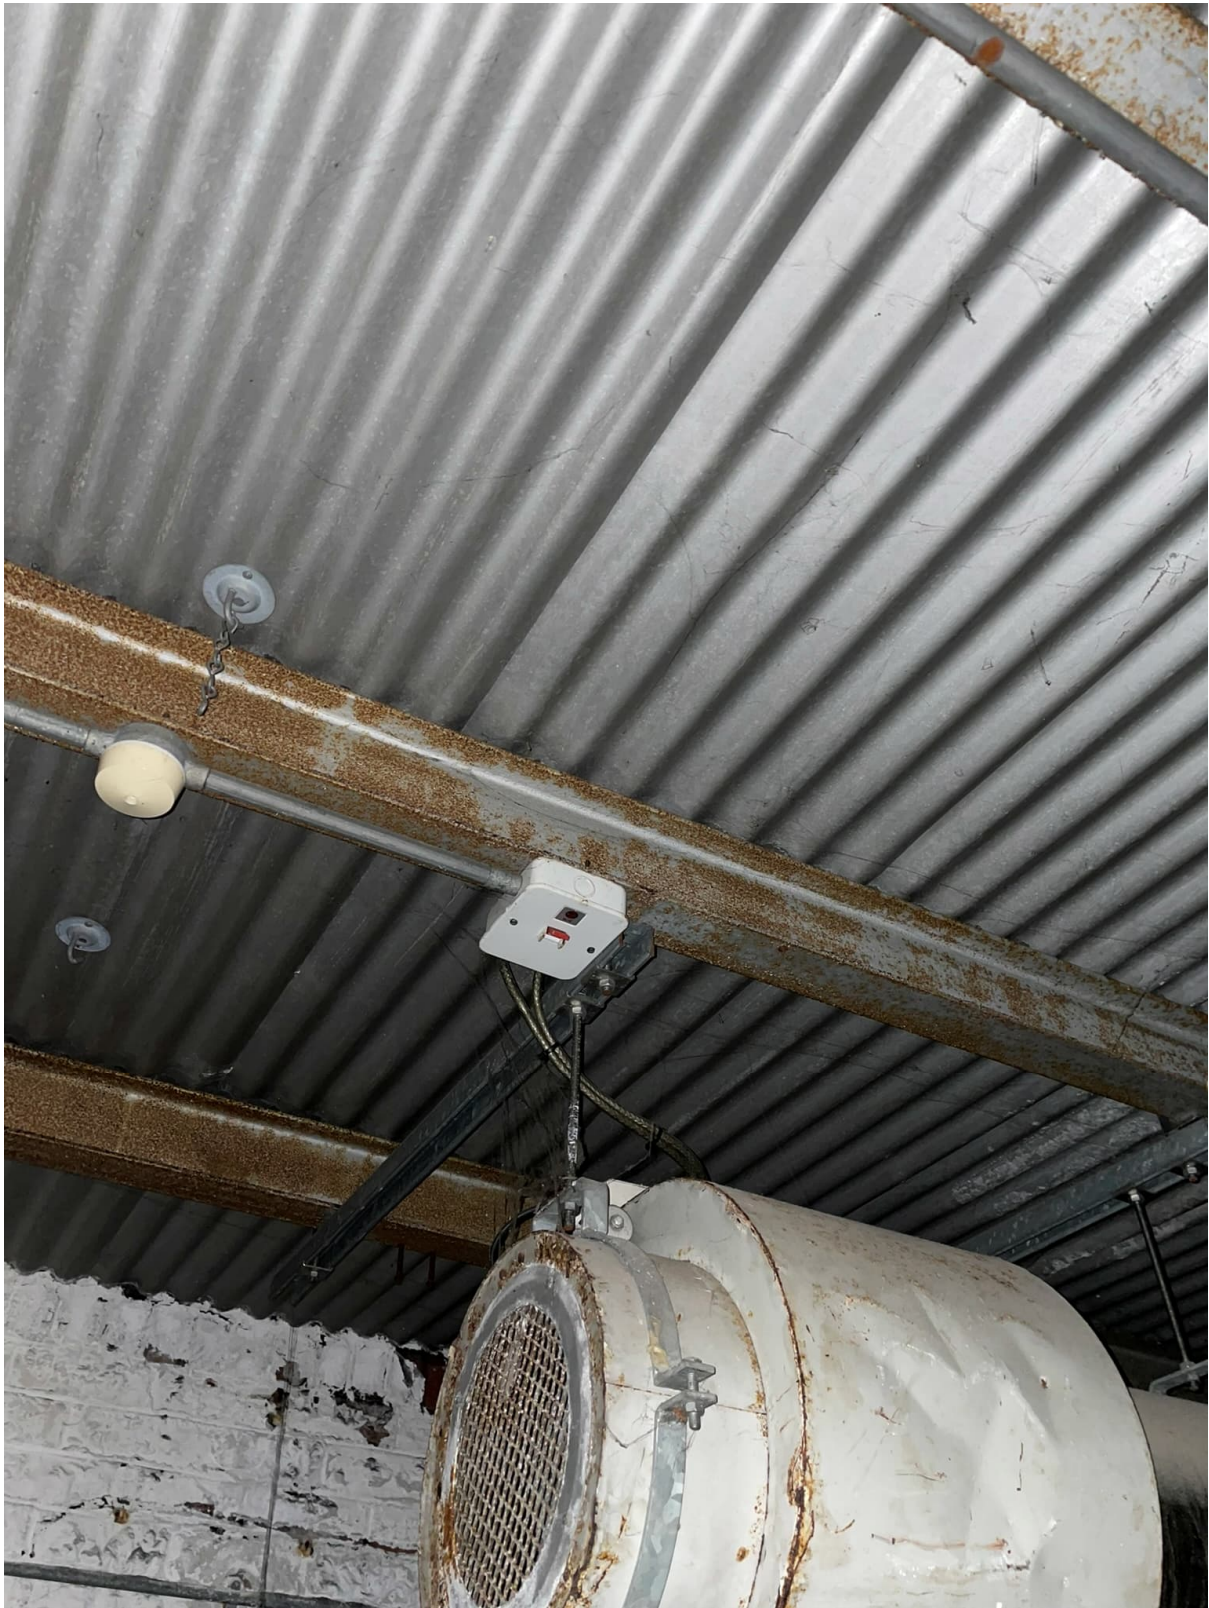
Corroded steelwork grillage in plant/extractor room.

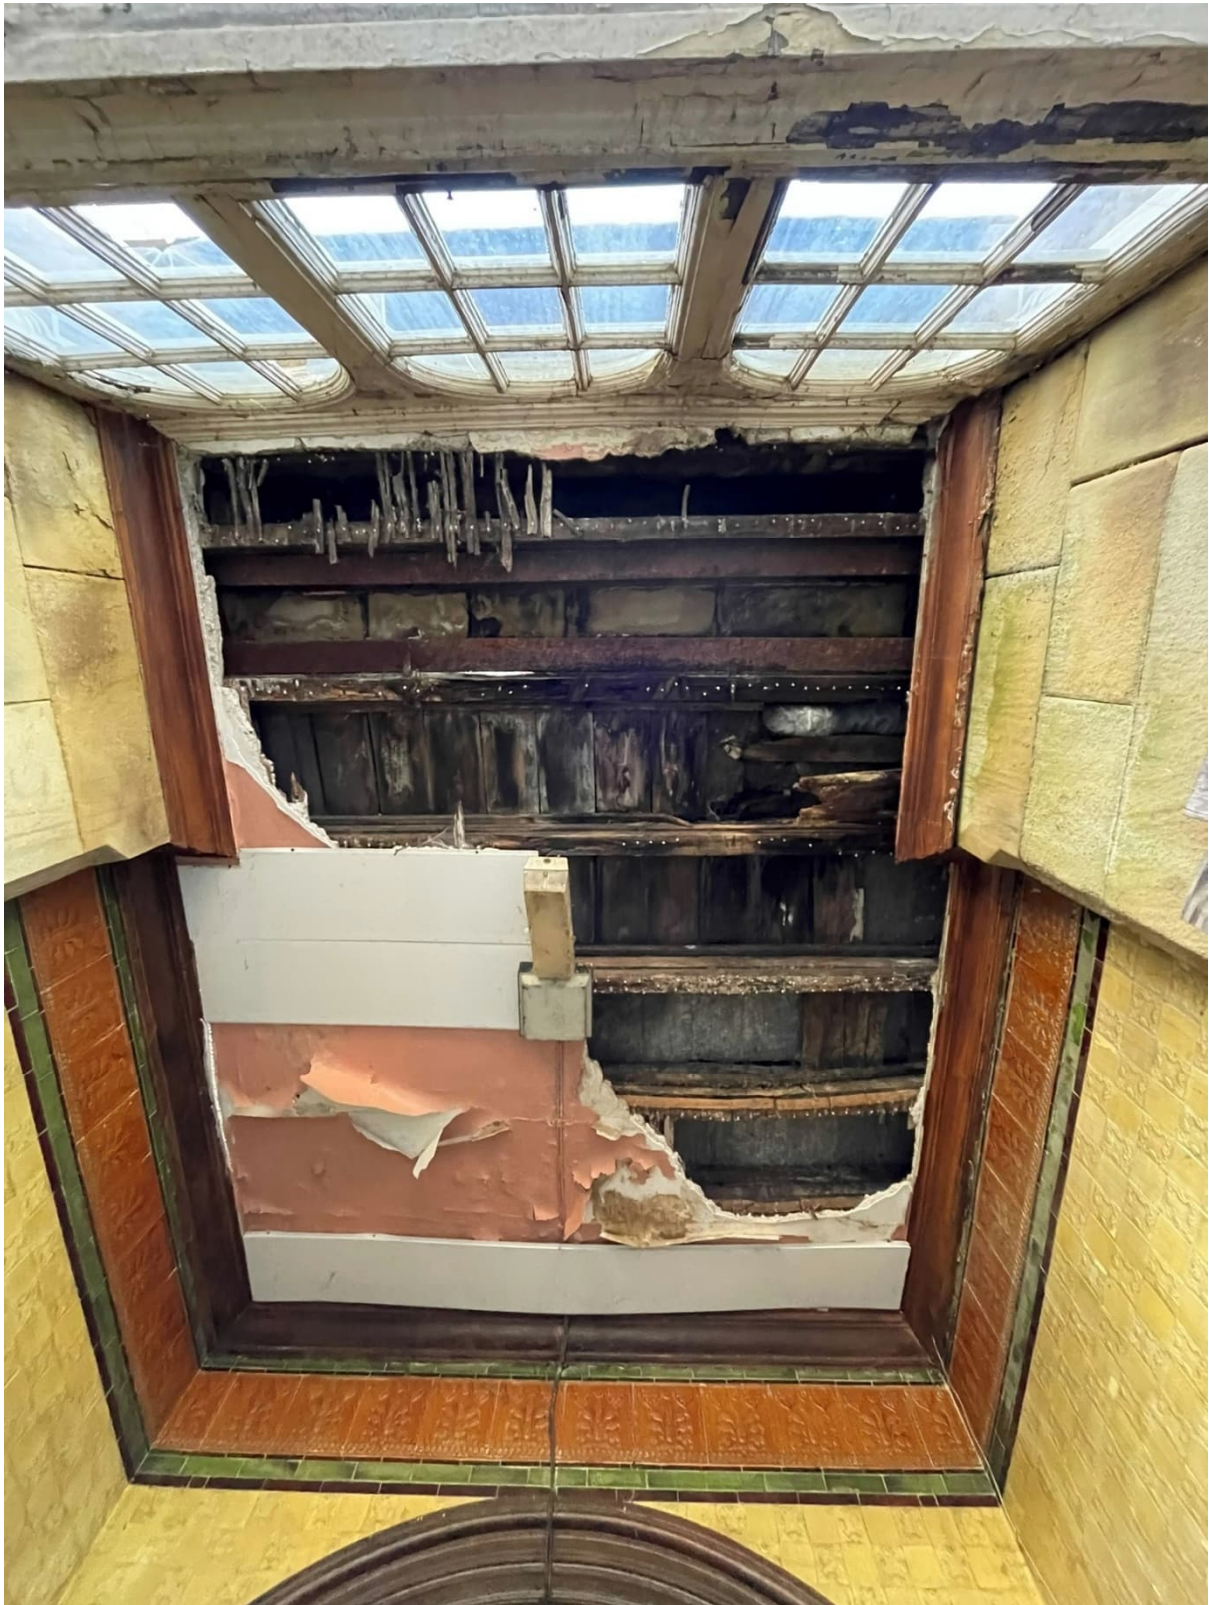
As you enter through the front gates, there is exposed timber joists and two steel beams above. All of which appear to have been exposed to the elements for a while. The joists are rotten, and the steel beams have oxidised. There is evidence of damp in this area with staining and mould on the walls.

Rotten joists and corroded steelwork over entrance.

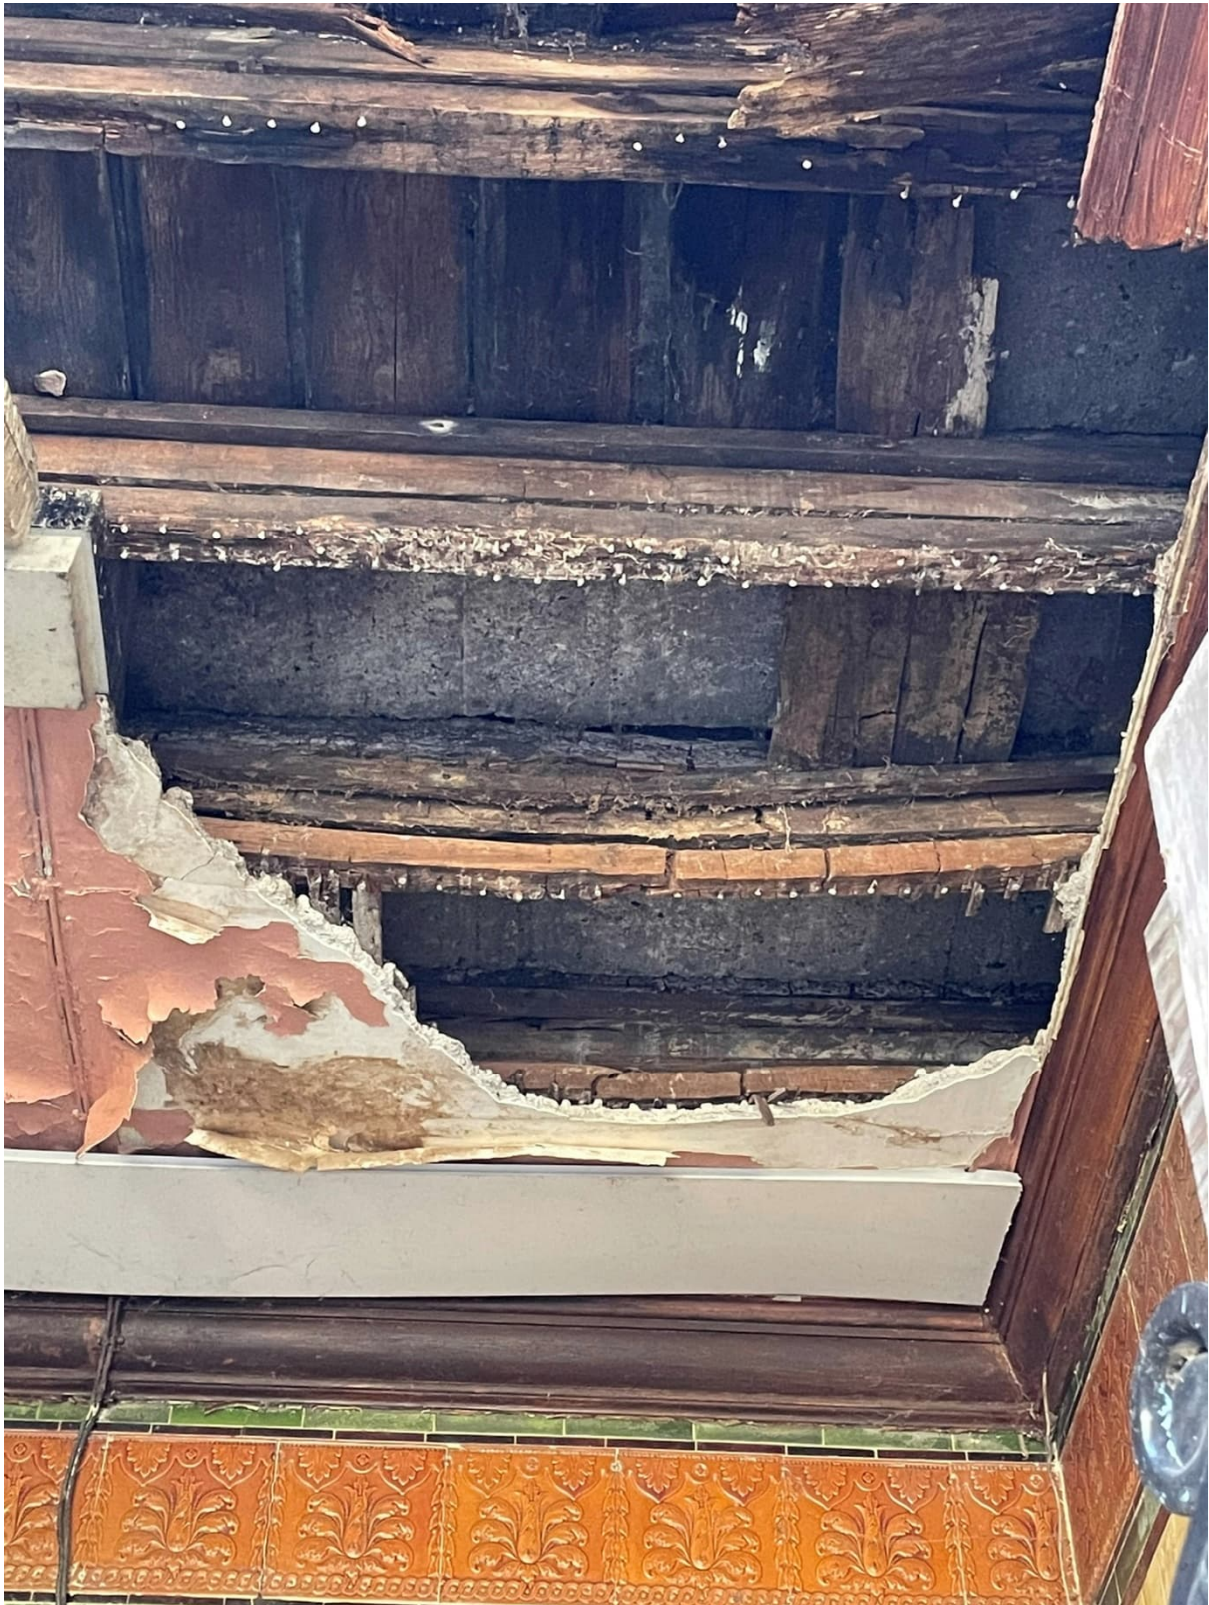
Rotten joists over entrance.

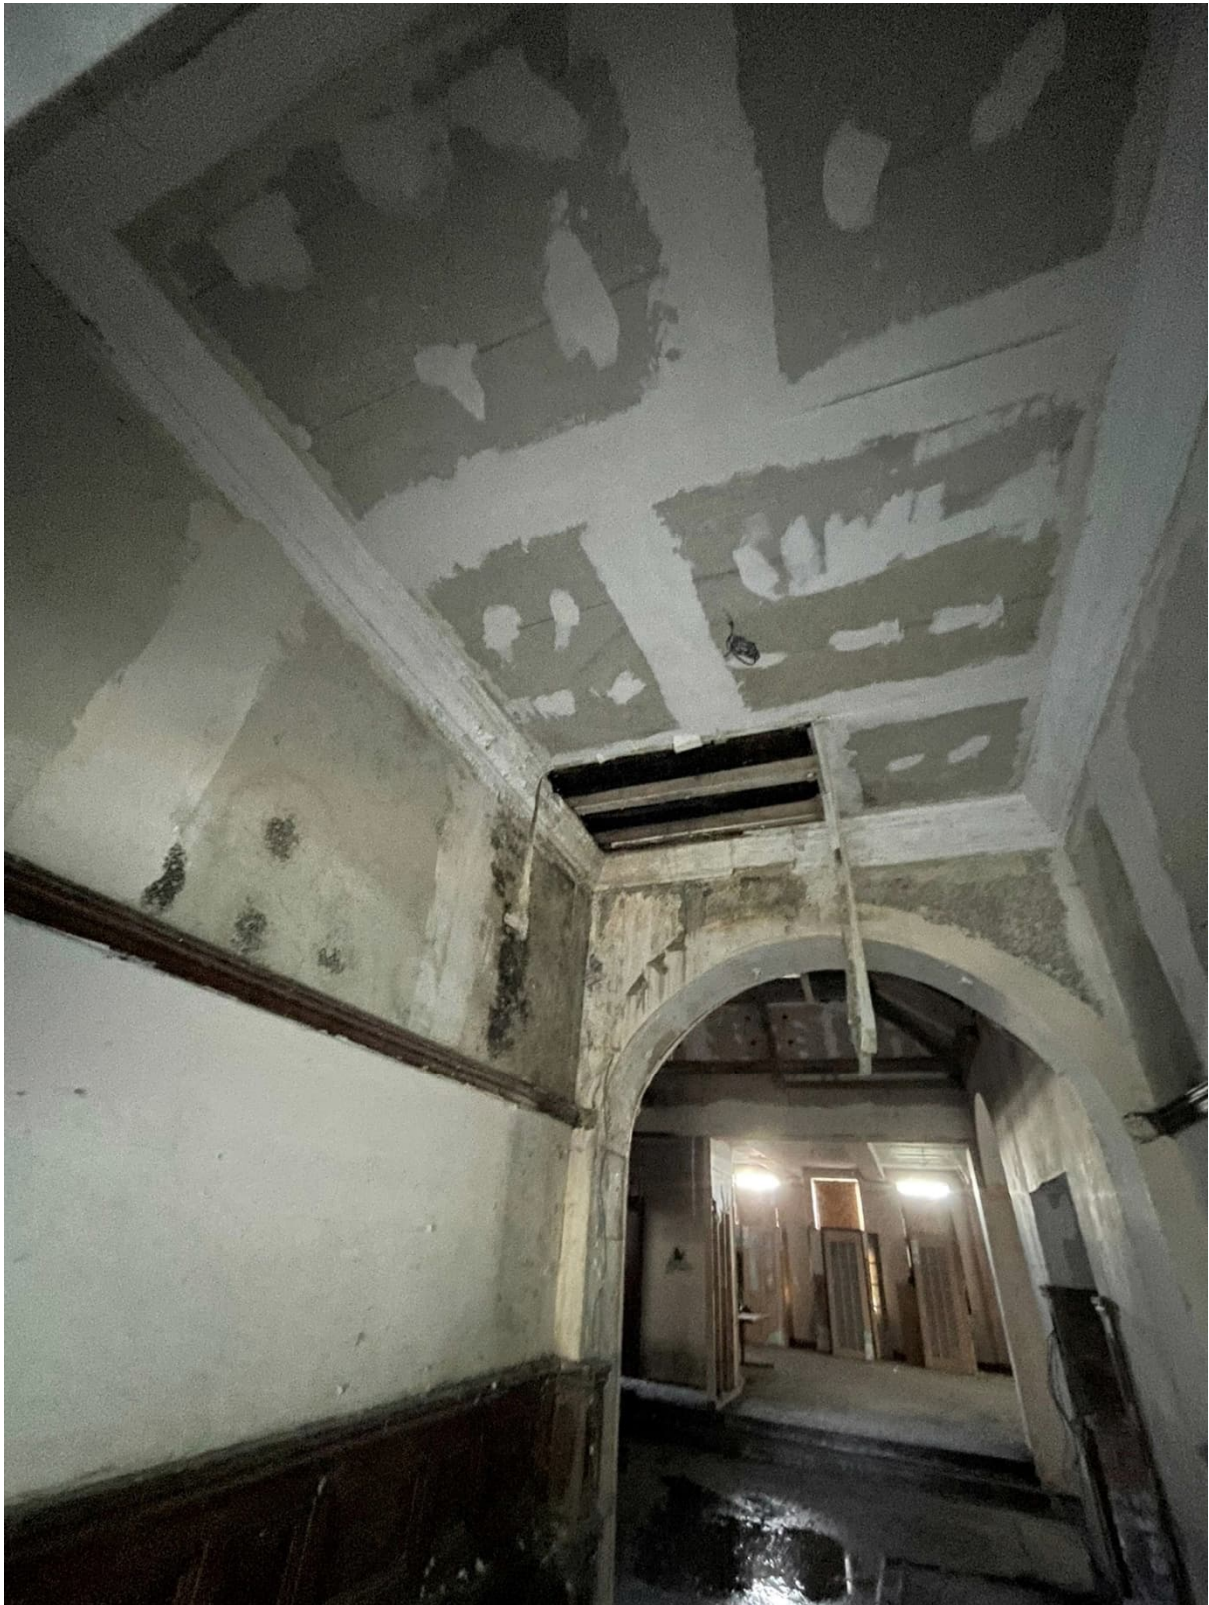
Signs of damp in entrance hallway.

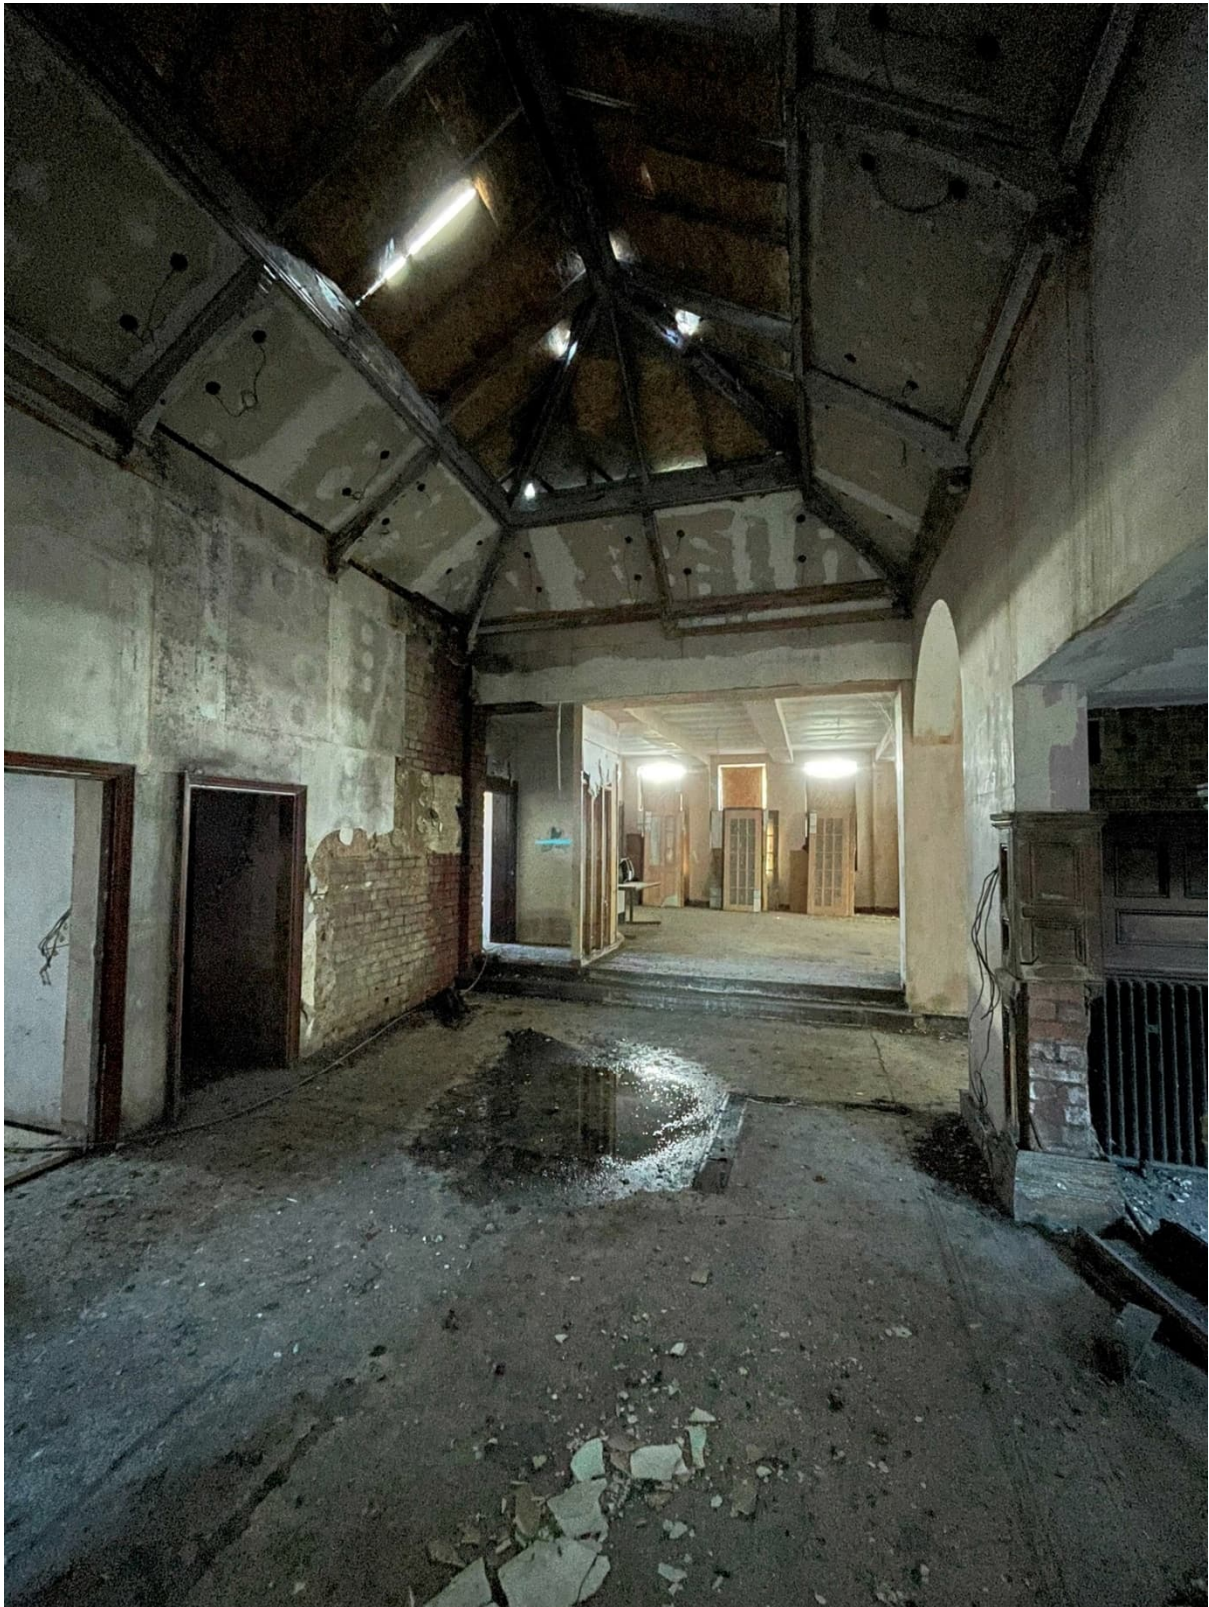
Moving to the location of the lantern, which is boarded up, there is pooling water on the floor, where the water is pooling the floor appears to be very uneven.

Boarded up lantern & water pooling on the ground floor.
