STRUCTURAL INSPECTION REPORT

LOCATION:
Dewsbury Library, Dewsbury.

DOCUMENT REF:
25343-SIR-001

REVISION/DATE:
Revision B / 01.10.2025

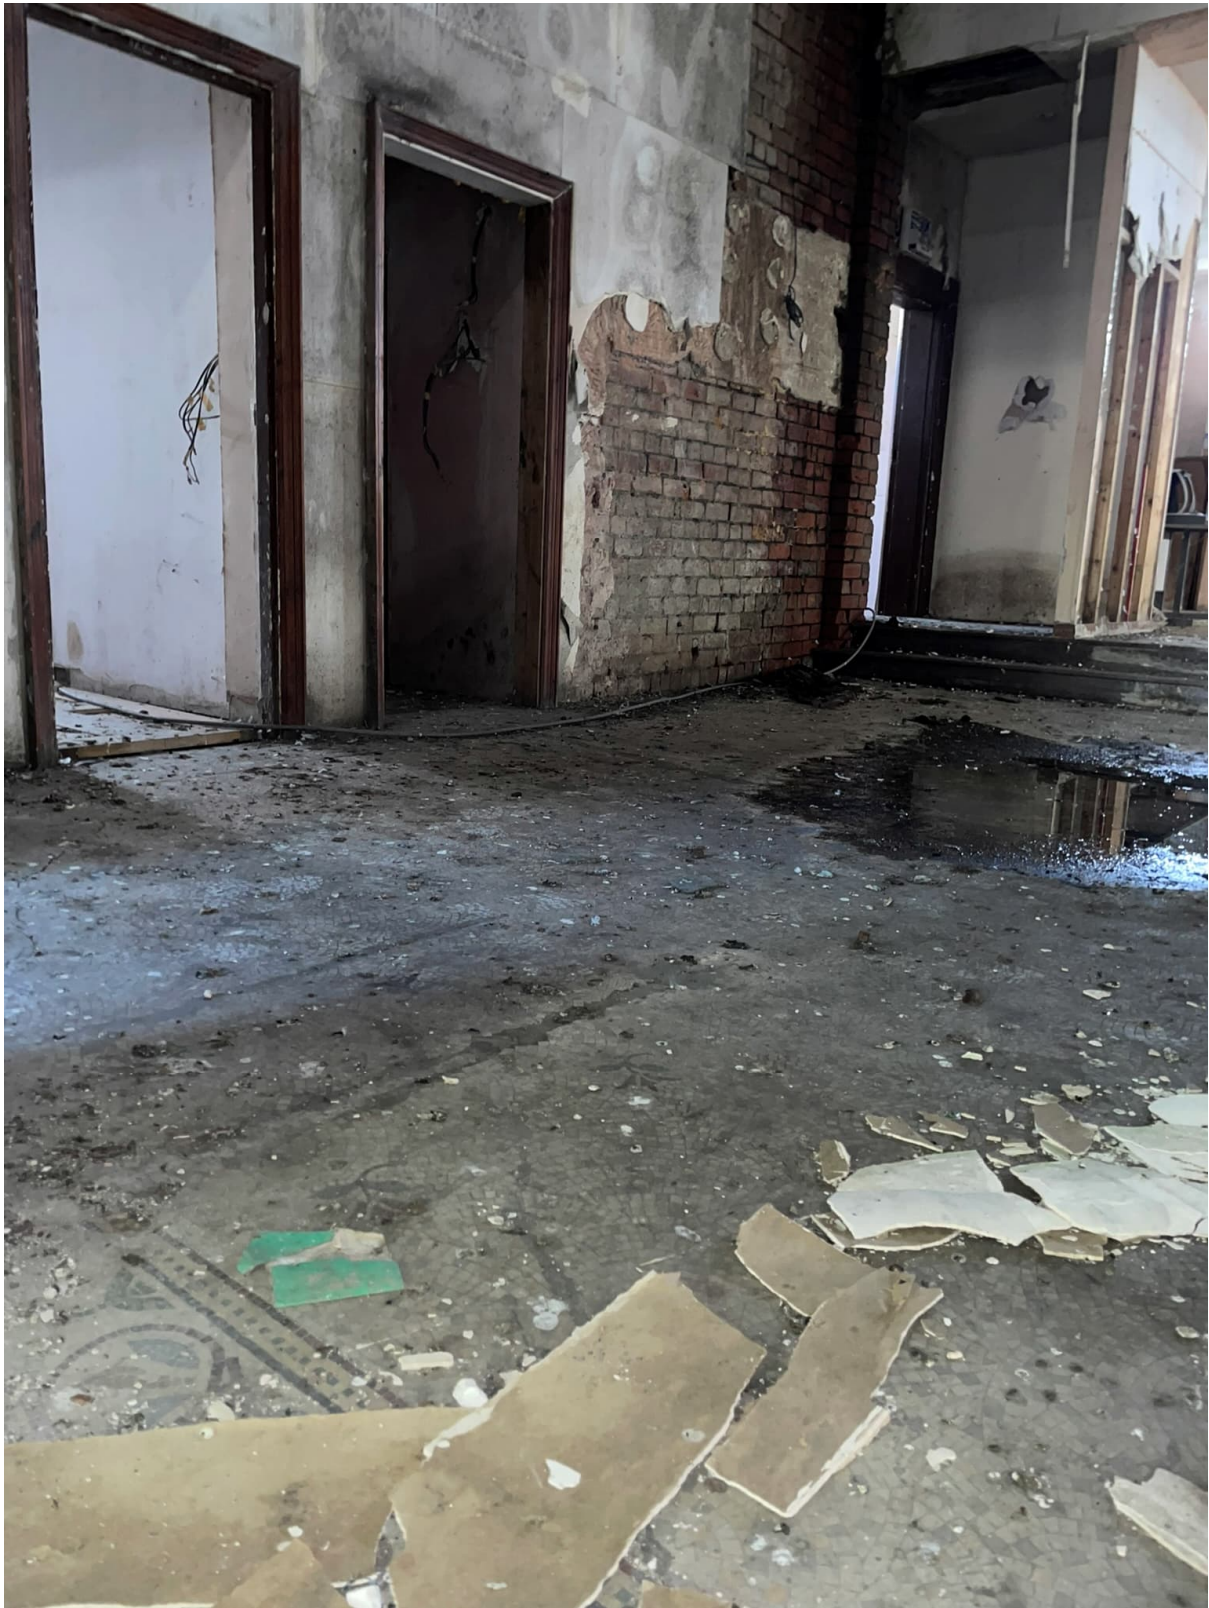
Sunk/bowing ground floor where water is pooling.

The existing ground floor build up is unknown, this will need to be investigated to identify what the build up is over the existing basement, also to identify the build-up where the basement is not present. Especially where the floor has sunk/bowed below the lantern near the main entrance.

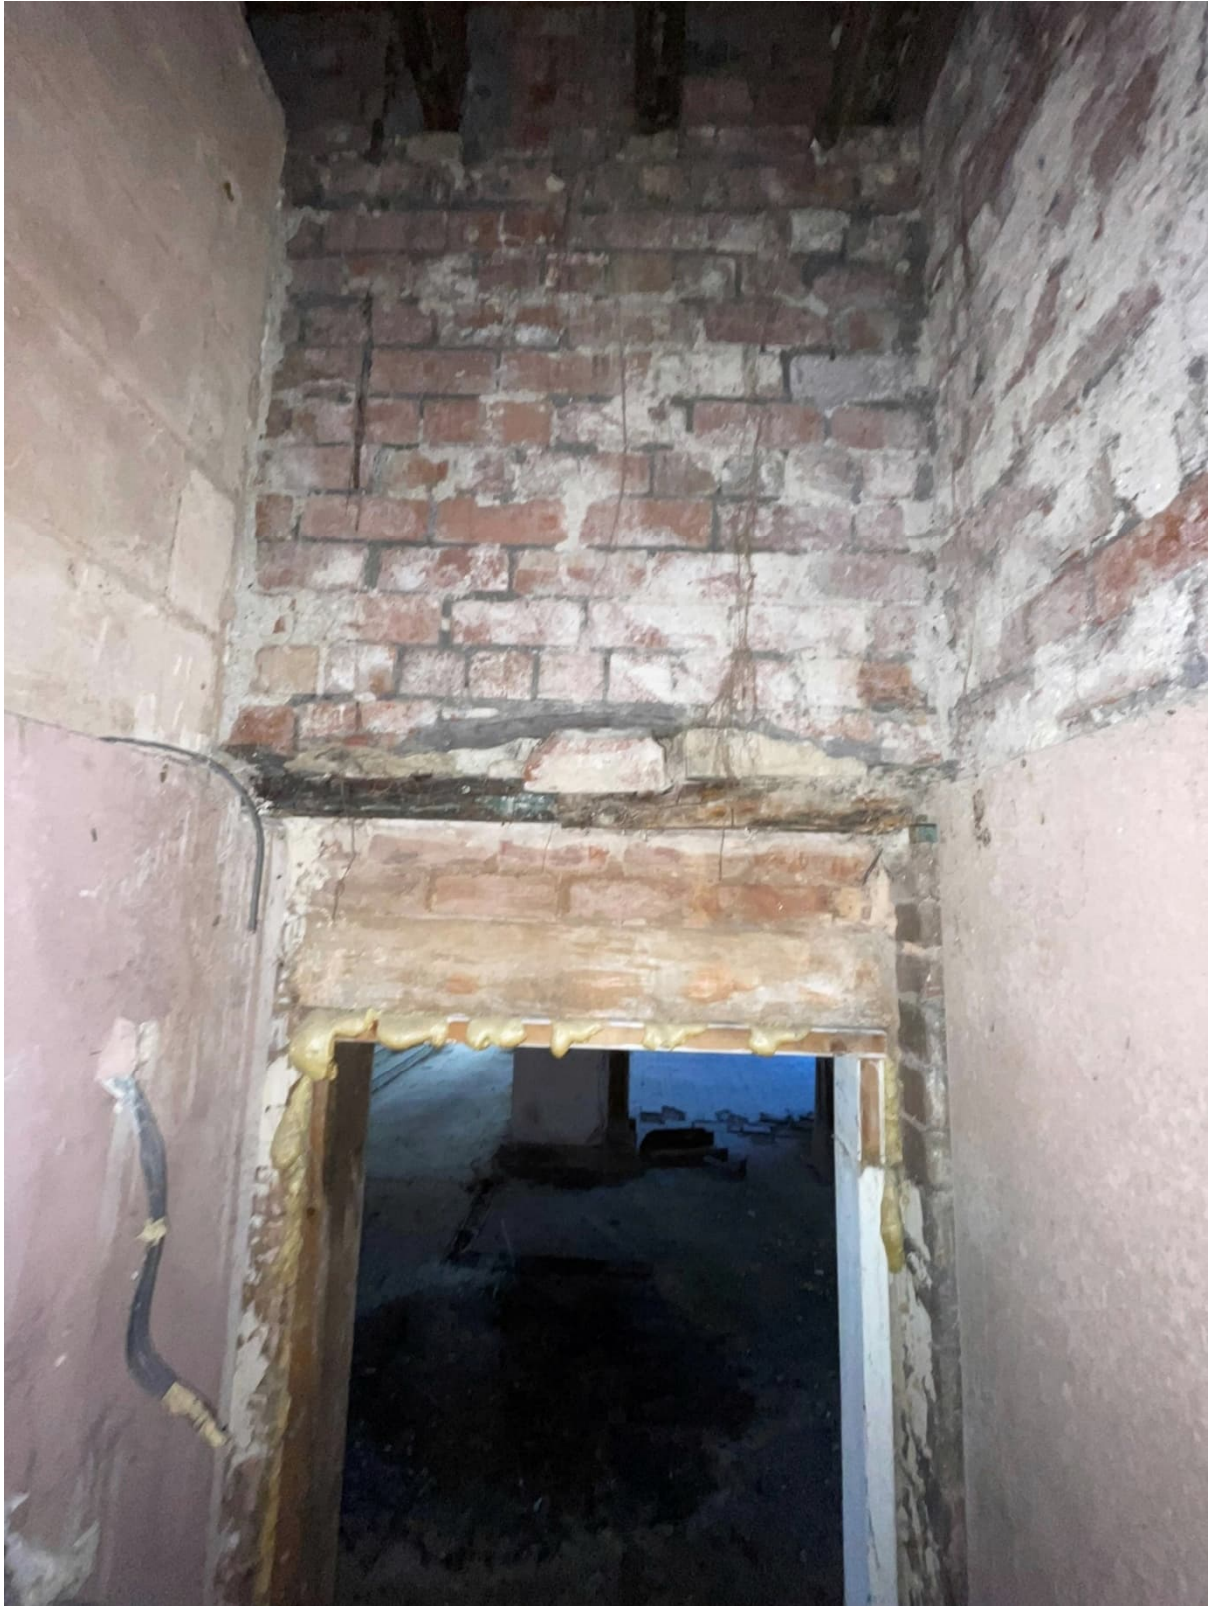
Rotten timber lintel over door opening into small store near toilets.

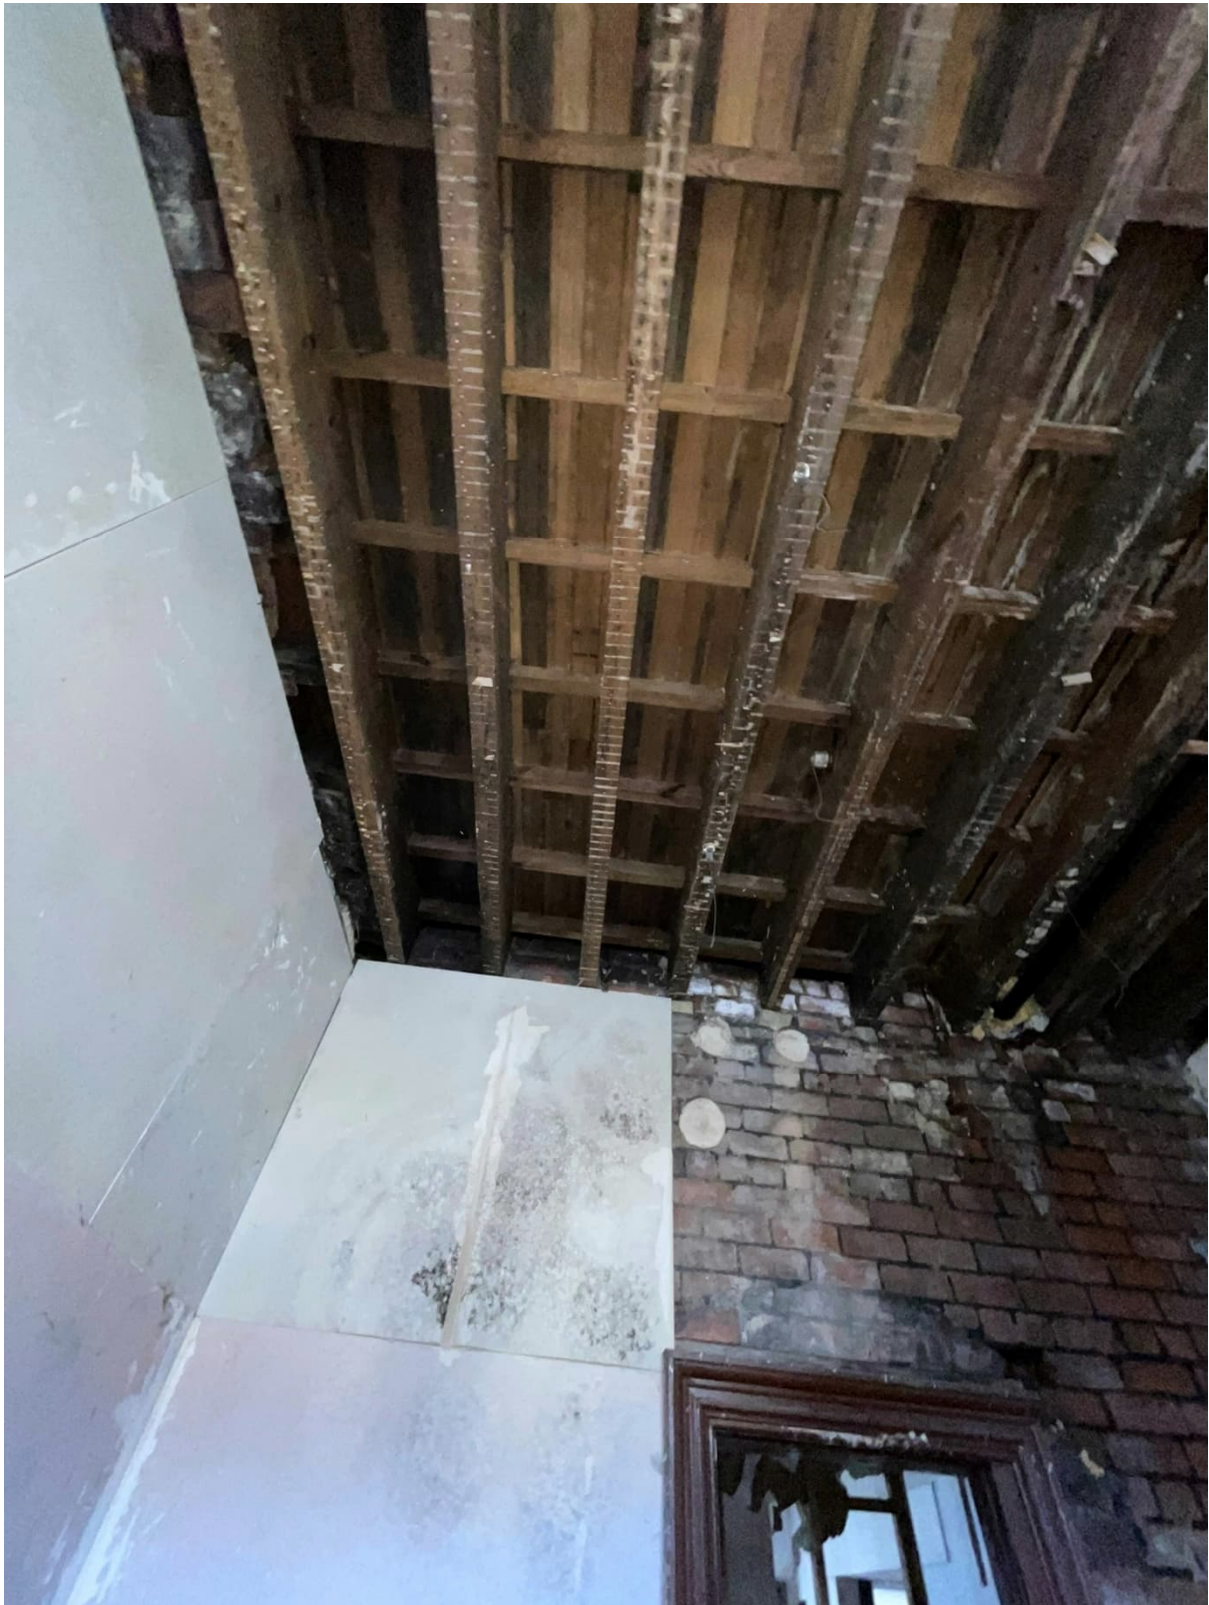
First floor joists over toilets.

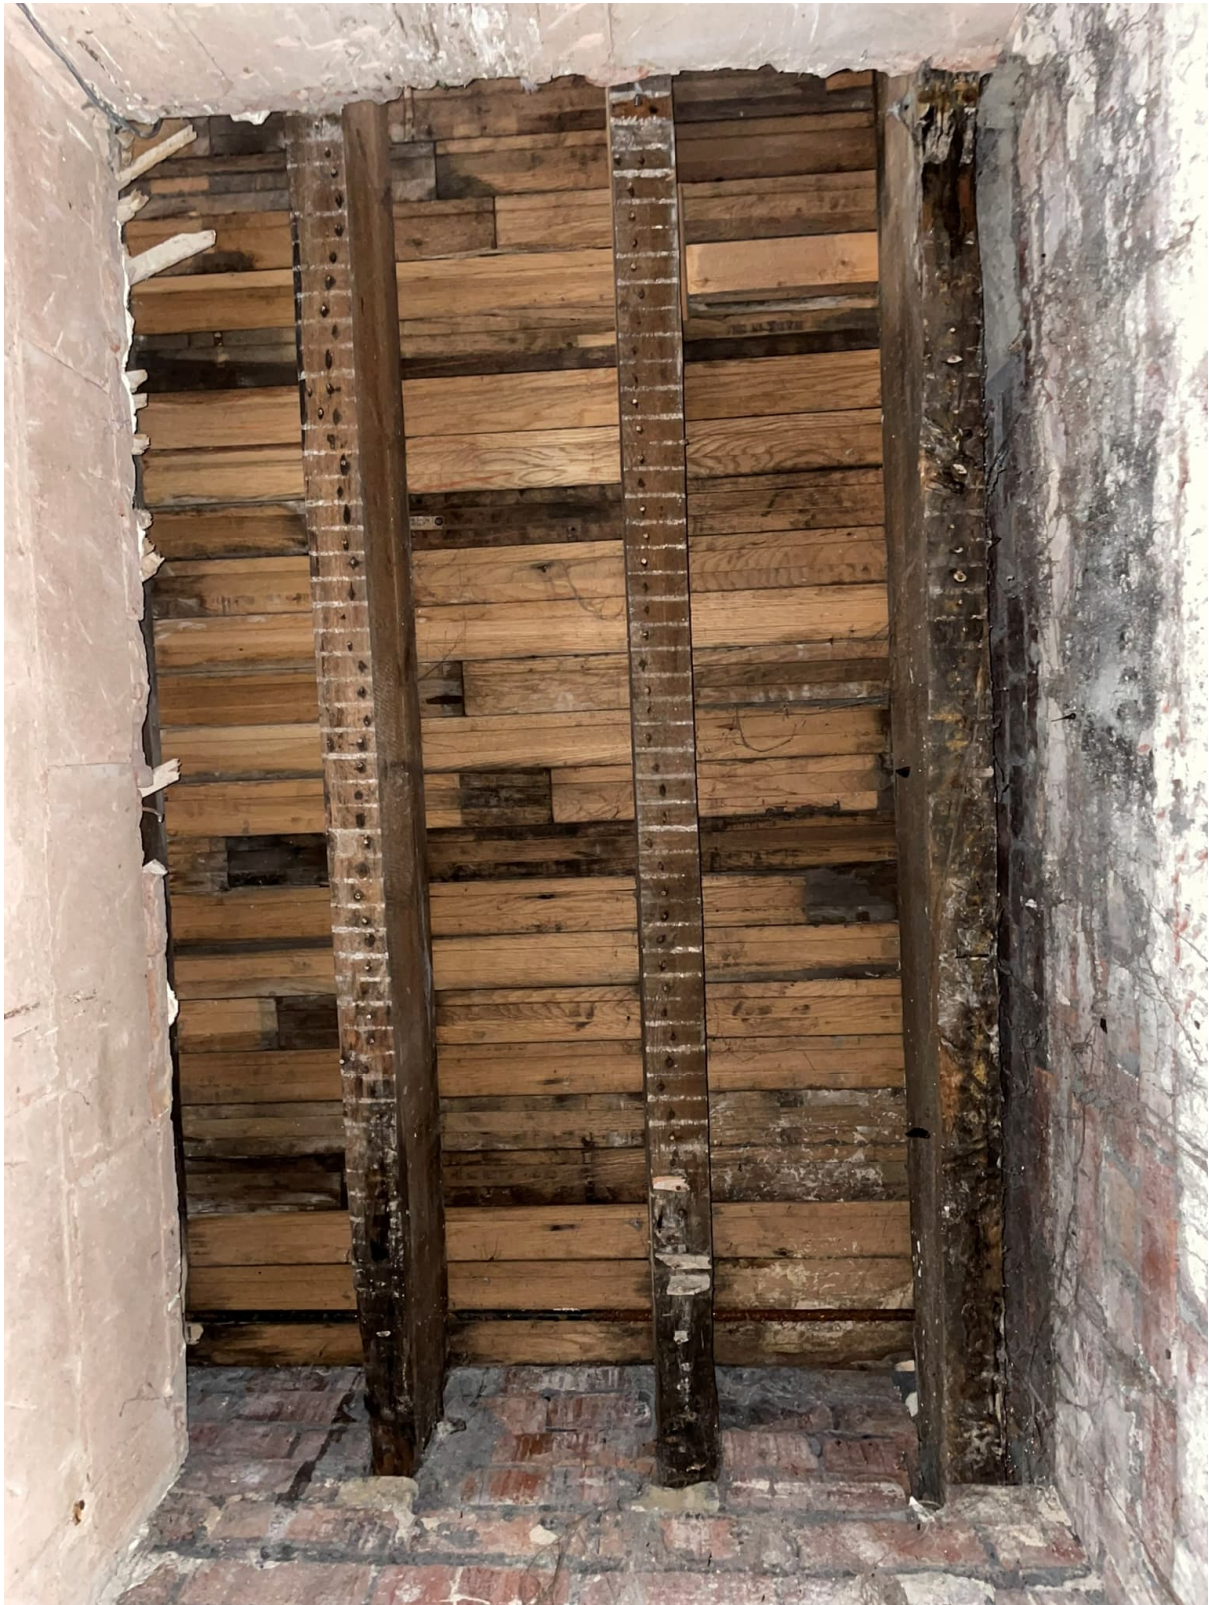
It is clear alterations have been made to the layout internally with large openings, isolated masonry piers and downstand beams. Also, different types of construction methods and materials are present in different areas. For example, Over the toilets appears to be traditional large spans with timber joists over sitting onto brick walls. There are several locations above the toilets and service area where the joist ends are rotten. Likely from the water ingress from the roof above (lantern).

Rotten perimeter joists and rotten joist ends to first floor joists over toilets/store area.

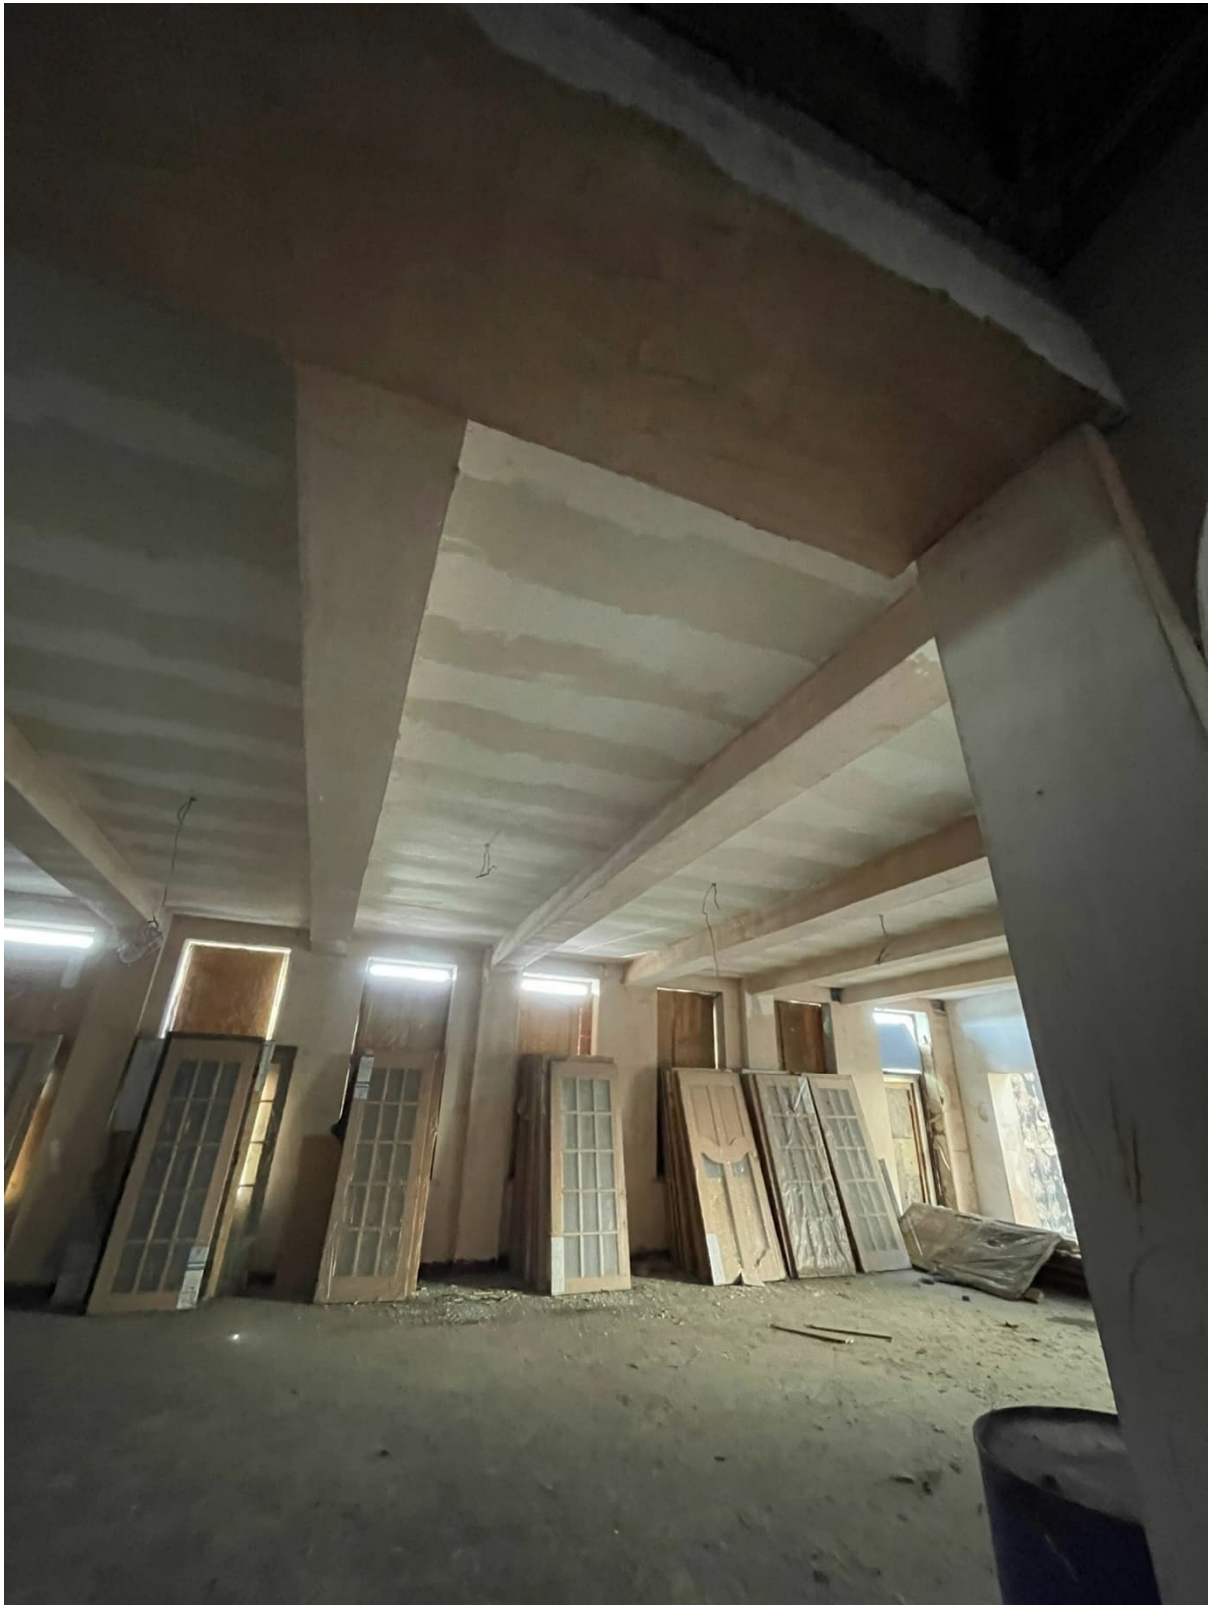
Whereas below the first-floor hall there is six downstand beams, these look as though they may have been installed to strengthen the original floor, assumed to be breaking up the span of the first-floor joists above. Also, there is a mezzanine at the front of the library with a spiral staircase leading to the first floor. The mezzanine appears to be a composite deck supported on steel beams which are in turn supported on columns. Both these examples are not a typical construction method for the period when the library was constructed.

Close centre downstand beams under first floor hall.

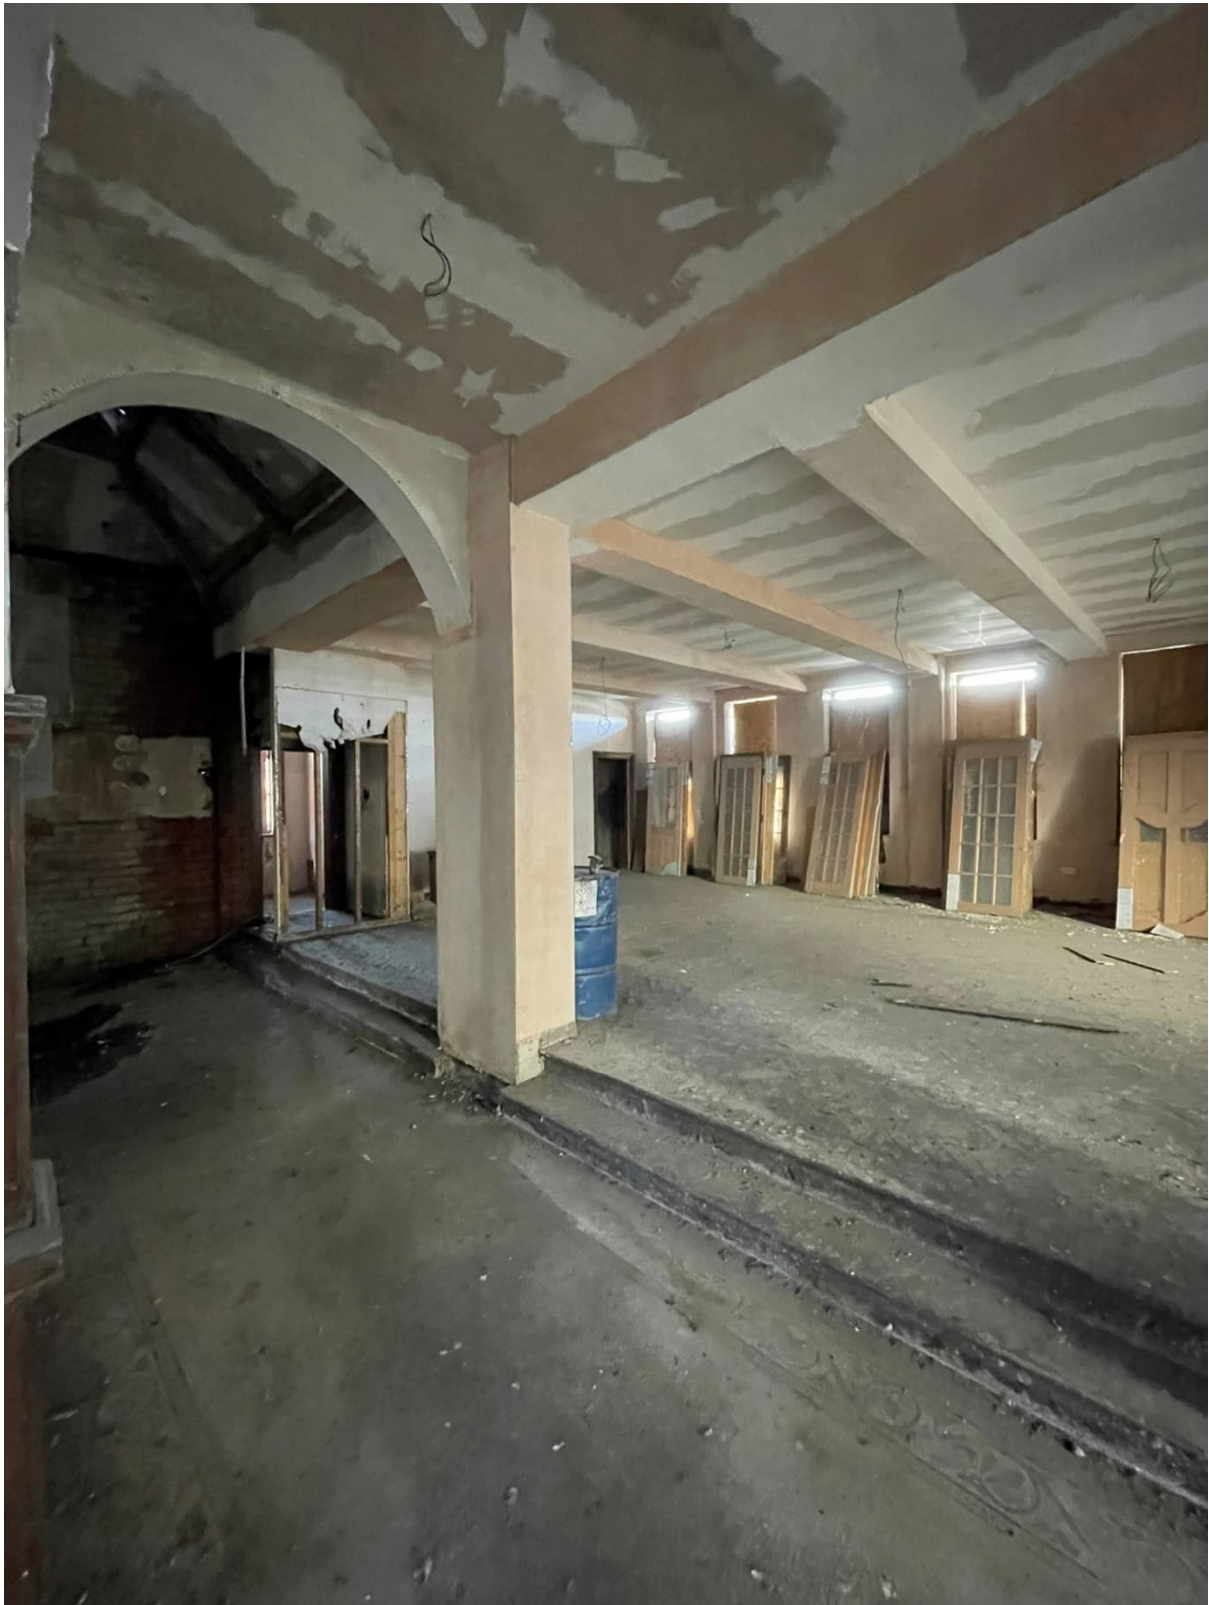
Downstand beams, likely from previous internal alterations.

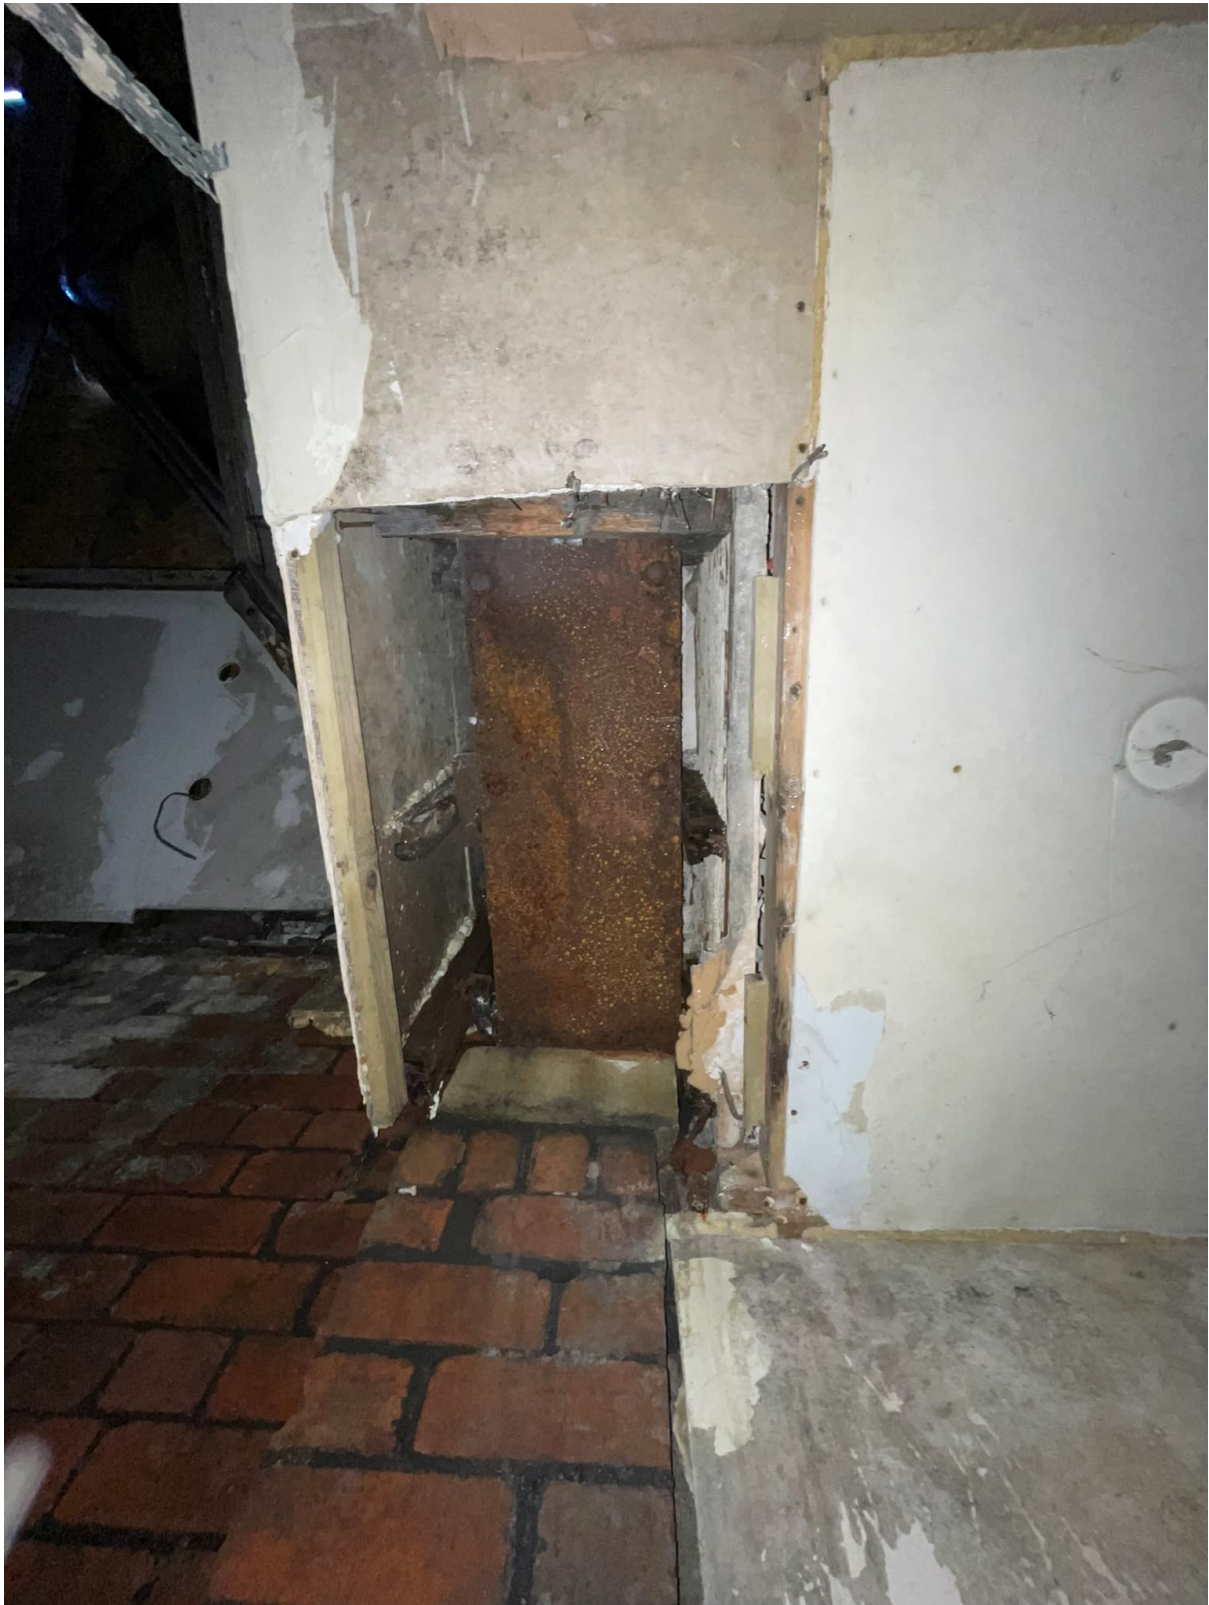
Corroded RSJ with rivets at first floor level.

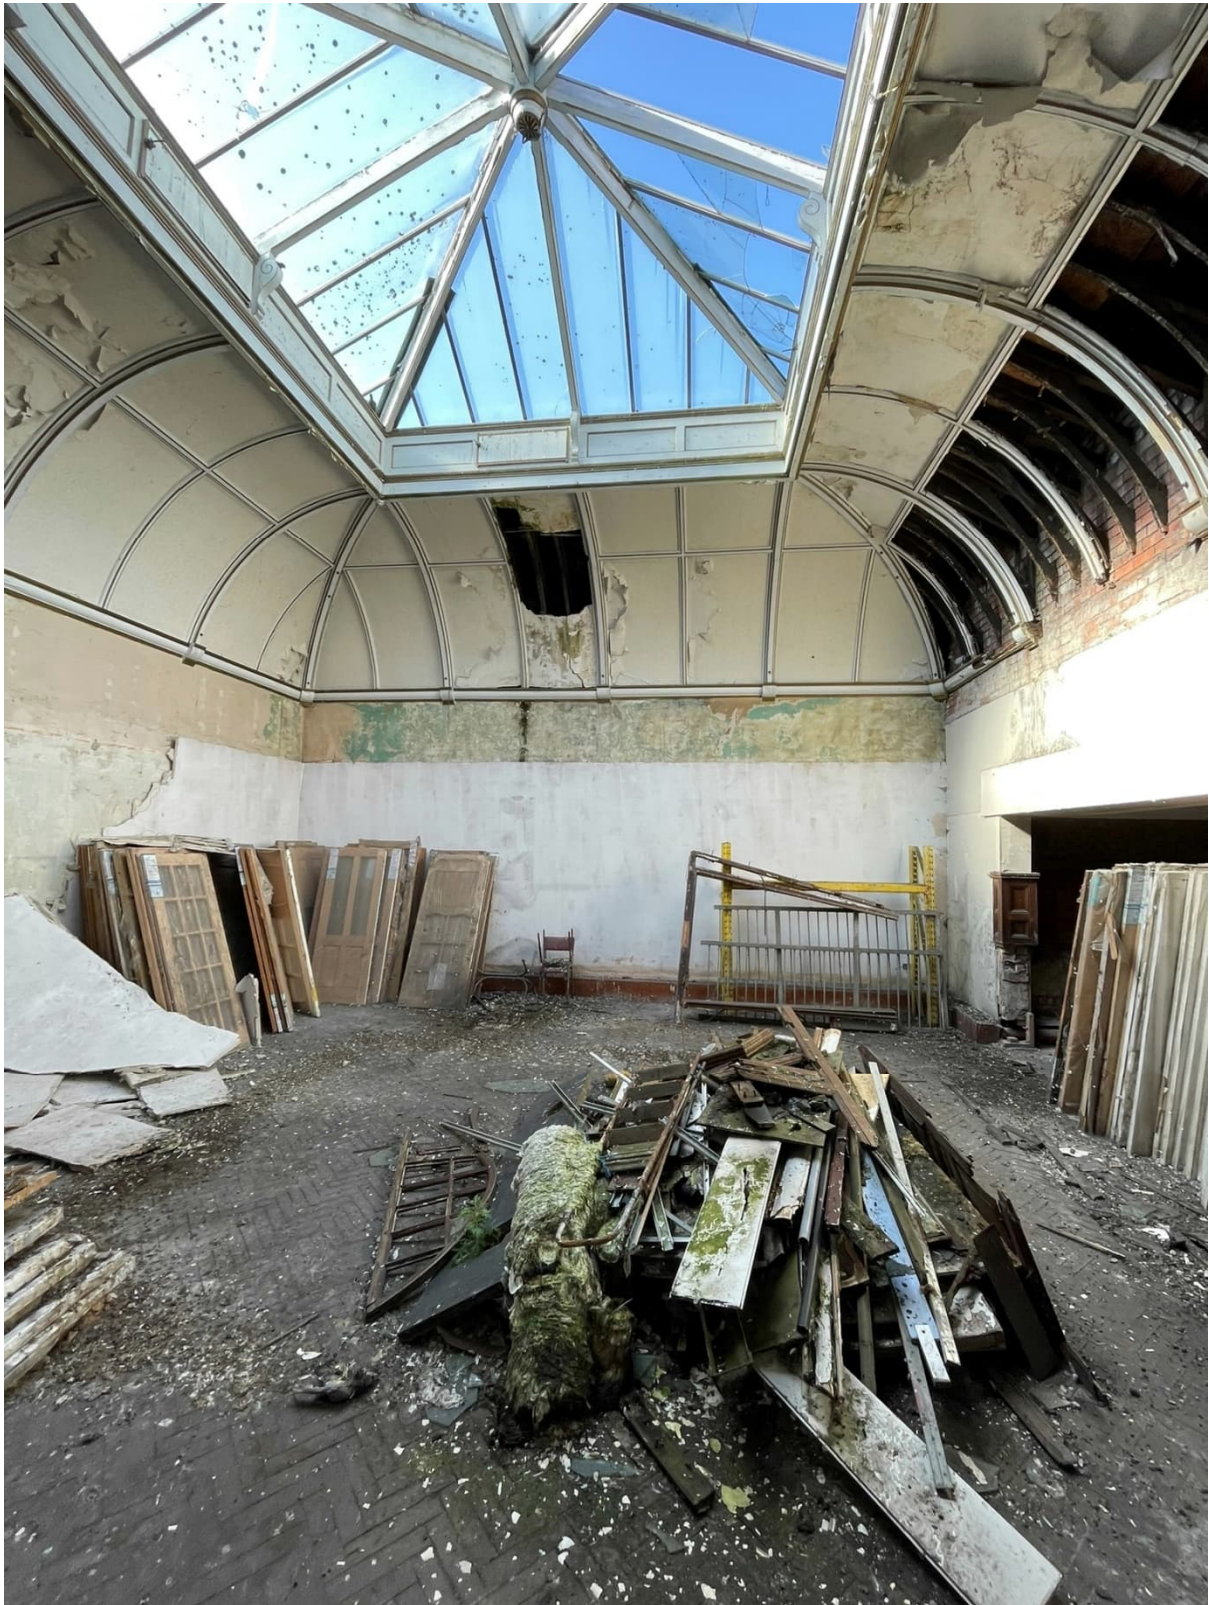
To the rear of the library is the second larger lantern, again in poor condition. Leading to water ingress and the rafters are in poor condition where they bear onto the brickwork.

Large damaged lantern and rotten rafters where they bear onto brickwork.

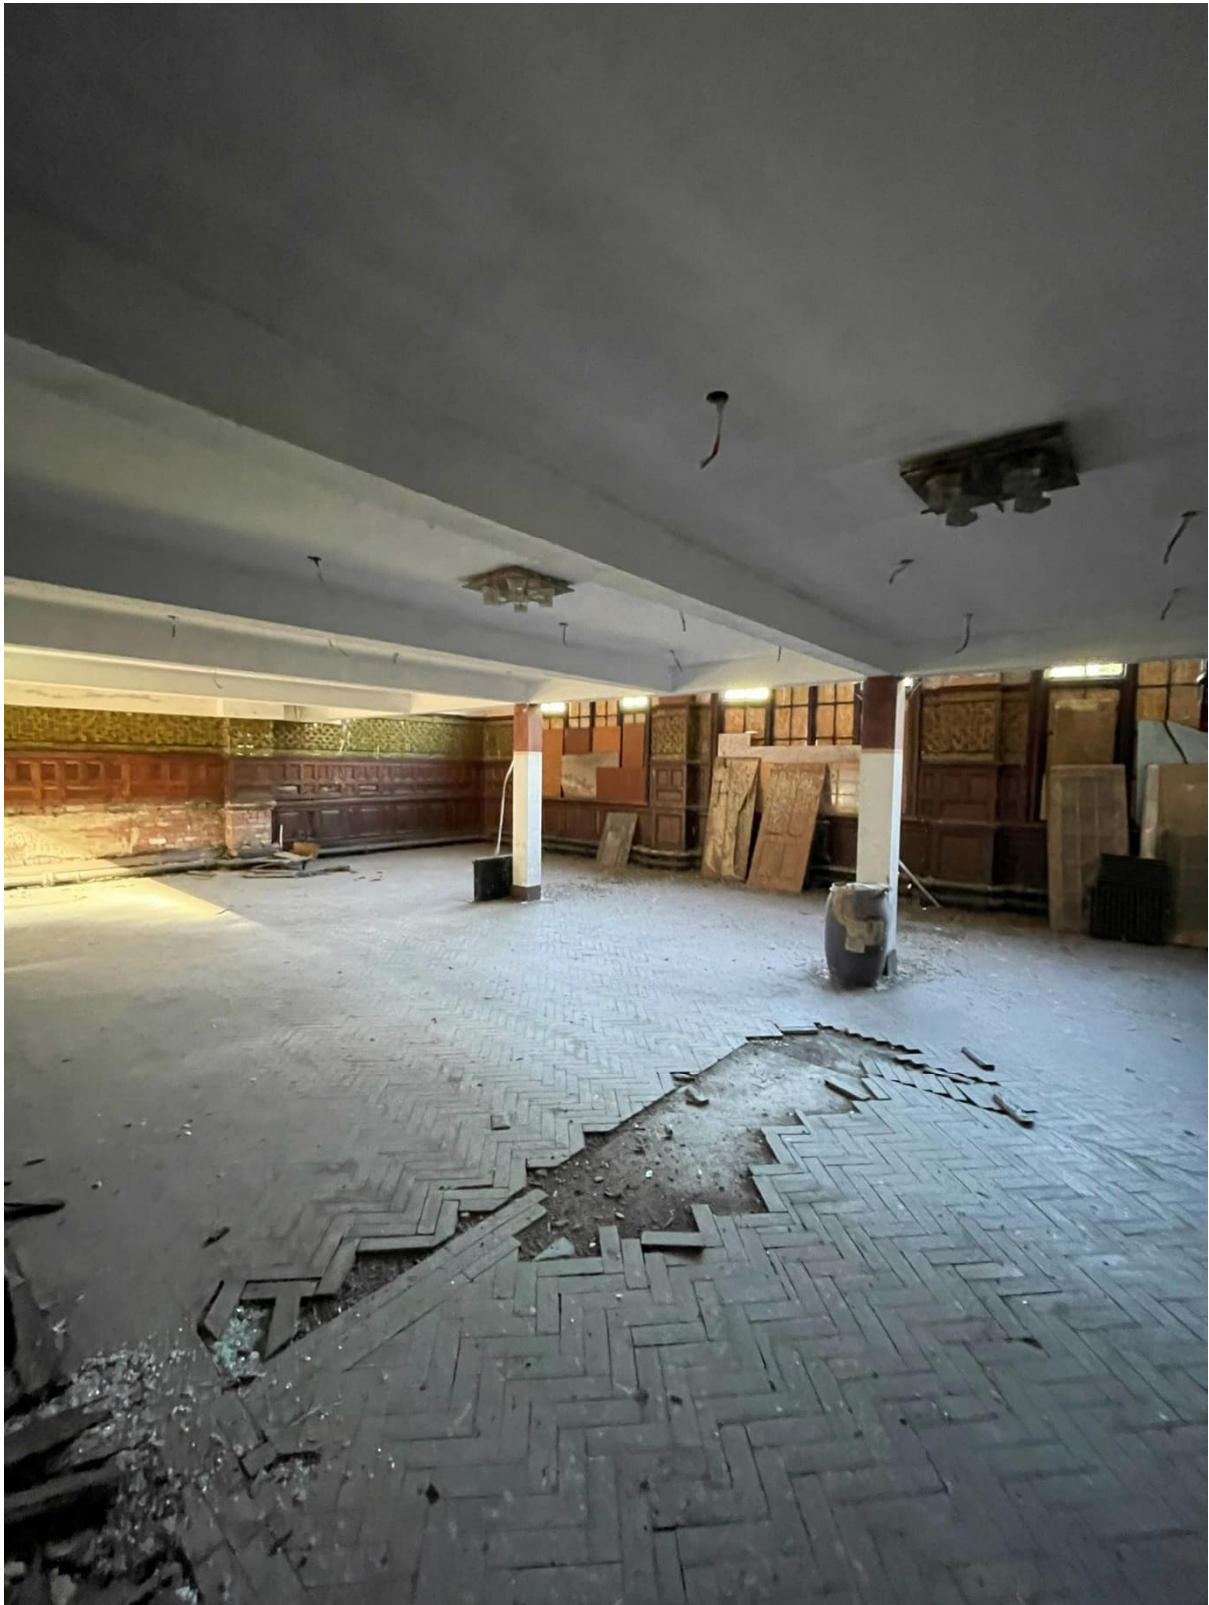
Mezzanine floor with downstand beams and columns.

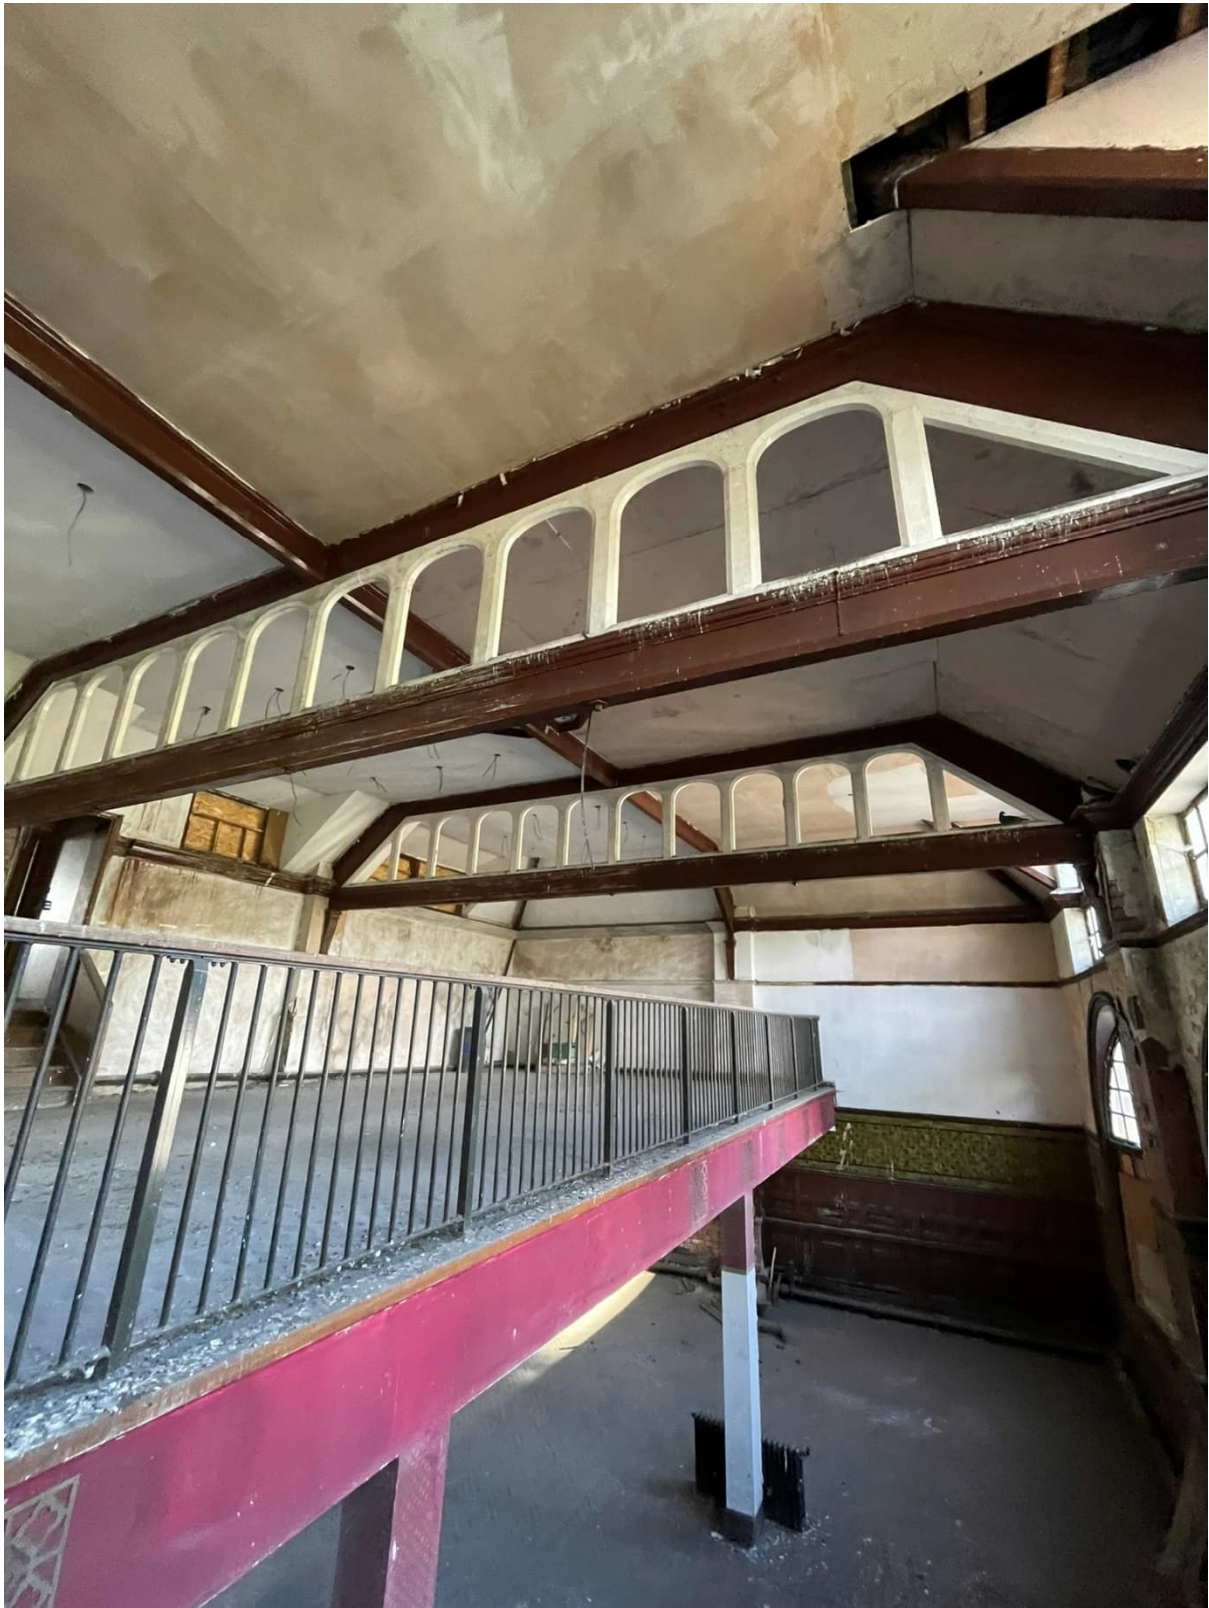
Trusses over first floor mezzanine in hipped roof.

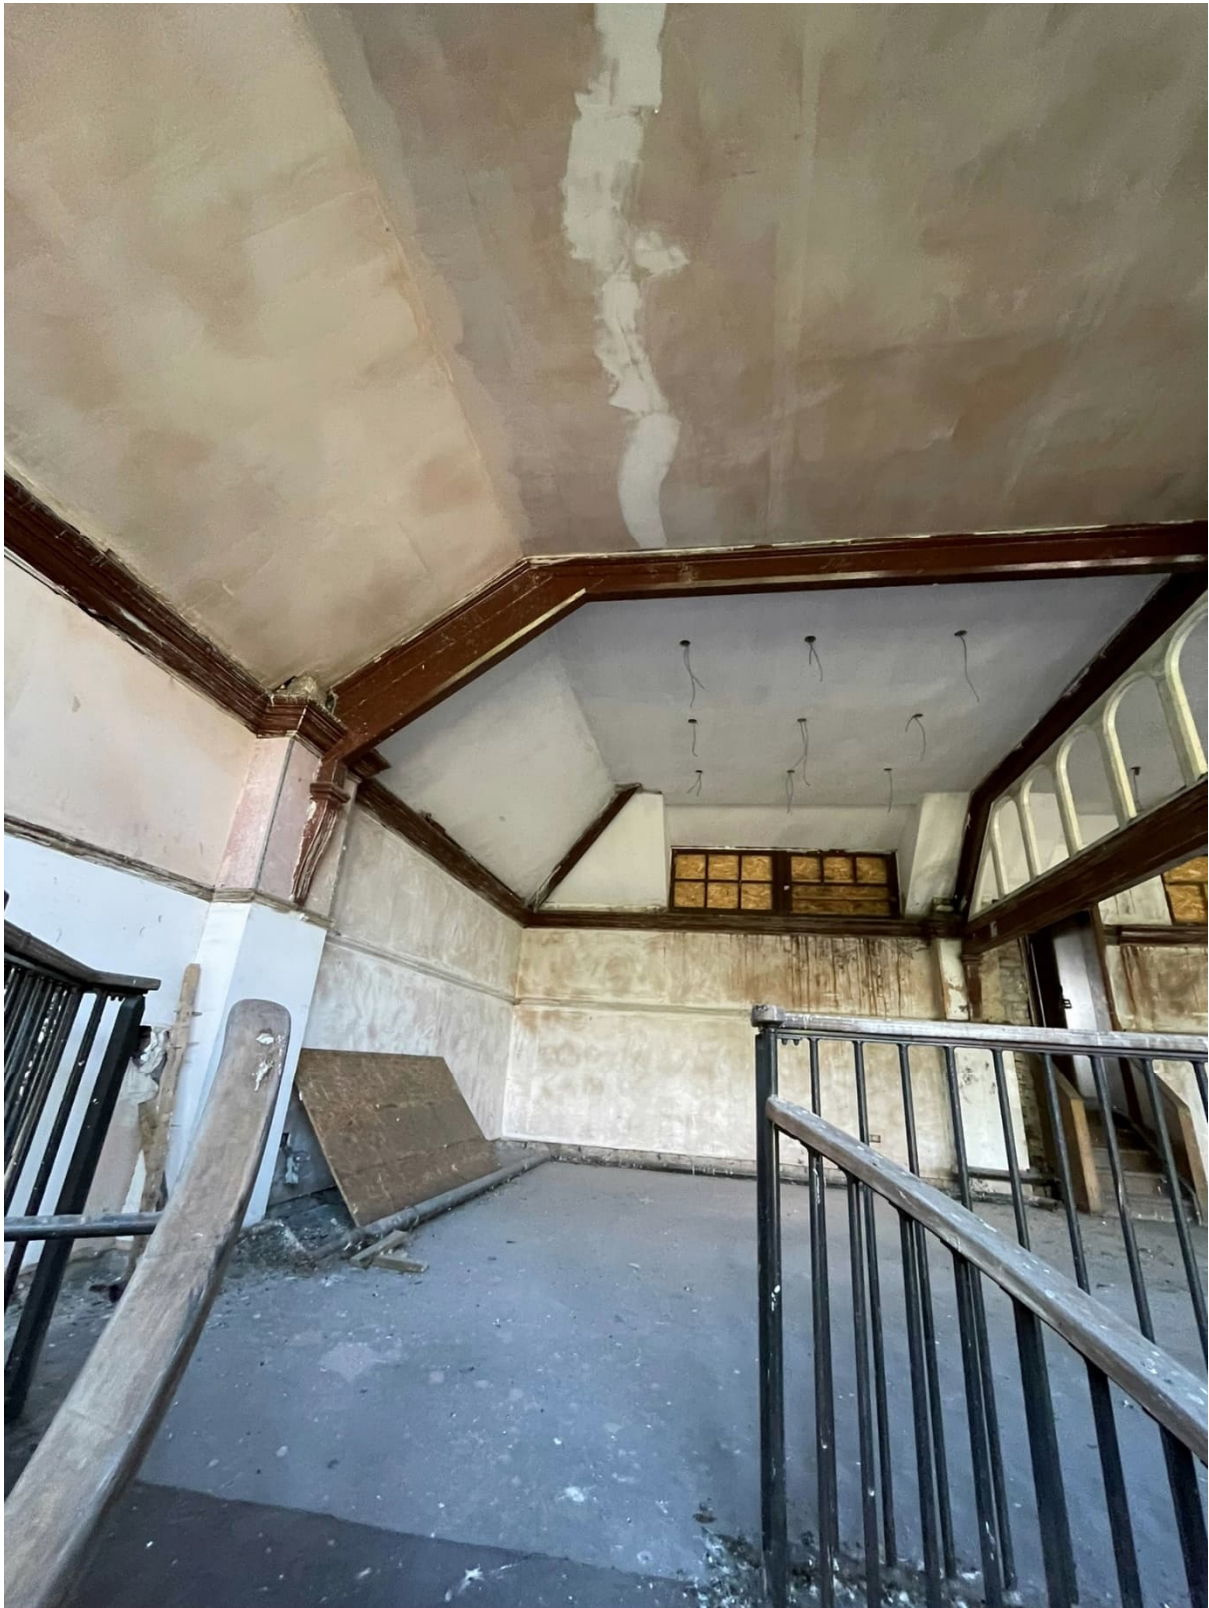
Masonry piers for truss bearing.
