STRUCTURAL INSPECTION REPORT

LOCATION:
Dewsbury Library, Dewsbury.

DOCUMENT REF:
25343-SIR-001

REVISION/DATE:
Revision B / 01.10.2025

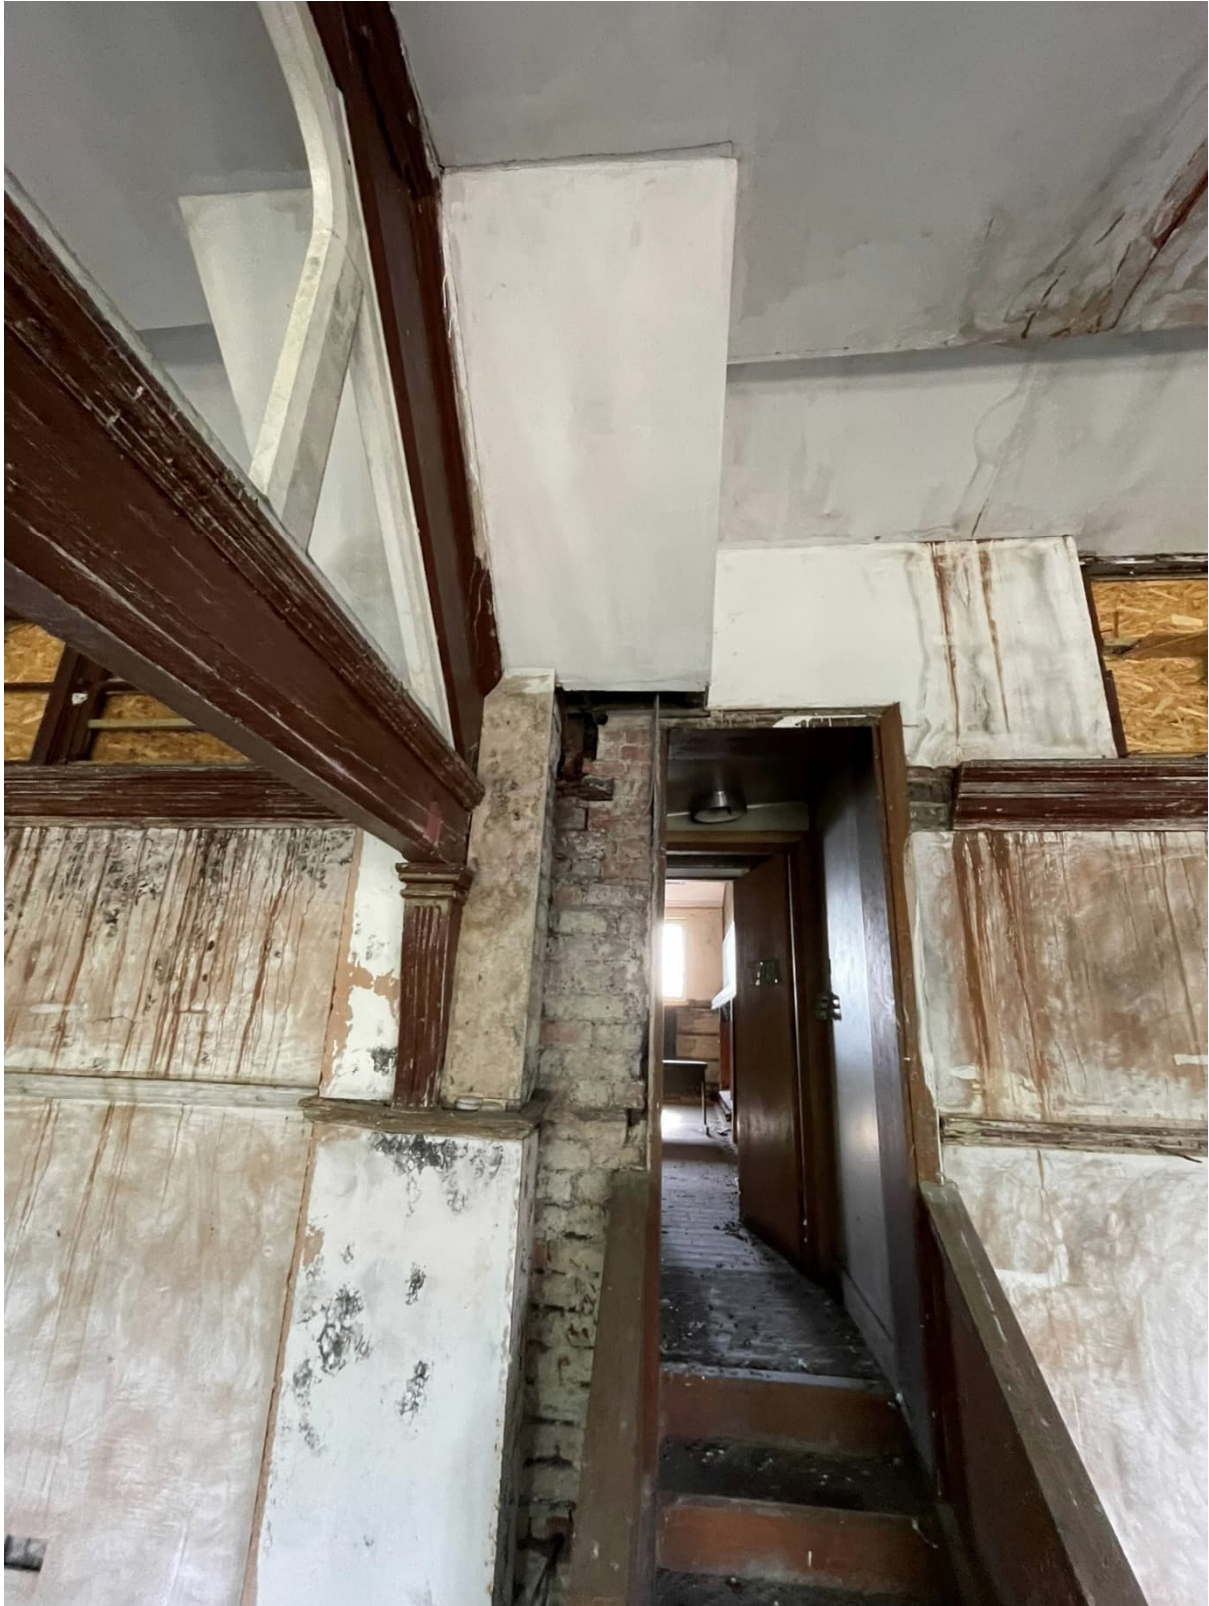
Over the mezzanine the hipped roof appears to be formed by large trusses sitting on solid masonry piers, the exact construction of the roof can not be established due the finishes. The masonry at the bearing for one of the trusses at the top was in poor condition and appeared loose.

Poor quality masonry to masonry pier supporting truss.

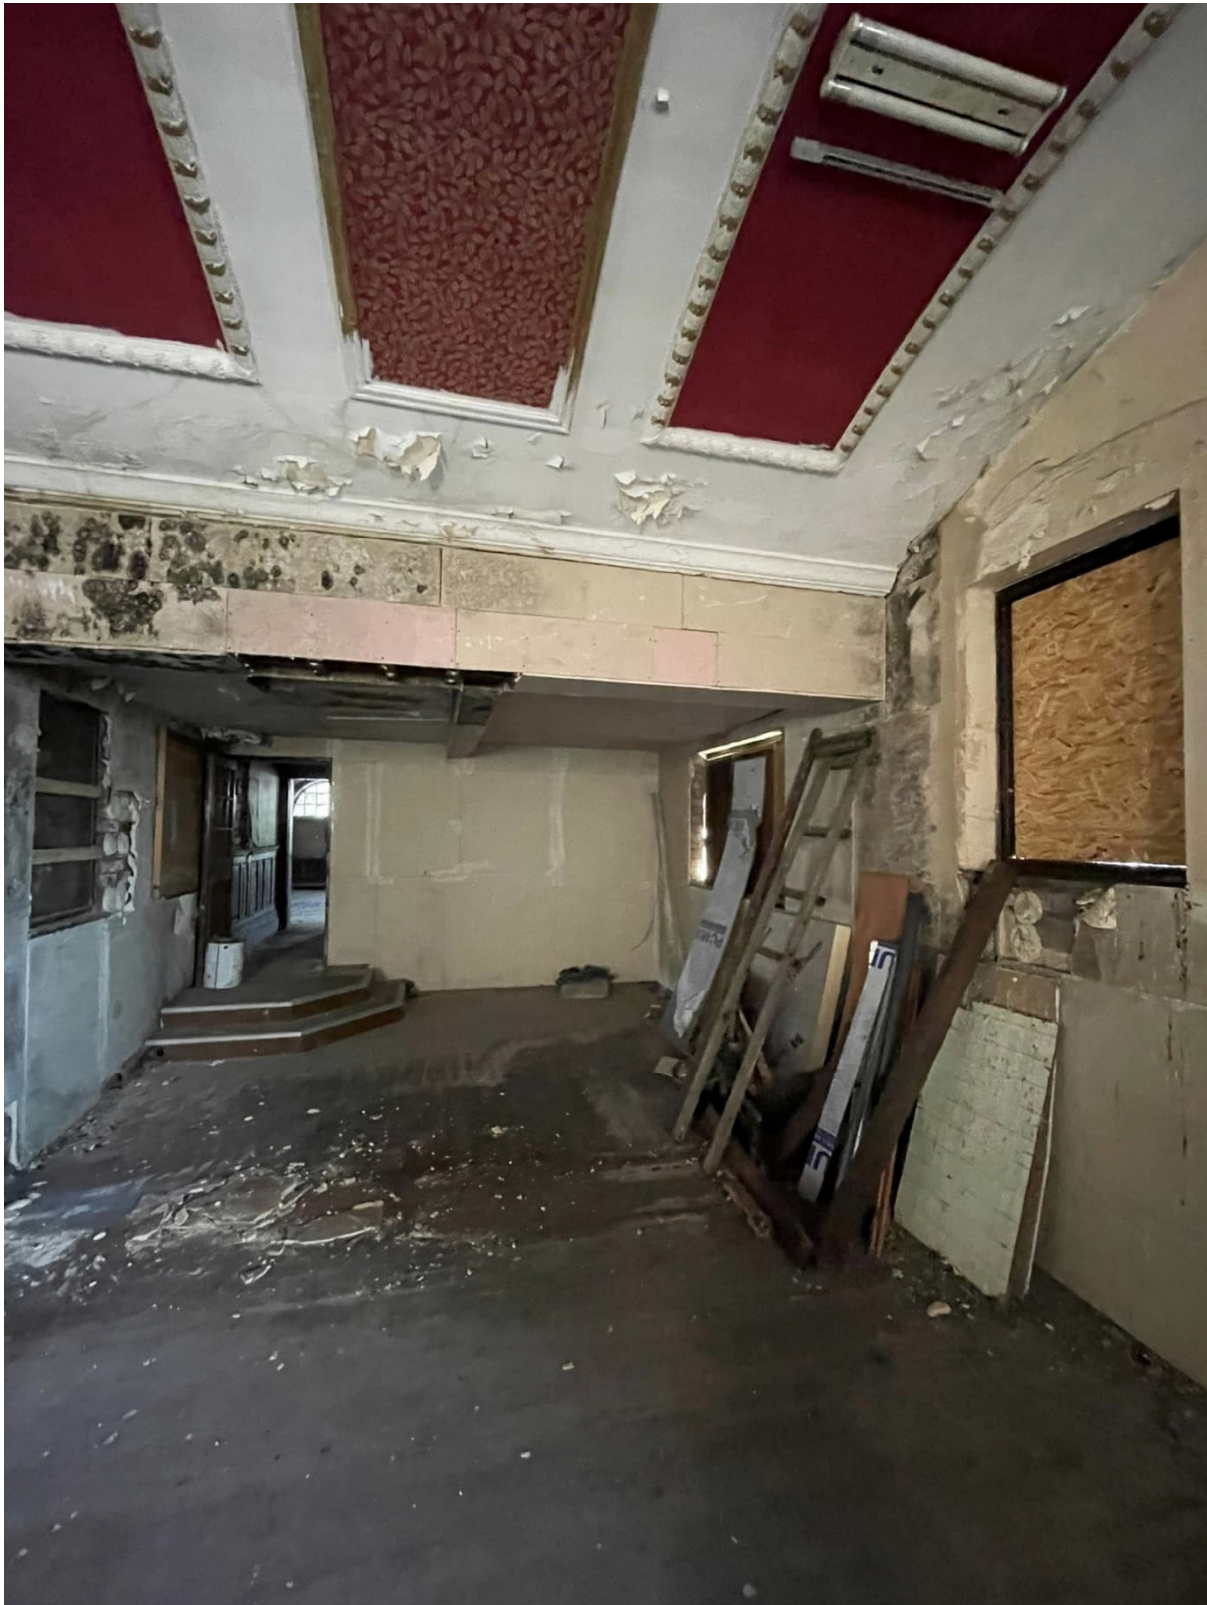
Downstand beams and damp over north-east of first floor hall.

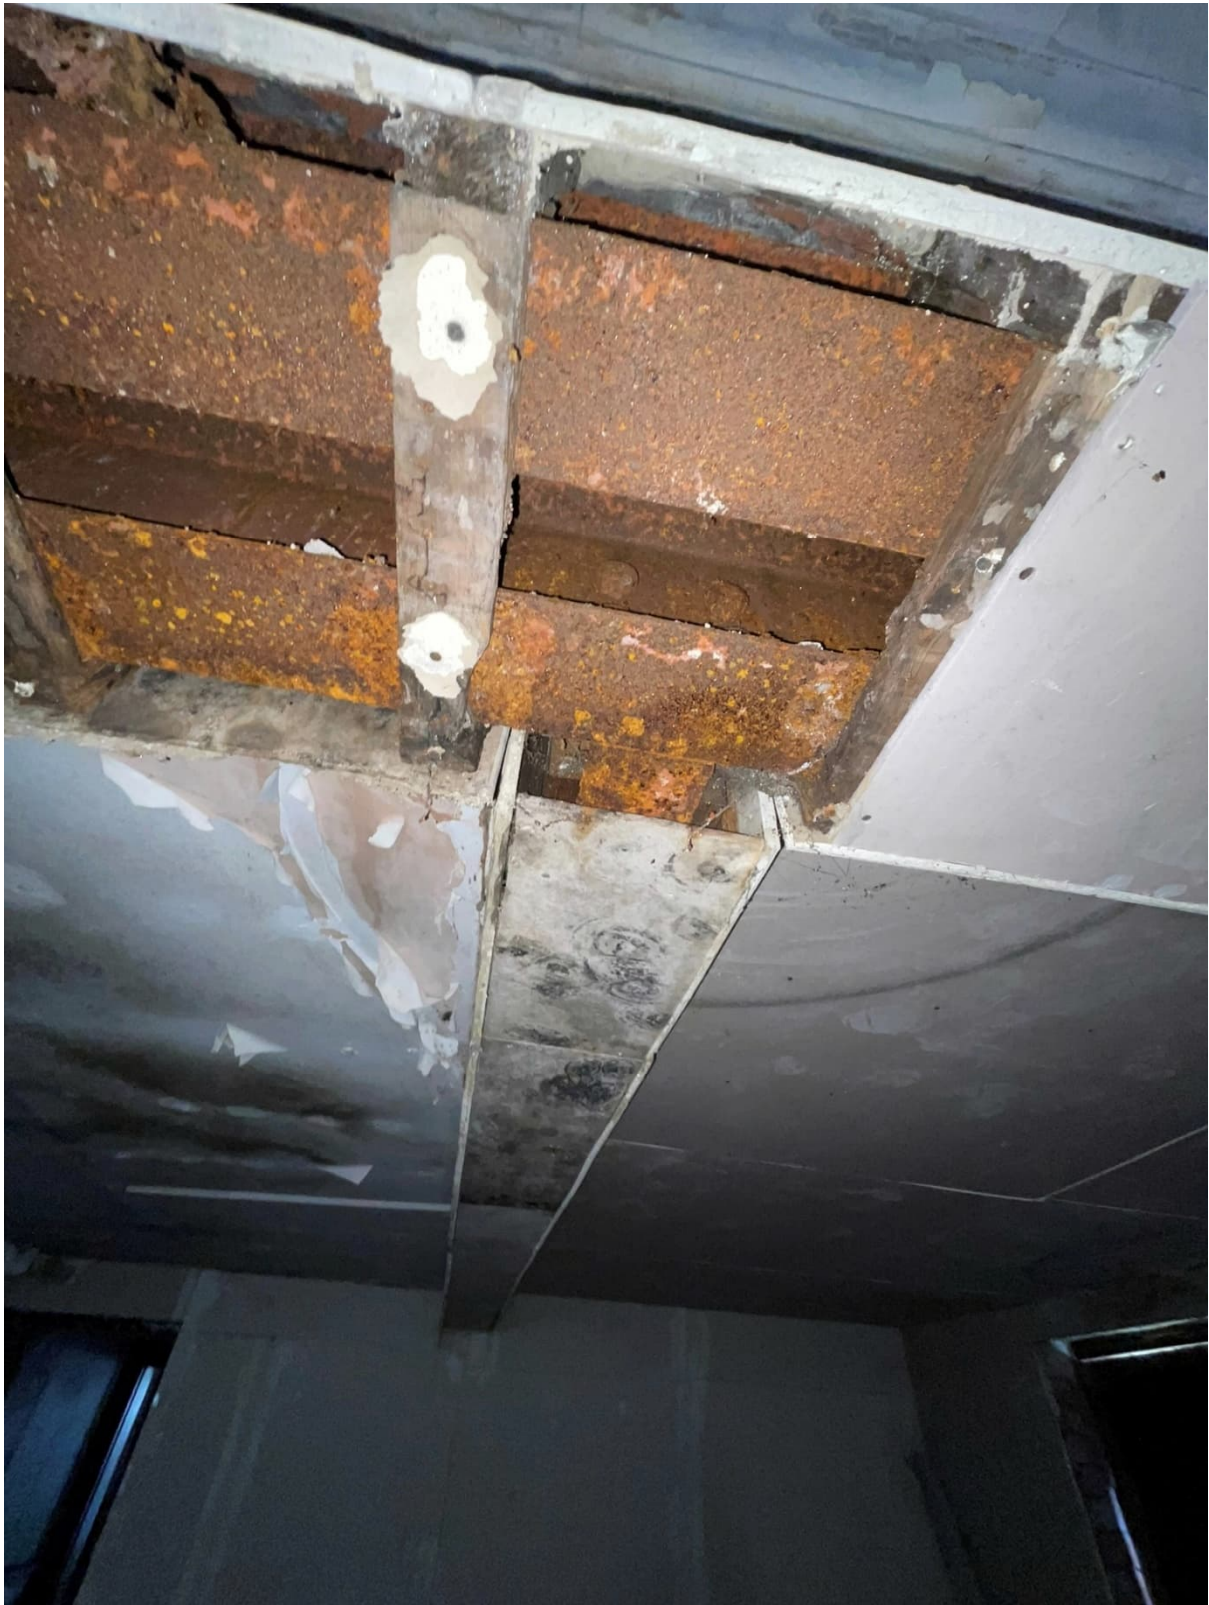
Walking from the hall towards the original staircase there is some existing steel beams. These are not original, suggesting that an existing wall has been removed at some point. The steelwork is heavily corroded. In the area of the steelwork there is clear signs of water ingress with mould and staining to the finishes. This would suggest an issue with the roof above.

Heavily corroded steel beams over north-east of first floor hall.

- Where steelwork is heavily corroded it is to be replaced.
- Where steelwork has surface corrosion and no loss of section, then they are to be fully exposed, cleaned and prepared for painting.
- Where existing timber members are defective, they are to be replaced.

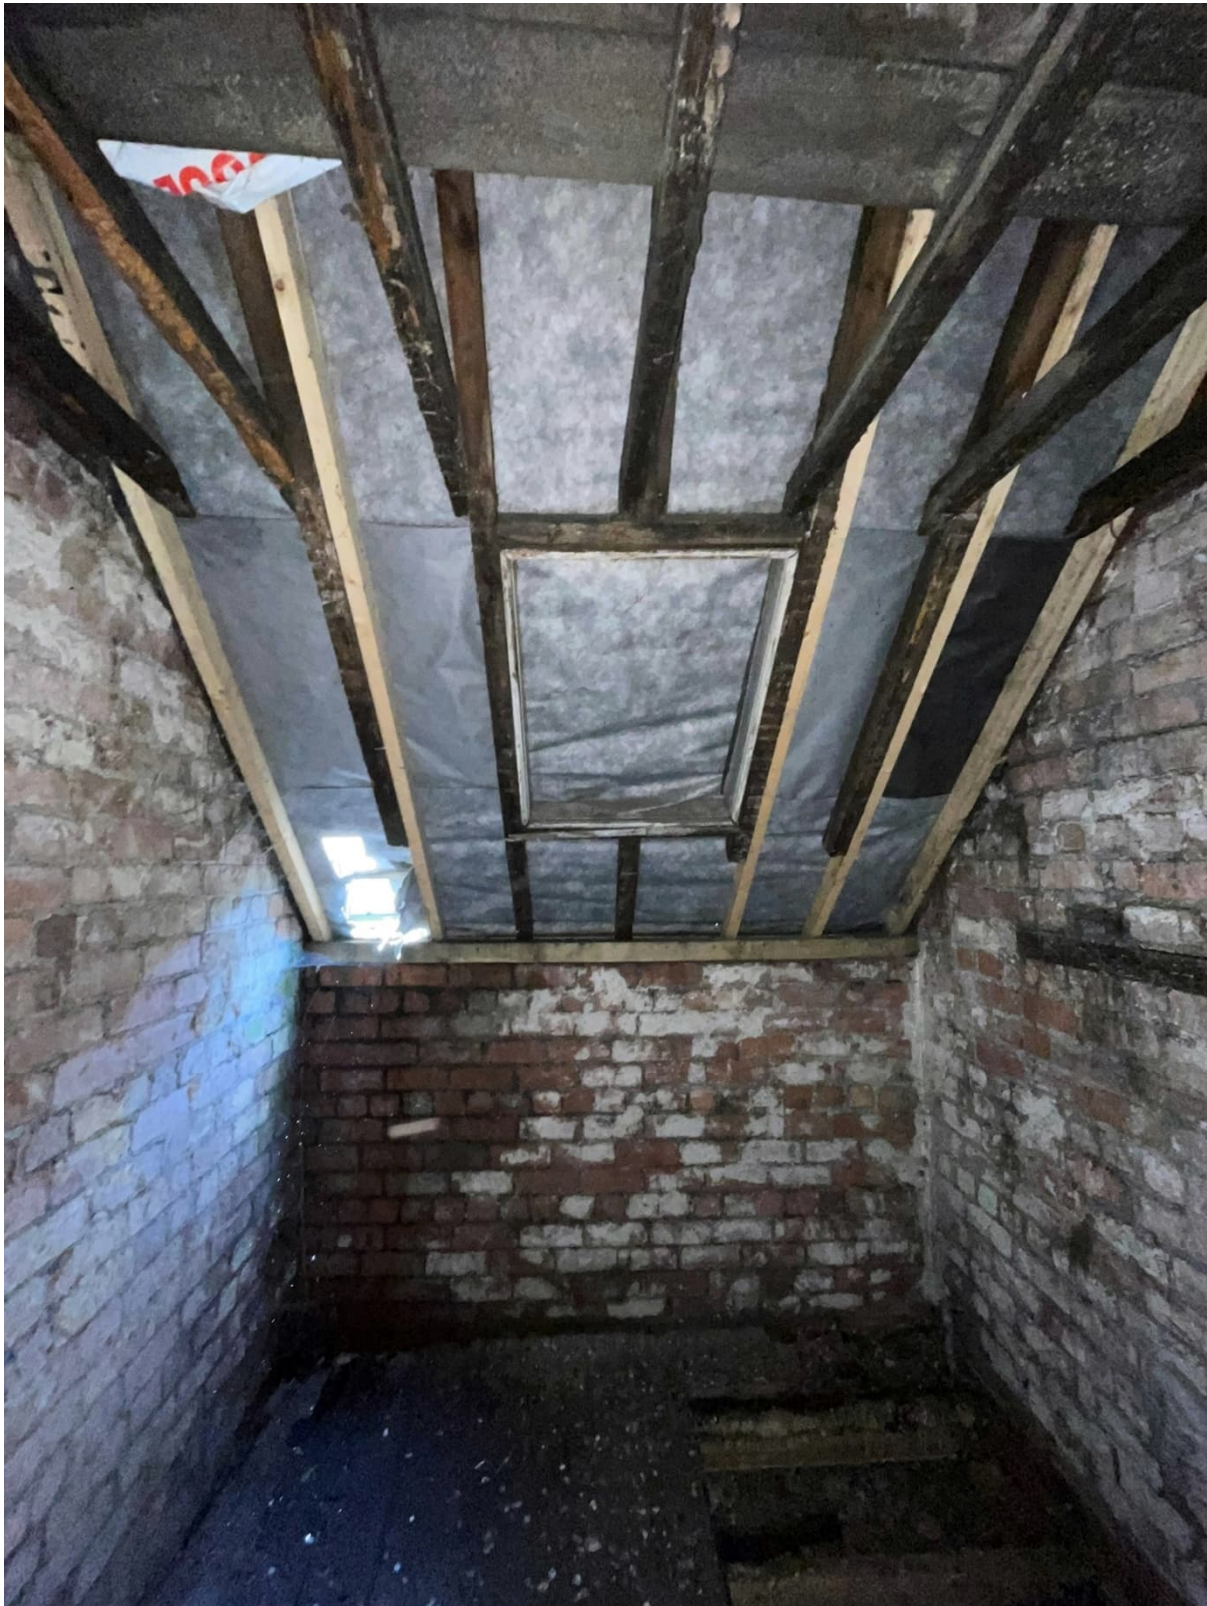
Rotten rafters over front of the building (over entrance).

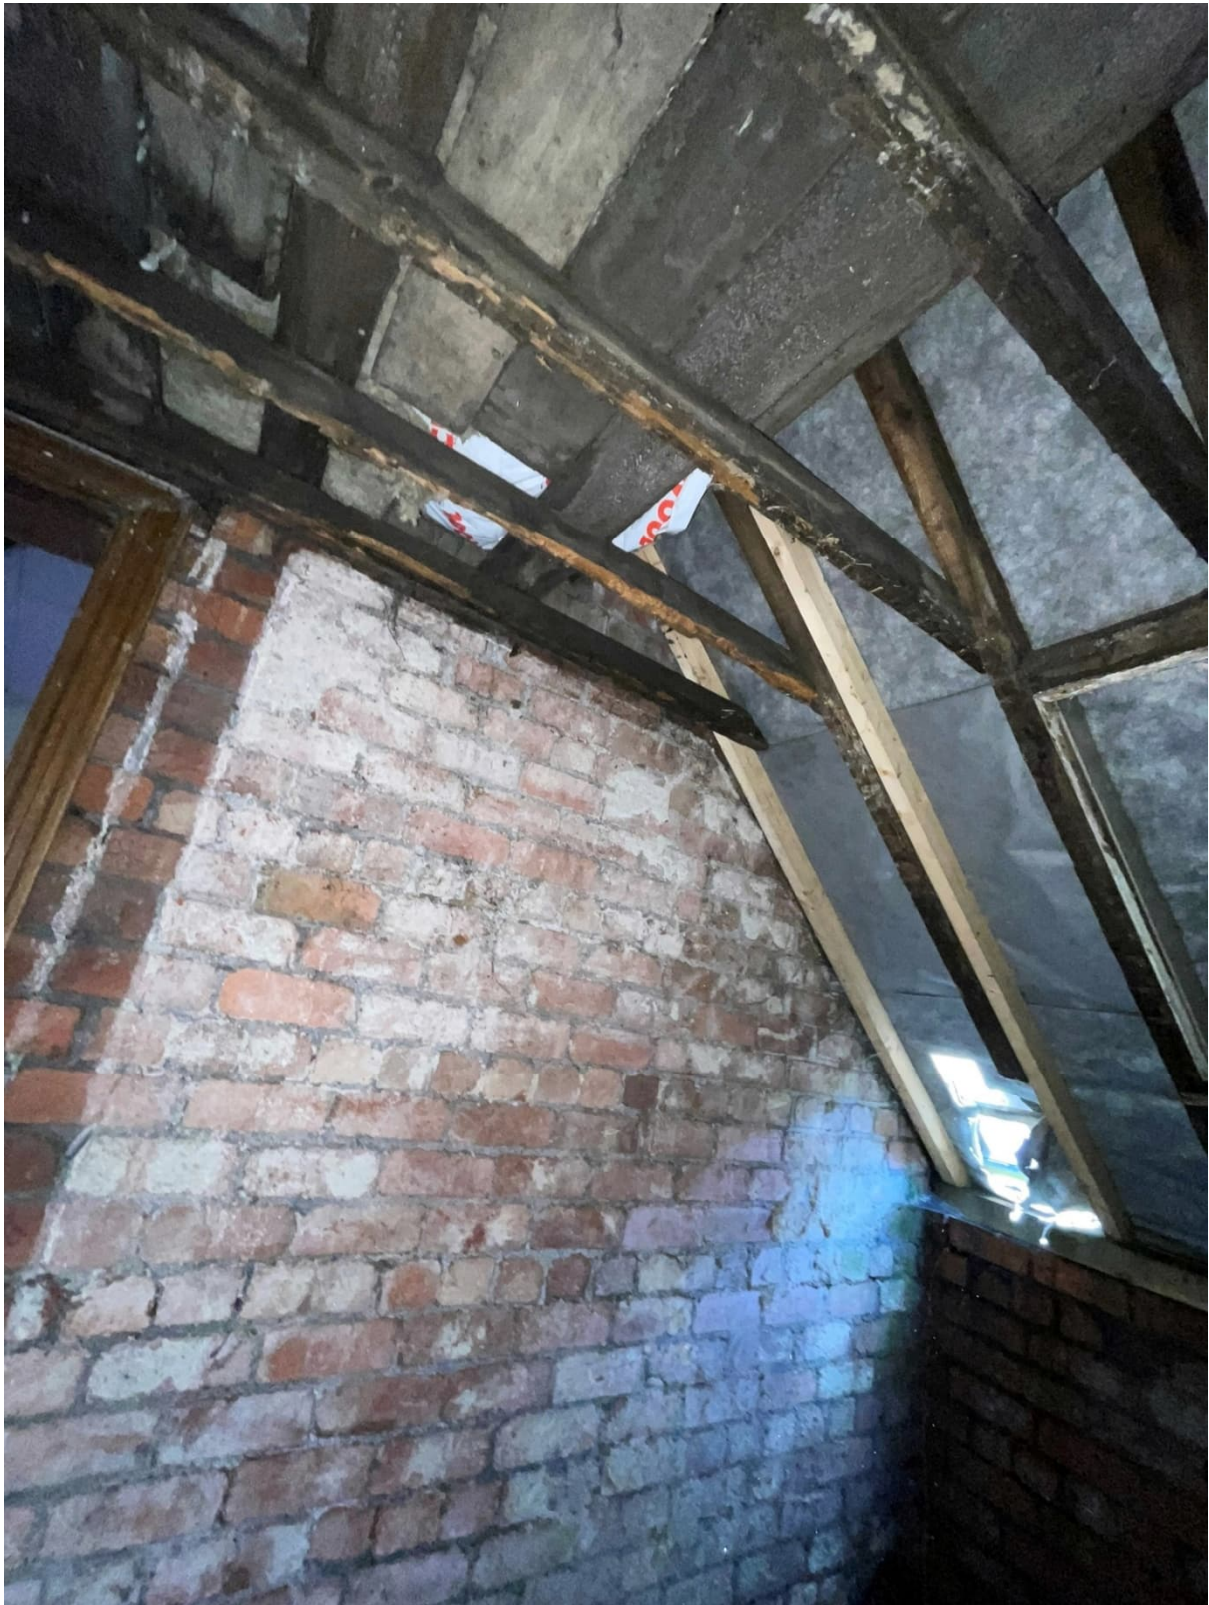
Purlin supporting rafters, sitting on wall to be removed.

To accommodate the proposals, there is a requirement for a knock-through opening in a solid brick wall in the basement. This will require either lintels or steel beams. On the ground floor there is one knock-through opening in the room at the far north-east (front of the building). This will require either lintels or steel beams. It's proposed for two solid walls in the toilets to also be removed. They don't appear to be loadbearing but this needs to be confirmed during opening-up works. The walls are solid and could be providing a buttressing effect to the external wall. The external wall will need to be checked for lateral stability. If the existing walls are required for stability, then windposts will need to be installed. A new staircase is to be installed for access from ground to first floor. This will be within the existing mezzanine floor. A void will need to be formed requiring alterations to the existing steelwork and the introduction of new steelwork. Where the existing mezzanine is located, the existing void is to be infilled. This will require new steel beams, analysis of the existing columns, bearing checks, specification of padstones and the design of new floor joists. Finally at first floor there is a solid loadbearing wall to be removed. This wall is supporting an existing purlin so this will require a steel beam.
