Grange Moor Roundabout S278
Works

Pre-Commencement Condition
Survey (Condition 34)

CLIENT: PCS Property Solutions Ltd
PROJECT TITLE: Grange Moor Roundabout
Section 278 Works
REPORT TITLE: Pre-Commencement Condition Survey (Condition 34)
PROJECT NUMBER: 165875
DOCUMENT NUMBER: 165875-SAN-GMR-XX-RP-C-01
ISSUE NUMBER: P04
DATE: June 2025

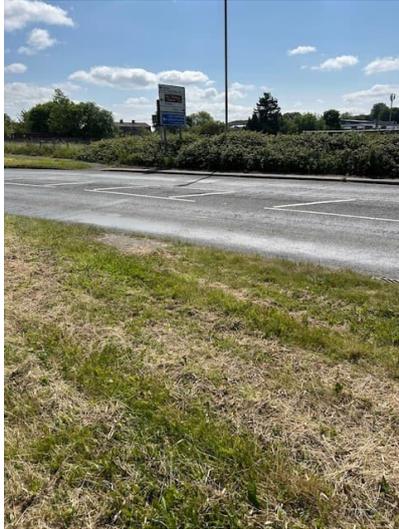
1. Liley Lane looking south west on the approach to the existing roundabout

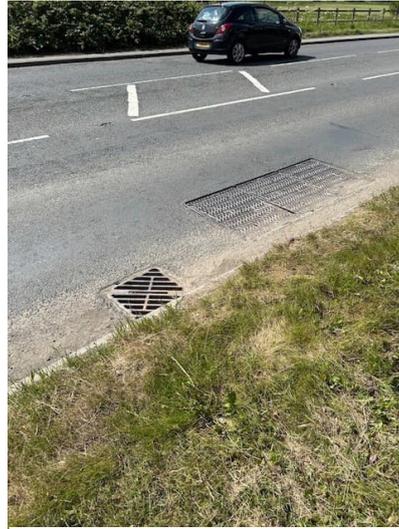
2. Liley Lane looking north east

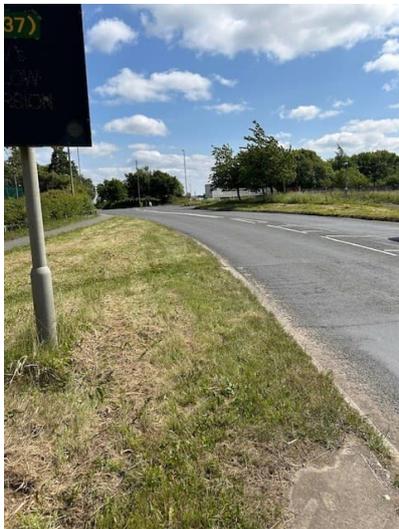
3. Liley lane facing south on approach to roundabout

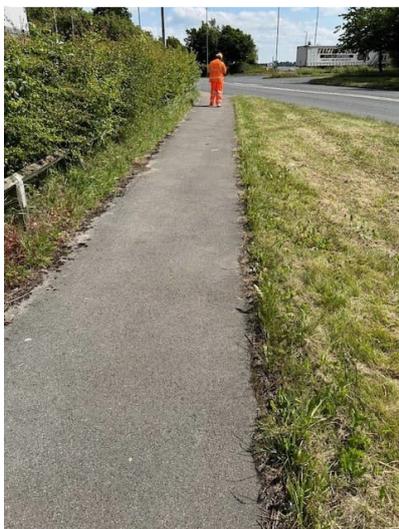
5. Footpath approaching around the roundabout, facing south

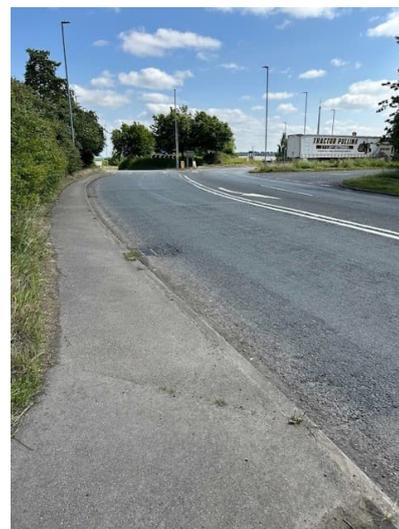
6. Liley Lane facing south on to Grange Moor roundabout

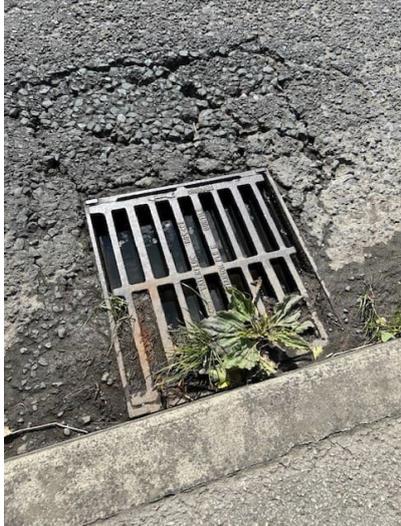
- 2.5 Several gullies within the boundary of the survey were observed to be blocked. In accordance with Kirklees Council's S278 delivery requirements, all gullies within the site boundary are to be cleaned and jetted upon completion of construction works.

7. Drainage gully on Liley Lane adjacent to industrial units.

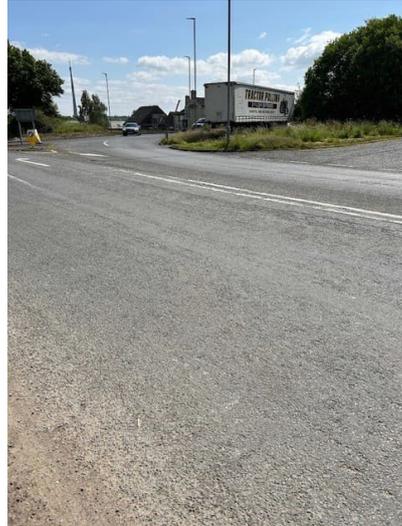
8. Liley Lane facing south west towards roundabout

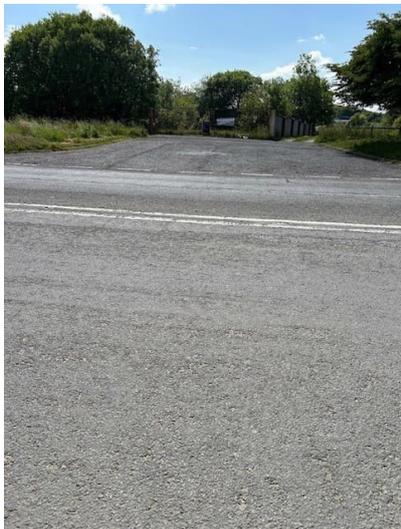
9. Entrance area for allotments facing west on Liley Lane

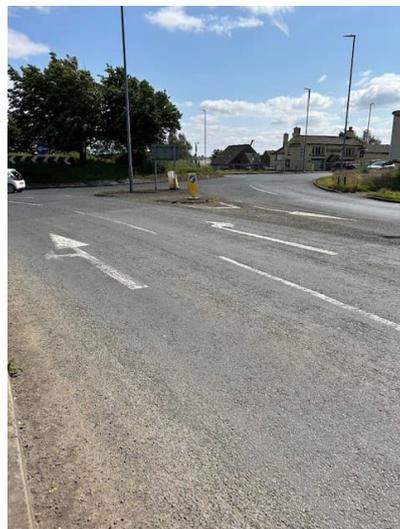
10. Road markings upon south bound entrance to roundabout

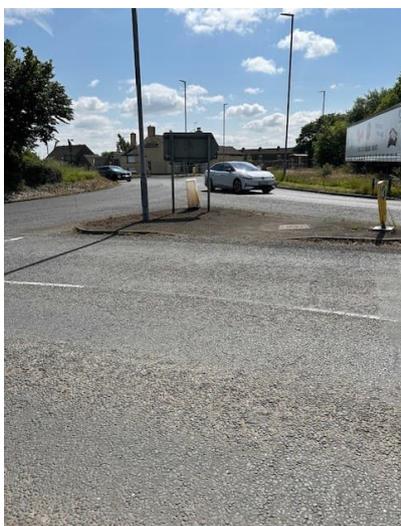
11. Splitter island on roundabout (northern arm)

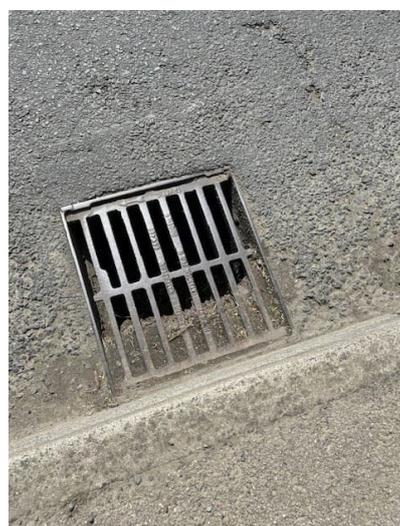
12. Drain on Liley Lane closest to roundabout

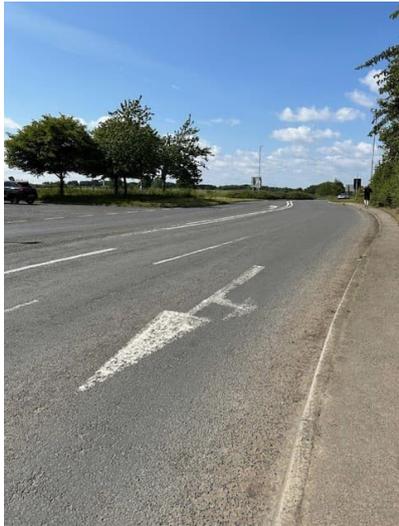
13. Liley Lane facing north east.

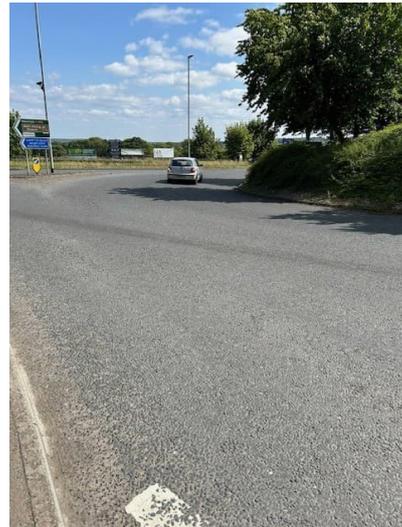
14. Curvature of the roundabout, road signs and direction bollards

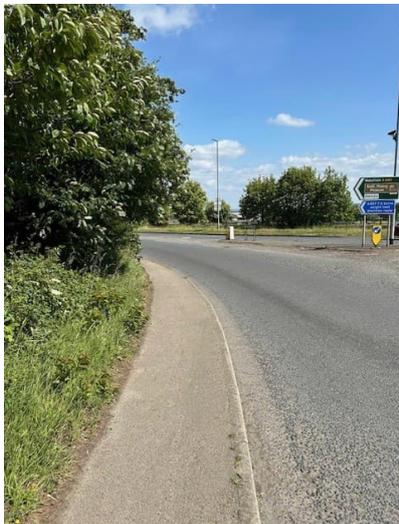
15. Exit off roundabout on to Wakefield Road

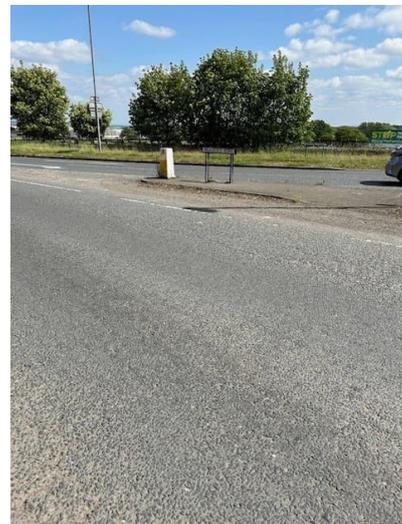
16. Splitter island and road sign on eastern arm of roundabout

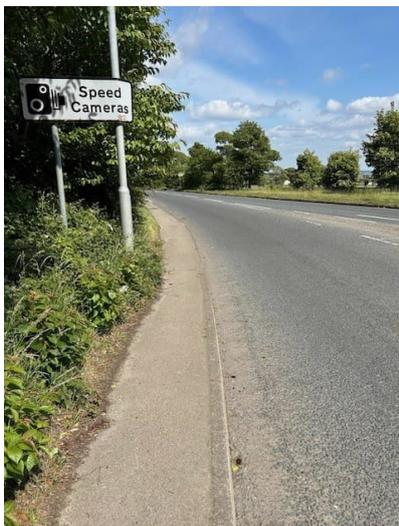
- 2.3 Full carriageway, footway and path resurfacing required within the extent of the S278 Works
- 2.4 It was noted that some existing signage on the approaches to the roundabout is damaged or missing. A full signage review is being undertaken as part of the roundabout design proposals. Any existing signage deemed suitable for reuse will be identified within the S278 design package.

17. Damaged road Signs and over grown footpath, facing south east

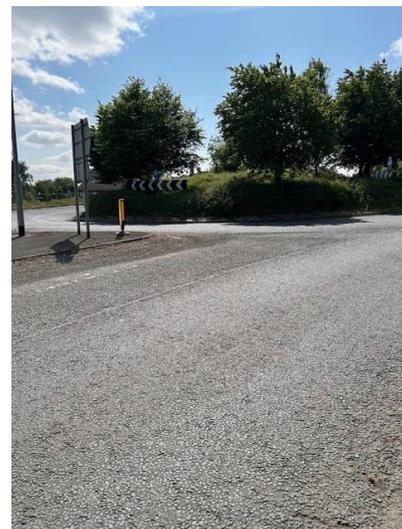
18. Roundabout facing west from Wakefield Road

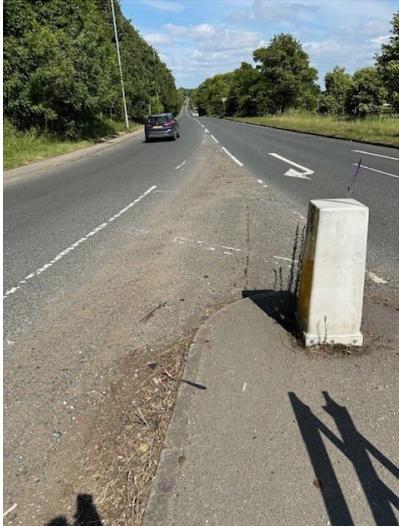
19. Splitter island on Wakefield Road facing east – debris in channel.

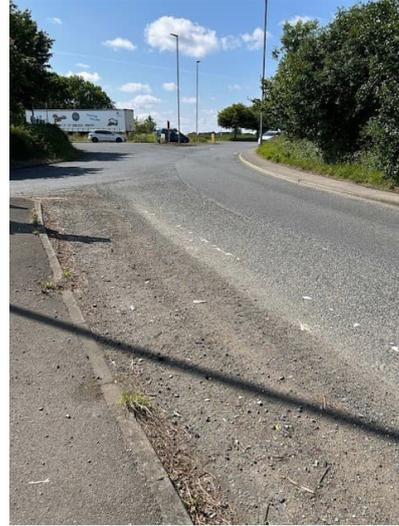
20. Approach from the east of roundabout, worn road markings

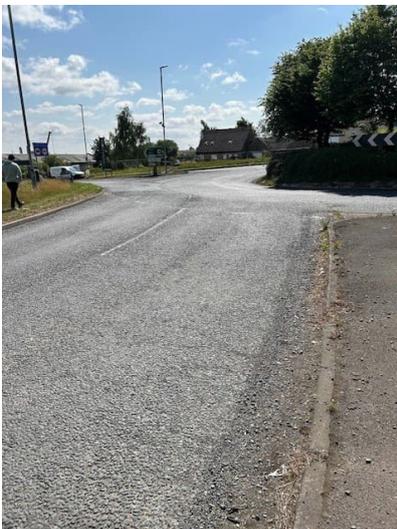
21. Westbound approach to roundabout on Wakefield Road

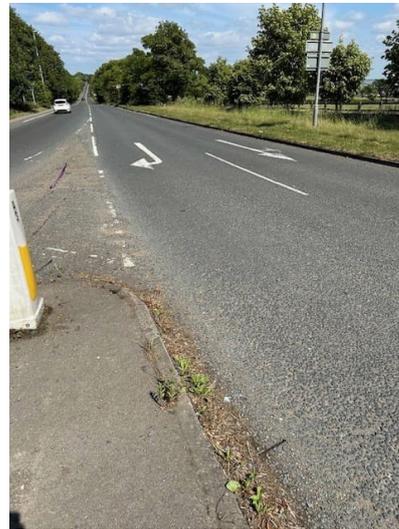
22. Westbound approach looking east on Wakefield Road.

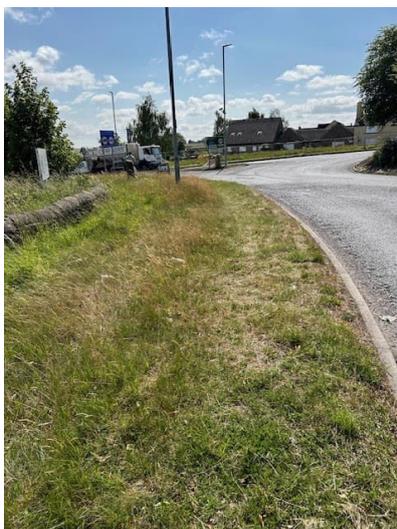
23. Grassed verge on south eastern side of roundabout, facing west

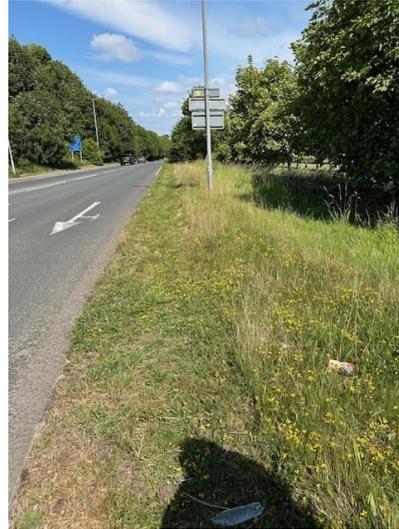
24. Grassed verge on southern side of Wakefield Road facing east.

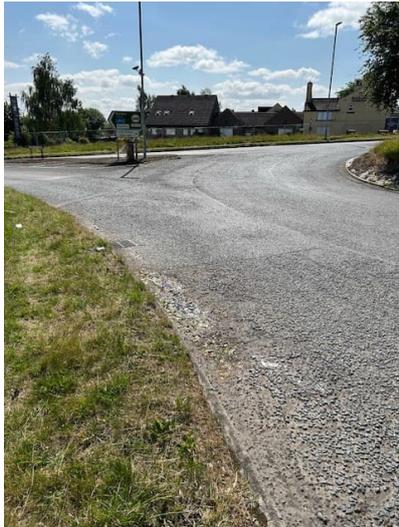
25. Southern arm of roundabout looking south west.

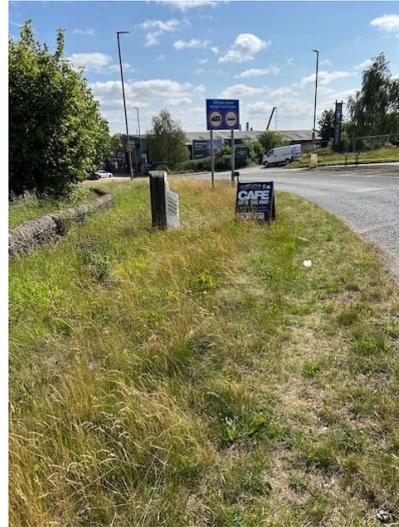
26. Grassed verge on southern side of roundabout

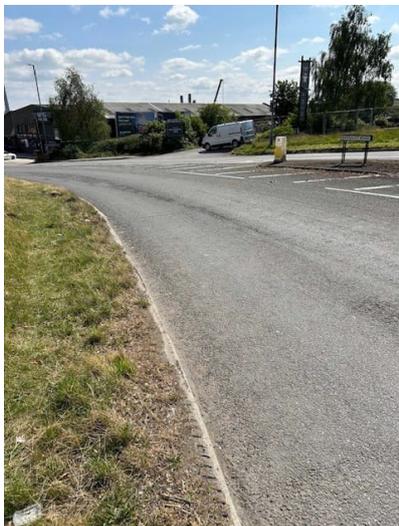
27. Splitter island looking south down Barnsley Road

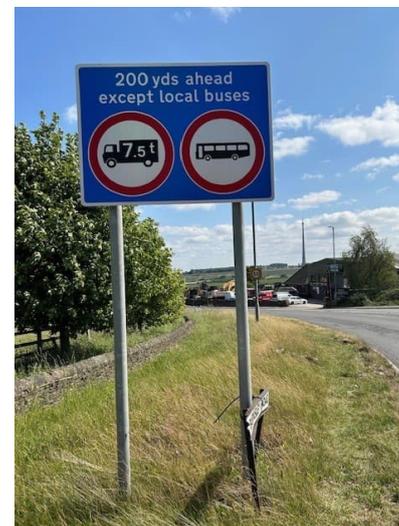
28. Grassed verge and signage on south west side of roundabout

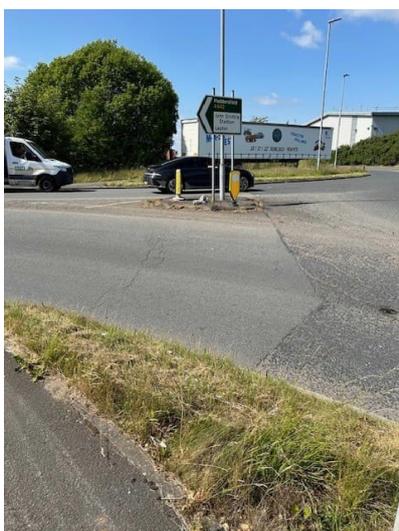
29. Splitter island with directional signs on western arm looking north

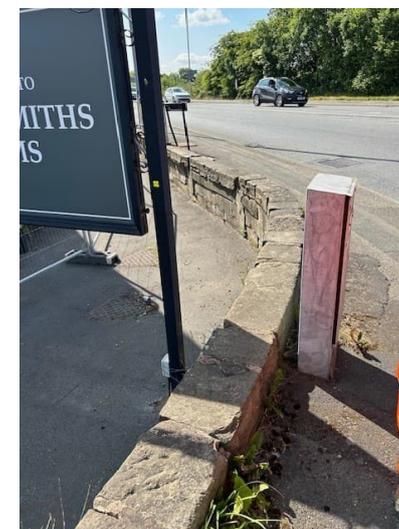
30. Existing Blacksmiths boundary wall on south western quadrant of roundabout

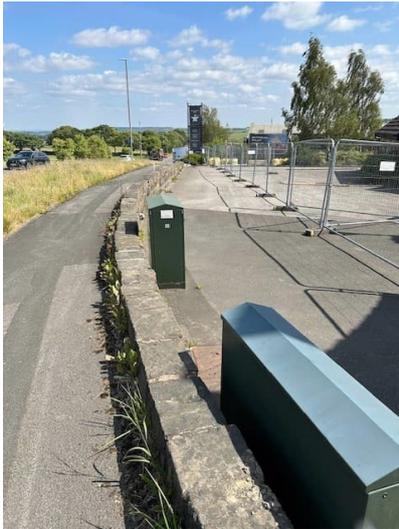
31. Barnsley Road adjacent to the Blacksmiths pub, looking south.

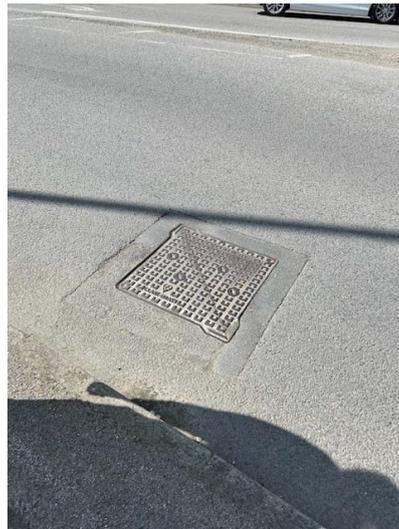
32. Manhole on Wakefield Road adjacent to Blacksmiths pub.

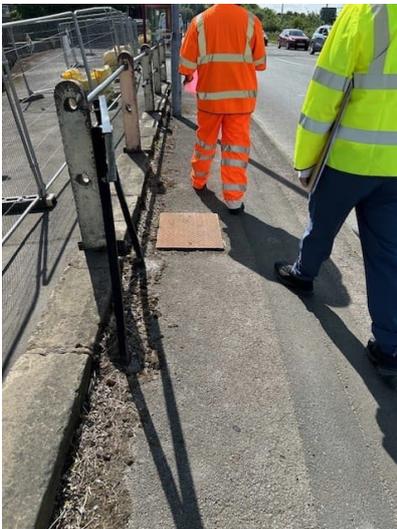
33. Utility cover and Blacksmith boundary wall looking north

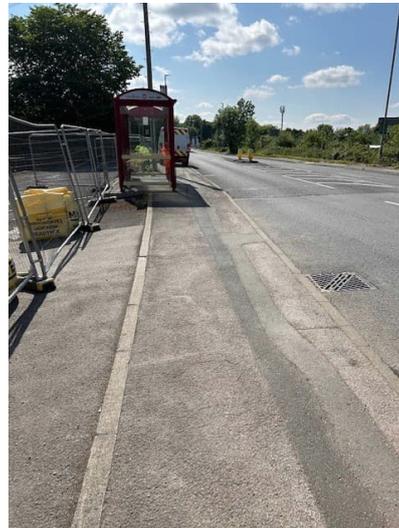
34. Bus stop and footway adjacent to Blacksmith's pub,

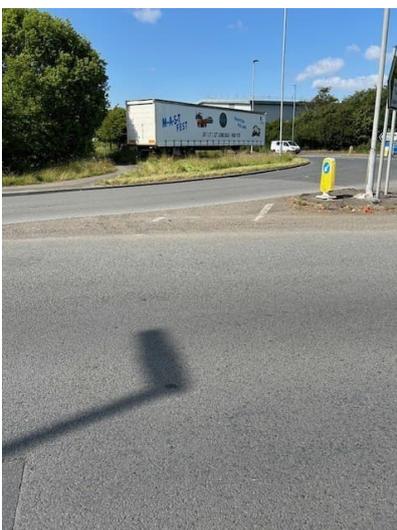
35. Wakefield Road stood adjacent to Blacksmiths looking north towards Liley Lane

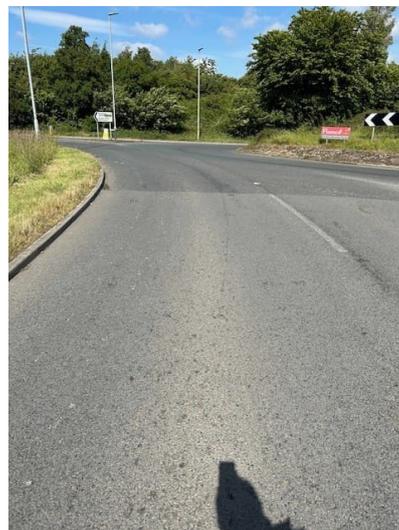
36. Barnsley Road looking north west to Wakefield Road

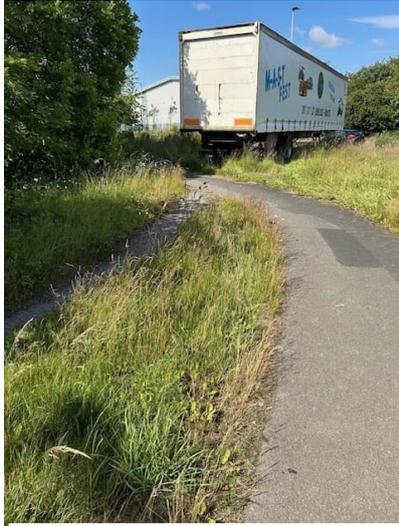
37. Footway on north western quadrant of roundabout looking north east

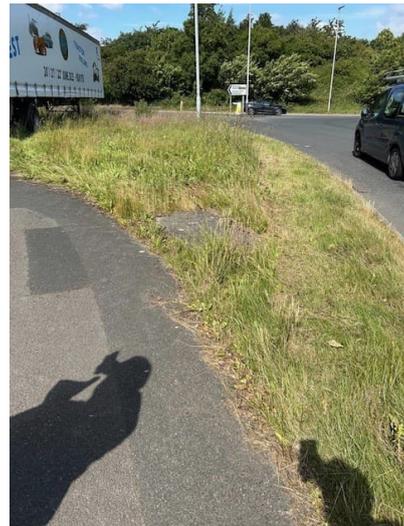
38. Barnsley Road, looking north on the western verge

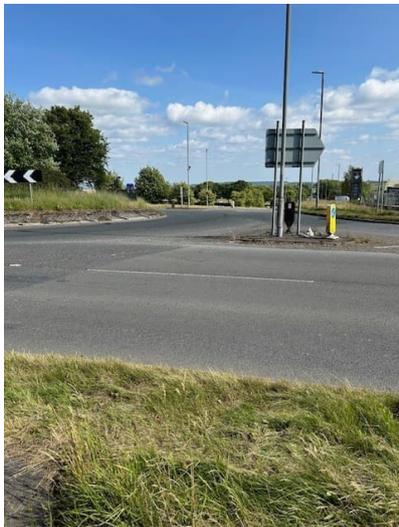
39. Western verge of roundabout looking south down Barnsley Road

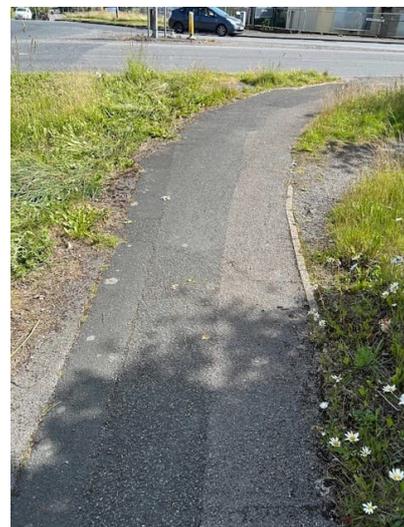
40. Footway on western verge off Liley Lane looking southbound

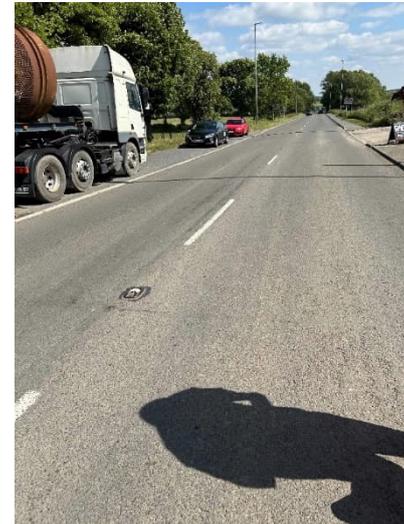
42. Barnsley Road, looking southbound adjacent to GMC.

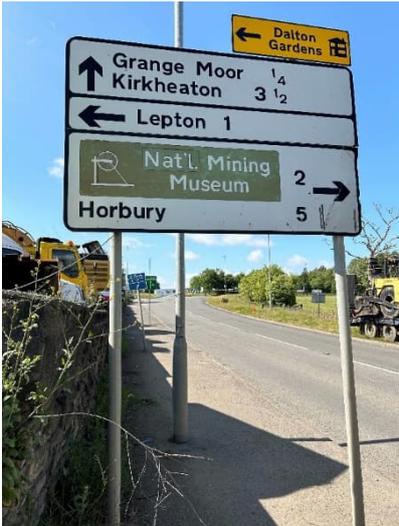
43. Road sign on footway, approaching roundabout from the south

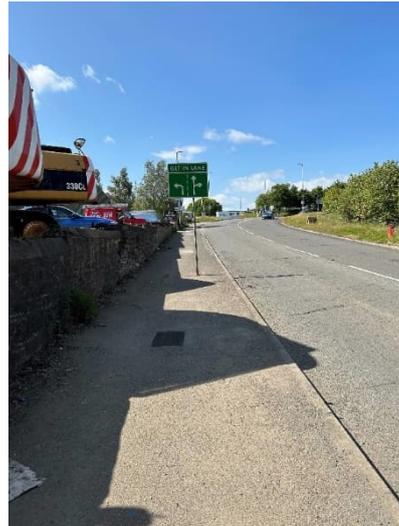
44. Footway and Barnsley Road looking north towards roundabout

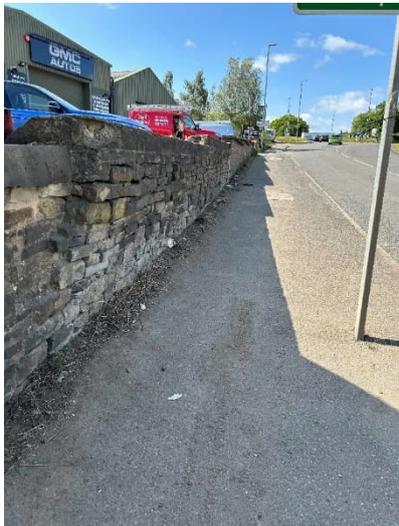
45. Barnsley Road looking towards roundabout, facing north

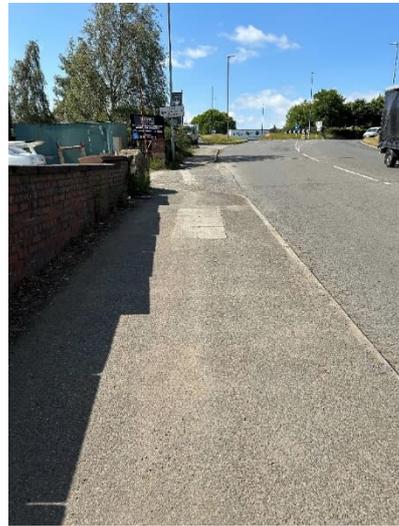
46. Barnsley Road looking north towards roundabout

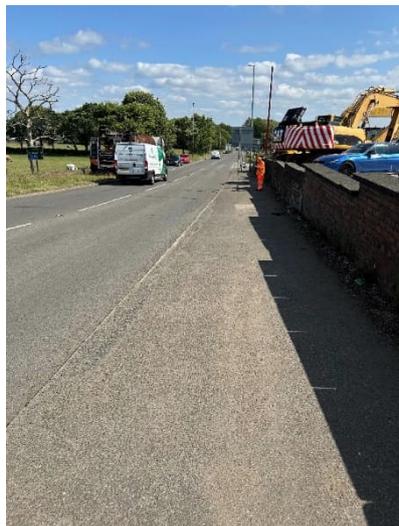
48. Barnsley Road looking south

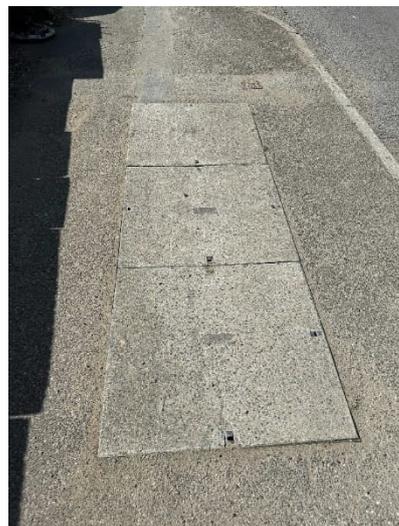
47. Existing utility chamber in footway adjacent to GMC Motors, Barnsley Road

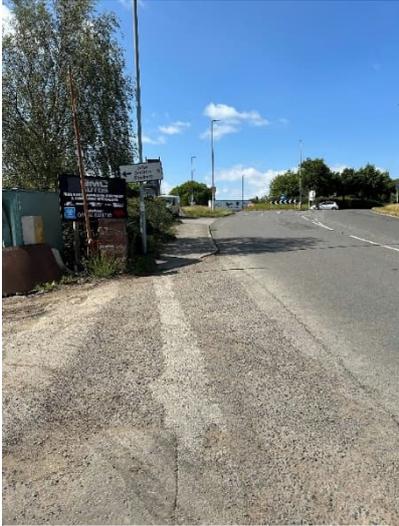
49. Access to existing GMC site, looking northbound

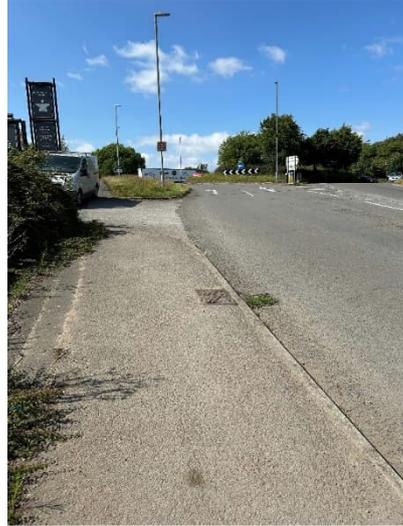
50. Access to Blacksmiths adjacent to GMC, looking northbound

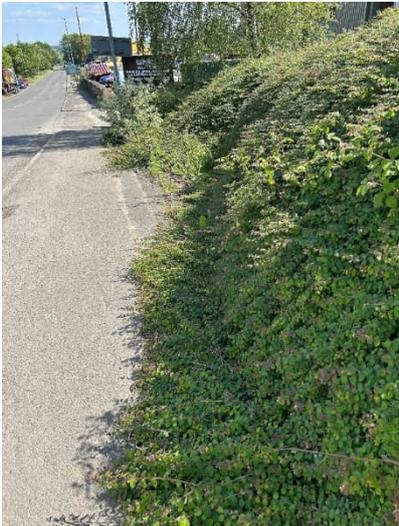
51. Vegetation adjacent Blacksmiths, facing south on Barnsley Road

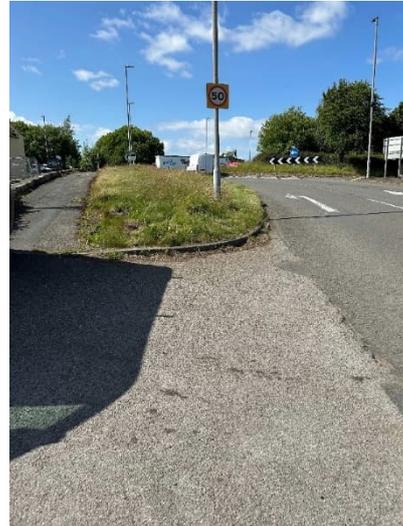
52. Access to Blacksmiths carpark facing north towards roundabout

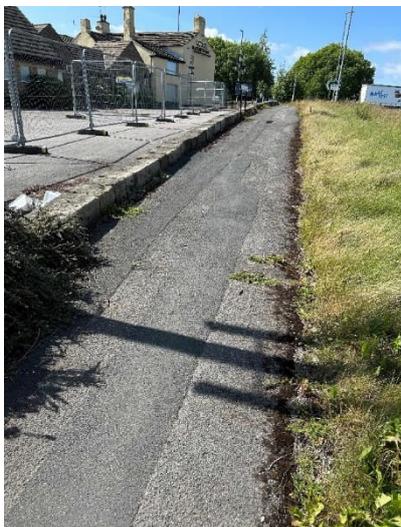
53. Footway adjacent to Blacksmiths pub, facing northbound

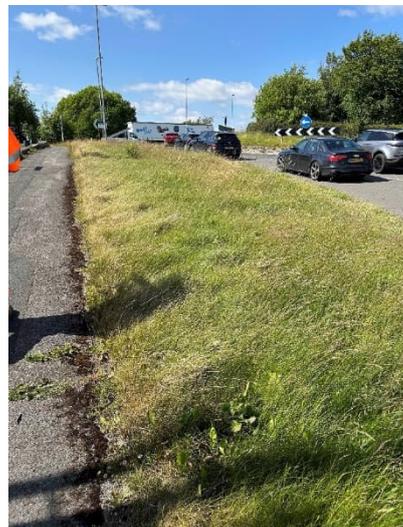
54. Adjacent to Black Smiths pub, SW verge
