5th September 2023

Whitehall Road West, Birkenshaw
Intrusive Coal Mining Investigation

Title **COAL MINING SITE
INVESTIGATION PLAN**

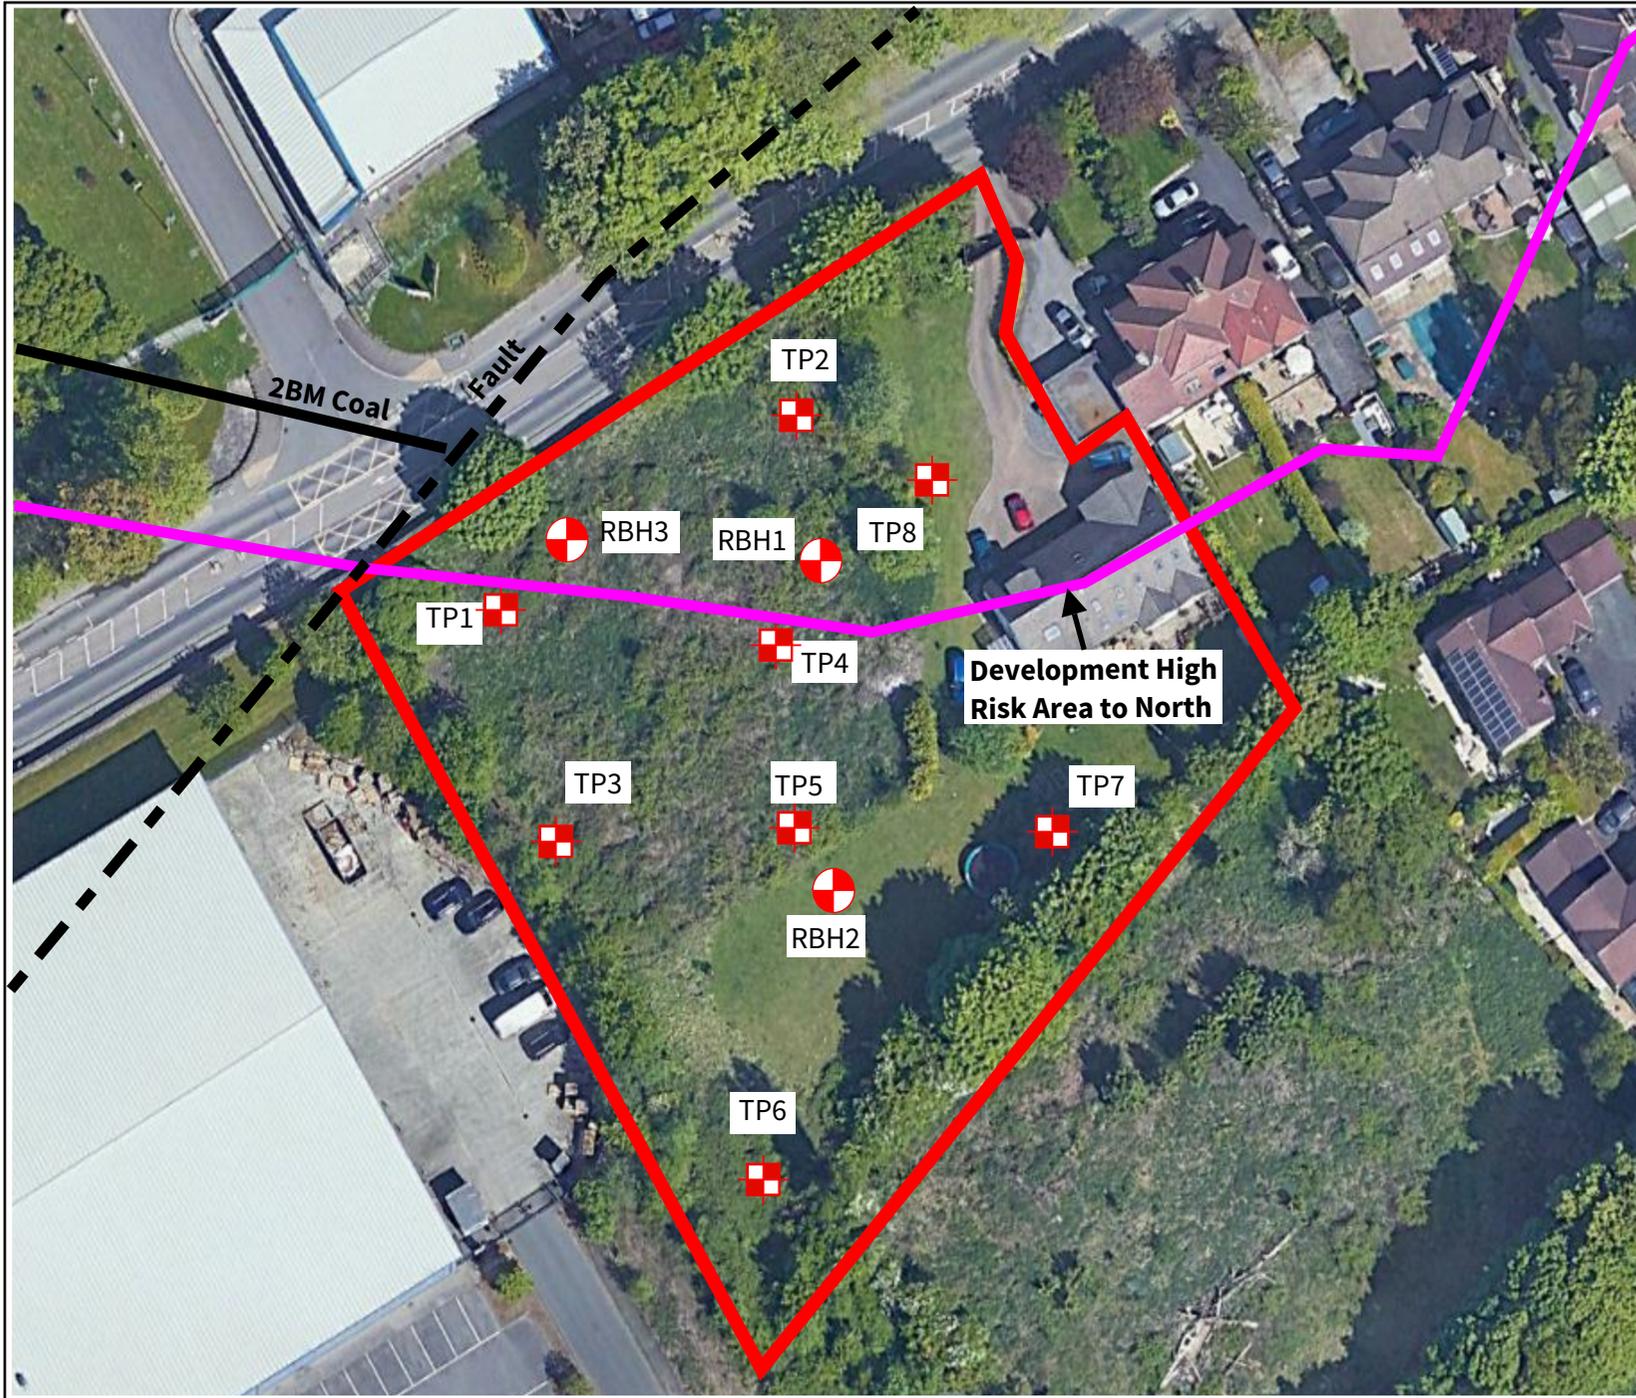
Part of the site is recoded as within a Development High Risk Zone. This high risk zone is marked on the 'Coal Mining Site Investigation Plan' which is attached to this letter (it should be noted there is some slight discrepancy of the high risk zone location between different sources of information).

A thin intact coal seam was identified in both phases of investigation across the entire site (the rotary investigation confirmed what was found in the main site investigation). The coal seam was encountered at depths of between 0.8m and 3.1m, with a thickness of between 0.2m and 0.4m.

The rotary borehole investigation encountered a second thin intact coal seam (0.1m to 0.2m thick) at depths of between 7.3m and 8.0m. No other coal seams were identified, to a depth of up to 25m, and no workings were found. The driller's logs are attached to this letter.

As such, drilling and grouting works are not required for the site. Because shallow coal mine workings were not identified, or any significant unweathered coal, there was considered to be no requirement to install gas monitoring apparatus and undertake gas monitoring (there are no other sources of ground gas identified). It should be noted that basic radon protection is required for the site, however.

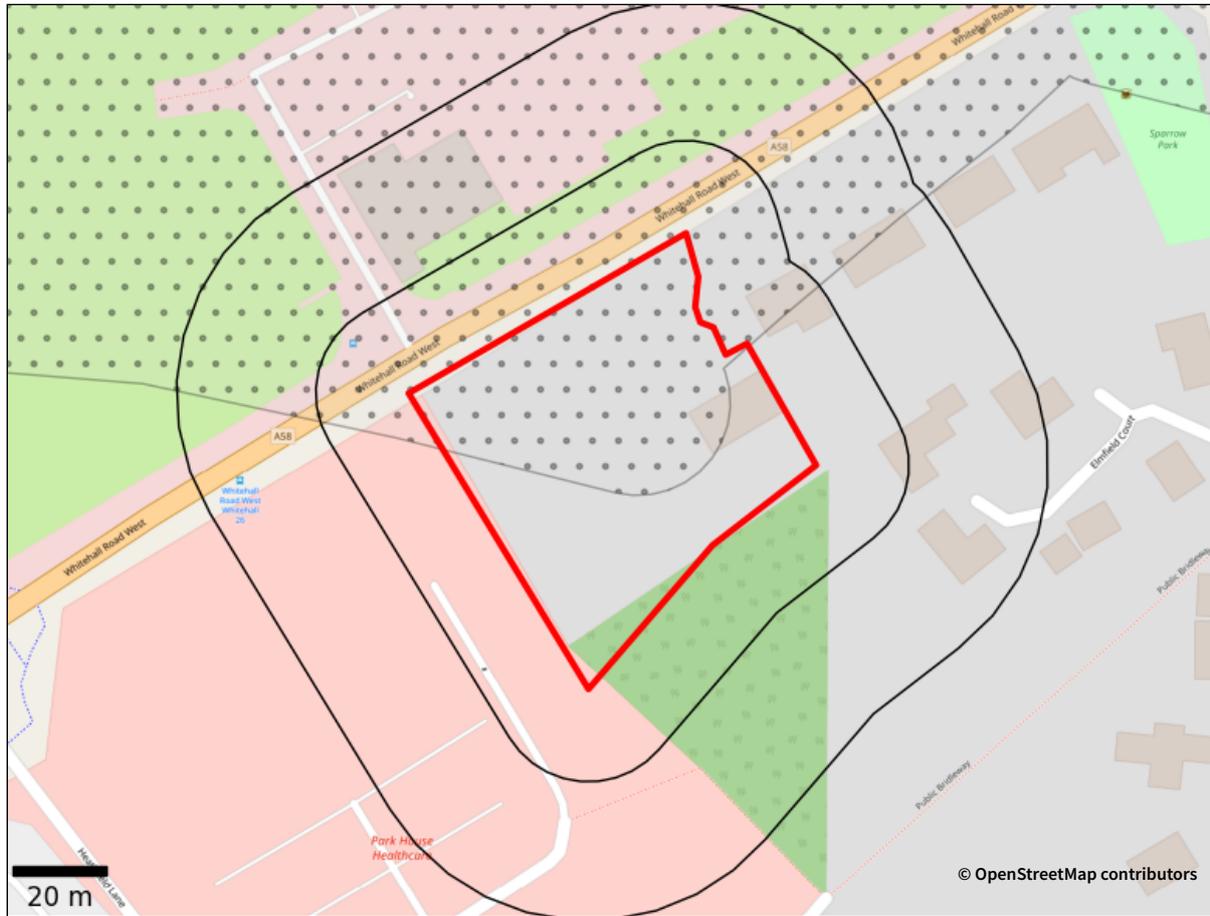
Mining Hazard Map

A coal seam has been identified within 20 metres of the Site and associated shallow unrecorded coal mine workings are suspected to have been historically worked beneath/within the immediate vicinity of the Site. Historical 'shaft-like' features, called 'Bell Pits', are also particularly common at/near coal outcrops, often occurring in clusters and being typically unrecorded in nature. Given the shallow depth of suspected coal mine workings (e.g., 'Bell Pits') beneath the Site, any movement within the worked coal seams may cause ground instability at the surface. Any previous movement in the ground should already be present in pre-existing structural defects; please see the report recommendations for further information.

The Site is likely located within a 'High Development Risk Zone', as defined by the Coal Authority. Due to the presence of recorded and/or unrecorded coal mining activity, any future development of the Site may trigger ground collapse and/or subsidence. It should be noted that prior to site works or future development, your local planning authority may require you to commission a full Coal Mining Risk Assessment (CMRA) or Site Investigation by a qualified mining geologist/engineer. In the event, you require further professional support, please contact our team directly to discuss the appropriate further steps.

It is considered prudent that an appropriate commercial RICS Structural and/or Building Survey is acquired for any properties/structures present on the Site in question to assess, amongst other important considerations, their structural condition. This report will highlight any subsidence-related defects, which may relate to ground instability, while also noting any serious or dangerous issues that may require attention. This survey will also include advice on any defects, repairs or maintenance decisions. Should any future signs of subsidence or collapse be identified, then we recommend you seek further expert assistance, however currently, no further reporting on ground instability is required. Our team can be contacted using the information supplied on the front page of this report.
