Condition Survey Report

Whitehall Road West, Birkenshaw.

May 2025

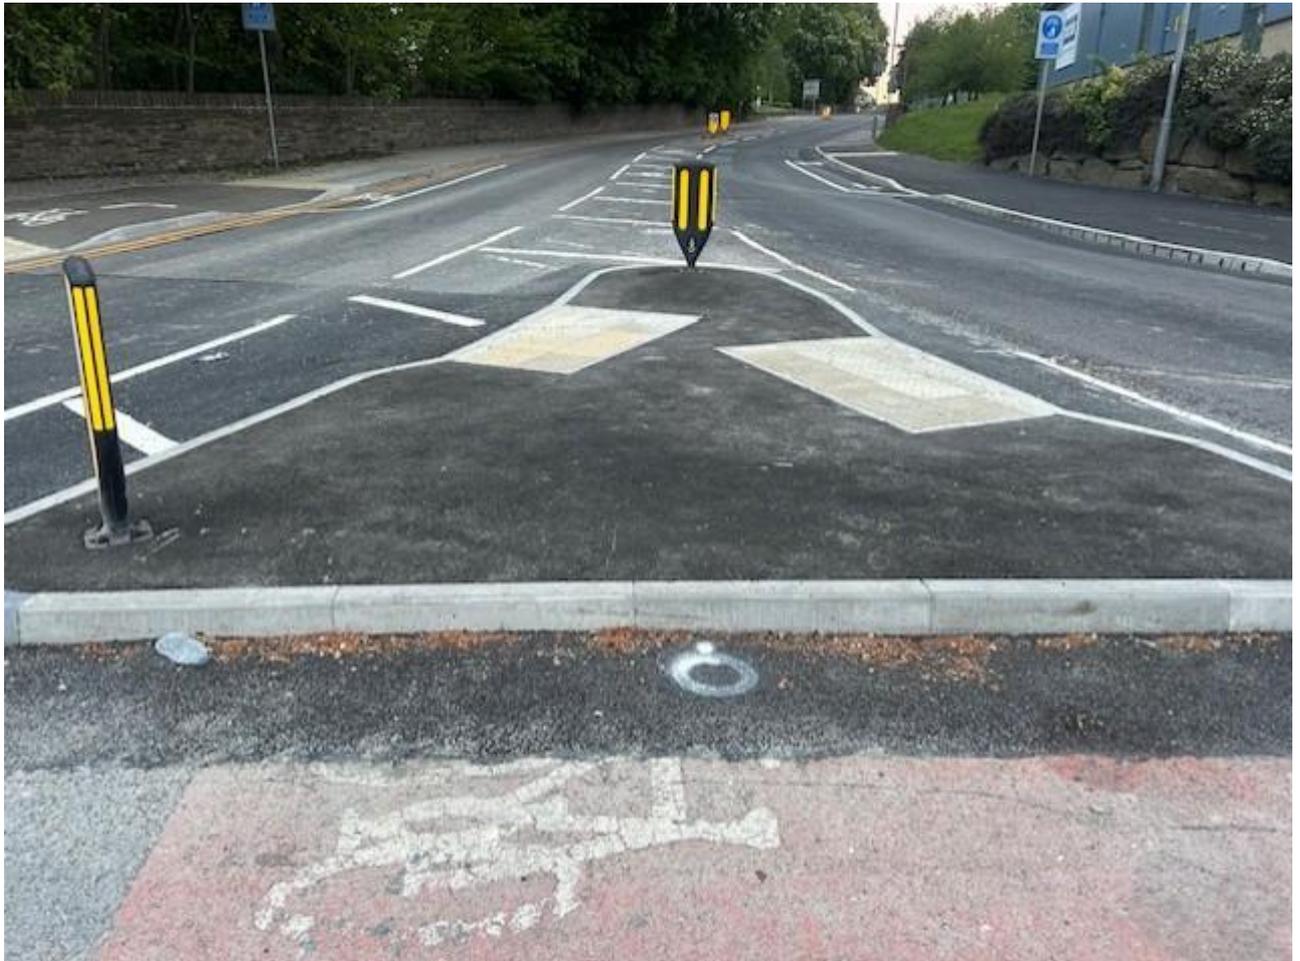
Comments – new carriageway construction as part of Section 278 works. No specific comments as all recently constructed.

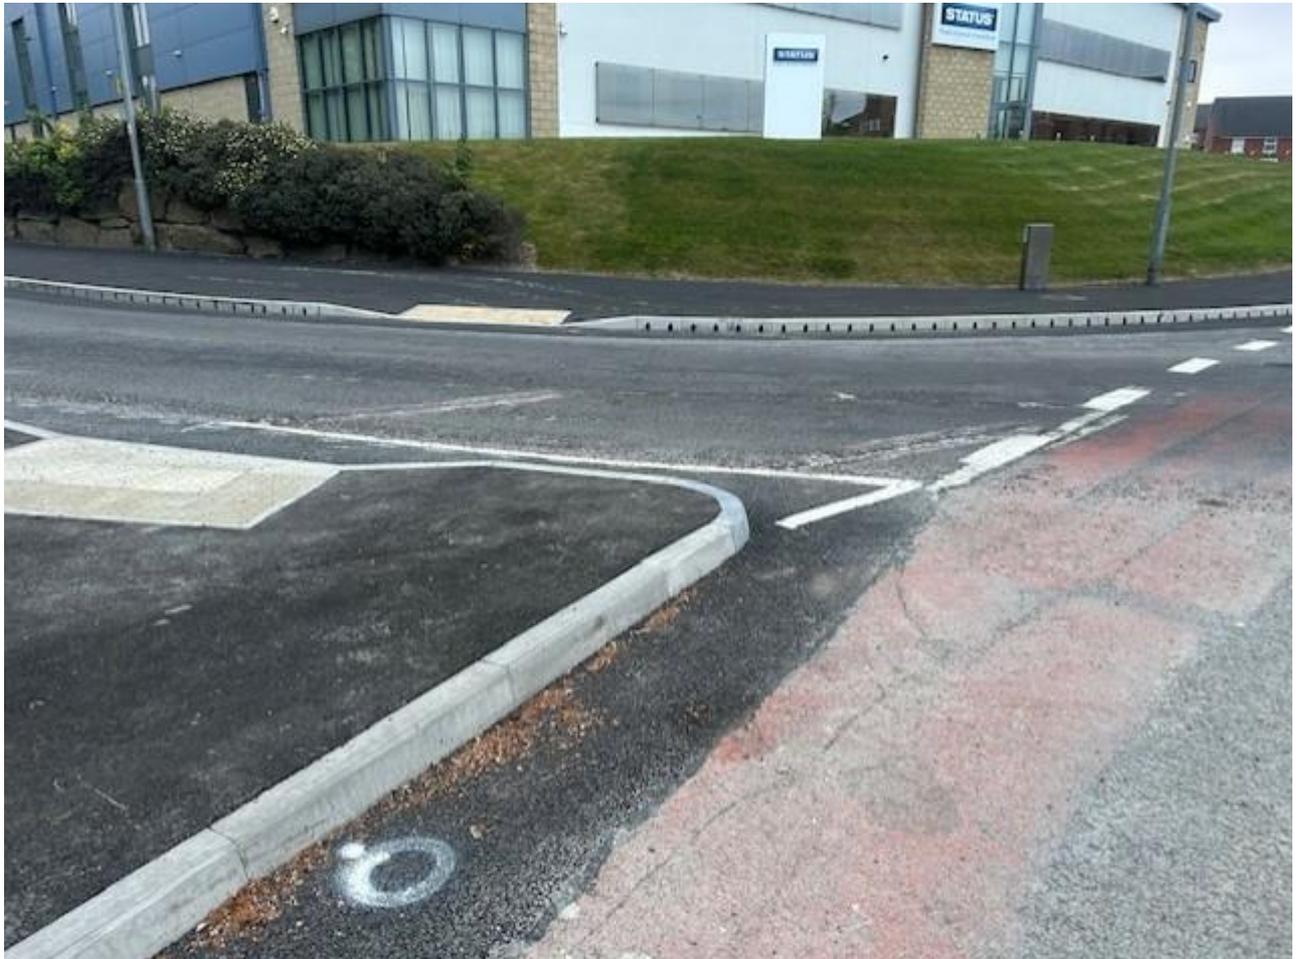
Comments – previous cycle lane / brindle surface dressing heavily worn. No details of whether this will be reinstated as part of the latest works.

Recommendation – Highway Authority to monitor.

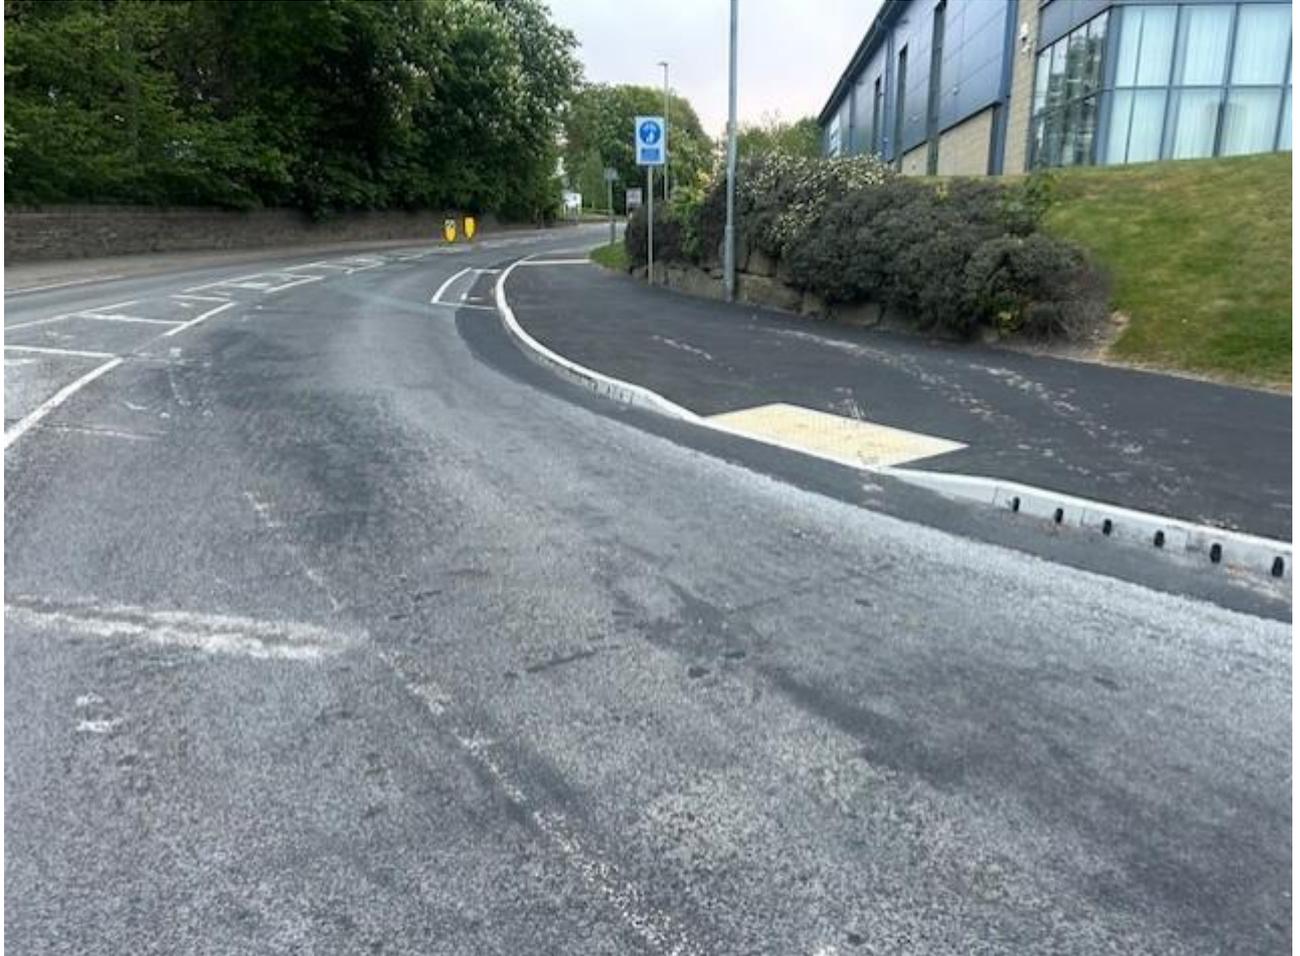
Comments – evidence of slight gap in surface course along parallel joint.

Recommendation – Highway Authority to monitor.

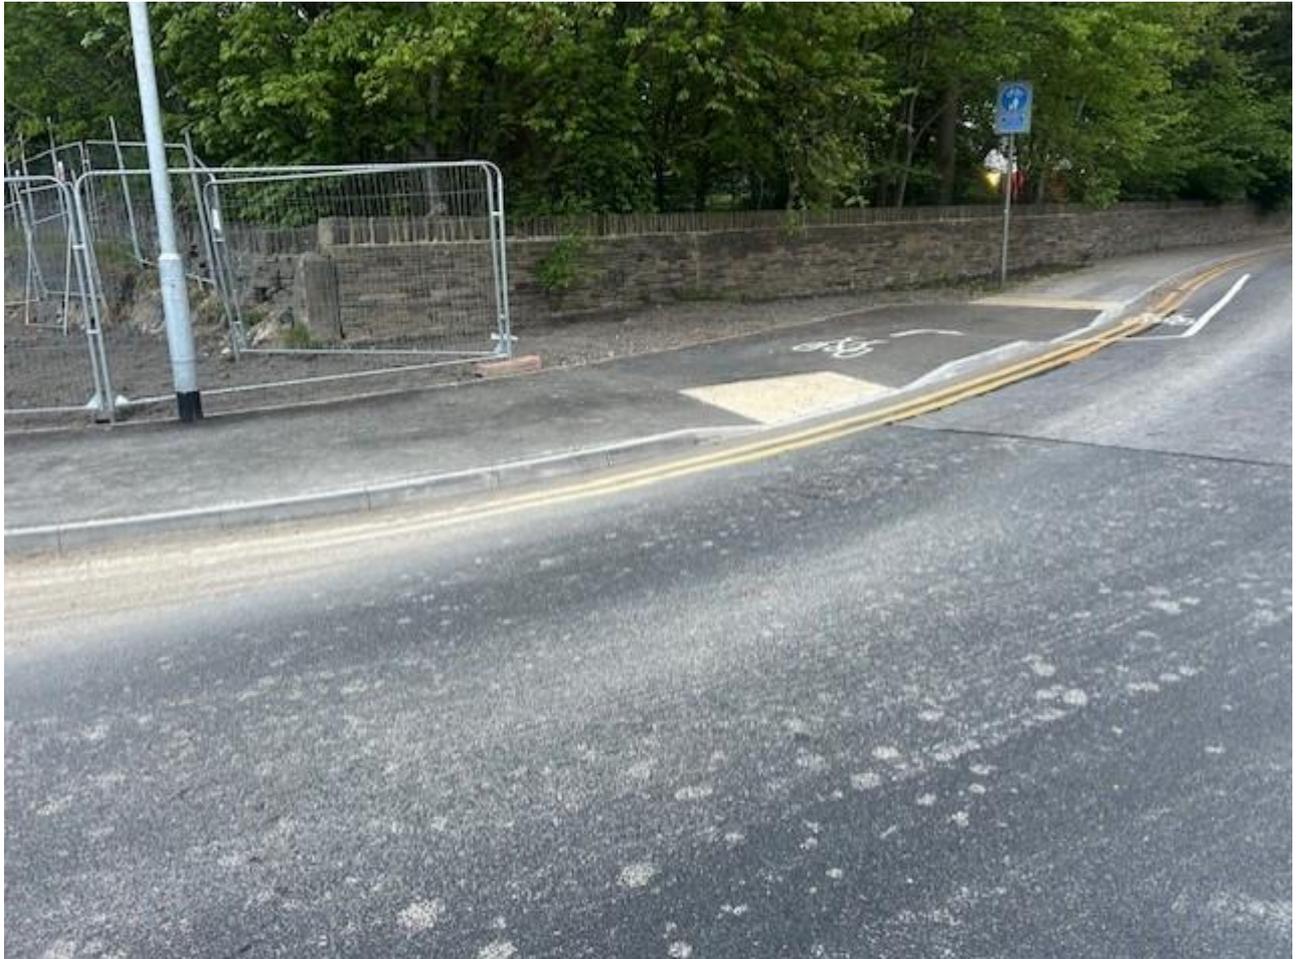
Comments – new surface course requires road sweeping.

Recommendation – Highway Authority to initiate Road Sweep.

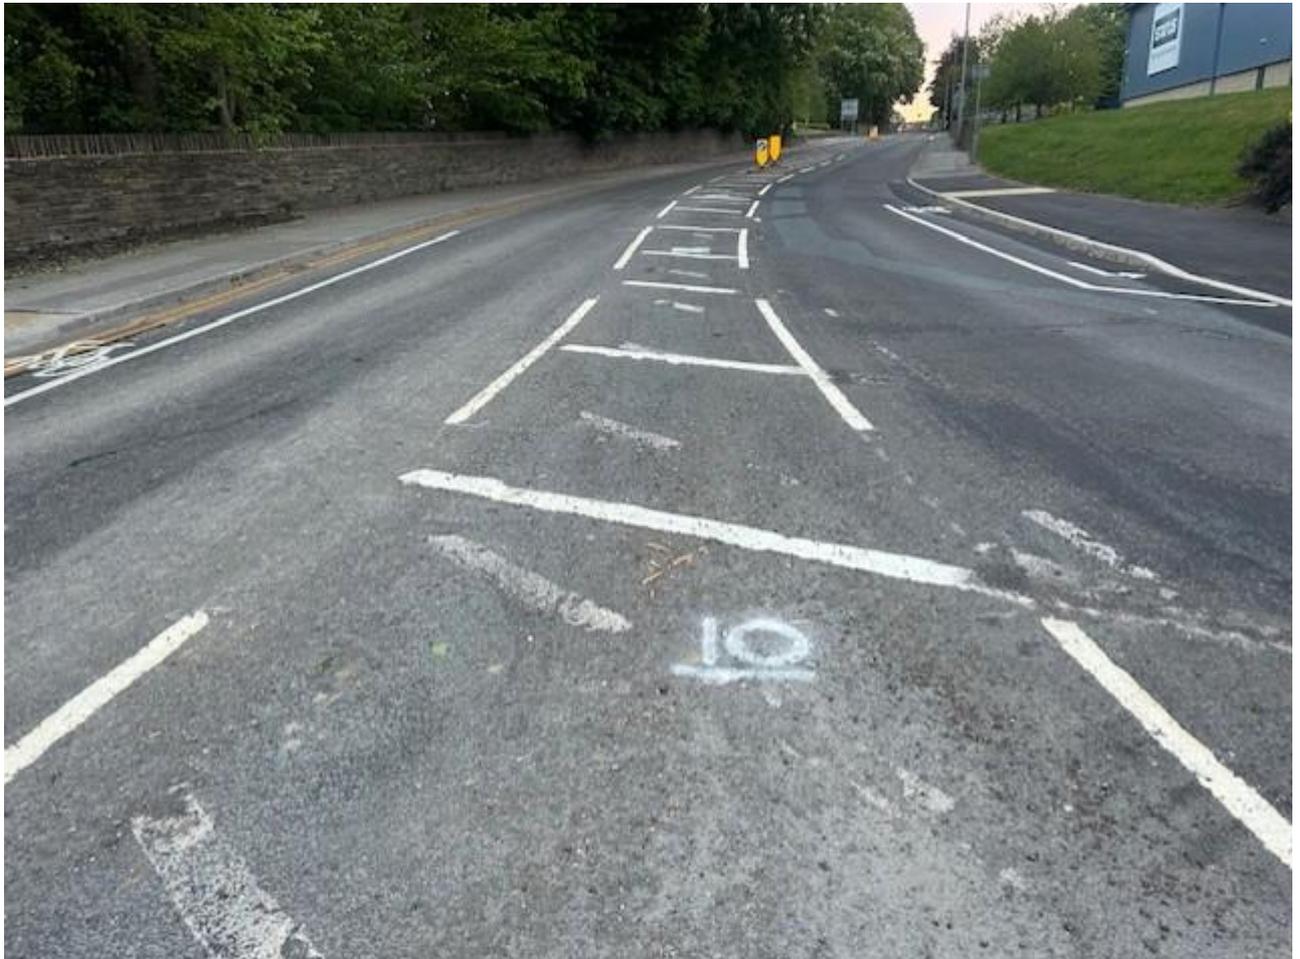
Comments – surface course requires a road sweep. Some evidence of previous road marking may require addressing as part of Road Safety Stage 3 for recent highway works.

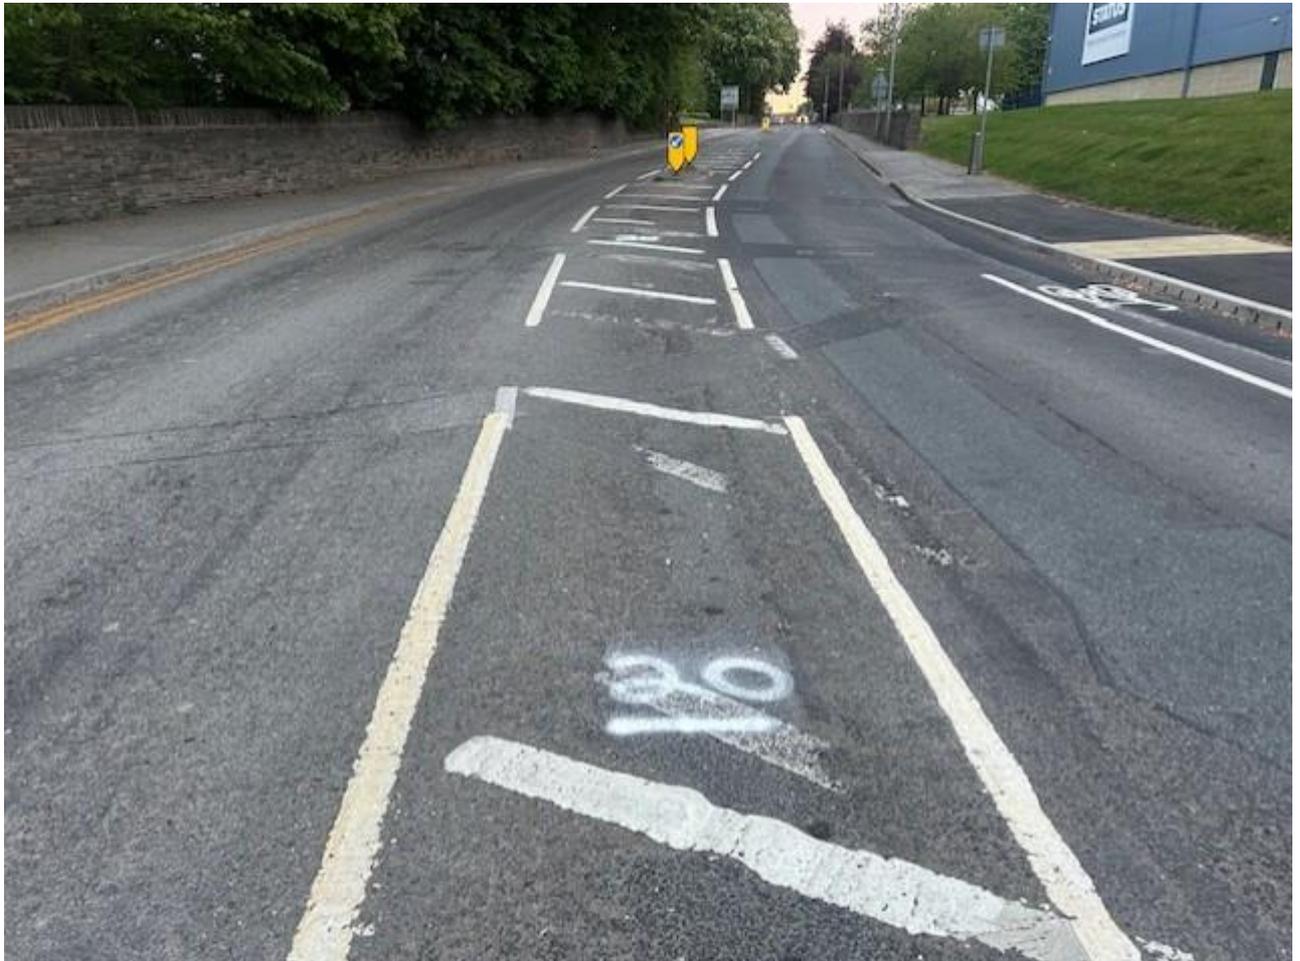
Comments – several trench reinstatements particularly at Ch 25m and also along the southern side of the carriageway where trenches cross over each other. Potential for accelerated settlement.

Recommendation – Highway Authority to monitor.

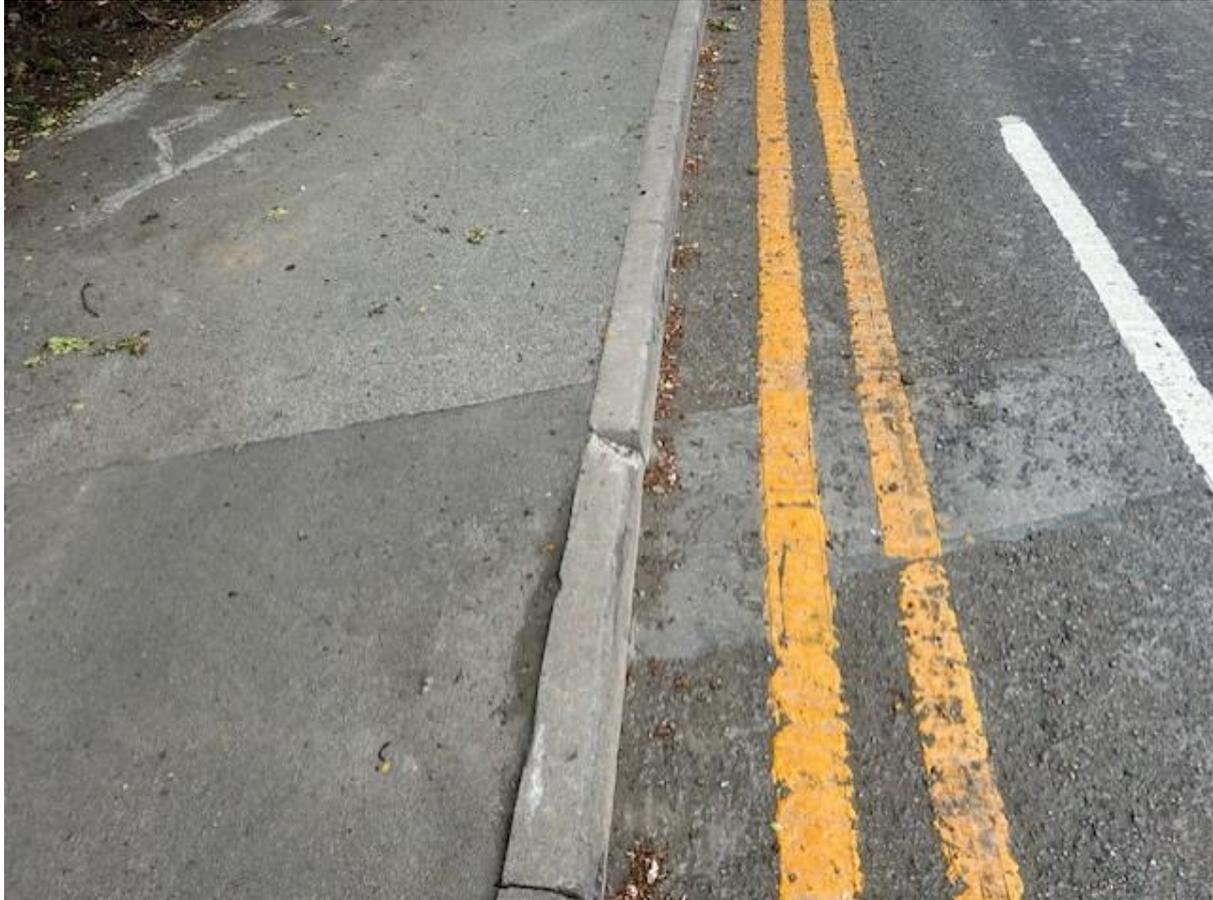
Comments – kerb block chipped where trench reinstatement works has occurred. Potential trip hazard.

Recommendation – Highway Authority to monitor.

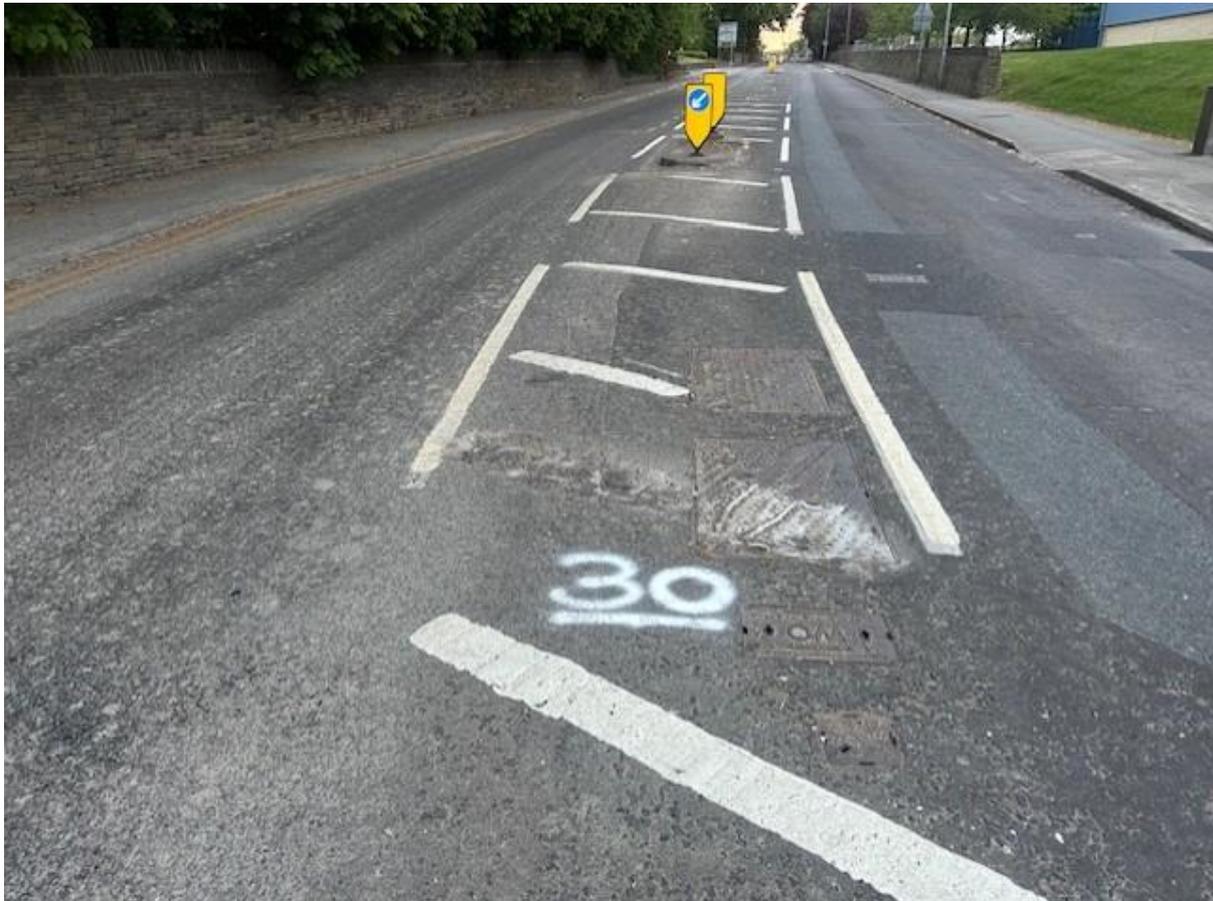
Comments – surface course of northern side of carriageway showing signs of becoming polished.
Note trench reinstatement on southern side.

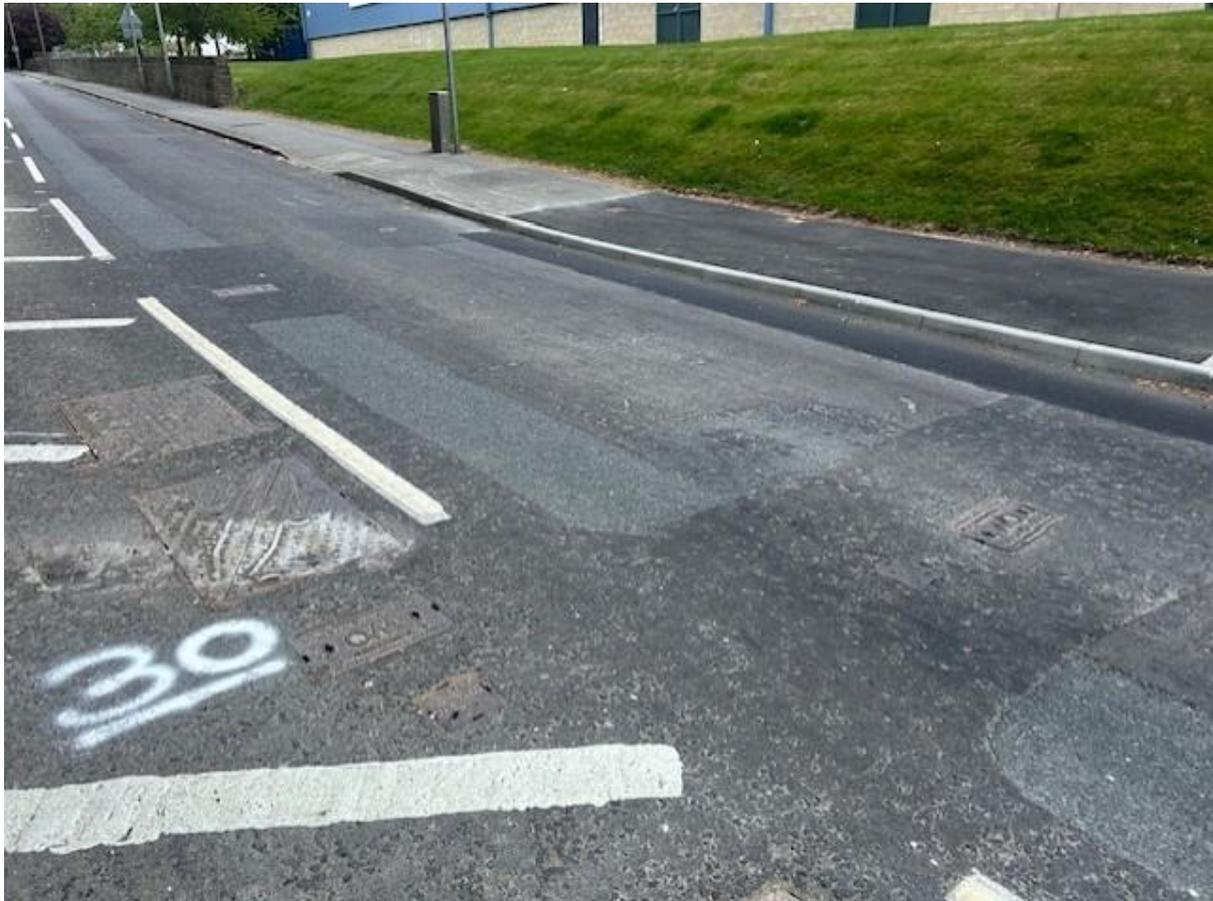
Comment – patchwork of trench reinstatements.

Recommendation – Highway Authority to monitor.

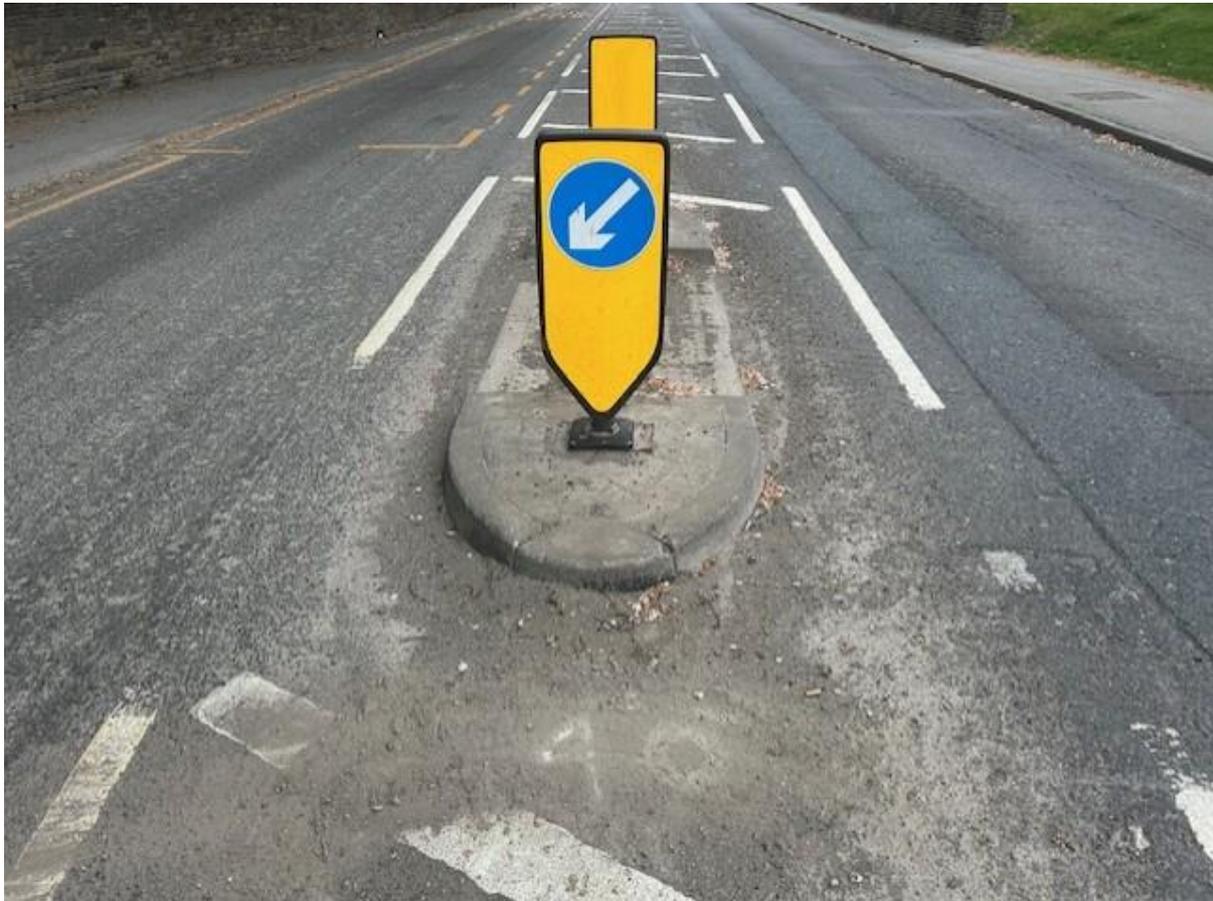
Comments – Carriageway surface requires a road sweeper.

Recommendation – Highway Authority initiate road sweeping.

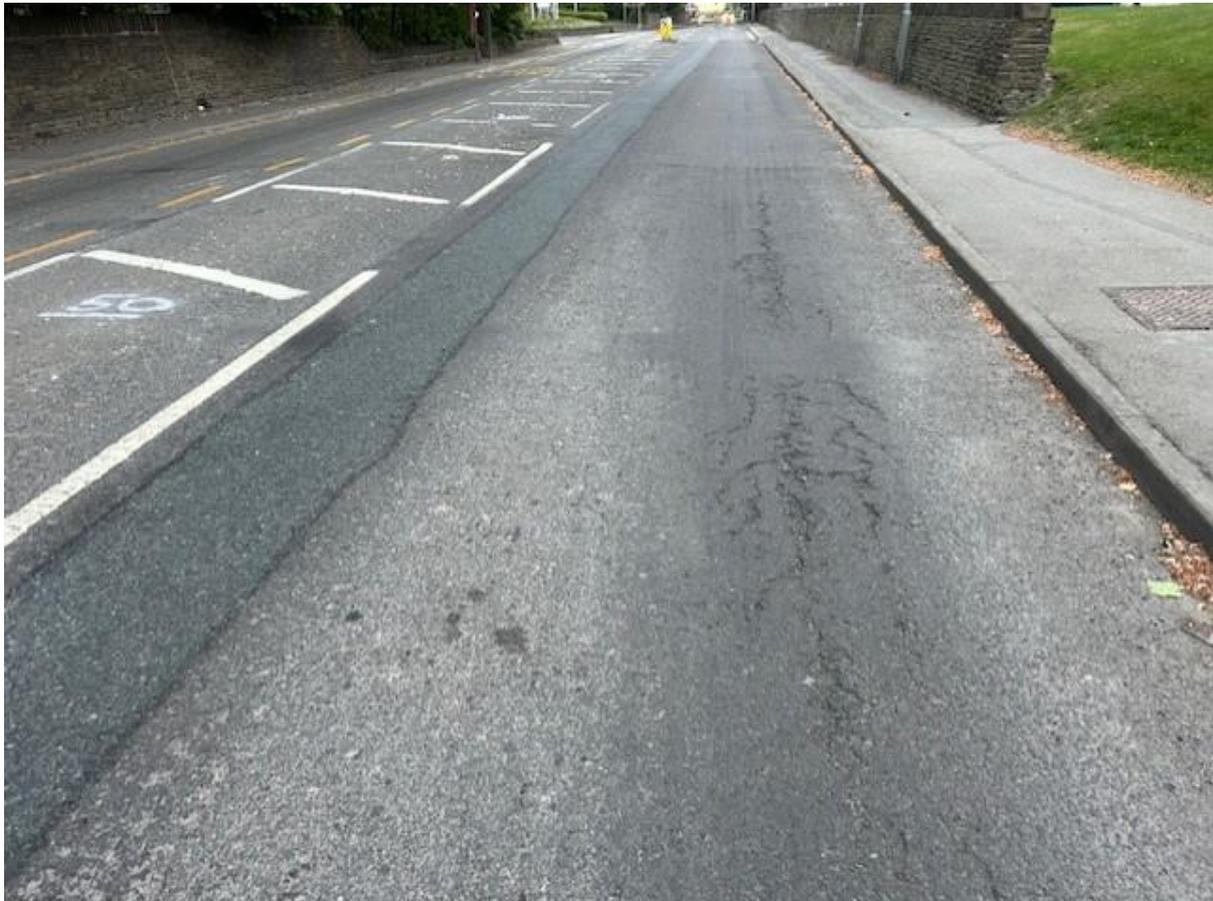
Comments – Surface course showing signs of tensile cracking along near side wheel track on south side of carriageway.

Recommendation – Highway Authority to monitor.

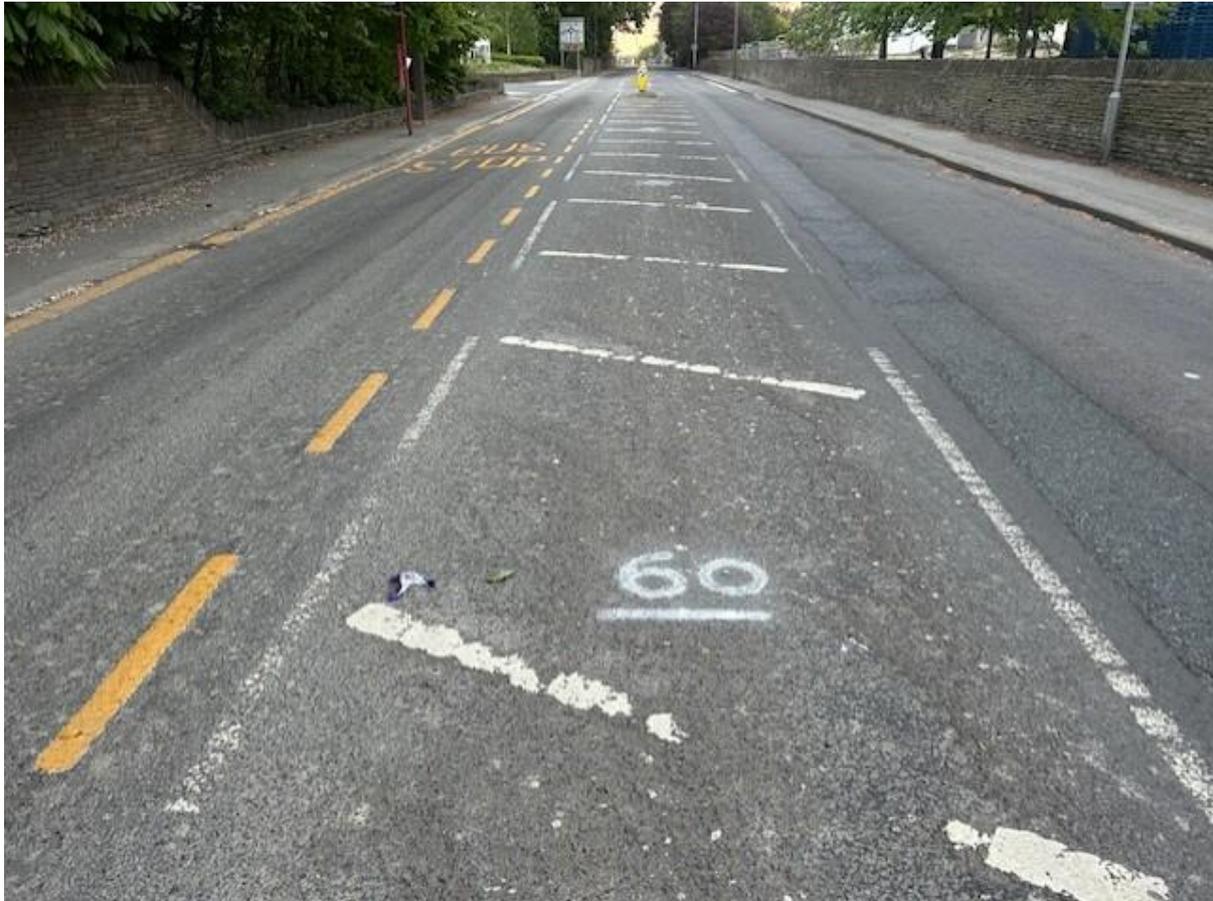
Comments – surface course requires road sweeping. Carriageway markings showing signs of wear.

Recommendation – Highway Authority to initiate Road Sweep.

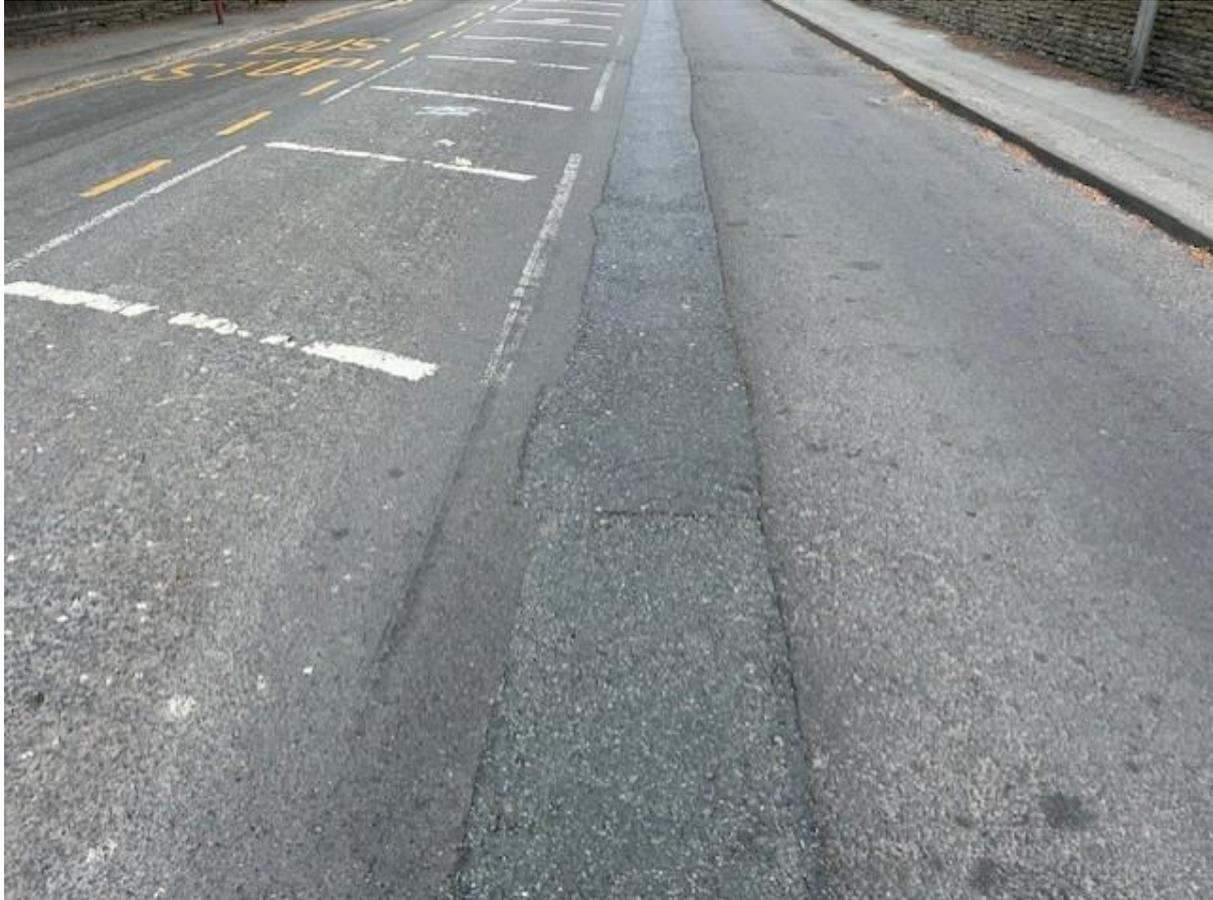
Comments – more detail of trench reinstatement showing some minor settlement.

Recommendation – Highway Authority to monitor.

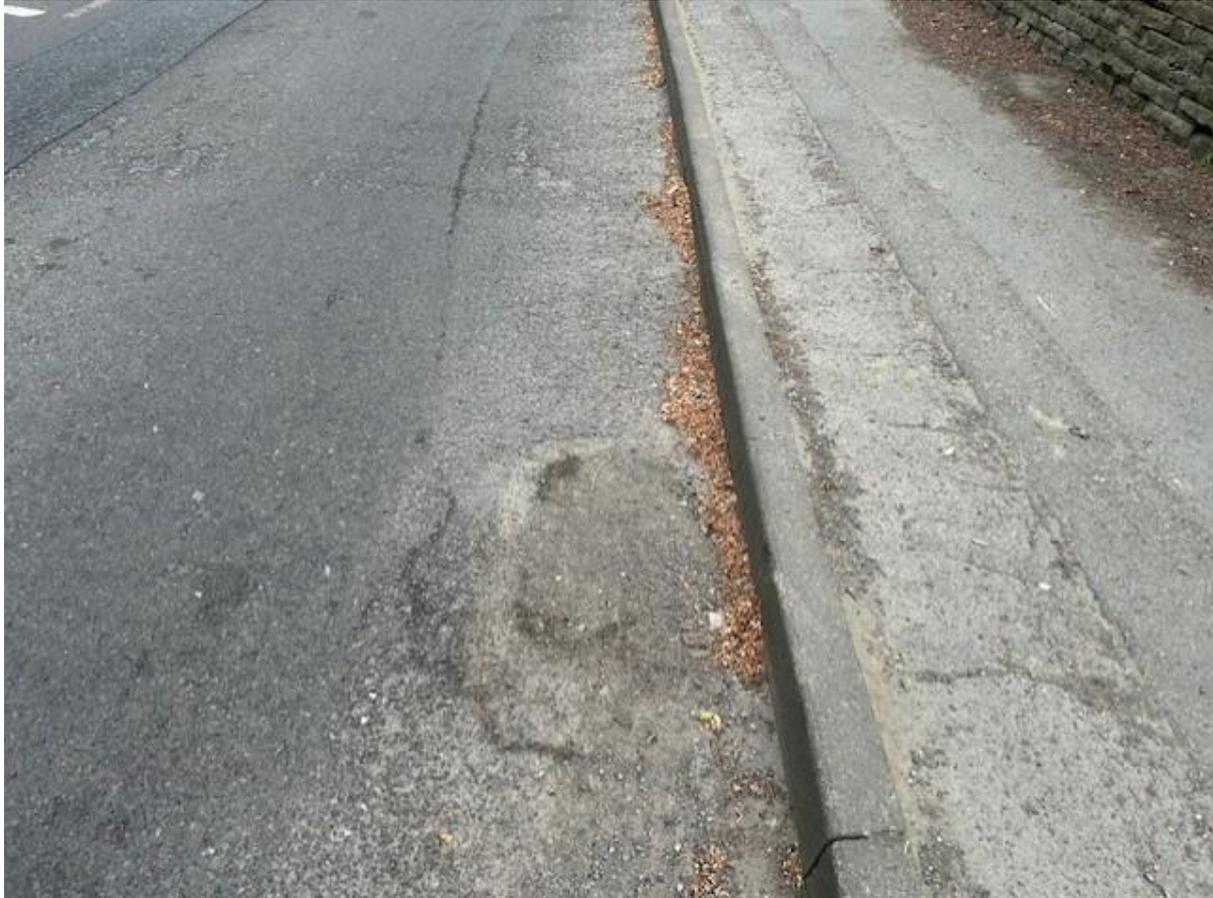
Comments – would suggest previously a surface water gully chamber has been covered over. Some signs of surface course settlement causing tensile cracking along the outline of the chamber.

Recommendation – Highway Authority to monitor.

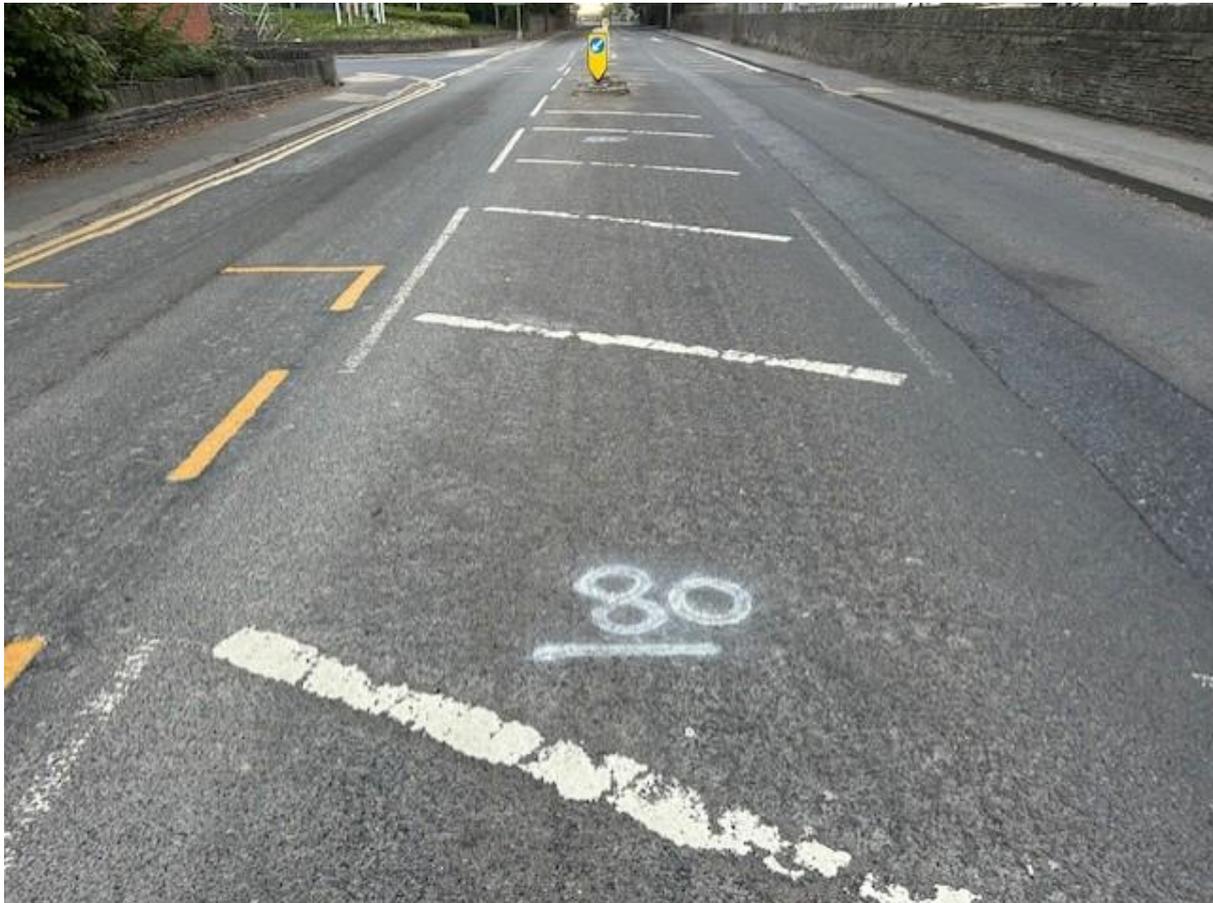
Comments – hazard warning lines worn on either side of carriageway. Trench reinstatement appears to have settled slightly.

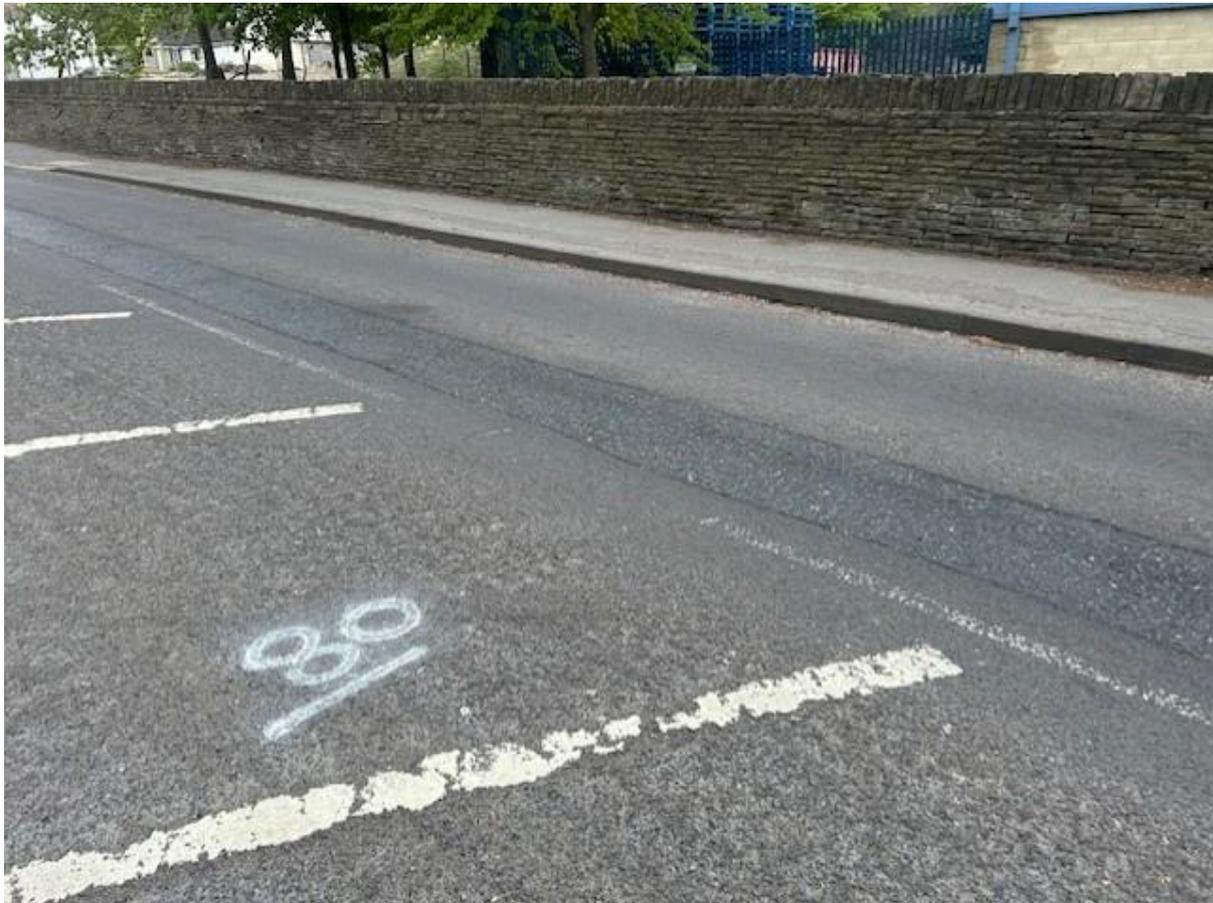
Comments – trench reinstatement may require attention.

Recommendation – Highway Authority to monitor.

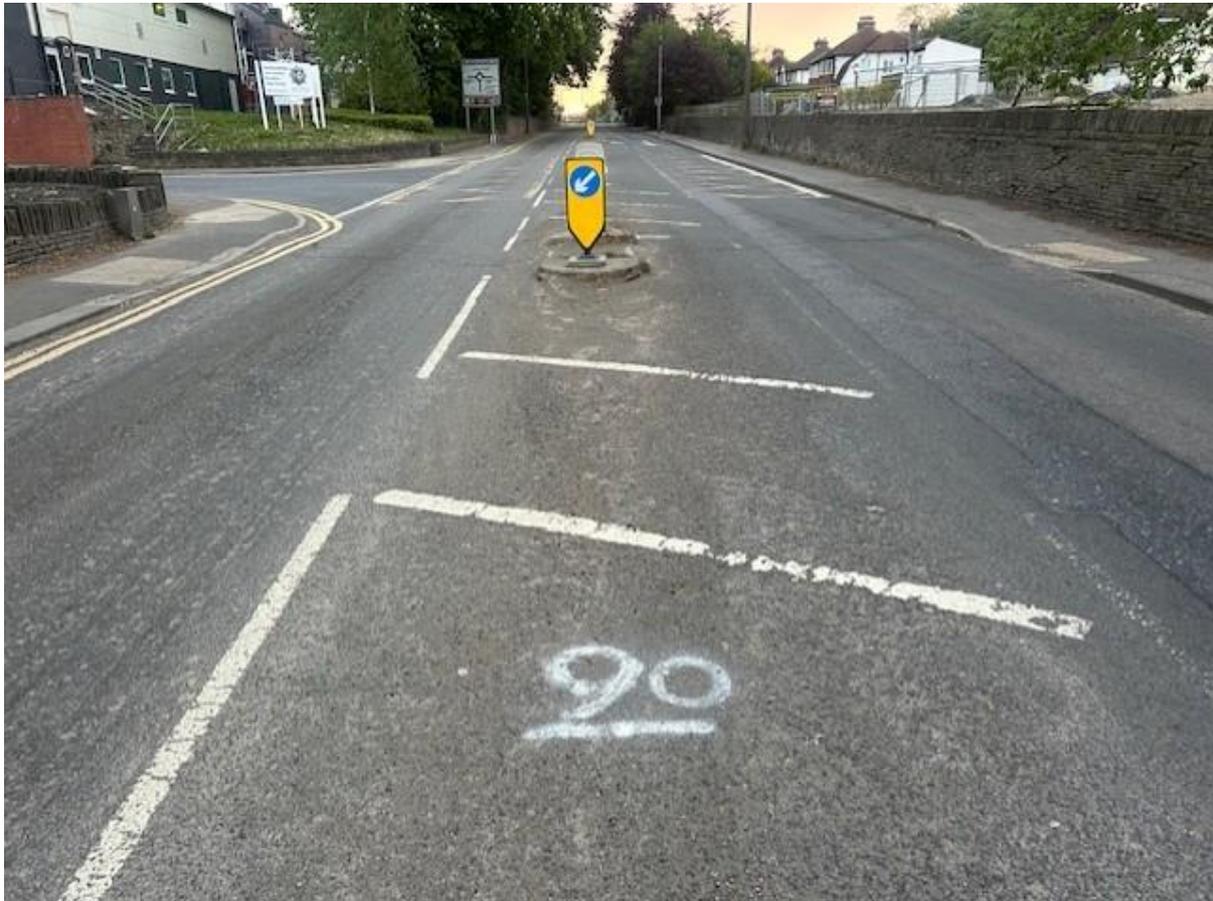
Comments – Hazard warning lines worn on south side of carriageway. Trench reinstatement showing signs of early settlement.

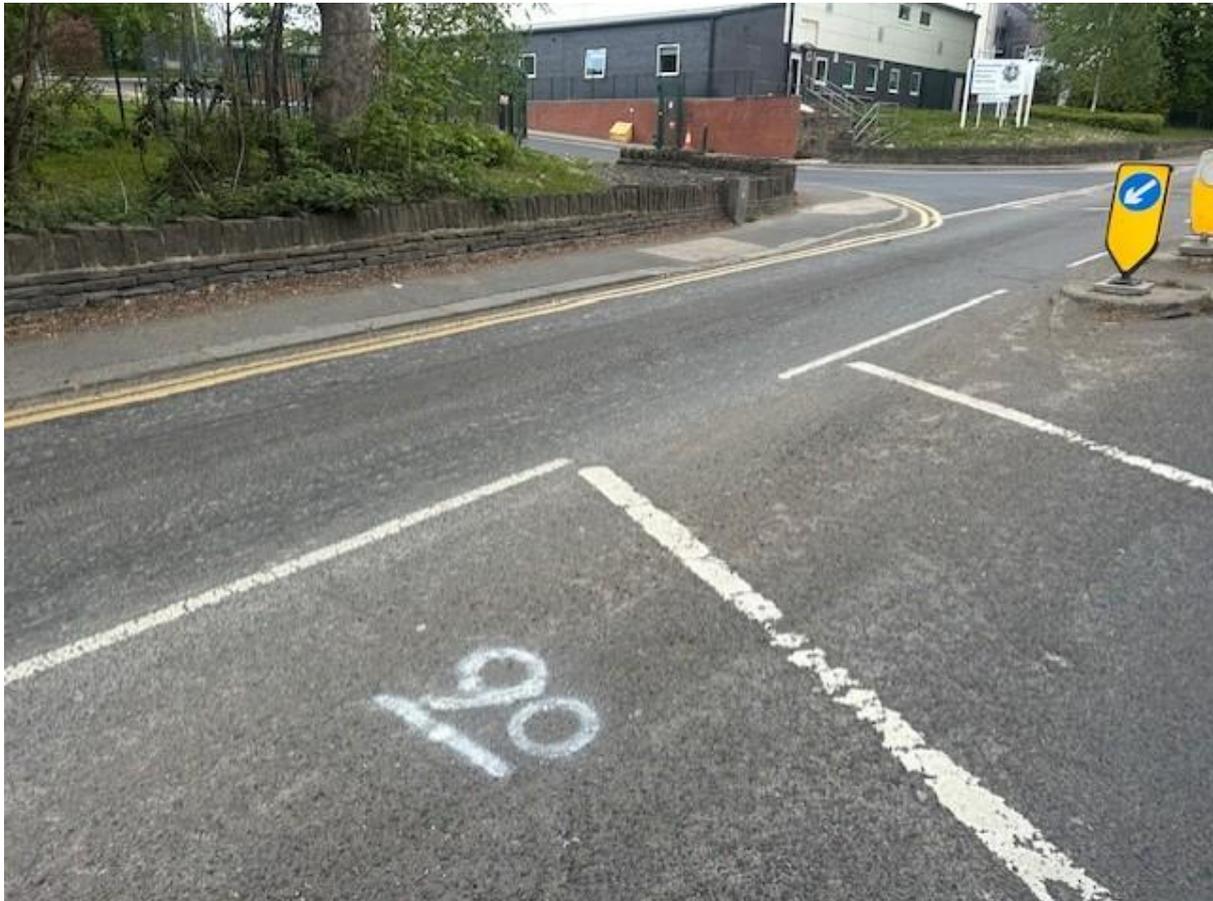
Comments – surface course becoming polished.

Recommendation – Highway Authority to monitor.

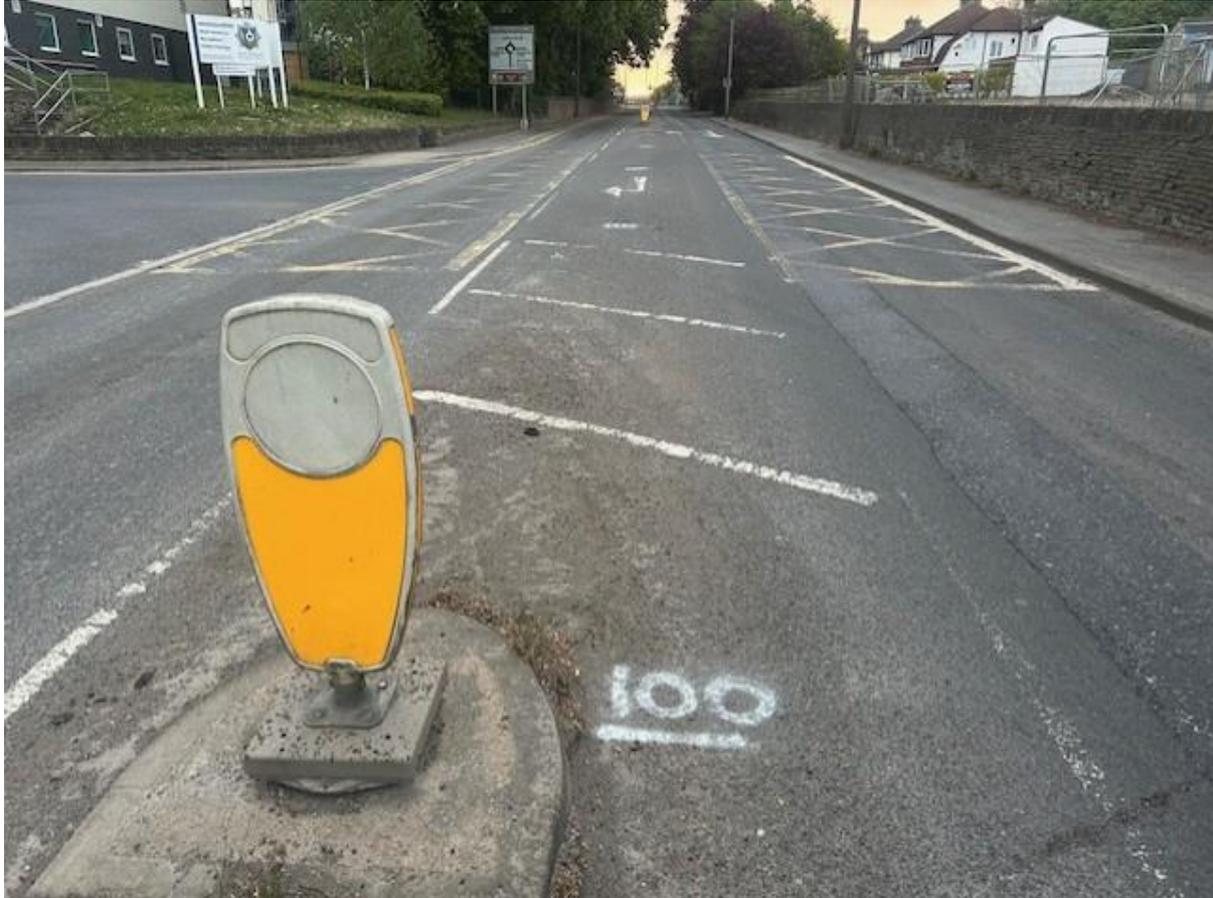
Comments – Road Sweeper required. Road marking starting to wear.

Recommendation – Highway Authority to initiate Road Sweeping.
