Condition Survey Report

Whitehall Road West, Birkenshaw.

May 2025

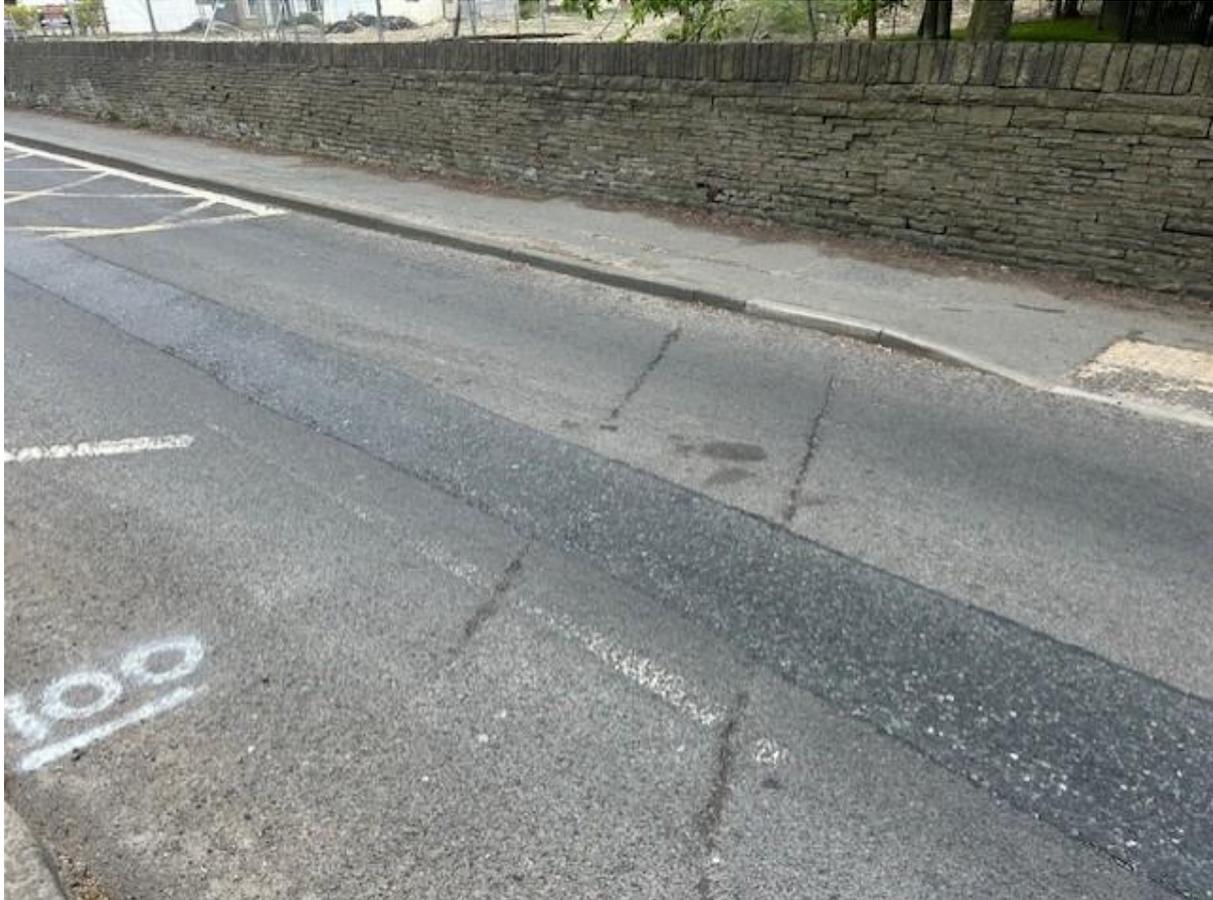
Comments – gaps in the previous trench reinstatement starting to appear.

Recommendation – Highway Authority to monitor.

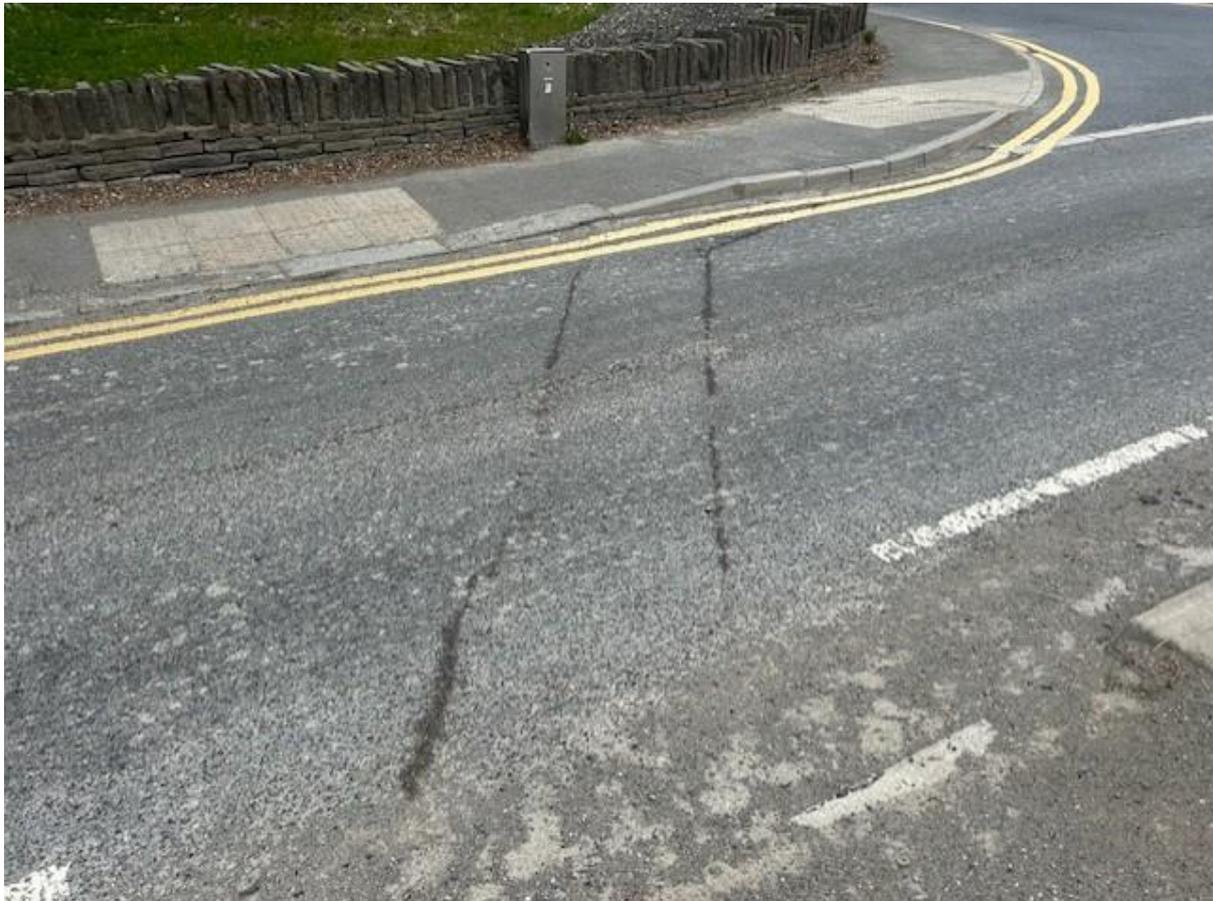
Comments – gaps in trench reinstatement starting to appear.

Recommendation – Highway Authority to monitor.

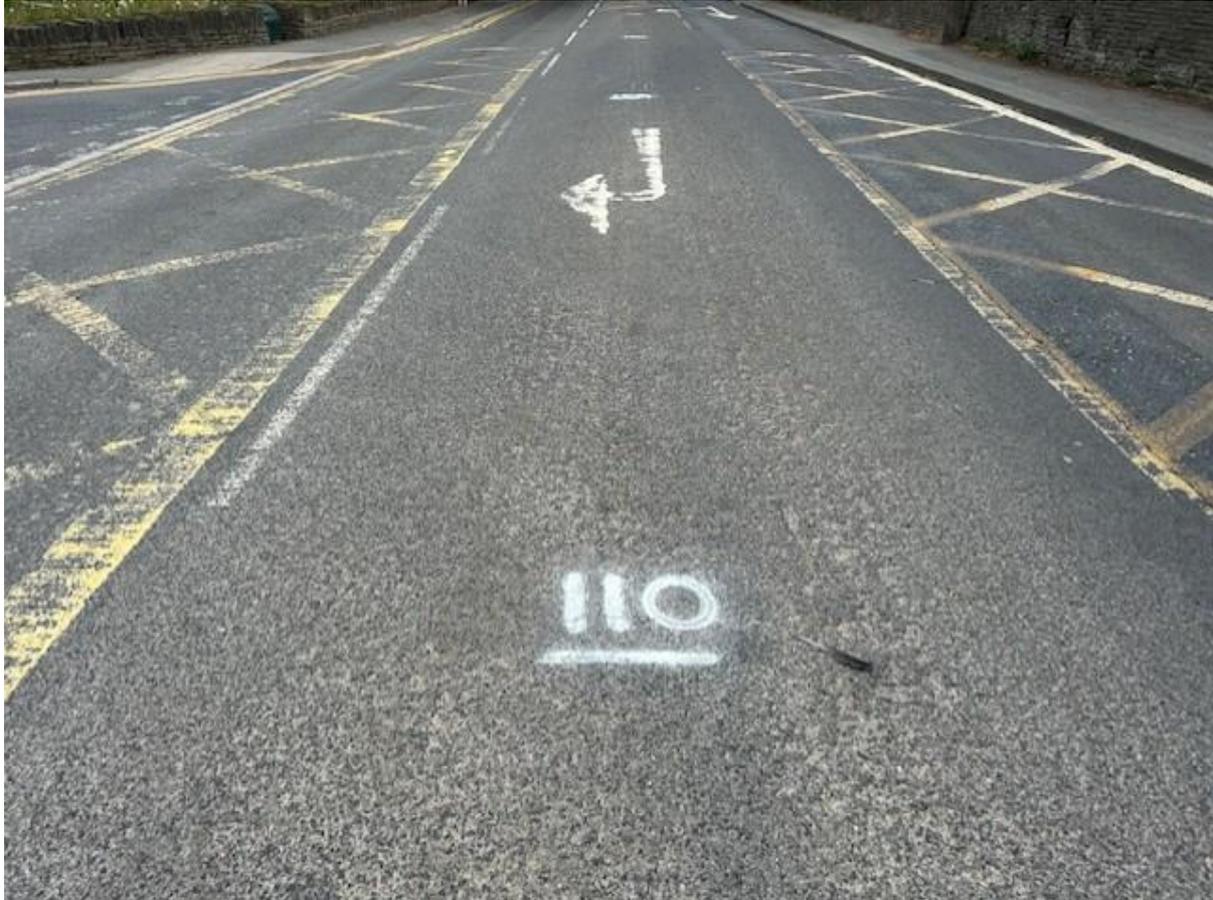
Comments – All carriageway markings suffering from premature wear because of heavy goods vehicles turning in and out of the Fire Service Headquarters.

Recommendation – Highway Authority to monitor.

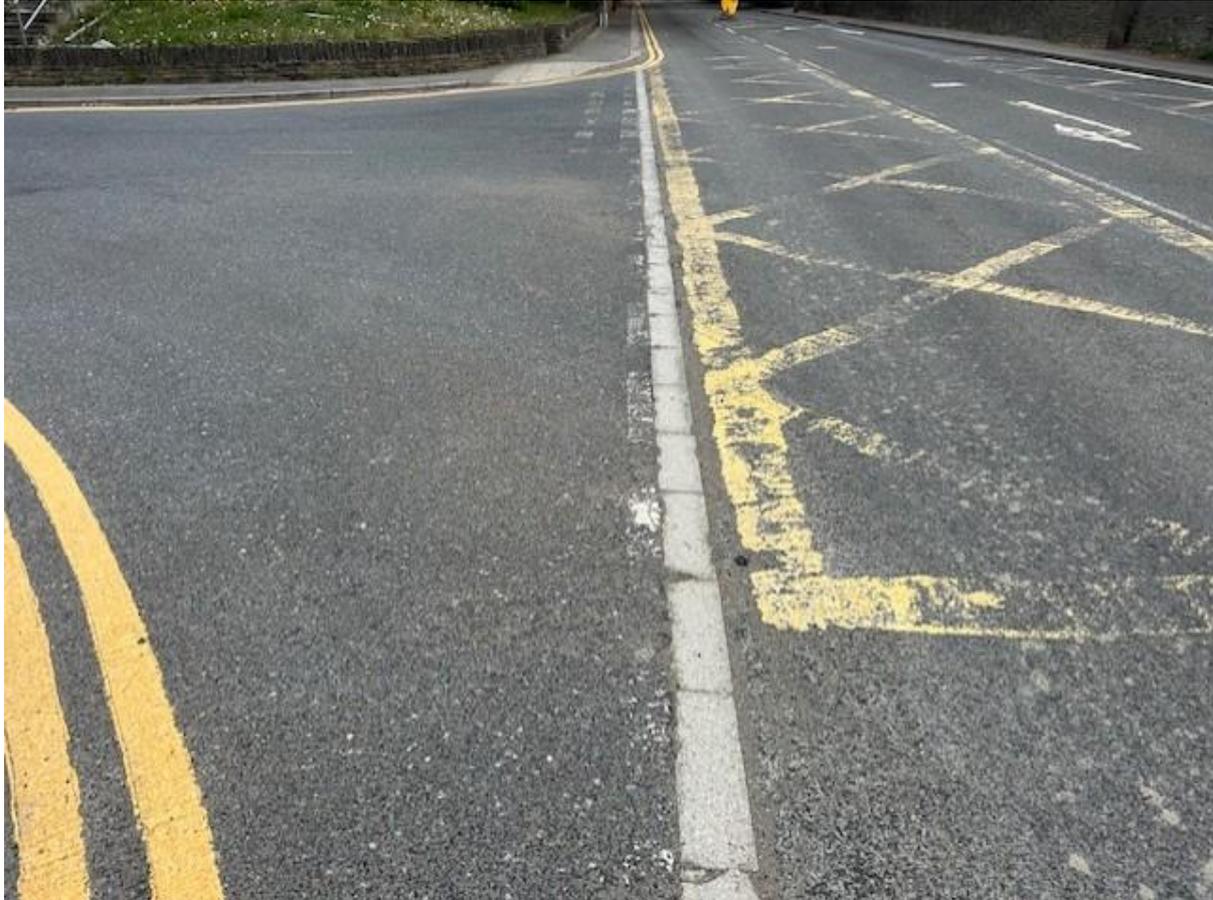
Comments = Existing drainage channel blocks are uneven. All centre line and give way markings from the Fire Service Headquarters heavily worn.

Recommendation – Highway Authority to monitor.

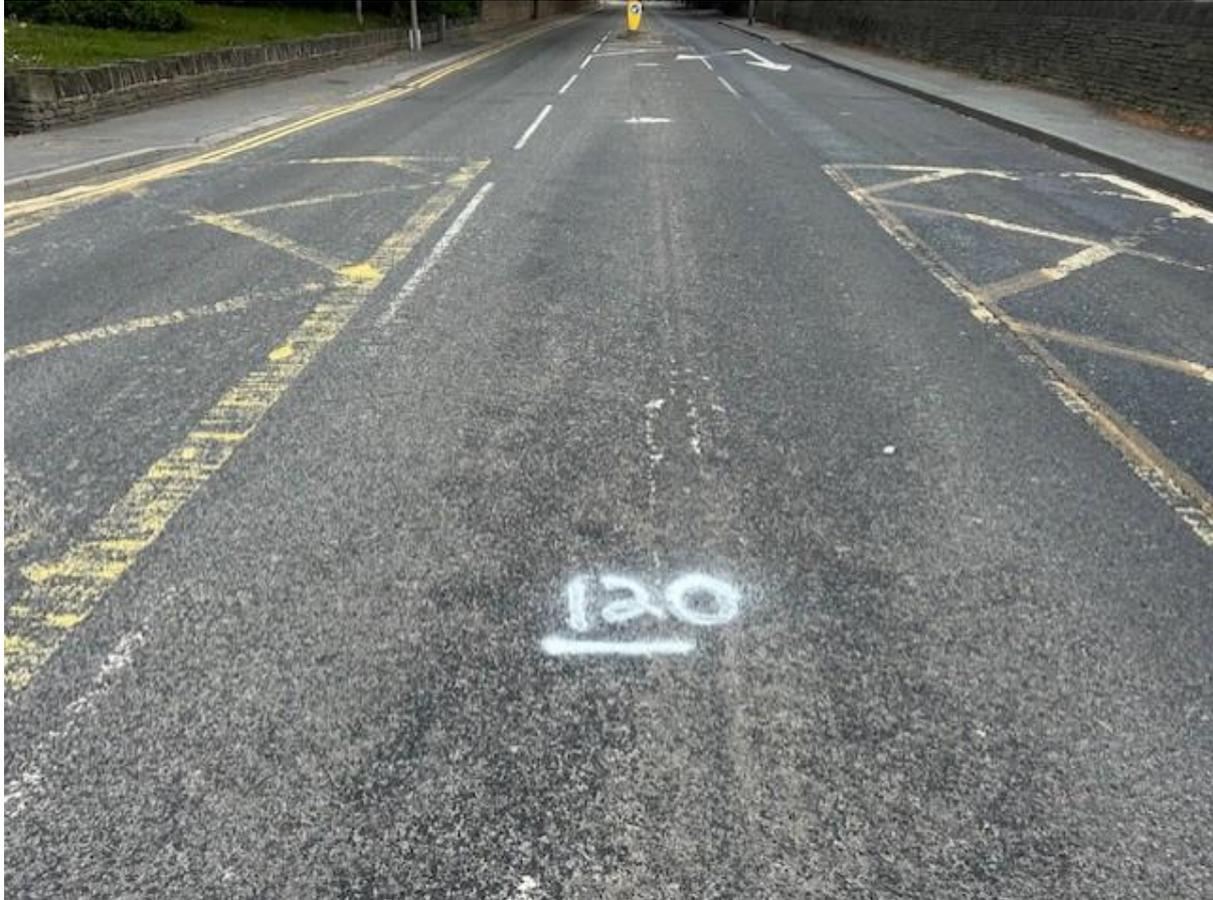
Comments – Surface course and road markings worn.

Recommendation – To be monitored by the Highway Authority.

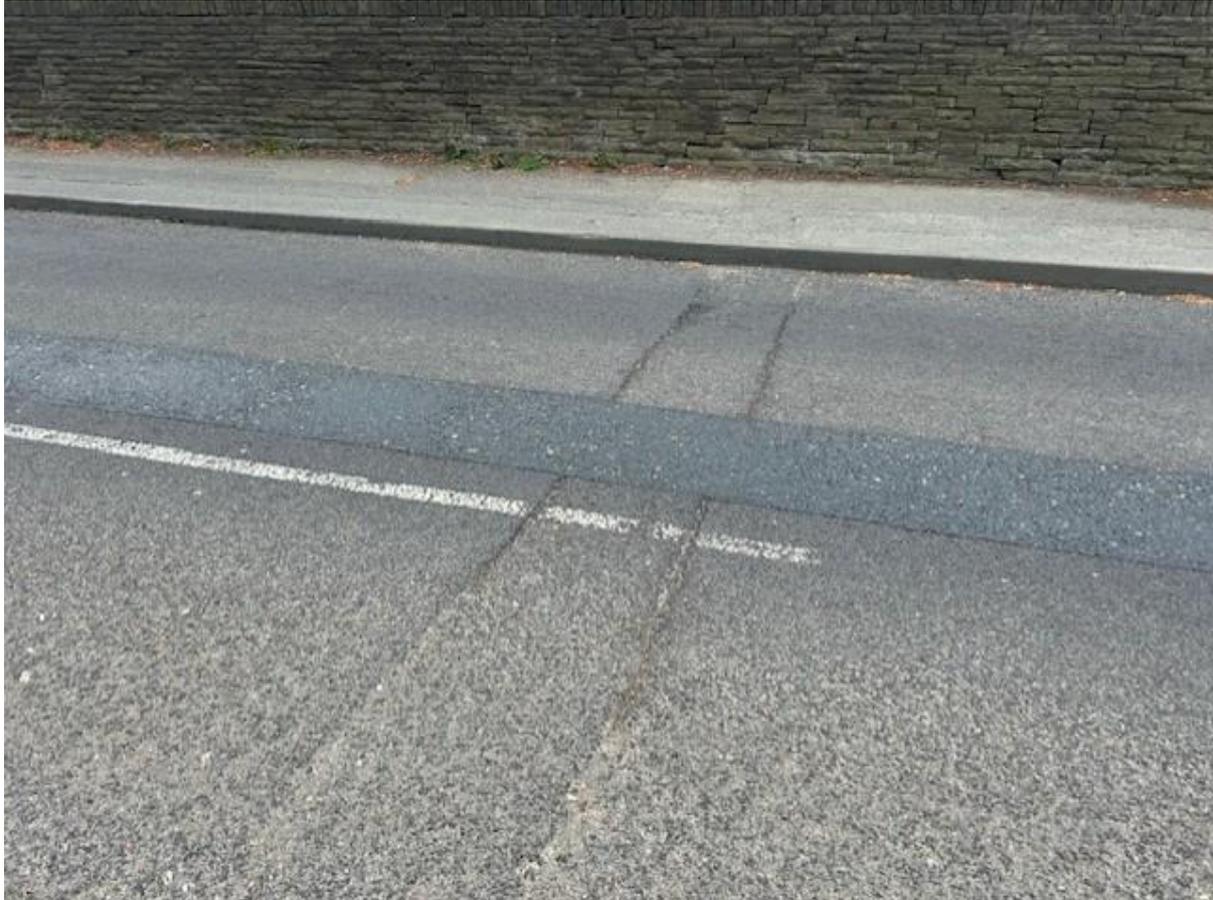
Comments – A more detailed photo of two trench reinstatements crossing each other. Note surface course gap starting to develop.

Recommendation – Highway Authority to monitor.

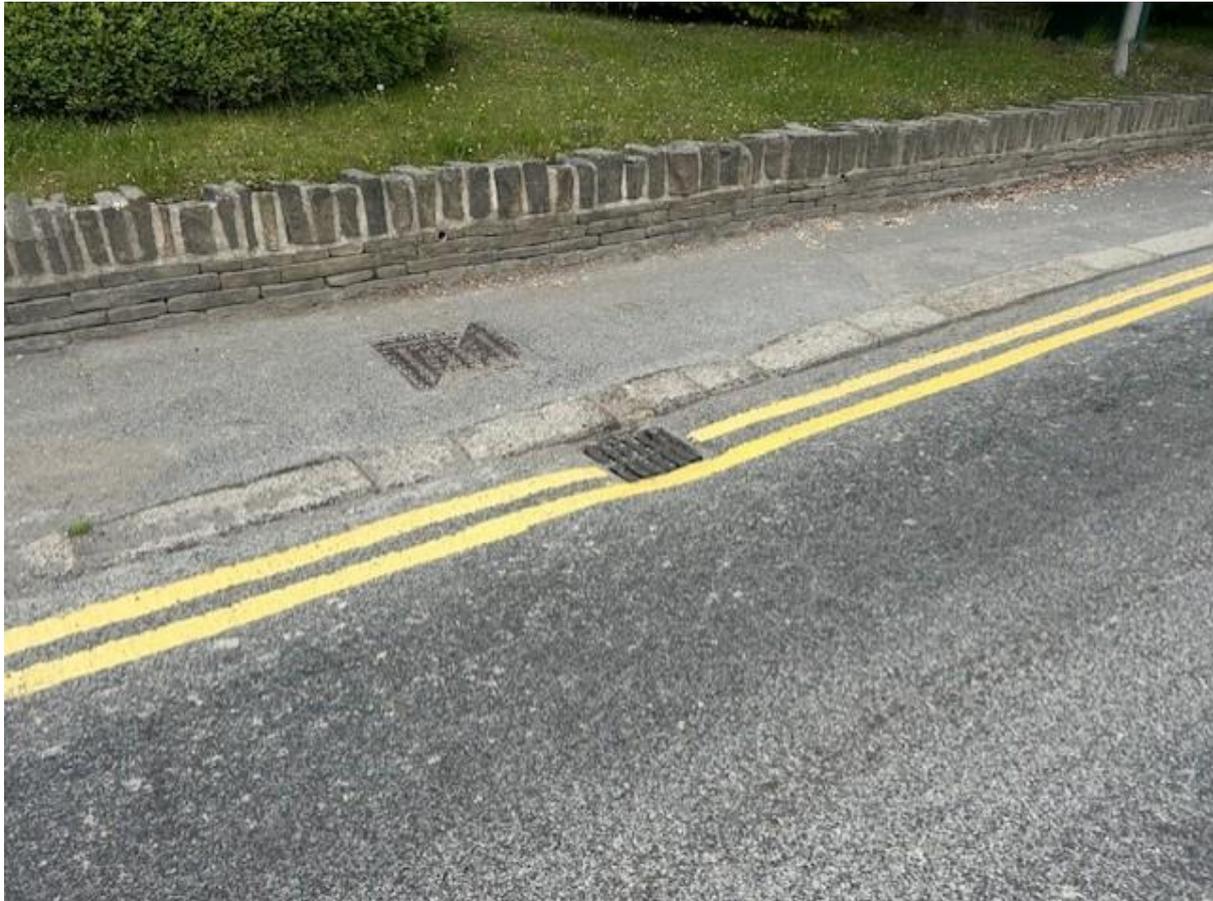
Comments – kerb line and carriageway showing signs of premature settlement.

Recommendation – Highway Authority to monitor.

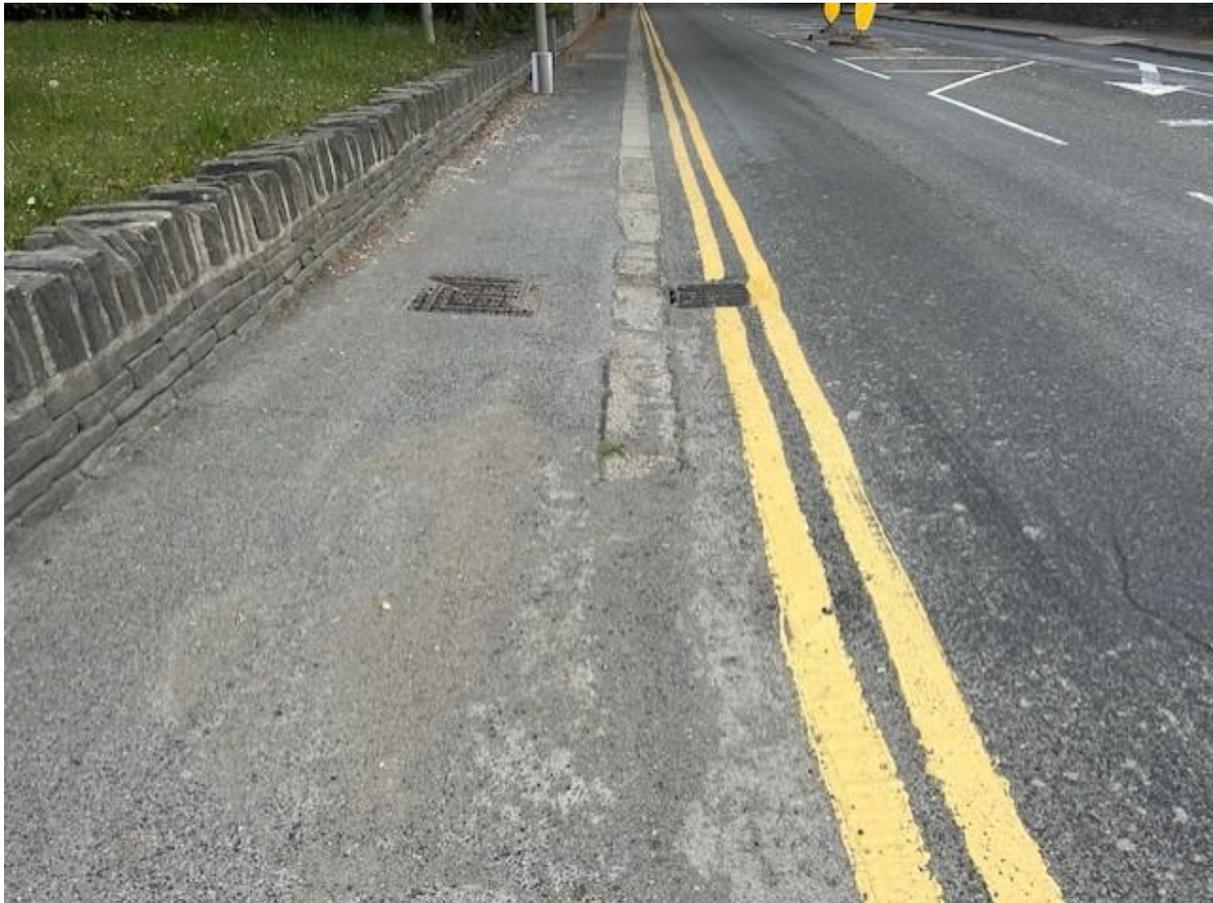
Comments – Signs of standing water where general detritus is gathering. Potential drainage problem with surface water.

Recommendation – Highway Authority to visit site in wet weather.

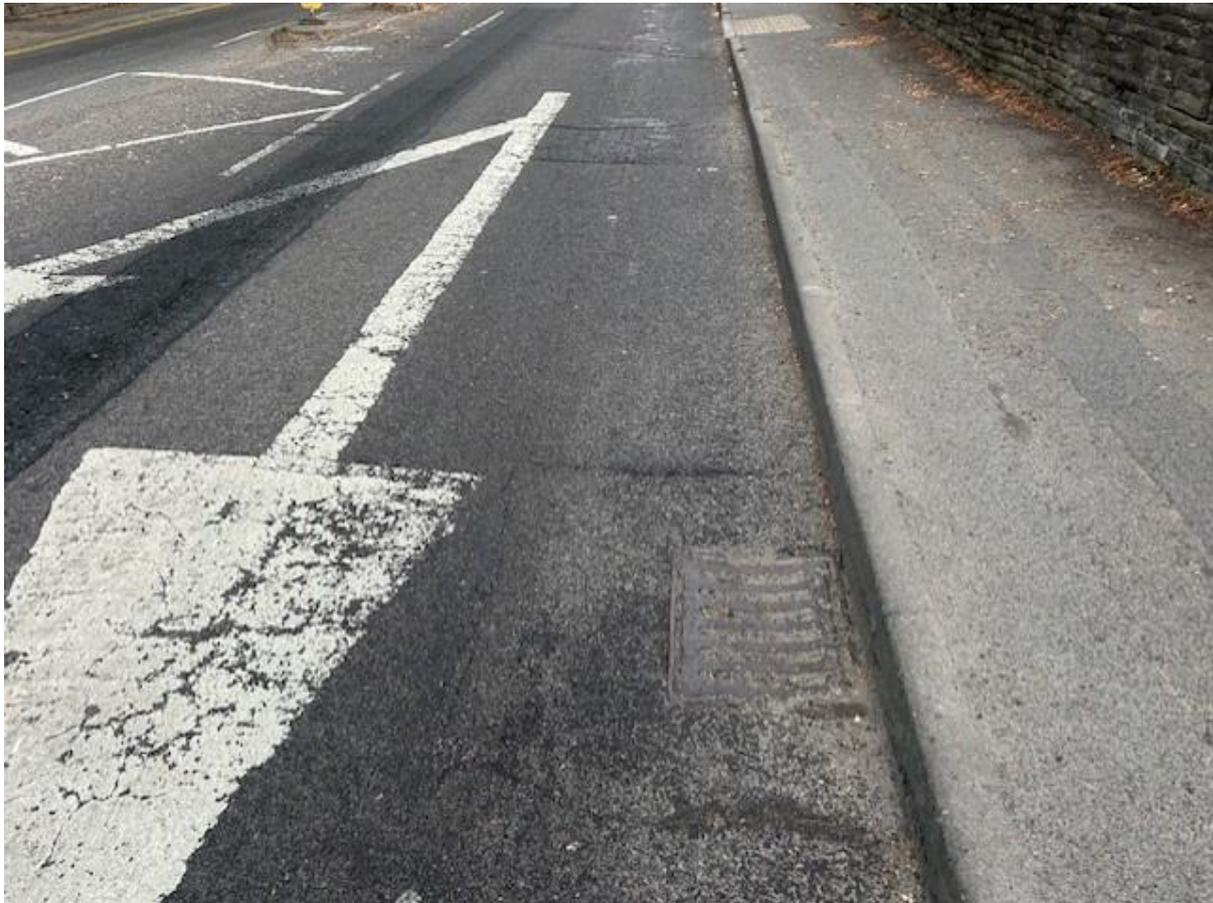
Comments – Surface water gully blocked.

Recommendation – Requires immediate attention by Highway Authority.

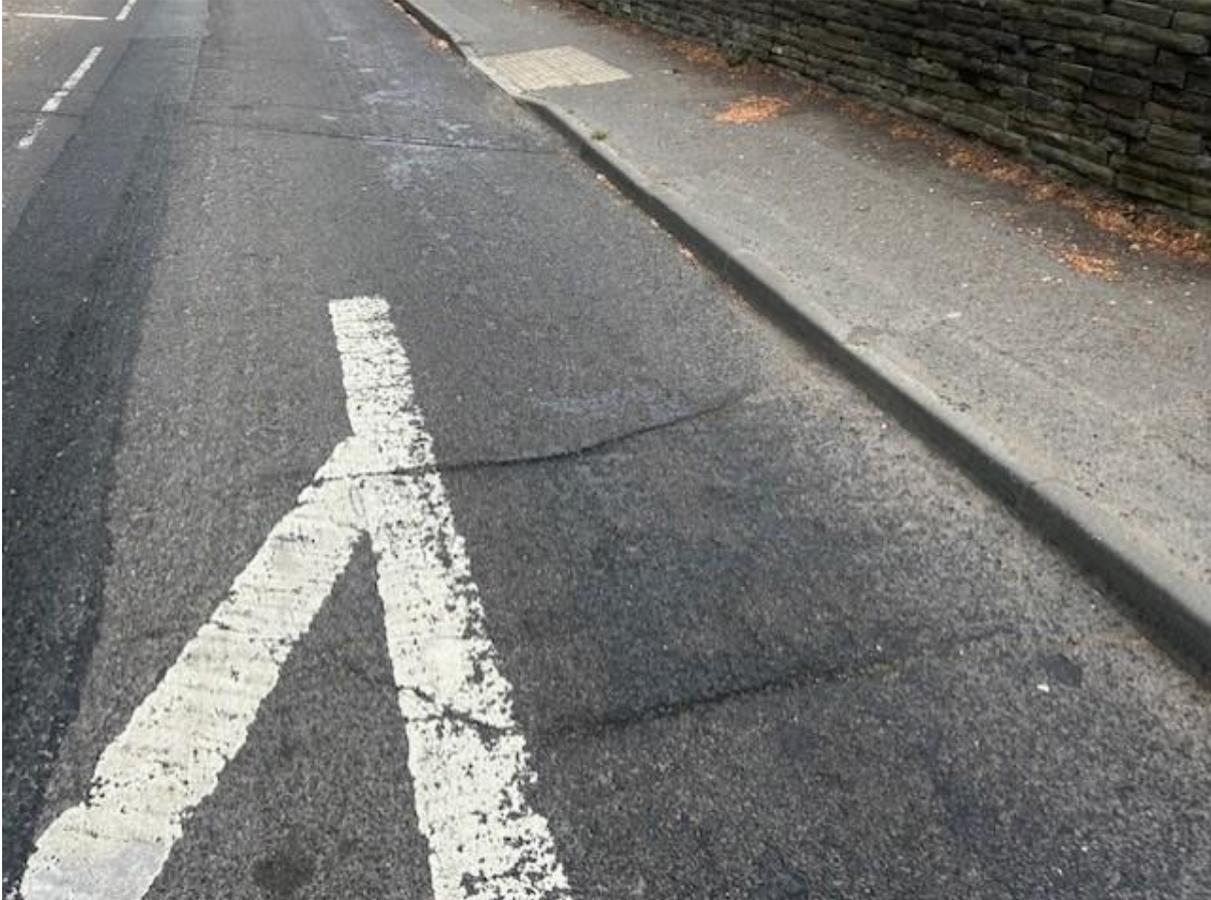
Comments – Signs of premature settlement causing tensile cracking of surface course.

Recommendation – Highway Authority to monitor.

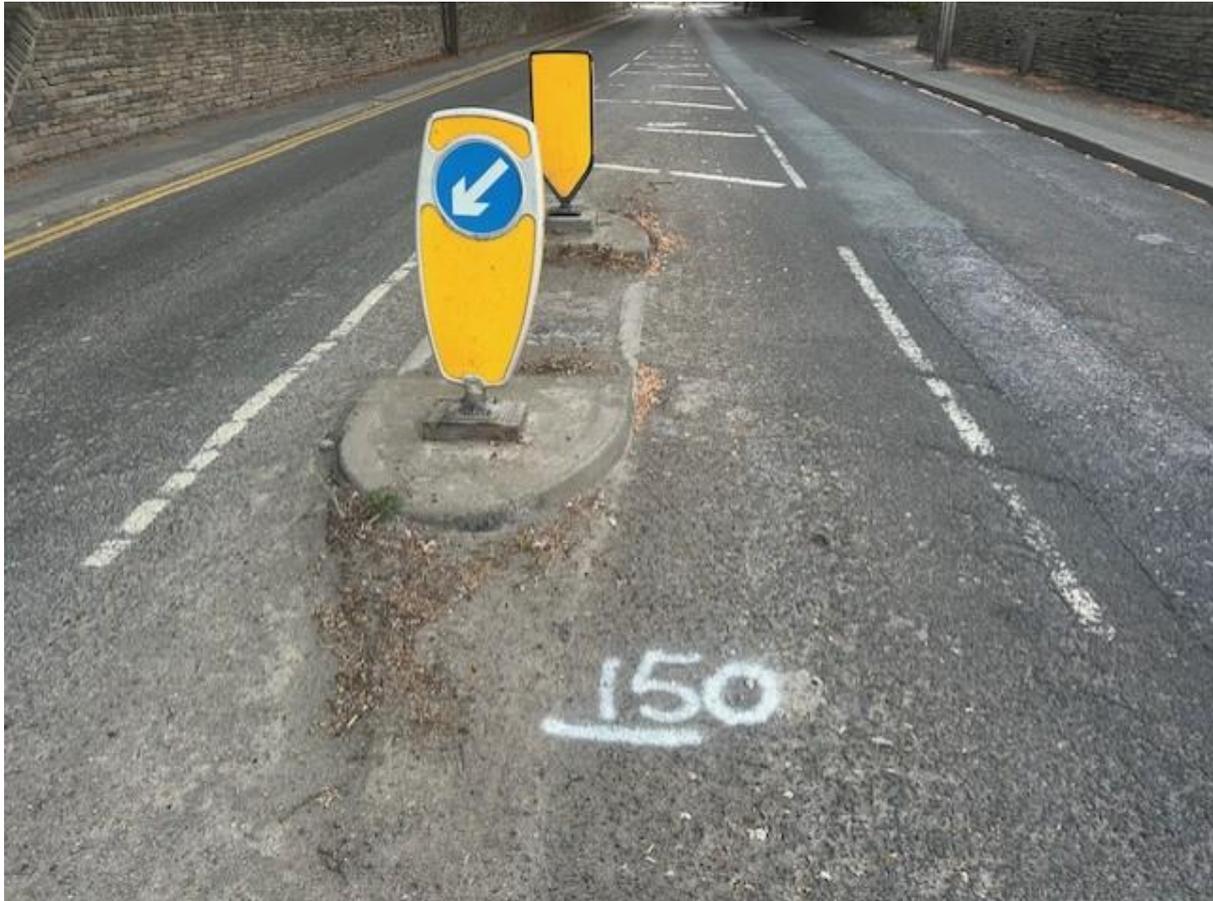
Comments – surface in need of road sweeping.

Recommendation Highway Authority to initiate Road Sweep.

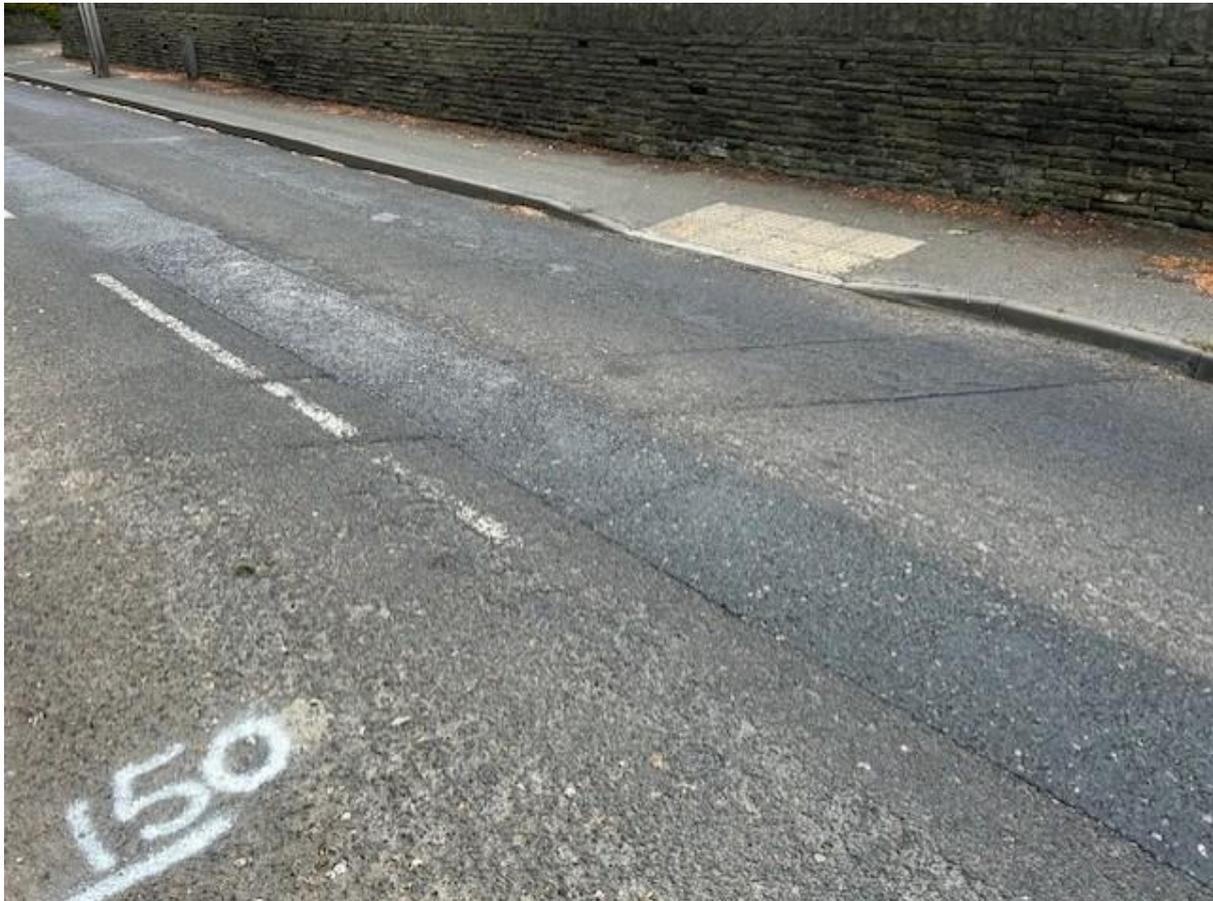
Comments – Trench reinstatements cross each other. Some signs of gaps in surface course starting to develop.

Recommendation – Highway Authority to monitor.

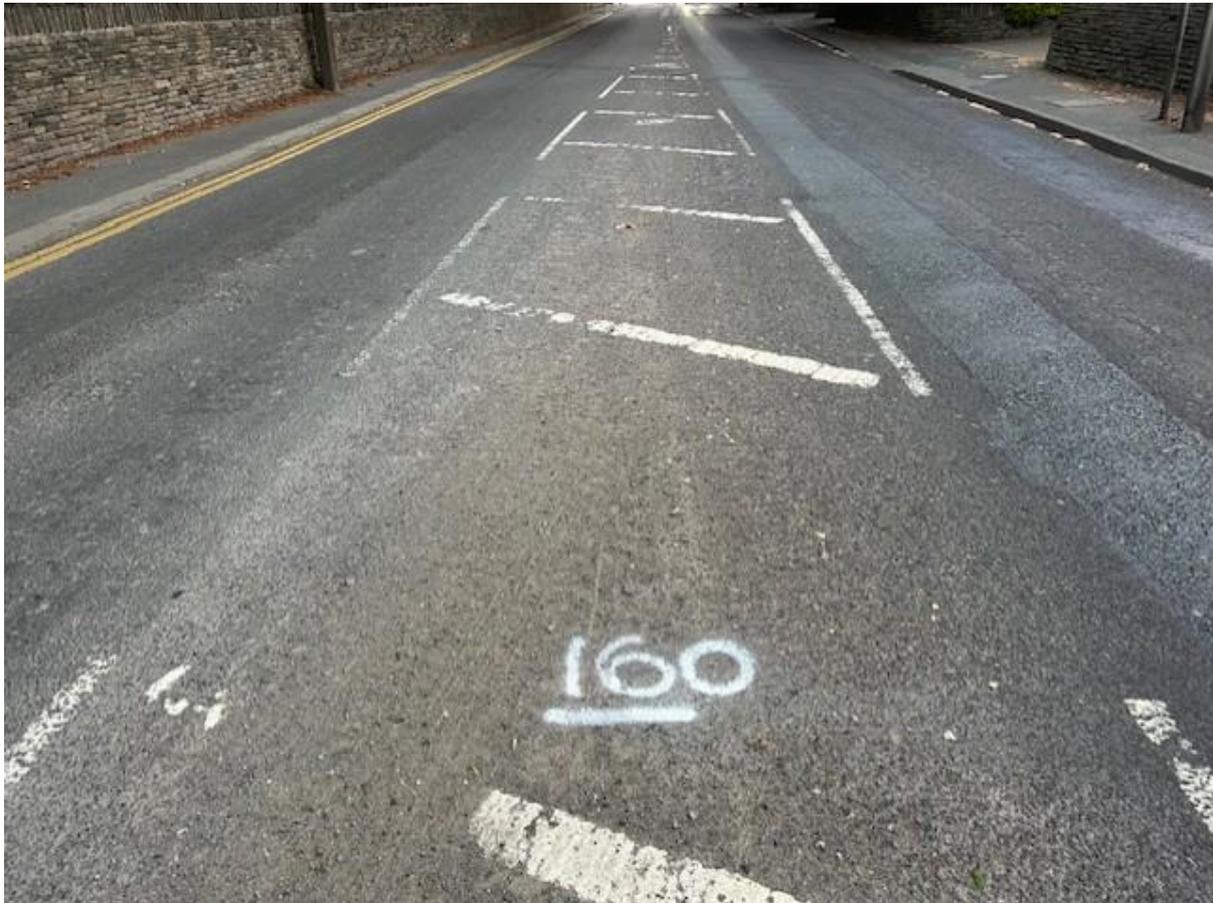
Comments – Hazard warning lines worn.

Recommendation – Highway Authority to monitor.

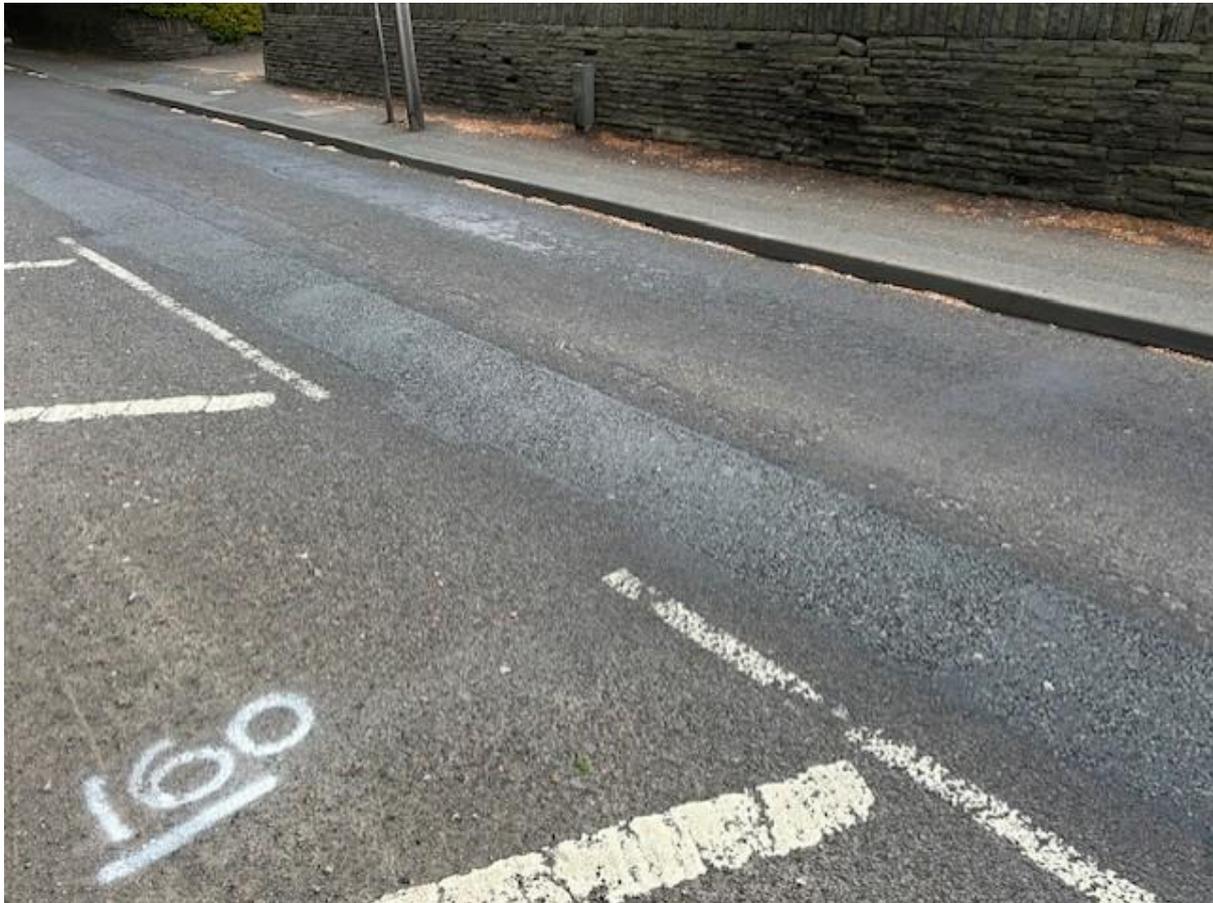
Comments – Surface course / drainage channel is uneven on south side of carriageway edge.

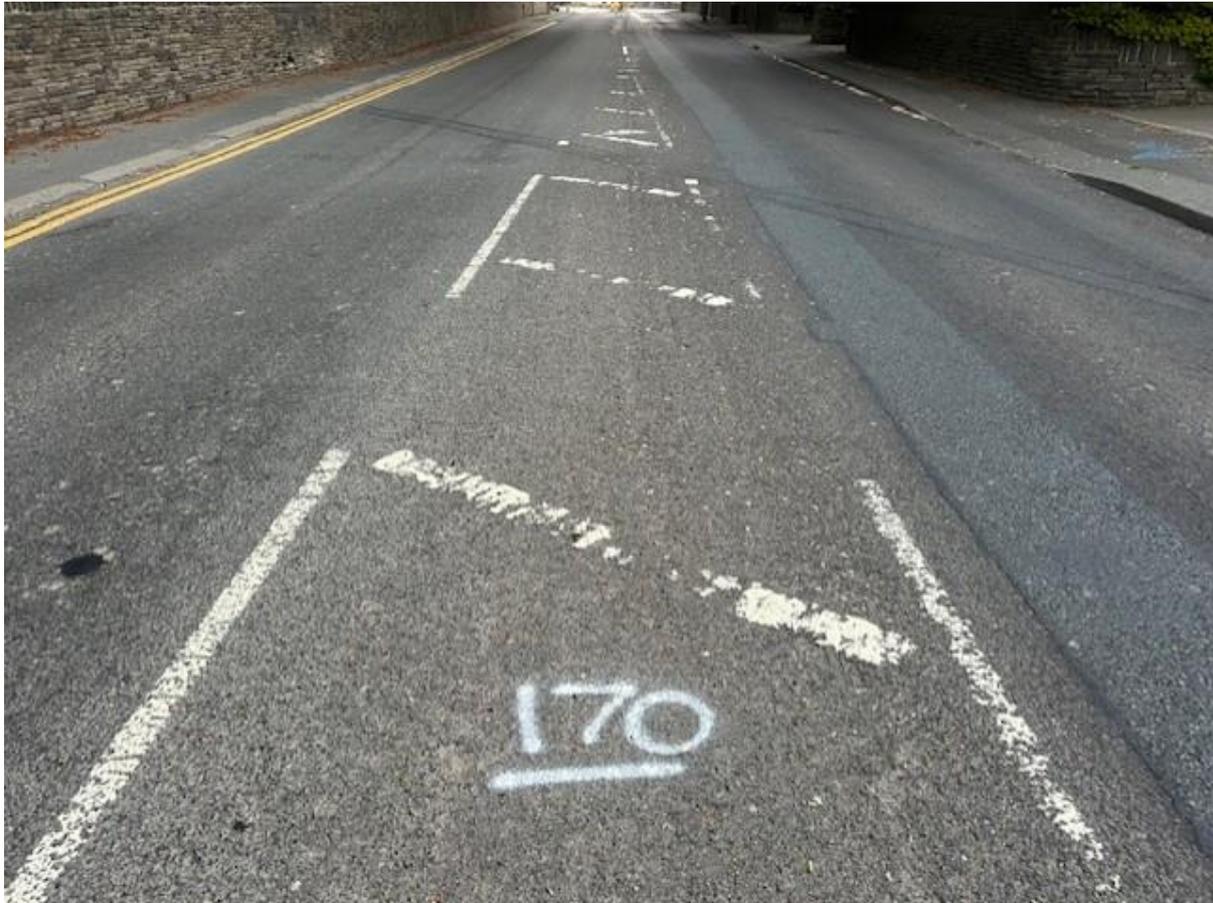
Comments – Road markings worn. Trench reinstatement cross each other at Ch 173m onwards.

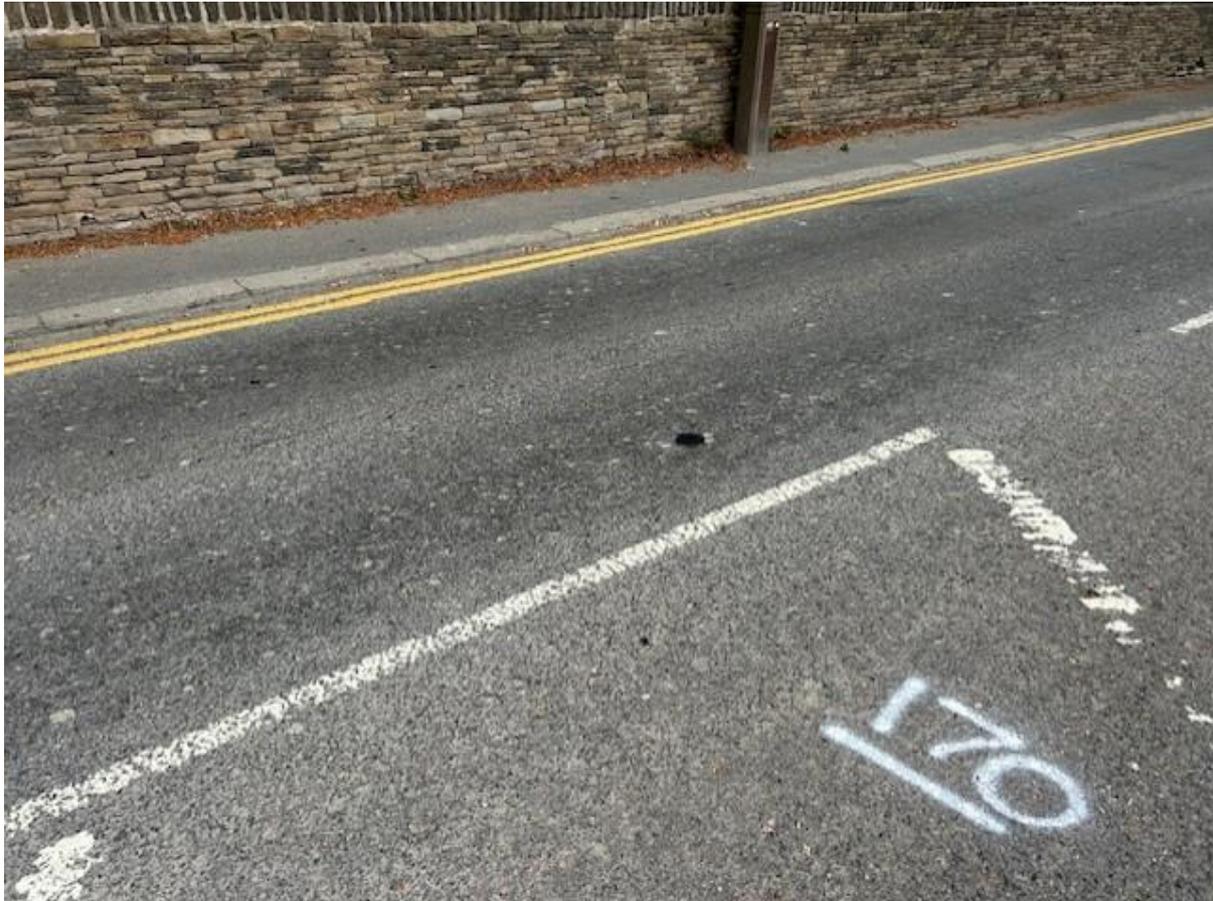
Comments – Minor defect in surface course at ch171m.

Recommendation – Highway Authority to monitor.

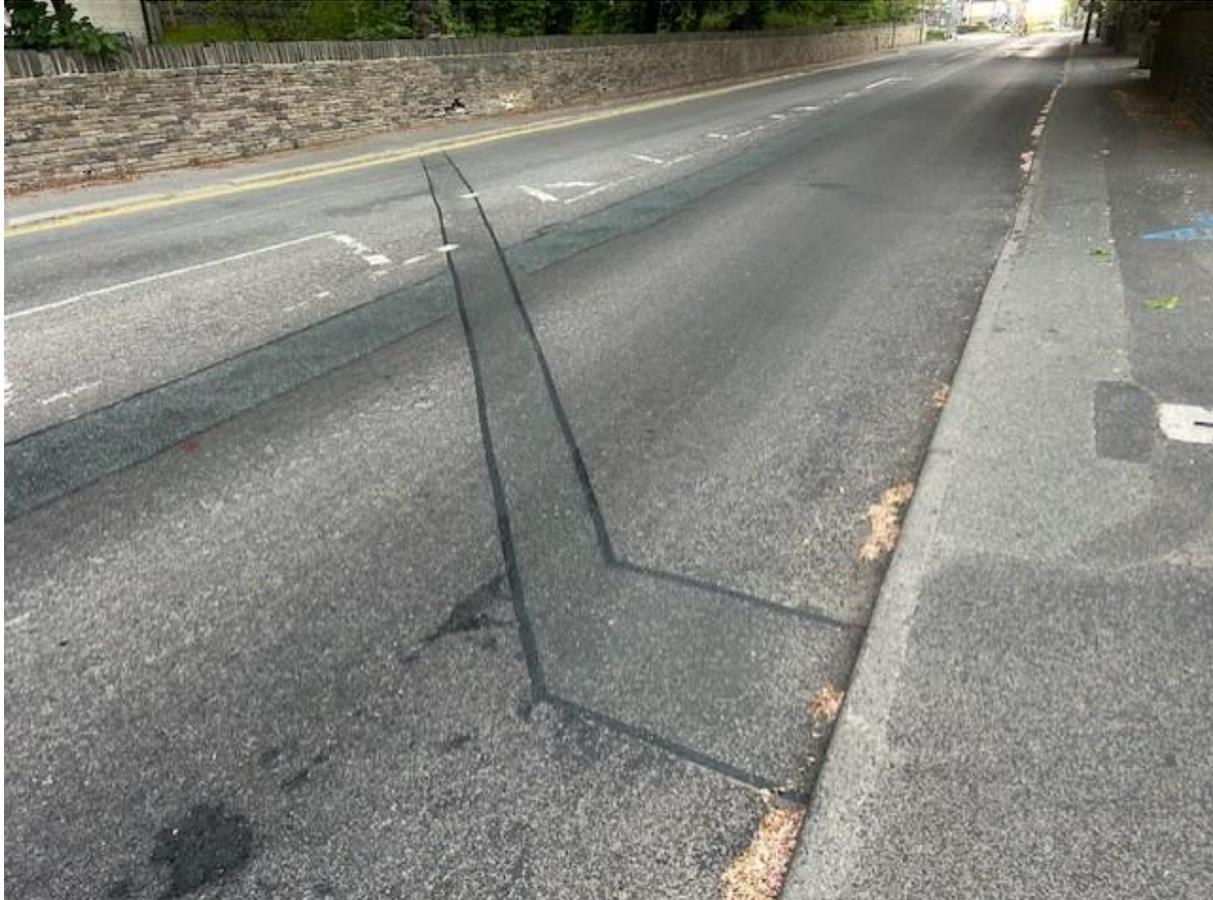
Comments – Diagonal trench reinstatement crosses full width of carriageway.

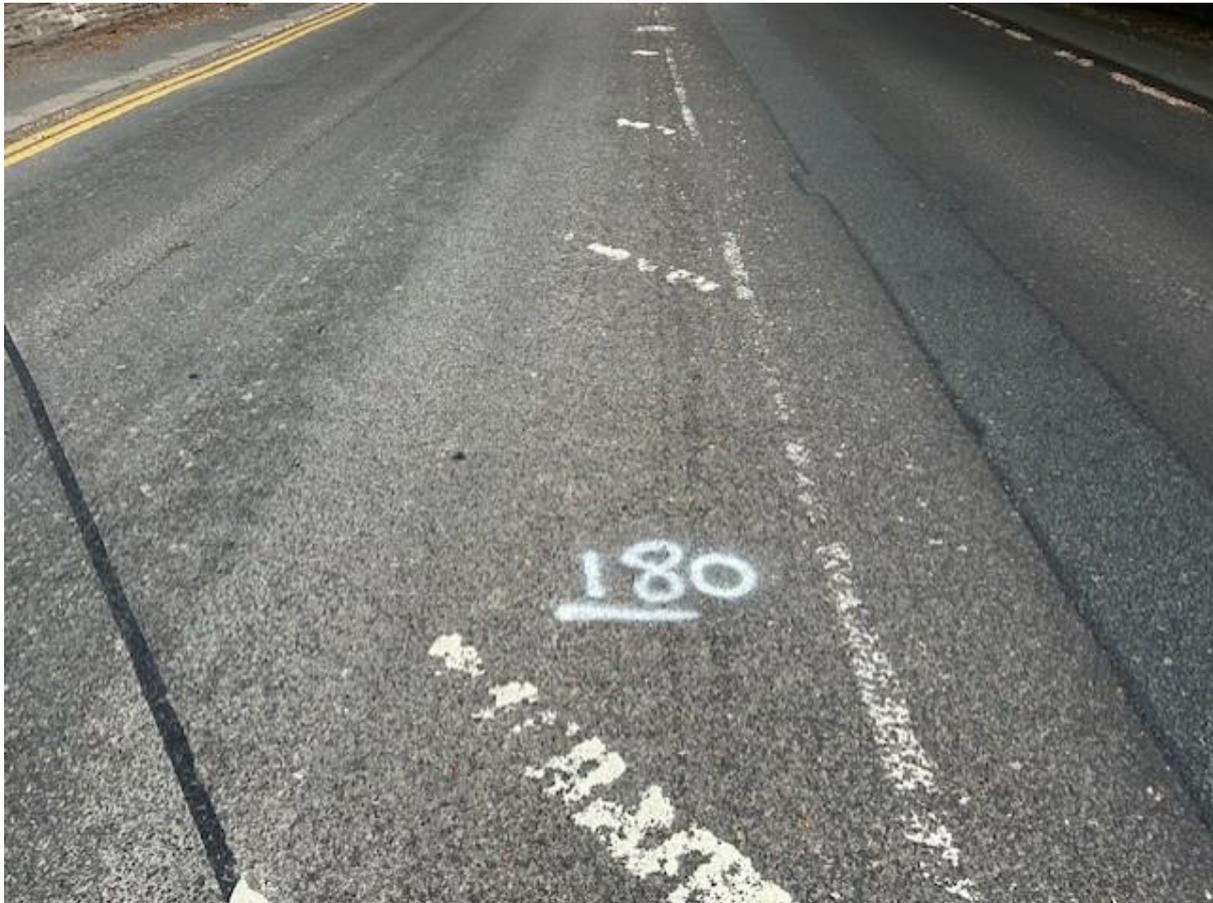
Comments – Road markings worn. Trench reinstatement continues along southern lane of carriageway.

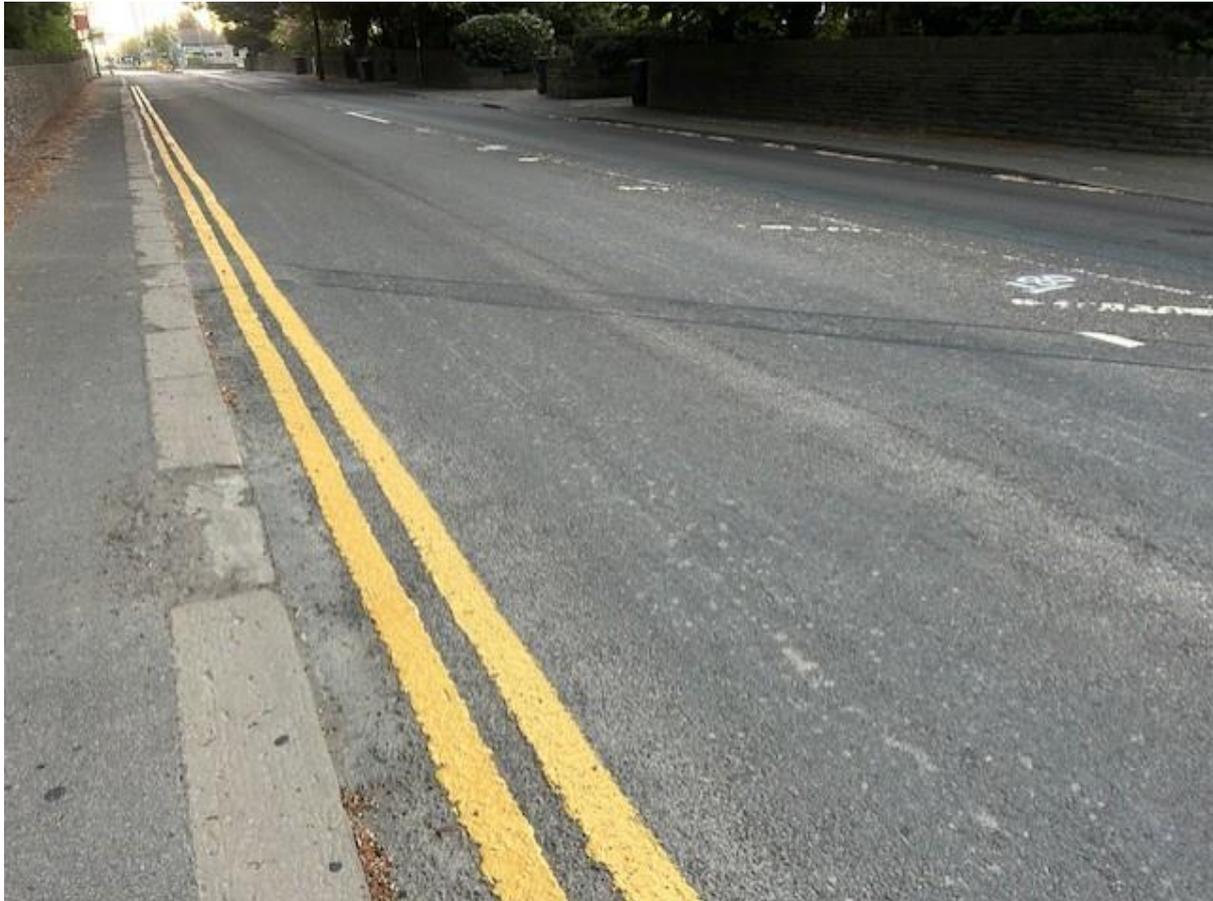
Comments – damaged kerbstone.

Recommendation – Highway Authority to replace.

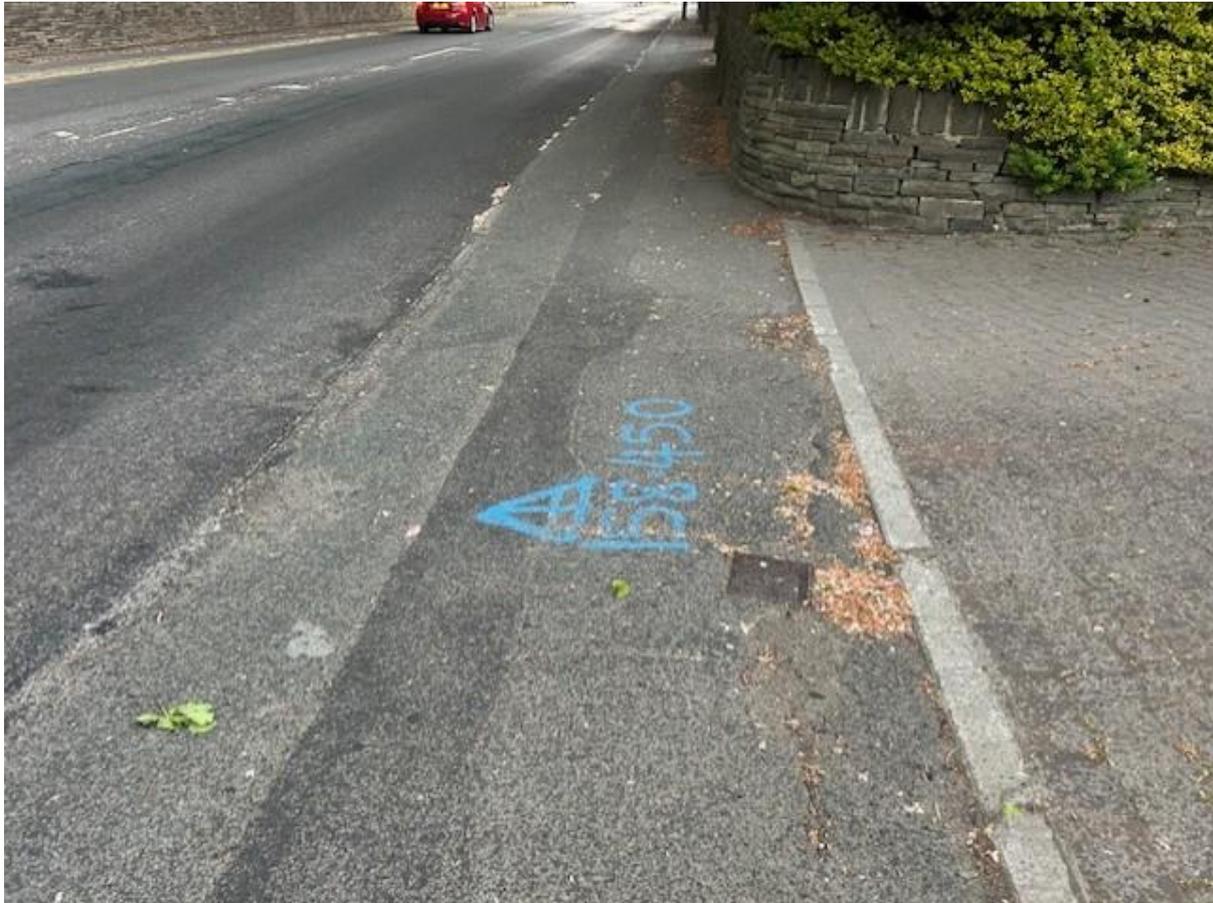
Comments – Kerbs adjacent to private driveway uneven. Some minor surface course degradation.
Two number trench reinstatements running parallel to each other.
