Condition Survey Report

Whitehall Road West, Birkenshaw.

May 2025

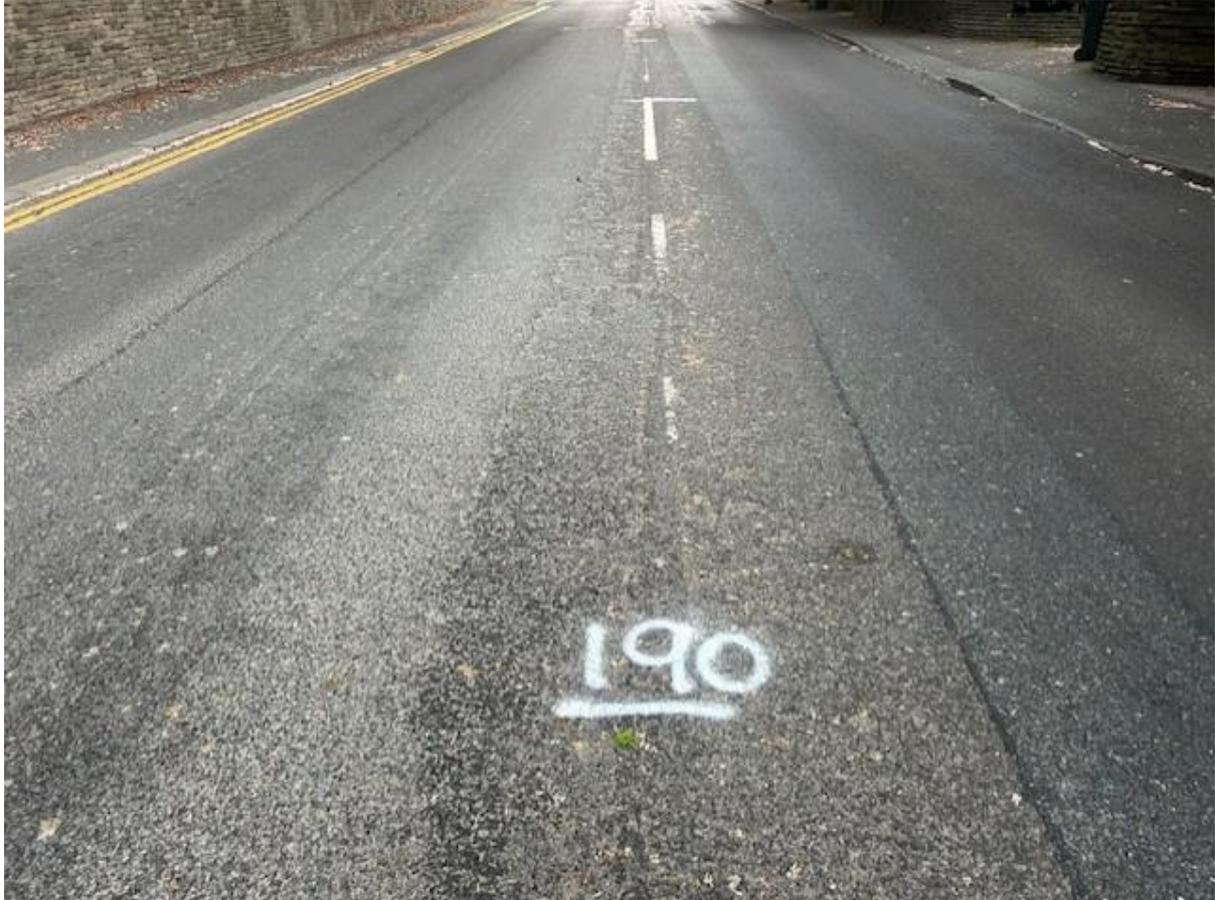
Comments – Centre line road markings worn.

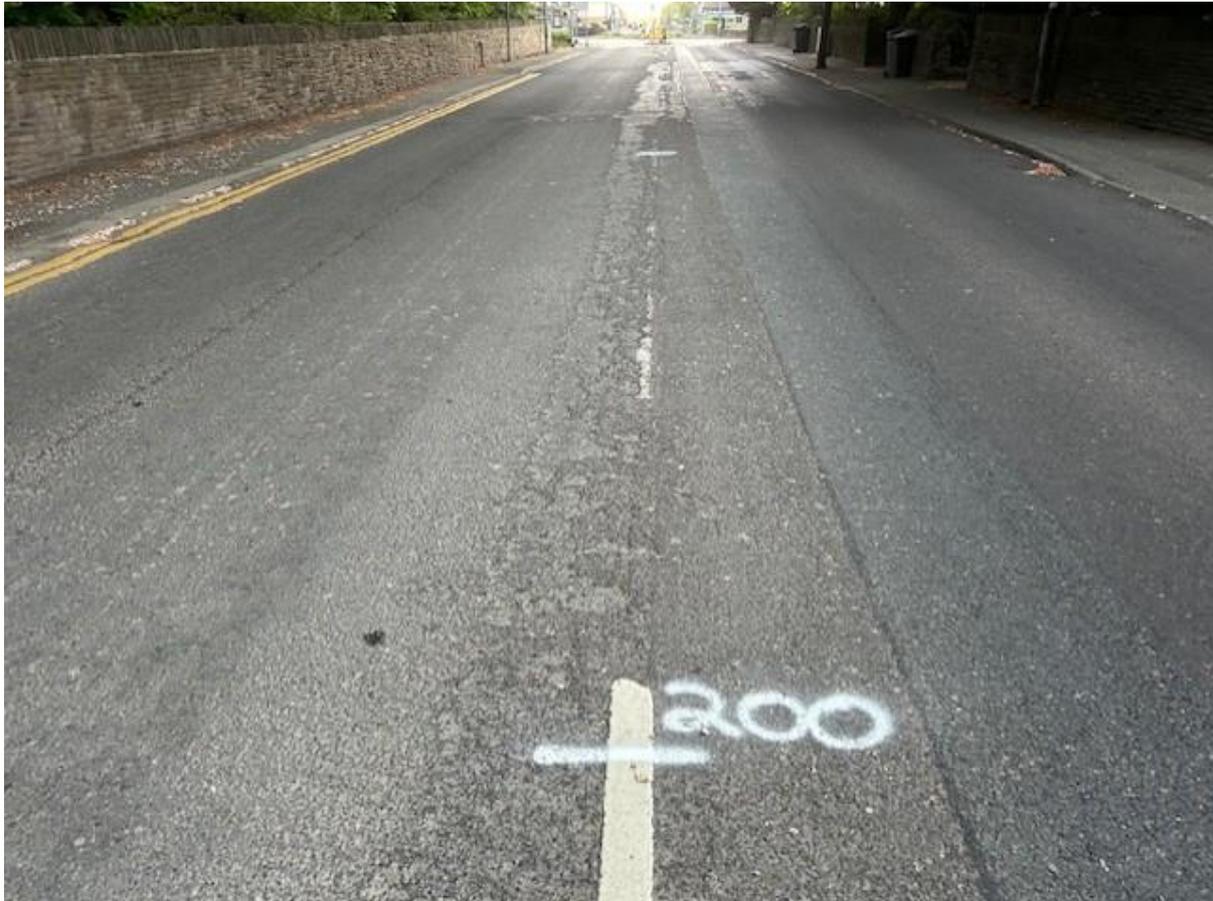
Comments – Signs of surface course degradation along centre line.

Recommendation – Highway Authority to monitor.

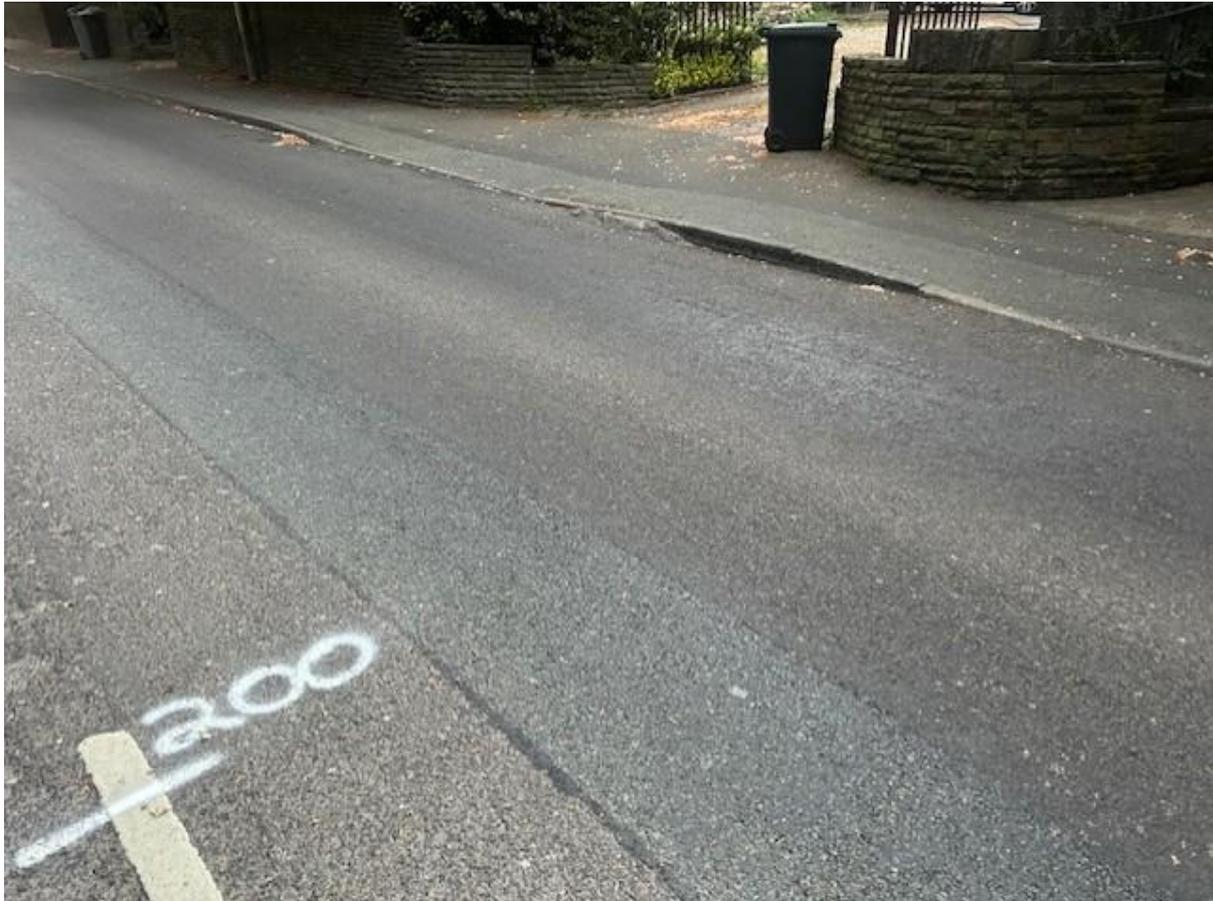
Comments – Uneven drainage channel and illegal obstruction adjacent to vehicle crossing.

Recommendation – Highway Authority to remove.

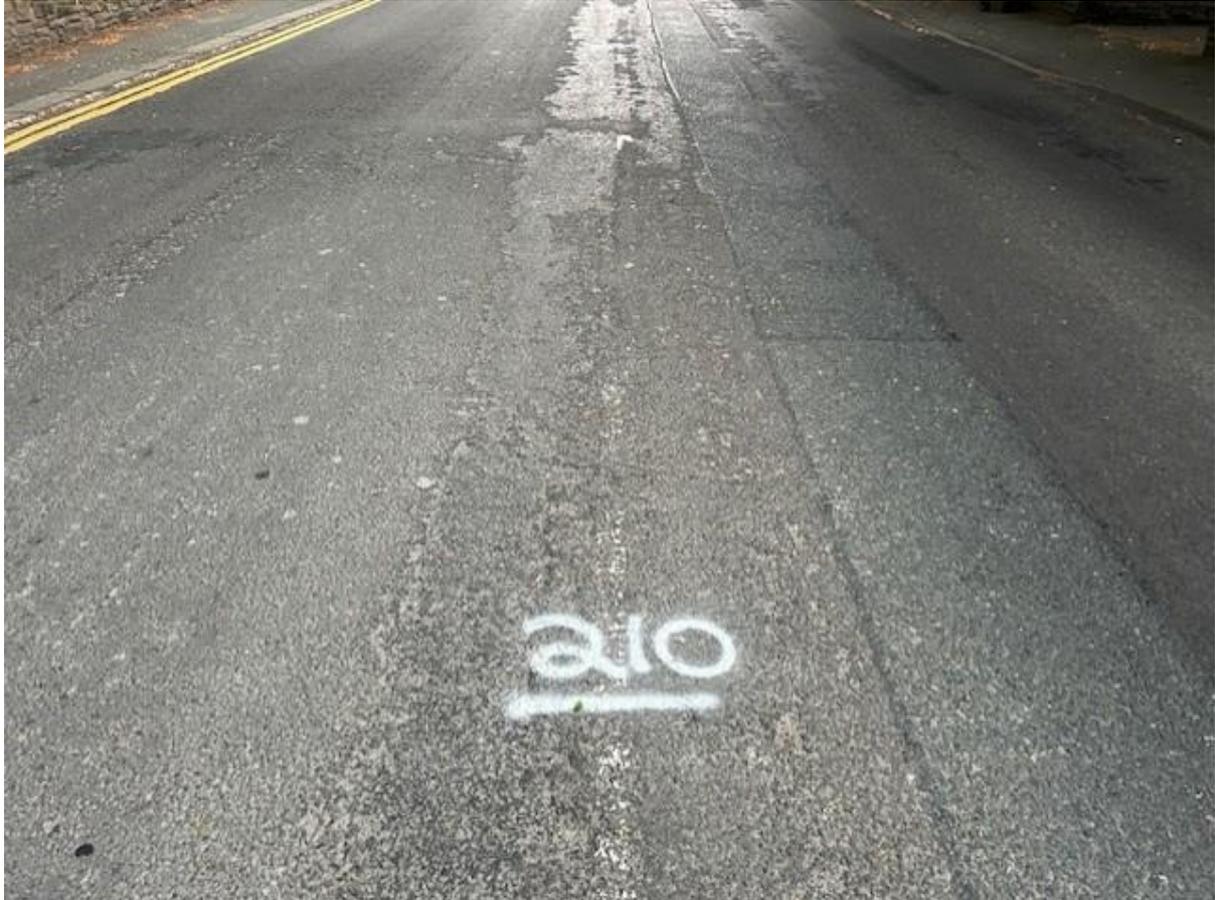
Comments – Premature wear of surface course along centre line.

Recommendation – Highway Authority to monitor.

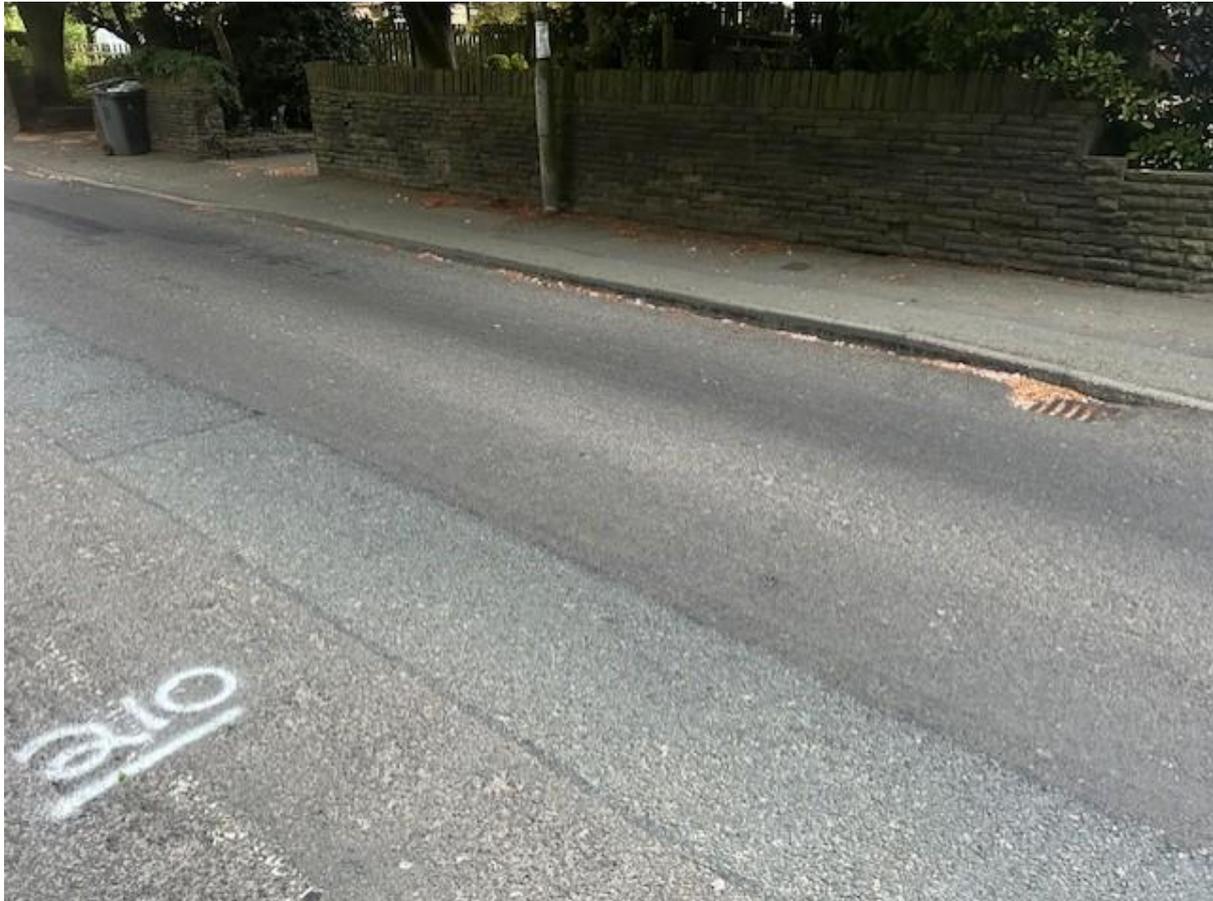
Comments – Blocked Road gully along south side of carriageway.

Recommendation – Highway Authority to action.

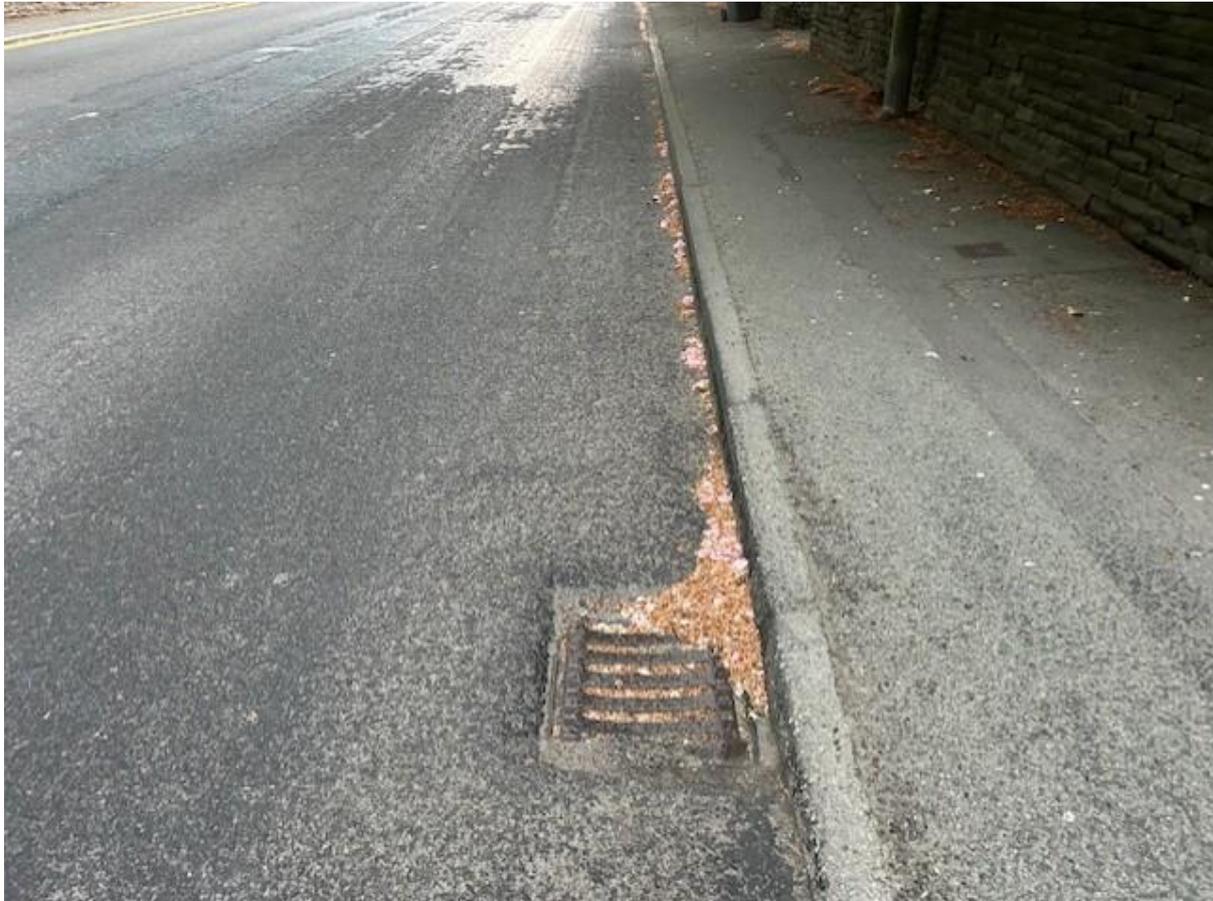
Comments – More detailed view of blocked road gully on southern side of carriageway.

Recommendation – Highway Authority to action.

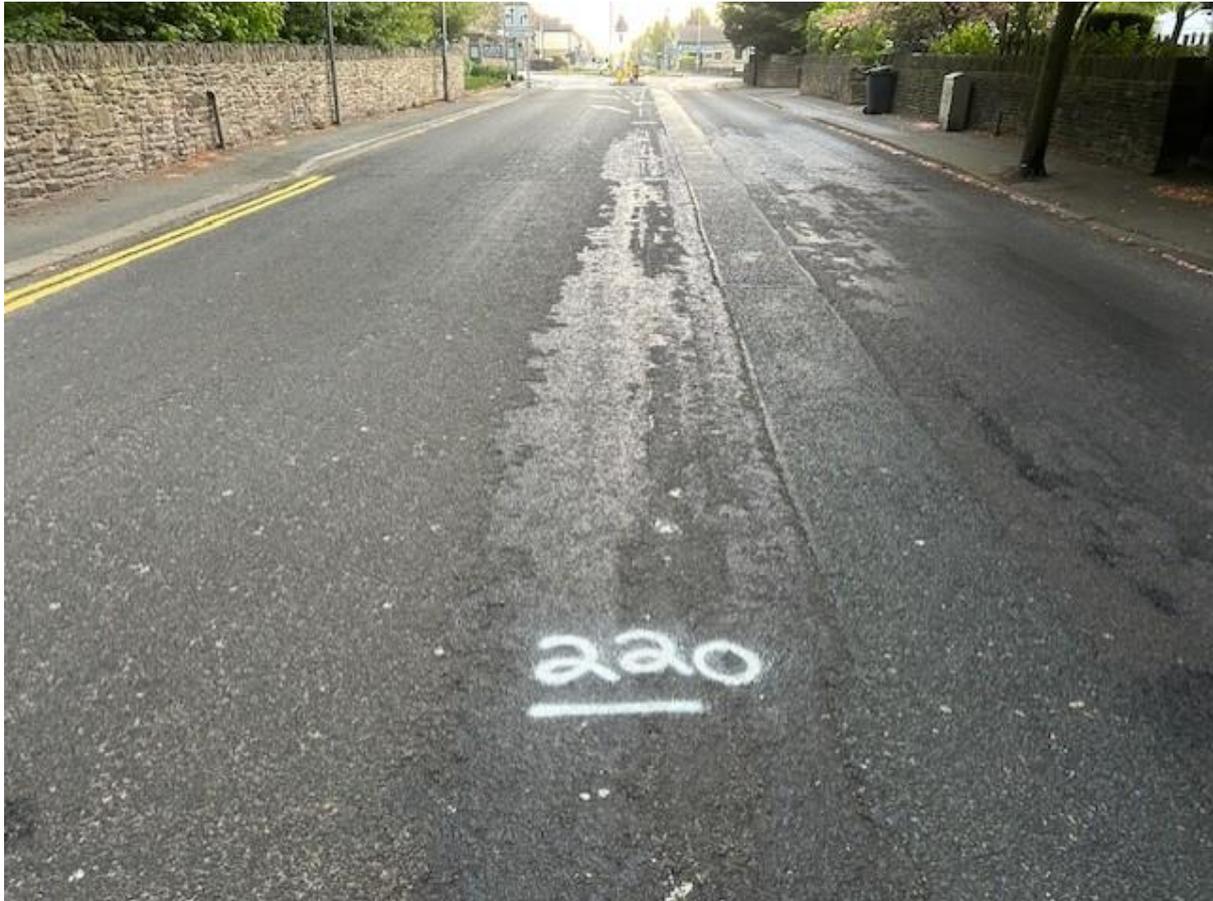
Comments – loss of aggregate in surface course resulting in a polished surface.

Recommendation – Require attention by Highway Authority.

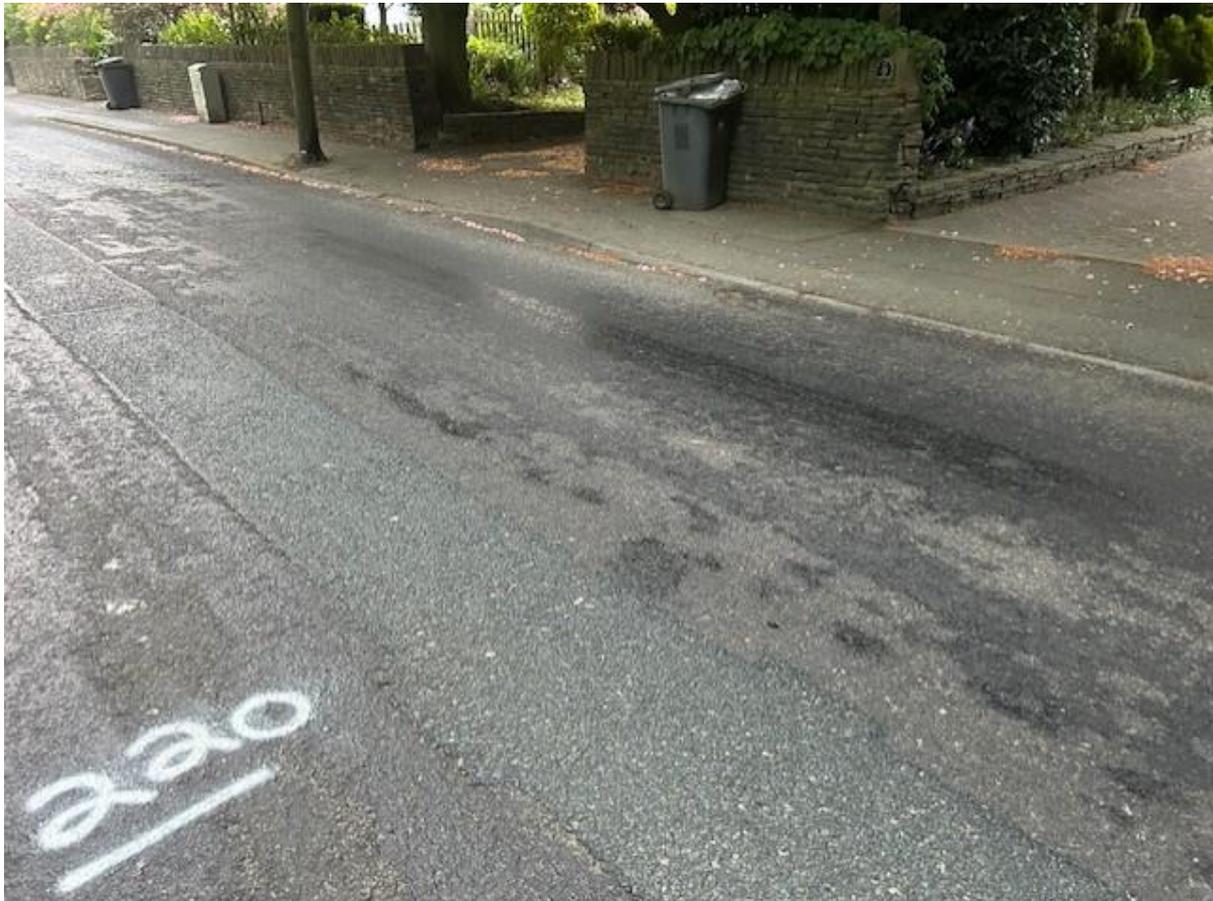
Comments – more evidence of polished surface course because of loss of aggregate.

Recommendation – Highway Authority to monitor.

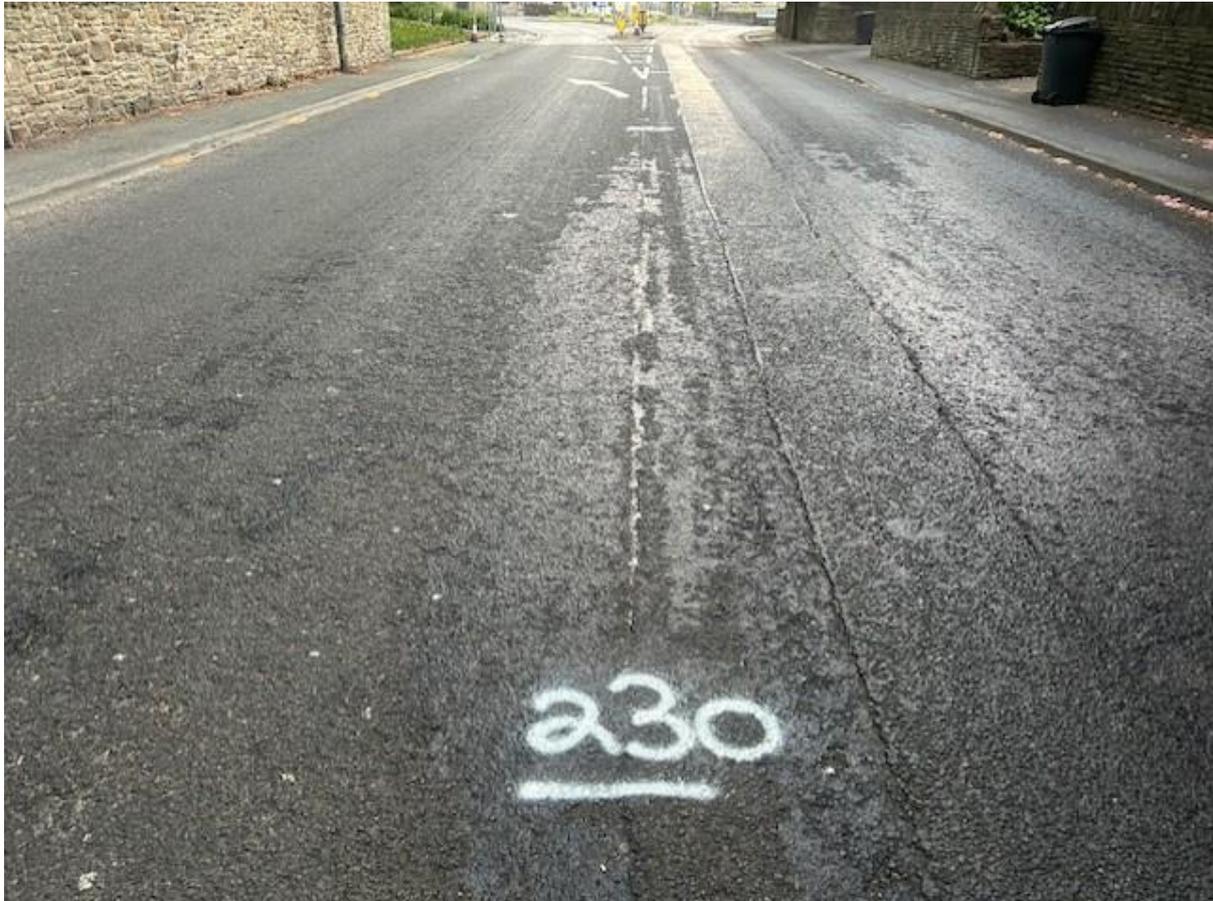
Comments – trench reinstatement continues along southern lane. Slight gap in centre line joint.
Polished surface course developing.

Recommendation – Highway Authority to monitor.

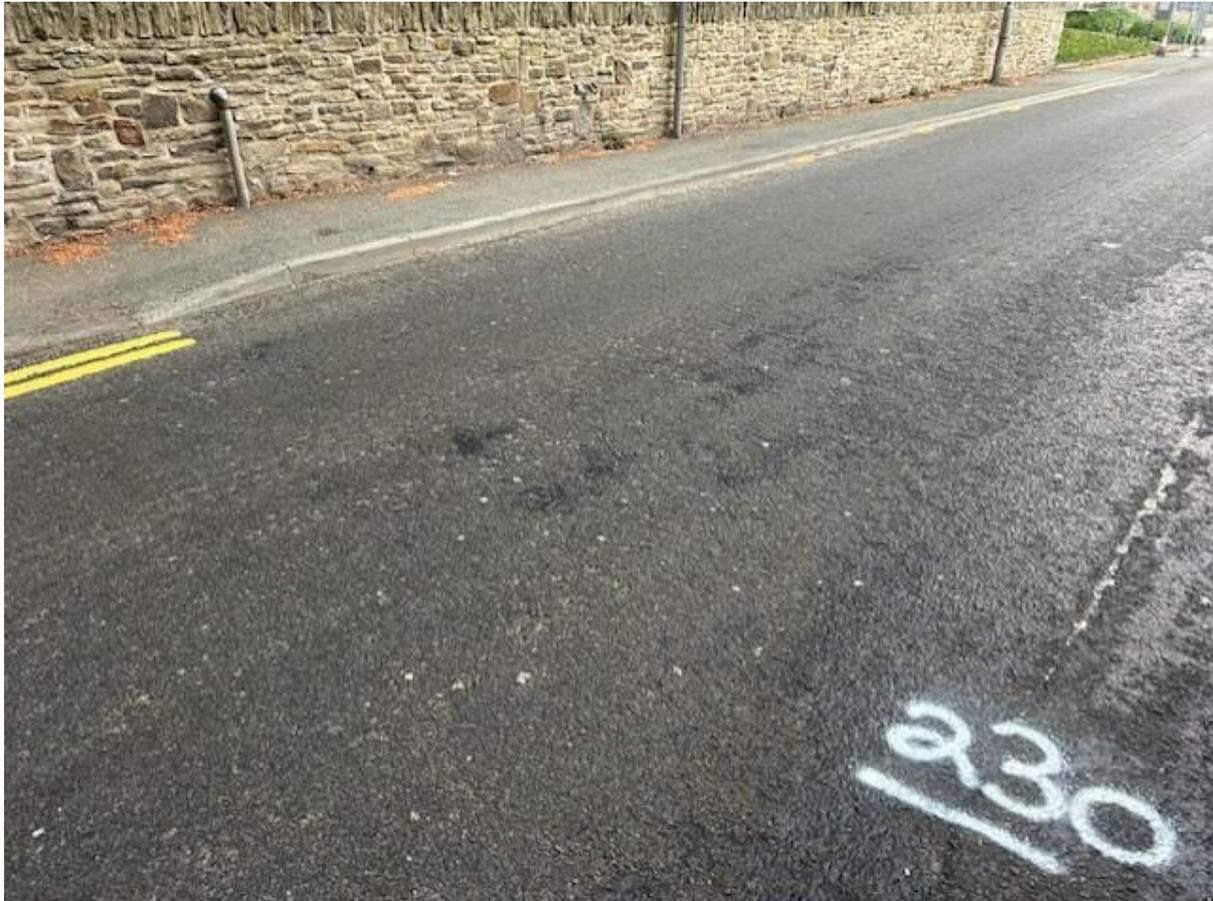
Comments – Surface course joint starting to develop.

Recommendation – Highway Authority to monitor.

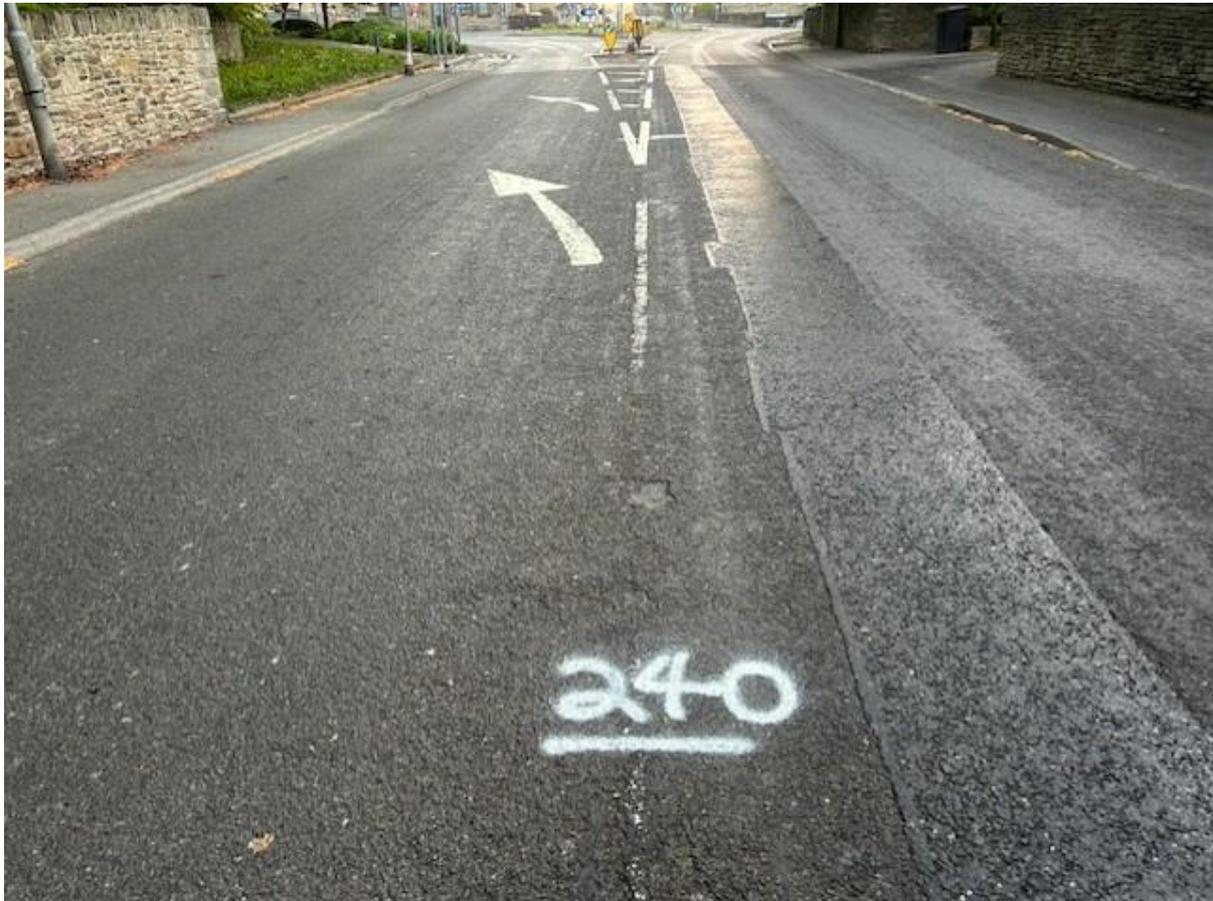
Comments - Trench reinstatement along southern flank. Minor surface course break up along centre line at Ch 241m. Centre line road markings worn.

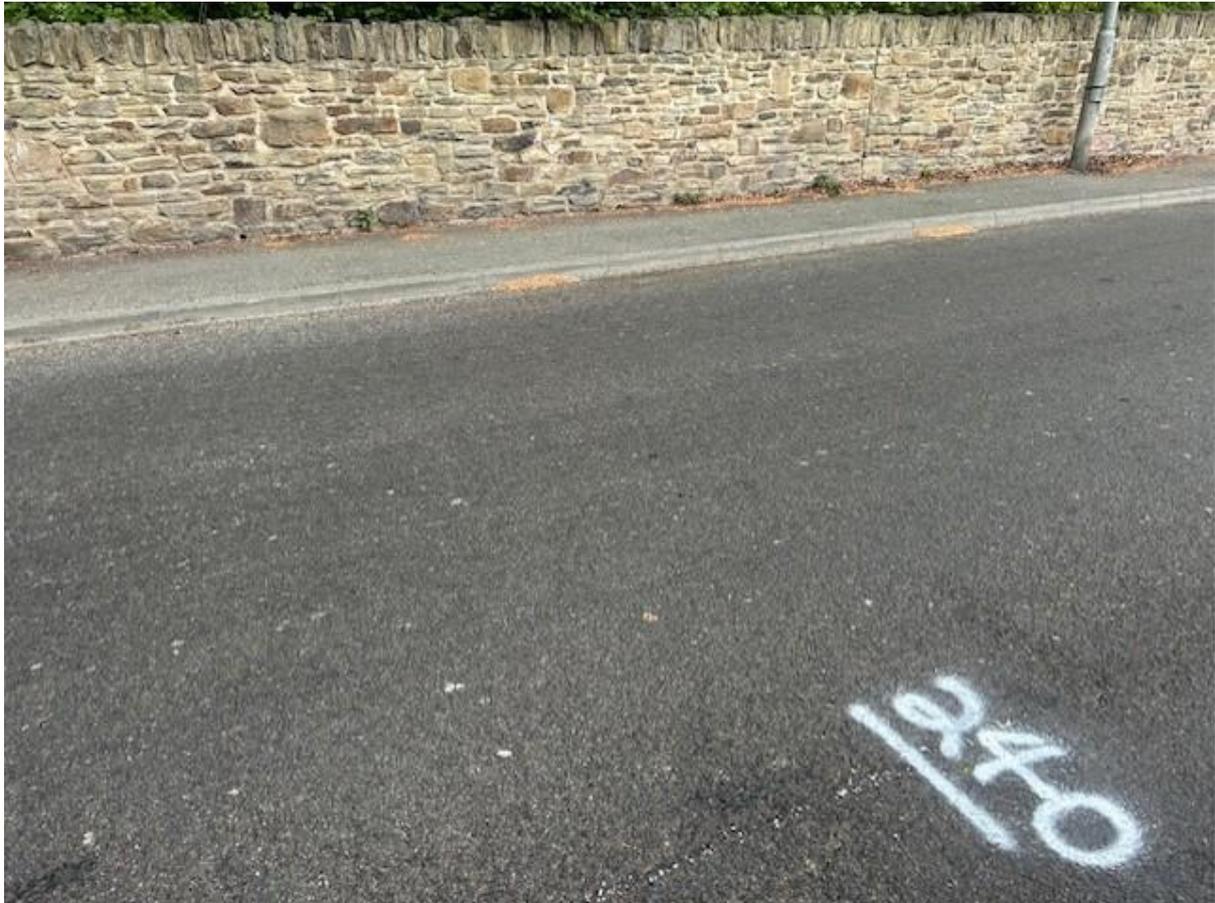
Comments – centre line worn.

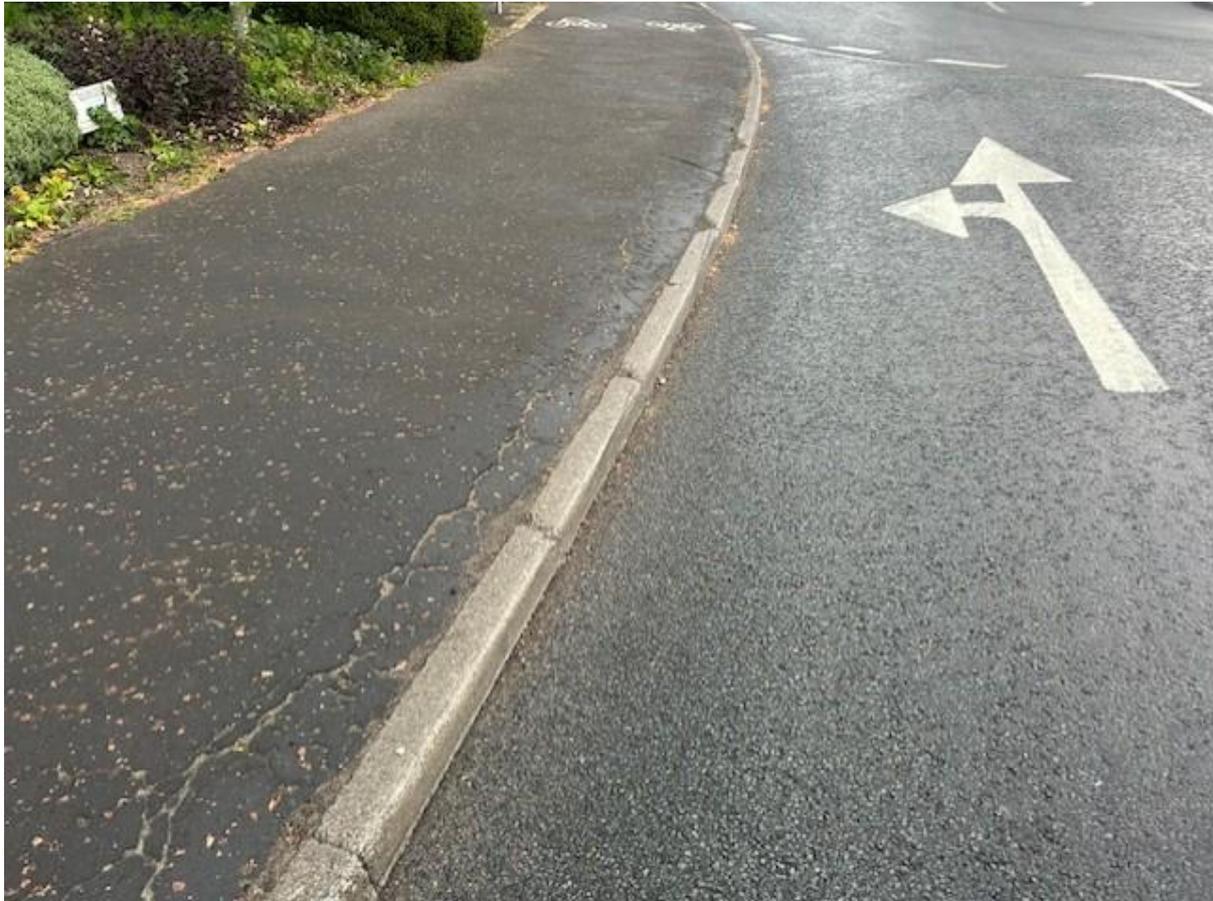
Comments – minor tensile cracks to footway surface course.

Recommendation – Highway Authority to monitor.
