Technical Note

250452 – Westgate, Cleckheaton

Dilapidation Survey

Our reference: AI/250452/DS01 – Rev00

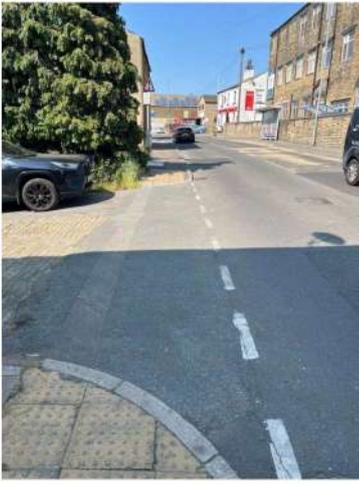
Issue 1

Trench scars across the junction with Westgate. Road markings beginning to fade. Tactile paving cracked.

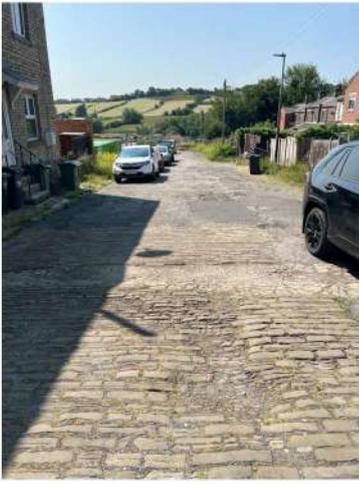
Issue 4

Overview of Iron Street from top of street. Uneven carriageway surface with localised low points. Surface cracked at various points.

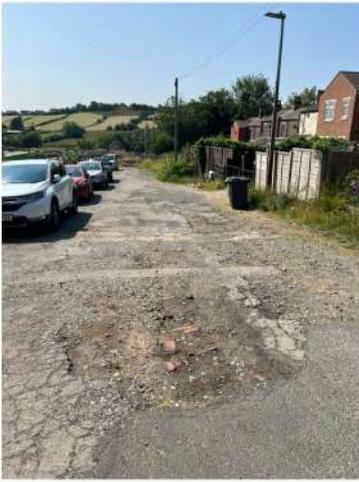
Issue 10

Carriageway surface is severely damaged.

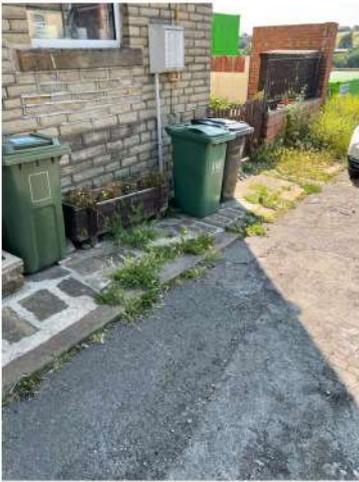
Issue 11

Block paved footway has been repaired. Vegetation overgrown. Carriageway surface severely cracked.

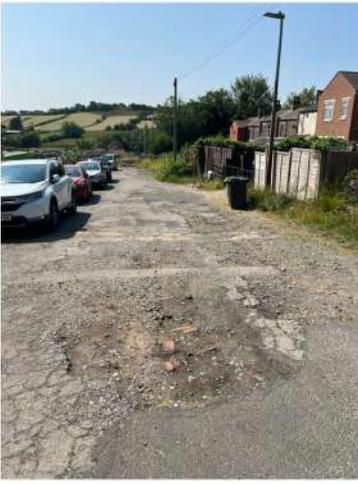
Issue 13

Carriageway surface severely damaged.

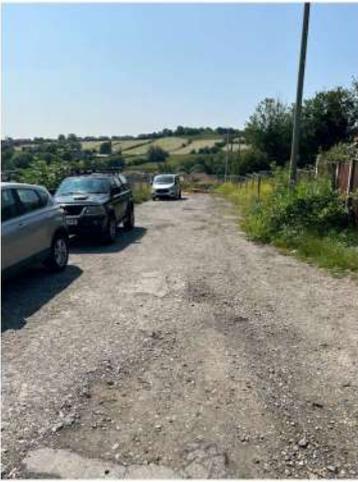
Issue 21

Carriageway surface severely damaged. Vegetation overgrown

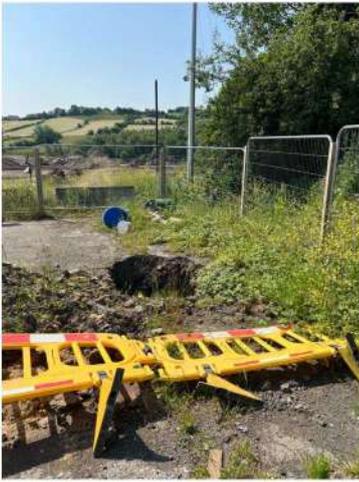
Issue 24

Barriers fallen, debris and open excavation at bottom of Iron Street (New defect identified during June 2025 visit)

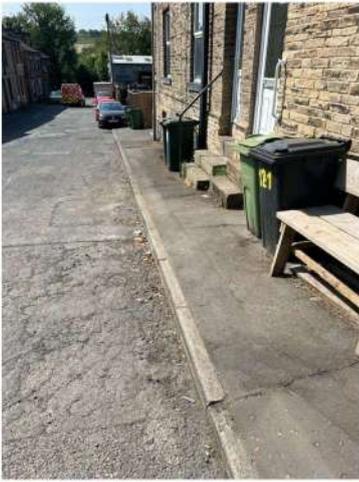
Issue 4

Carriageway surface severely damaged. Trench scars in footway.

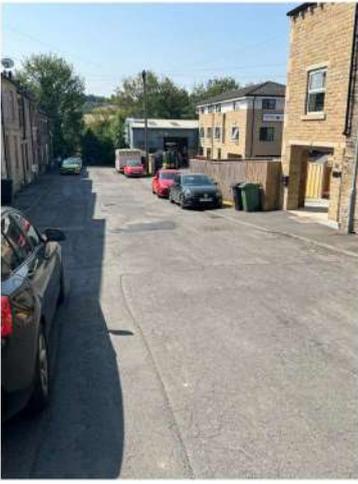
Issue 7

Trench scars through the carriageway and footway surface.

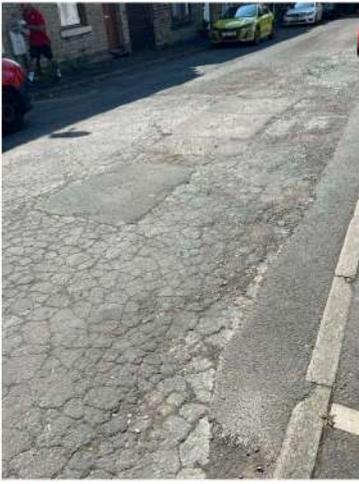
Issue 13

Carriageway surface severely damaged.

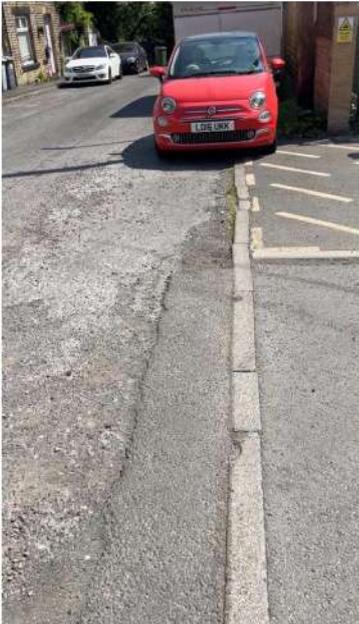
Issue 15

Debris build up at channel. Kerbs are damaged and out of line.

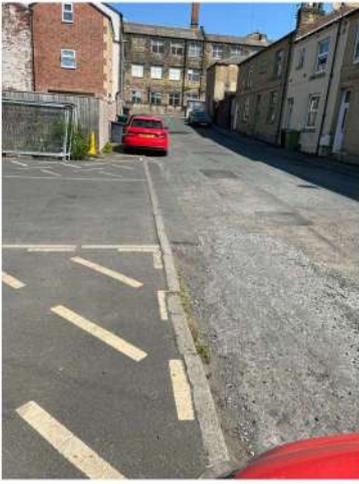
Issue 16

Debris build up at channel. Kerbs are damaged and out of line.

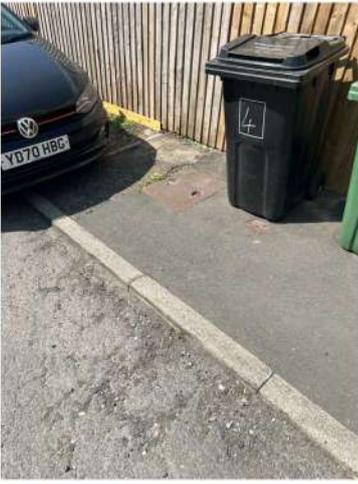
Issue 19

Carriageway surface damaged around chamber. (New defect identified during June 2025 visit)

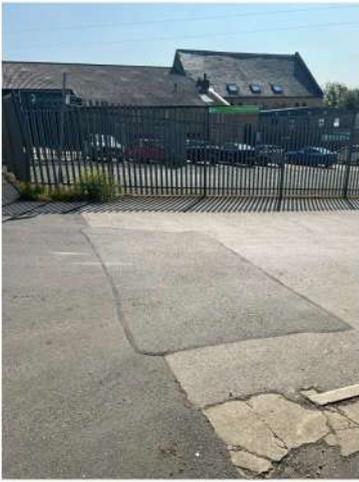
Issue 4

Resurfacing patch and clear changes in surface material.

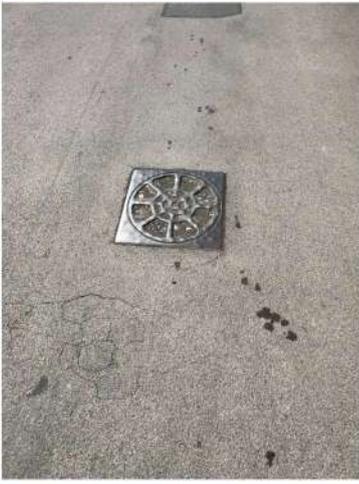
Issue 10

General wear of iron cover. Cracking of carriageway surface. Black staining on carriageway surface.

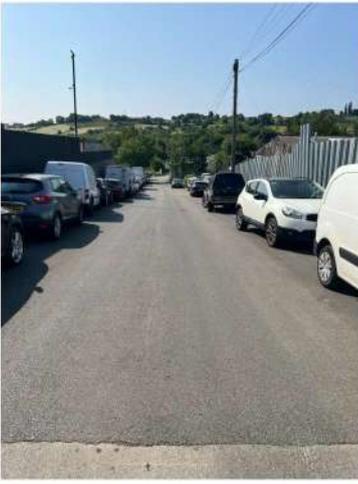
Issue 13

General wear of carriageway surface.

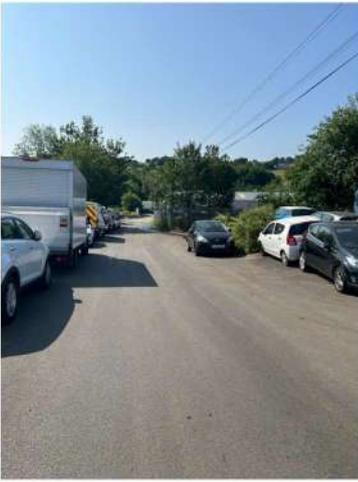
Issue 16

General wear of carriageway surface.

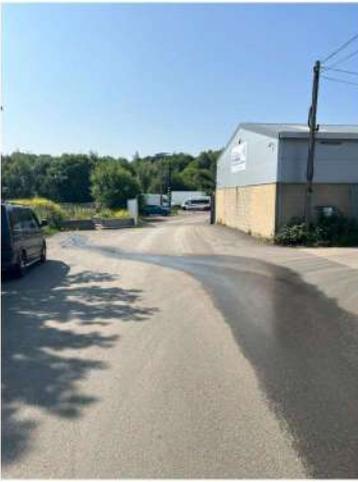
Issue 19

General wear of carriageway surface, Water flow path across road.

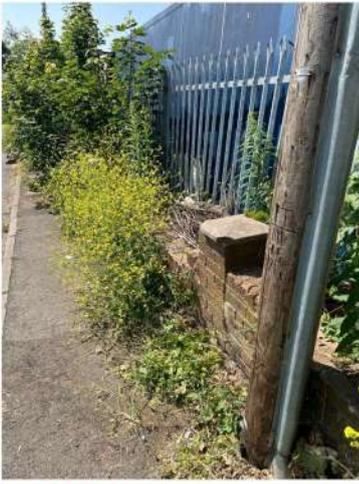
Issue 4

Wall in bad condition. Vegetation overgrown on footway.

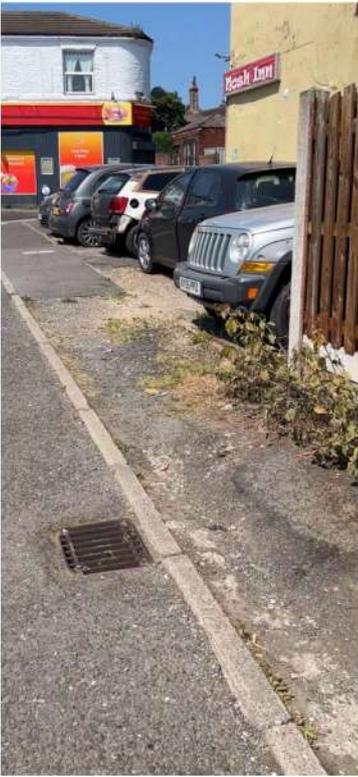
Issue 10

Damaged footway surfacing, overgrown vegetation.

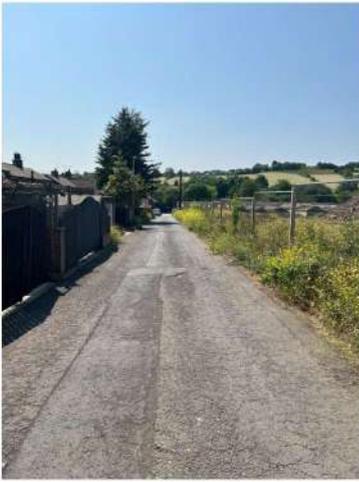
Issue 13

Cracked surfacing and overgrown vegetation.

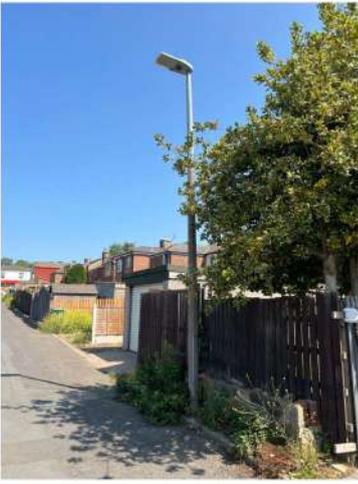
Issue 16

Lighting column is in good condition. Vegetation overgrown.

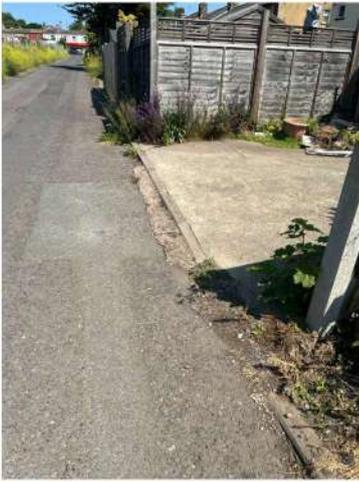
Issue 20

Sediment deposit at kerb line. Kerbing damaged and out of line and some are missing. Vegetation is overgrown.

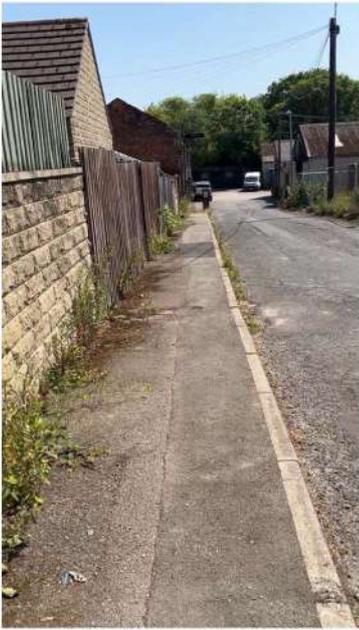
Issue 23

Kerbs are cracked and out of line. Trench scars in footway and carriageway. Vegetation overgrown. Carriageway and footway is in bad state of wear.

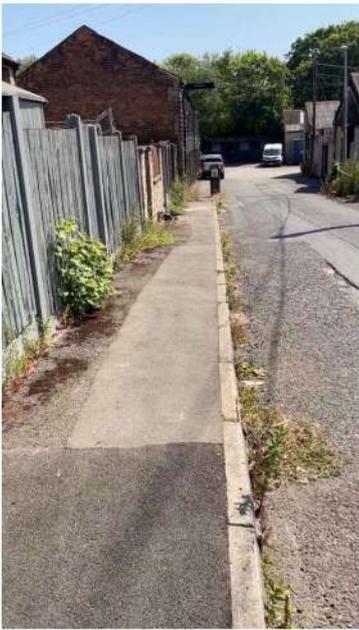
Issue 24

Gully blocked by vegetation.

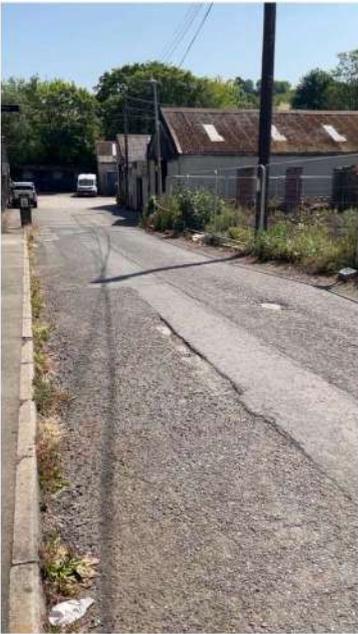
Issue 25

Carriageway severely damaged. Vegetation overgrown along channel. Kerbs are chipped and in bad condition.

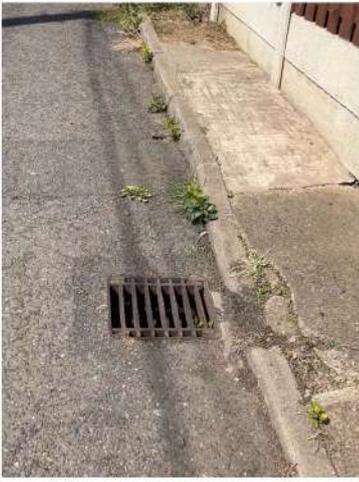
Issue 28

Kerbs and footway damaged around gully. Vegetation overgrown along channel edge.

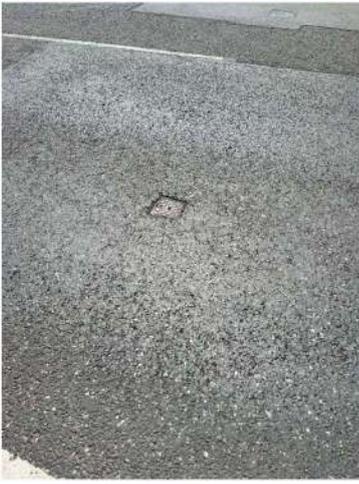
Issue 1

Cover slightly sunk into carriageway but in ok condition.

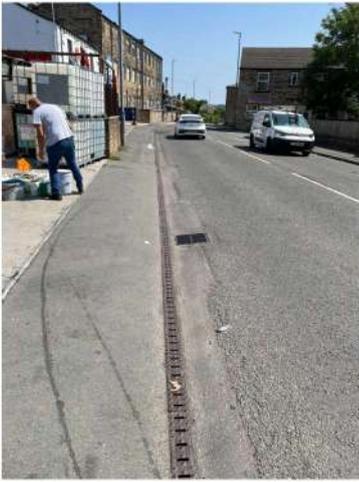
Issue 12

Trench scars across length of carriageway ahead of drainage channel. Black stains across the footway. Pitting on carriageway surface.

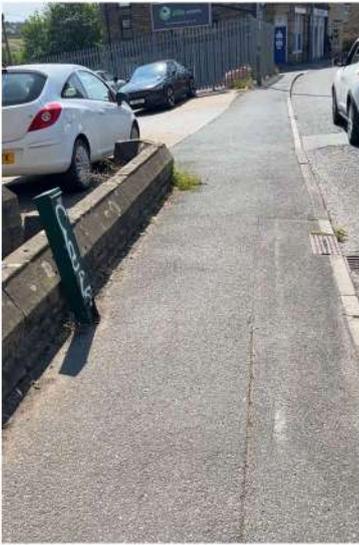
Issue 16

Damaged and vandalised box on footway.

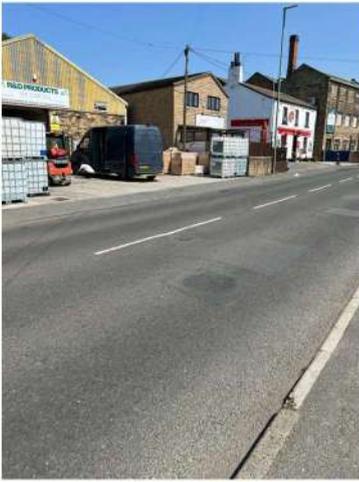
Issue 19

General wear of carriageway with some resurfacing patches.

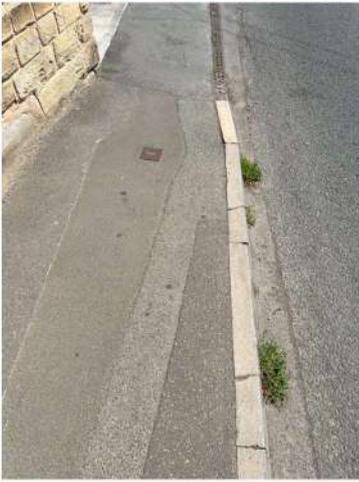
Issue 22

Cracked kerbs, trench scars in footway. Vegetation growth at channel.

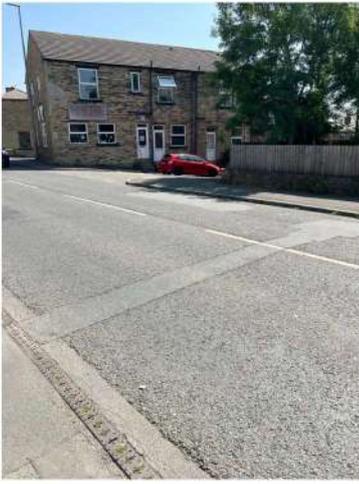
Issue 25

Trench scars in carriageway.

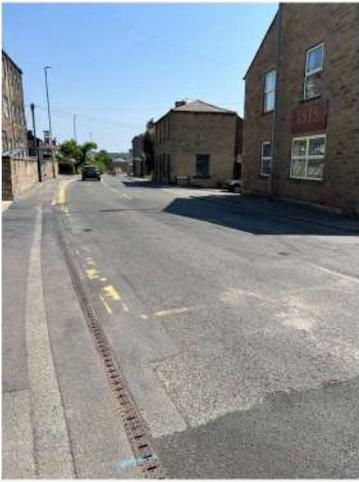
Issue 28

Faded bus stop road marking. Centre line missing from resurfacing patch. Trench scars visible.

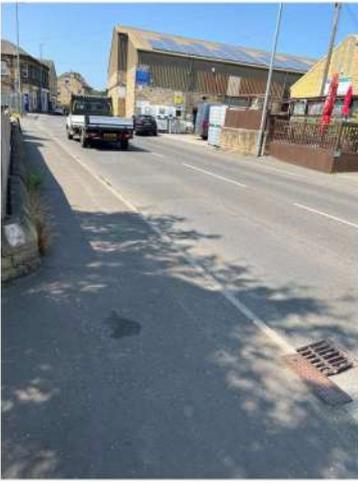
Issue 31

Trench scars in footway. Black stains in footway.

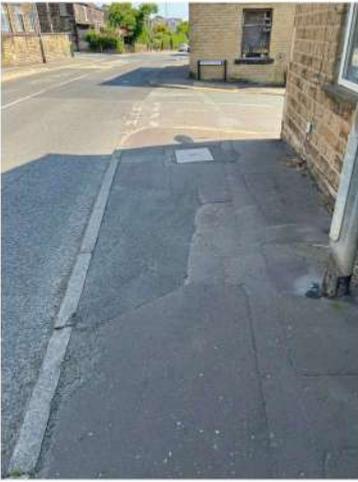
Issue 34

Sediment build up at back of kerb. Damaged kerbs. Trench scars in footway.

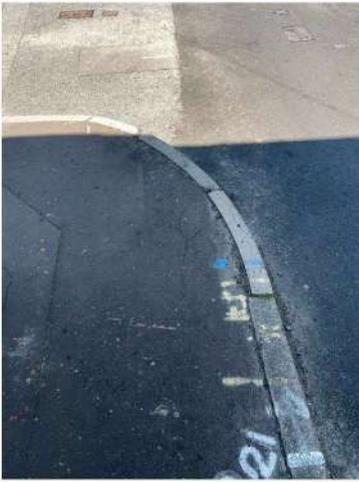
Issue 37

Cracked kerbs and footway surface. Visible trench scars.

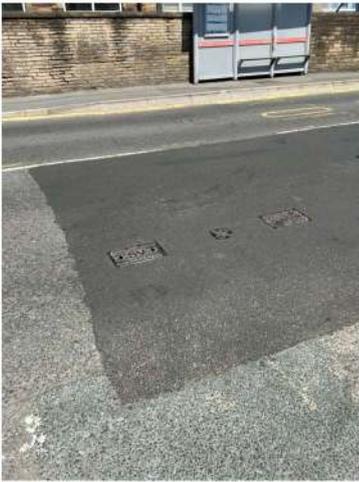
Issue 38

Resurfacing patch in carriageway. Faded road markings

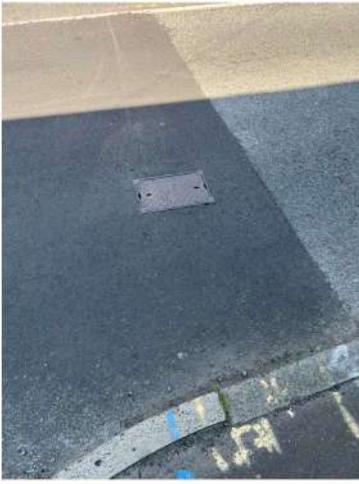
Issue 40

Cracked kerbs, sediment build up behind kerb. Resurfacing patch in carriageway.

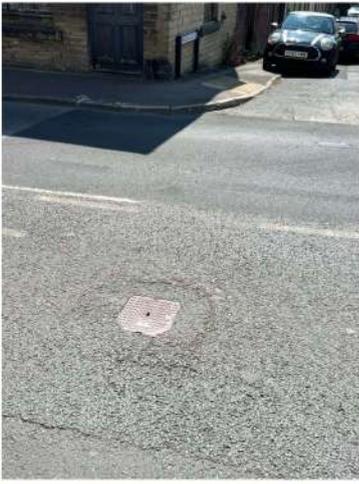
Issue 43

Road marking faded. Carriageway failing around cover.

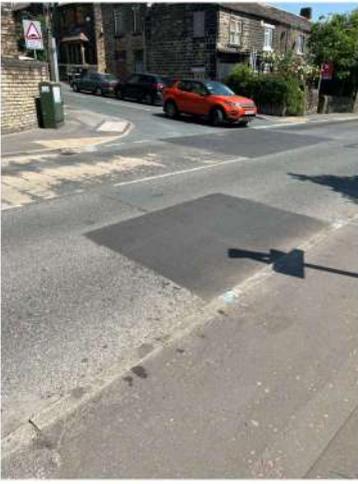
Issue 46

Black stains on footway and carriageway. Surfacing is worn. Resurfacing patches visible.

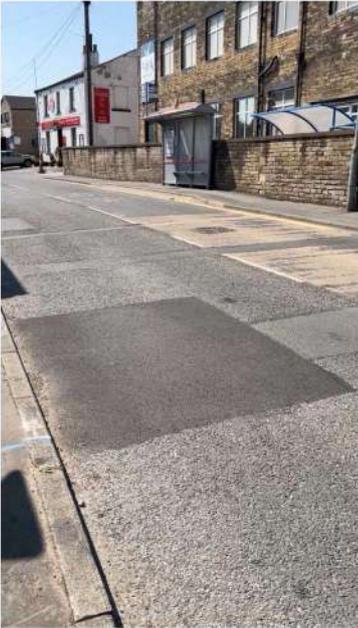
Issue 47

Trench scar in carriageway.

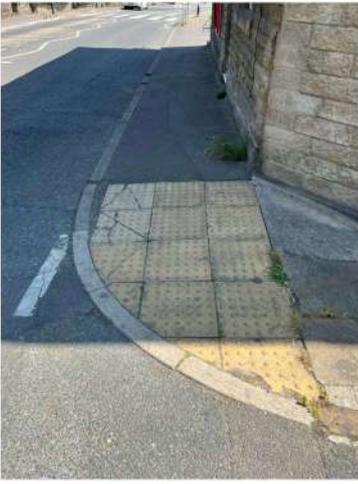
Issue 52

Tactile cracked. Kerbs in bad condition, trench scar along footway. Overgrown vegetation at back of footway and crossing.

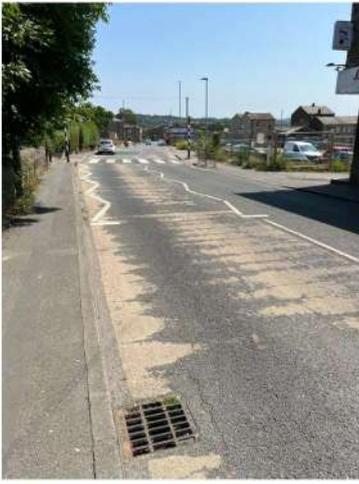
Issue 55

Carriageway surfacing worn.

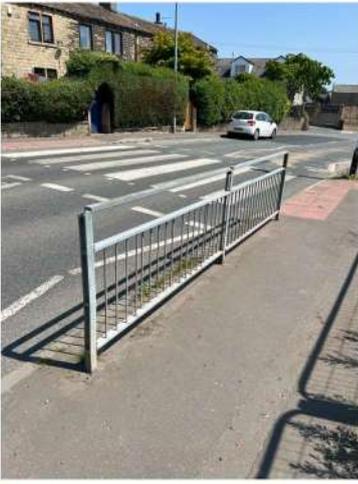
Issue 59

Pedestrian guard rail in good condition.

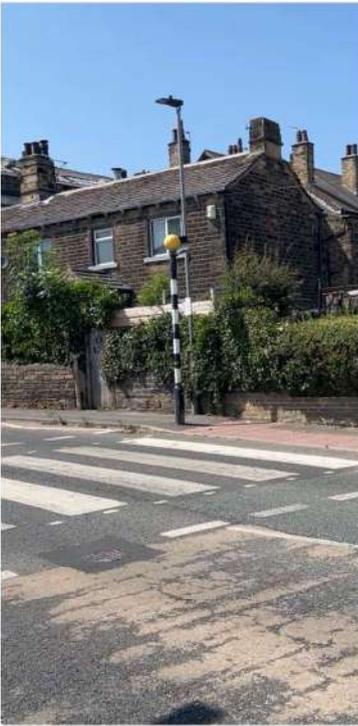
Issue 62

Surfacing faded. Beacon in good condition.

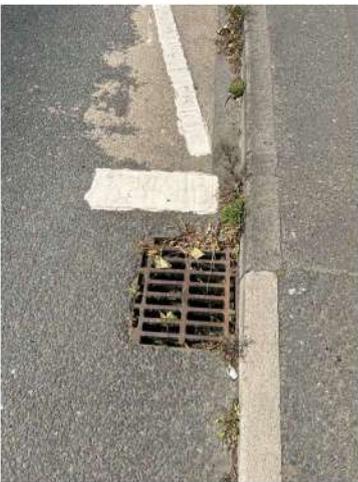
Issue 63

Gully covered in debris. Vegetation overgrowth.

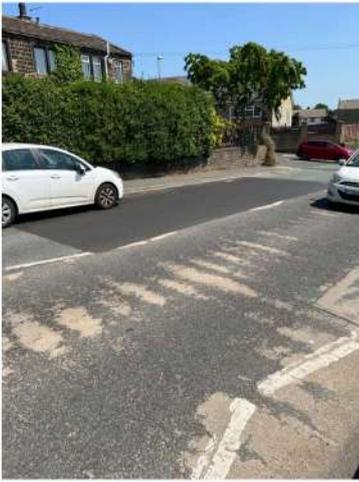
Issue 68

Surfacing faded. Resurfacing patches with missing road markings.

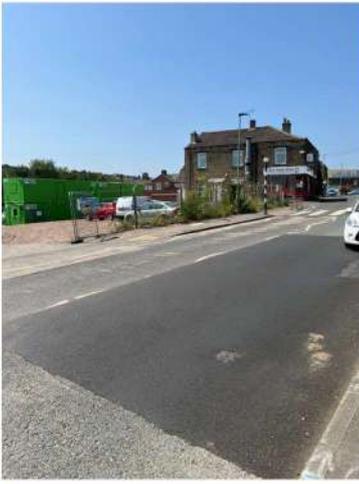
Issue 71

Surfacing worn on half the carriageway. Road markings faded.

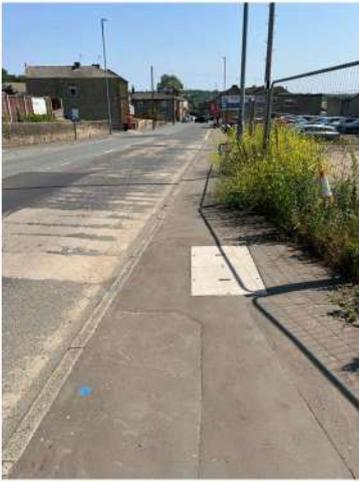
Issue 74

Trench scars visible in footway. Surfacing worn. Overgrown vegetation.

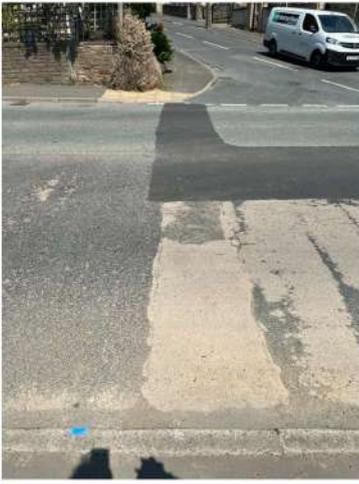
Issue 77

Trench scar in footway. Rest of carriageway surface is worn.

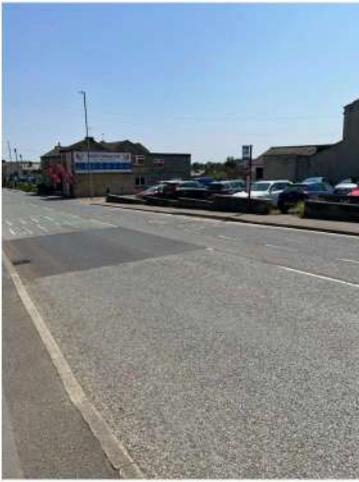
Issue 81

Road markings faded. Kerb line misaligned. Carriageway cracking on joint of the centreline of carriageway. Resurfacing patch in carriageway.

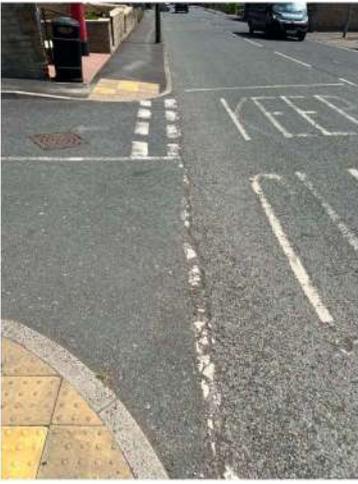
Issue 84

Road markings faded, carriageway cracking at junction.

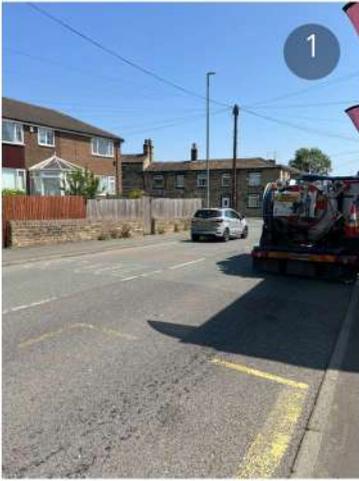
Issue 94

Road markings faded. Kerbs slightly misaligned.

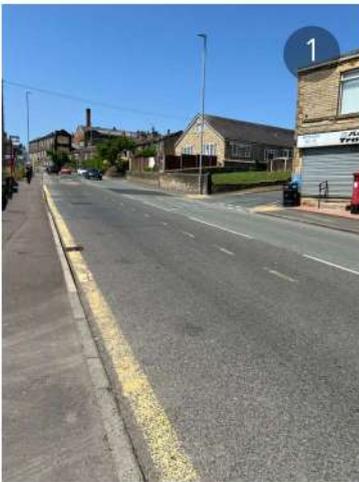
Issue 95

Road markings faded. Carriageway cracked, trench scar in centre of footway.

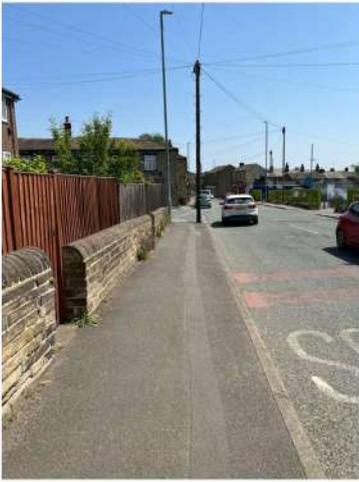
Issue 96

Trench scars in footway. Vegetation growth at back of footway.
Carriageway surface worn.

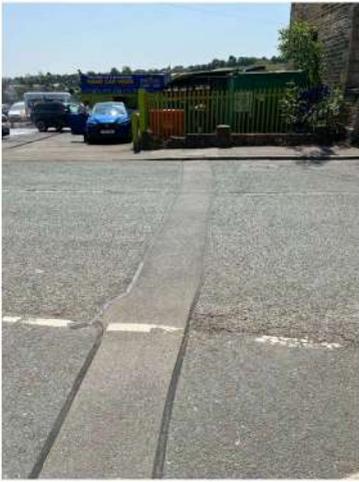
Issue 99

Trench scar in carriageway. Road marking faded.

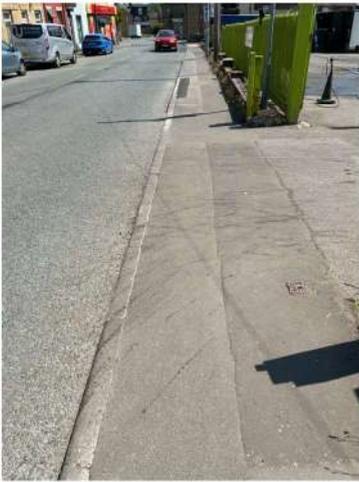
Issue 103

Kerbs cracked. Trench scars in footway and carriageway. Black stains on footway.

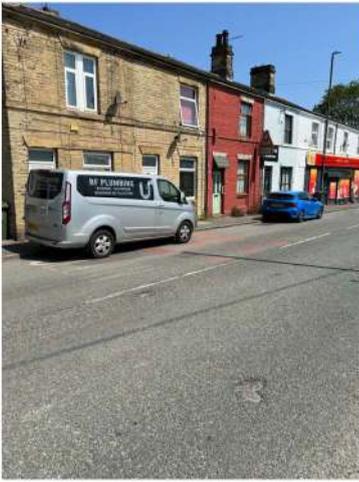
Issue 105

Potholes in carriageway. Road markings faded.

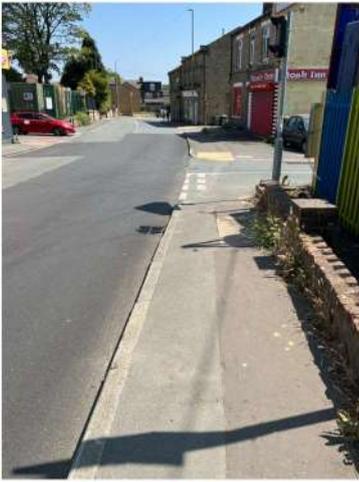
Issue 114

Kerbs are misaligned. Road marking centre line is missing.

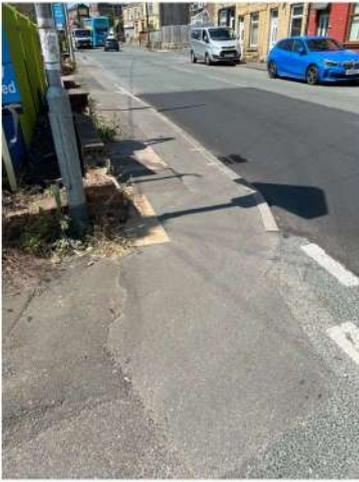
Issue 117

Missing kerbs and tactiles. footway surfaces in bad conditions and scarred. Vegetation growth at the back of footway, missing carriageway centreline. Brick wall damaged.

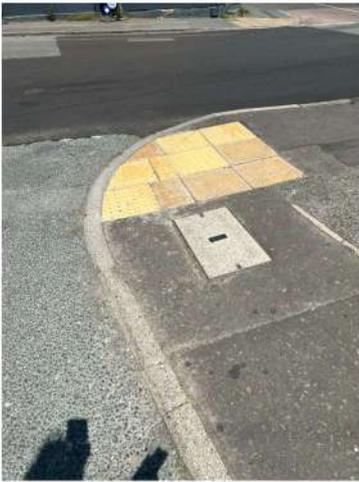
Issue 118

Tactiles in good condition.

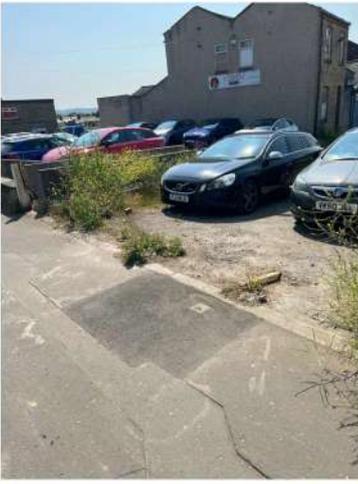
Issue 1

Damaged bollards at entry. Footway surfacing in bad conditions and scarred.

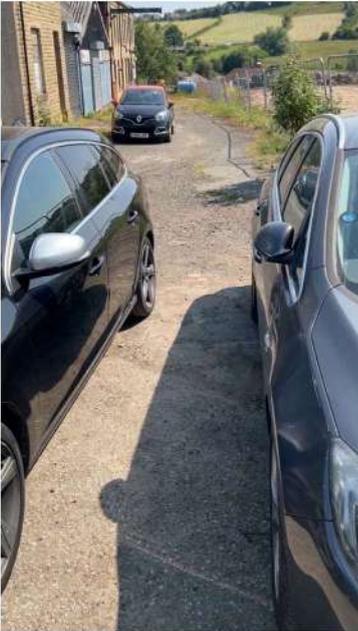
Issue 3

Surface of carriageway is in bad state of wear.

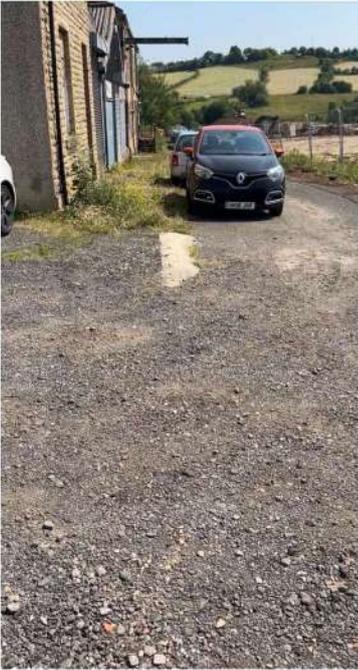
Issue 5

Surface of carriageway is in bad state of wear, vegetation overgrown.

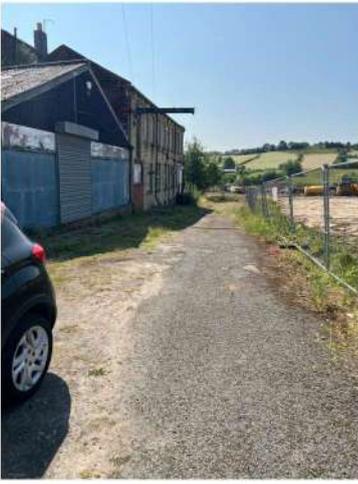
Issue 7

Surface of carriageway is in bad state of wear, vegetation overgrown.

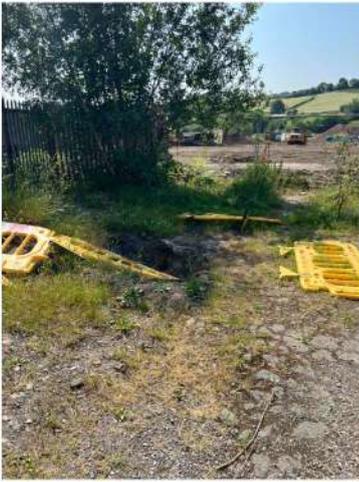
Issue 10

Hole dug out, barriers have fallen and hole is unprotected from access. (New defect identified during June 2025 visit)

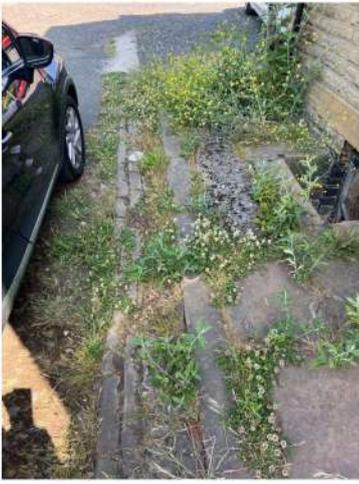
Issue 13

Footway uneven and vegetation is overgrown. (New defect identified during June 2025 visit)
