ARBORICULTURAL ASSESSMENT REPORT

23 Hawthorne Way, Shelley, Huddersfield, HD8 8JX

PRI Ref: 261611

Survey Date: 15/06/2023

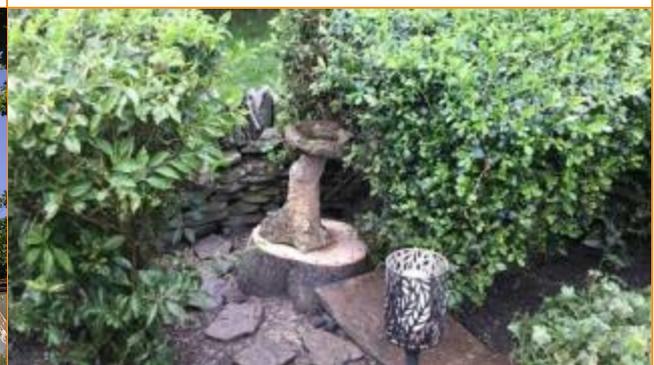
T1 - Oak (Turkey) felled in August 2023

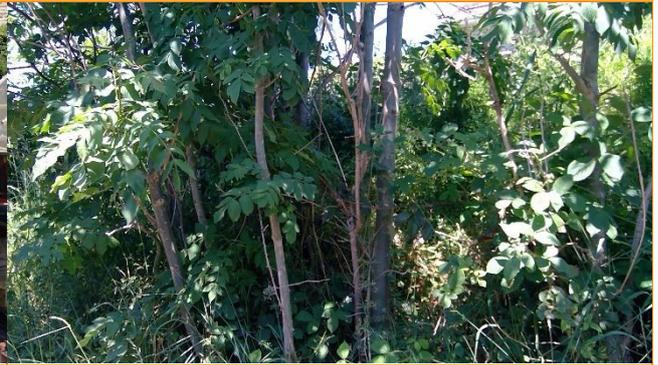
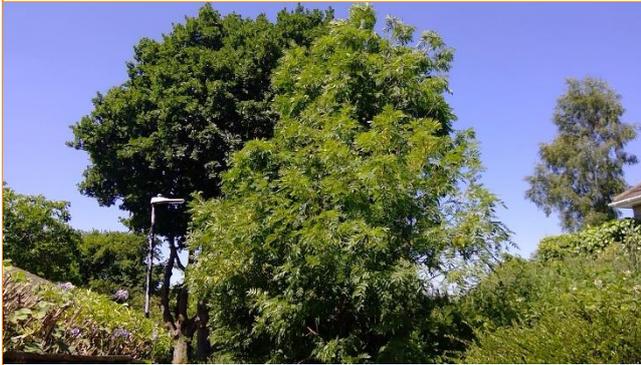
TG1 - Ash (Common)

TG1	Ash (Common)	Semi-Mature	Fair	5.6	5.0	85	3.90	N	No significant past tree works.	No work required.		PH advised that it's unclear who owns this land.	District Land Registry Search Required	UKN

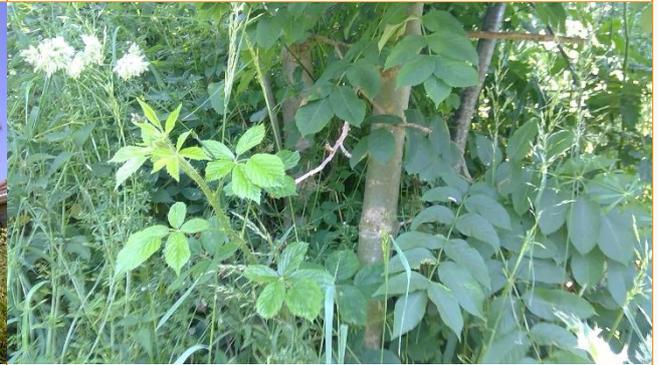
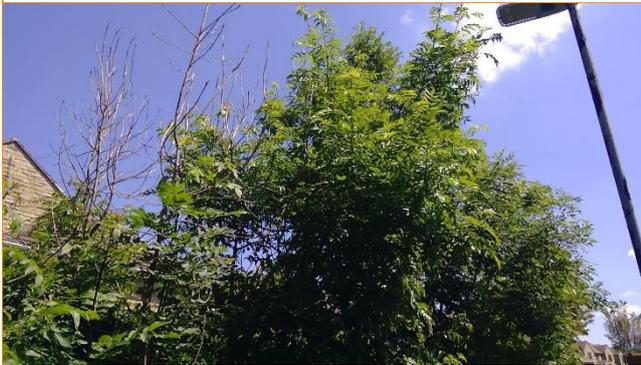
T2 - Ash (Common)

T2	Ash (Common)	Semi-Mature	Fair	4.6	3.8	80	4.59	N	No significant past tree works.	No work required.		PH advised that it's unclear who owns this land.	District Land Registry Search Required	UKN

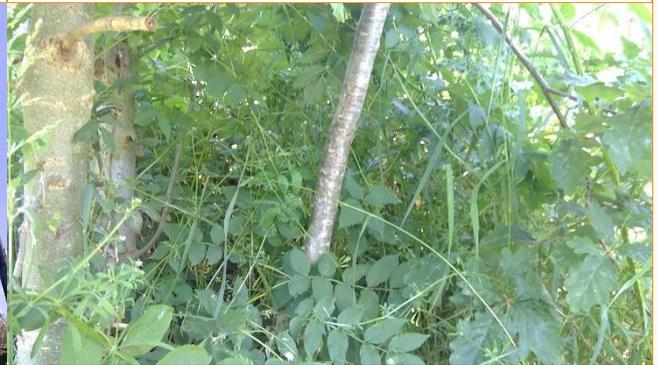
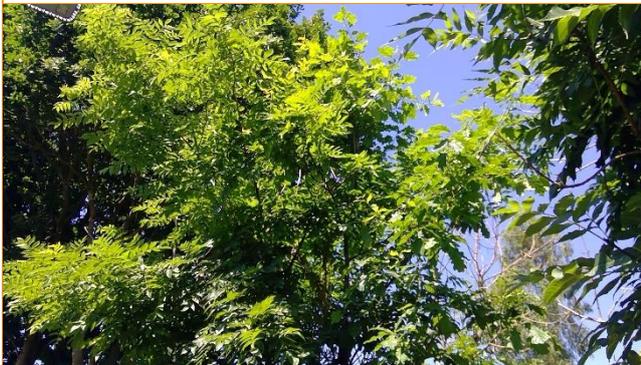
T3 - Oak

Tree No	Common Name	Age Class	Condition	Height (m)	Crown Spread (m)	Stem diam. (mm)	Dist to bldg. (m)	Roots Implicated	Pruning history	Recommendation	Tree work constraints	Notes	Owner address	Owner
T3	Oak	Young	Fair	4.8	2.50	45	5.1	N	No significant past tree works.	No work required.		PH advised that it's unclear who owns this land.	District Land Registry Search Required	UKN
T4	Oak	Mature	Fair	14.5	15.2	480	8.49	Y	Subject to past management. No significant recent management.	Fell and treat stump with eco plugs (broadleaved).	Pre cone/signage/ barriers action required - footpaths/public access. Obstructions sheds/greenhouses.	PH advised that it's unclear who owns this land.	District Land Registry Search Required	UKN
T5	Oak	Mature	Fair	14.1	13.0	720	10.2	Y	Subject to past management. No significant recent management.	Fell and treat stump with eco plugs (broadleaved).	Pre cone/signage/ barriers action required - footpaths/public access. Obstructions sheds/greenhouses.	PH advised that it's unclear who owns this land.	District Land Registry Search Required	UKN

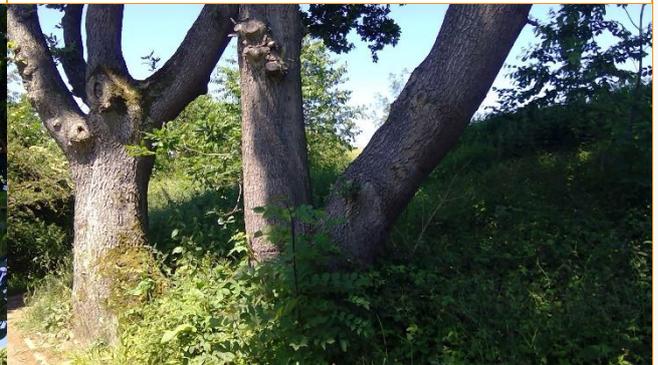
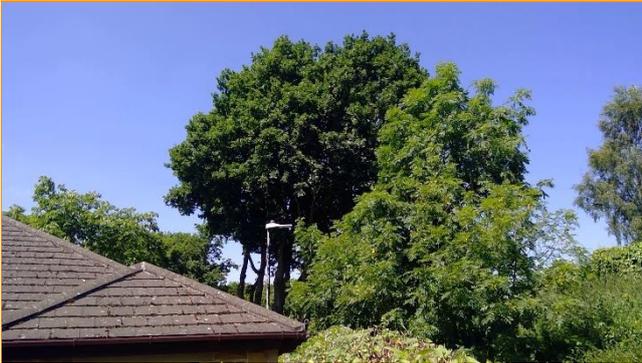
T4 - Oak

A review of Kirklees Council's website has confirmed that T4 & T5 Oaks of the implicated vegetation is subject to a Tree Preservation Order. There are no Conservation Area controls.

Tree No:	Species	Works Required	CA	TPO	Ownership
T1	Oak	Fell and treat stump with eco plugs (broadleaved)	No	No	PH
T4	Oak	Fell and treat stump with eco plugs (broadleaved)	No	Yes	UKN
T5	Oak	Fell and treat stump with eco plugs (broadleaved)	No	Yes	UKN
