**Condition Report**

Huddersfield Open Market  
Brook Street  
Huddersfield  
HD1 1RY

06 November 2023

**Client:** Kirklees Council

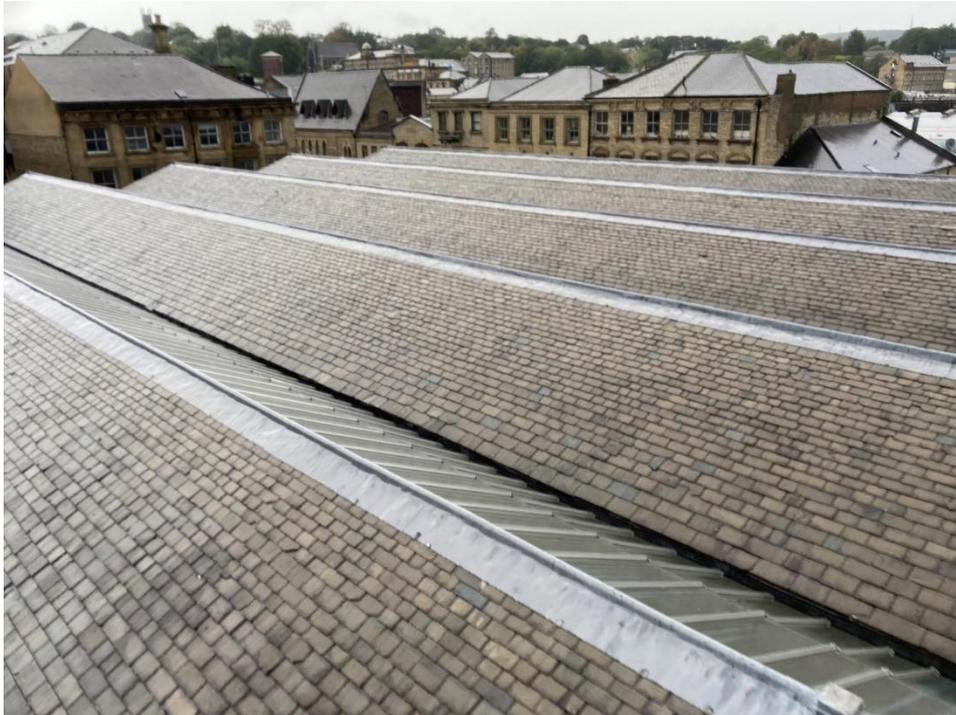
**3.** General view of slated pitches of roofs – generally in good condition, with a handful of slipped and missing slates

| | Observation | Recommendation |
|---|---|---|
| 3 | Roofs are in generally good condition throughout, with small, localised areas of slipped and cracked slates (c. 5% throughout). | Undertake a scheme of small-scale repairs to the roofs.<br>Access from above has been allowed for within the overall scaffolding costs. |

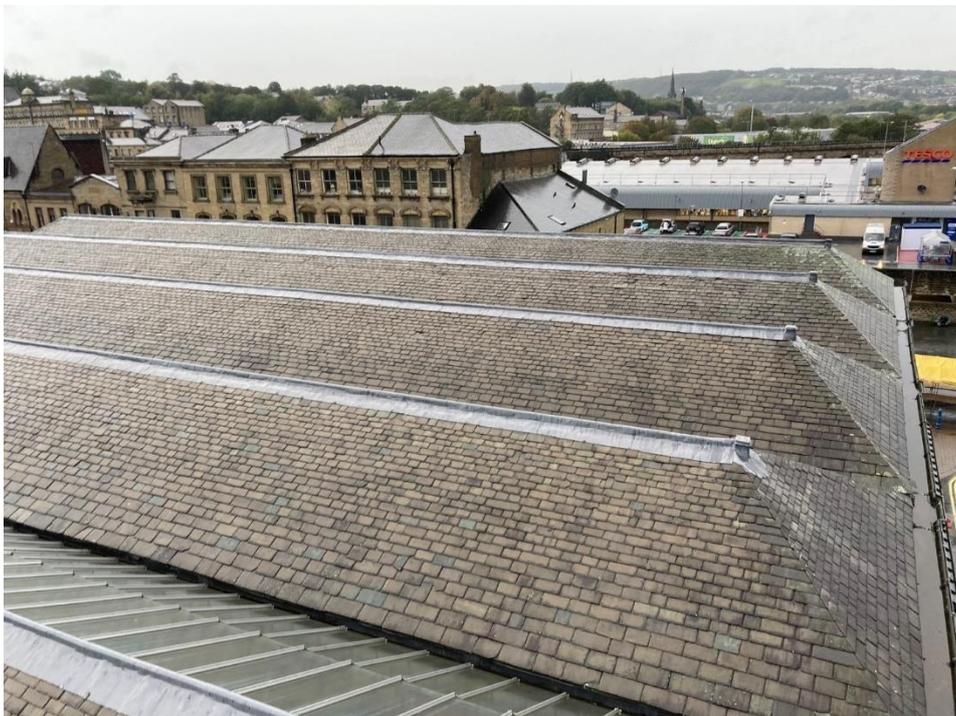
**4.** General view of slated pitches of roofs –as above

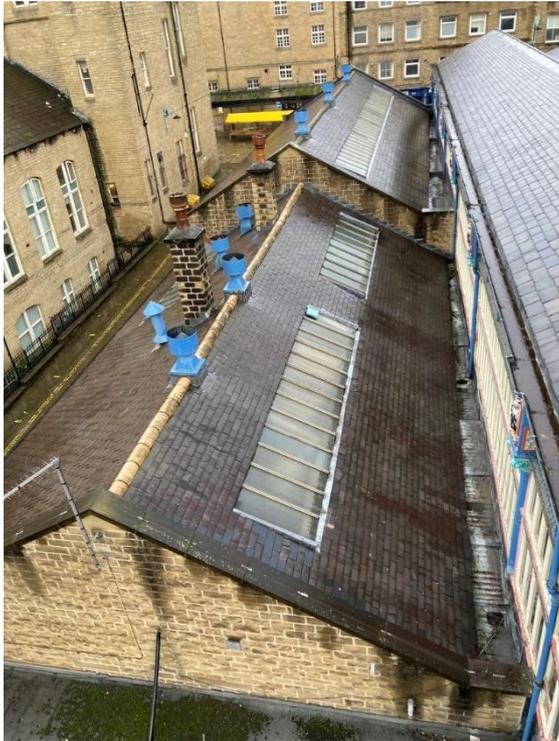
| 3 | Stone extension: mortar pointing to stone parapet wall capping has failed and the elevation affected by water ingress through the joints. | Repoint. |

7. General view of stone extension roofs (ER1 and ER2) – note the redundant vents and saturation of stonework due to failure of parapet coping jointing

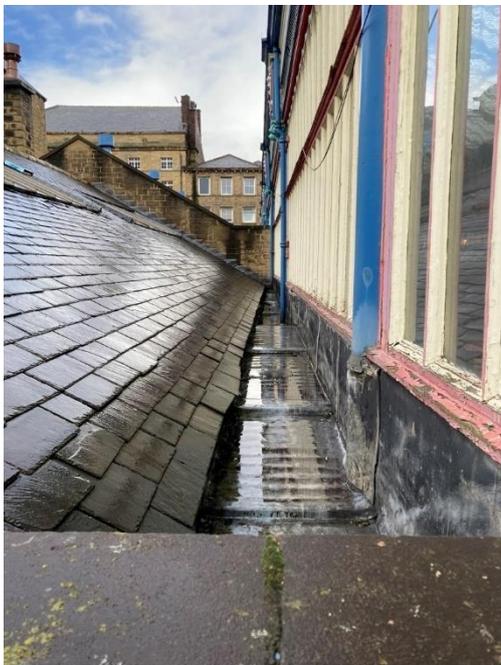
| 3 | <p>Valley gutter between extension and main building is lead-lined, wide and in good condition with minor soil build-up.</p> | <p>Clean down and monitor.</p> |

8. Box gutter between main market building and stone extension

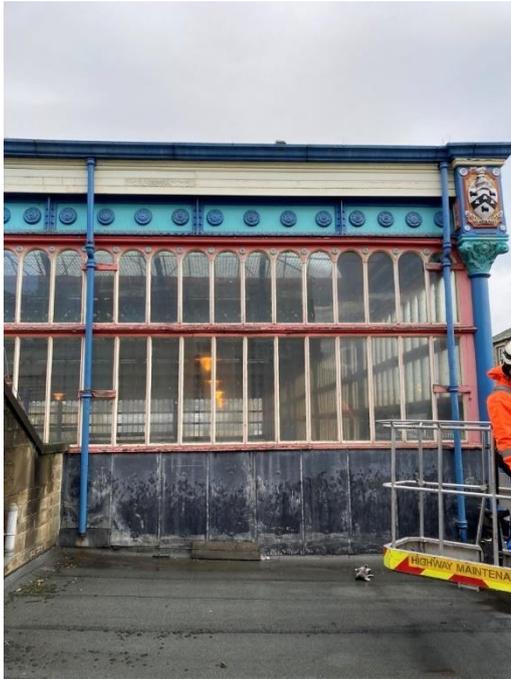
9. Bay 6 of the Back Street elevation of the main market – window frame has significant rot to bottom bar and glazing has dropped

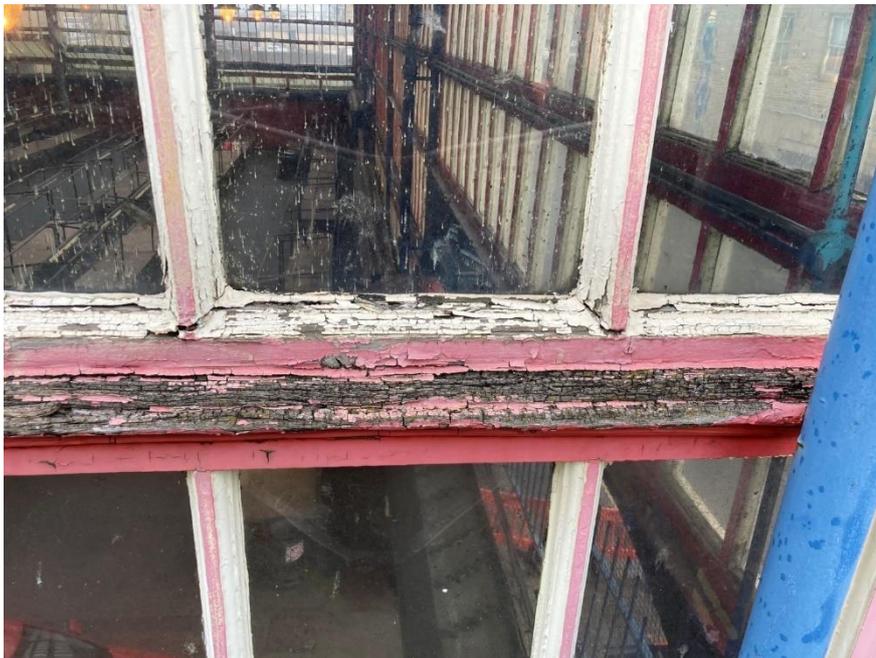
10. Bay 6 of the Back Street elevation of the main market – window frame has significant rot to bottom bar

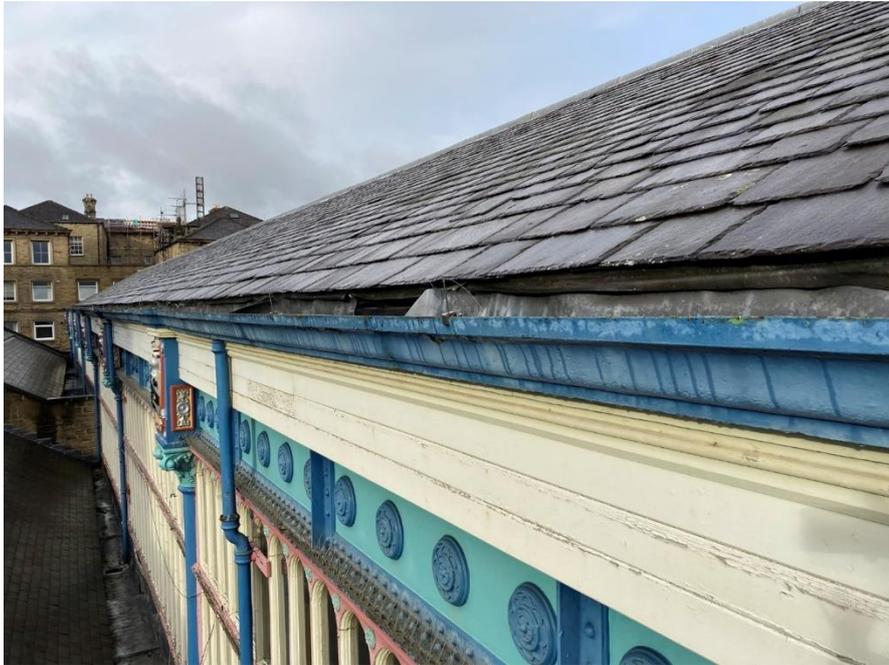
| 3 | External timber (fascias and cornice) has a failed decorative finish and weathering. | A percentage allowance for timber repairs to this section should be accounted for. Otherwise, rub down and redecorate. |

| Item | Façade | Bay | Element (Asset Group) | Component (Asset Description) | Specific Defect | Repair Action | Condition rating | Priority rating | Cost | Eligible for HE funding | Priority 1 | Priority 2 | Priority 3 |
|---|---|---|---|--|---|--|---|---|---|---|---|---|---|
| 1.4 | | R4 | | | Missing and detached sections of leadwork are present to the Back Street side of main market structure. | Renew. | C | 2 | £ | | | | |

**11.** Back Street elevation of the main market – missing leadwork and typical condition of fascia board with decorative finish failing but minimal amounts of rot

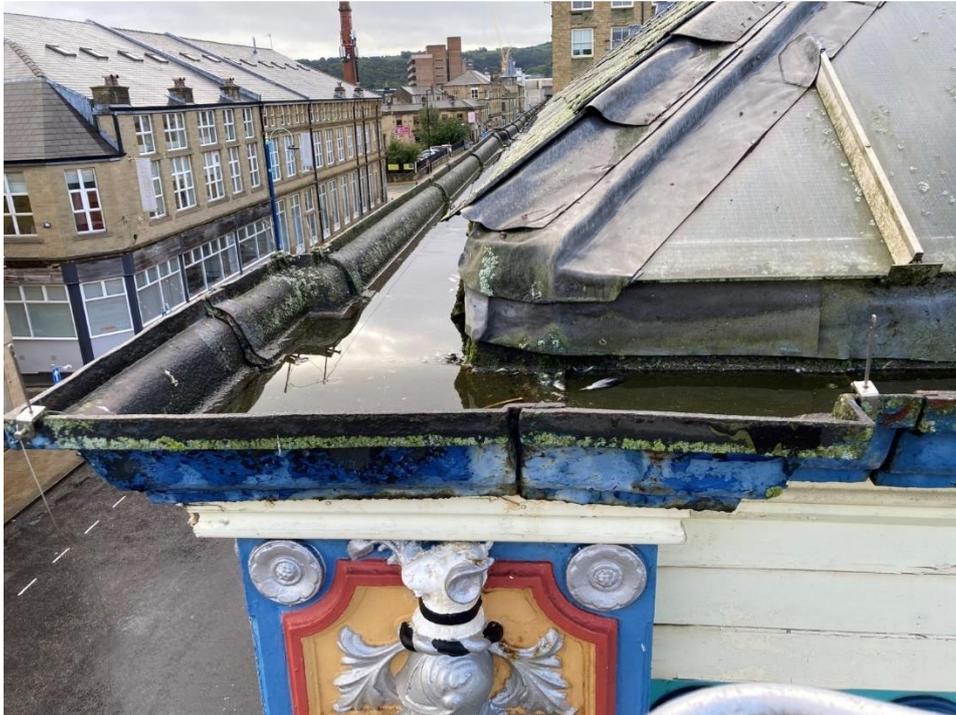
| 3 | <p>Perimeter gutters: throat to outlet is bigger than the downpipe by some degree and causes issues during heavy rainfall.</p> <p>Perimeter gutters have recently been cleaned, but are corroded, with flaking ironwork. Joints leaking and rusting, with rainwater affecting materials and finishes below the gutters.</p> | <p>Remove all flaking material, then prime ready for re-lining. Fill all joints. Reline the entirety of the gutter with liquid gutter liner and gutter repair system.</p> |

| Item | Façade | Bay | Element (Asset Group) | Component (Asset Description) | Specific Defect | Repair Action | Condition rating | Priority rating | Cost | Eligible for HE funding | Priority 1 | Priority 2 | Priority 3 |
|---|---|---|---|--|---|--|---|---|---|---|---|---|---|
| 1.6 | | Main | Gutters | Cast iron moulded perimeter gutters, painted blue. | Gutters themselves are corroded, with flaking ironwork. Joints leaking and rusting, with rainwater affecting materials and finishes below the gutters. | Remove all flaking material, then prime ready for re-lining. Fill all joints. Reline the entirety of the gutter with liquid gutter liner and gutter repair system. | C | 2 | £ | | | | |

15. Typical condition of perimeter gutters

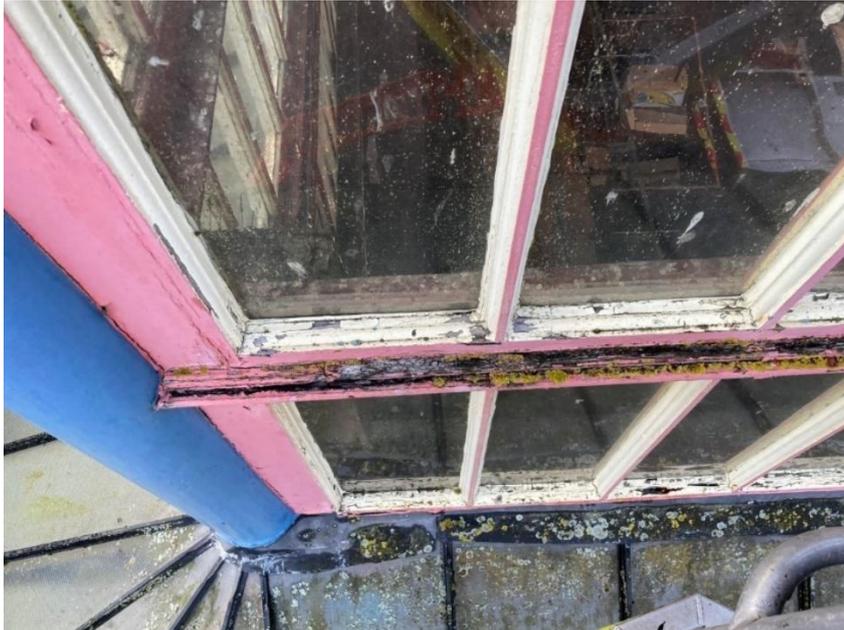
| <p>2</p> | <p>Failure of decorative finish and weathering of timber to window frames is present throughout. This is more significant to the Lord Street/Brook Street corner due to higher exposure to weather at this part of the site.</p> | <p>Circa 25% timber repairs required to the external elements, and circa 15% repairs to internal beading of windows, followed by filling, rubbing down and full redecoration of both faces. This issue is of significant scale given the building's design.</p> |

**17.** Bay 6 of Lord Street and Brook Street due to heightened weather exposure -

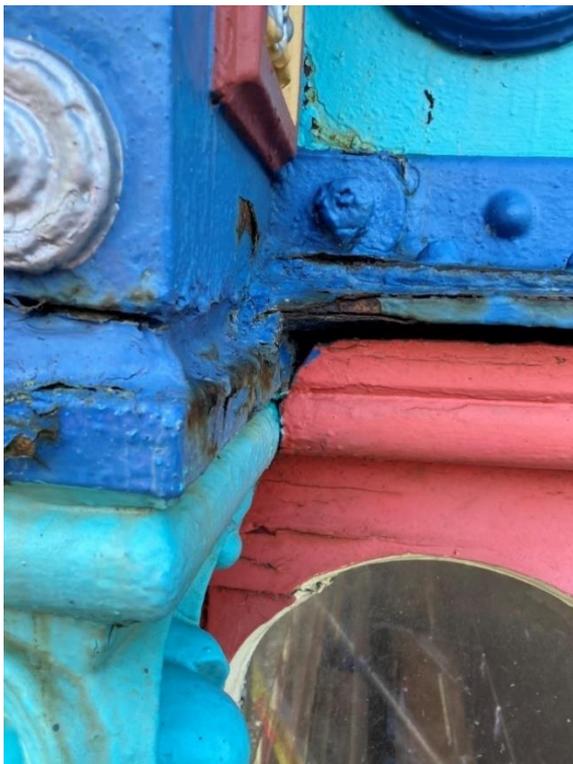
| <b>2</b> | <p>There is very little visible damage to the cast iron upon inspection but there is some minor loss of section to the flanges of the steel work to beam-to-column connections at fascia level, as well as delamination of flange to exposed east corner. A structural engineer should be appointed to review the whole structure and specify any relevant works to the beam-to-column connection.</p> <p>There are two cracks to the spandrels of the northernmost vehicle entrance on Lord Street. Cold repair techniques should be employed for repairs such as straps, metal stitching, threaded studs and/or bonding using epoxy resin. This can be done in situ.</p> |

**18.** Slight loss of section on flange of beam-to-column connection

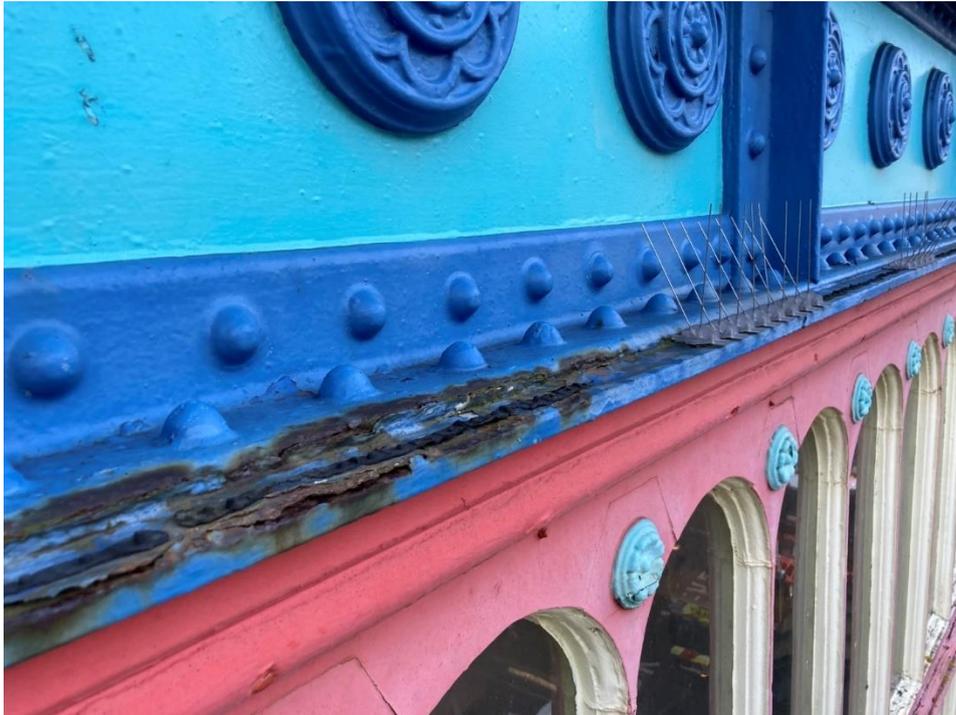
19. Delamination of flange to exposed east corner

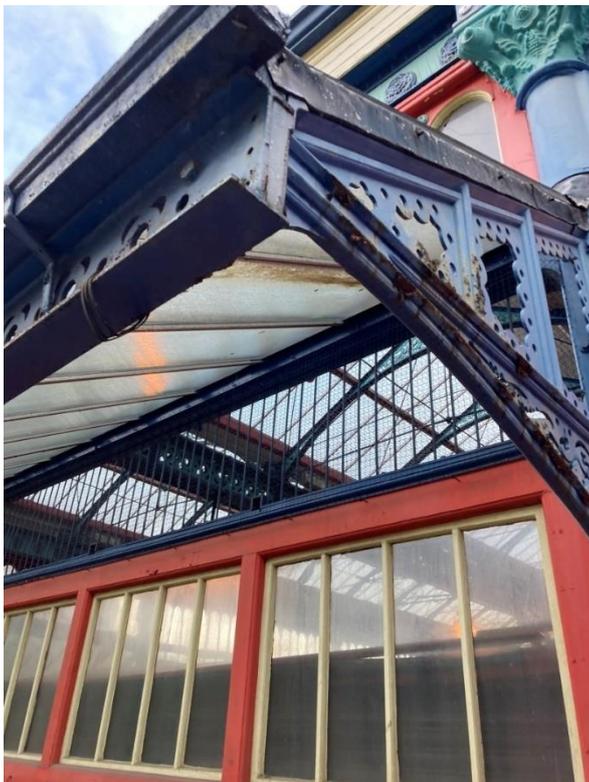
| 3 | Cast iron spandrels with perforated decorative detail to canopy throughout have heavier corrosion than elsewhere. | As with the other cast iron elements, the spandrels should be cleaned back to a sound surface. Redecorate cast iron frame, using appropriate paints and a zinc rich primer. Further details are to be supplied within the specialist paint report. |

20. Corrosion of canopy spandrels – typical throughout

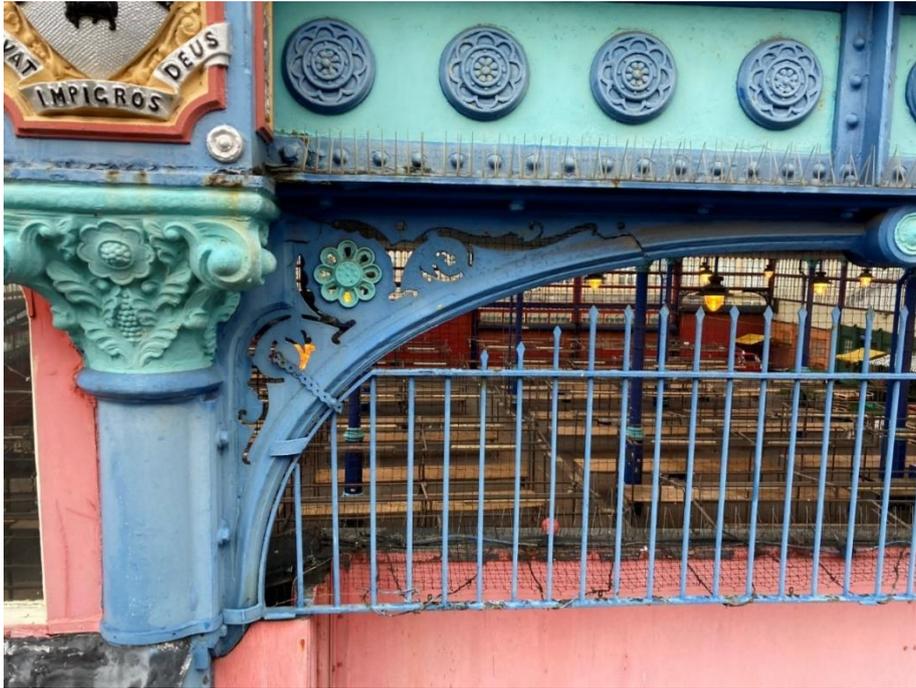
| | Observation | Recommendation |
|---|--|--|
| 3 | There are two cracks to the spandrels of the vehicle entrances on Lord Street and Byram Street. | Following structural review, a mixture of cold and hot work techniques should be employed to repair the spandrels. A relevant specialist contractor has been engaged with, and costs have been included. |

21. Crack to spandrel on Byram Street

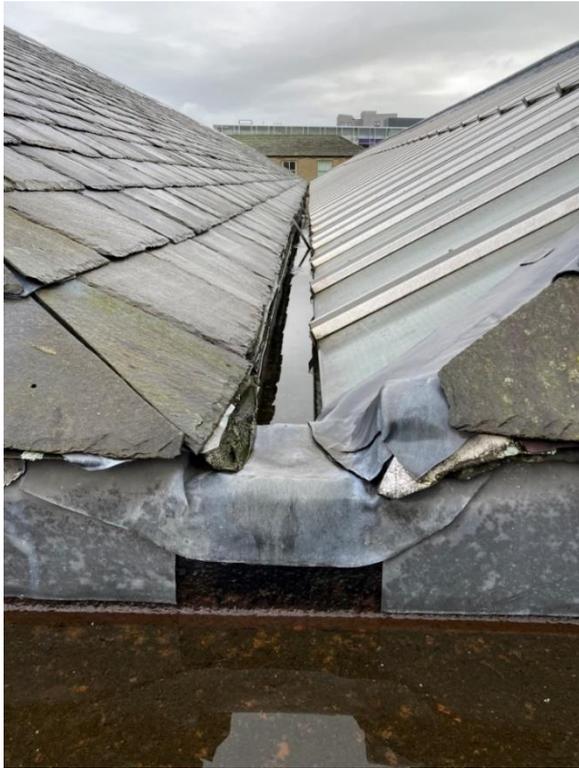
**22.** Typical condition of box gutter

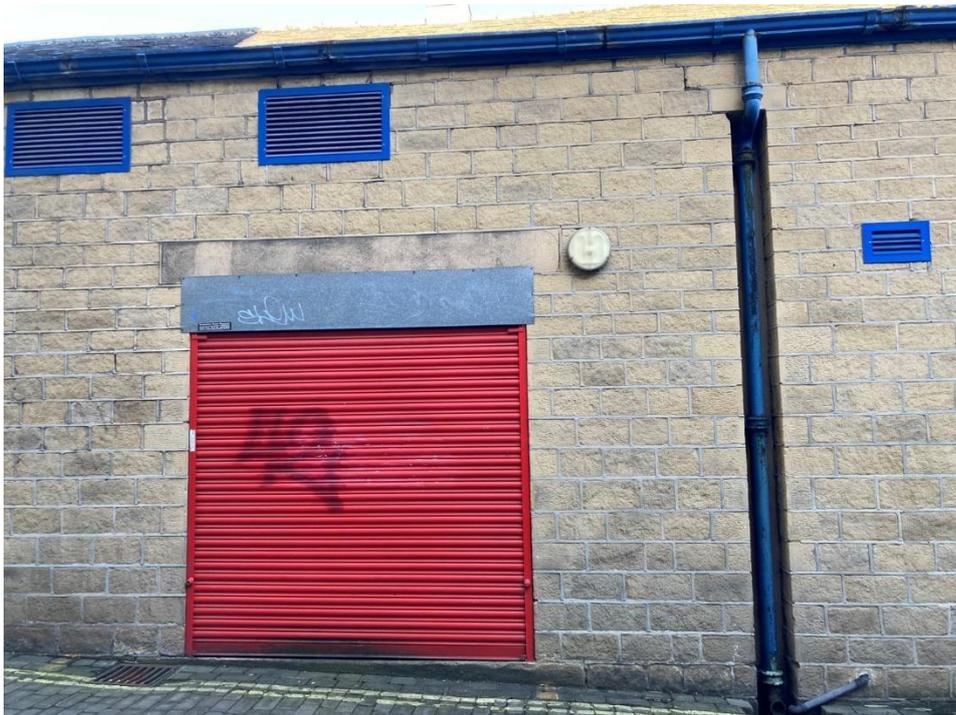
| <p>3</p> | <p>Mixture of cast iron and plastic downpipes are present externally to the stone extension. Two sections of downpipe are beyond repair and there is peeling and flaking paint throughout.</p> <p>Leaks and staining/build up to downpipe joints.</p> <p>Cast iron hoppers are present to Back Street and Lord Street, with lead throats. These regularly block with rubbish thrown by passersby.</p> | <p>Replace cast iron downpipes to match existing.</p> <p>Install mesh hoppers to prevent blockages.</p> |

| 3 | Stone extension: there are minor areas of mortar loss and washout on each elevation, as well as one cracked area. | Repoint.<br>Install Helifix ties to the cracked areas and repoint. |

25. Back Street elevation of stone extension – corroded downpipe and cracking to masonry

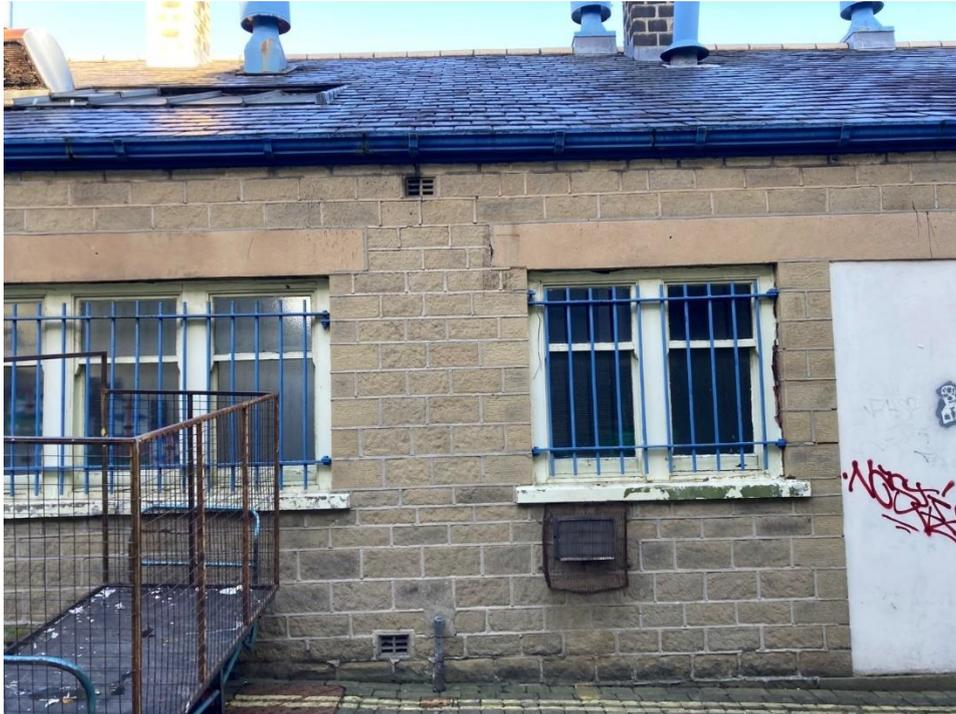
26. Back Street elevation of stone extension – typical condition of windows

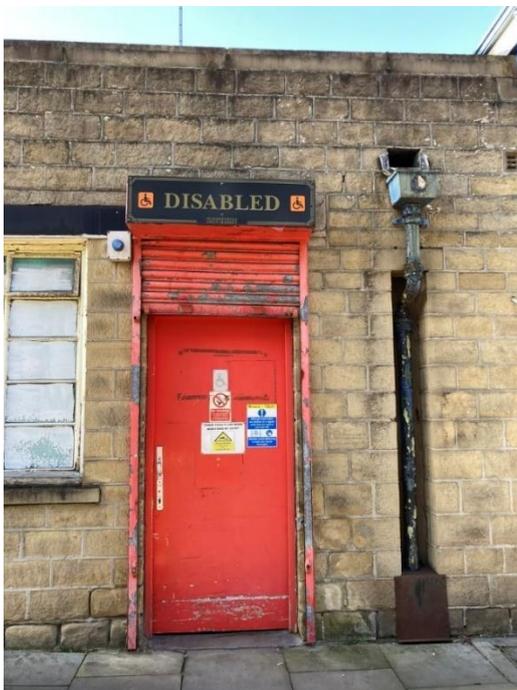
27. Lord Street elevation of stone extension – note cracking to lintel behind roller shutter housing and typical condition of cast iron downpipe

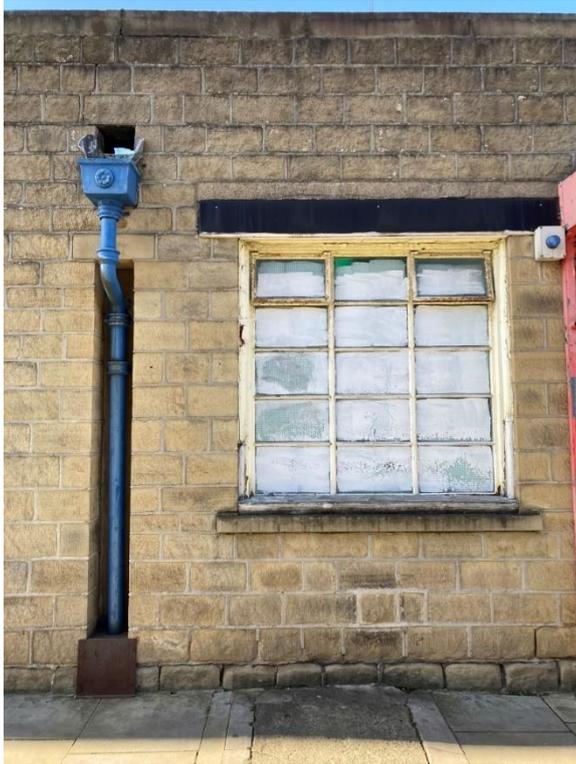
**28.** Lord Street elevation of stone extension – poor decorative condition of metal-framed window and relatively open hopper to downpipe (blocked)

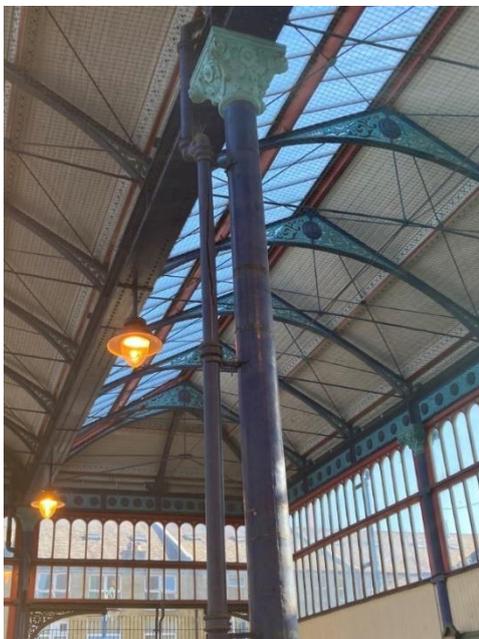
| <p>3</p> | <p>In fair condition generally with ad hoc issues with blockages.</p> <p>D9 has a large vertical crack + D14 has multiple patch repairs and a poor connection into below ground drainage.</p> | <p>D9 and D14 should be replaced to match existing.</p> <p>Downpipe D5 has water cascading down the outside of the pipe during heavy rain, affecting electrical equipment below. Install sealant to throat of gutter and downpipe to ensure proper rainwater flow.</p> |

**29.** Downpipe (D9) cracked and general view of netting

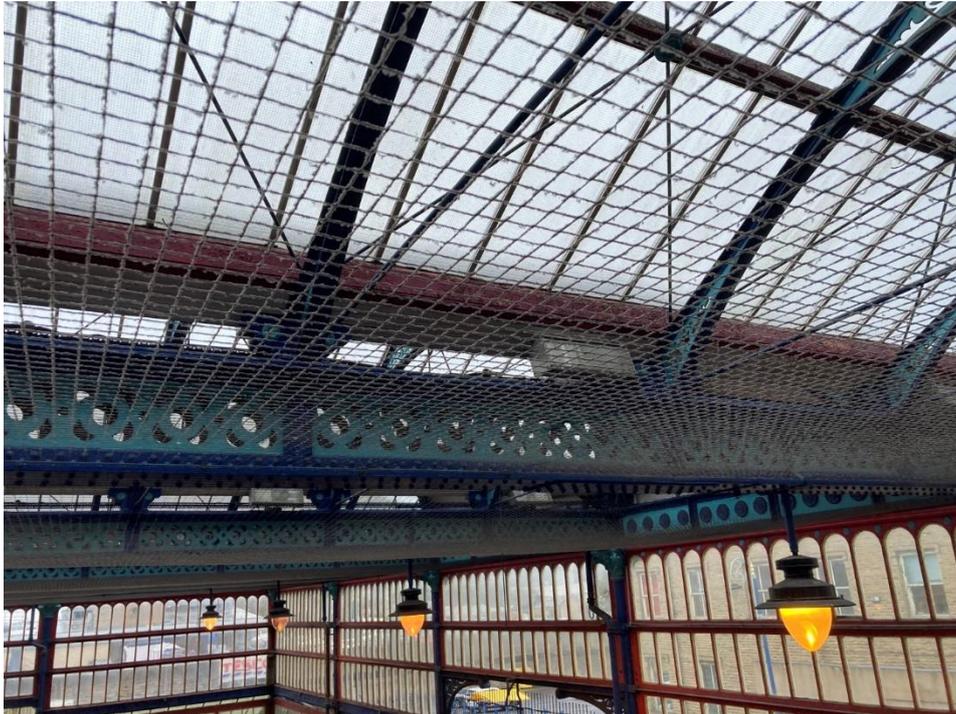
30. Closeup of netting showing general build up of soil

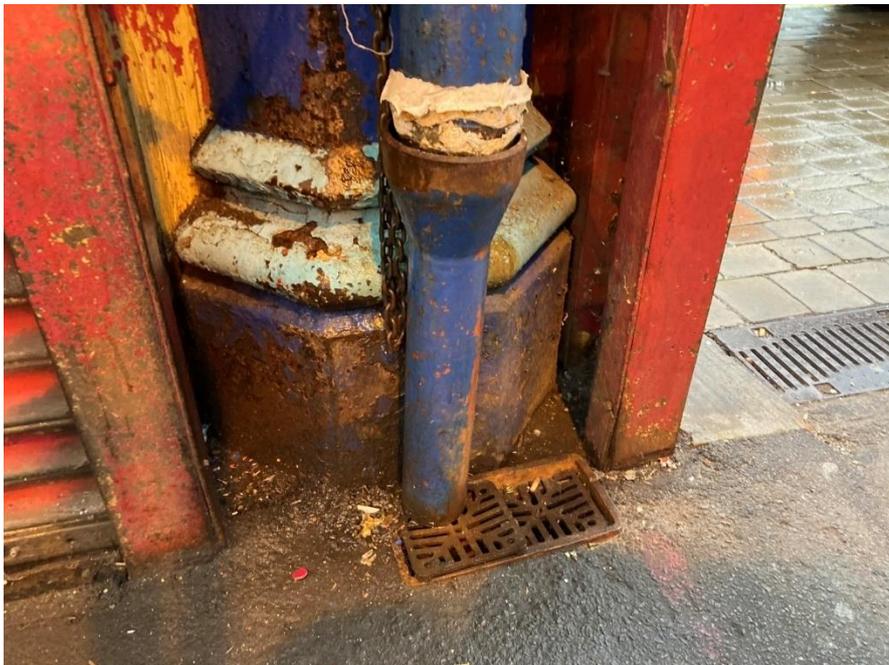
31. Downpipe (D14) with poor connection between lengths and into below ground drainage

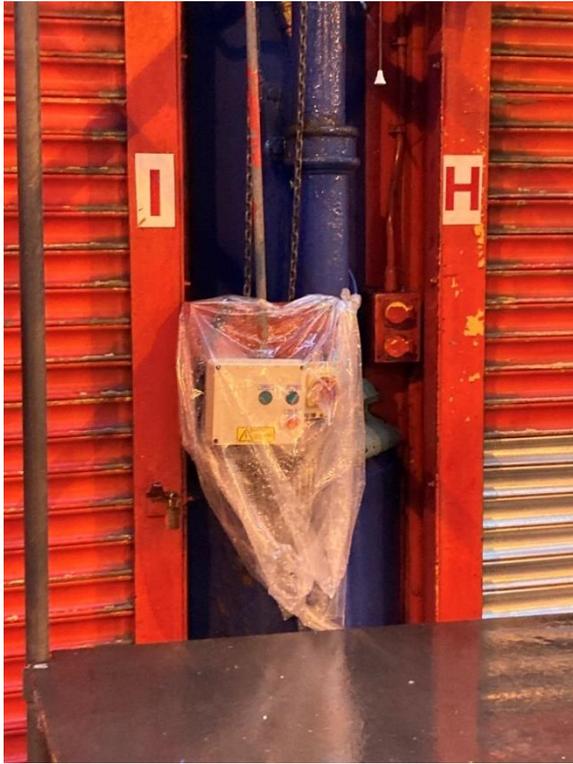
| | Observation | Recommendation |
|---|--|--|
| 2 | Site staff report M&E difficulties during events, and heavy rainwater was witnessed in the area of electrical equipment via downpipe leaks. | M&E testing of services, including inspection and reporting of all LL equipment with a view to proposed future usage should be undertaken. |

**32.** Blocked downpipe (D5) has resulted in water cascading onto electrics (roller shutter mechanism)

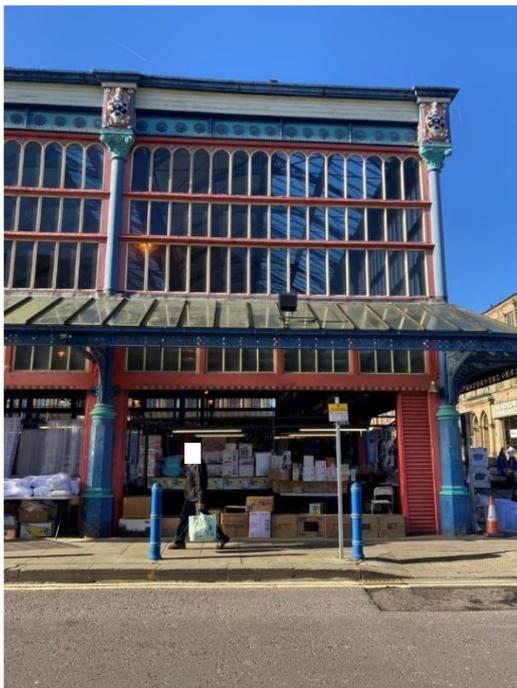
**33.** Bay 6 of Lord Street – a more exposed location with a corresponding higher amount of repairs

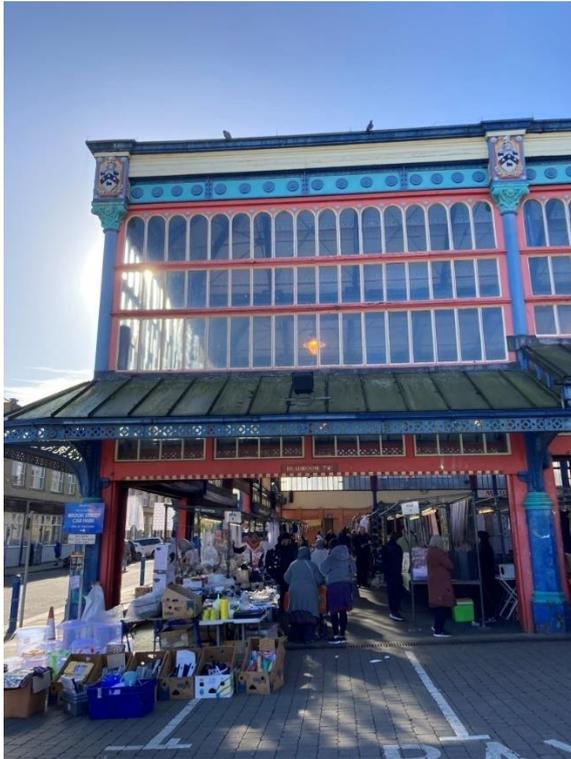
**34.** Bay 6 of Byram Street – a more exposed location with a corresponding higher amount of repairs
