# **Condition Report**

Huddersfield Open Market  
Brook Street  
Huddersfield  
HD1 1RY

**Report Date**  
06 November 2023

**Client:** Kirklees Council

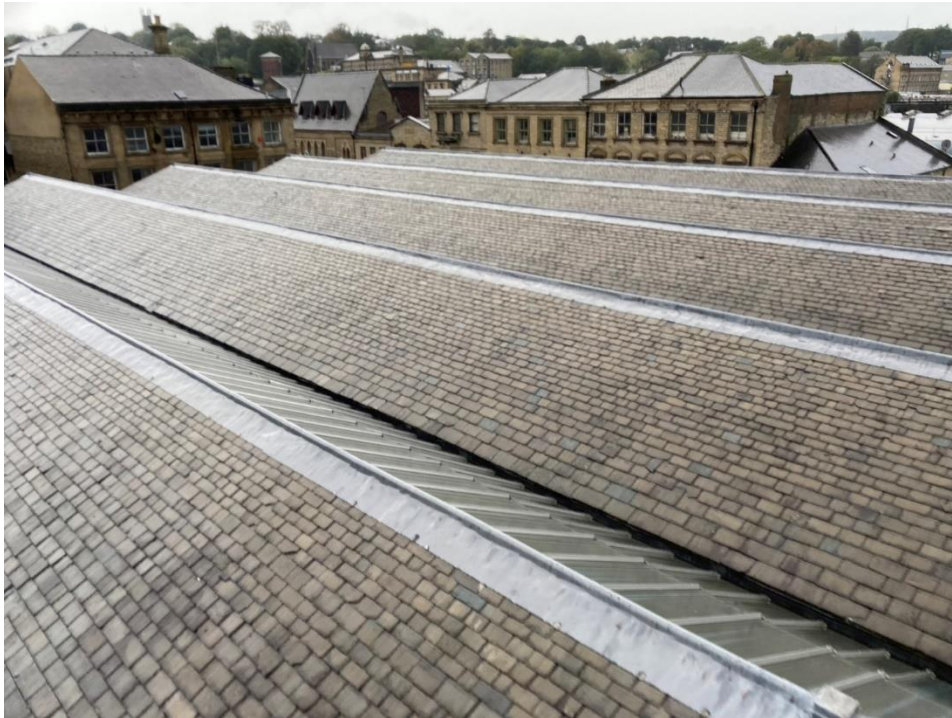
| | Observation | Recommendation |
|---|---|---|
| 3 | Roofs are in generally good condition throughout, with small, localised areas of slipped and cracked slates (c. 5% throughout). | Undertake a scheme of small-scale repairs to the roofs.<br><br>Access from above has been allowed for within the overall scaffolding costs. |

**3.** General view of slated pitches of roofs – generally in good condition, with a handful of slipped and missing slates

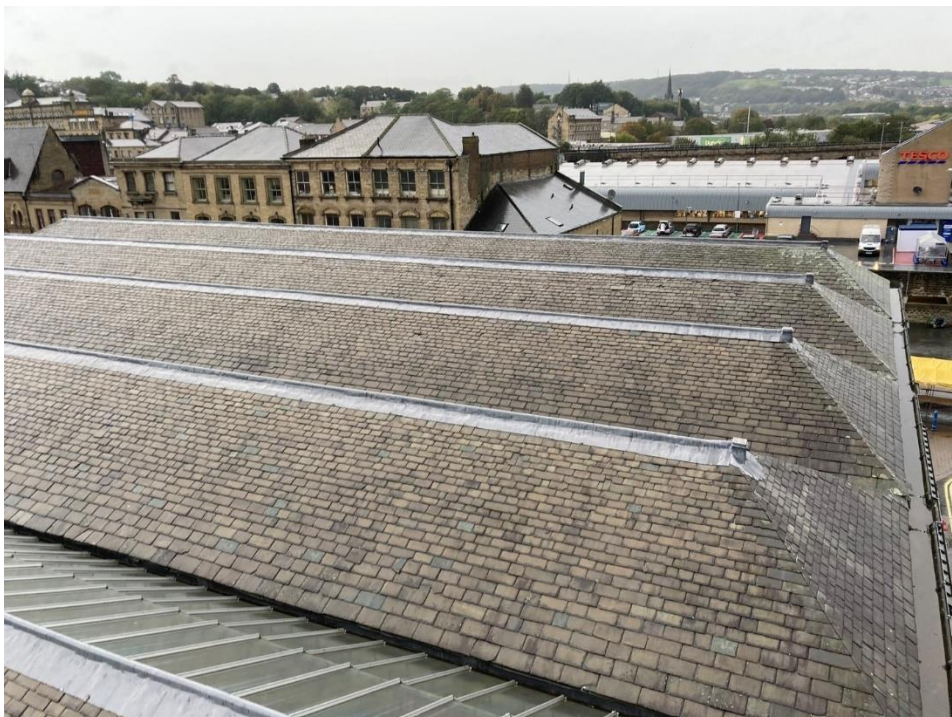
**4.** General view of slated pitches of roofs –as above

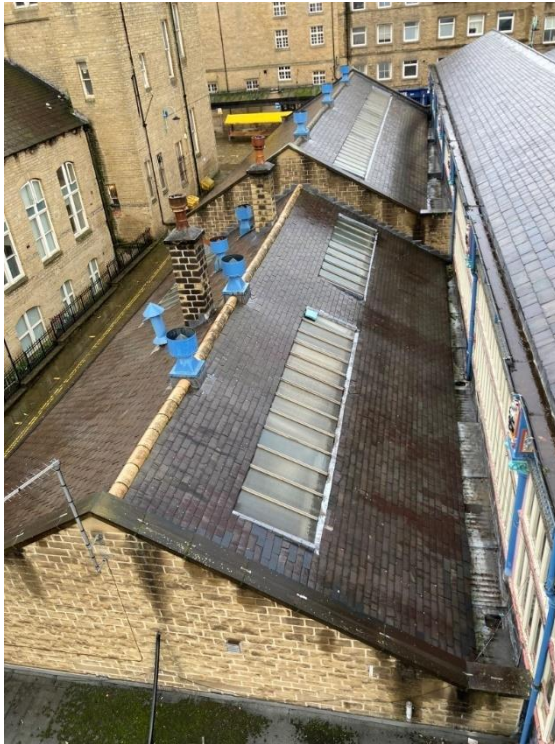
| 3 | Stone extension: mortar pointing to stone parapet wall capping has failed and the elevation affected by water ingress through the joints. | Repoint. |

7. General view of stone extension roofs (ER1 and ER2) – note the redundant vents and saturation of stonework due to failure of parapet coping jointing

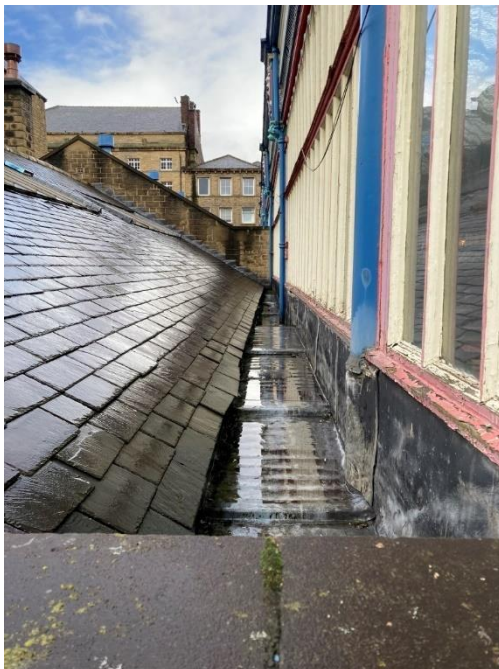
| 3 | <p>Valley gutter between extension and main building is lead-lined, wide and in good condition with minor soil build-up.</p> | <p>Clean down and monitor.</p> |

8. Box gutter between main market building and stone extension

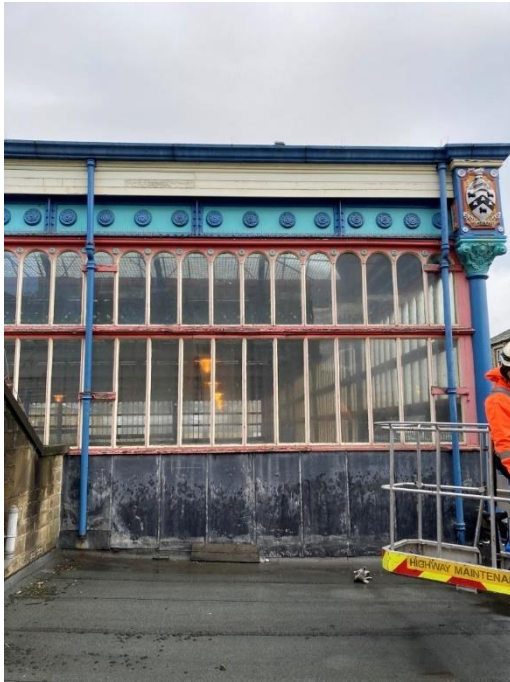
**9.** Bay 6 of the Back Street elevation of the main market – window frame has significant rot to bottom bar and glazing has dropped

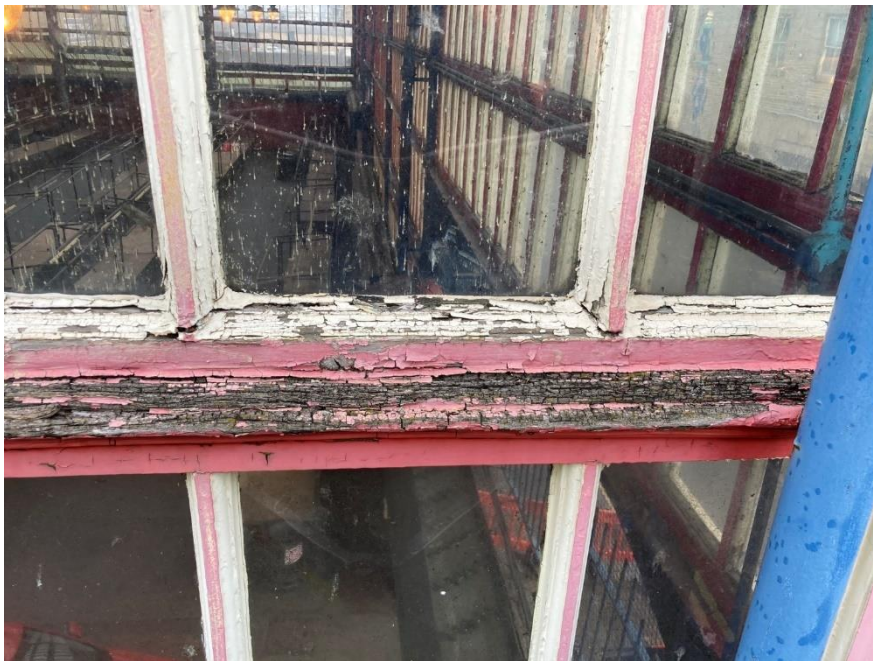
**10.** Bay 6 of the Back Street elevation of the main market – window frame has significant rot to bottom bar

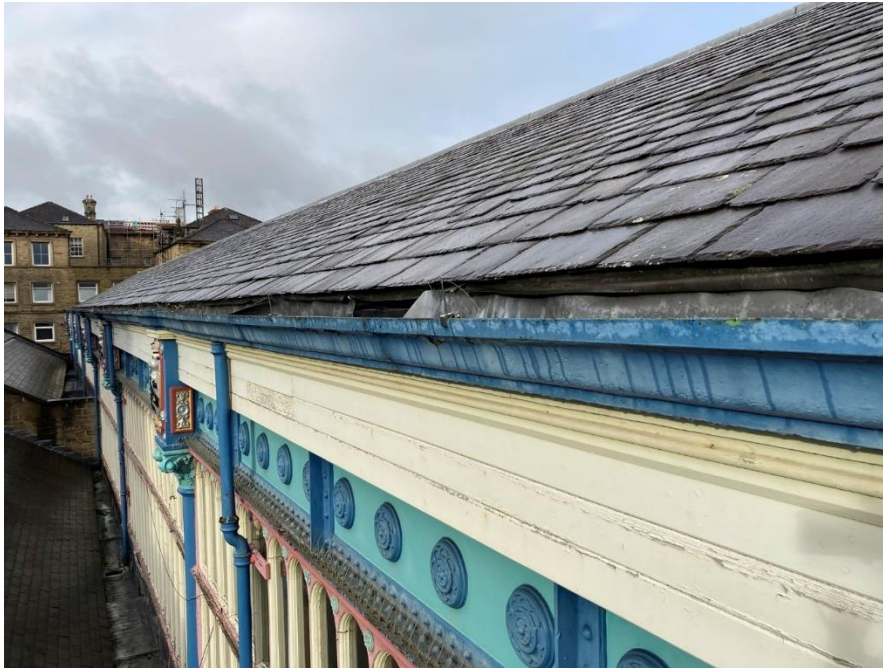
| Item | Façade | Bay | Element<br>(Asset Group) | Component<br>(Asset Description) | Specific Defect | Repair Action | Condition<br>rating | Priority<br>rating | Cost | Eligible for HE<br>funding | Priority 1 | Priority 2 | Priority 3 |
|---|---|---|---|---|---|---|---|---|---|---|---|---|---|
| 1.4 | | R4 | | | Missing and detached sections of leadwork are present to the Back Street side of main market structure. | Renew. | C | 2 | £ | | | | |

**11.** Back Street elevation of the main market – missing leadwork and typical condition of fascia board with decorative finish failing but minimal amounts of rot

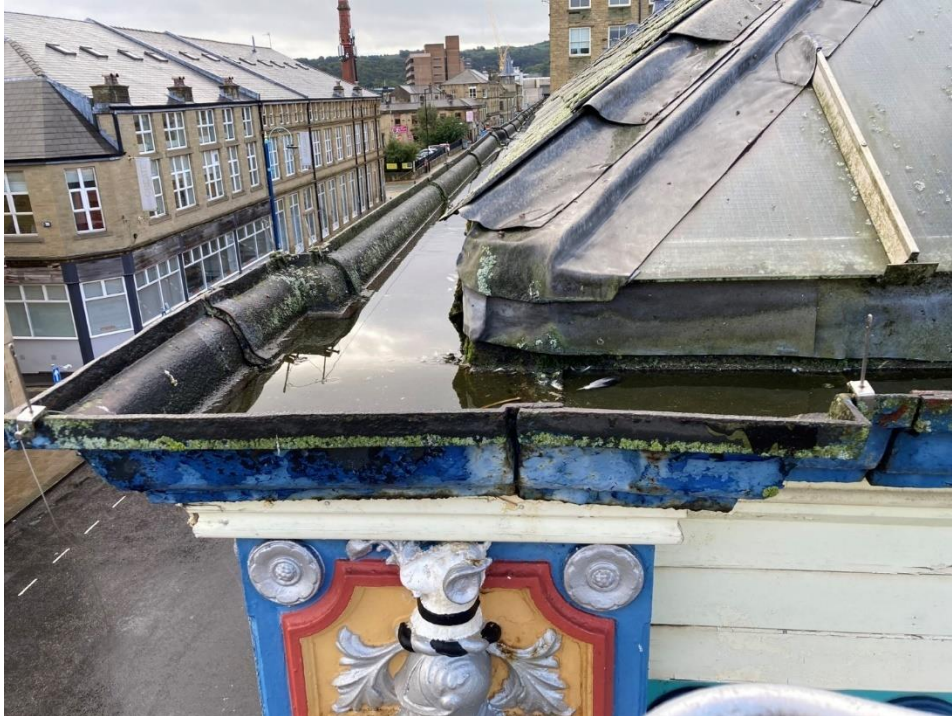
| 3 | <p>Perimeter gutters: throat to outlet is bigger than the downpipe by some degree and causes issues during heavy rainfall.</p> <p>Perimeter gutters have recently been cleaned, but are corroded, with flaking ironwork. Joints leaking and rusting, with rainwater affecting materials and finishes below the gutters.</p> | <p>Remove all flaking material, then prime ready for re-lining. Fill all joints. Reline the entirety of the gutter with liquid gutter liner and gutter repair system.</p> |

**15.** Typical condition of perimeter gutters

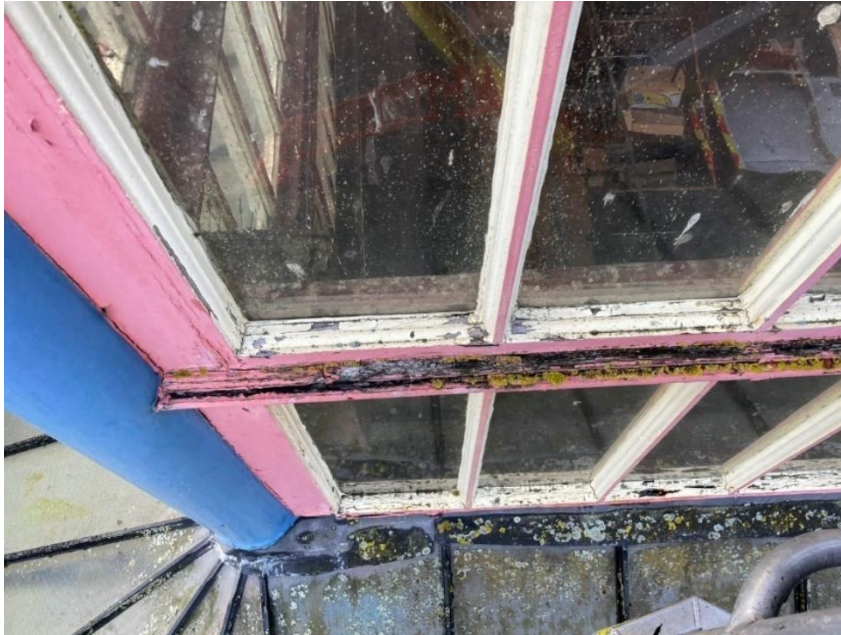
**17.** Bay 6 of Lord Street and Brook Street due to heightened weather exposure -

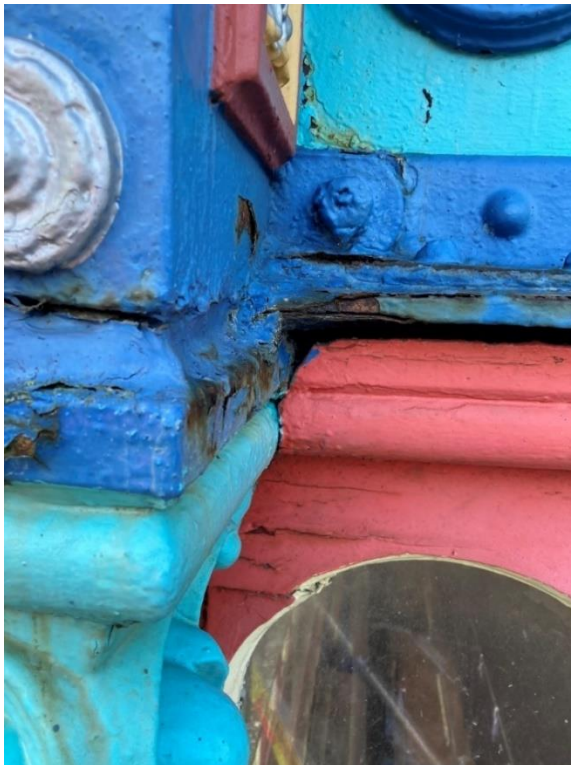
| 2 | <p>There is very little visible damage to the cast iron upon inspection but there is some minor loss of section to the flanges of the steel work to beam-to-column connections at fascia level, as well as delamination of flange to exposed east corner. A structural engineer should be appointed to review the whole structure and specify any relevant works to the beam-to-column connection.</p> <p>There are two cracks to the spandrels of the northernmost vehicle entrance on Lord Street. Cold repair techniques should be employed for repairs such as straps, metal stitching, threaded studs and/or bonding using epoxy resin. This can be done in situ.</p> |

**18.** Slight loss of section on flange of beam-to-column connection

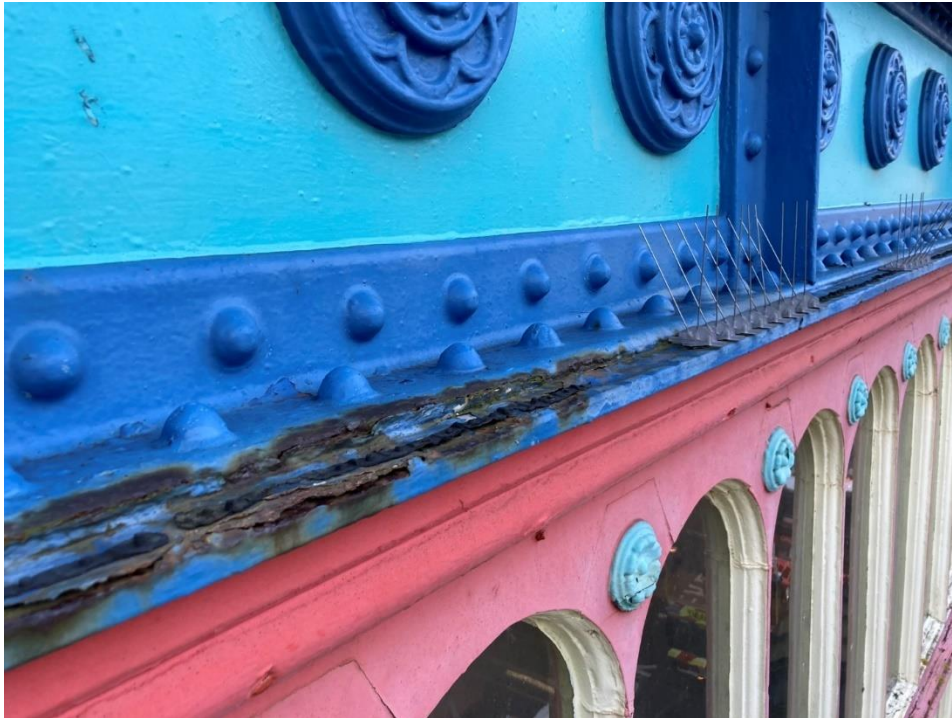
**19.** Delamination of flange to exposed east corner

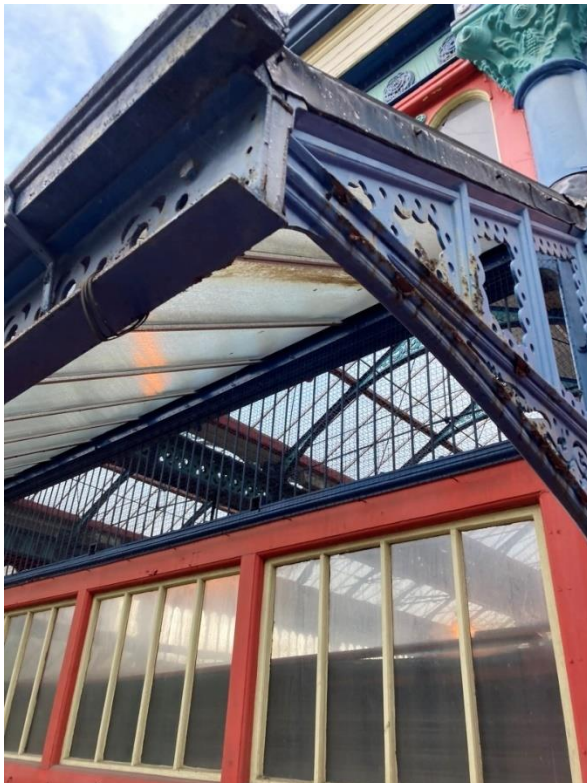
| 3 | Cast iron spandrels with perforated decorative detail to canopy throughout have heavier corrosion than elsewhere. | As with the other cast iron elements, the spandrels should be cleaned back to a sound surface. Redecorate cast iron frame, using appropriate paints and a zinc rich primer. Further details are to be supplied within the specialist paint report. |

**20.** Corrosion of canopy spandrels – typical throughout

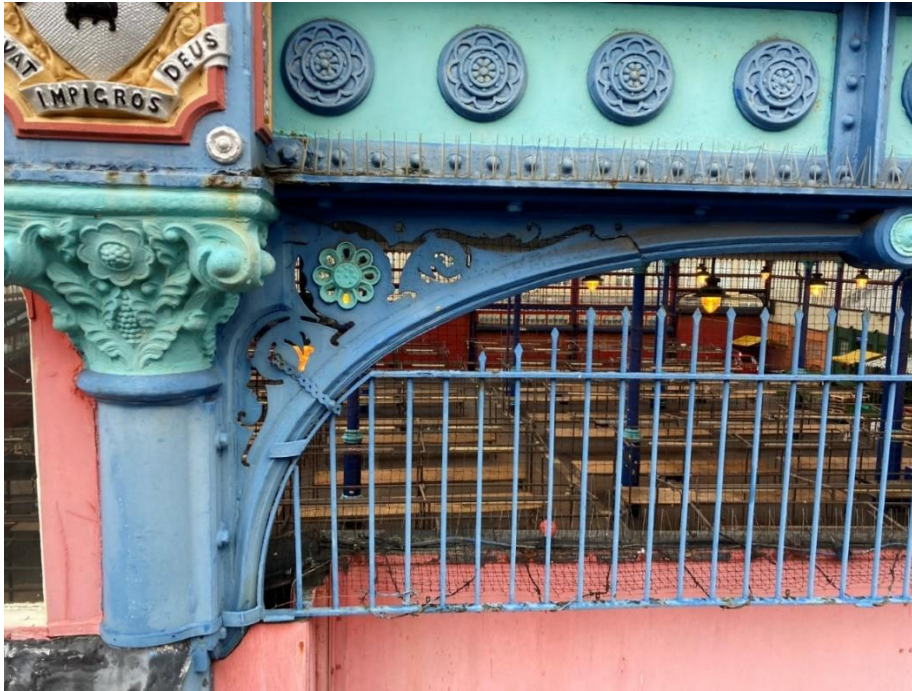
| | Observation | Recommendation |
|---|---|---|
| 3 | There are two cracks to the spandrels of the vehicle entrances on Lord Street and Byram Street. | Following structural review, a mixture of cold and hot work techniques should be employed to repair the spandrels. A relevant specialist contractor has been engaged with, and costs have been included. |

**21.** Crack to spandrel on Byram Street

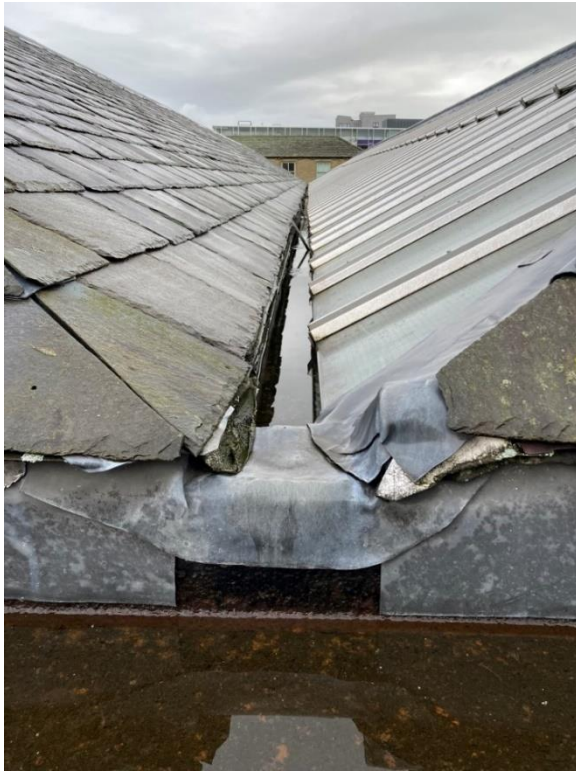
**22.** Typical condition of box gutter

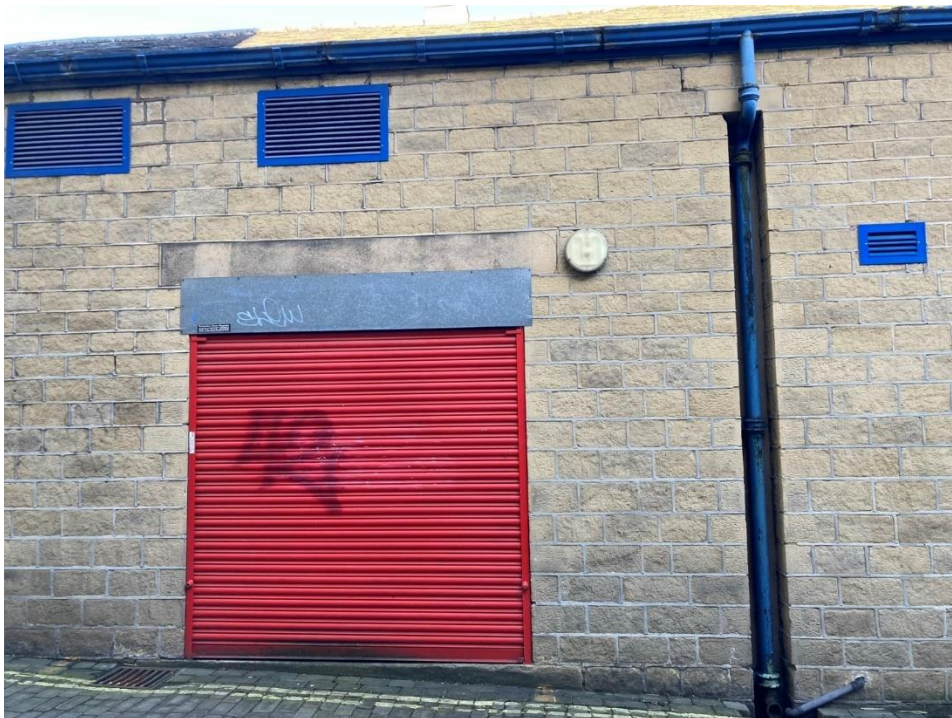
**25.** Back Street elevation of stone extension – corroded downpipe and cracking to masonry

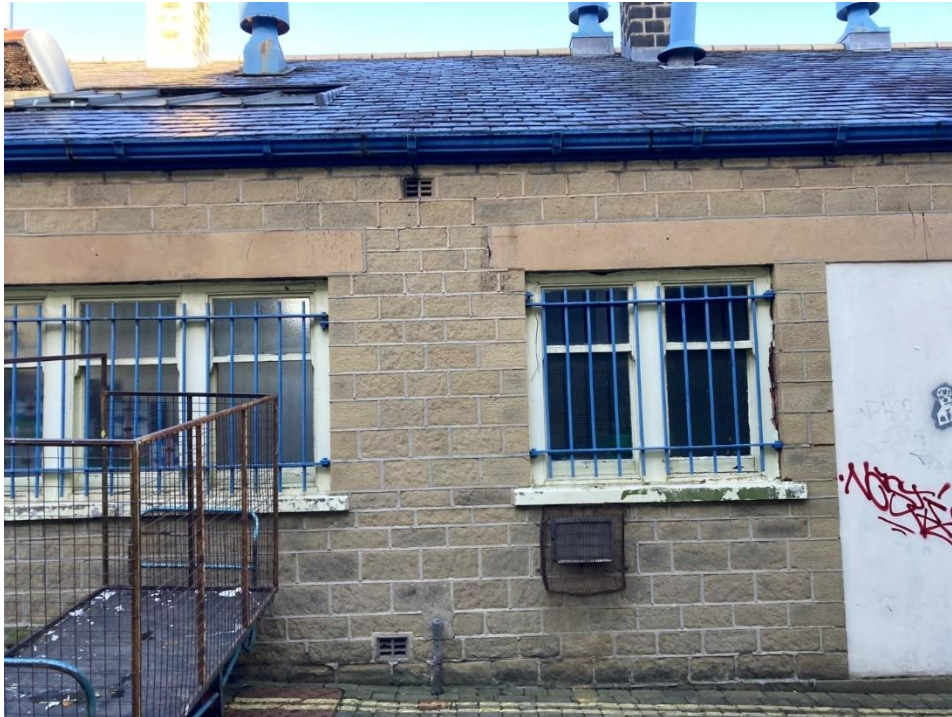
**26.** Back Street elevation of stone extension – typical condition of windows

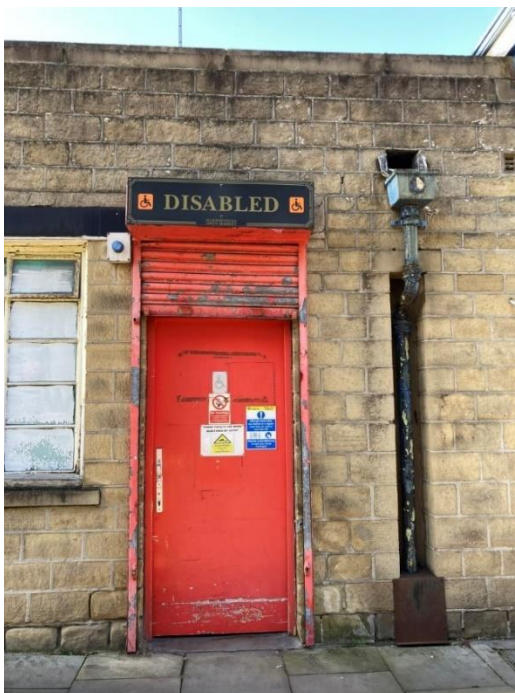
**27.** Lord Street elevation of stone extension – note cracking to lintel behind roller shutter housing and typical condition of cast iron downpipe

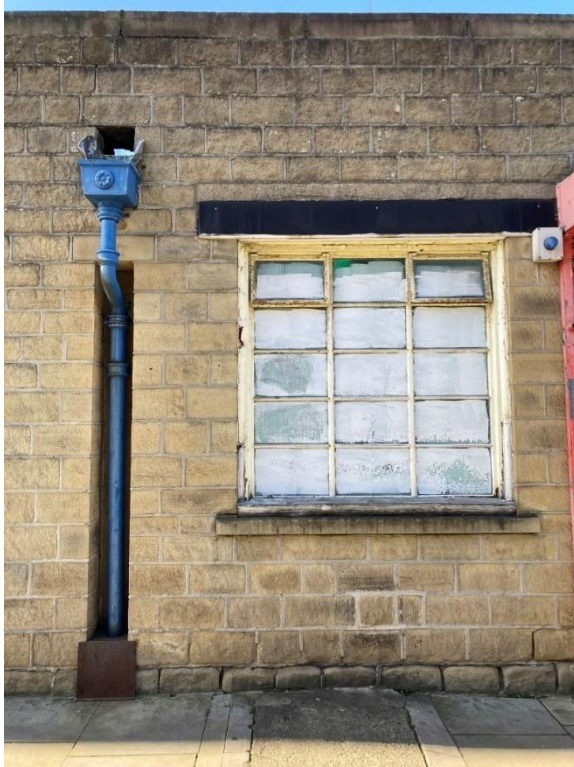
**28.** Lord Street elevation of stone extension – poor decorative condition of metal-framed window and relatively open hopper to downpipe (blocked)

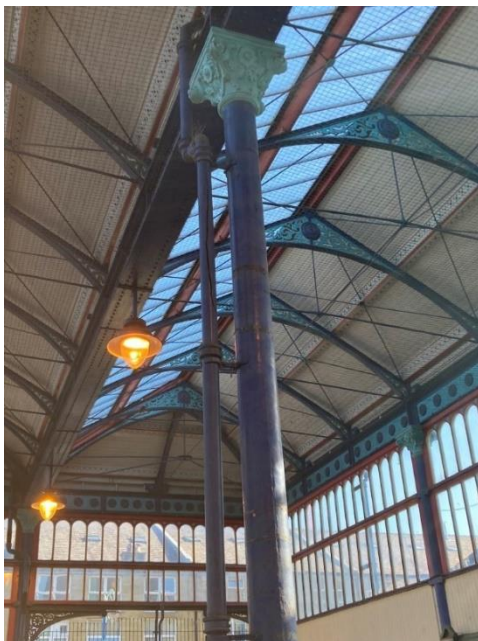
| 3 | <p>In fair condition generally with ad hoc issues with blockages.</p> <p>D9 has a large vertical crack + D14 has multiple patch repairs and a poor connection into below ground drainage.</p> | <p>D9 and D14 should be replaced to match existing.</p> <p>Downpipe D5 has water cascading down the outside of the pipe during heavy rain, affecting electrical equipment below. Install sealant to throat of gutter and downpipe to ensure proper rainwater flow.</p> |

**29.** Downpipe (D9) cracked and general view of netting

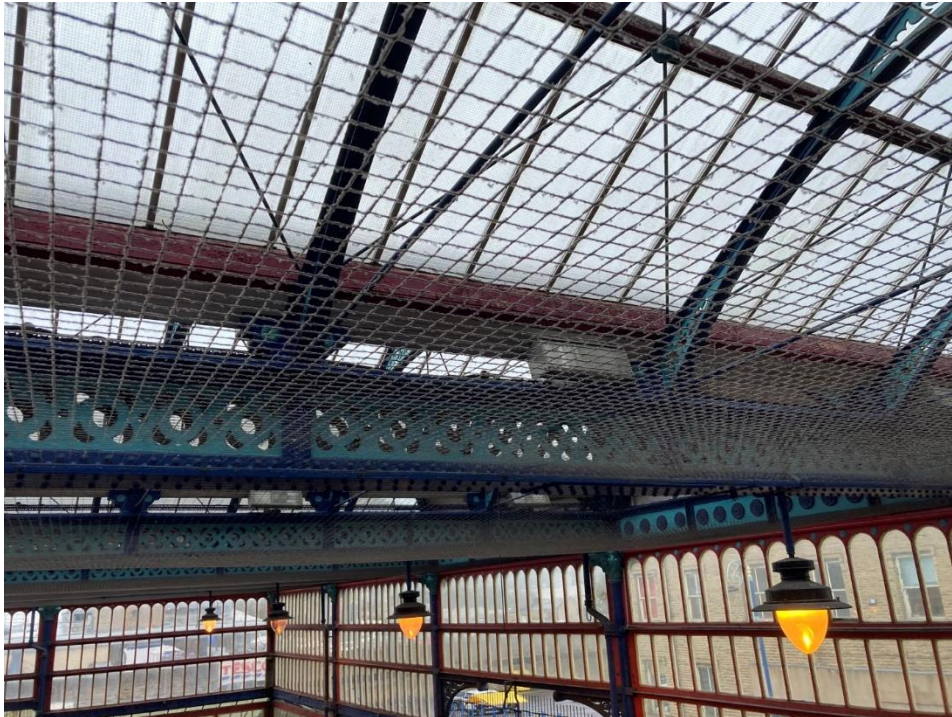
**30.** Closeup of netting showing general build up of soil

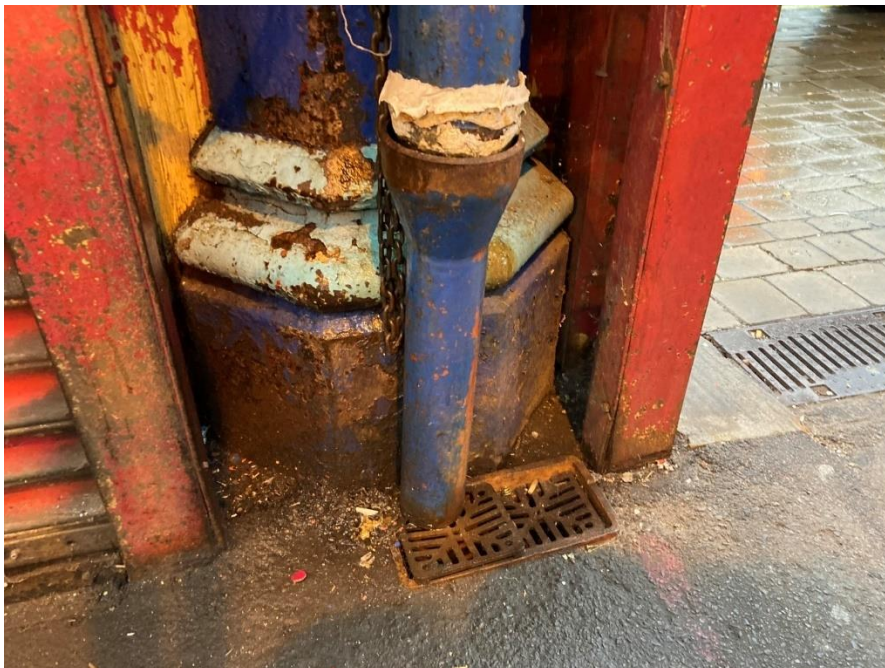
**31.** Downpipe (D14) with poor connection between lengths and into below ground drainage

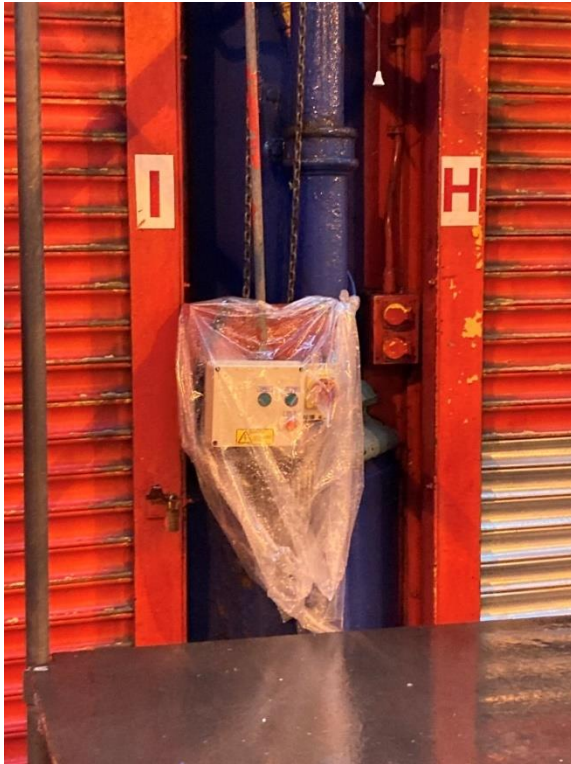
| | Observation | Recommendation |
|---|---|---|
| 2 | Site staff report M&E difficulties during events, and heavy rainwater was witnessed in the area of electrical equipment via downpipe leaks. | M&E testing of services, including inspection and reporting of all LL equipment with a view to proposed future usage should be undertaken. |

**32.** Blocked downpipe (D5) has resulted in water cascading onto electrics (roller shutter mechanism)

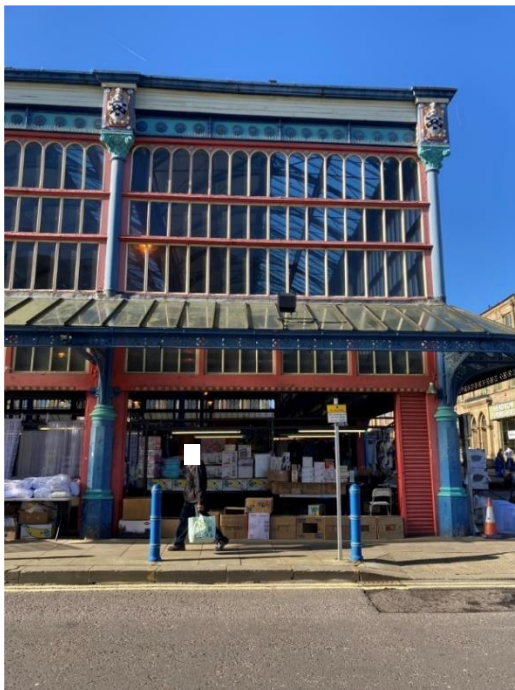
**33.** Bay 6 of Lord Street – a more exposed location with a corresponding higher amount of repairs

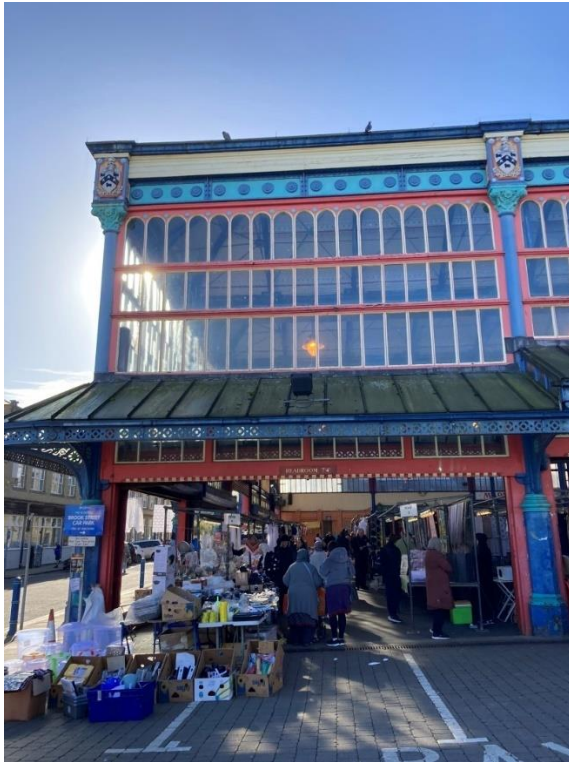
**34.** Bay 6 of Byram Street – a more exposed location with a corresponding higher amount of repairs

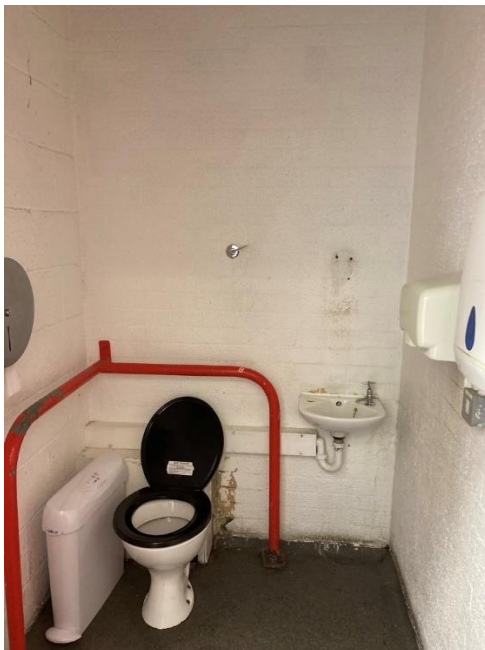
**35.** Typical condition of public WCs

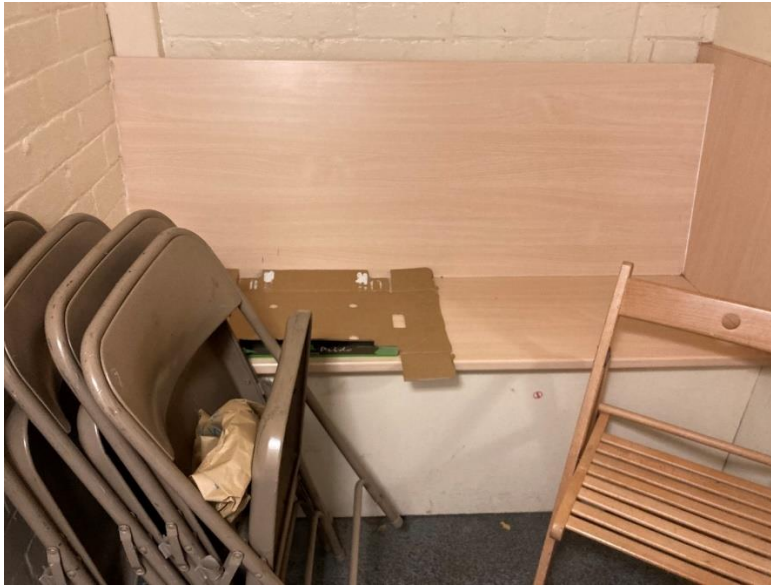
**36.** Typical condition of changing rooms

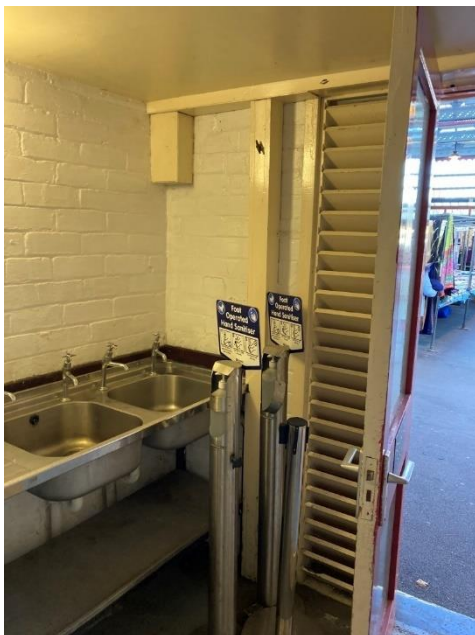
**37.** Typical condition of changing rooms
