**Project Name: Huddersfield Open Market**

Paint & mortar analysis

October 2021

Ref: 2021/22 [rev.1]

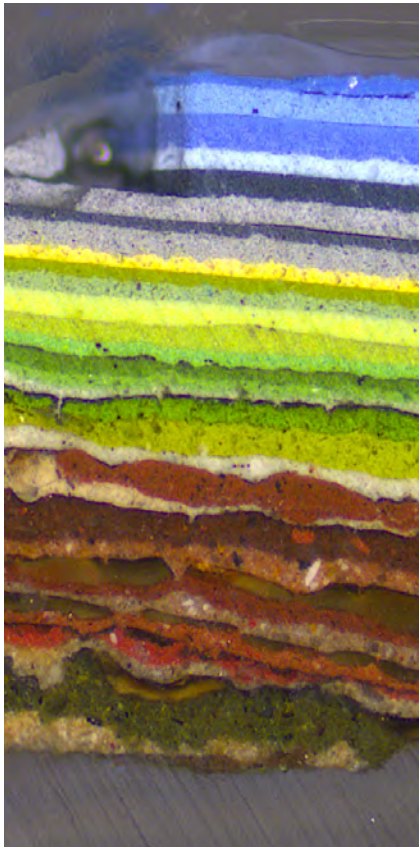
**Sample 3 (lower shaft)**

Phase 3 (post-war): initially in black oil paint with collars picked out in gold. Latterly blues (current appearance)

Phase 2: several schemes of green oil paint applied uniformly to shafts and collars

Phase 1 (earliest): lower shaft in green oil paint with the upper shaft & collars in stone. Red and brown oil paints applied later

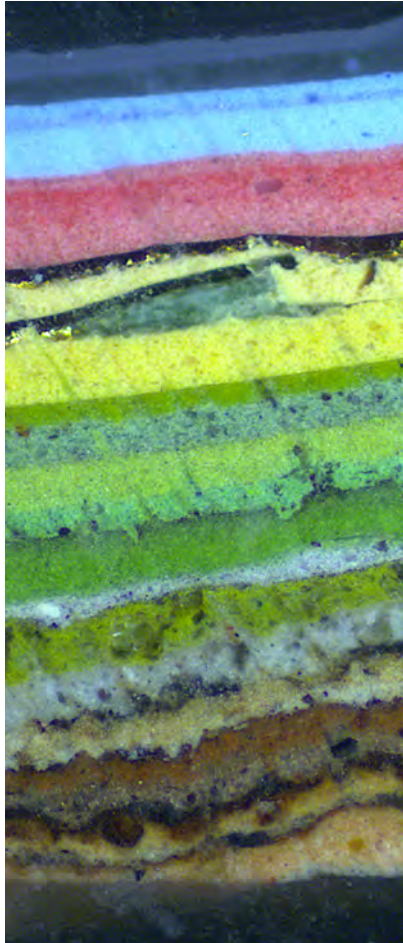
Sample 29 (flower)

Phase 3 (post-war):  
predominantly in red with  
cream glazing bars

Phase 2: several schemes  
of green oil paint

Phase 1 (earliest): initially  
in pale stone with white  
glazing bars, then salmon  
pink. Later pale brown with  
flower ornament picked out  
in dark brown

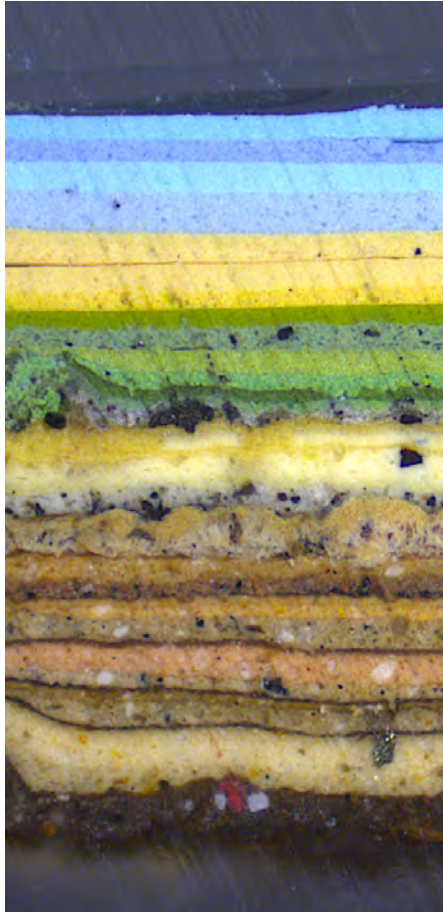
**Sample 48 (frieze)**

Phase 3: blue & turquoise

Phase 2: greens

Phase 1 (earliest): frieze background in cream with rosettes picked out in paler cream. Frieze frame painted orange/cream. Later browns and salmon colour.

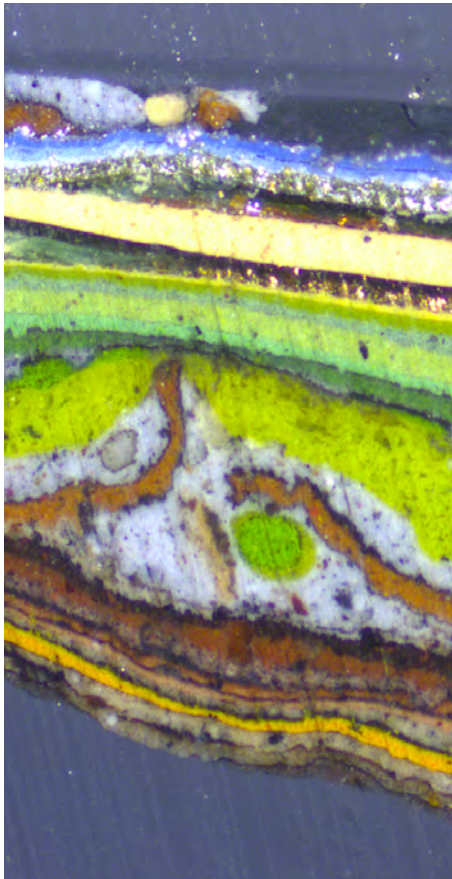
**Sample 52 (rosette)**

Phase 3: current appearance, red frame, silver rosettes & blue background

Phase 2: greens

Phase 1: initially grey background and rosettes in a gilded frame. Later a bluish green background with yellow rosette. Gilded frame retained.

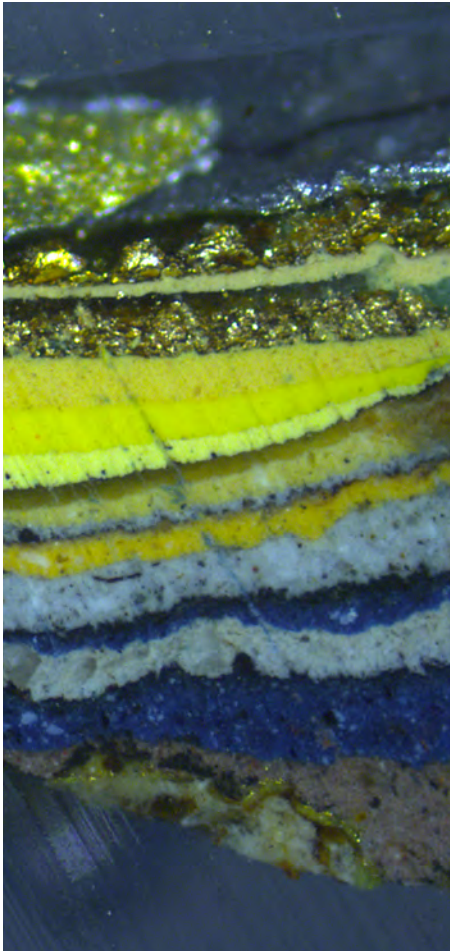
Sample 41 (background)

Phase 3: features currently picked out in silver; previously gold oil paint

Phase 2: greens

Phase 1: initially gilded shield background, green foliage and pale steel blue helm.

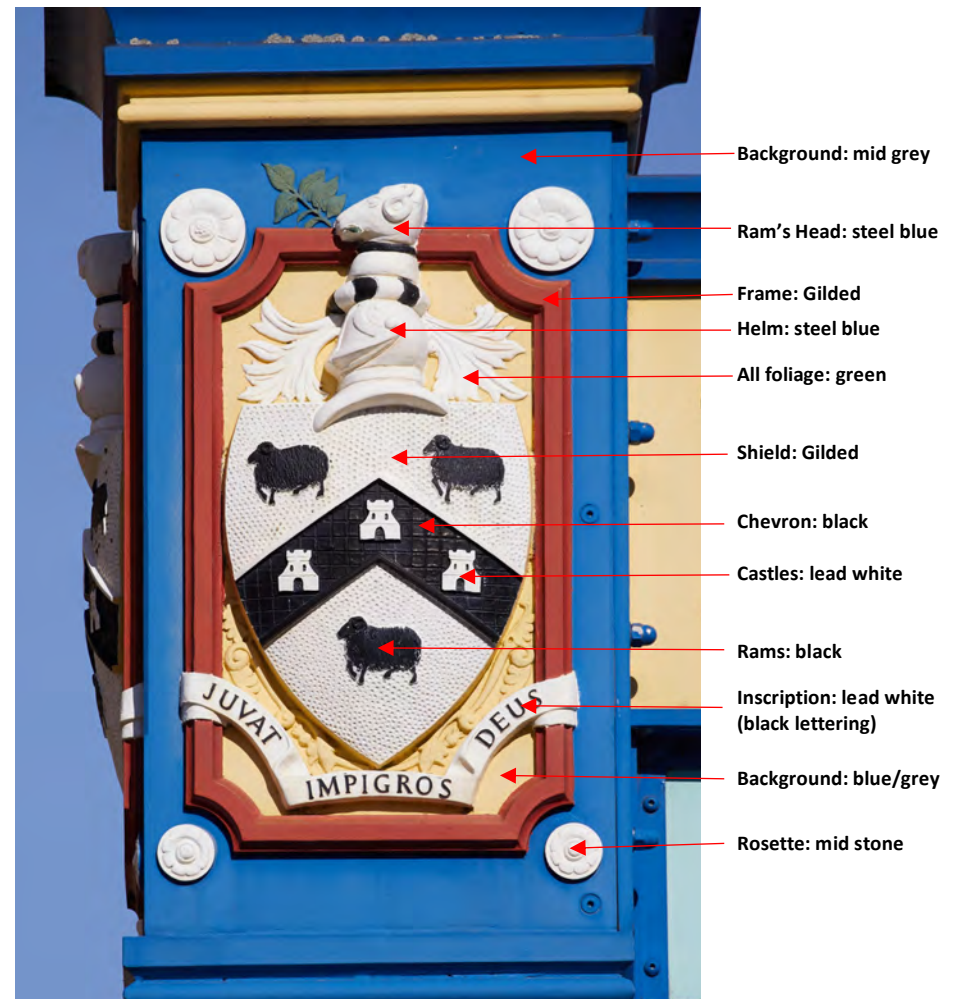
Figure 3: Suggested colour allocation for the armorial<sup>4</sup>

The current colour allocation of the Huddersfield coat of arms above the column capitals is presented as a silver shield and helm, picked out in black and silver, set against an ochre background, bounded by a red frame. These colours are

anathema to the historic appearance of the armorial and do not represent the historic colour allocation.

- vii) One of the key decorative features here is the Huddersfield Coat of Arms armorial capping each of the supporting columns. The remaining paint evidence on the example sampled was quite fragmentary and a little confused due to the cleaning and preparation of surfaces prior to repainting.
- viii) A suggested colour allocation for the armorial is provided in fig.3 that represents the original late 19<sup>th</sup> century appearance.

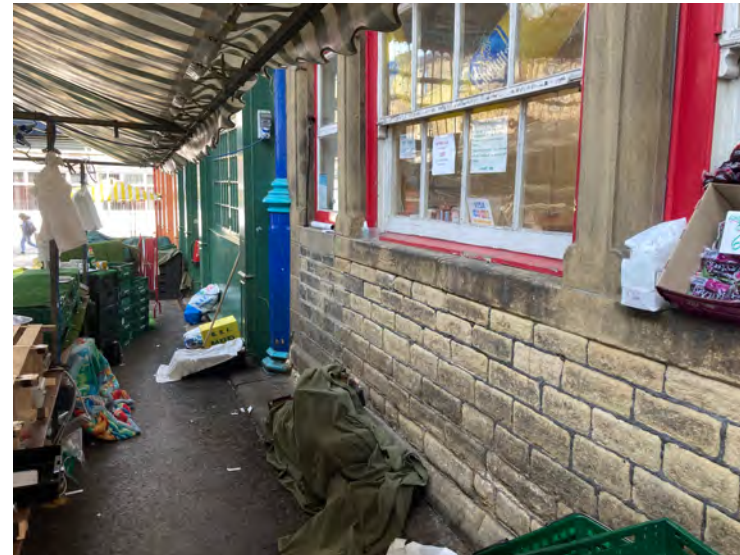
Sample 1:  
Black re-pointing

The aggregate was comprised primarily of gypsum, calcite (limestone) and quartz (sand). Also present were the pyroxene (silicate) minerals enstatite and ferrosilite which are common in the earth's crust co-existing with other igneous and metamorphic rocks and presumably present as mineralogical impurities. These minerals were only present at appreciable levels in this sample and may be responsible for the dark appearance of the sample compared to the other mortars. Alternatively, a dye or colourant may have been added, that is not detectable using this type of analysis. The only difference between the aggregate and binder fractions was the presence of Muscovite (mica) in the binder fraction. This is an aluminosilicate mineral which was again presumably only present as an impurity. The sample mineralogy was consistent with a **non-hydraulic lime mortar**, possibly with a limestone aggregate used together with sand.

- i) The original non-hydraulic lime mortar underlies a later dark re-pointing on the interior wall inside the market (samples 1 and 2). Both are non-hydraulic lime, with similar strong mix ratios (approx. 2 parts aggregate to 1-part binder). The later re-pointing has a high compressive strength and is very dark (almost black) in colour, rendering it inappropriate in this location and should be removed prior to re-pointing.

A non-hydraulic repair mortar (NHL 2.0) of a neutral limestone colour using a 2:1 mix ratio with an average aggregate grain size is suggested for this location.

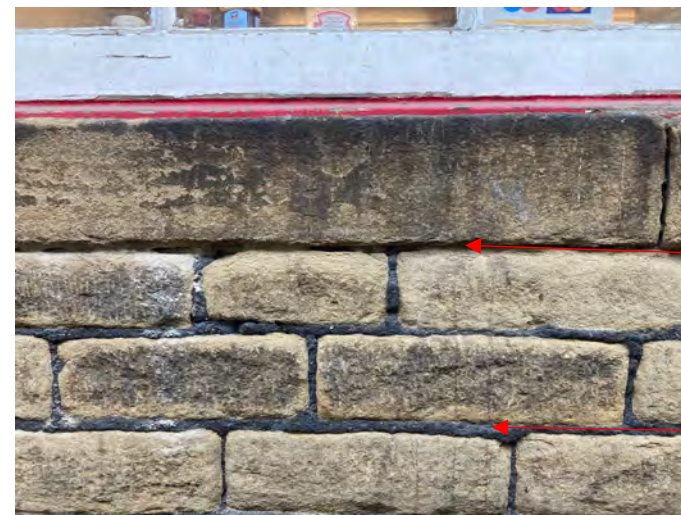
Sample 2:  
Underlying early mortar

The sample was compositionally similar to sample 1 with the additional presence of anorthite observed. This is a rare aluminosilicate mineral and its detection is unusual in these types of samples. In addition, chlorite, another aluminosilicate, was observed in the binder fraction only. Overall, the sample mineralogy was consistent with a **non-hydraulic lime mortar**, possibly with a limestone aggregate used together with sand.

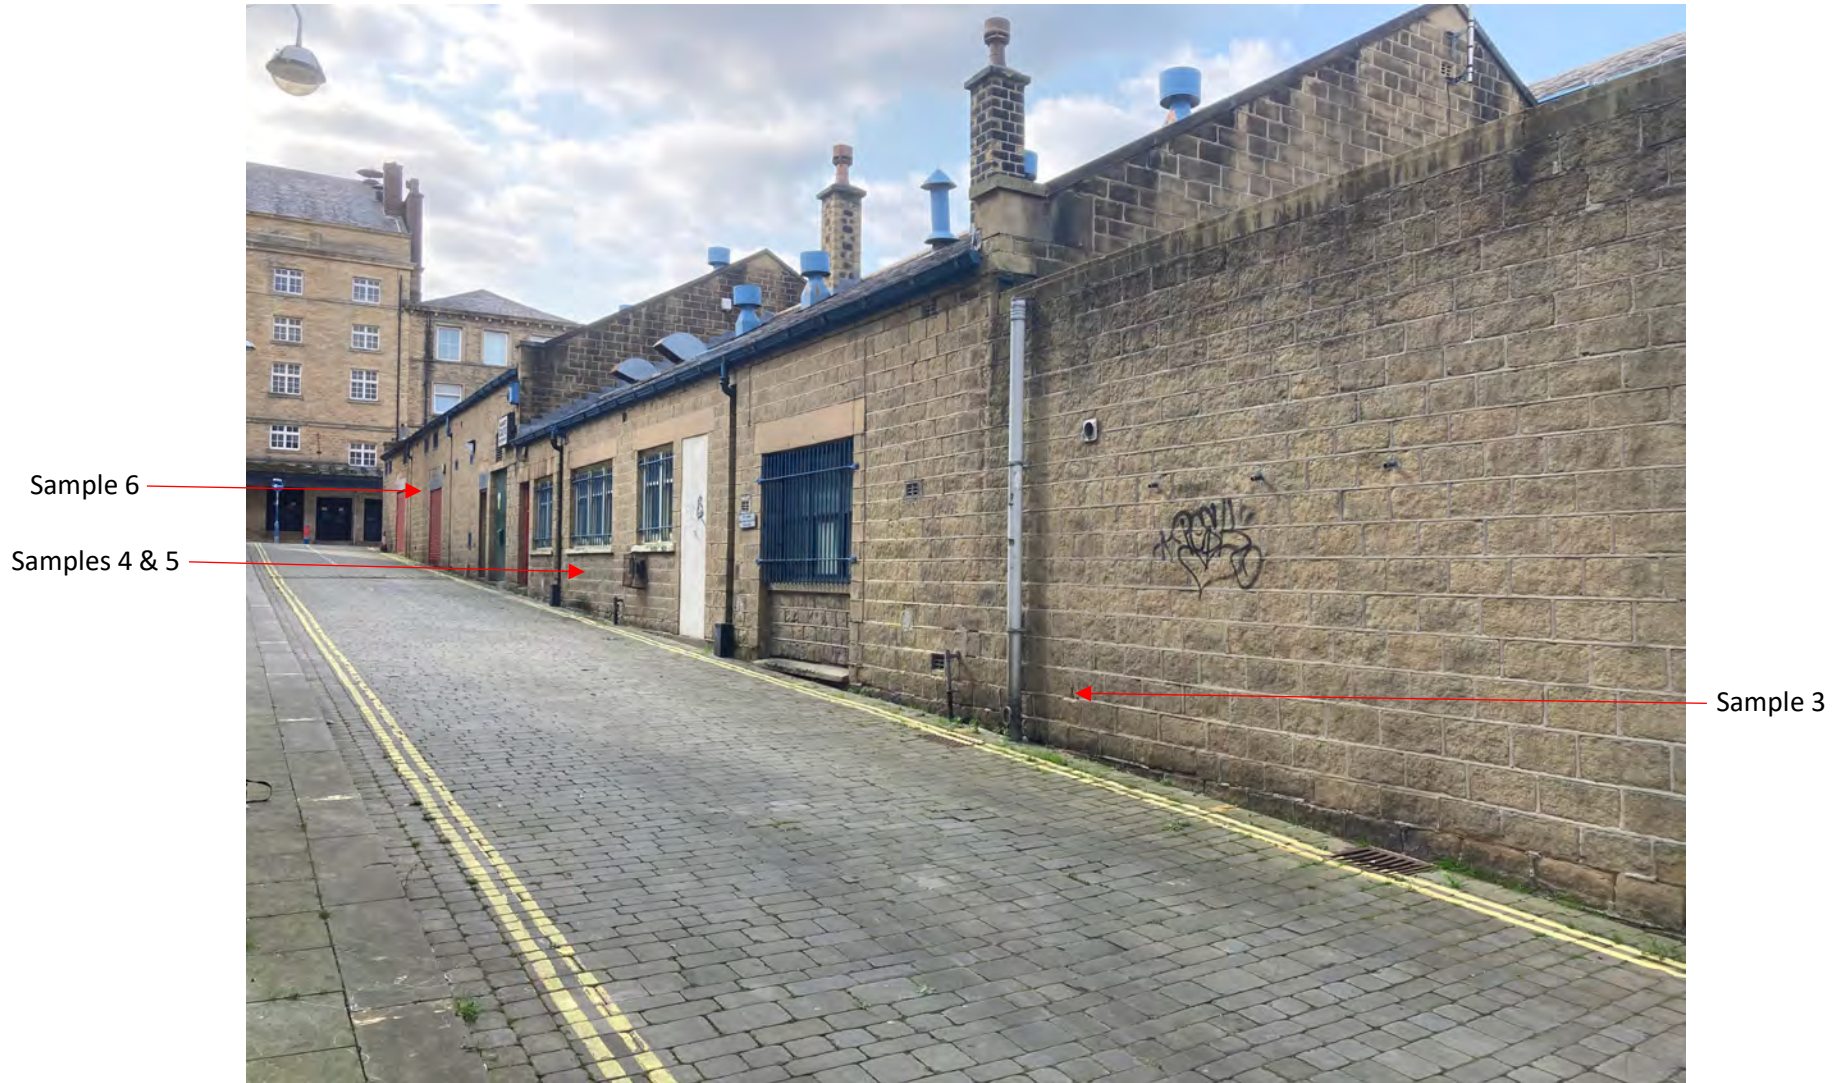
9.2.2: Samples 3 - 6

- ii) Samples 3 and 4 were removed from the hard 'ribbon' re-pointing applied relatively recently (possibly during the 1980 restoration or even later). This is a hard and inflexible Ordinary Portland Cement (OPC) overlying the original lime mortars defined here as samples 5 and 6.

- iii) Samples 5 & 6 are early mortars that lie beneath the later OPC ribbon pointing. Both are lime based, with sample 5 defined as a hydraulic lime and sample 6 as non-hydraulic. Presumably both samples were applied at different periods and may represent an example of earlier repair or repointing. In both cases a mix ratio of approx. 4 parts aggregate to one part binder was used with an average aggregate grain size of 0.5 – 1.0mm.
