Contaminated Land Phase One Desk Study for proposed residential dwelling on land at 21a Jagger Lane, Emley Moor, Huddersfield, Kirklees, HD8 9SY.

April 2025

Summary

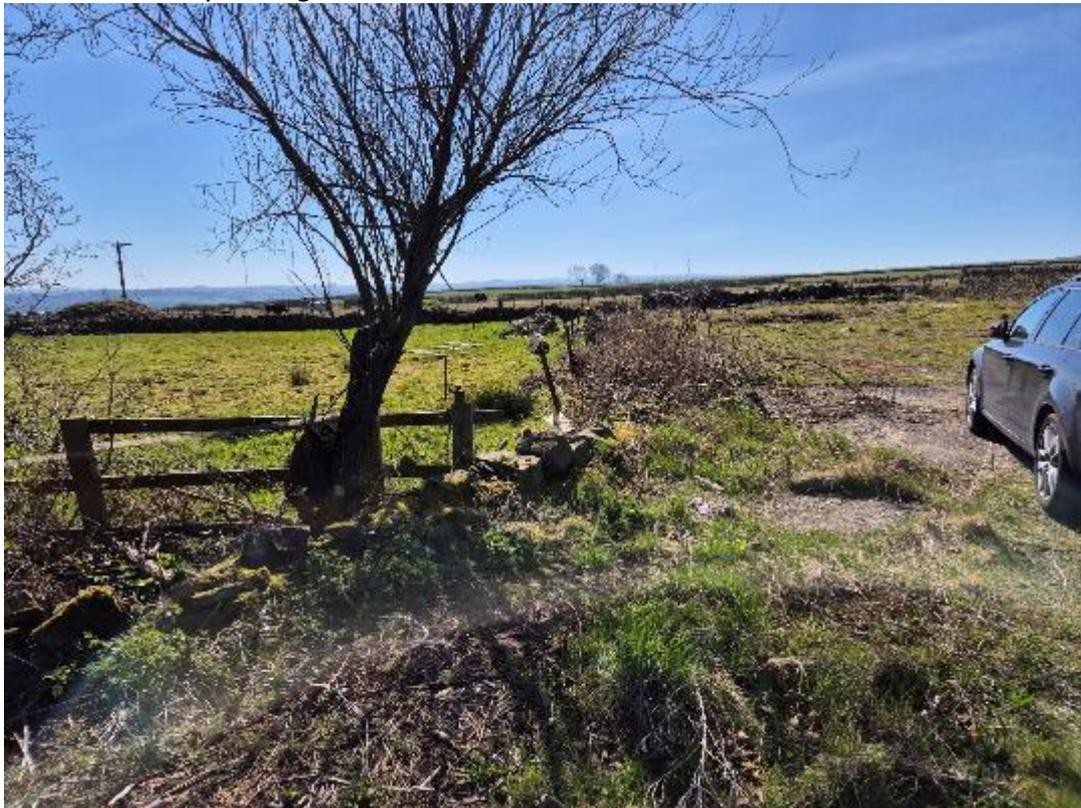
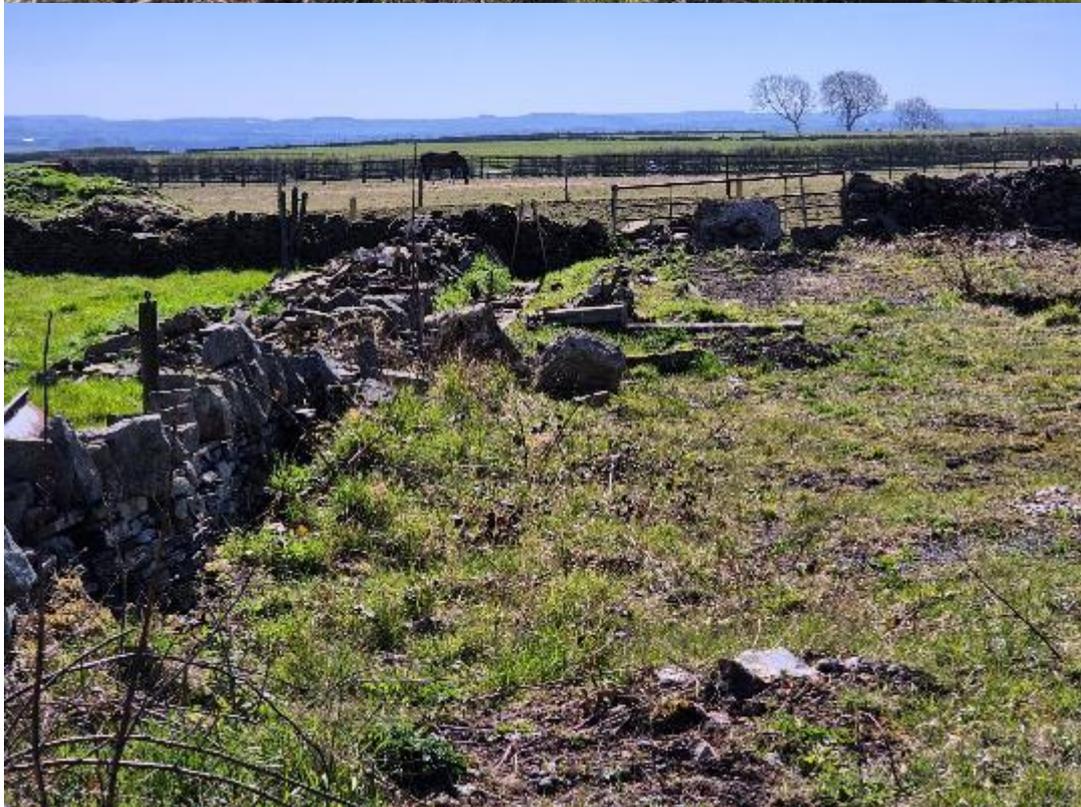
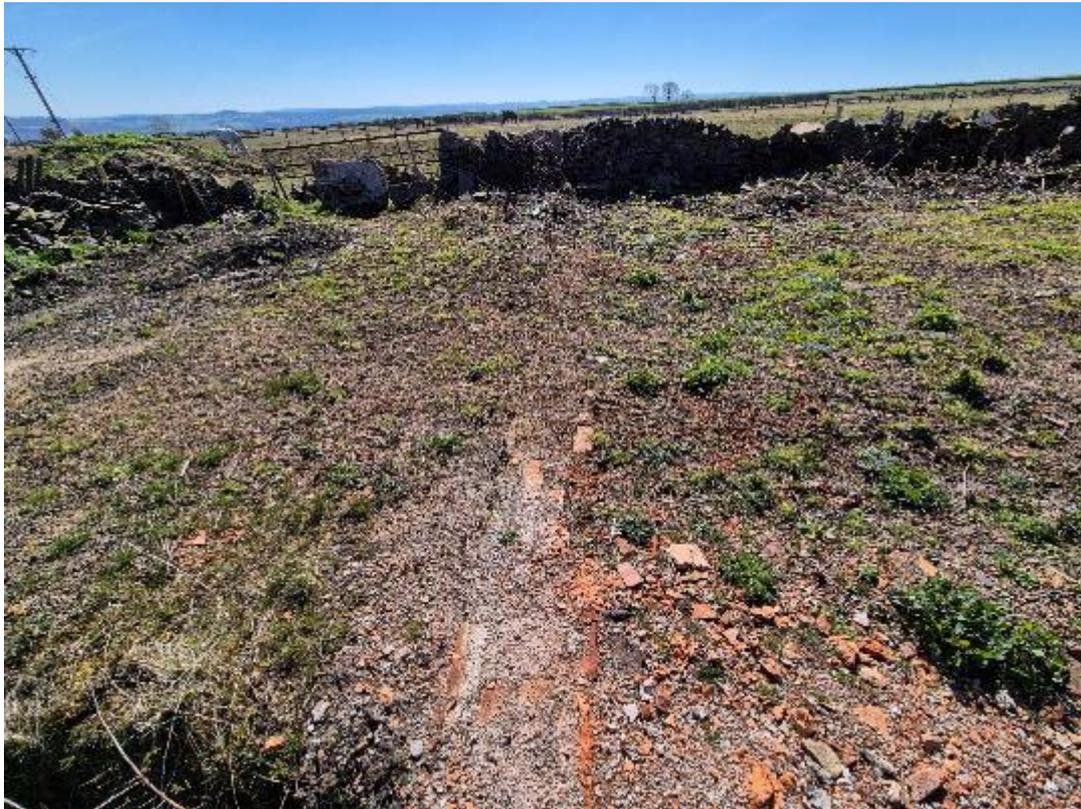
Eastern boundary looking south

The site is accessed from Jagger Lane to the north, via a shared driveway with 21a. Roughly rectangular in shape the site is bound by stone walls to all sides, although in a state of repair to the eastern boundary.

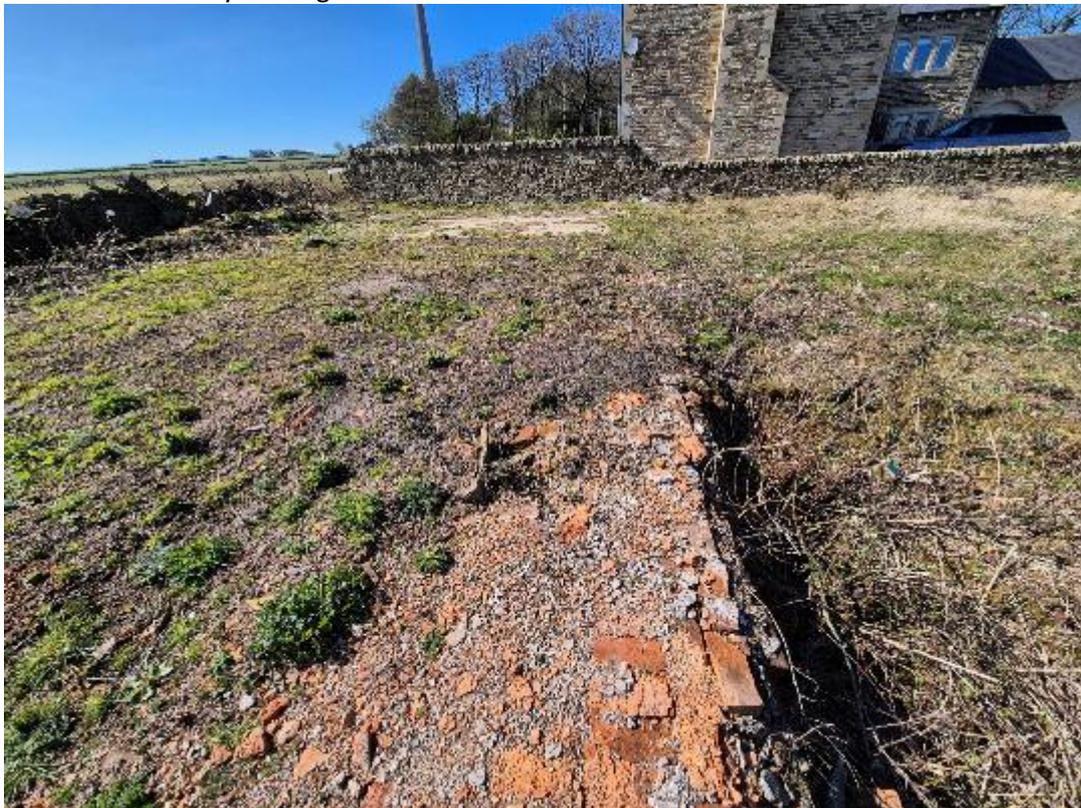
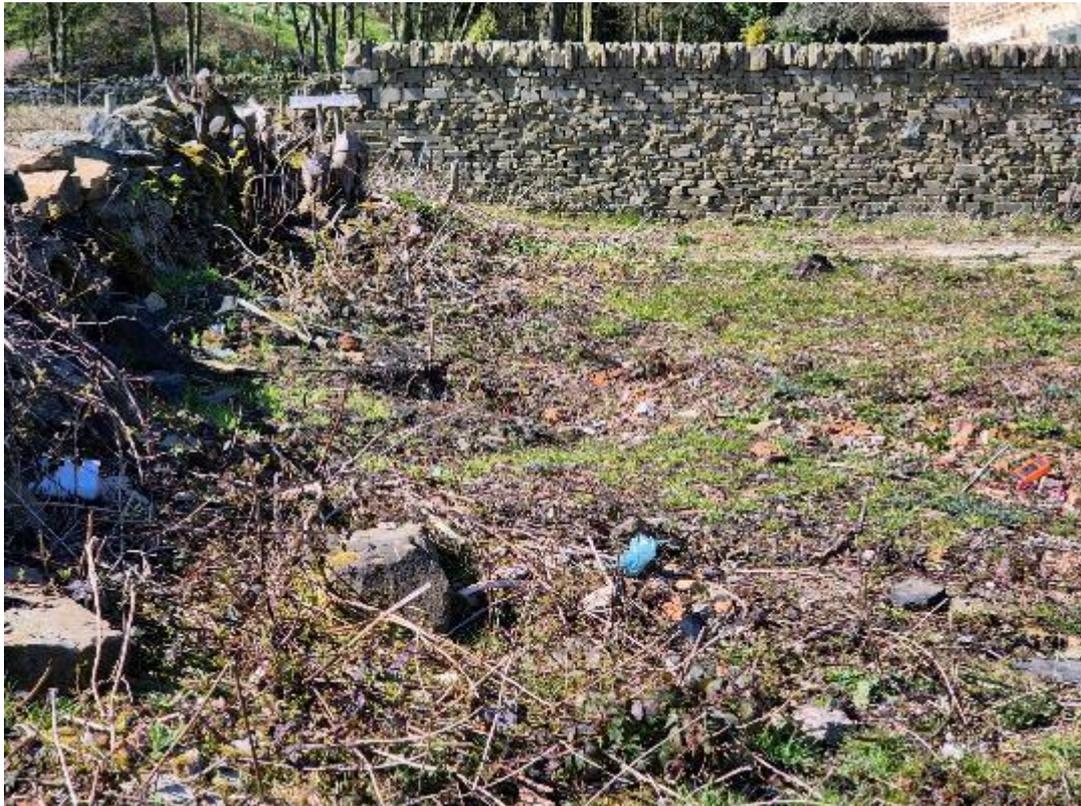
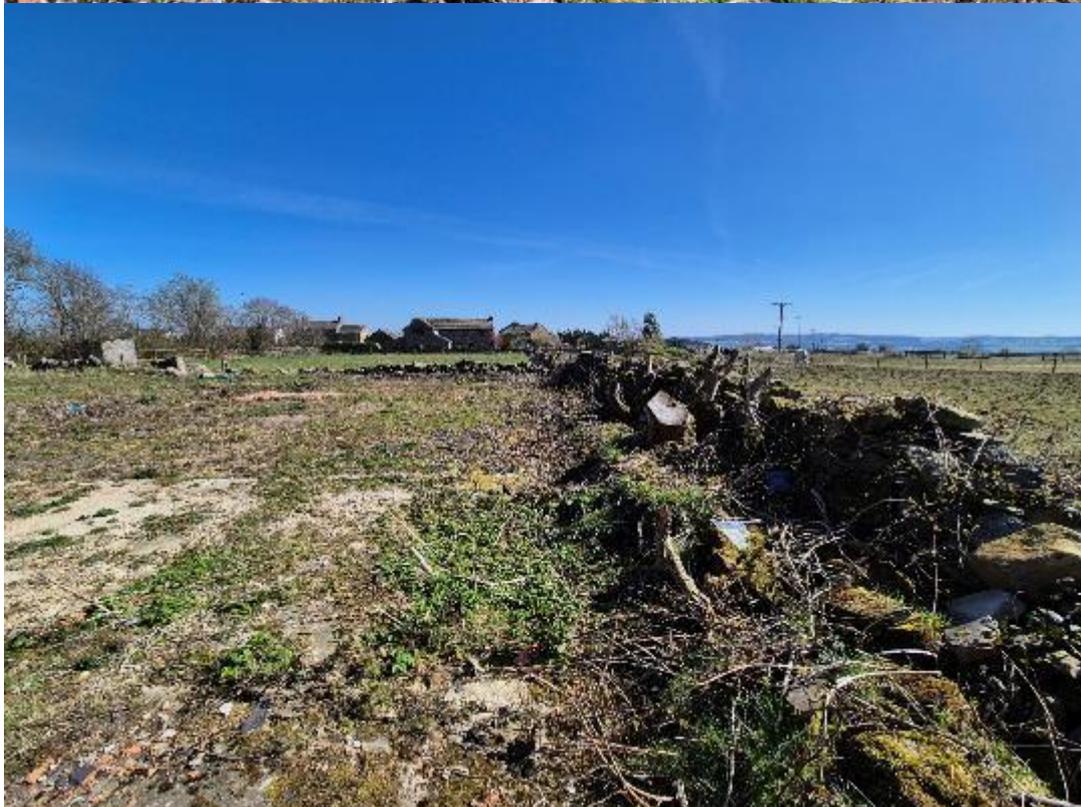
Southern boundary looking west then east

The site had been cleared with patches of vegetation growing through the soil. To the rear south of the site the foundation from the former building were evident with a concrete pad to the southwest corner.

However, given the presence of the former footings of the brick building at surface level it does not appear that, but has not been confirmed that, the recommended clean cover material(0.35m) following the previous investigations, has been placed over the site, although those reports do contain photographic evidence of excavation of contaminated areas which have been filled.

- Confirmation of a clean cover system be confirmed following the previous site work. An additional cover system of at least 600mm is provided within the garden amenity spaces. Ideally with a no dig/warning layer below.
