29th August 2025

JCA Ref: 22667b/ChC

**Arboricultural Report at: Fieldhead, Snelsins Road, Cleckheaton,
West Yorkshire, BD19 3UE**

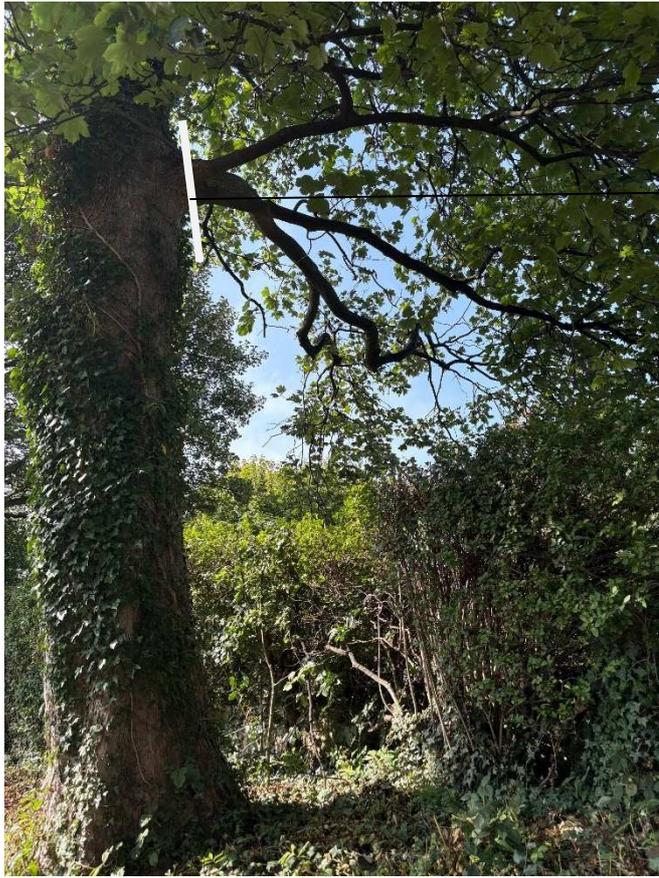
- 3.2 This tree is situated around 5.5m from the front corner of the dwelling and the canopy is now in very close proximity to the roof in this location. Whilst the tree appears to have been crown lifted in the past, the canopy is quite low when compared to **T1**.
- 3.3 We therefore recommend that **T2** is crown lifted by removing several of the lower branches back to the main stem, to achieve a 5m crown lift, as shown in the below photo.

Remove back to the main stem

Remove back to the main stem

- 3.4 In addition, we also recommend that the canopy be reduced back from the roof of the dwelling to achieve a 2m clearance with the aim of minimising the risk and nuisance to the dwelling.

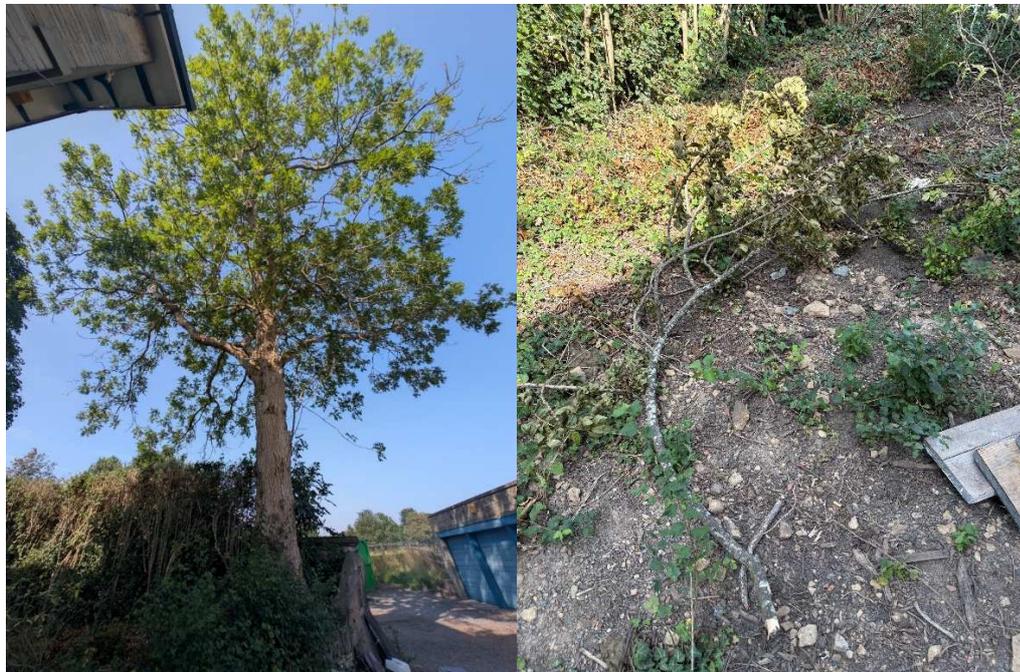
- 3.5 This tree is situated 6m away from the rear corner of the dwelling in a restricted area adjacent to a stone wall. This tree is infected by Ash Dieback (*Hymenoscyphus fraxineus*) with major stem cankers and dead branches present, some of which have already snapped out onto the ground which could have caused major injury or damage.
- 3.6 Given the location adjacent to the dwelling, access paths and play area, we consider this to be a high target and high risk tree, unsuitable for retention. Photos of **T3** evidencing the canopy sparseness, general decline due to the disease and recent branch failures are shown below.

- 3.7 Ash dieback is a highly destructive fungal disease affecting Ash trees across the country. Progress of the disease within infected trees can lead to dead or dying branches becoming brittle and falling. It can also leave the trees more susceptible to other diseases or pathogens which can result in major limb or stem failure. Timescales for decline are difficult to define and are dependent on multiple physiological and environmental factors. However, once trees become infected it is unlikely that they will recover so depending on the target, usually removal and replacement is the most suitable course of action, especially relevant in high target areas.

T 3	Mature Ash <i>Fraxinus excelsior</i>	22 #	7	77	6.25 5.25 7		6.5	Situated just 6m away from the corner of the dwelling. Twin-stemmed from 6m with a tight union and little reactionary growth. Slightly leaning towards the house. Signs of historically shed branches (10-15cm circumference). Moderate signs of Ash Dieback (<i>Hymenoscyphus fraxineus</i>). This tree will continue to decline and its removal is inevitable given the high target, so it should be felled now before the timber becomes brittle and unsafe to climb for a contractor. Replacement planting required to mitigate the loss and to retain tree cover on site.	Remove to ground level for health and safety reasons. Replacement planting of two new trees as detailed on the site plan at Appendix 2 . High	POOR	FAIR	HIGH	MOD	<10

- 3.8 We are aware that a recent application to fell this tree was refused by Kirklees Council, due to lack of supporting evidence. However, due to the high target of this tree, the recent branch failures and the inevitability of its continued decline over the forthcoming years, we recommend that a proactive approach is taken and that the tree be safely removed and appropriately replaced, before the timber becomes brittle and unsafe for a contractor and to avoid further failures which may lead to serious injury or damages.
- 3.9 We recommend that two new trees (1x Whitebeam & 1x Himalayan Birch) be planted in the location as shown on the site plan at **Appendix 2**, in order to mitigate the loss of **T3** and to retain tree cover on the property.
