Tree Condition Survey Report (VTA)

Site: Cleveland House Care Home, 2 Cleveland Road, Edgerton,
Huddersfield, West Yorkshire, HD1 4PN

Client: Bupa

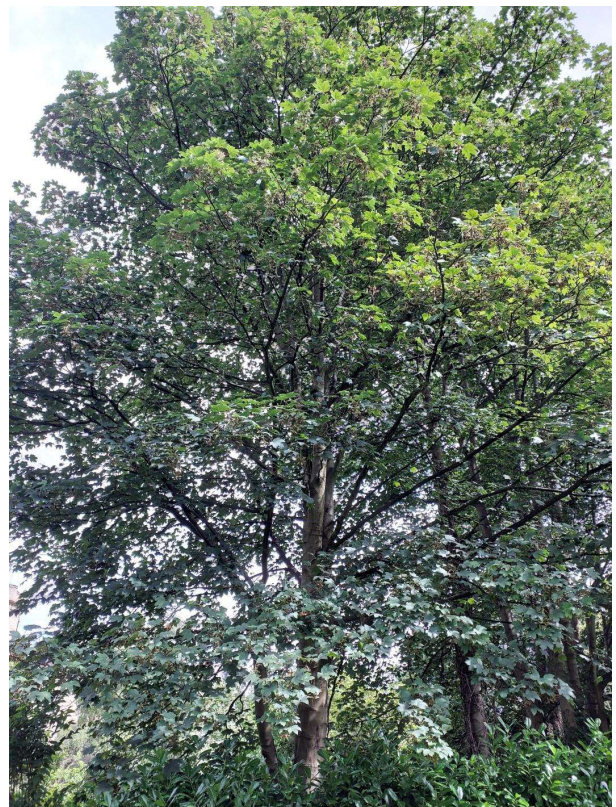
Sycamore Tree ID #20

Common Name:	Sycamore
Scientific Name:	Acer pseudoplatanus
Genus:	Acer
Tree Height [m]:	
Number of Stems:	
Stem Diameter [mm]:	450
(N) Branch Spread [m]:	
(E) Branch Spread [m]:	
(S) Branch Spread [m]:	
(W) Branch Spread [m]:	
Height of First Significant Branch [m]:	
Height of Canopy Above Ground Level [m]:	
Physiological Condition:	Good
Structural Condition:	Good
Quality Category:	
Quality Sub-Category:	
Status:	Alive
Comments:	
Recommendations:
