Condition Survey Report

Denby Lane, Grange Moor.

Ref: HDC/ENG/DENBY LANE/FINAL

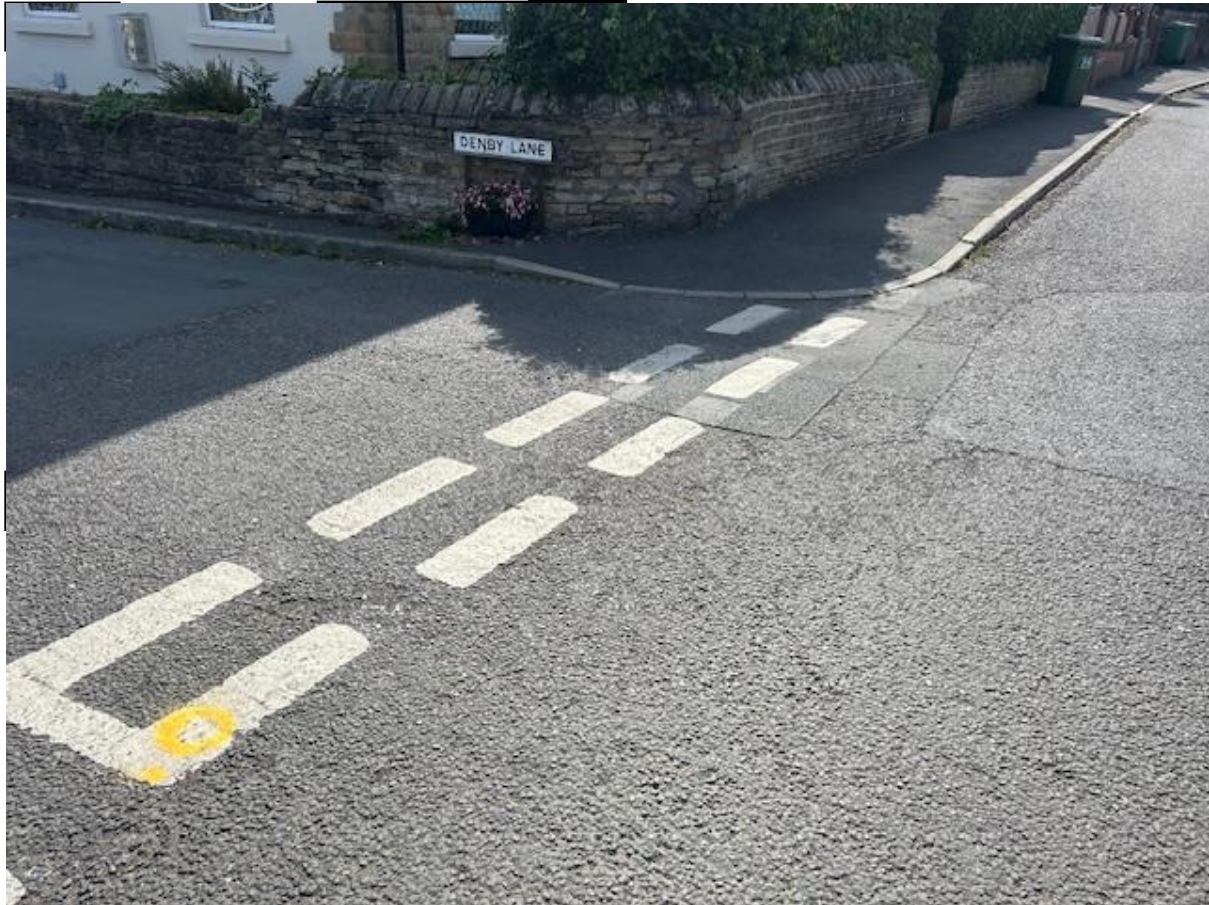
Comments – minor patchwork repair at junction with Bristfield Road.

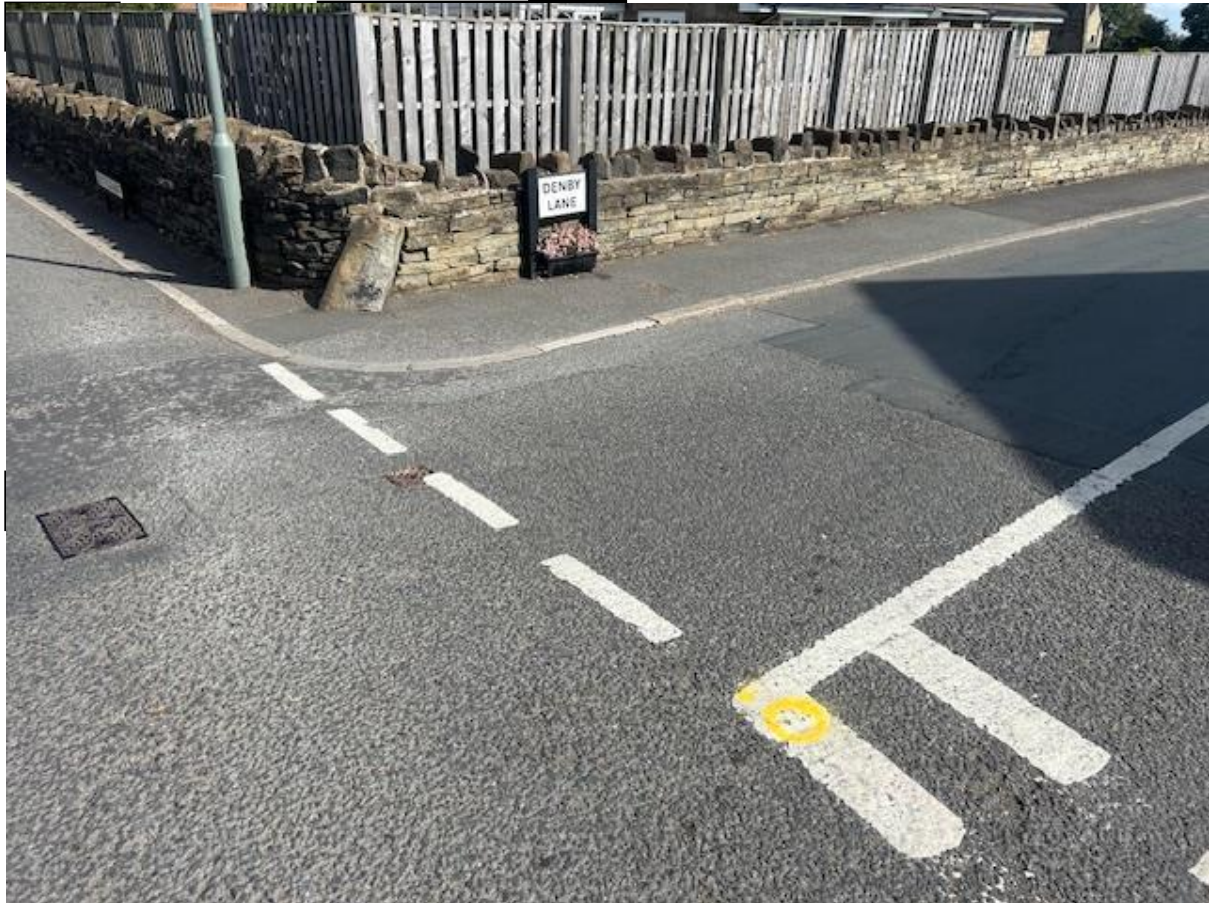
Comments – minor patchwork along northern drainage channel and flush kerb radius.

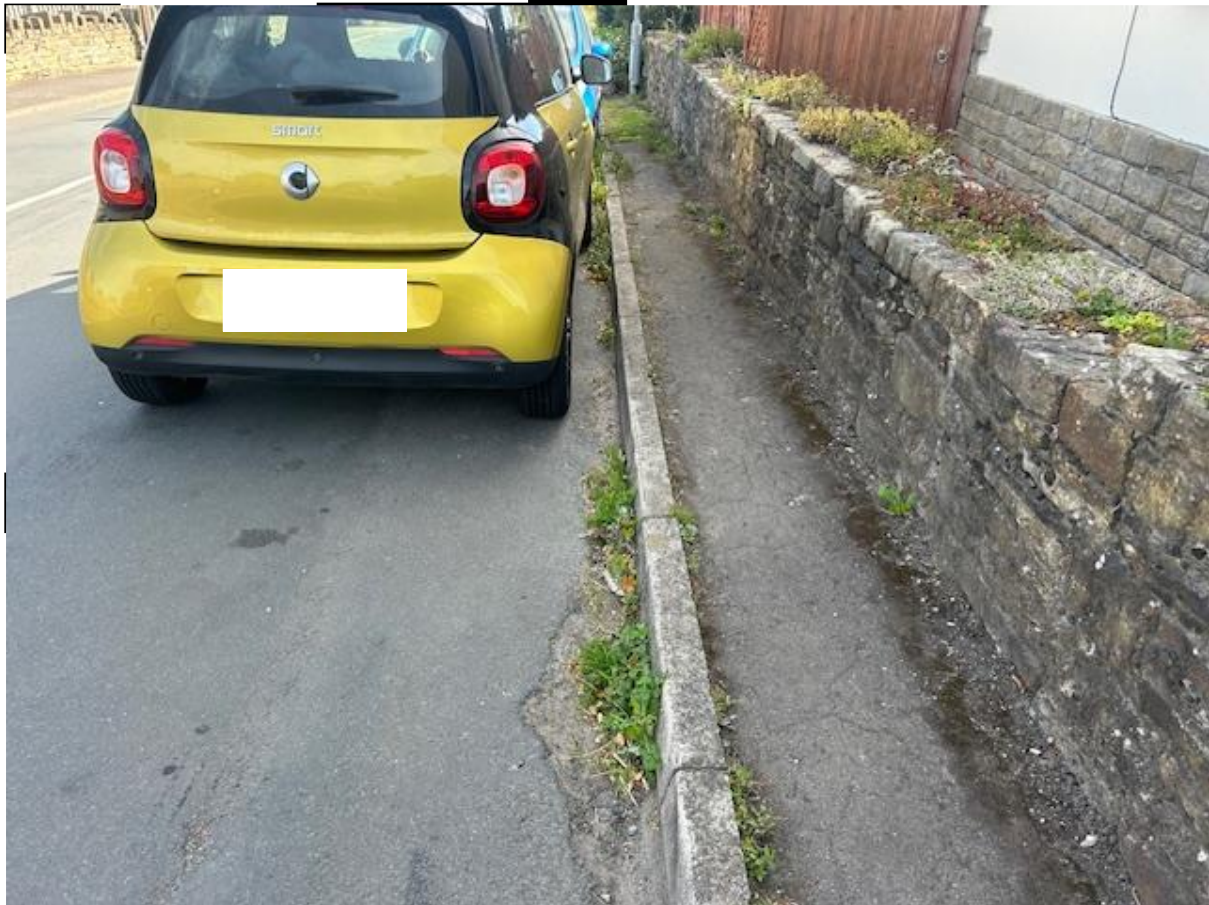
Comments – surface course along drainage channel eroded with evidence of seeded weeds developing top and bottom of kerbs.

Recommendation – Highway Authority inspection required.

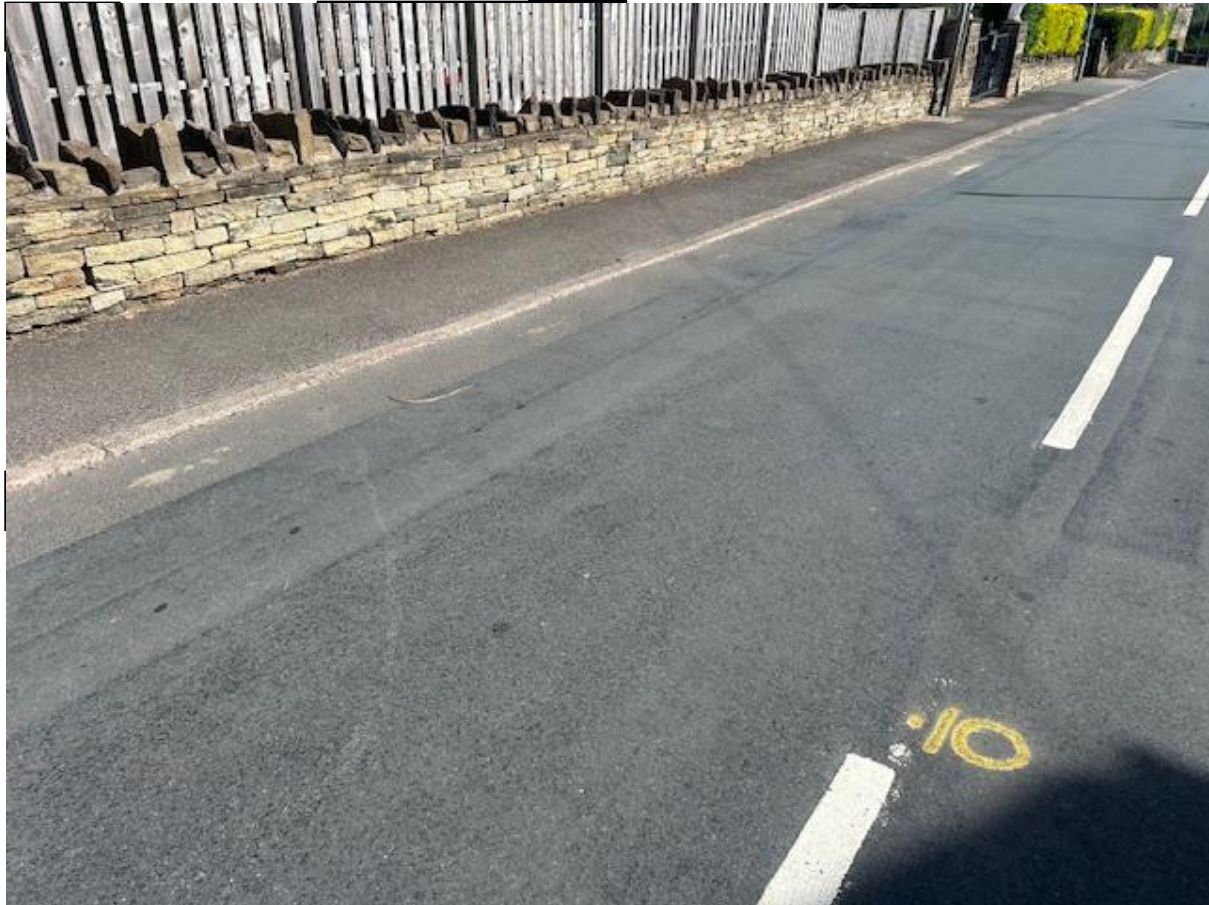
Comments – evidence of trench reinstatement and surface path repair along north side of carriageway.

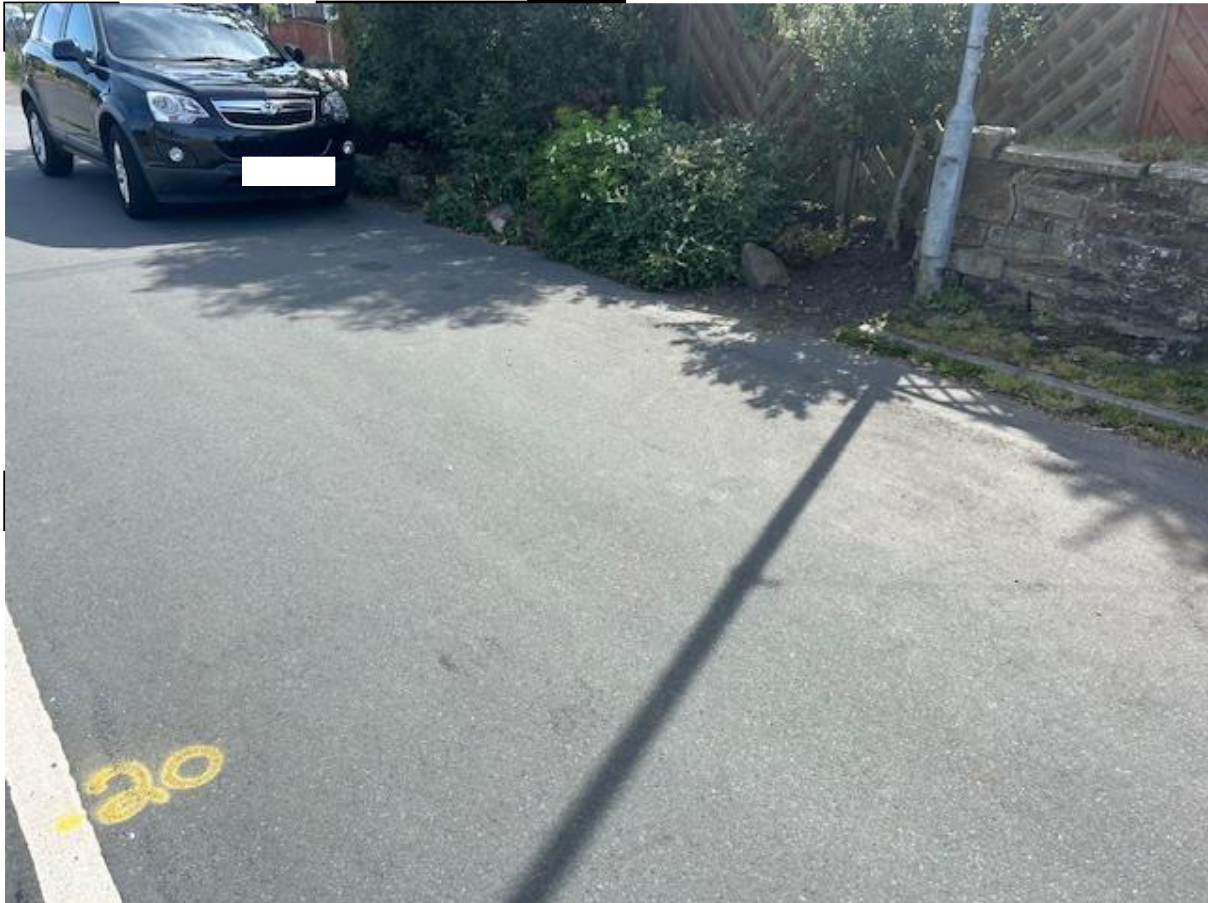
Comments – significant weed growth along southern kerb and drainage channel.

Recommendation – Highway Authority inspection.

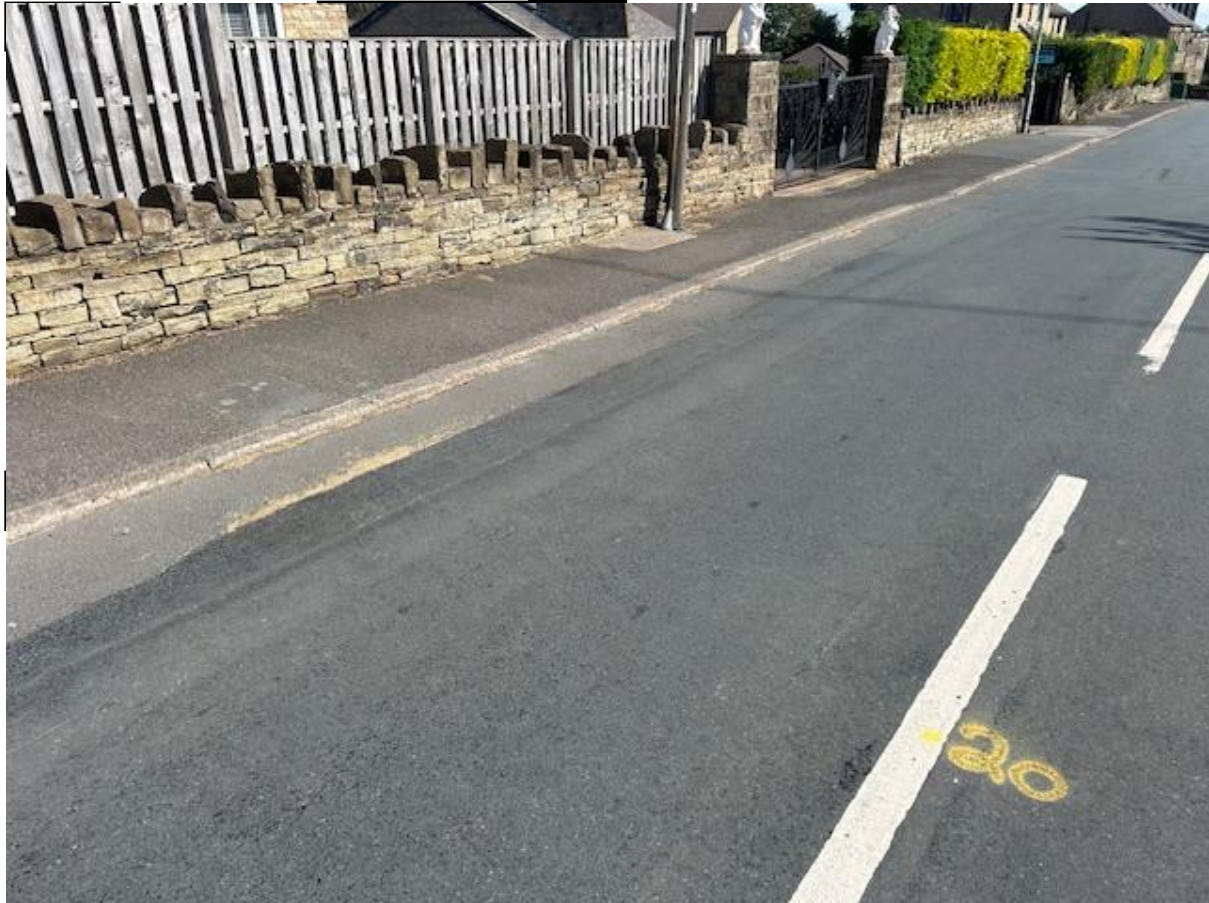
Comments – evidence of trench reinstatement and surface patch repair along north side of carriageway. Joint between existing and patch repair appears to be opening.

Recommendation – Highway Authority Inspection

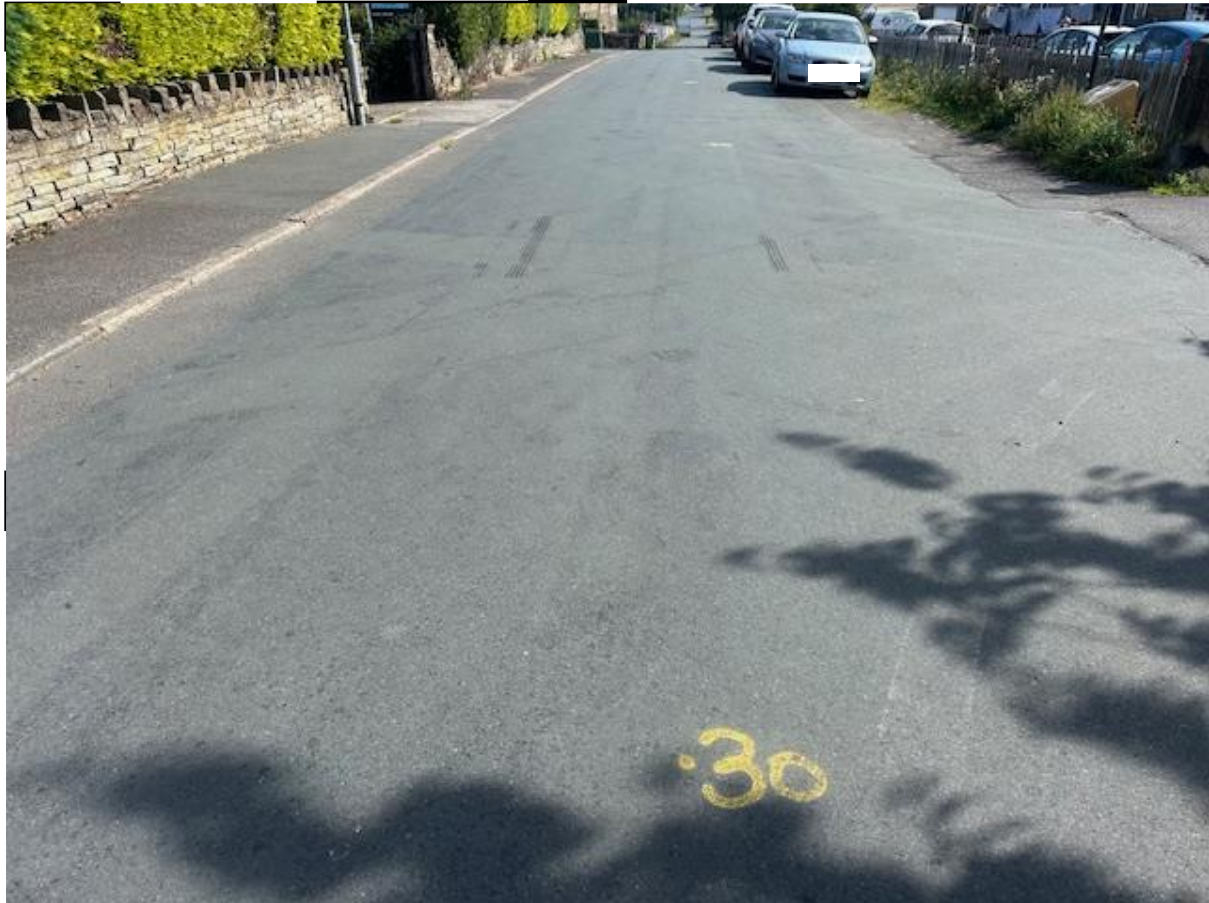
Comments – evidence of surface patch repair along north side of carriageway.

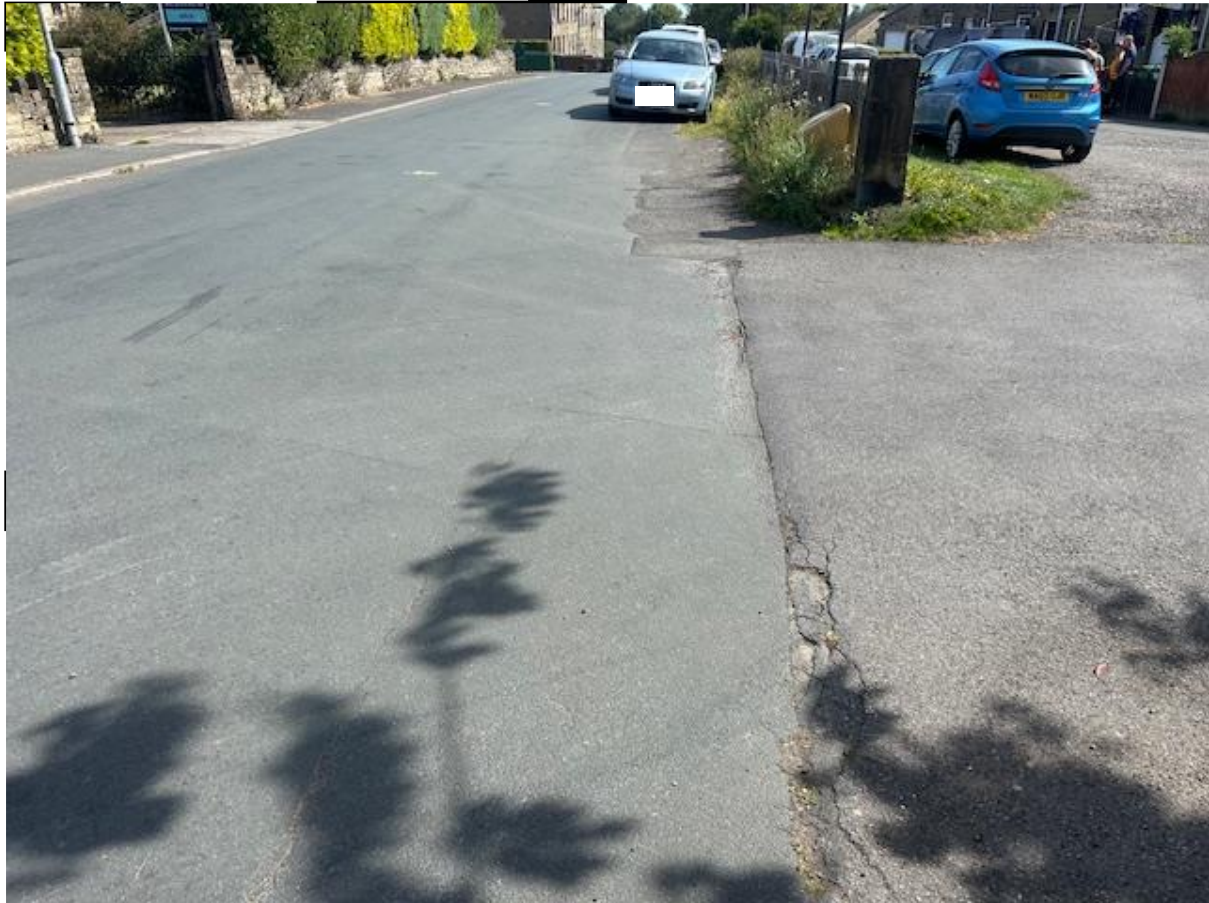
Comments – evidence of failing joint along edge of carriageway.

Recommendation – Highway Authority Inspection

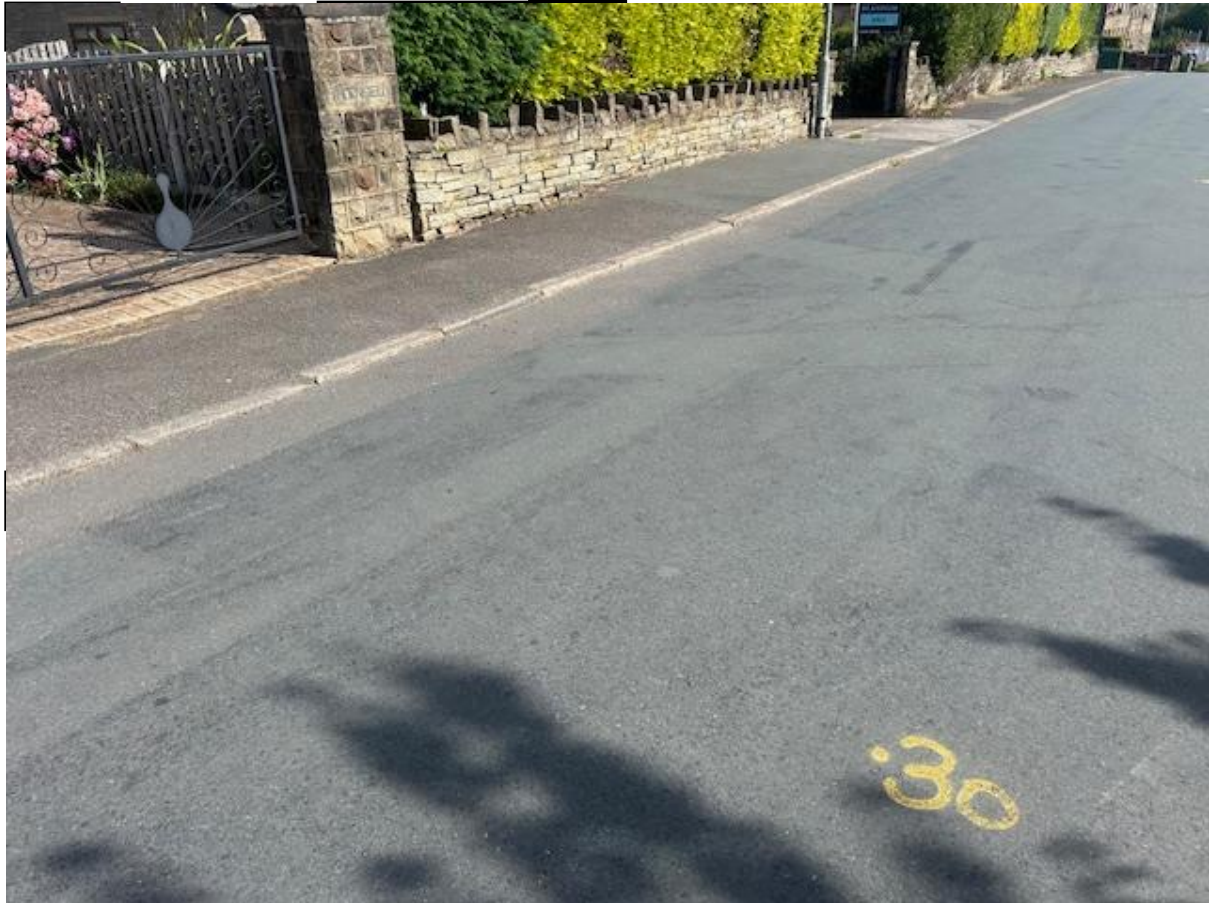
Comments- surface course trench reinstatement and minor settlement of dropped kerbs.

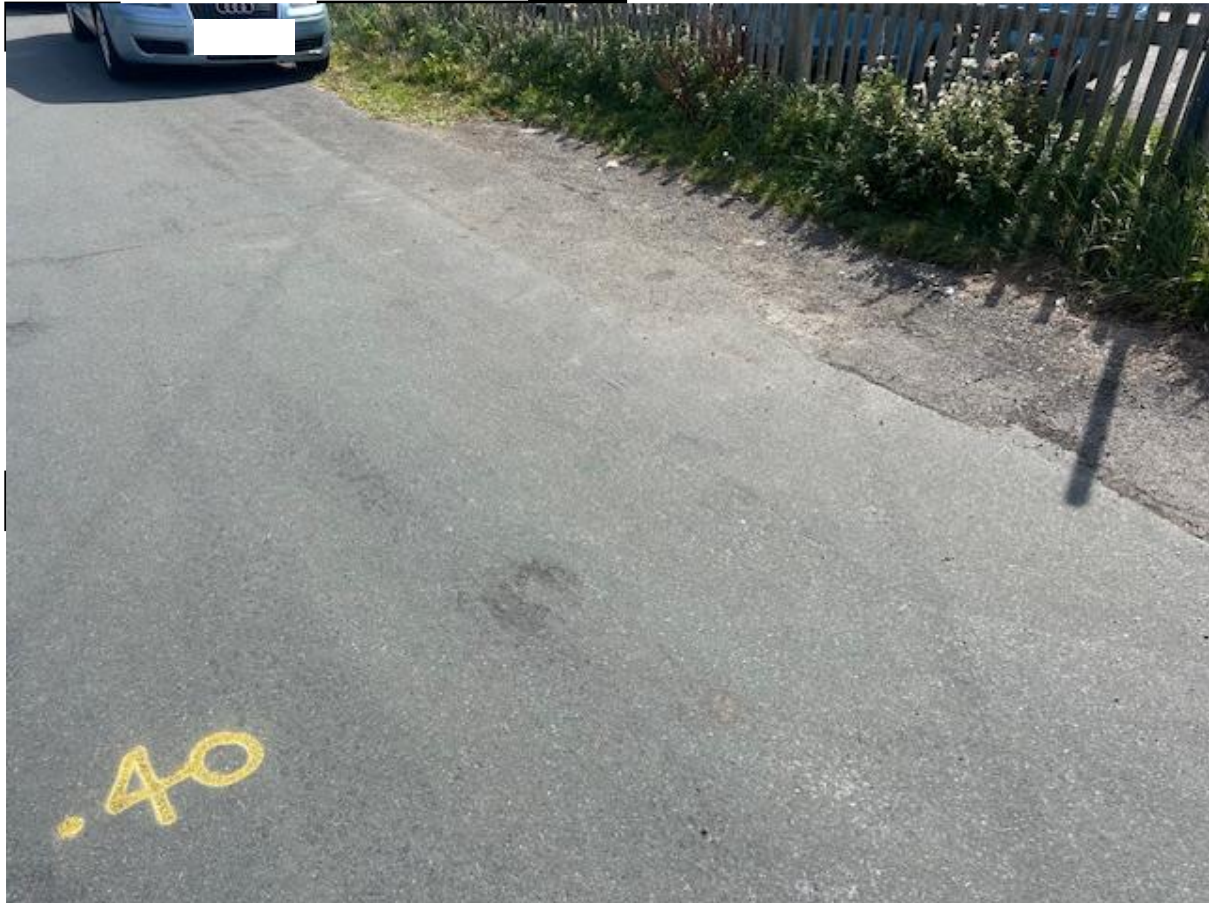
Comments – surface course on southern carriageway edge poorly repaired.

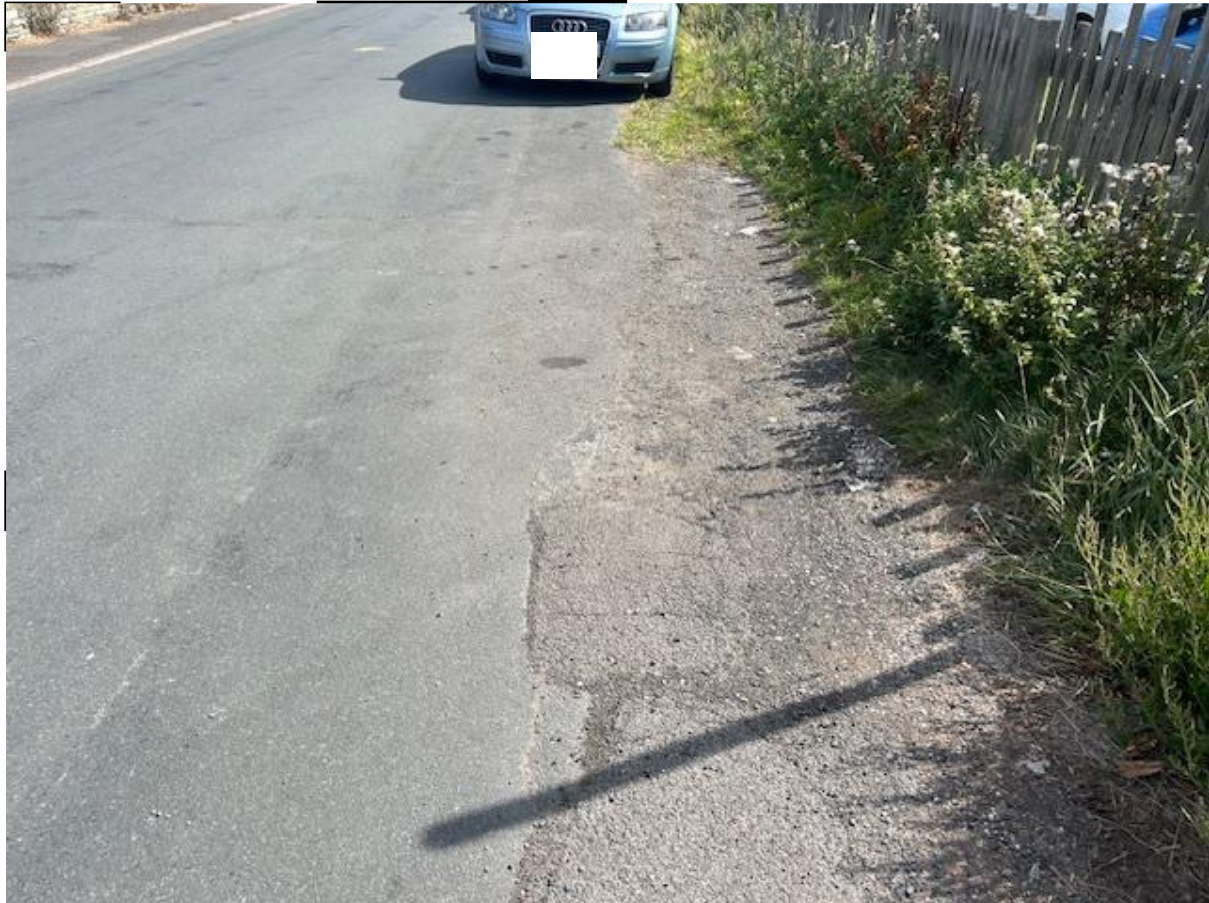
Comments – as above but showing more detail of poor workmanship.

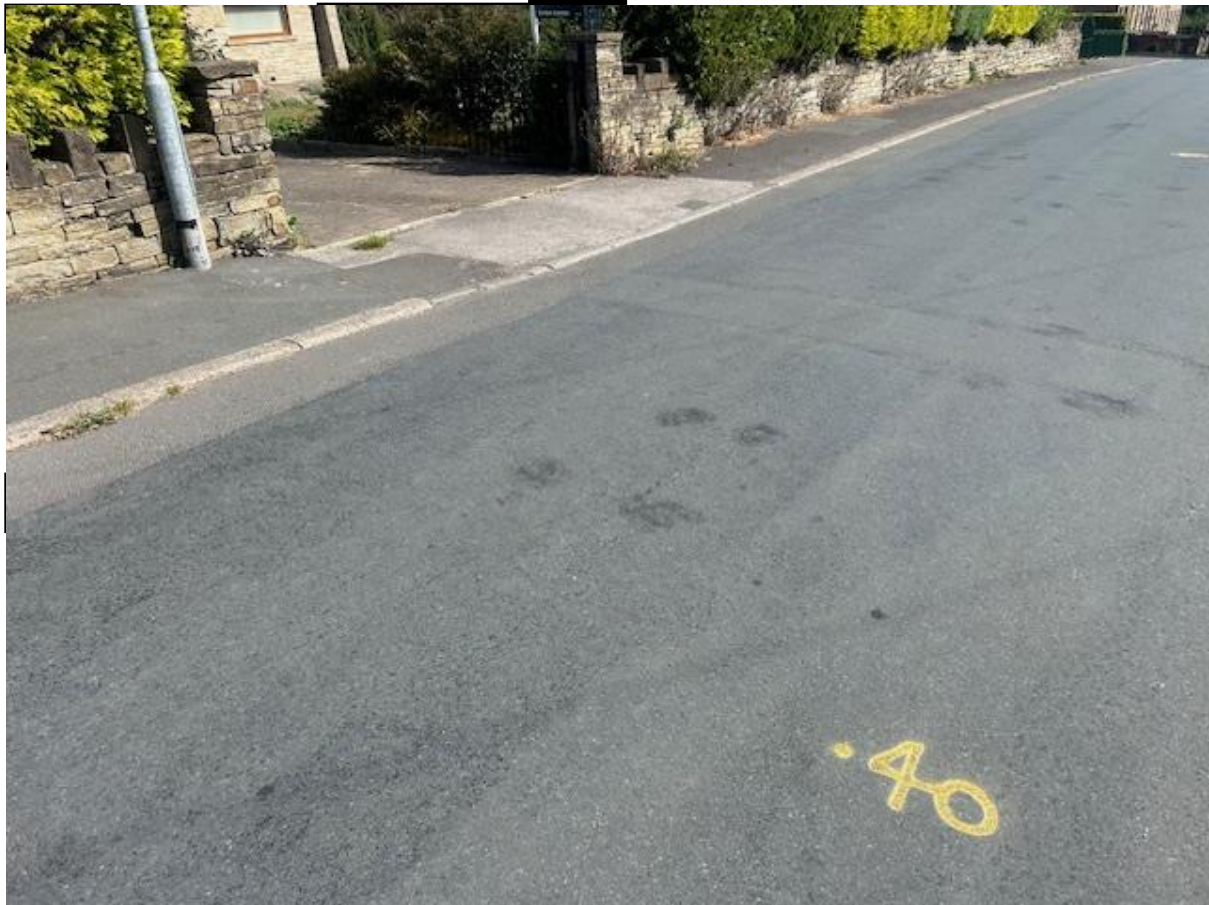
Comments – some minor weed growth against drainage channel and trench reinstatement at Ch 43m

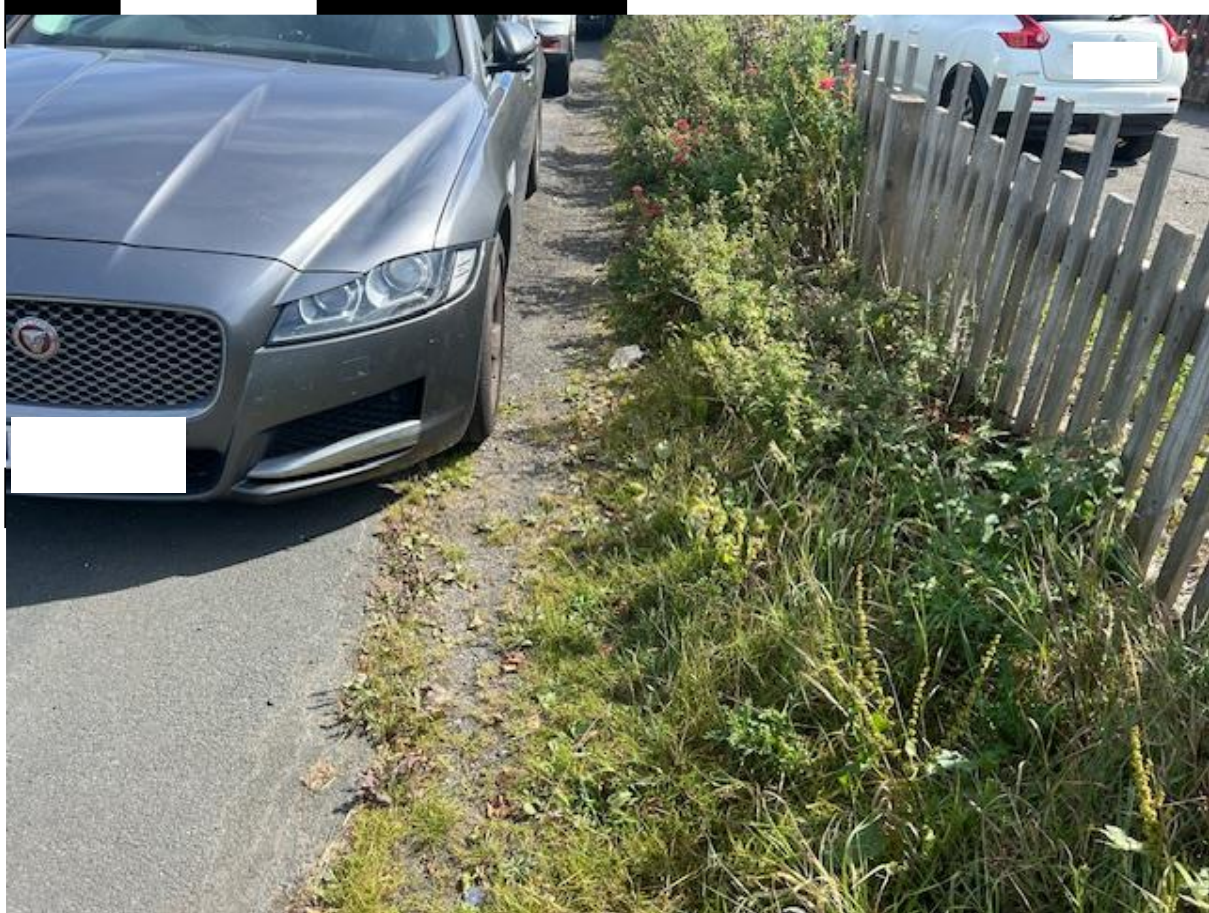
Comments – some minor tensile cracking of surface course along edge of carriageway on southern flank.

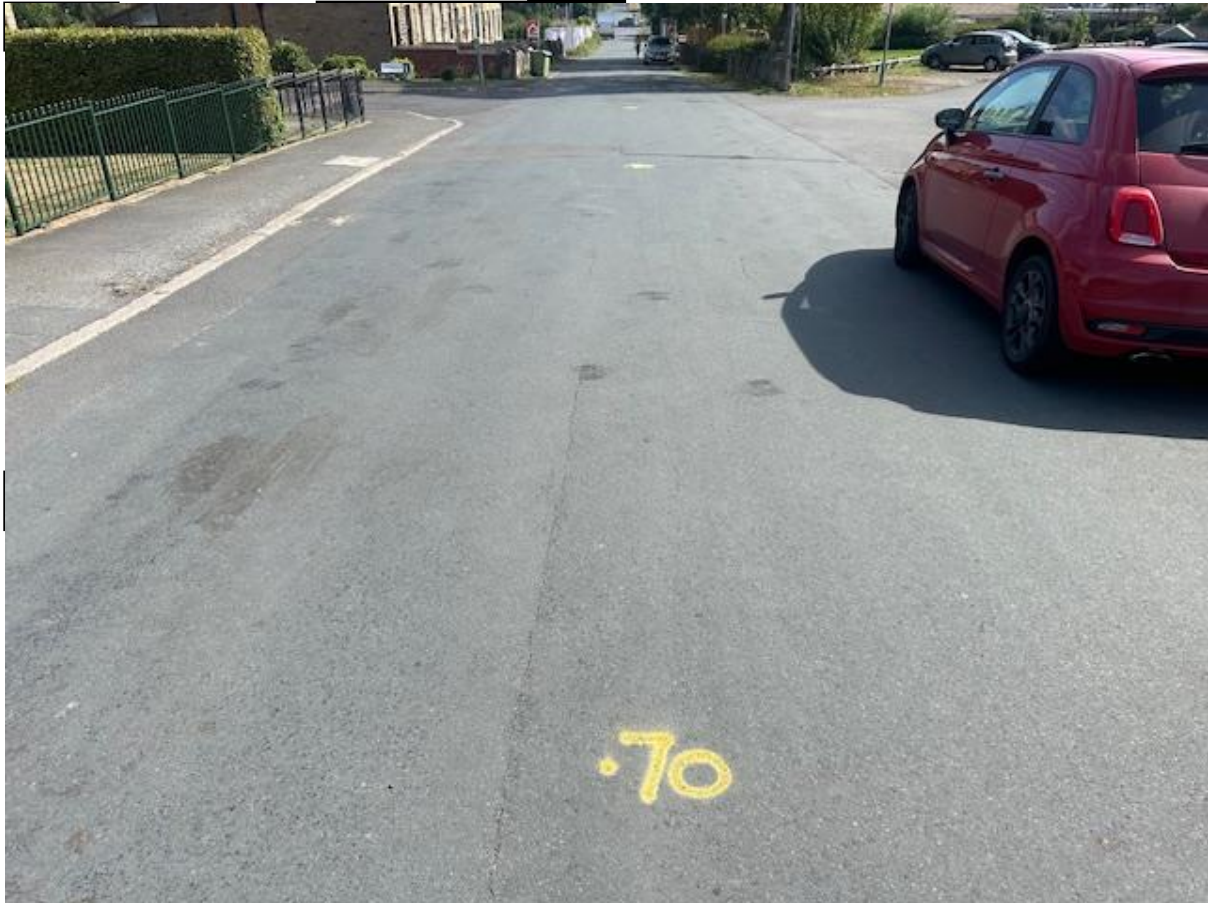
Comments – longitudinal surface course crack starting to appear centreline of surface course.

Recommendation – Highway Authority Inspection

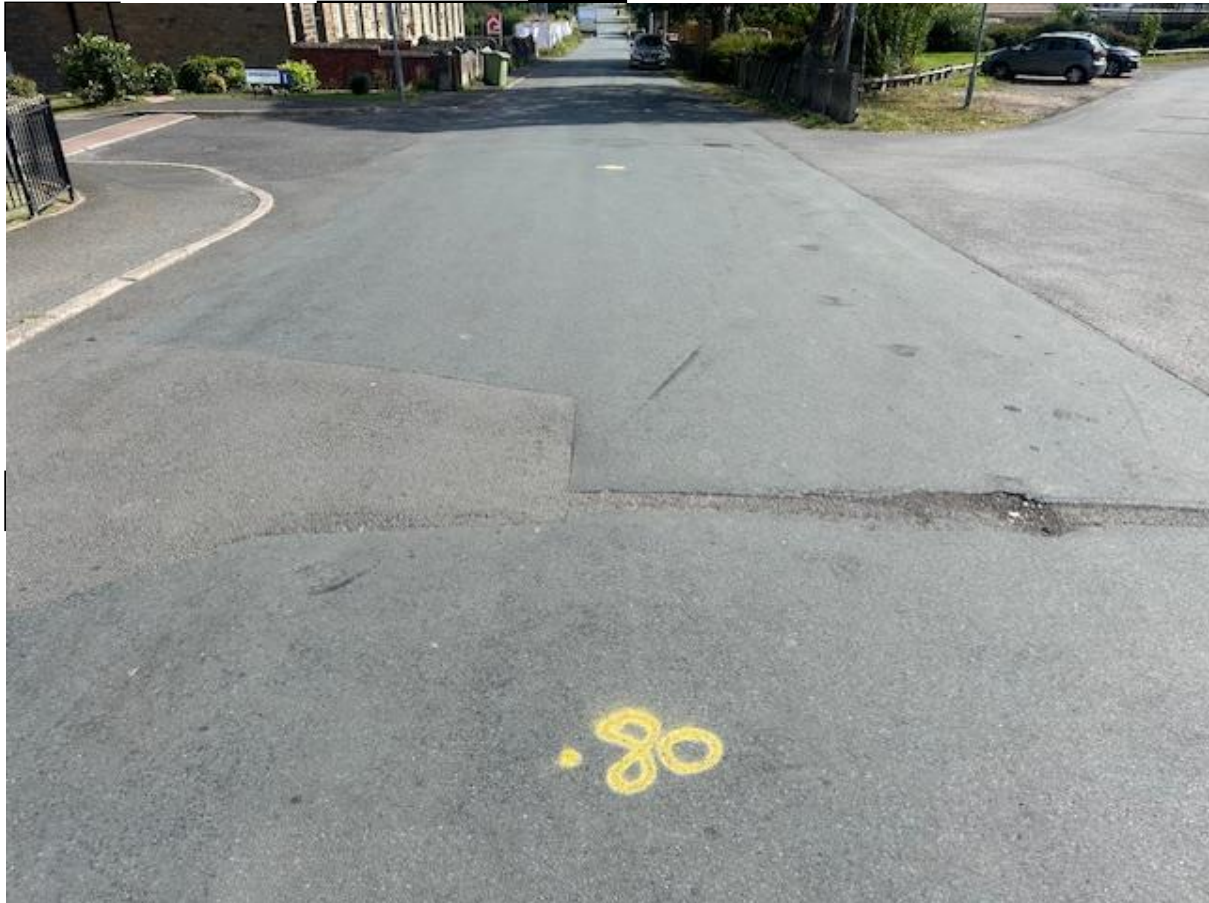
Comments – trench reinstatement showing signs of settlement across Denby Lane.

Recommendation – Highway Authority Inspection and monitor internally.

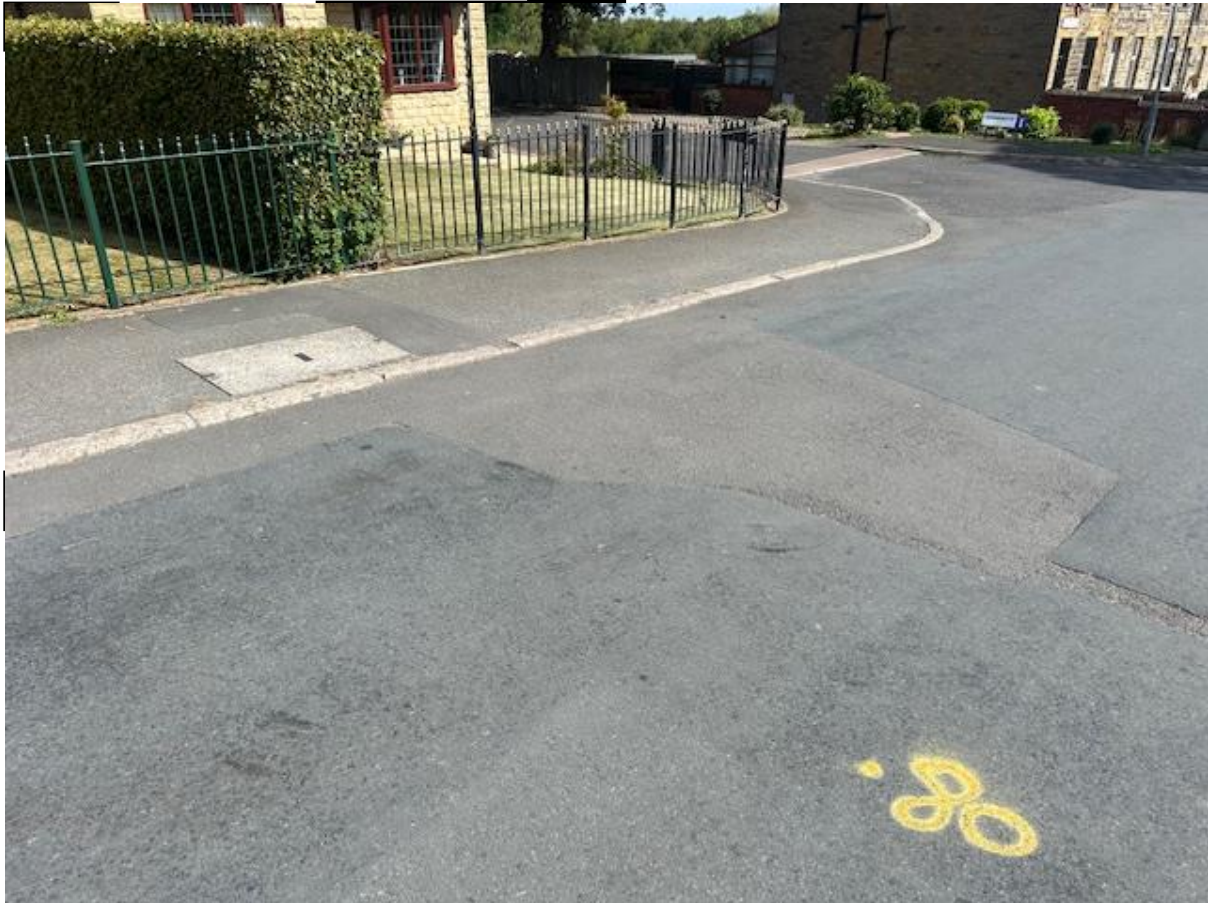
Comments – trench reinstatement across Denby Lane showing further signs of settlement.

Recommendation – Highway Authority Inspection and monitor internally.

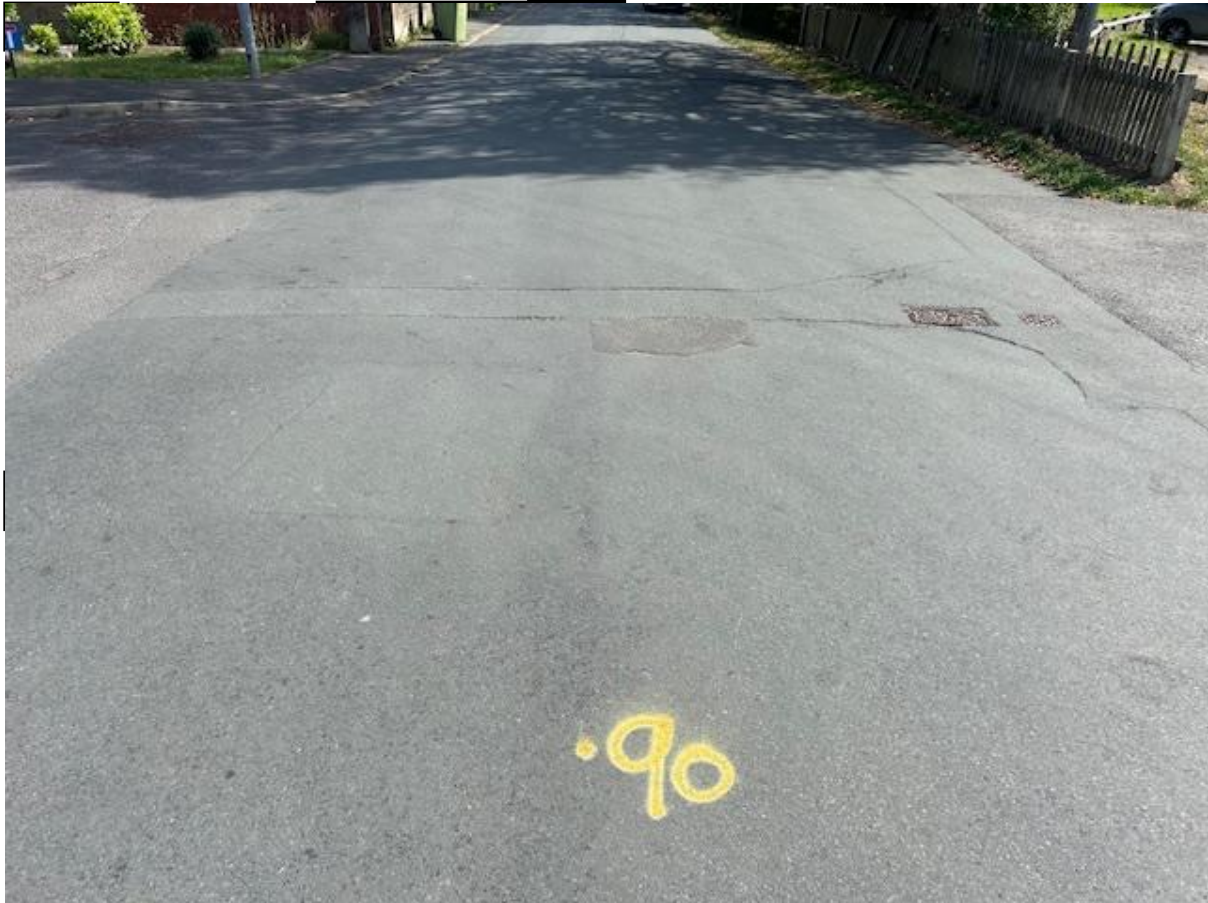
Comments – trench reinstatement across Denby Lane showing signs of settlement.

Recommendation – Highway Authority Inspection and monitor internally.

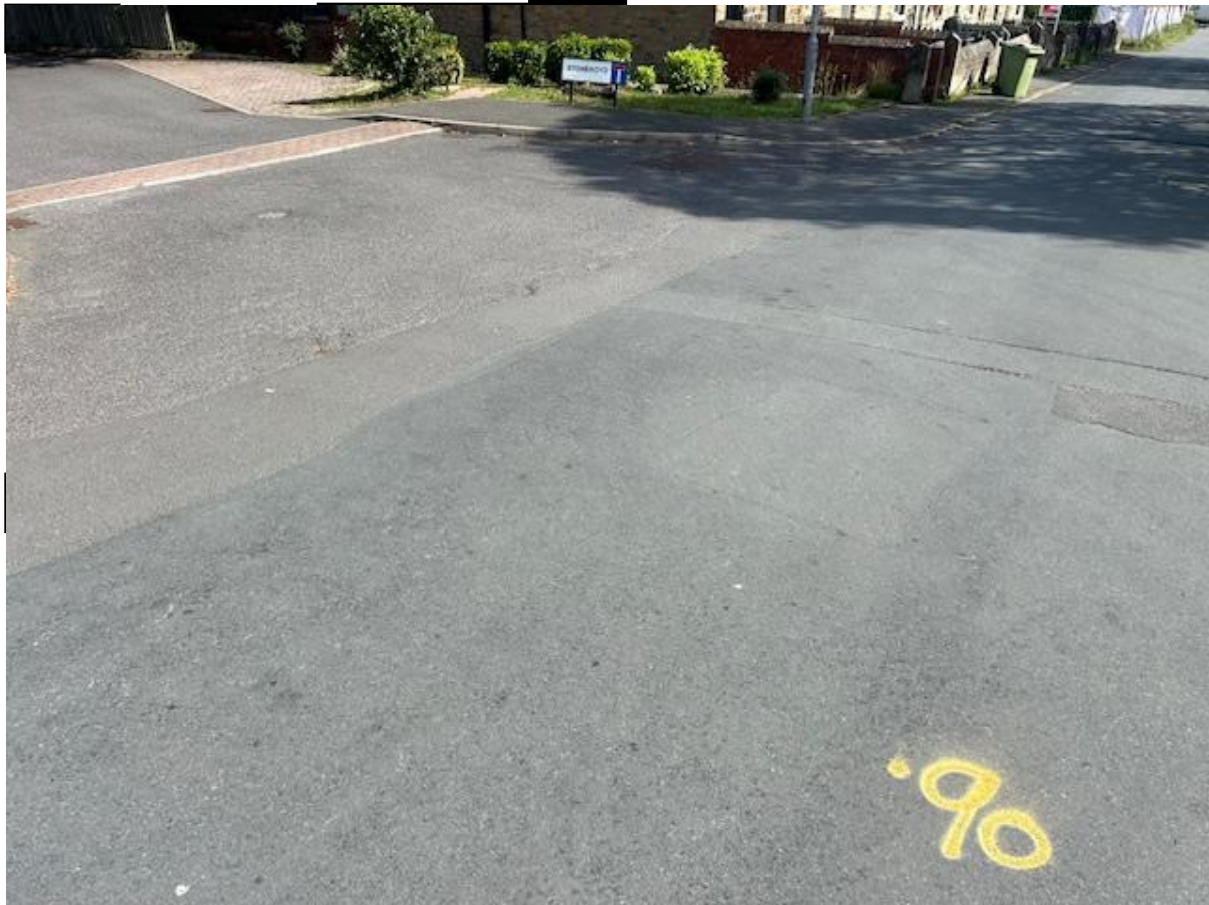
Comments – trench reinstatement along bell mouth of Stoneyroyd.

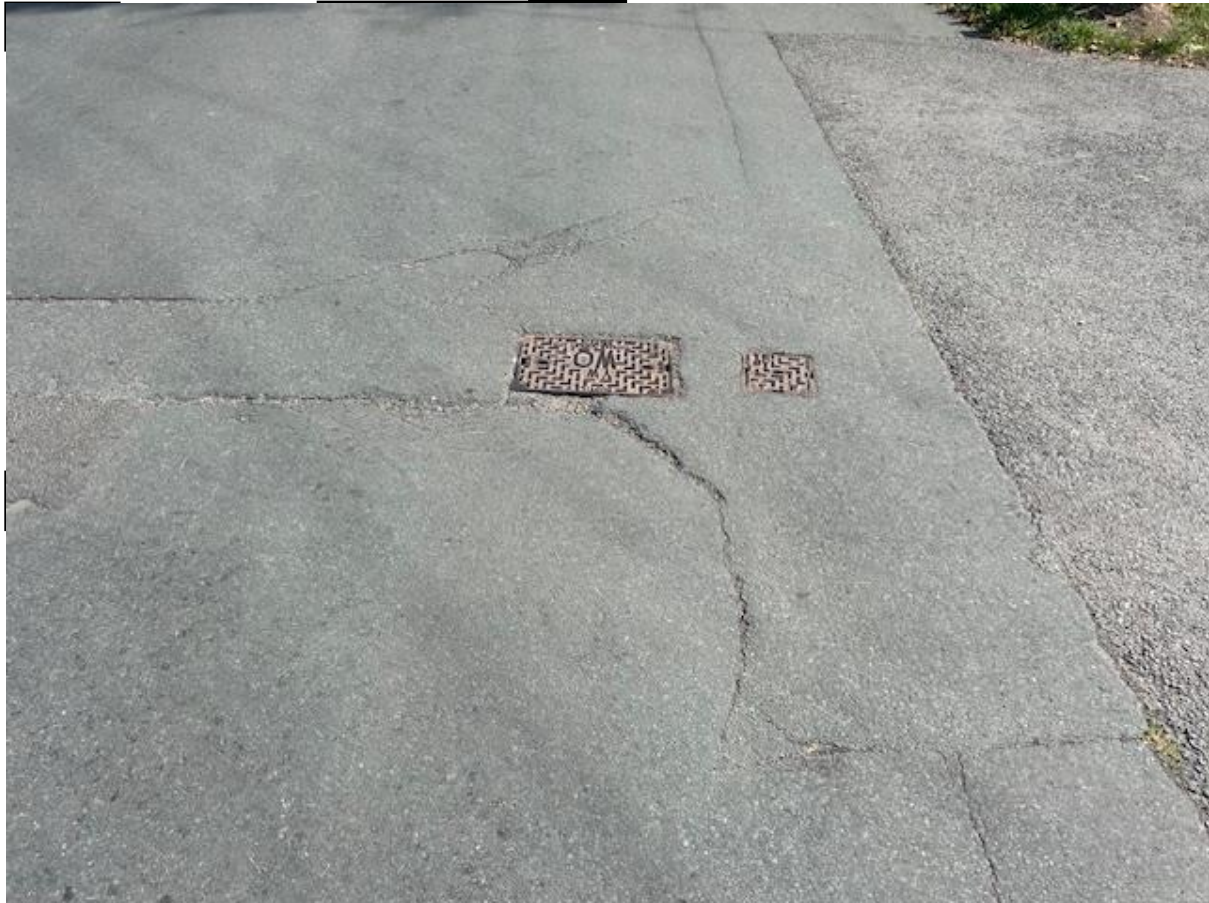
Comments – poor surface course reinstatement leading up to ironwork.

Recommendation – Highway Authority Inspection and monitor internally.

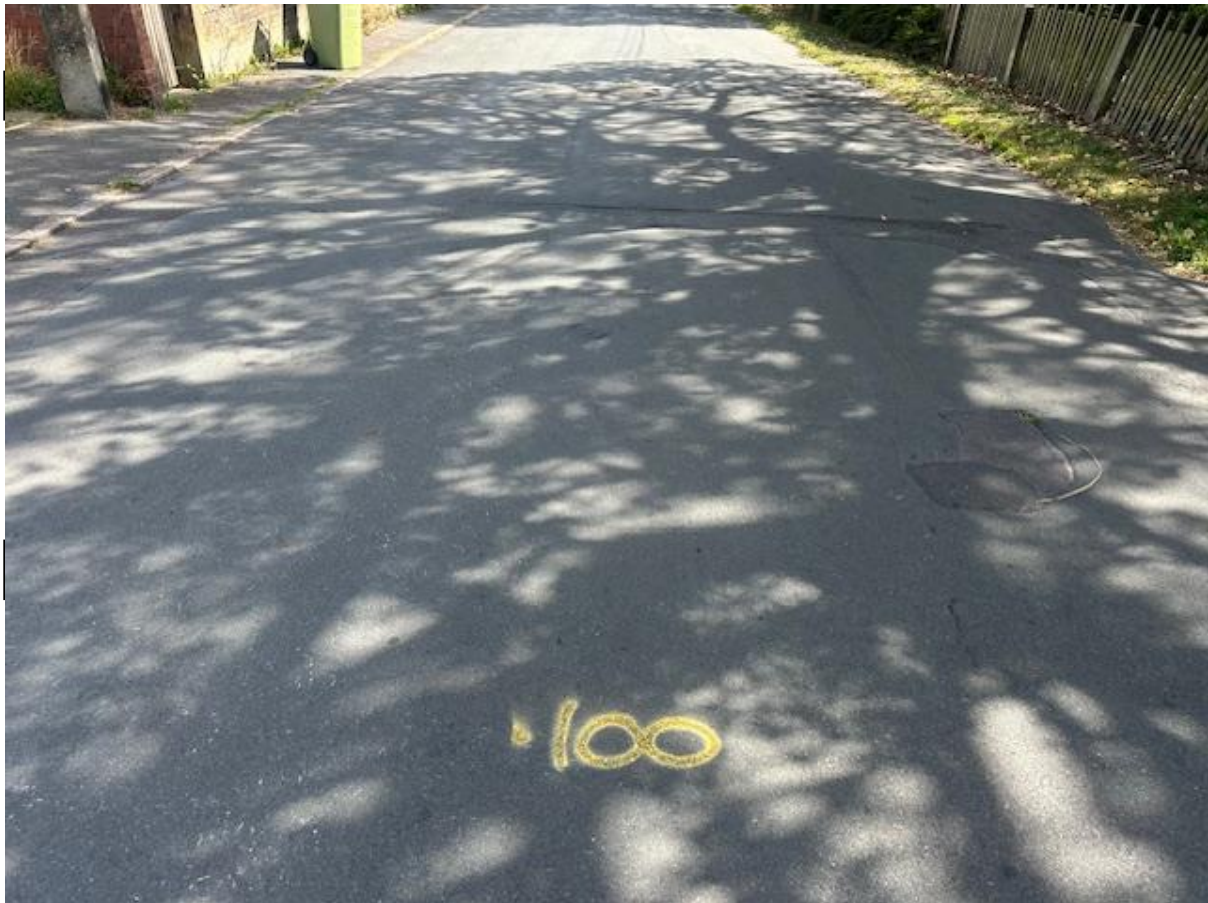
Comments – trench reinstatement across Denby Lane plus separate patch repair. Some settlement observed.

Recommendation – Highway Authority Inspection and monitor internally.
