Condition Survey Report

Denby Lane, Grange Moor.

Ref: HDC/ENG/DENBY LANE/FINAL

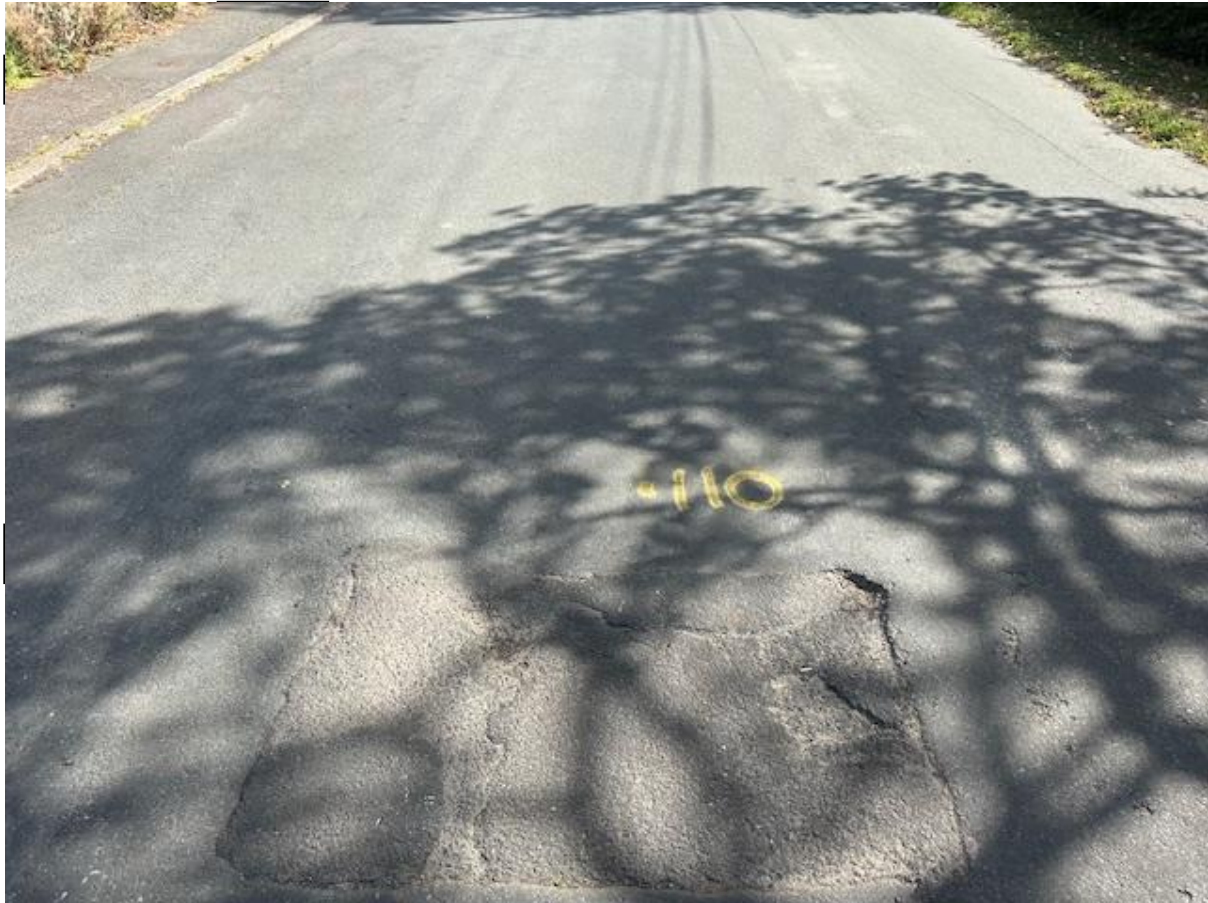
Comments – surface course patch repair in poor state and will progressively worsen.

Recommendation – Highway Authority Inspection and monitor internally.

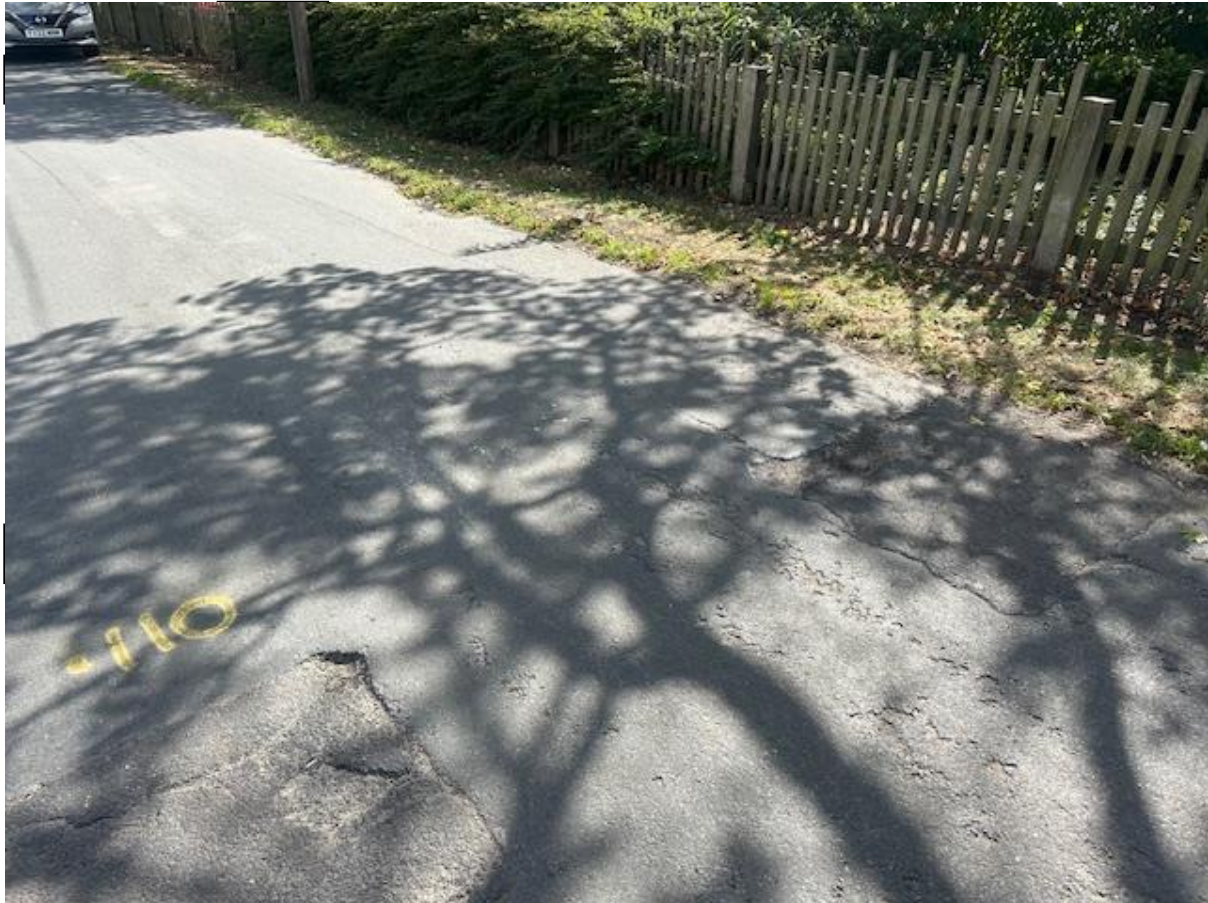
Comments – additional surface course repair in poor state on southern flank of Denby Lane.

Recommendation – Highway Inspection and monitor internally.

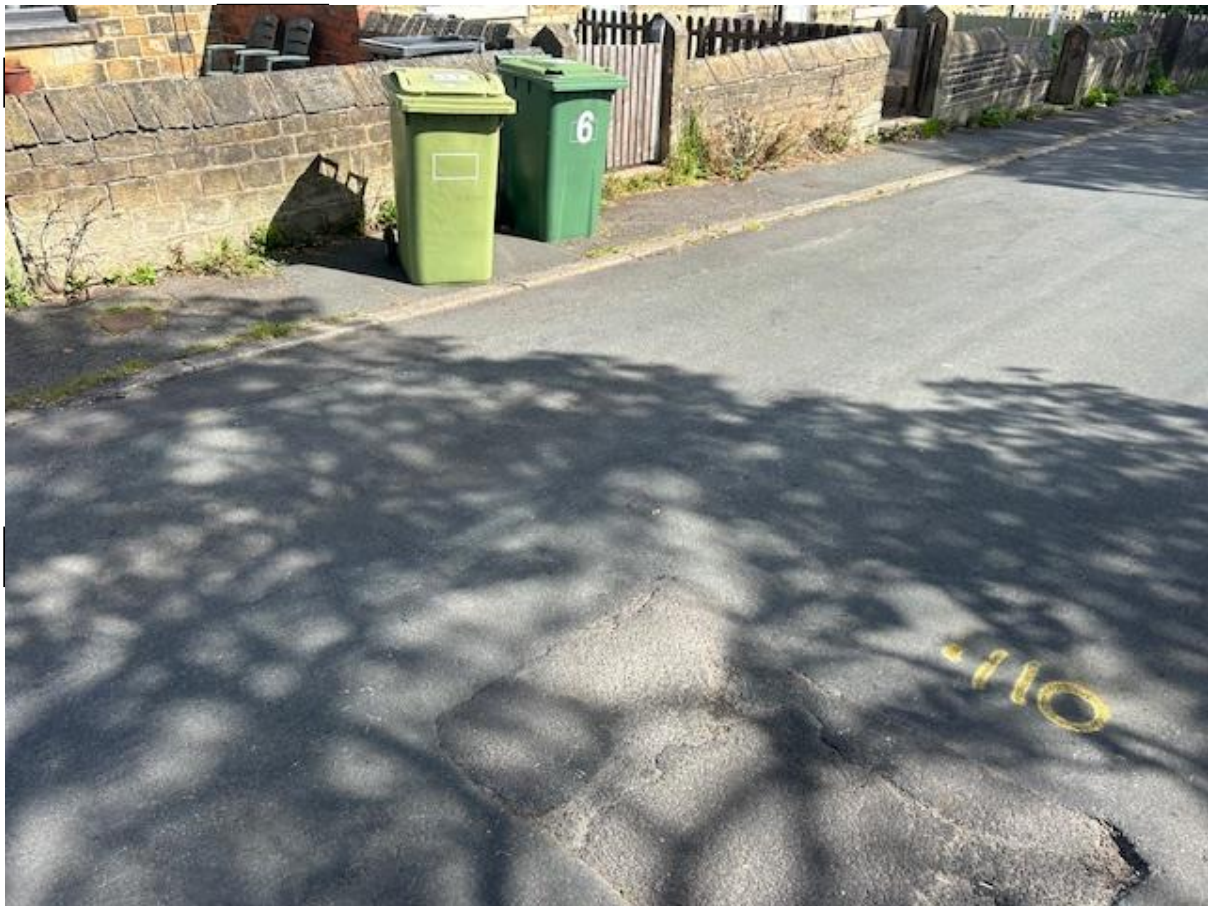
Comments – as above plus evidence of weeds growing in footway.

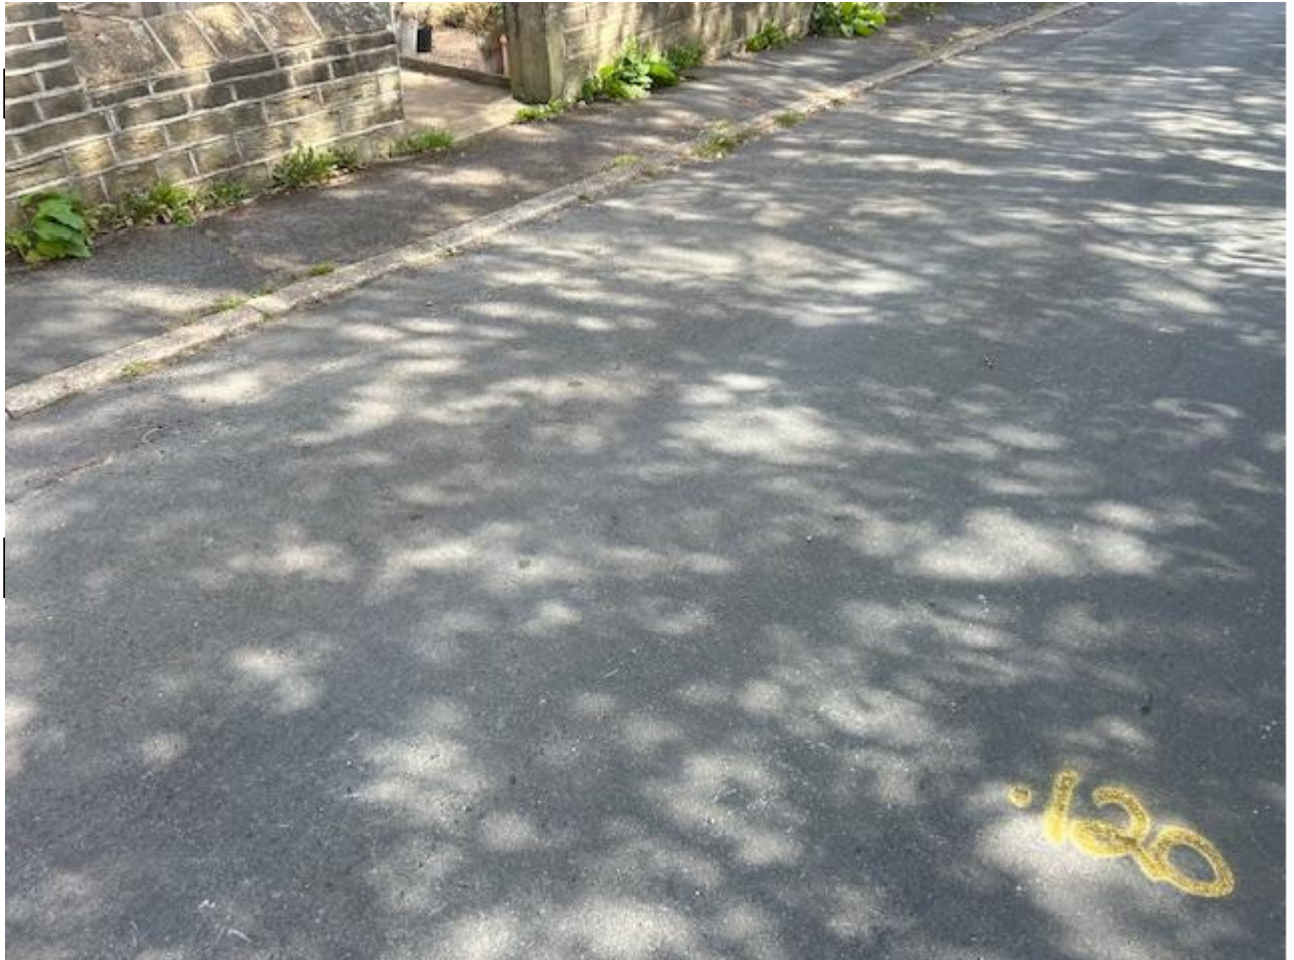
Comments – trench reinstatement terminates, evidence weeds growing on northern footway.

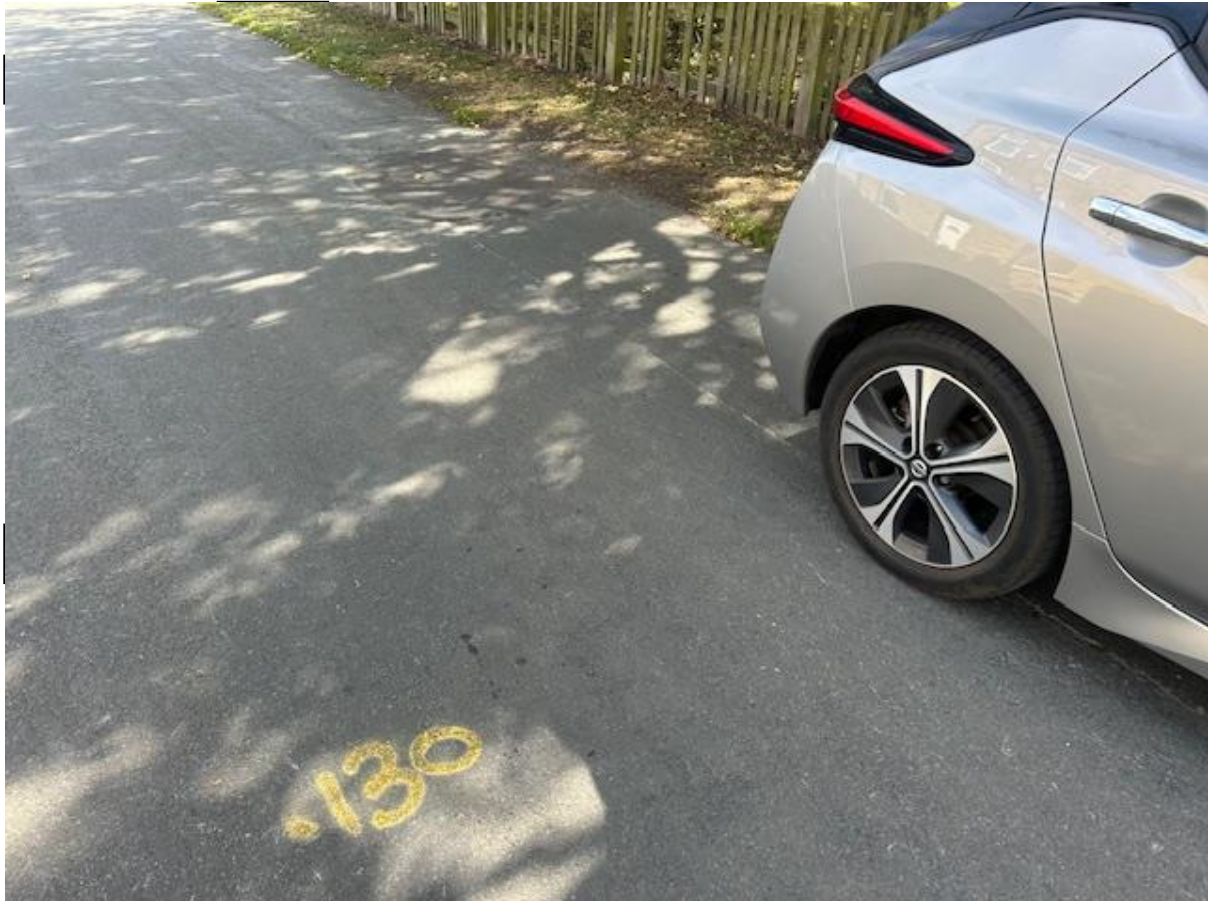
Comments – surface course patch repair.

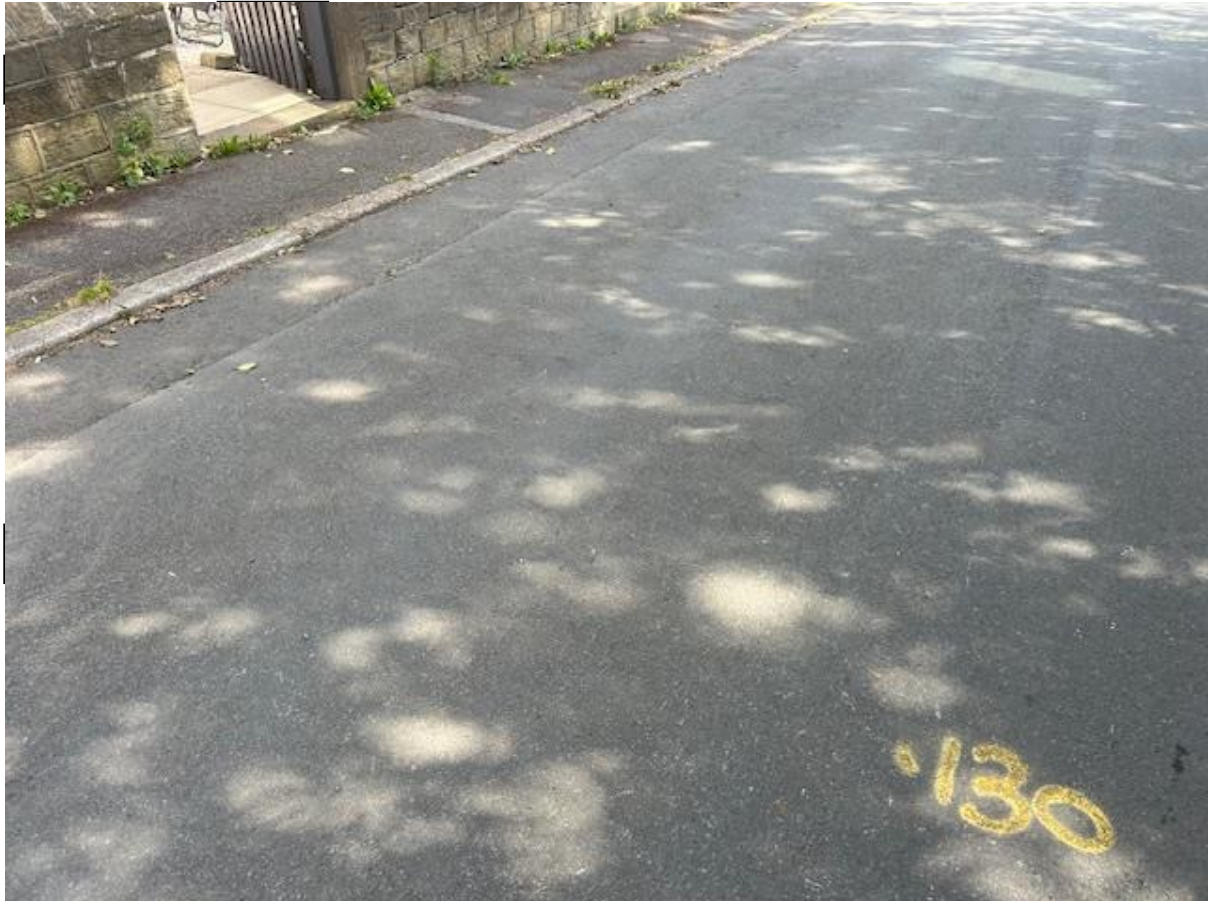
Comments – trench reinstatement along northern drainage channel. Weeds growing along kerb edge of footway.

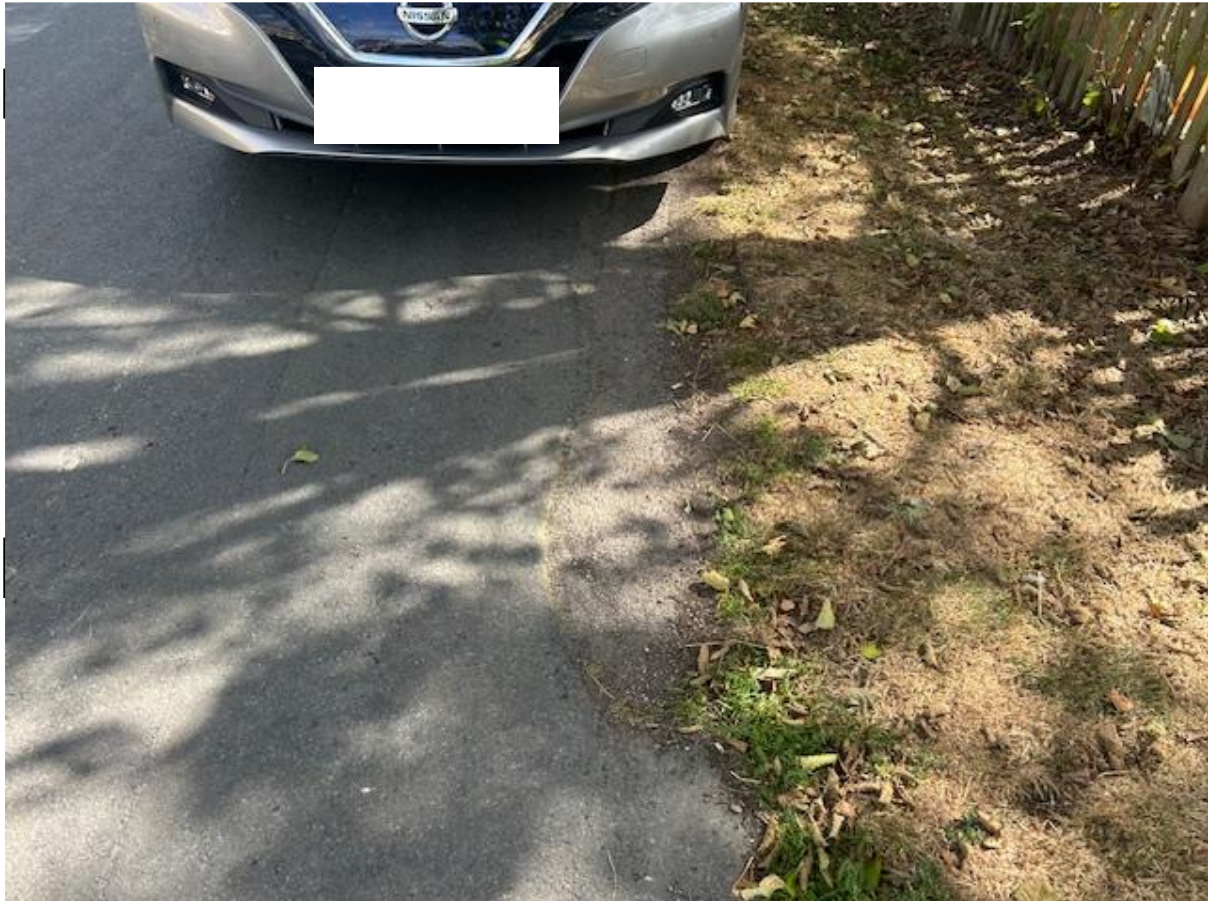
Comments – longitudinal patch repair to surface course / drainage channel along southern flank of Denby Lane.

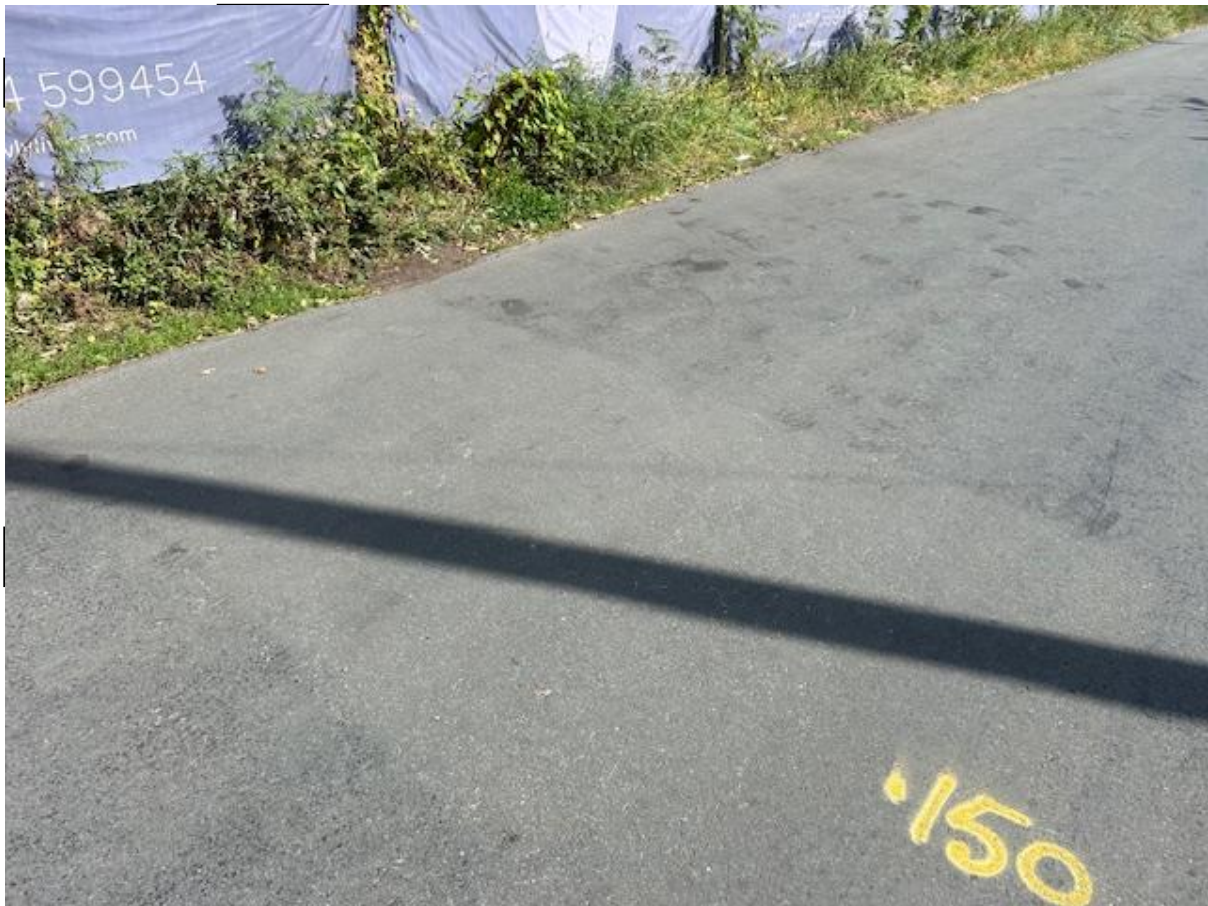
Comments – evidence of minor settlement along northern flank of Denby Lane.

Recommendation – Highway Inspection and monitor internally.

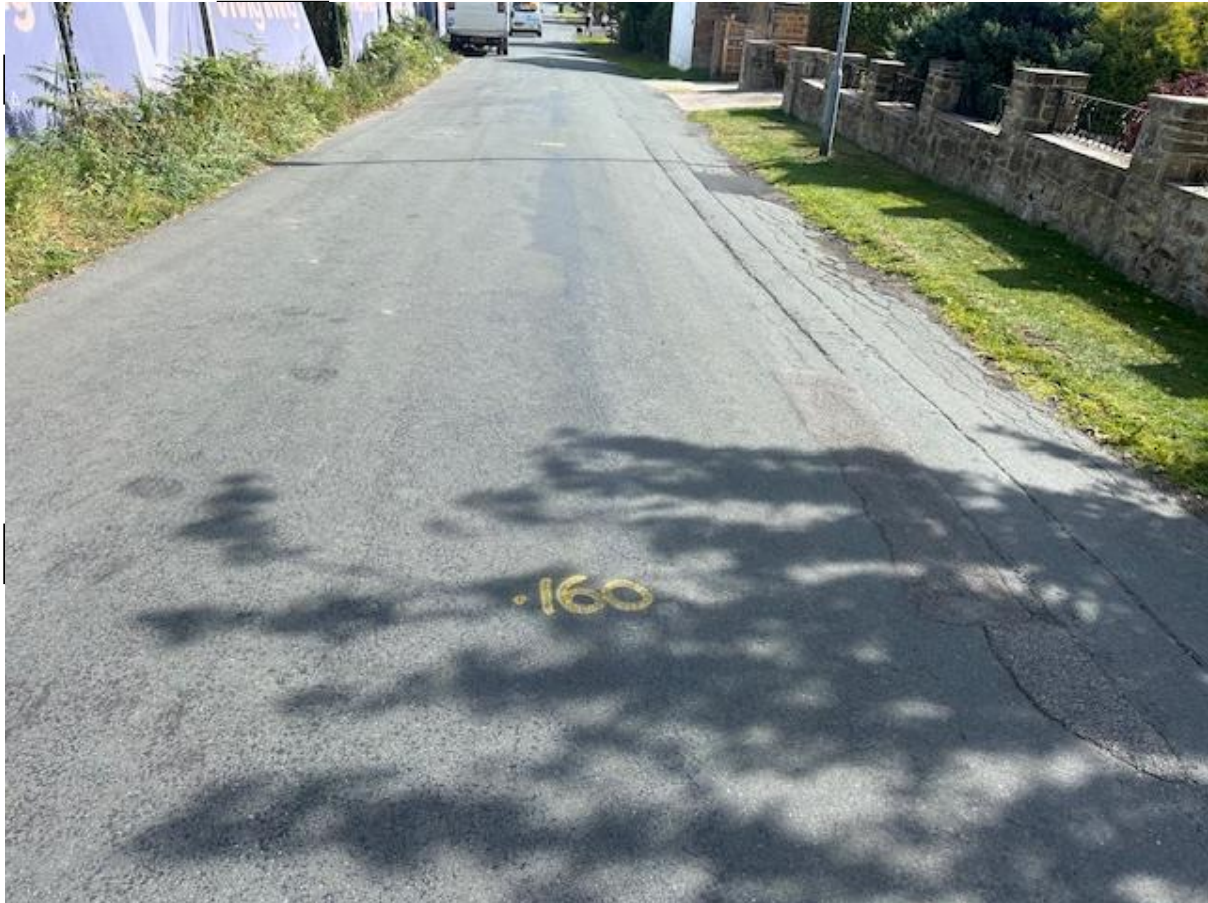
Comments – trench reinstatement joints starting to fail plus poor surface course patch repair.

Recommendation – Highway Authority Inspection and monitor internally.

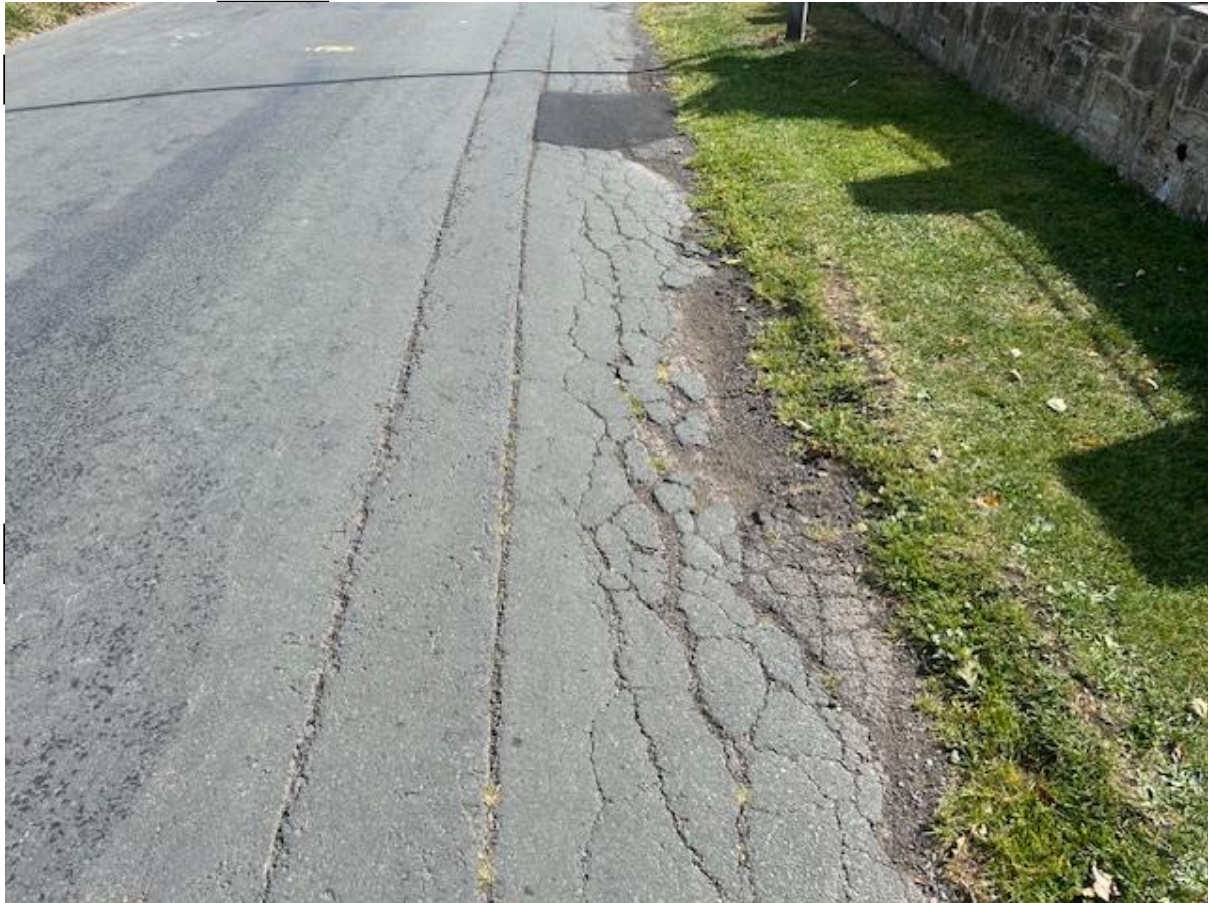
Comments – evidence of tensile cracks developing alongside poor trench reinstatement.

Recommendation – Highway Authority Inspection and monitor internally.

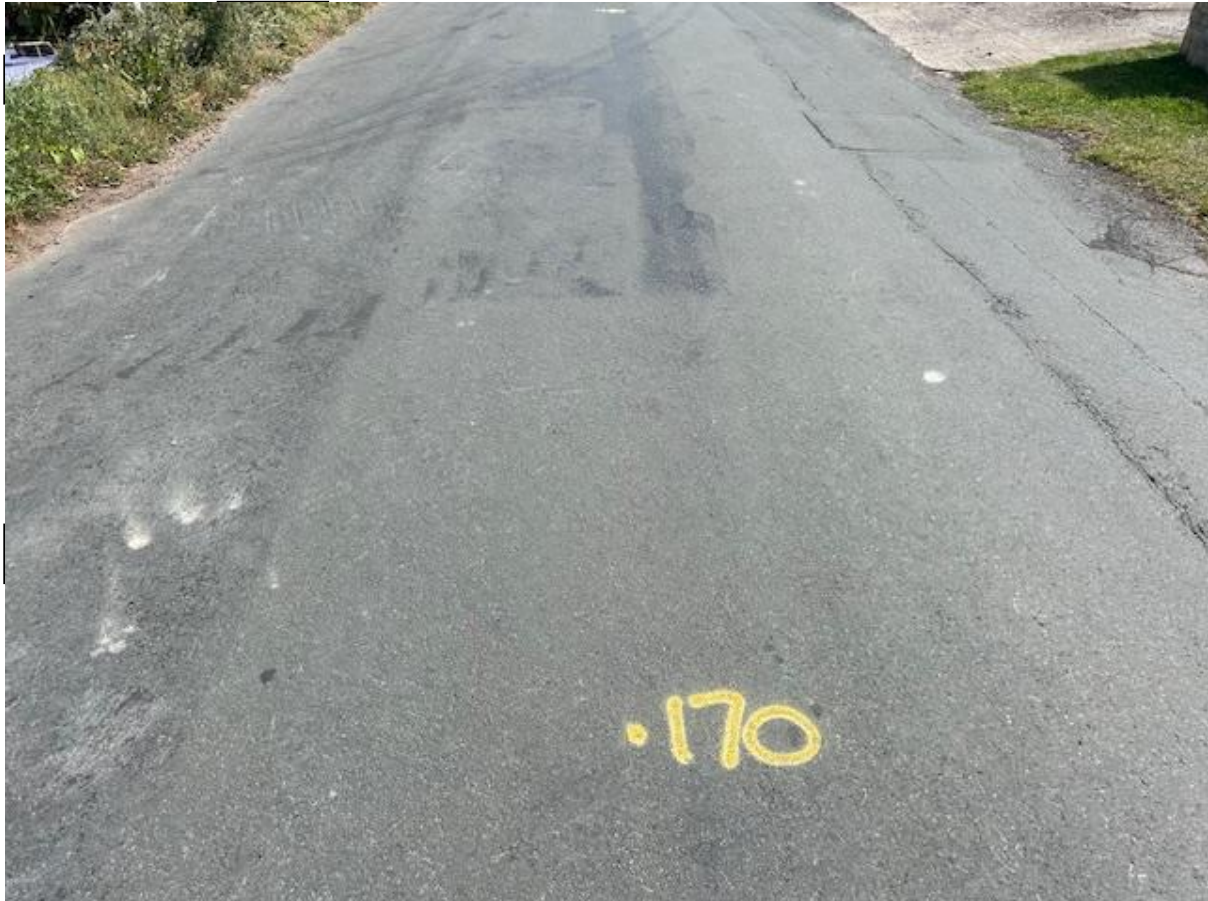
Comments – trench reinstatement joints starting to fail plus poor surface course patch repair.

Recommendation – Highway Authority Inspection and monitor internally.

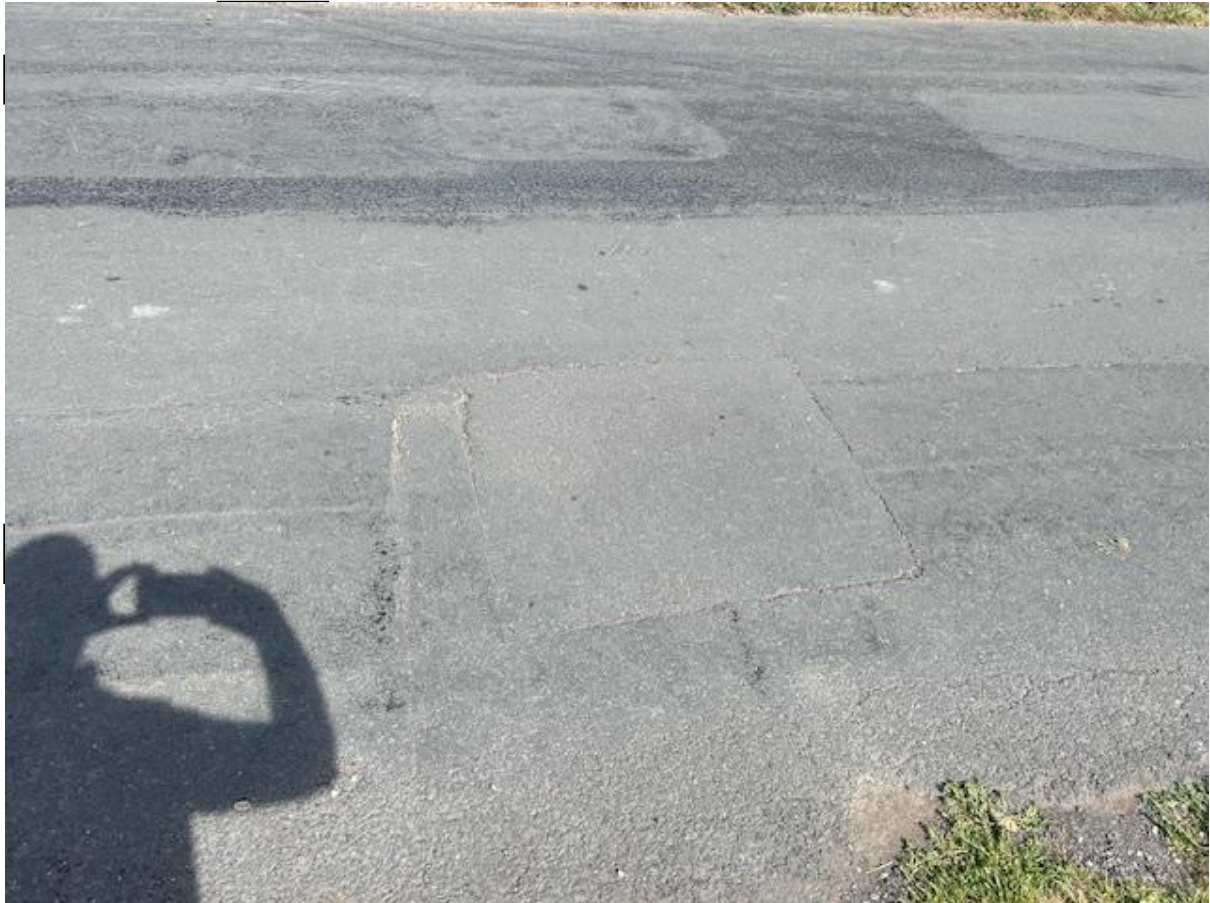
Comments – surface course patch repair in and amongst trench reinstatement.

Recommendation – Highway Authority Inspection and monitor internally.

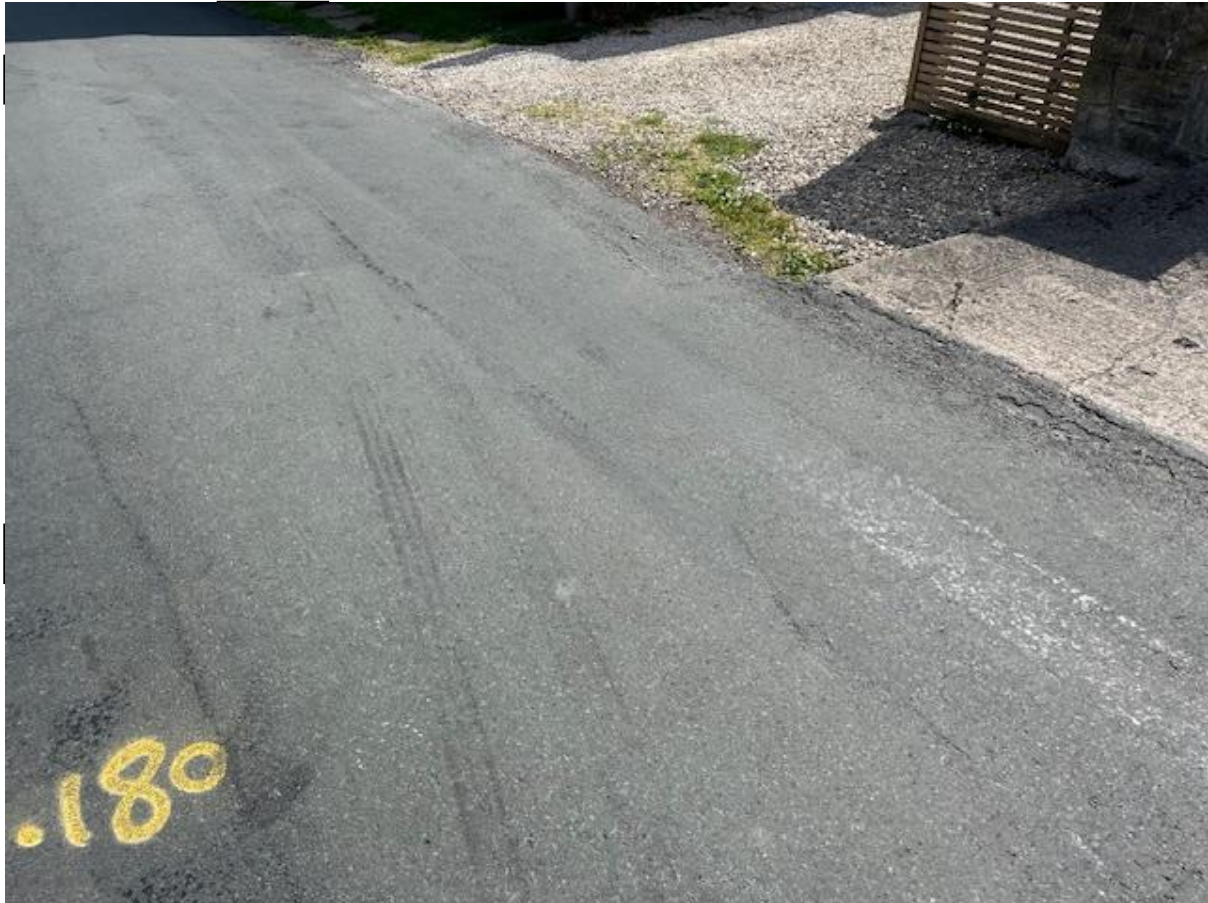
Comments – some minor surface course deterioration along north drainage channel.

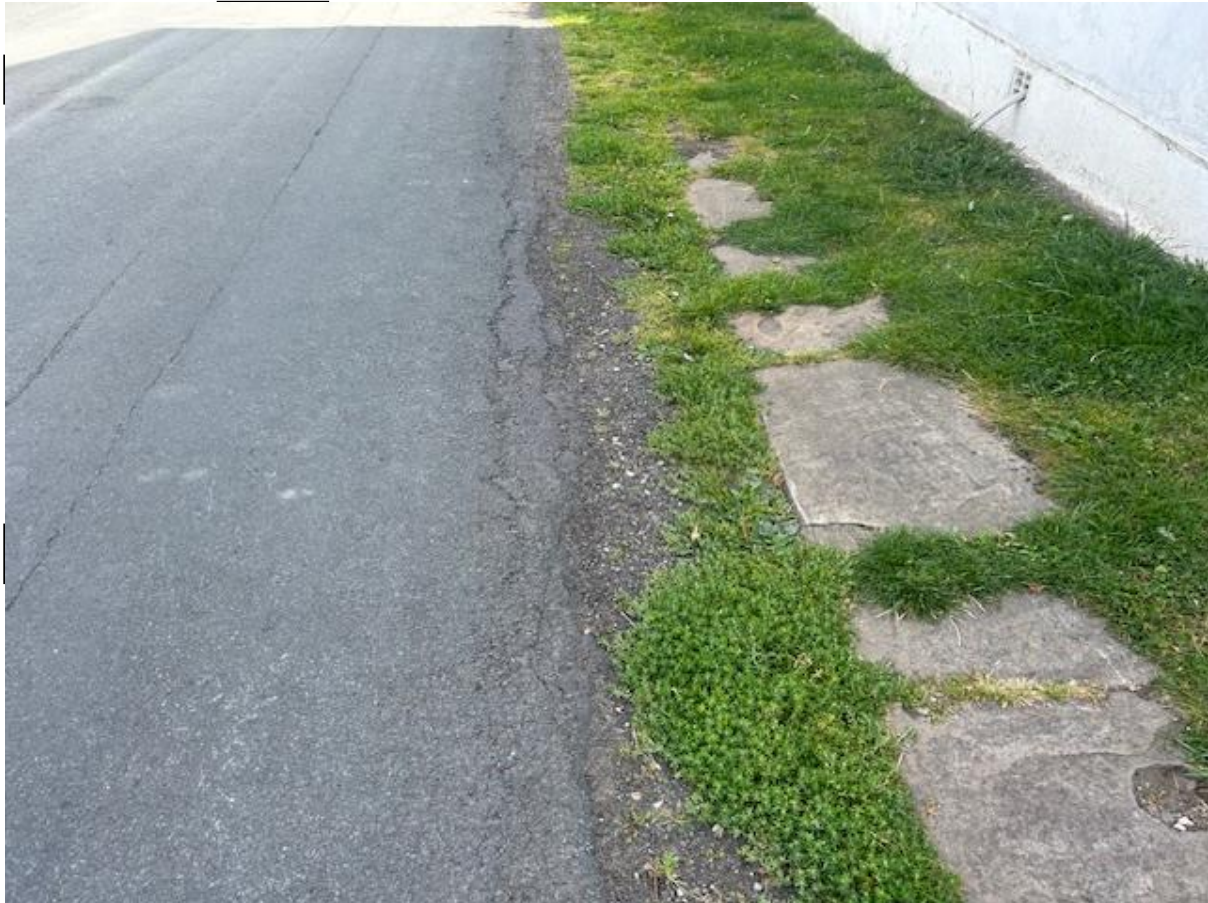
Comments - trench reinstatement joints in early stages of starting to fail plus tensile crack along drainage channel. Poor surface water drainage with evidence of weeds growing.

Recommendation – Highway Authority Inspection and monitor internally.

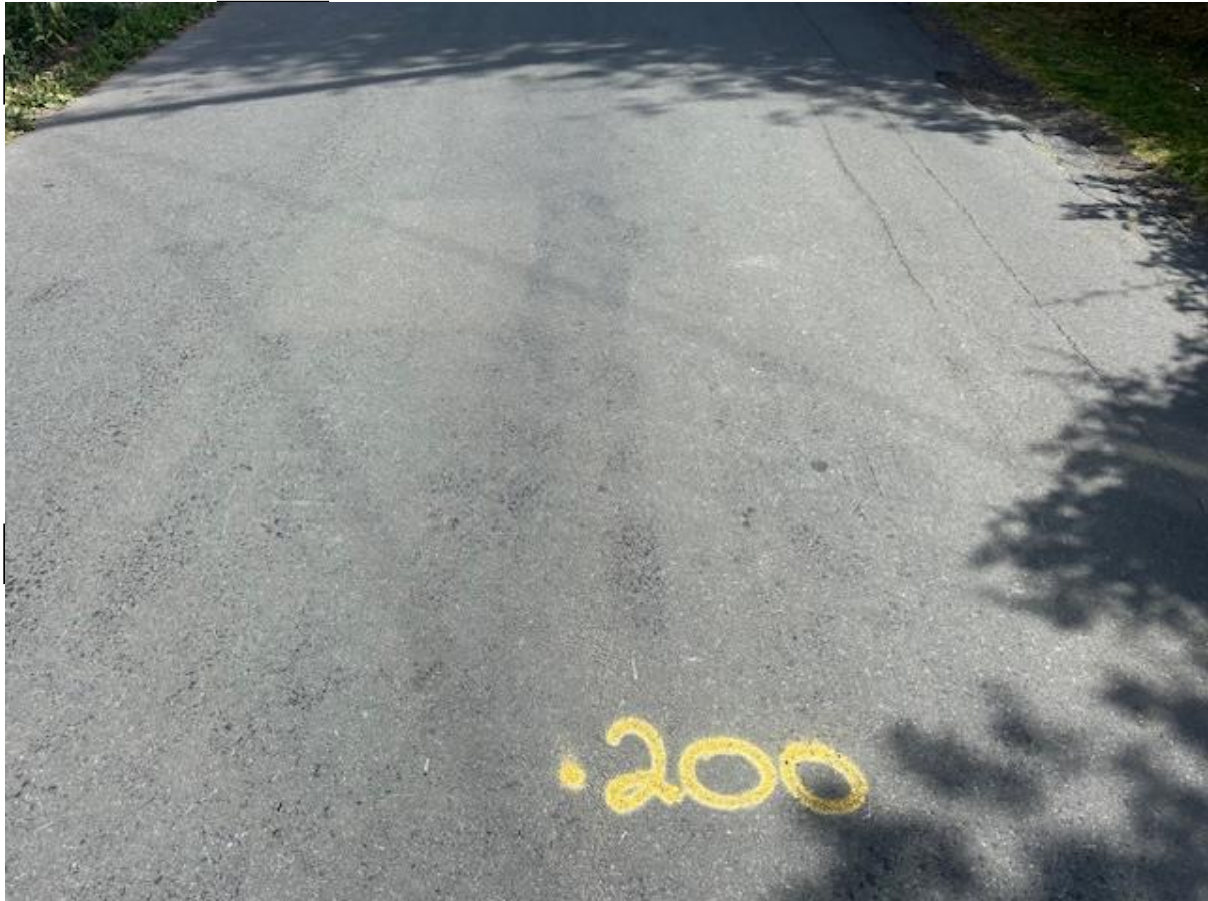
Comments – trench reinstatement continues.

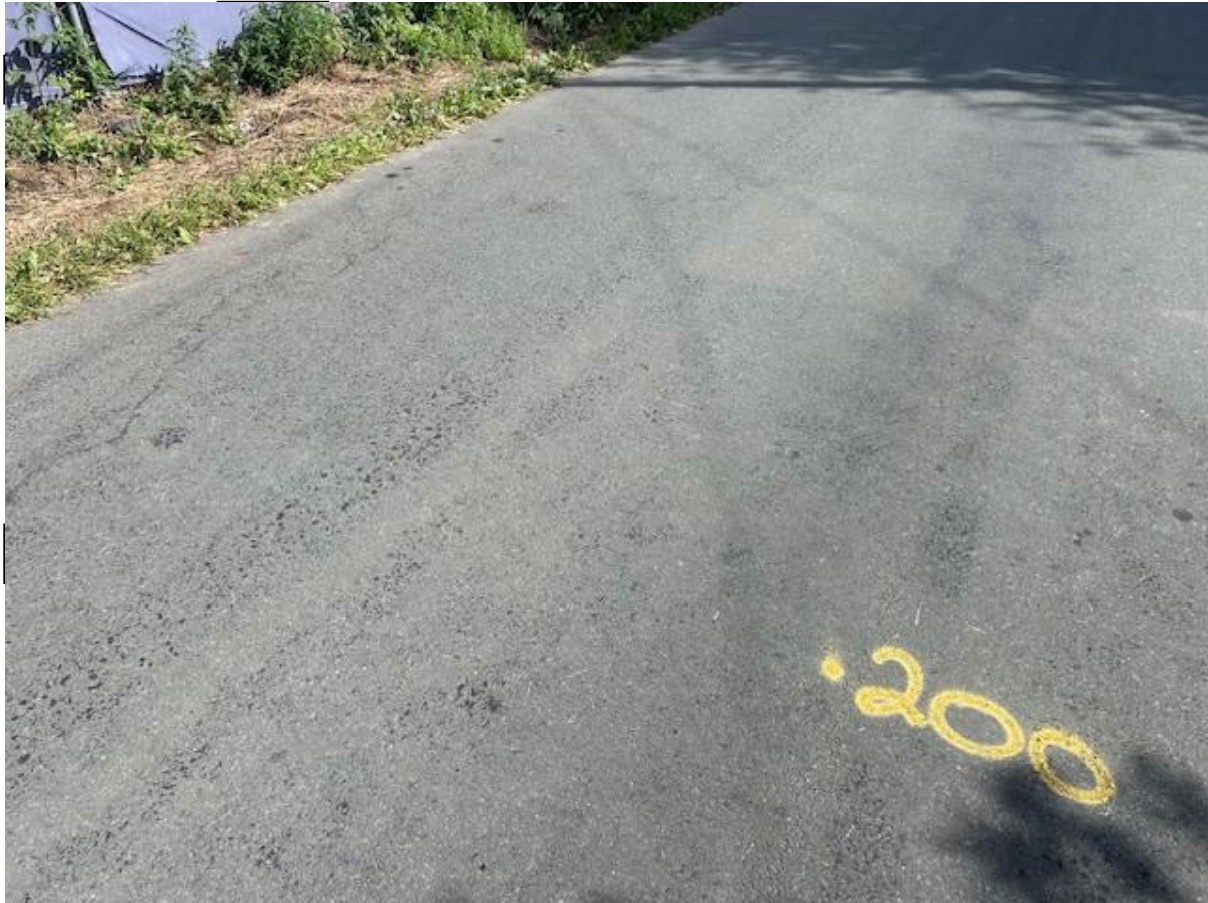
Comments – evidence of some minor surface course deterioration.

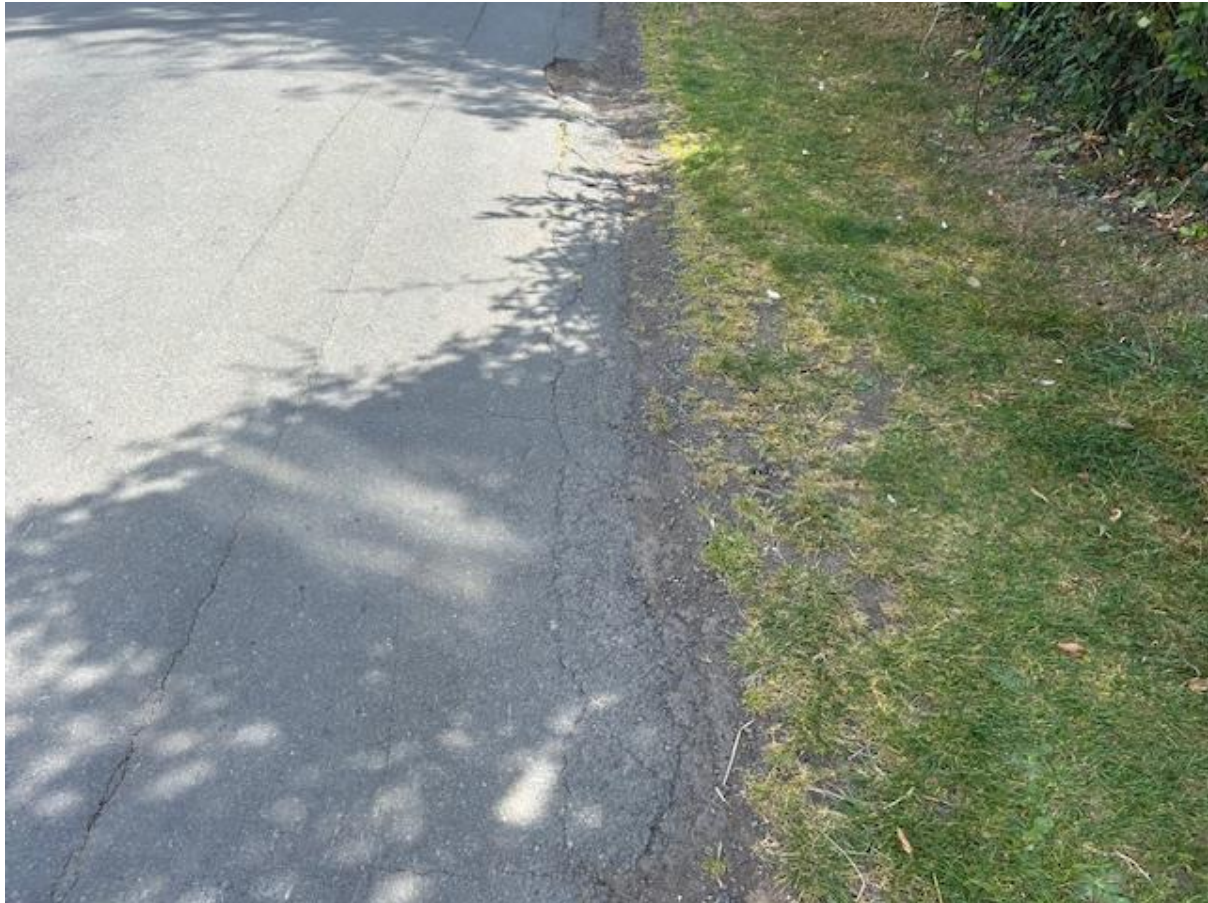
Comments trench reinstatement joints starting to fail plus surface tensile cracks developing along drainage channel.

Recommendation – Highway Authority Inspection and monitor internally.

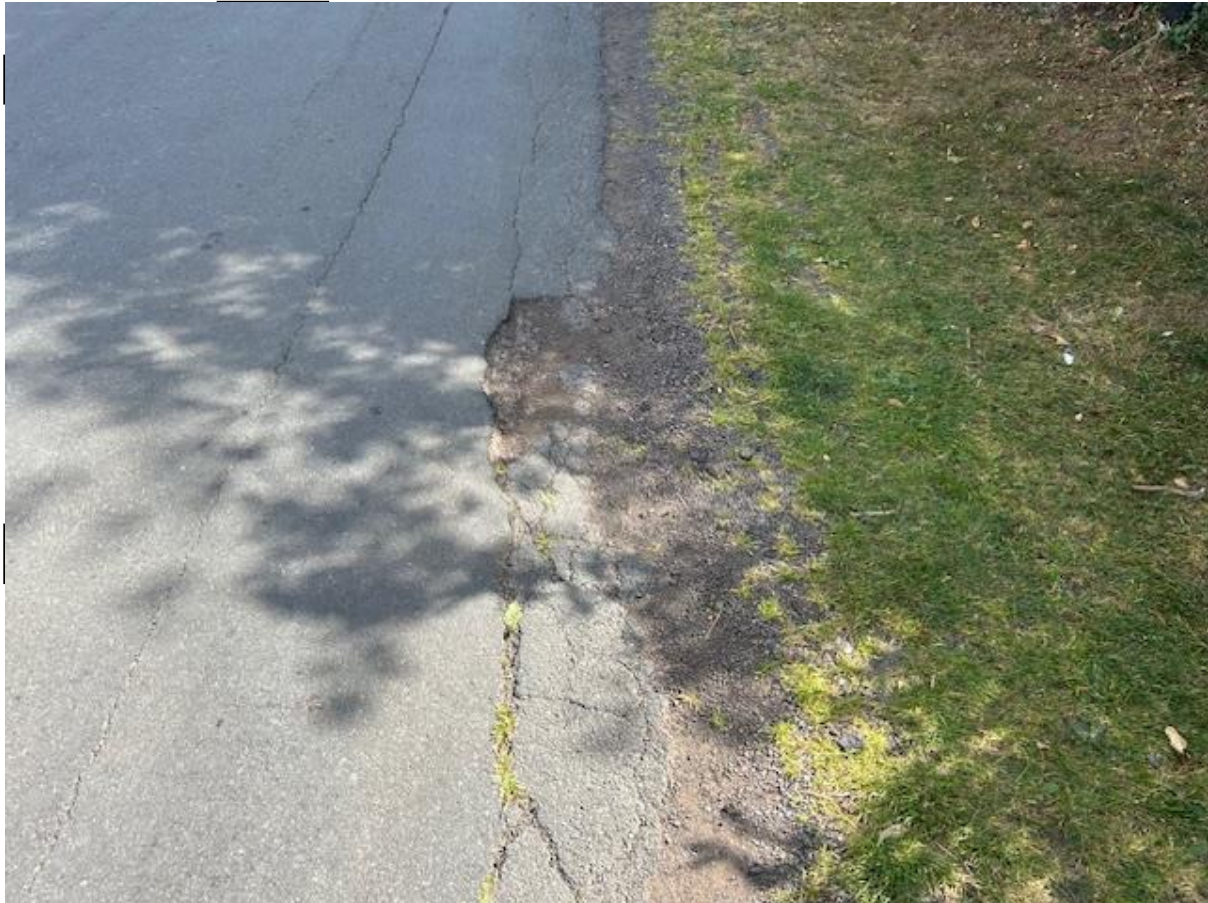
Comments - surface course tensile cracks starting to impact on integrity of carriageway. Pothole developed.

Recommendation – Highway Authority Inspection and monitor internally.

REMEDIAL ACTION REQUIRED.

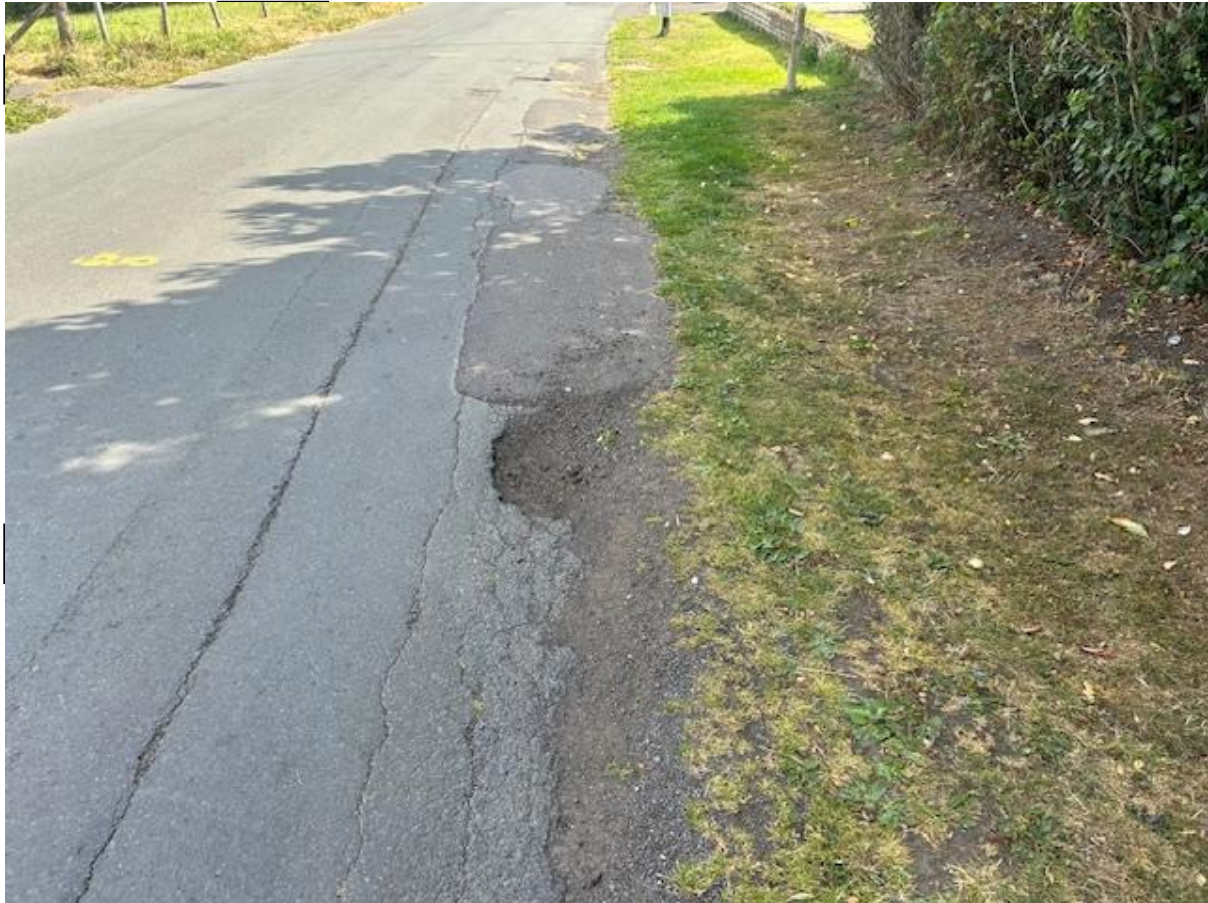
Comments - trench reinstatement joints starting to fail plus poor surface course patch repair. As above.

Recommendation – Highway Authority Inspection and monitor internally.

REMEDIAL ACTION REQUIRED.

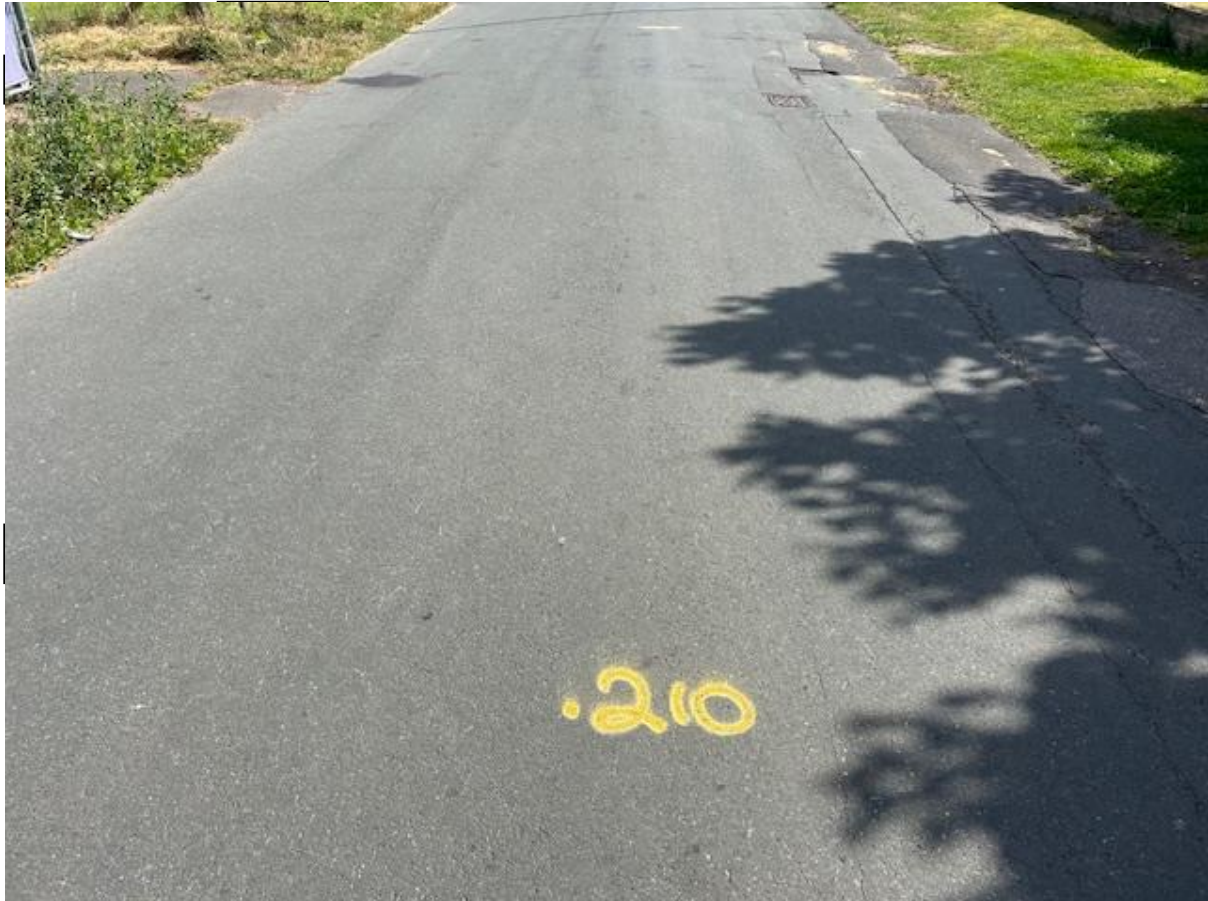
Comments trench reinstatement joints starting to fail plus poor surface course patch repair.

Recommendation – Highway Authority Inspection and monitor internally.
