Condition Survey Report

Denby Lane, Grange Moor.

Ref: HDC/ENG/DENBY LANE/FINAL

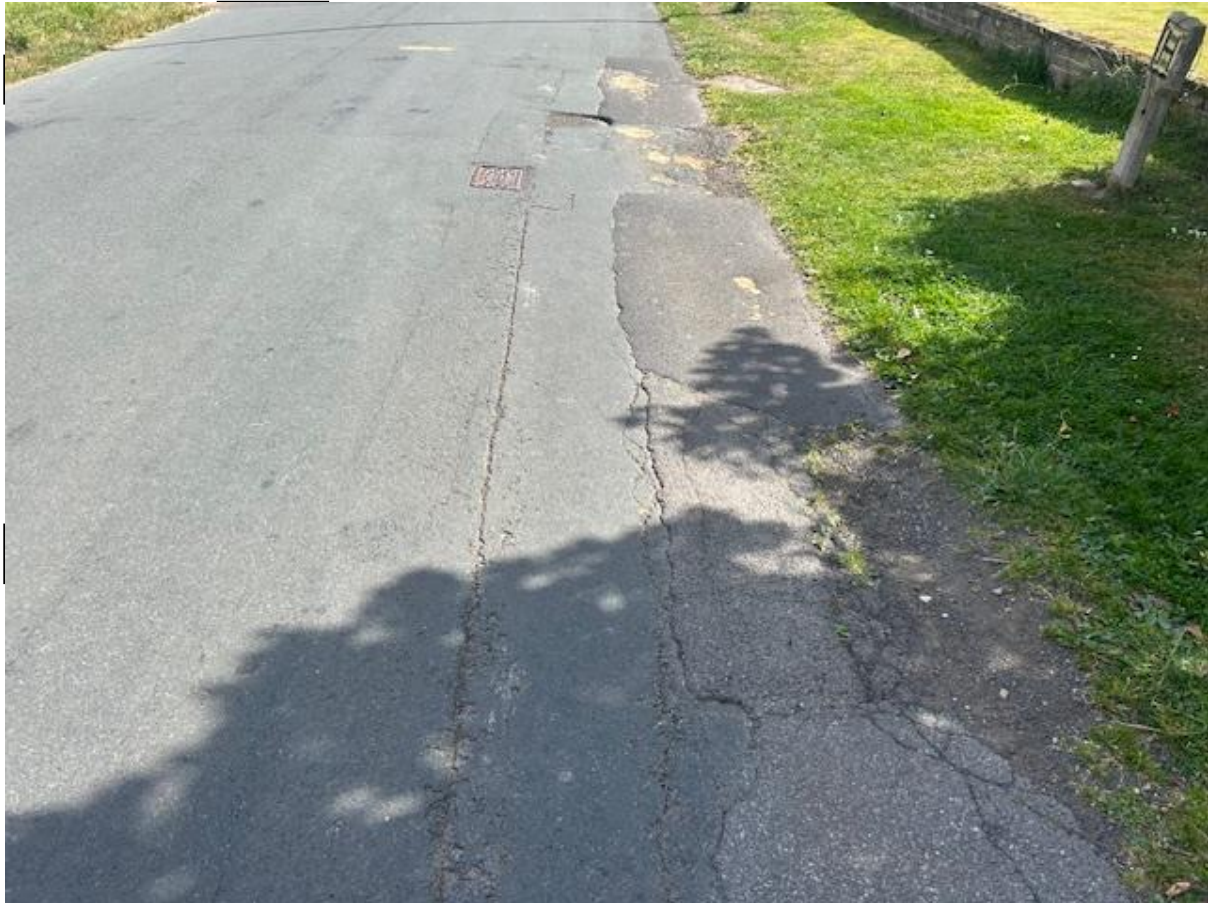
Comments - trench reinstatement joints starting to fail plus poor surface course patch repair. As above.

Recommendation – Highway Authority Inspection and monitor internally.

REMEDIAL ACTION REQUIRED.

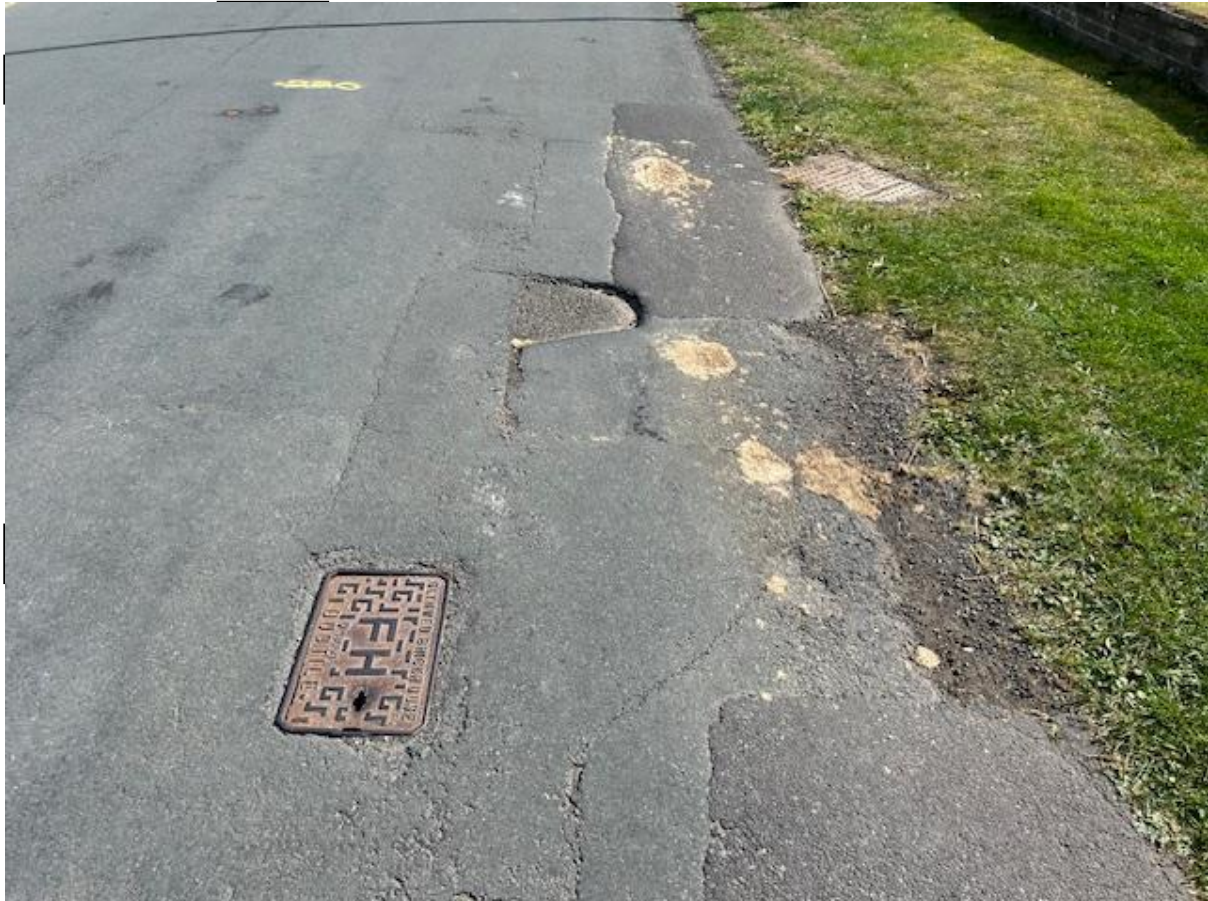
Comments - trench reinstatement joints starting to fail plus poor surface course patch repair.
Pothole developed.

Recommendation – Highway Authority Inspection and monitor internally.

REMEDIAL ACTION REQUIRED.

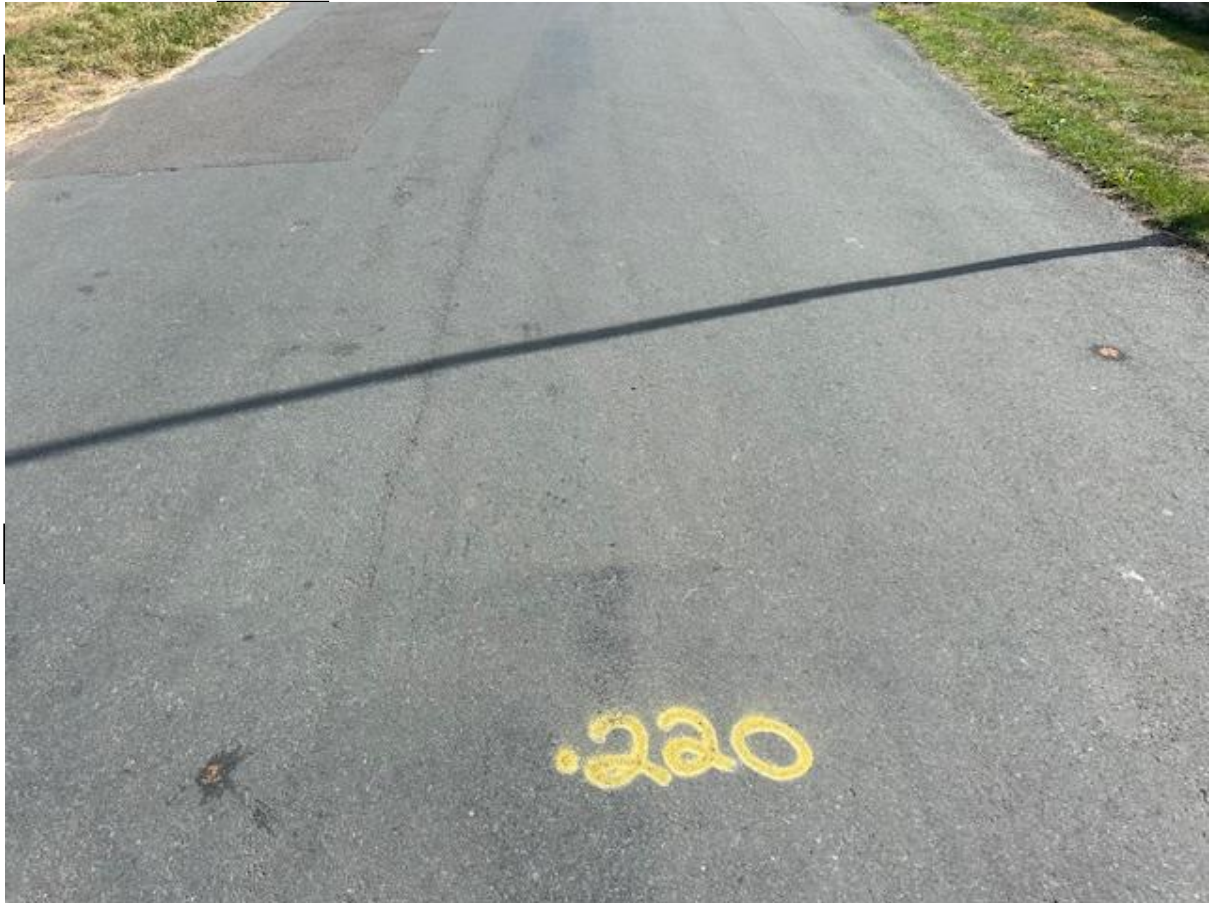
Comments – surface course patchwork repair.

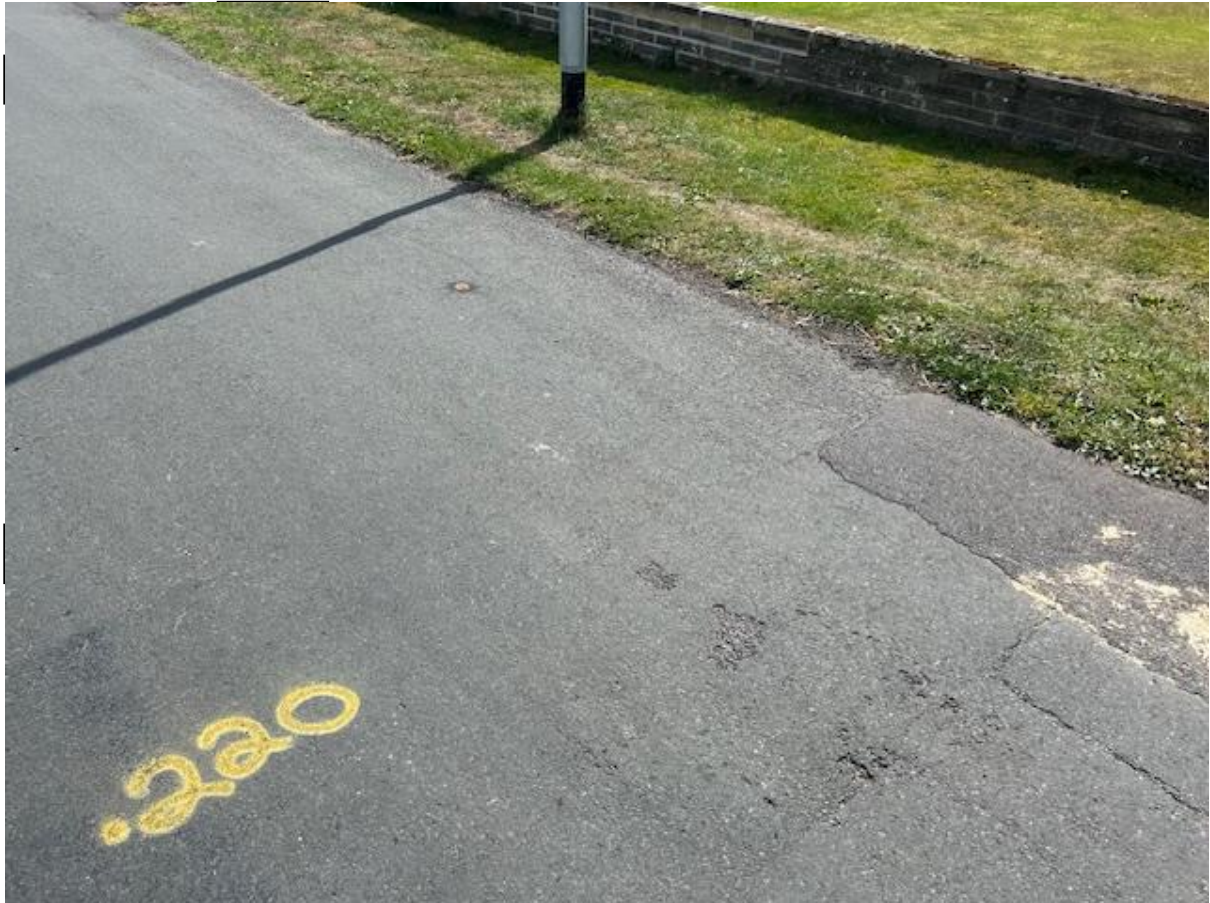
Comments – surface course patch repair.

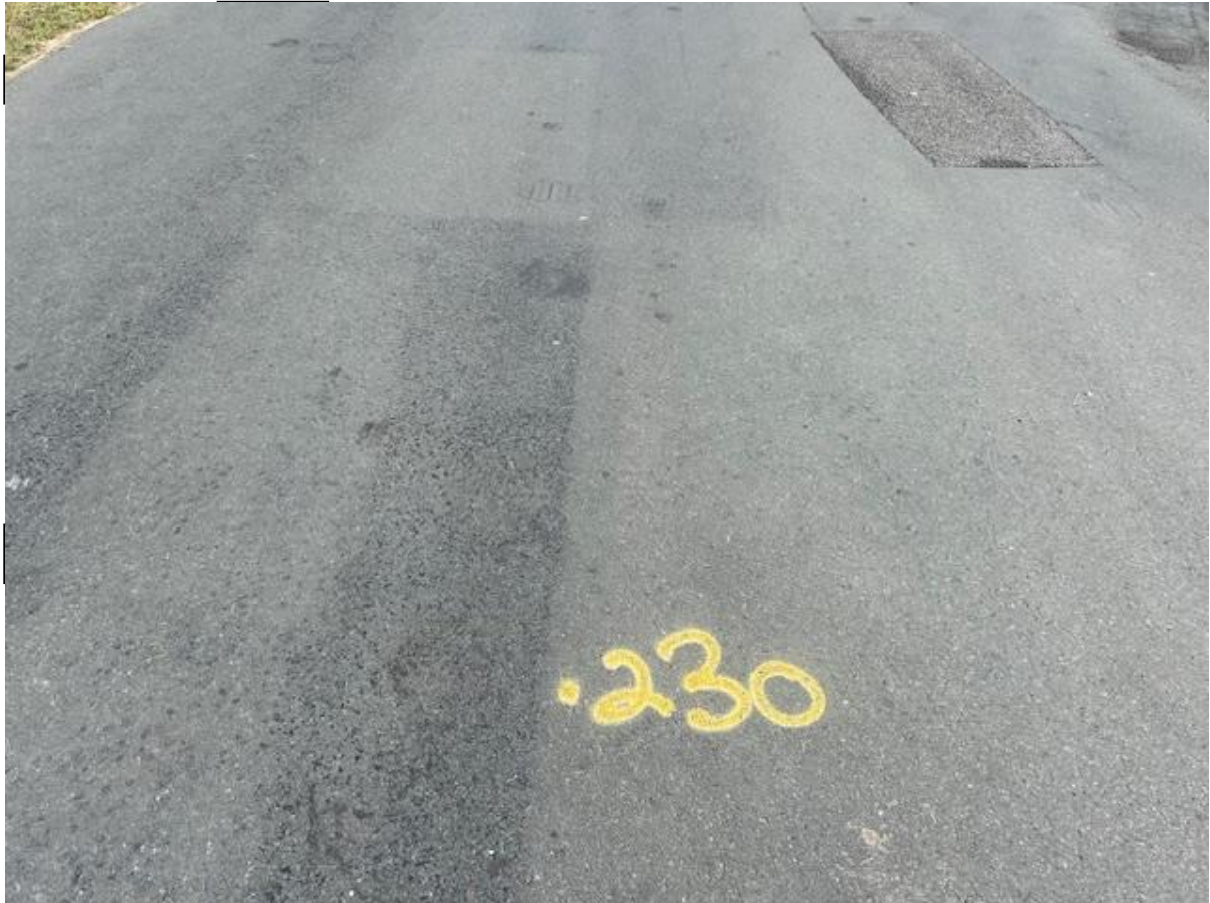
Comments -surface course patch repair.

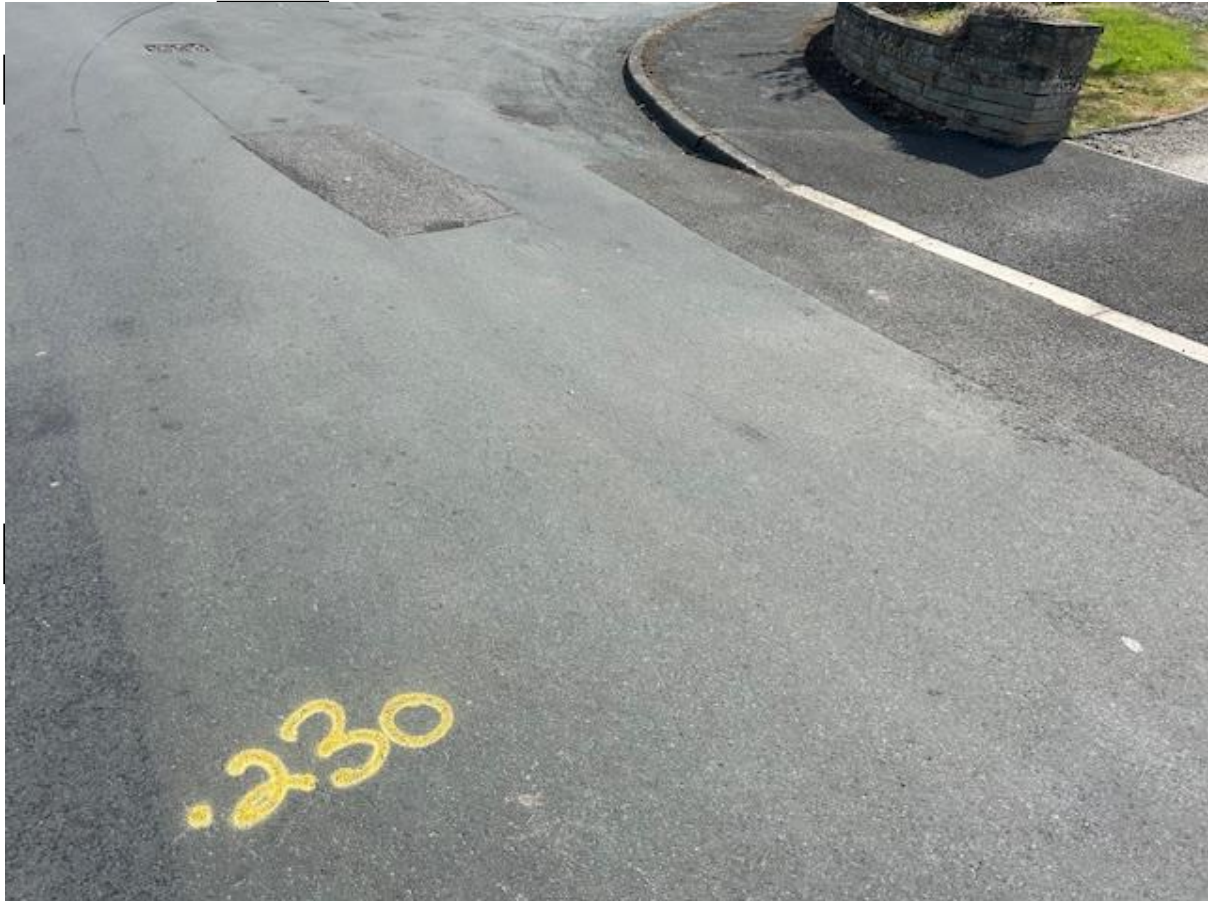
Comments – surface course repairs.

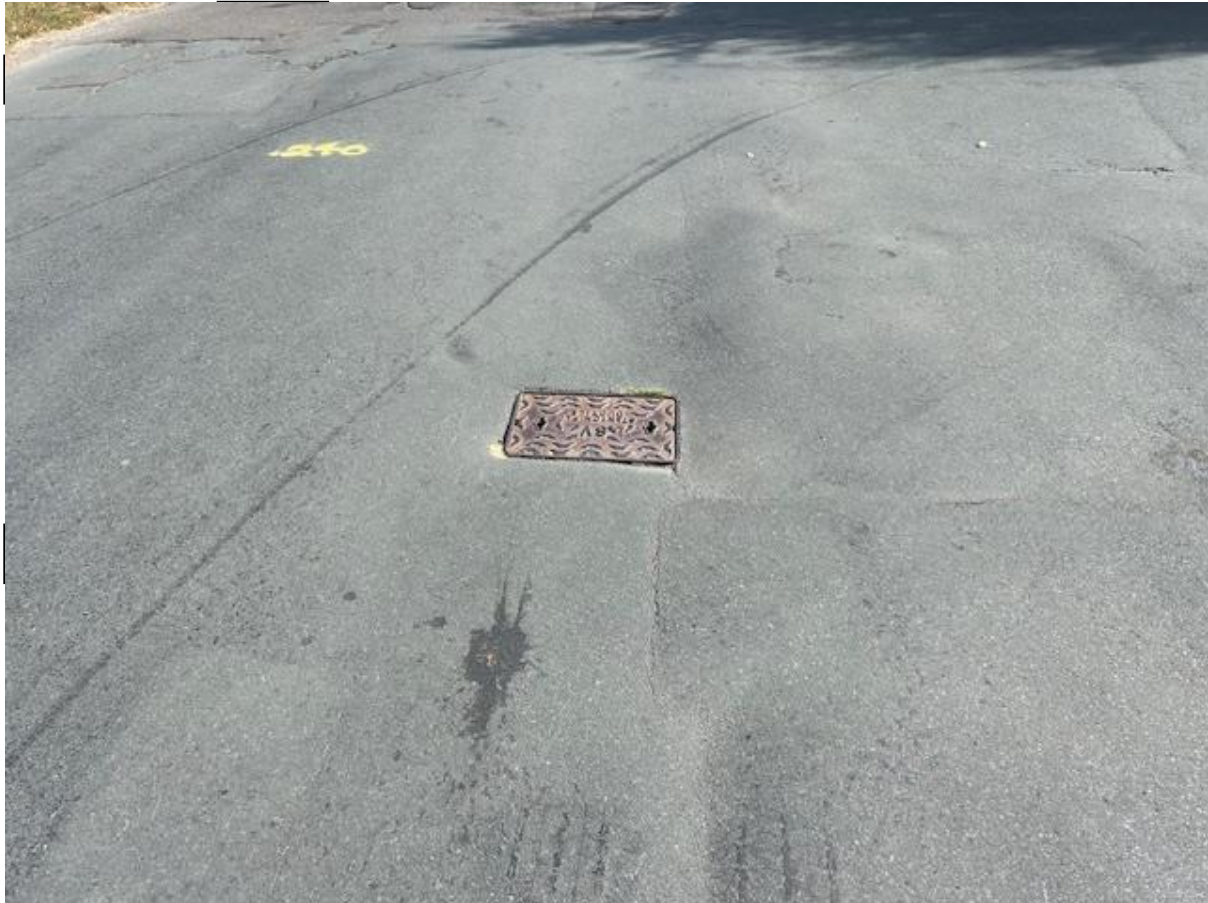
Comments – evidence of some settlement within carriageway.

Recommendation – Highway Authority Inspection and monitor internally.

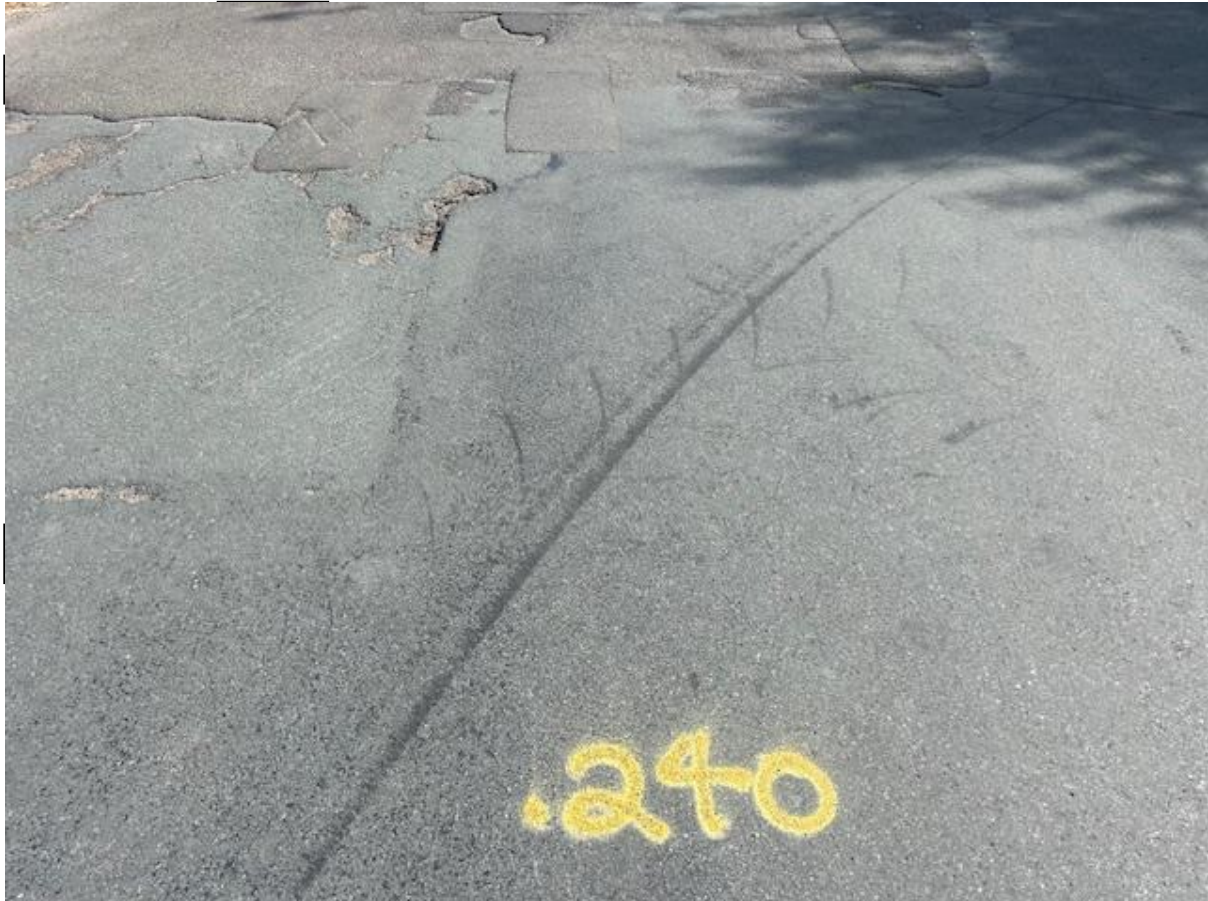
Comments – Poor surface course patch repair and deterioration of surface course leading to emerging potholes.

Recommendation – Highway Authority Inspection and monitor internally.

REMEDIAL ACTION REQUIRED.
