Our Ref: E19/7612/OF/015

**Re: Development at Cumberworth Road, Skelmanthorpe**

Further to your request we have attended the above site to undertake an inspection of the gas membrane to confirm that the quality of the installation is satisfactory in Plots 100-106 & 125-128 at the above site.

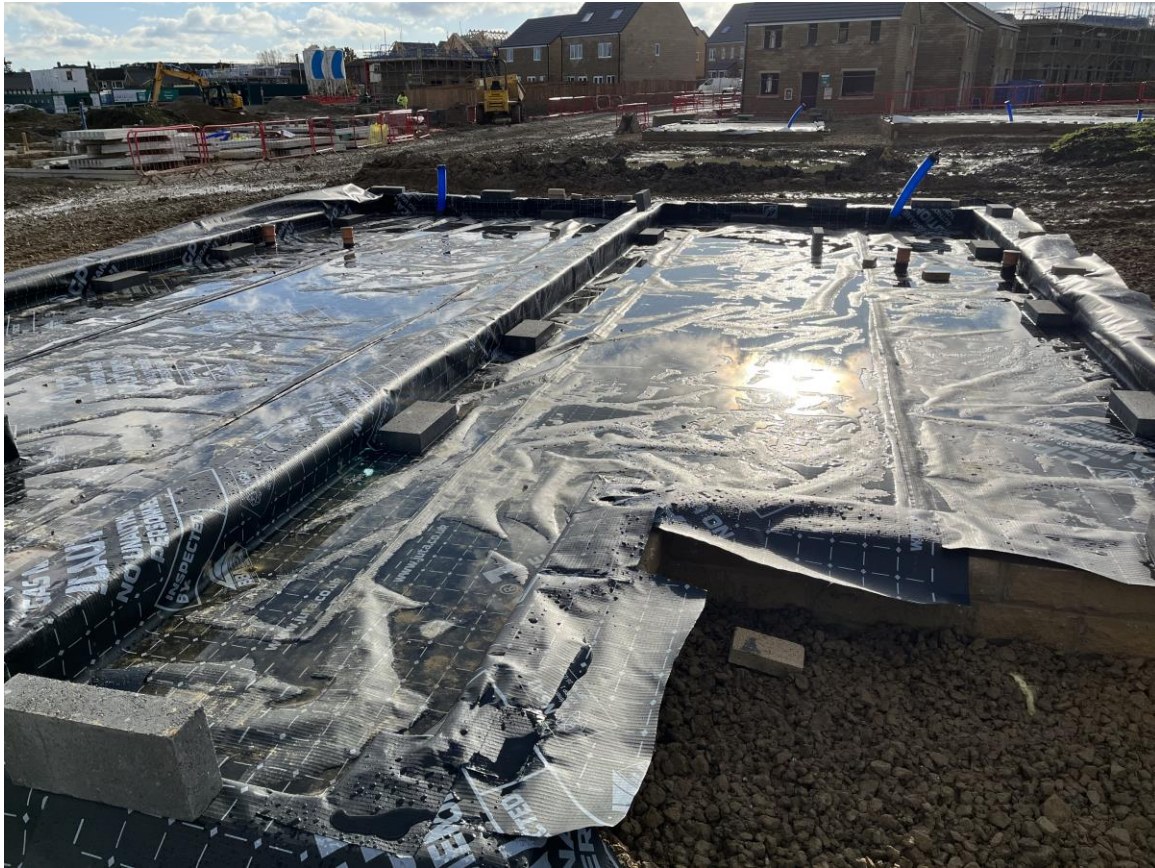
Plots 100 & 101 – Overall membrane layout

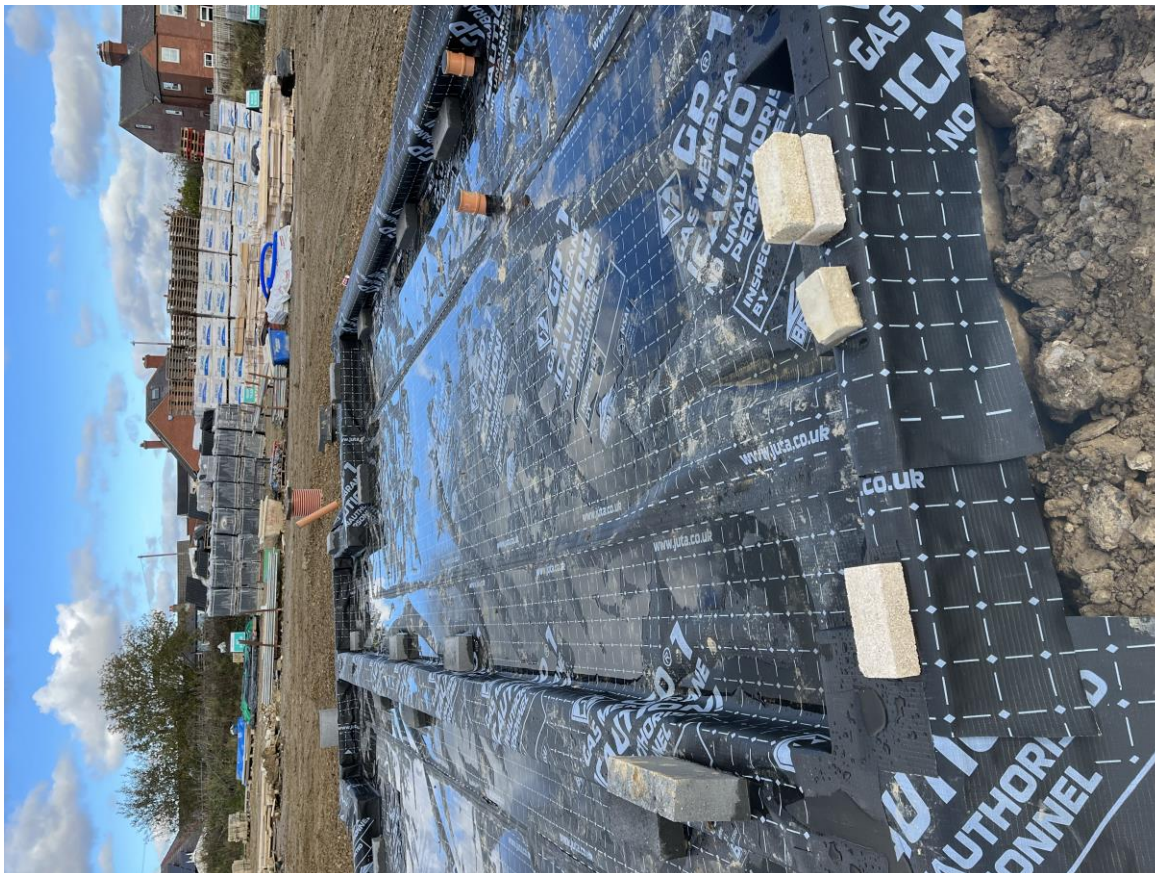
Plots 100 & 101 - Membrane layout with party wall and jointing

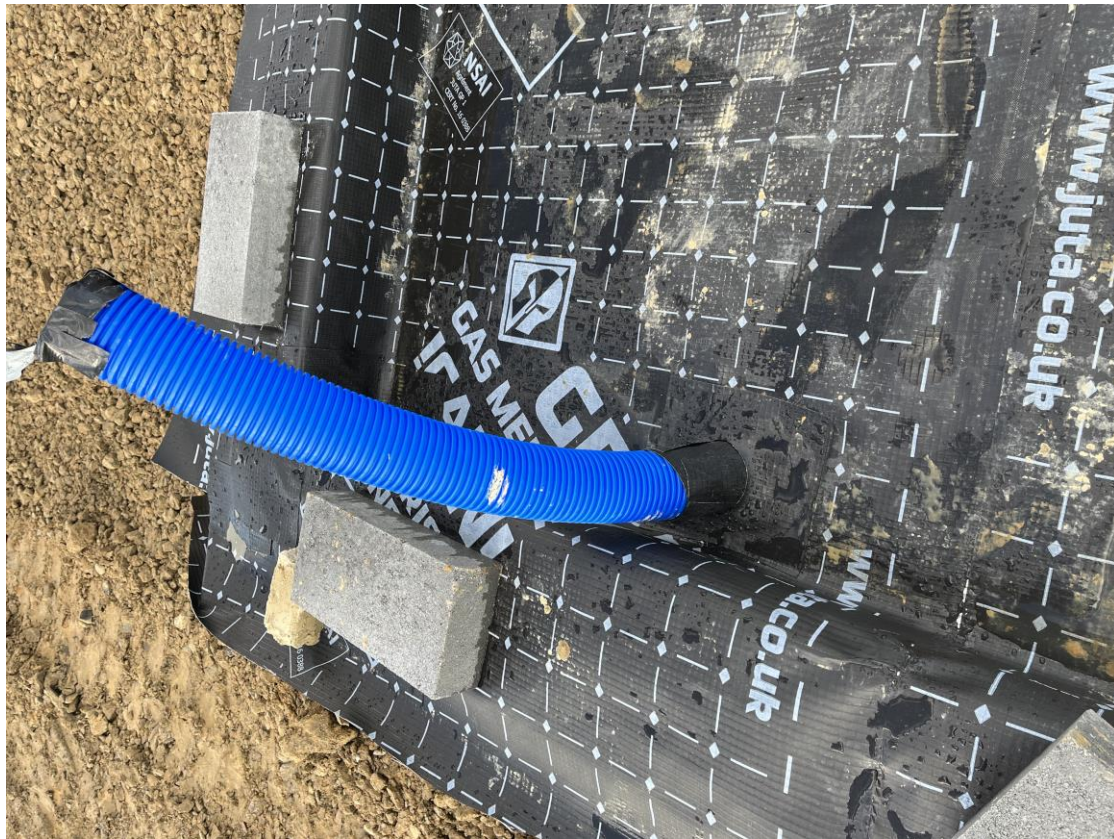
Plots 100 & 101 – Membrane layout with tophat and jointing

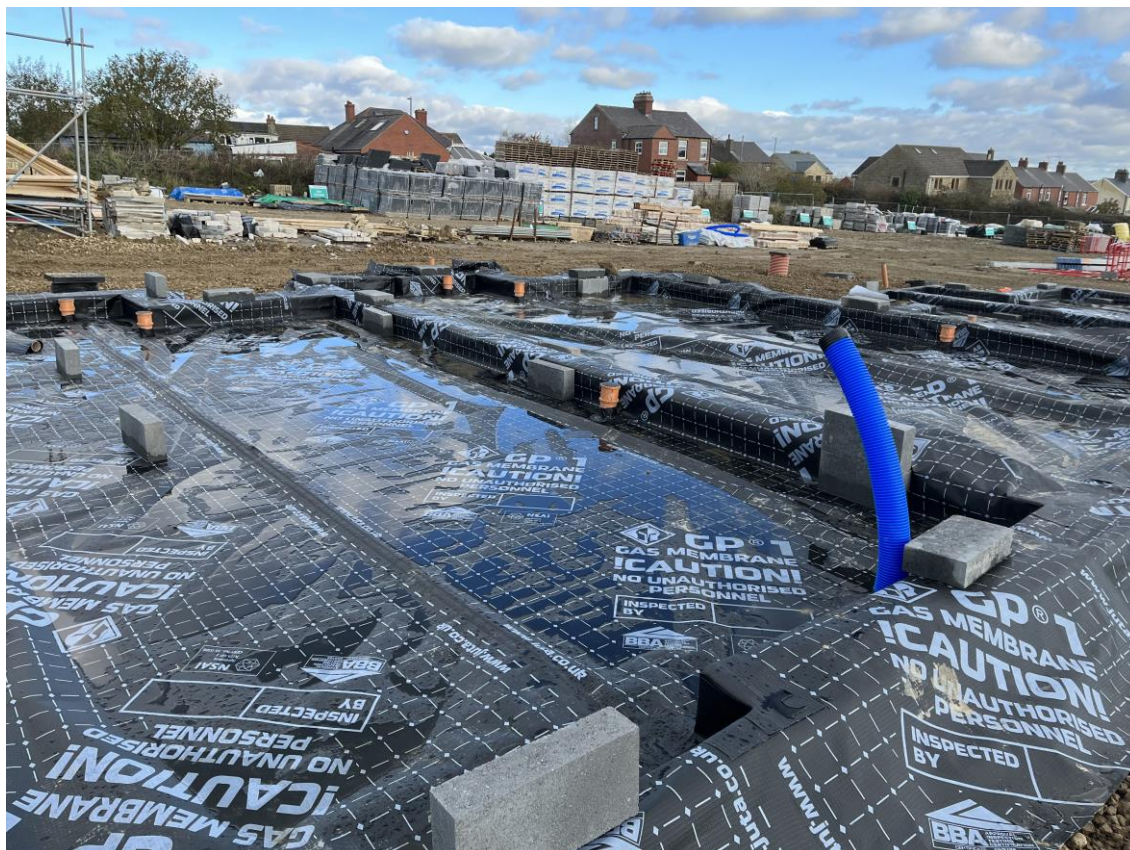
Plots 102-104 – Overall membrane layout with weld, party wall and tophats

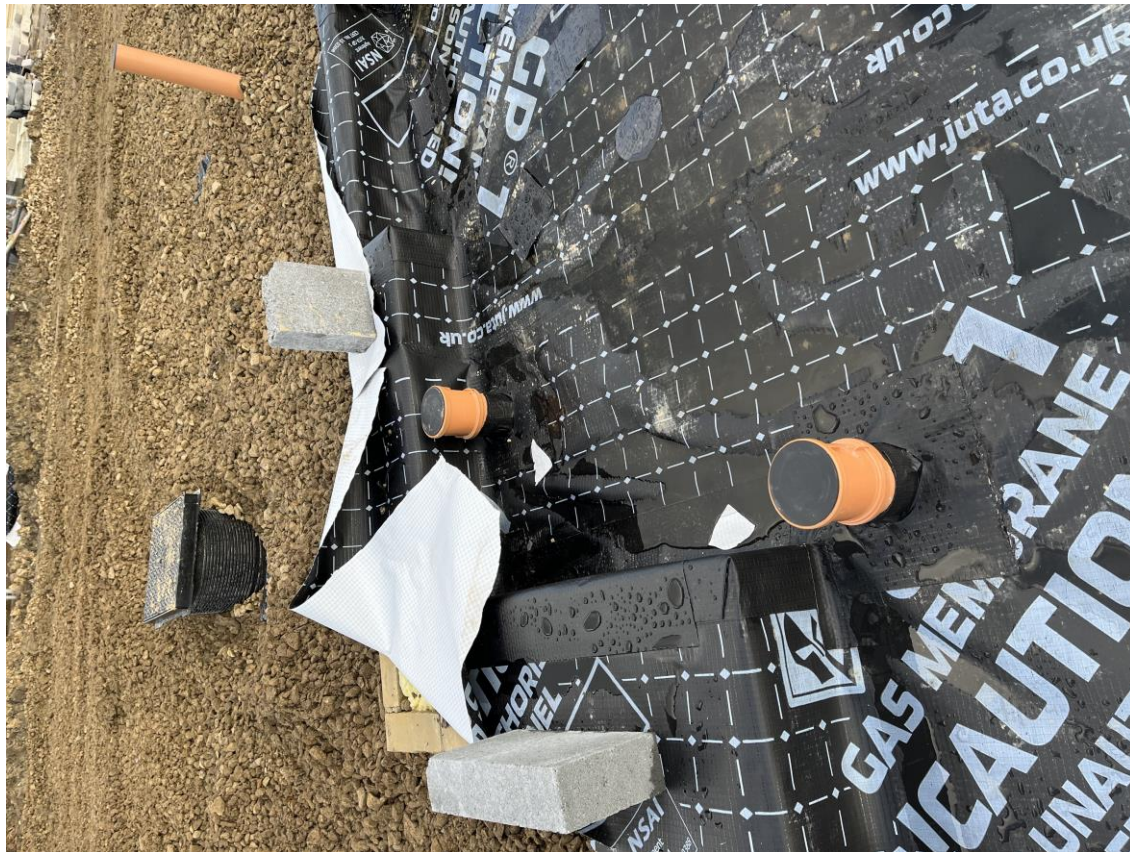
Plots 102-104 - Membrane layout with tophat and jointing

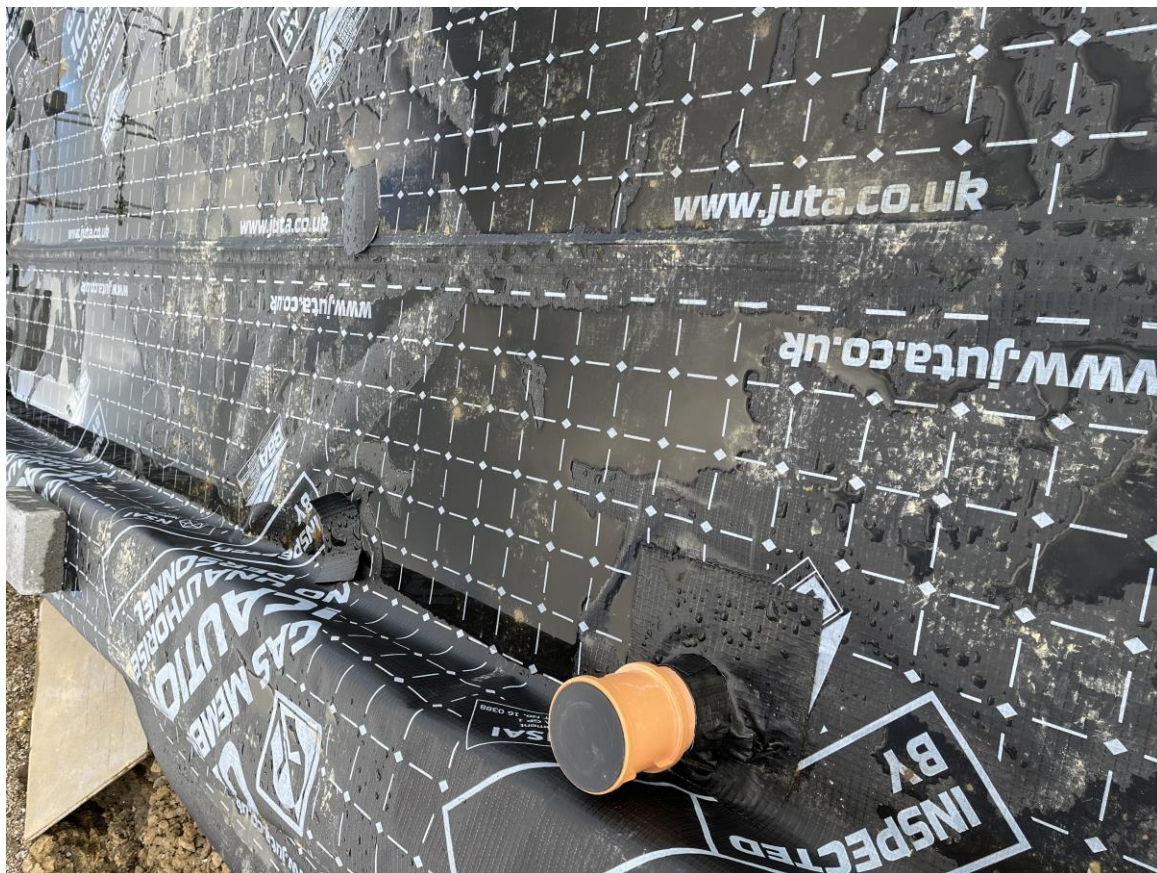
Plots 102-104 – Membrane layout with weld and tophat with jointing

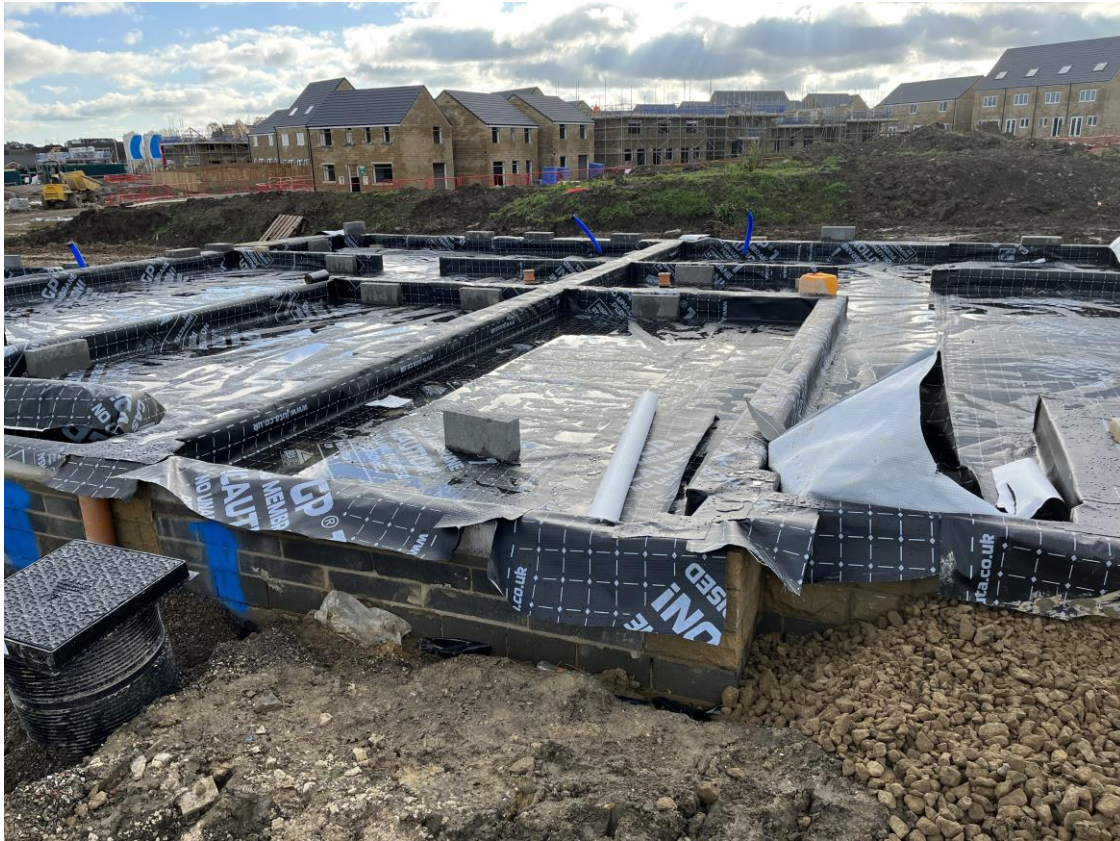
Plots 105 & 106 – Overall membrane layout

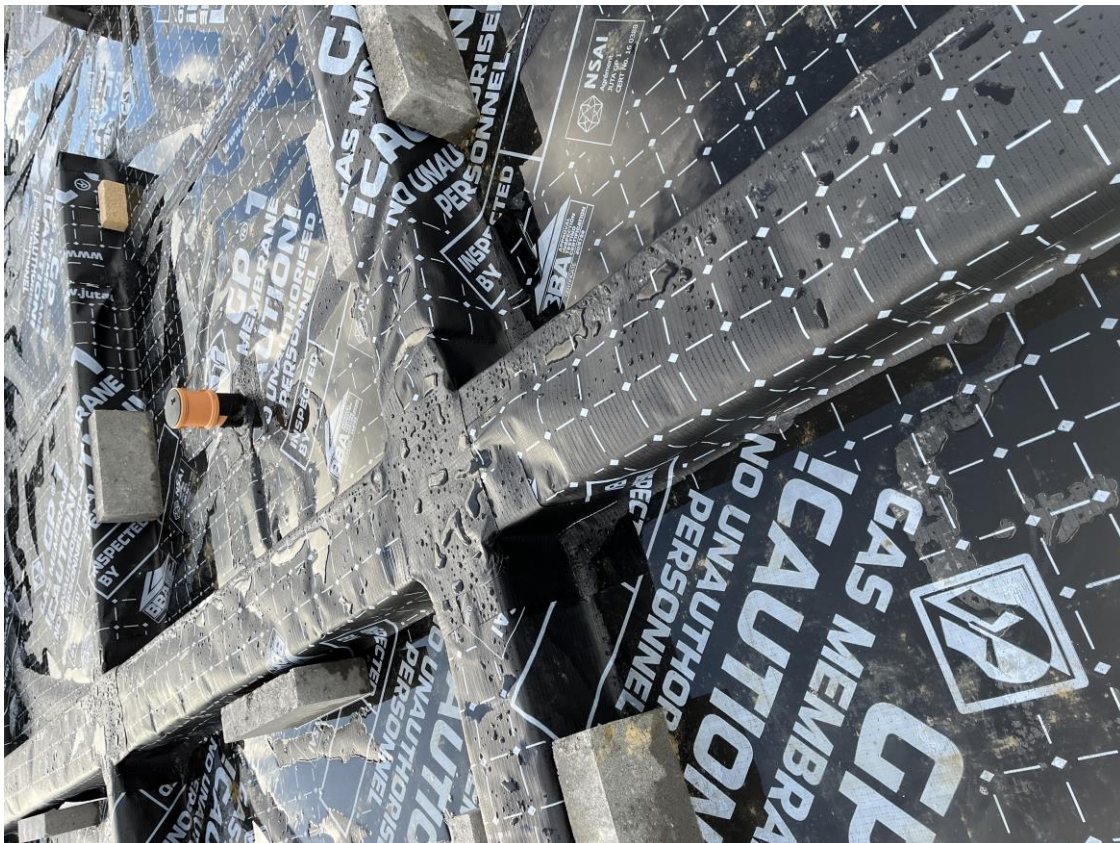
Plots 105 & 106 - Internal wall and party wall membrane layout with jointing

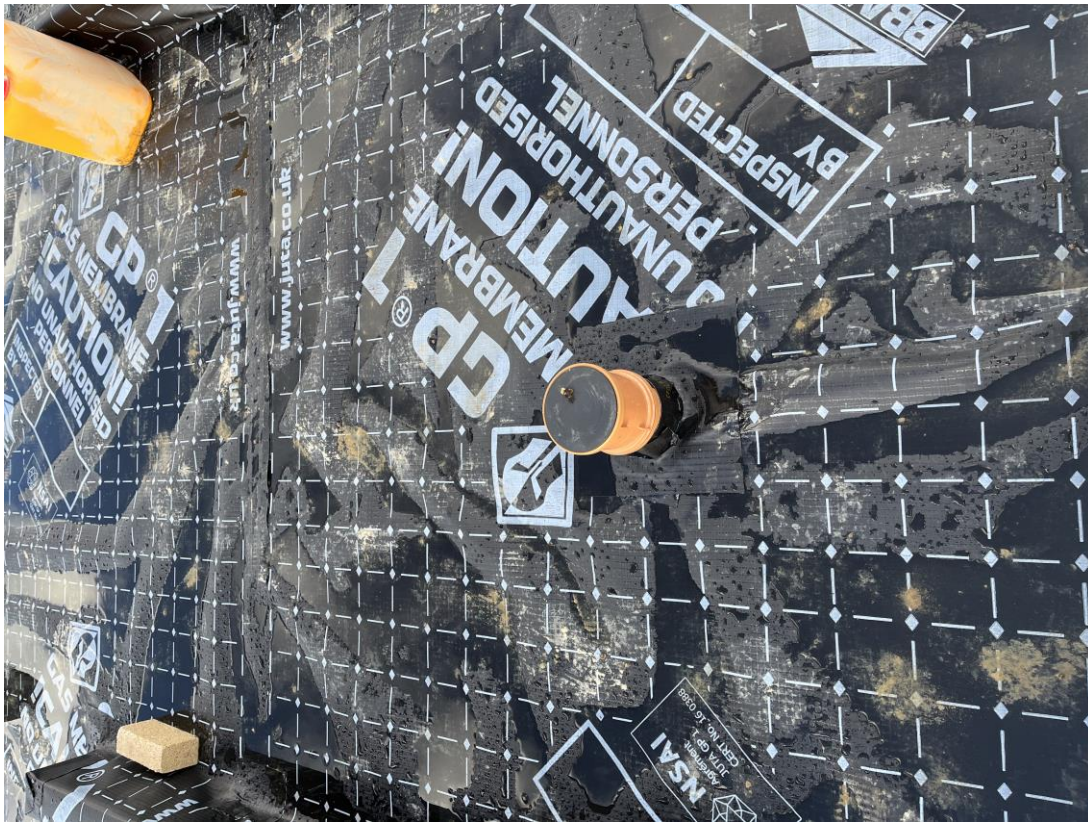
Plots 105 & 106 – Membrane layout with tophat and jointing

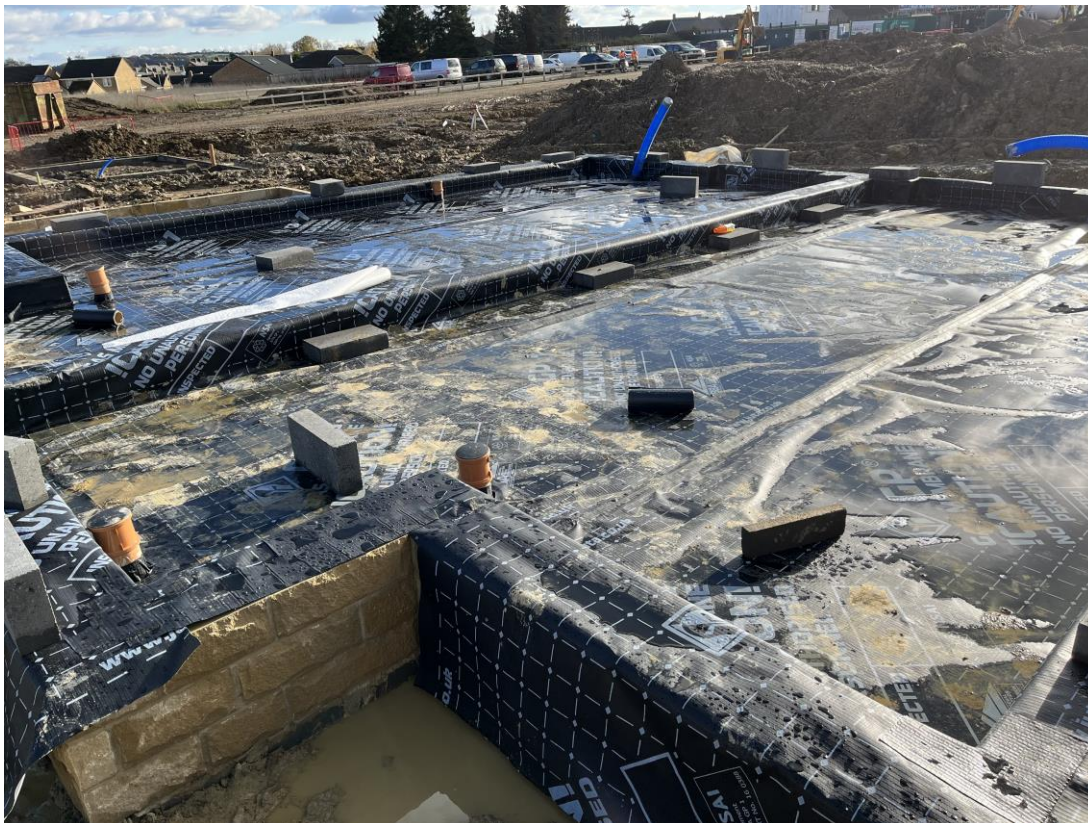
Plots 125 & 126 – Overall membrane layout

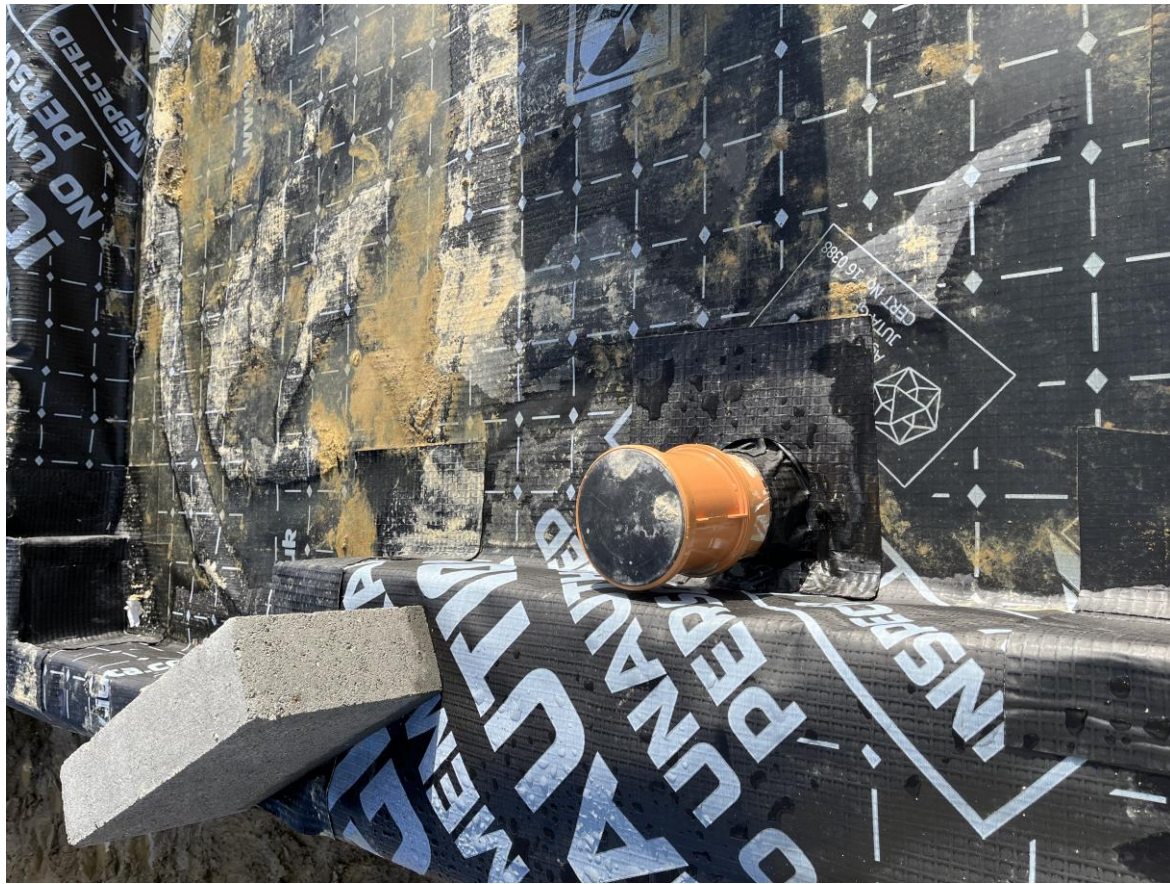
Plots 125 & 126 – Membrane layout with tophat and jointing

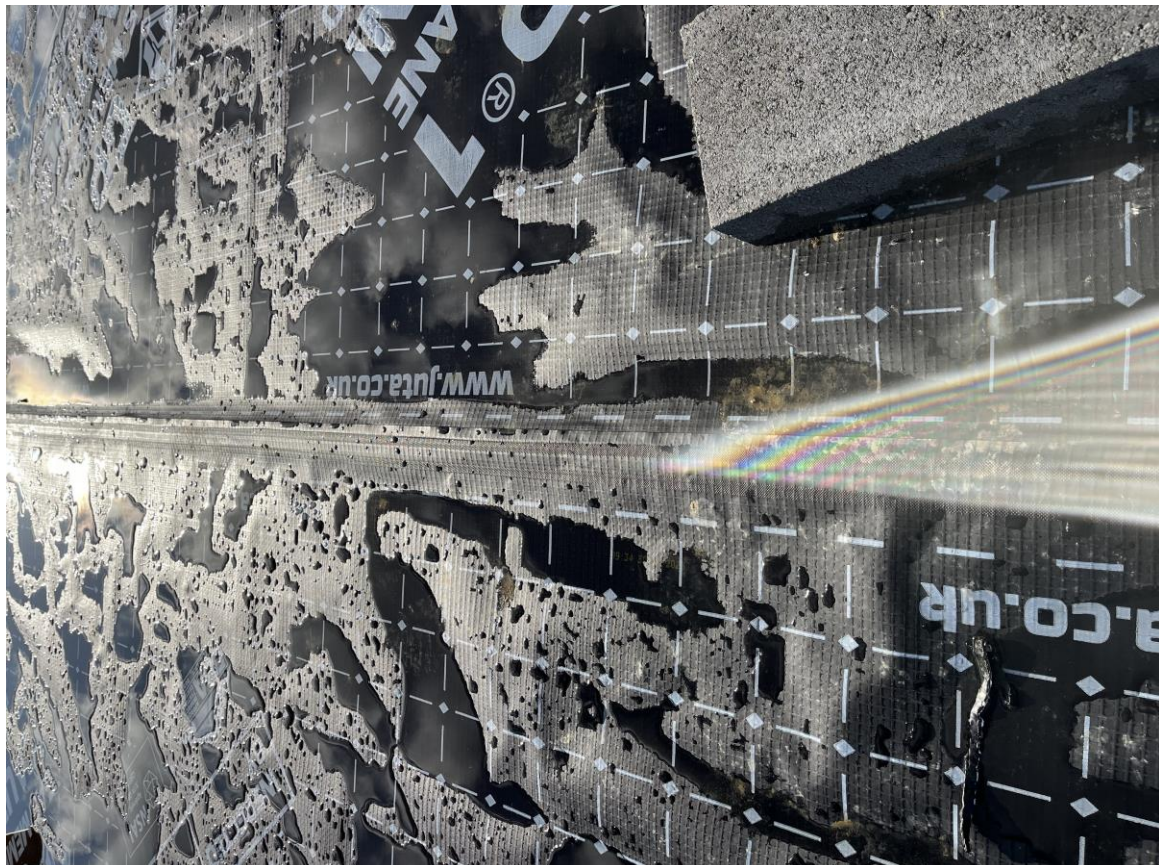
Plots 125 & 126 – Membrane layout with welds

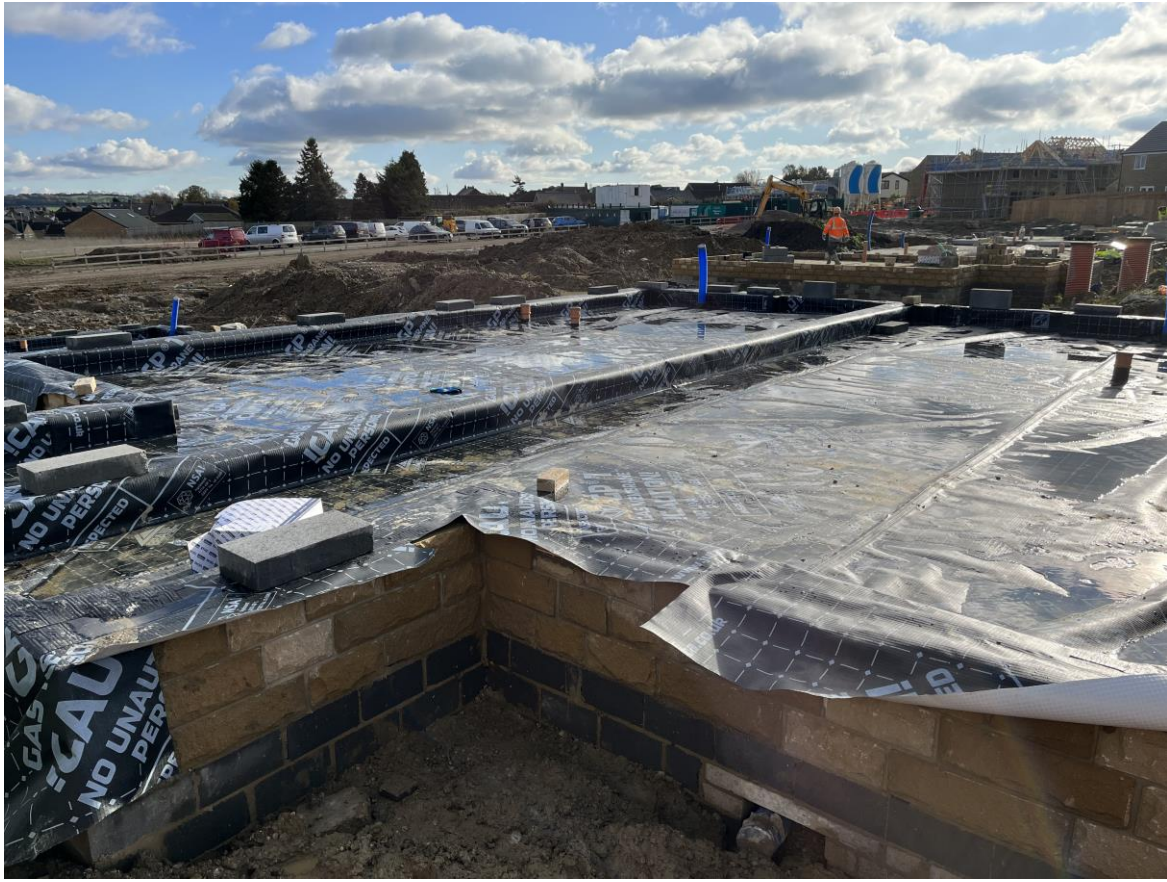
Plots 127 & 128 – Overall membrane layout

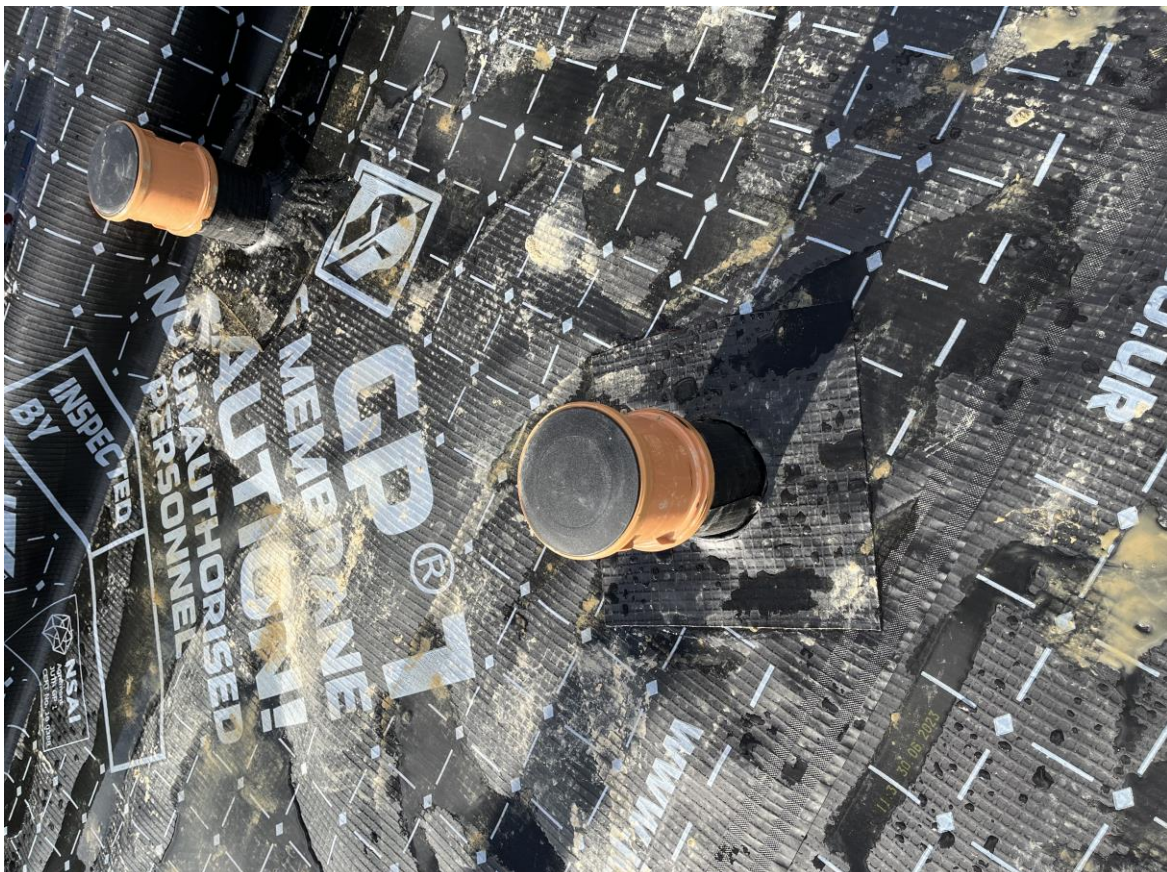
Plots 127 & 128 – Membrane layout with tophat and jointing

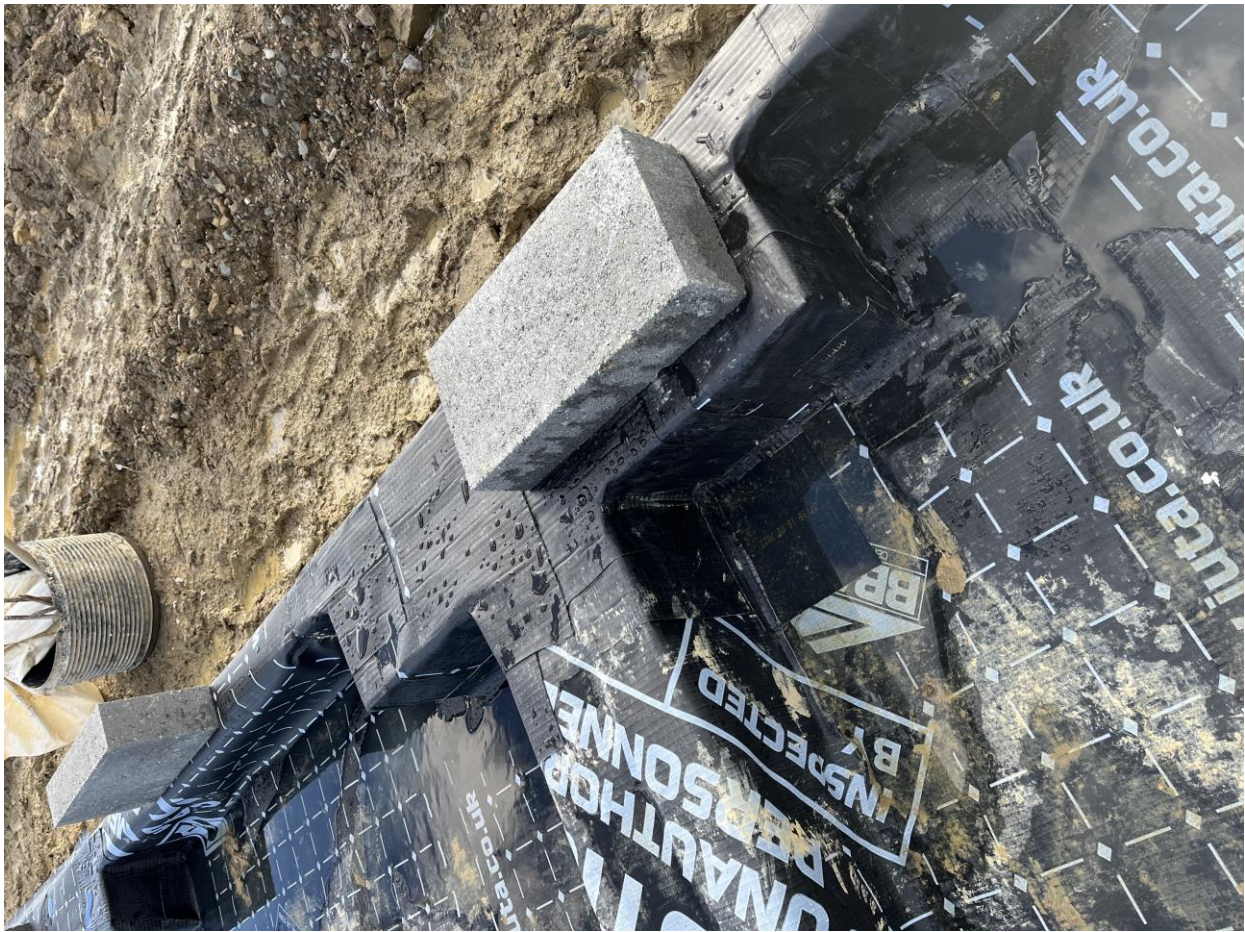
Plots 127 & 128 – Membrane layout with party wall and jointing
