Our Ref: E19/7612/OF/014

**Re: Development at Cumberworth Road, Skelmanthorpe**

Further to your request we have attended the above site to undertake an inspection of the gas membrane to confirm that the quality of the installation is satisfactory in plots 129-135 at the above site.

# Inspection Checklist

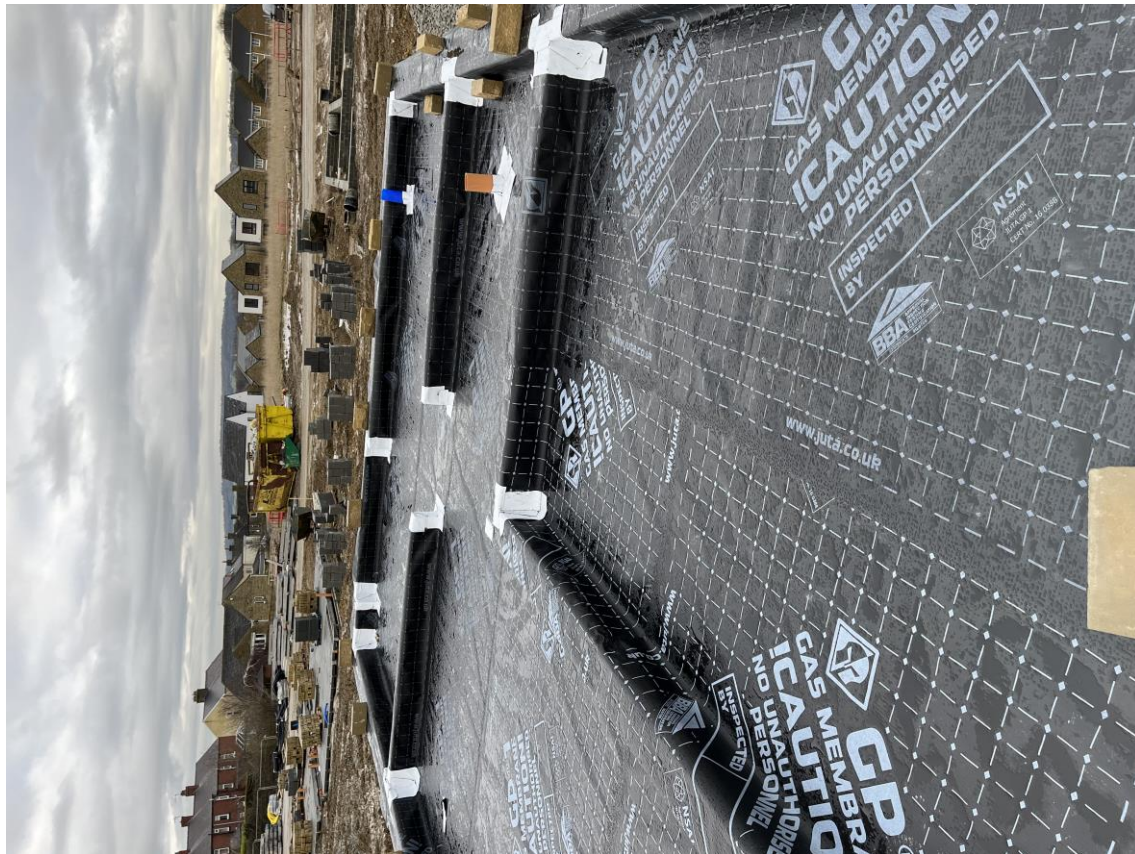
Plot 129 – Overall membrane layout

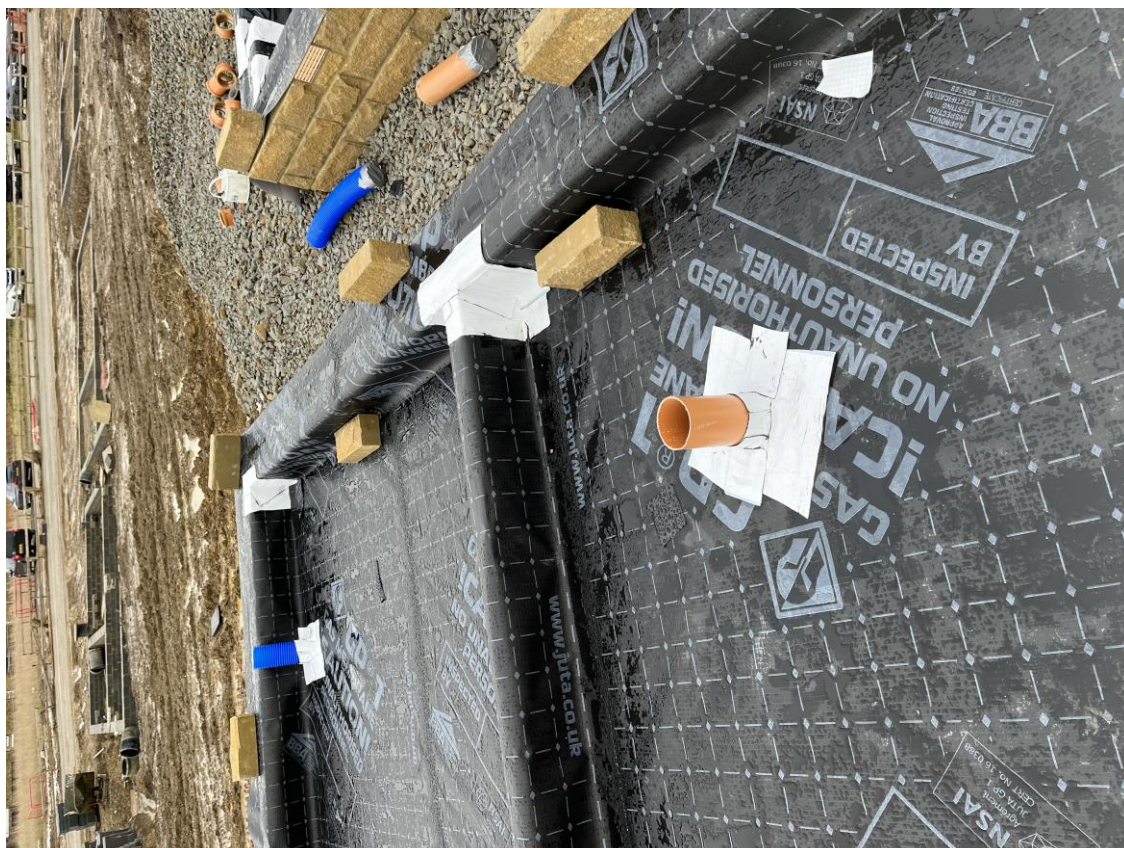
Plot 129 - Membrane layout with tophat and jointing

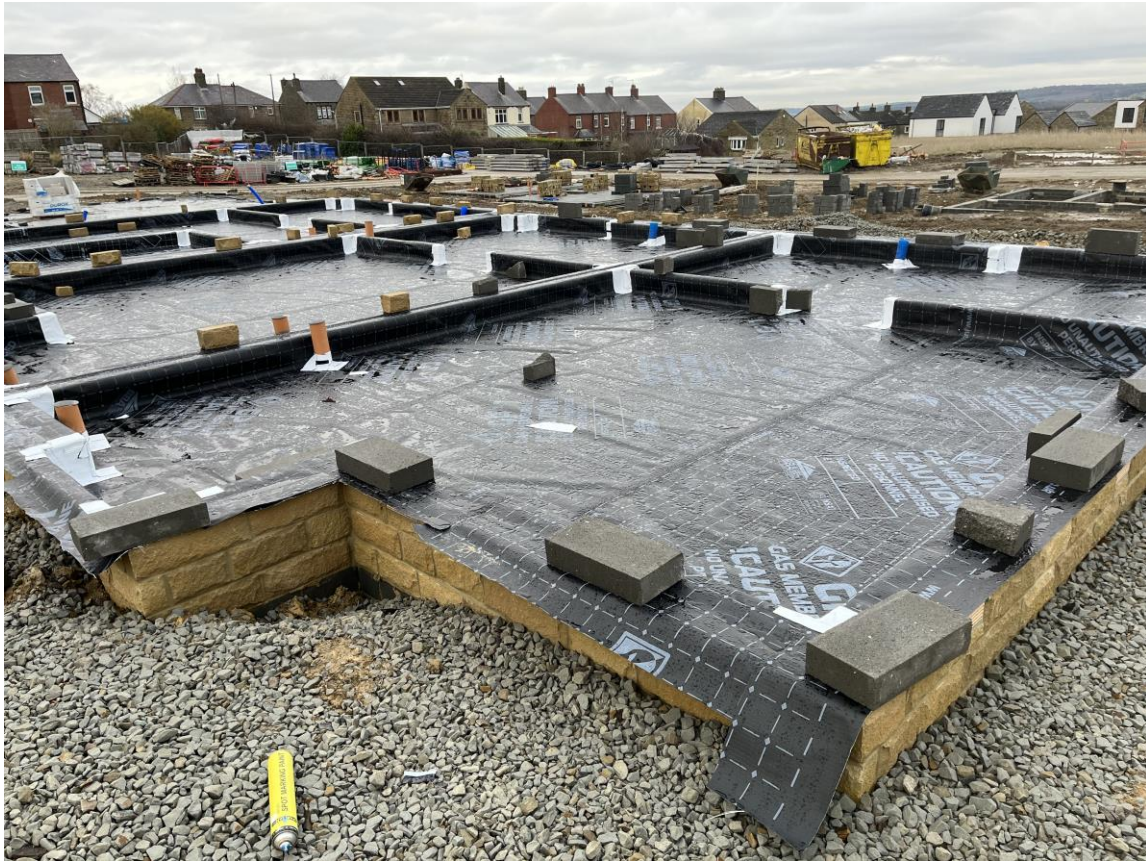
Plots 130 & 131 – Overall membrane layout

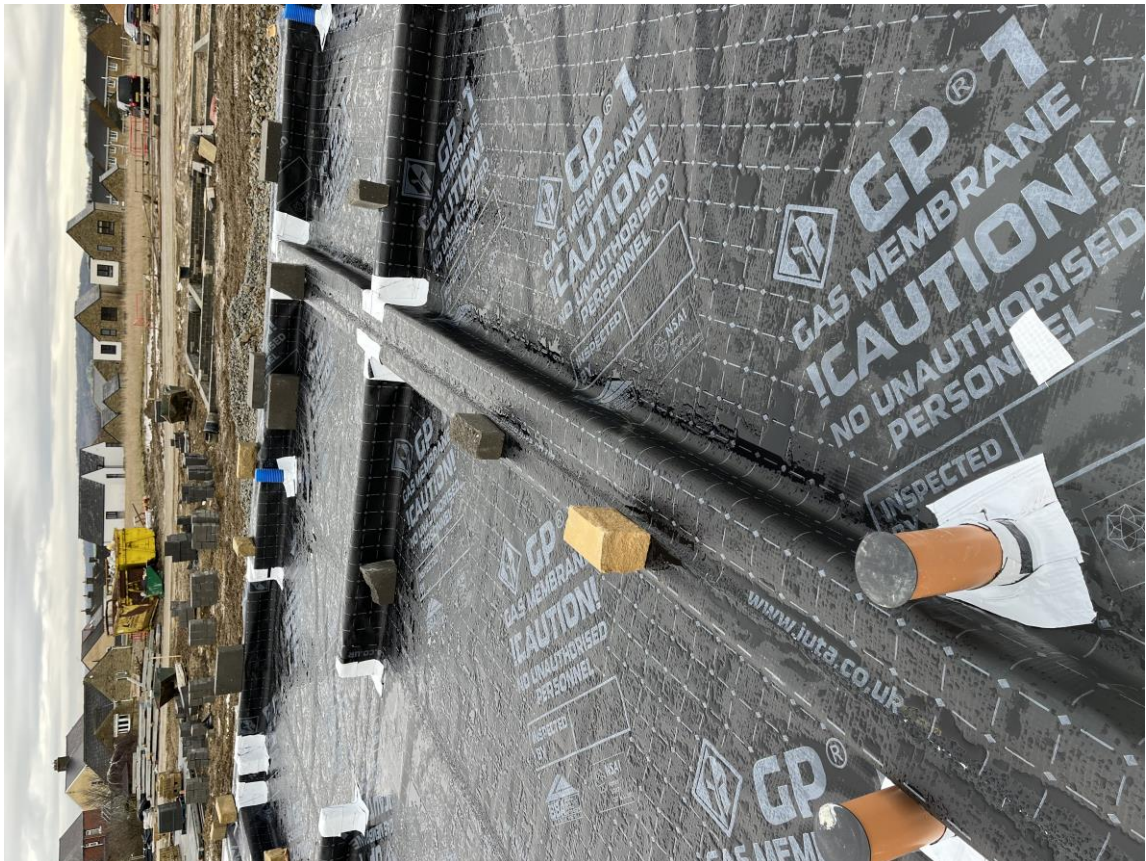
Plots 130 & 131 – Overall membrane layout with party wall and tophat with jointing

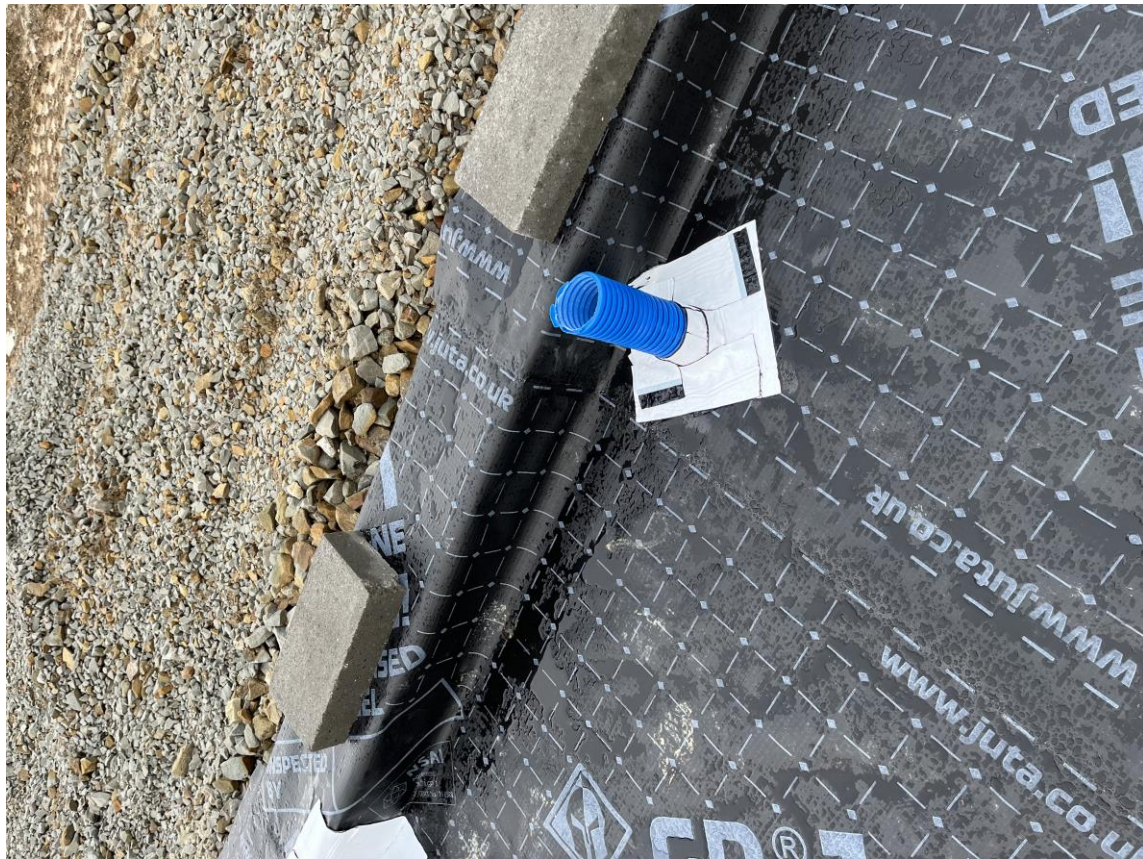
Plots 130 & 131- Membrane layout with tophat and jointing

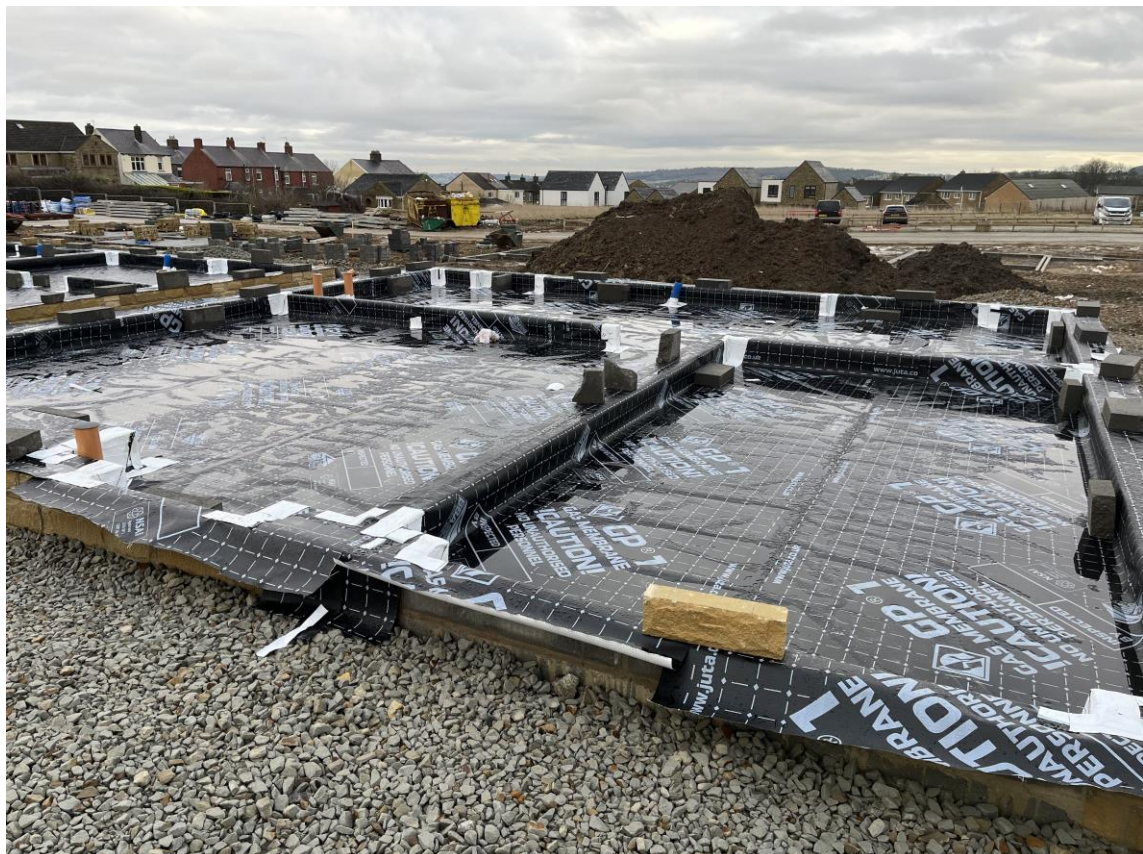
Plot 132 – Overall membrane layout

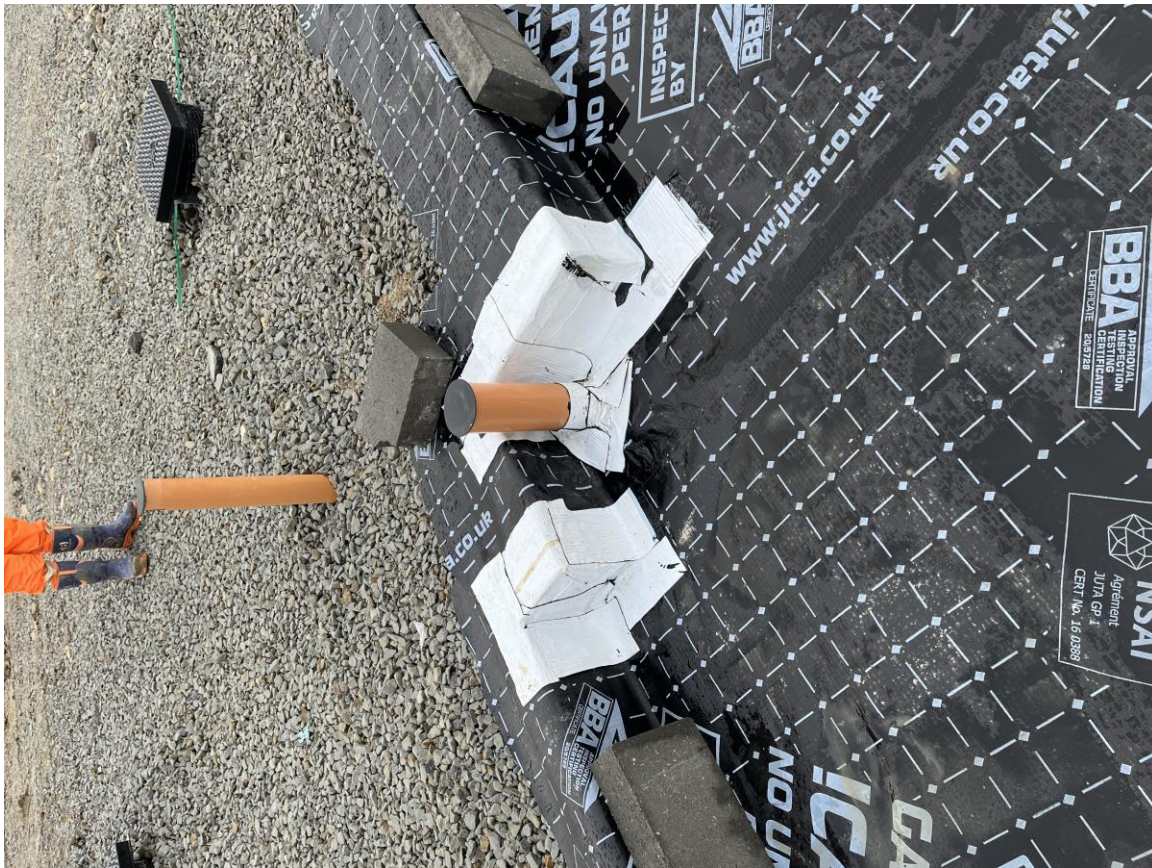
Plot 132 – Membrane layout with tophat and jointing

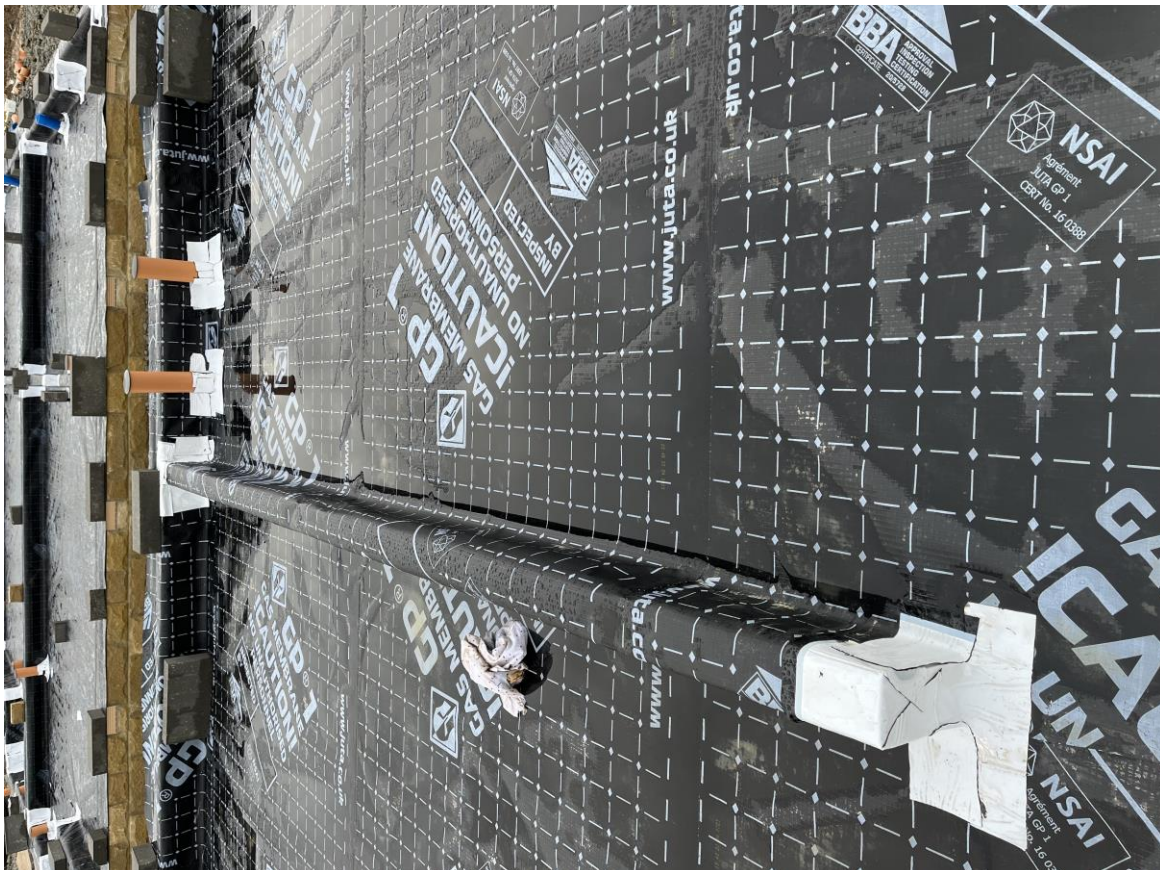
Plot 132 - Internal wall membrane layout with weld and jointing

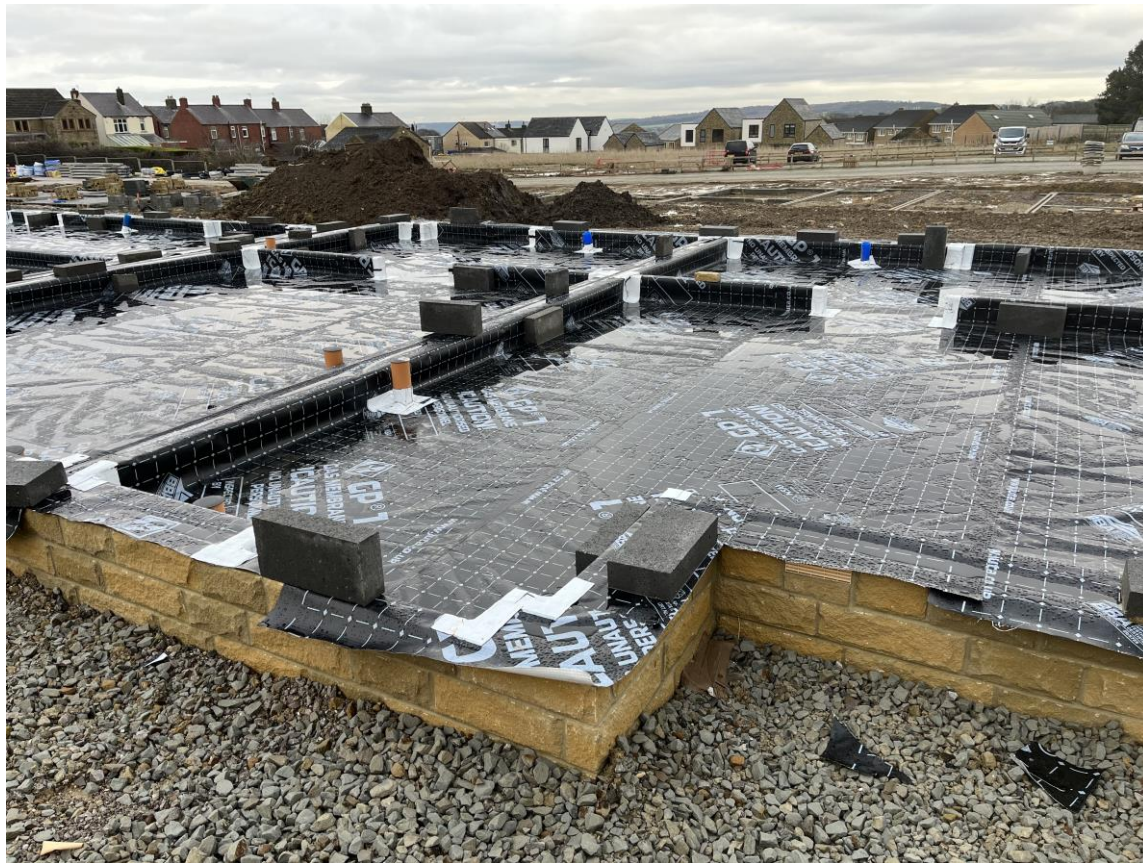
Plots 133 & 134 - Overall membrane layout

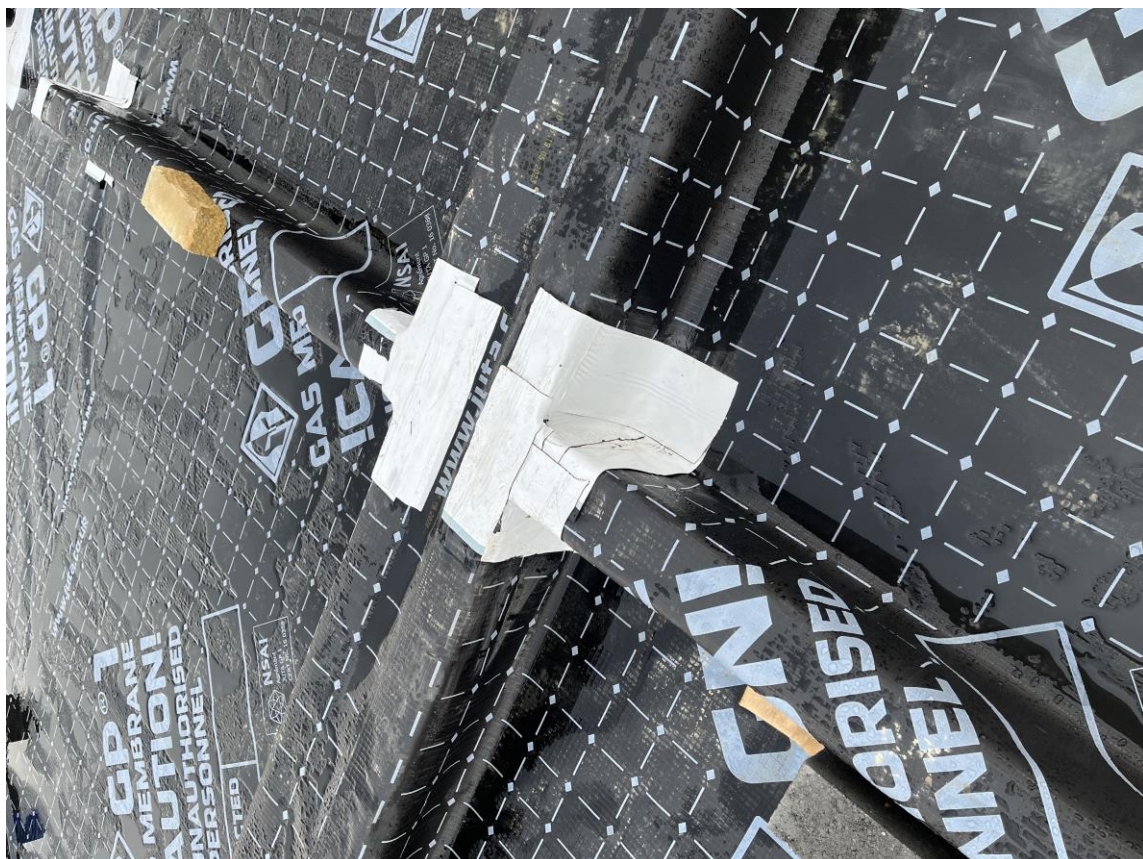
Plots 133 & 134 – Party wall membrane layout with jointing

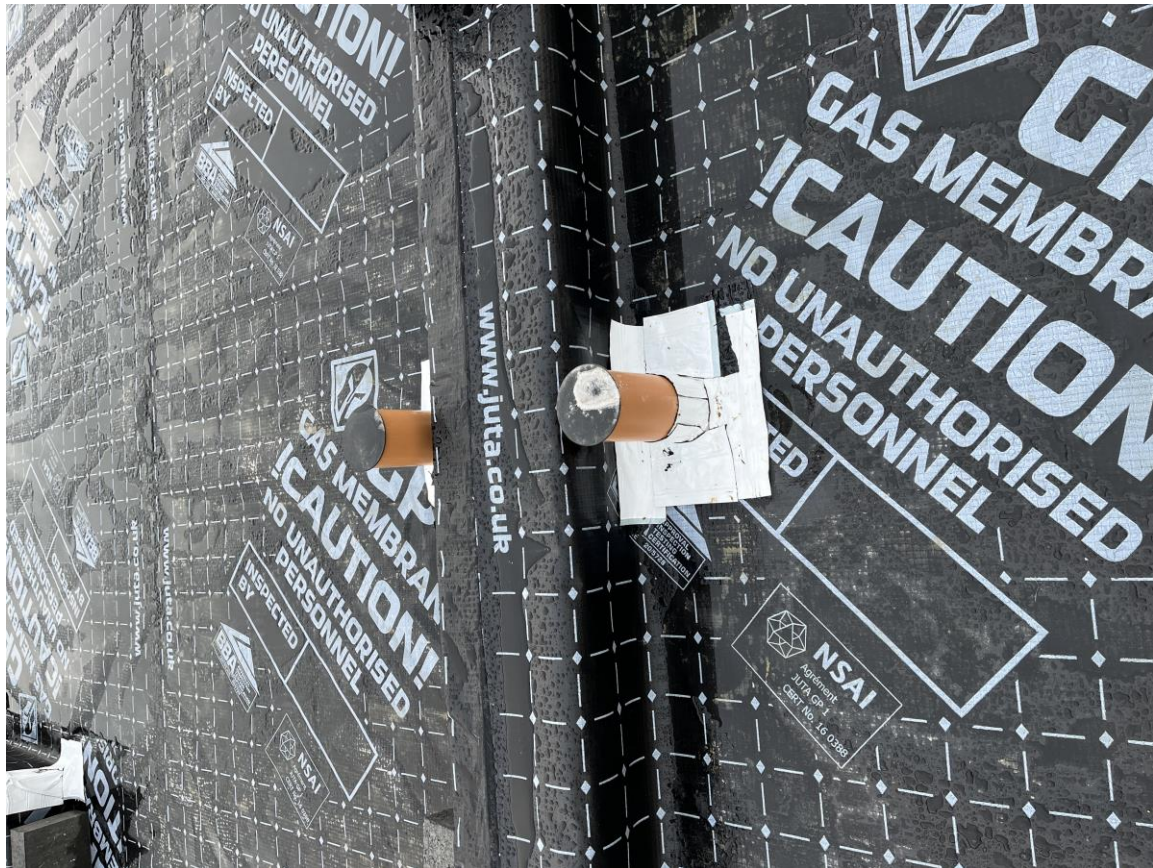
Plots 133 & 134 – Party wall membrane layout with tophats and jointing

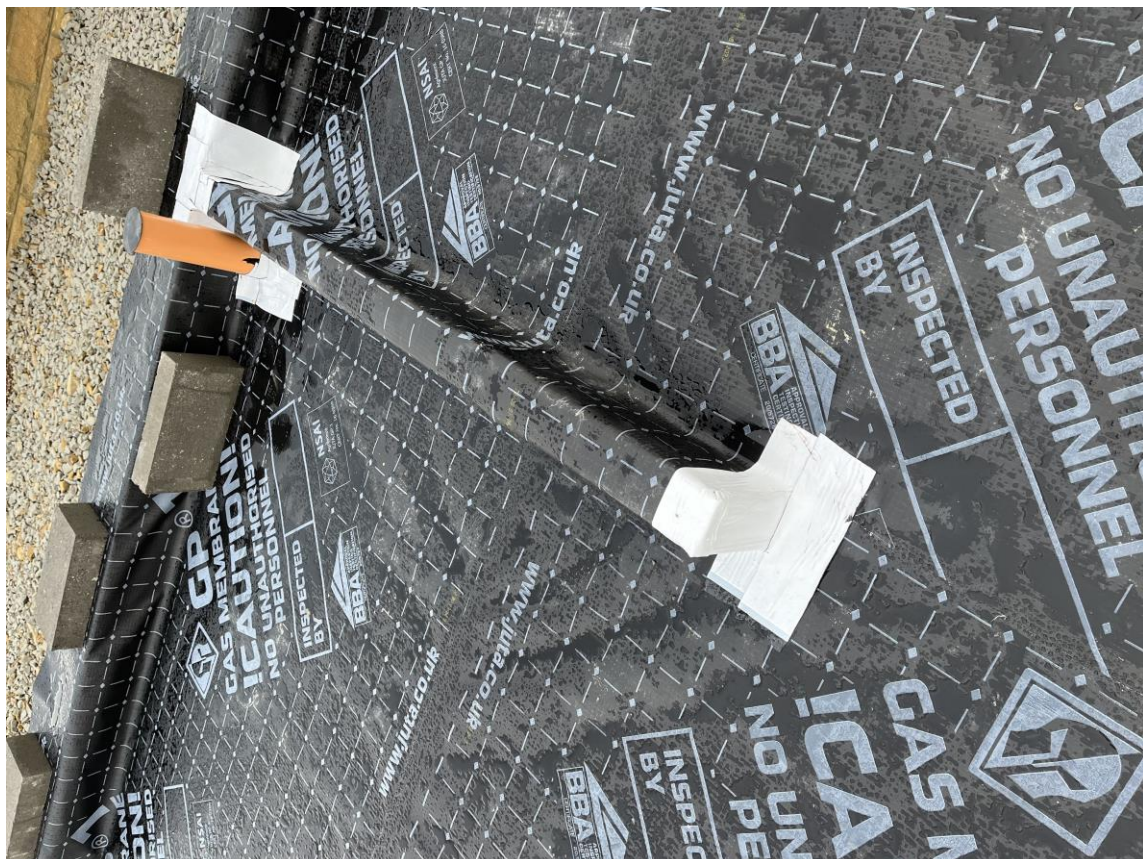
Plot 135 – Internal wall membrane layout with tophat and jointing

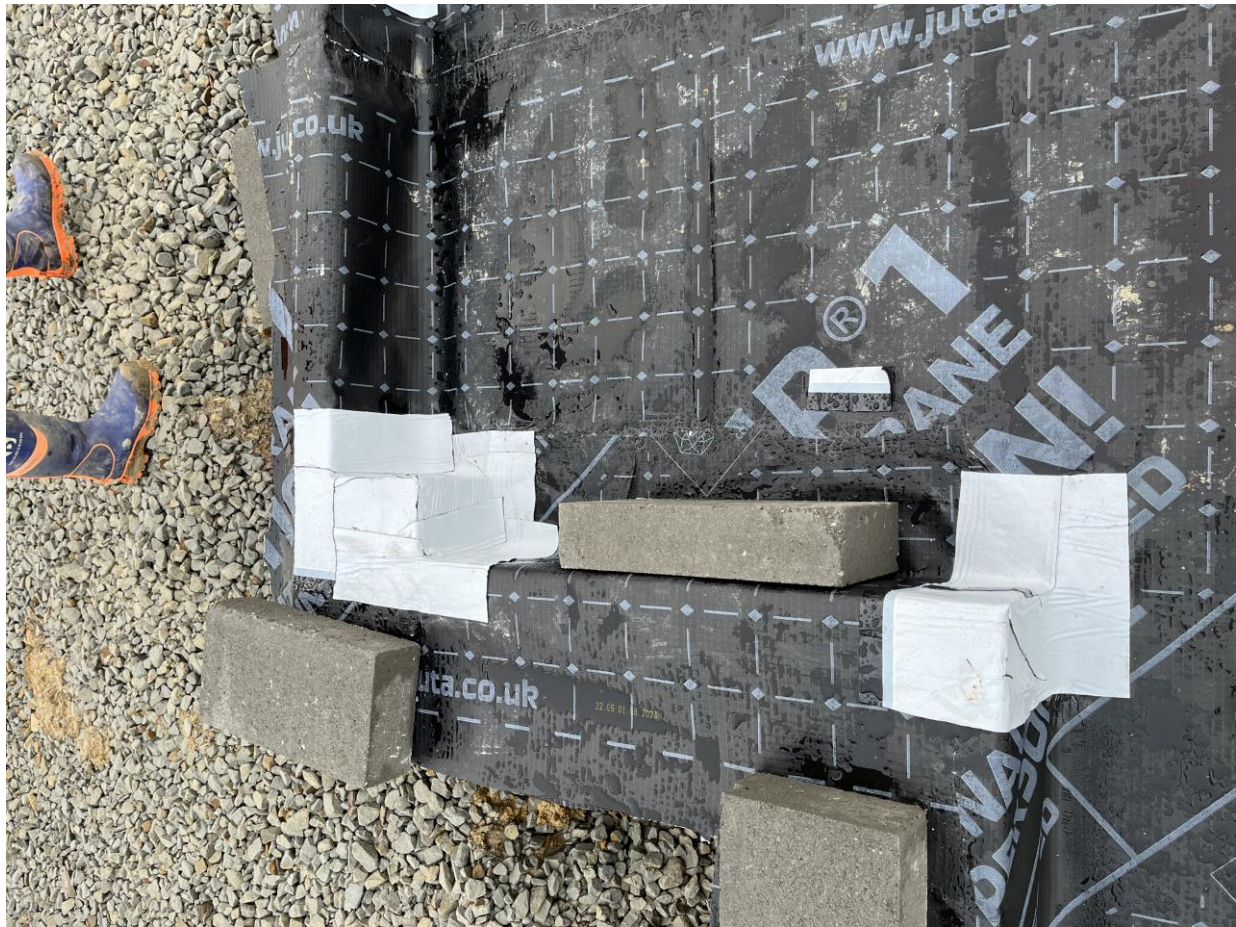
Plot 135 - Membrane layout with jointing
