Our Ref: E19/7612/OF/019

**Re: Development at Cumberworth Road, Skelmanthorpe**

Further to your request we have attended the above site to undertake an inspection of the gas membrane to confirm that the quality of the installation is satisfactory in Plots 70-72 & 97-99 at the above site.

# Inspection Checklist

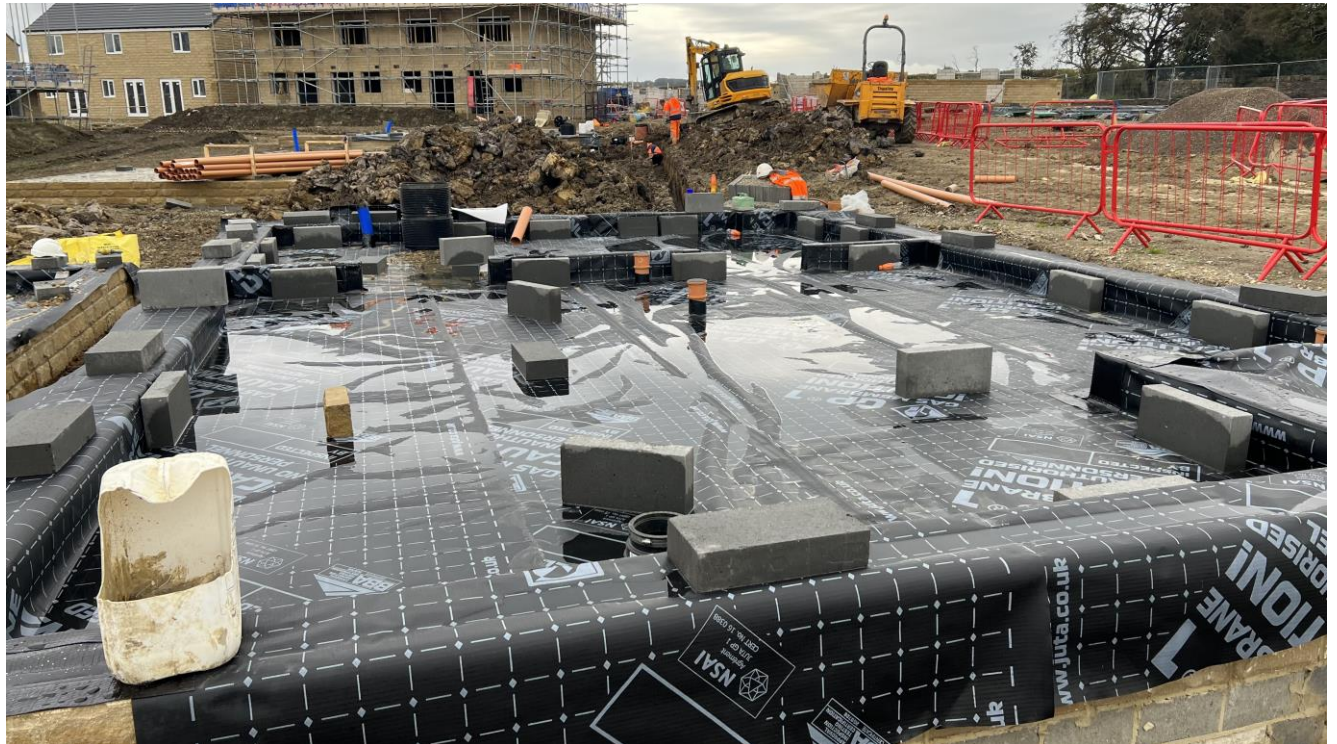
Plot 70 – Overall membrane layout

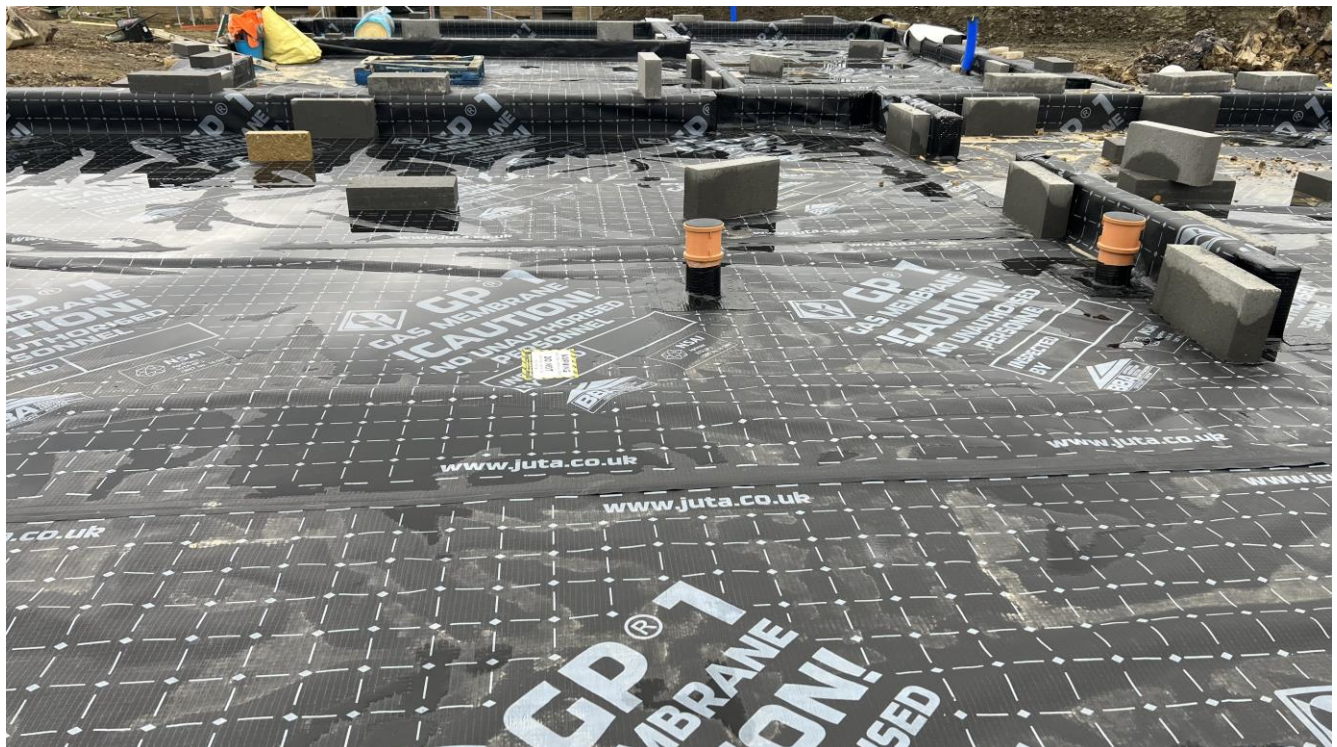
Plot 70 - Membrane layout with tophats and jointing

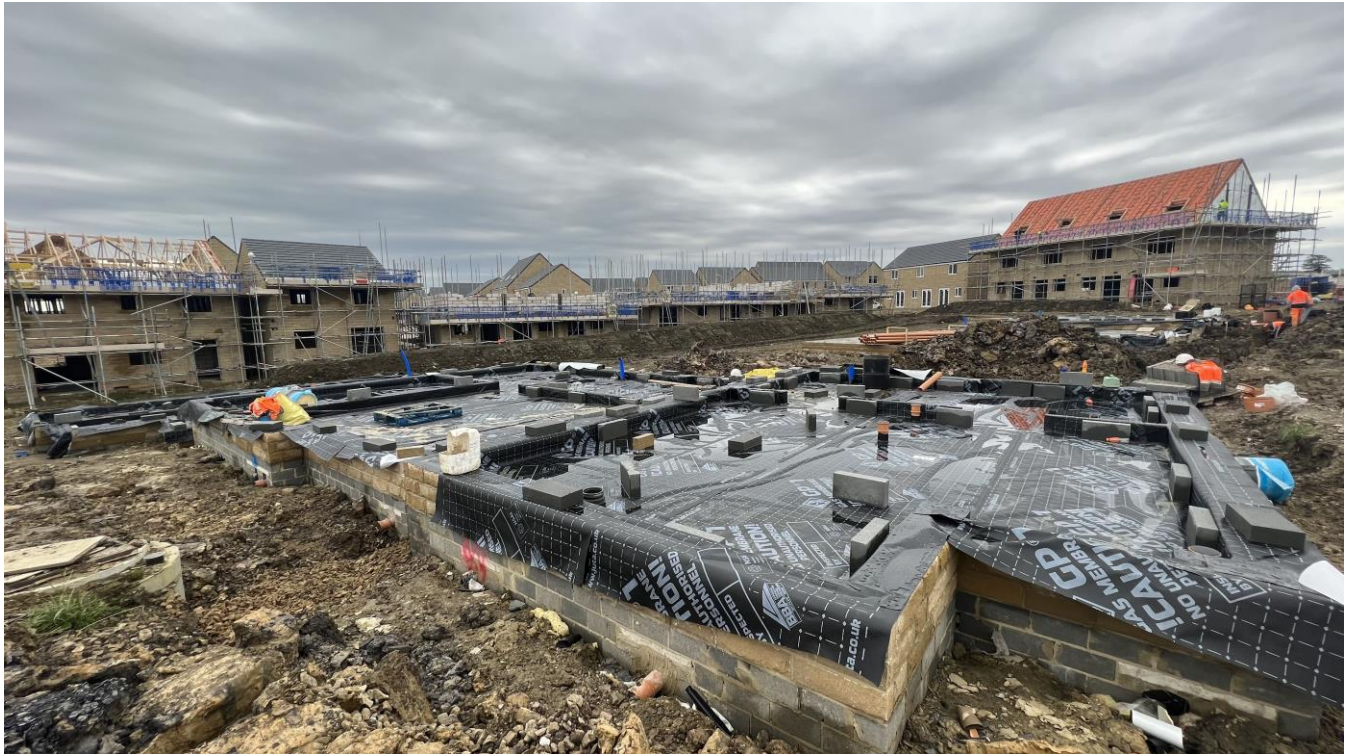
Plots 70 & 71 – Overall membrane layout

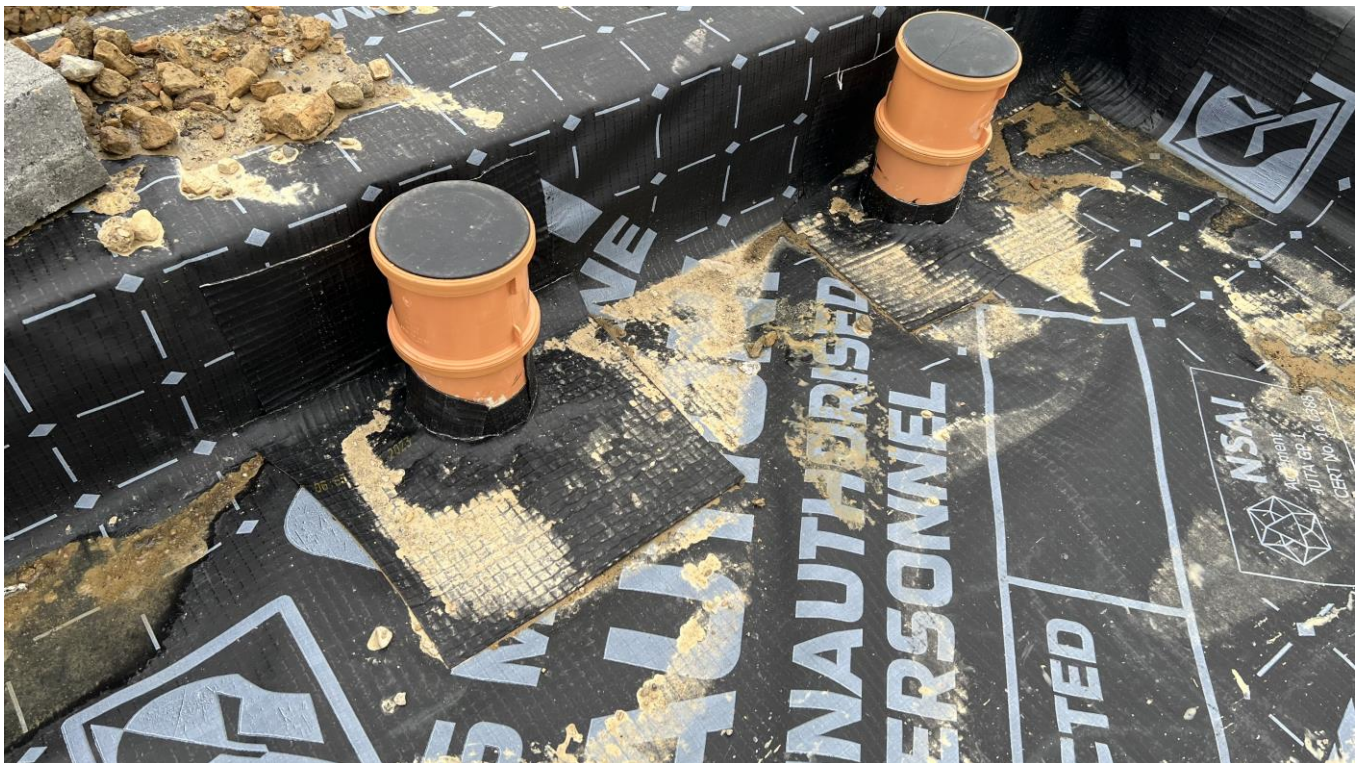
Plot 71 – Membrane layout with tophats and jointing

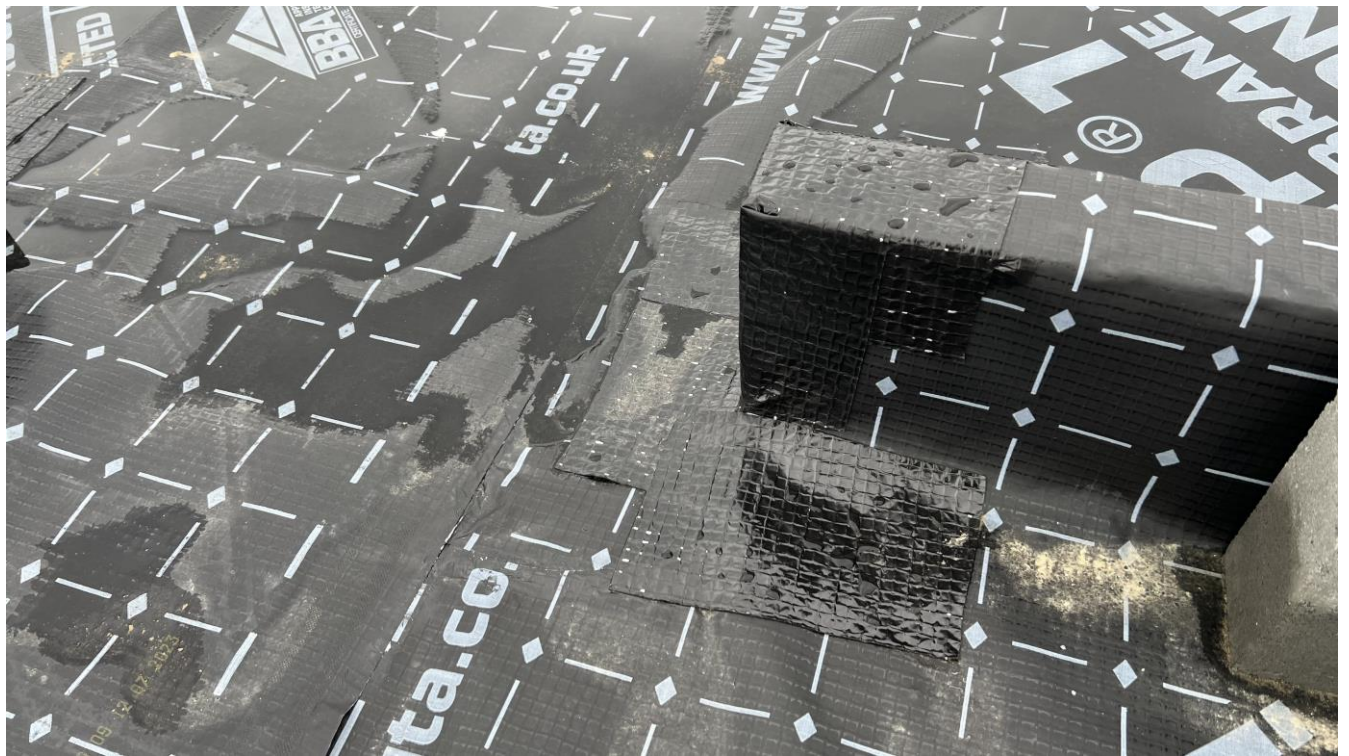
Plot 71 – Internal wall membrane layout with jointing

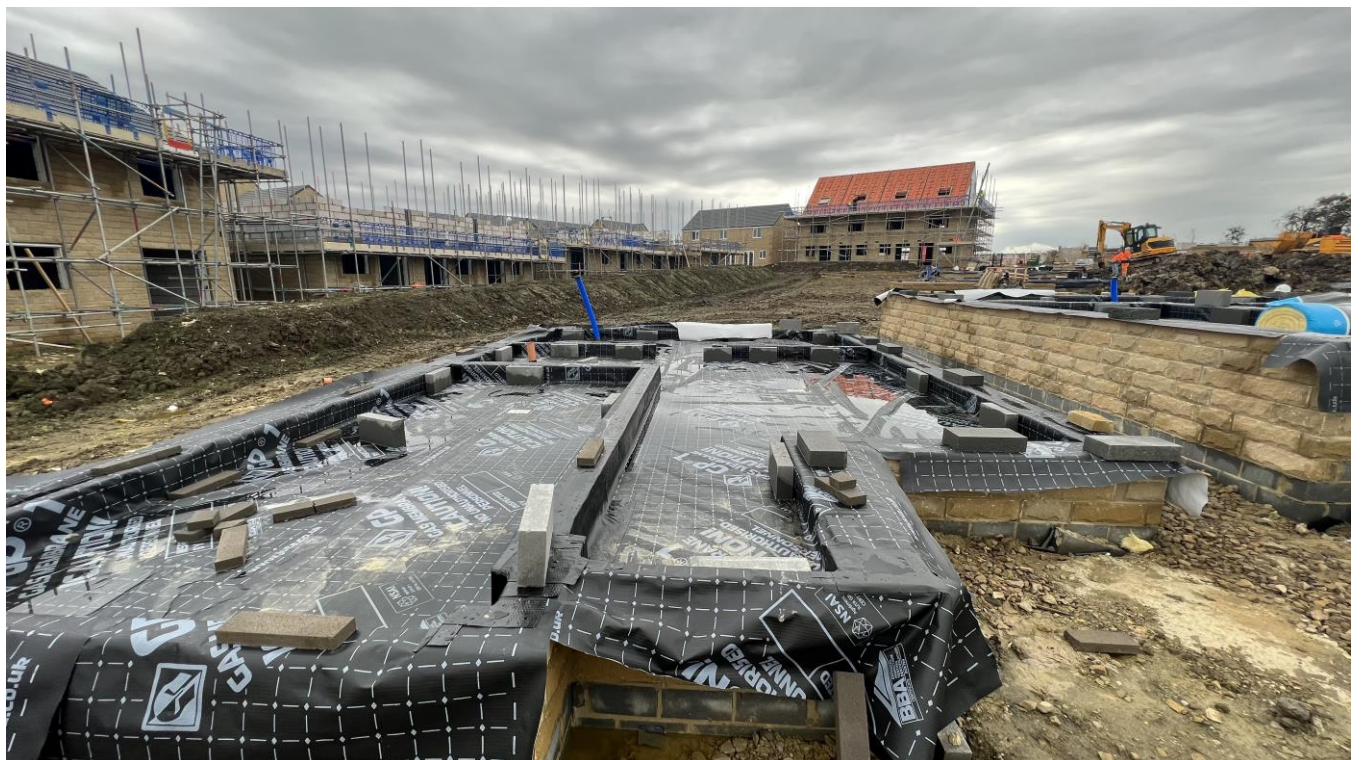
Plot 72 – Overall membrane layout

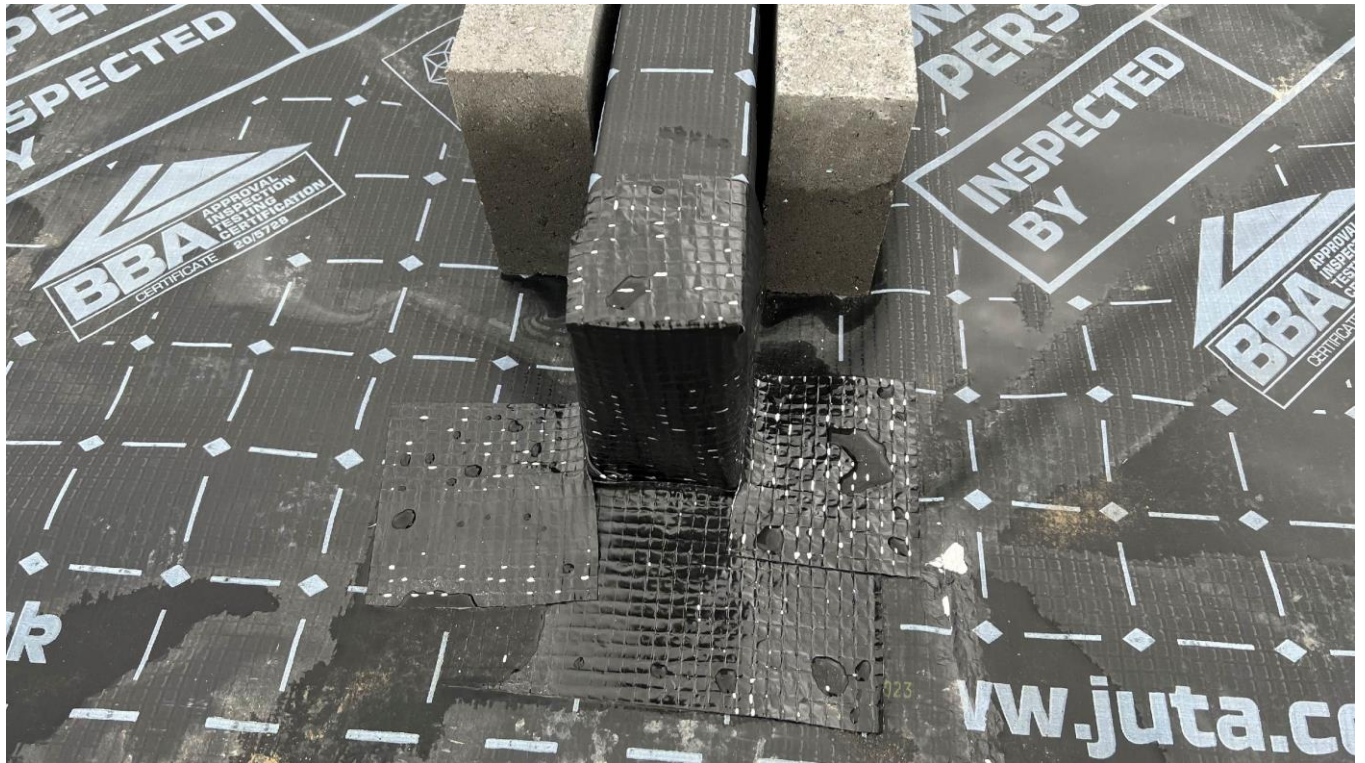
Plot 72 – Membrane layout with internal wall and jointing

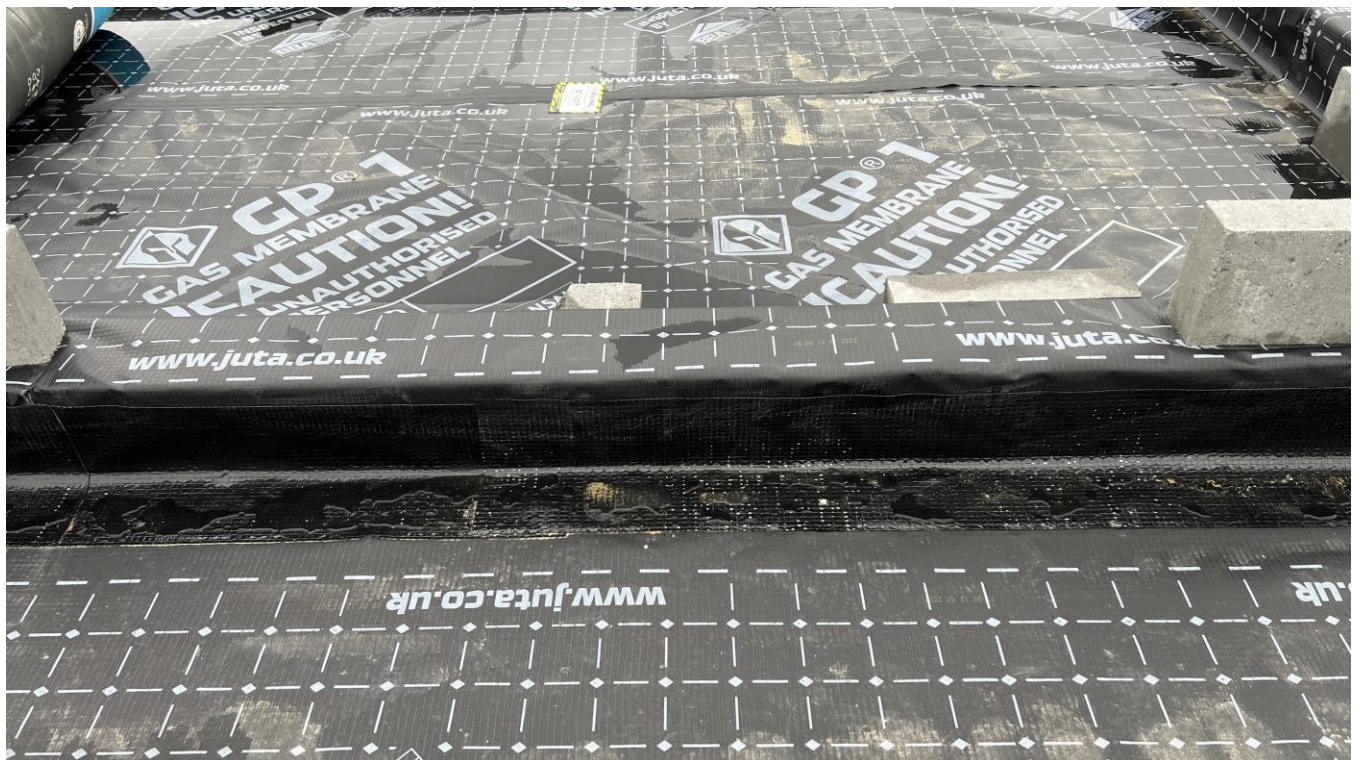
Plots 97 & 98 – Membrane layout with internal wall and jointing

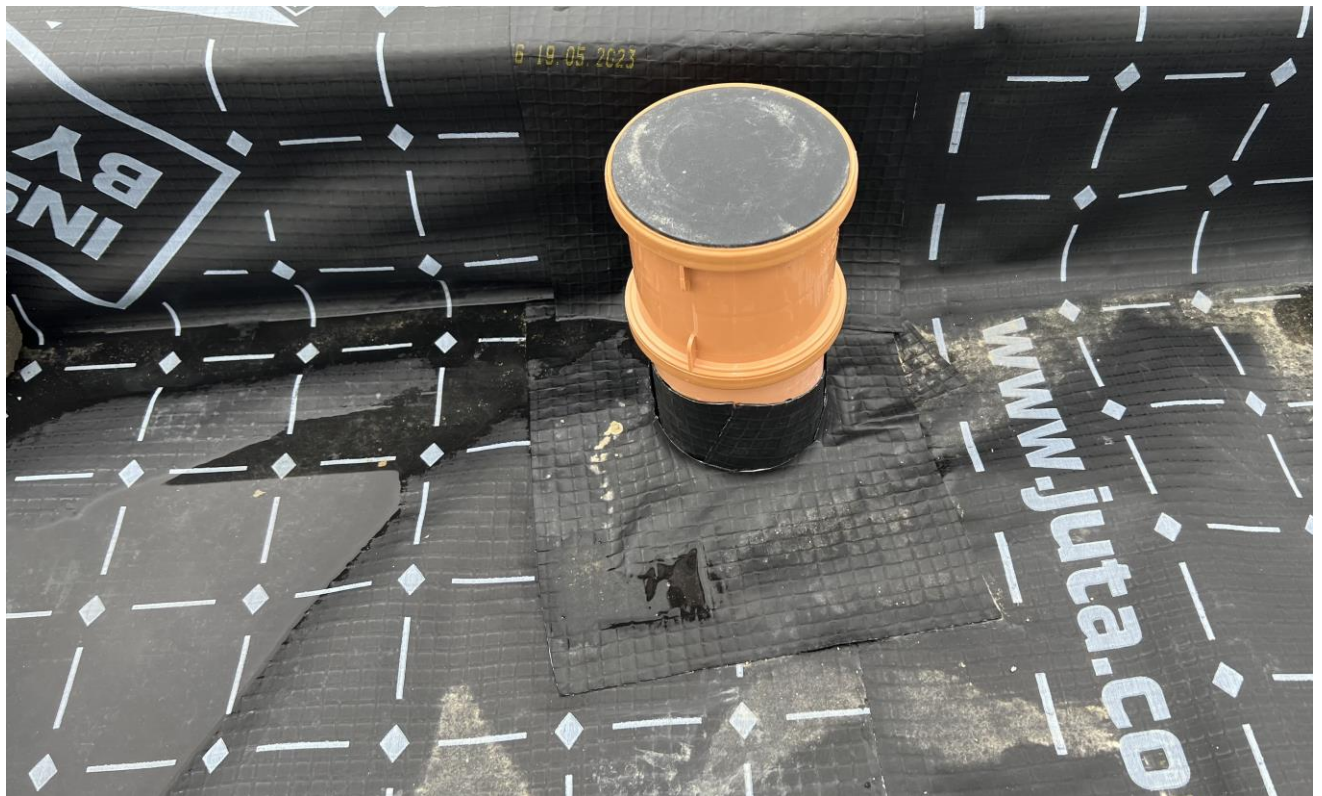
Plots 97 & 98 – Membrane layout with tophat and jointing

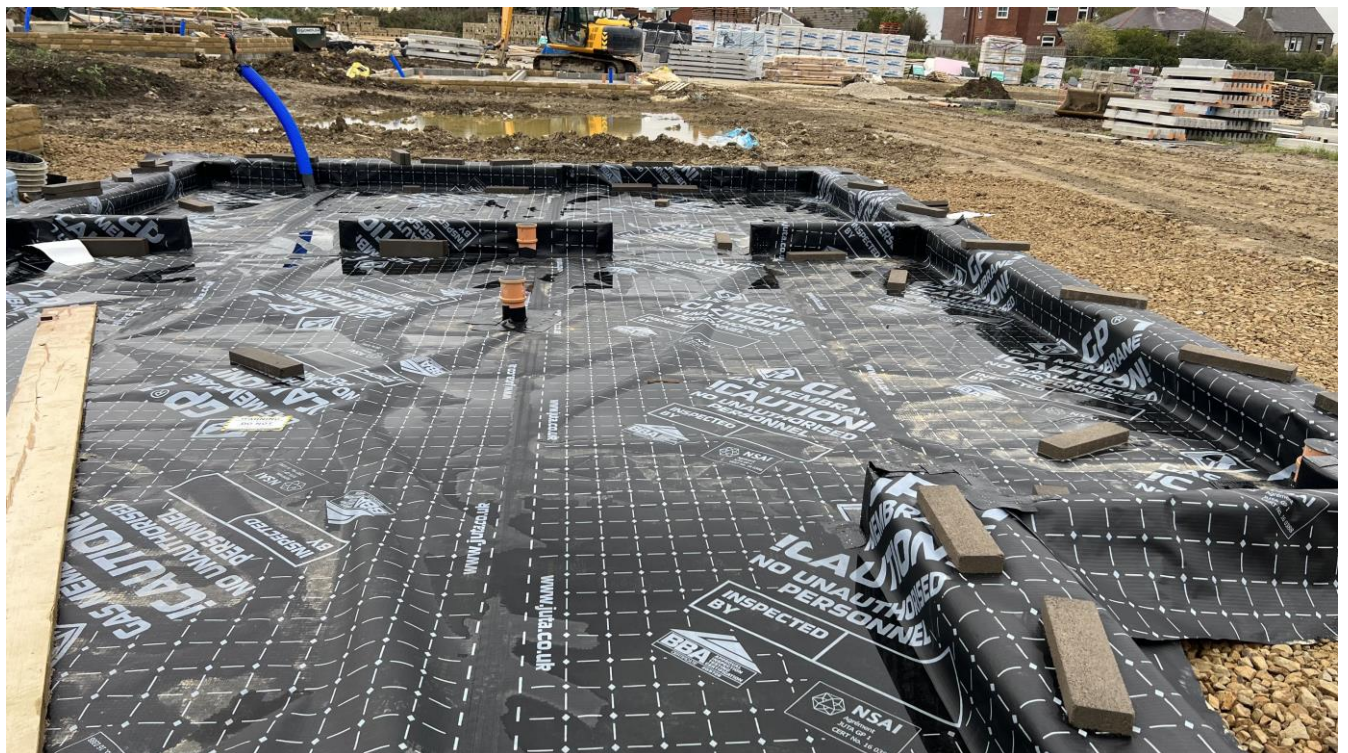
Plot 99– Overall membrane layout

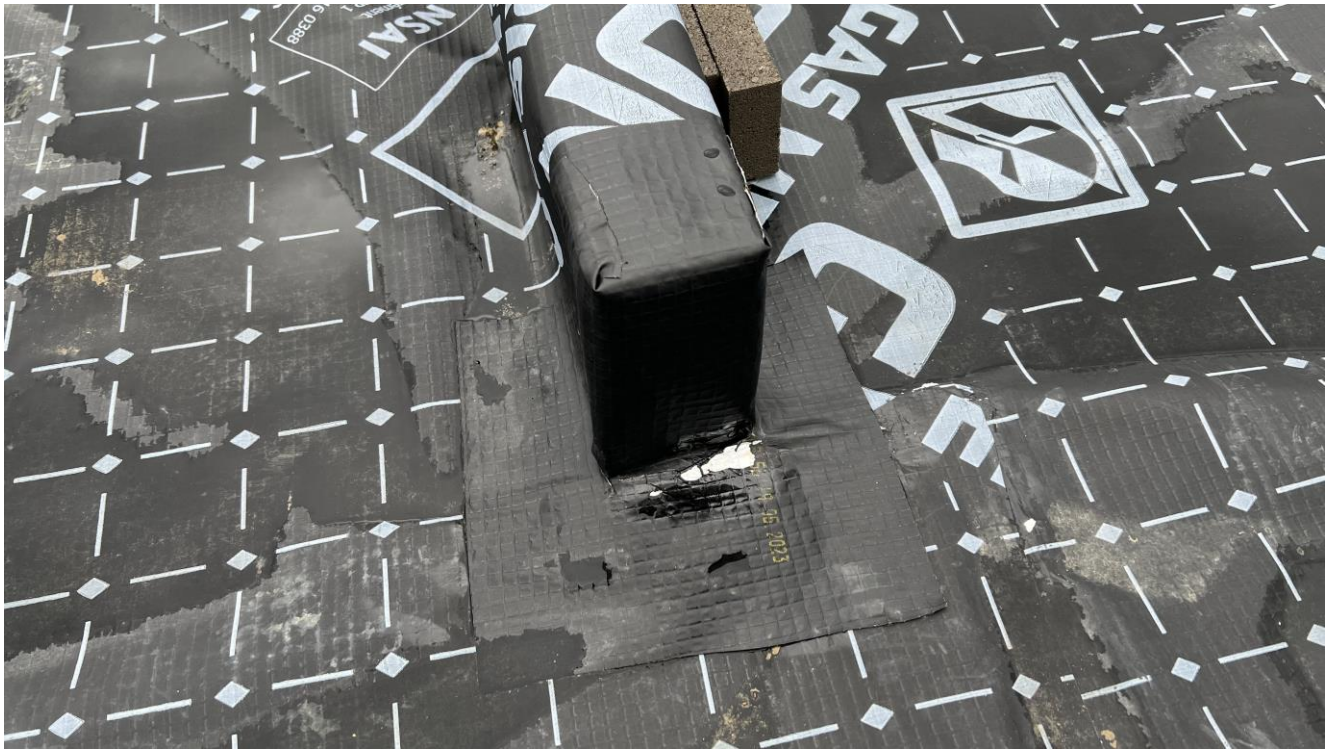
Plot 99 – Membrane layout with internal wall and jointing
