Road Condition Survey Report

Proposed Residential Development

LAND ADJ, 67, CHAPELGATE, SCHOLES (2022/62/92406/W)

September 2025

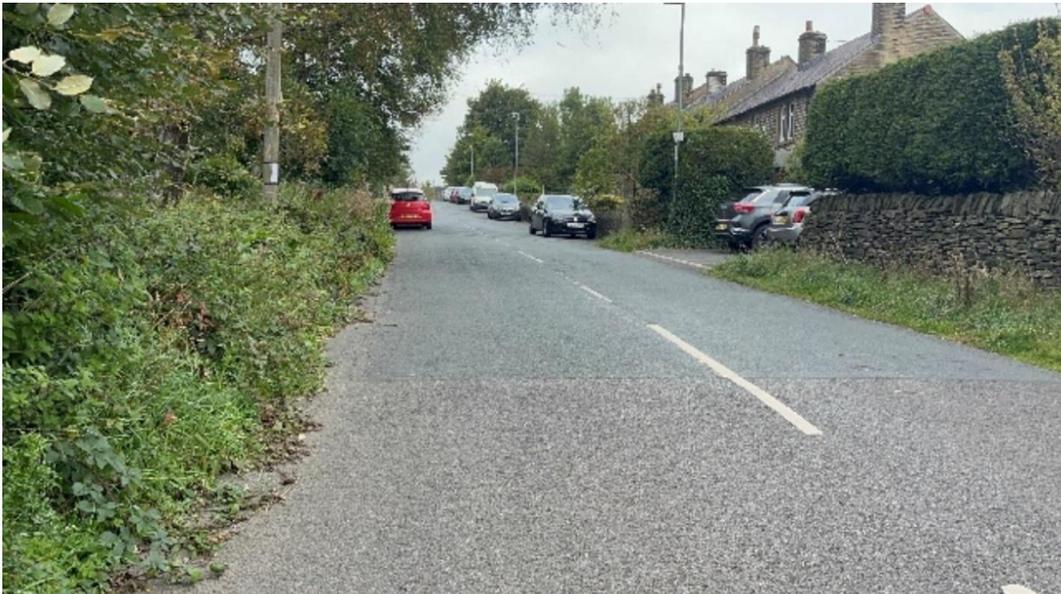
Photograph 1: Chainage 0m – Surface course intact

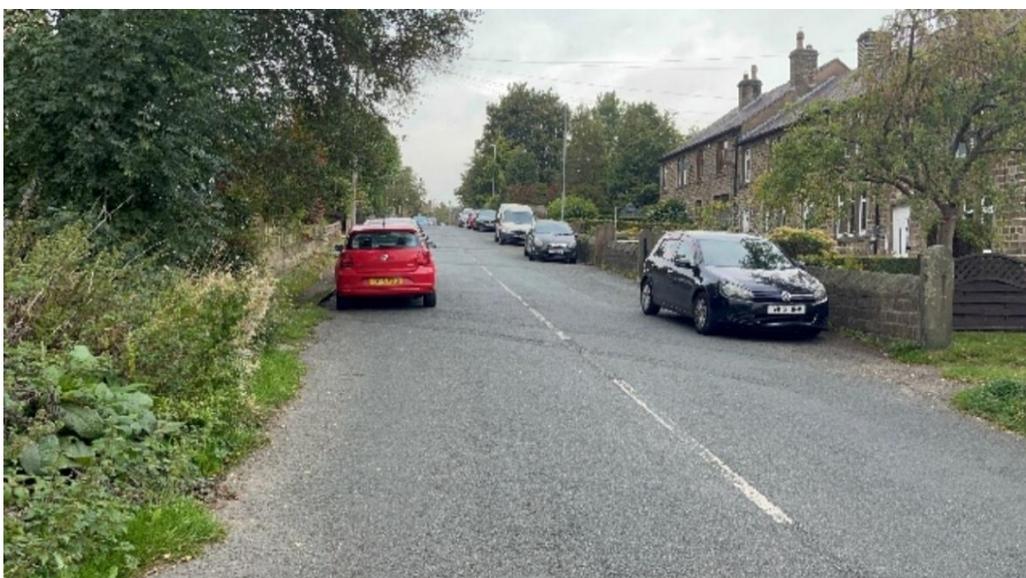
Photograph 2: Chainage 10m – Surface course intact

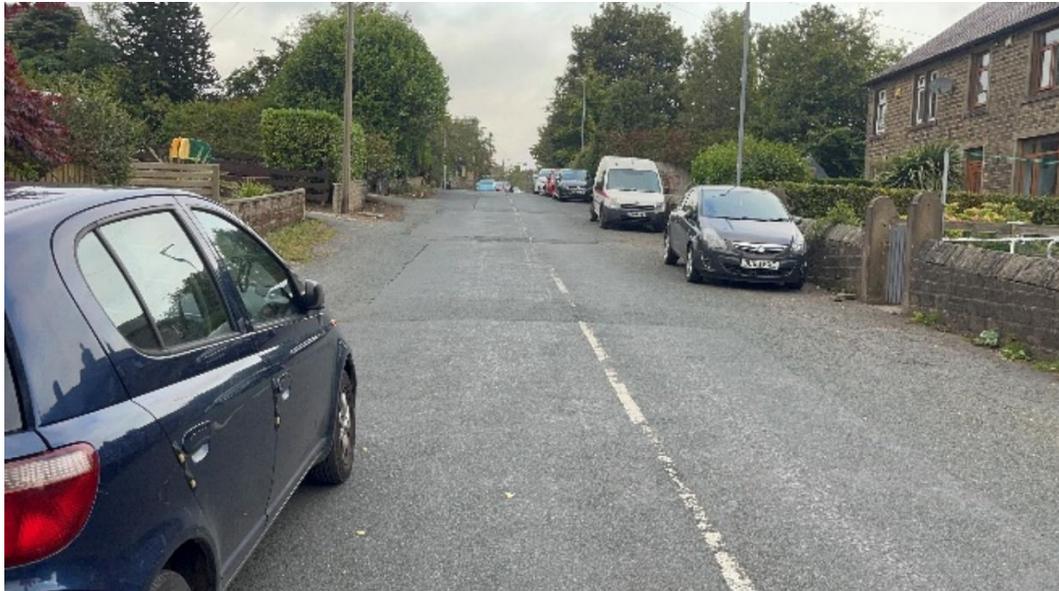
Photograph 3: Chainage 20m – Surface course intact

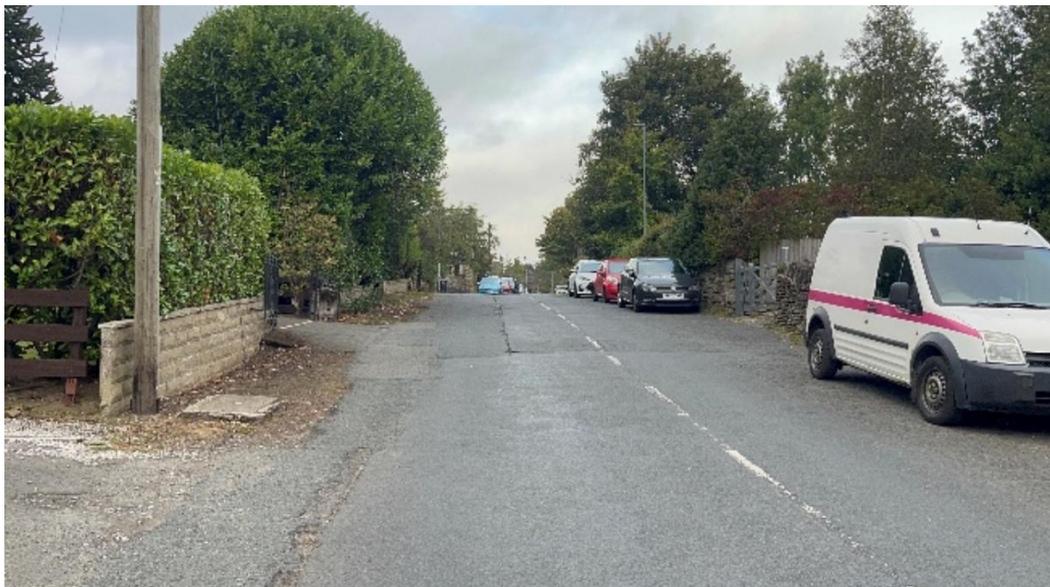
Photograph 4: Chainage 30m – Deteriorating carriageway surface outside driveway

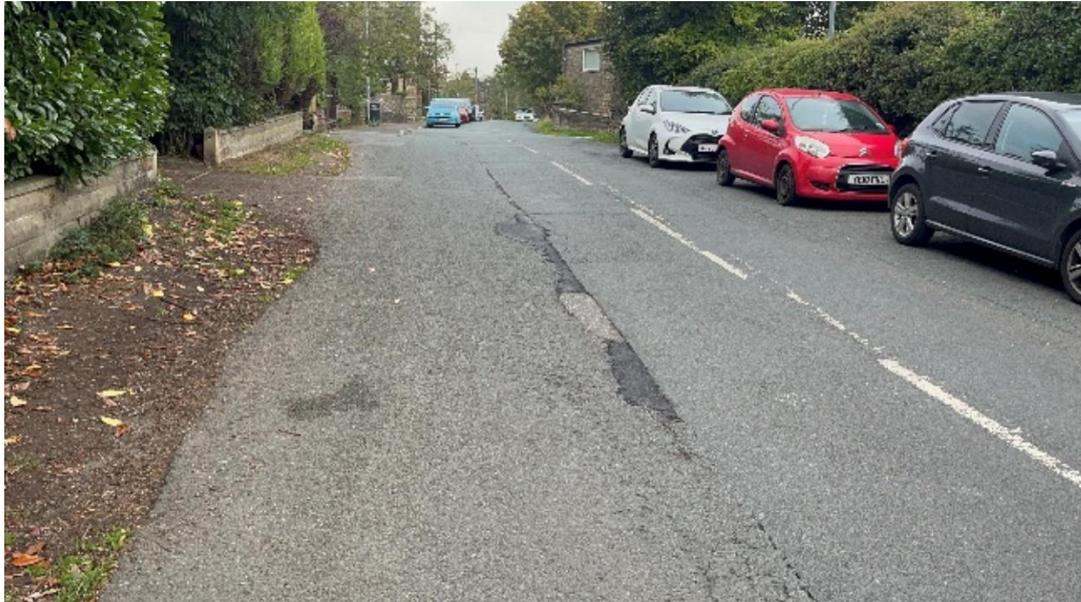
Photograph 5: Chainage 40m – road surface deterioration

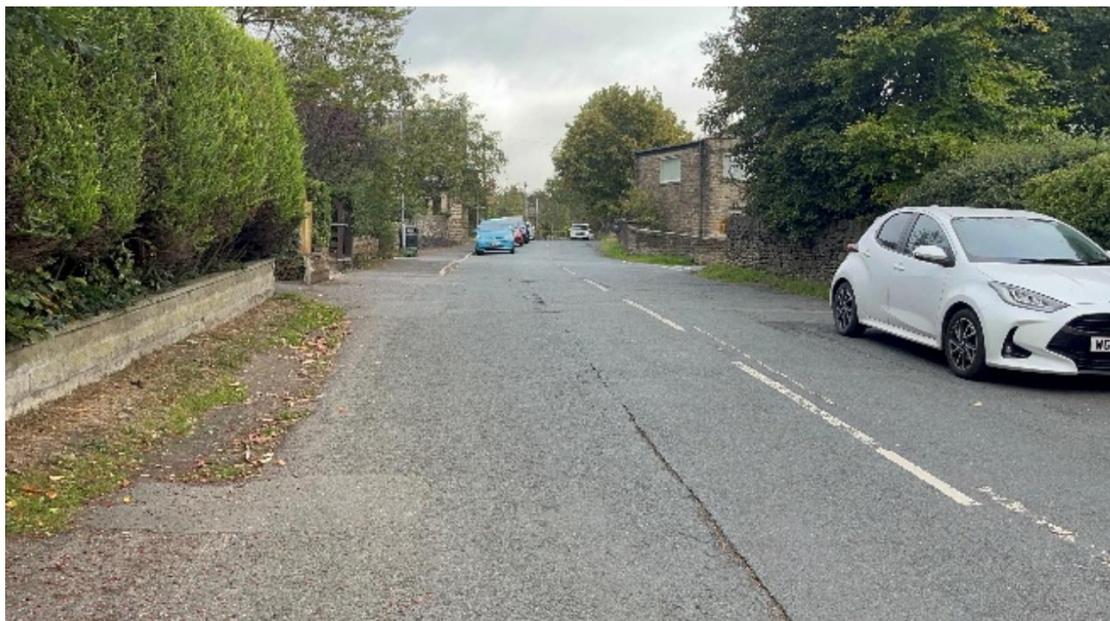
Photograph 6: Chainage 50m – road surface deterioration / joint line failure

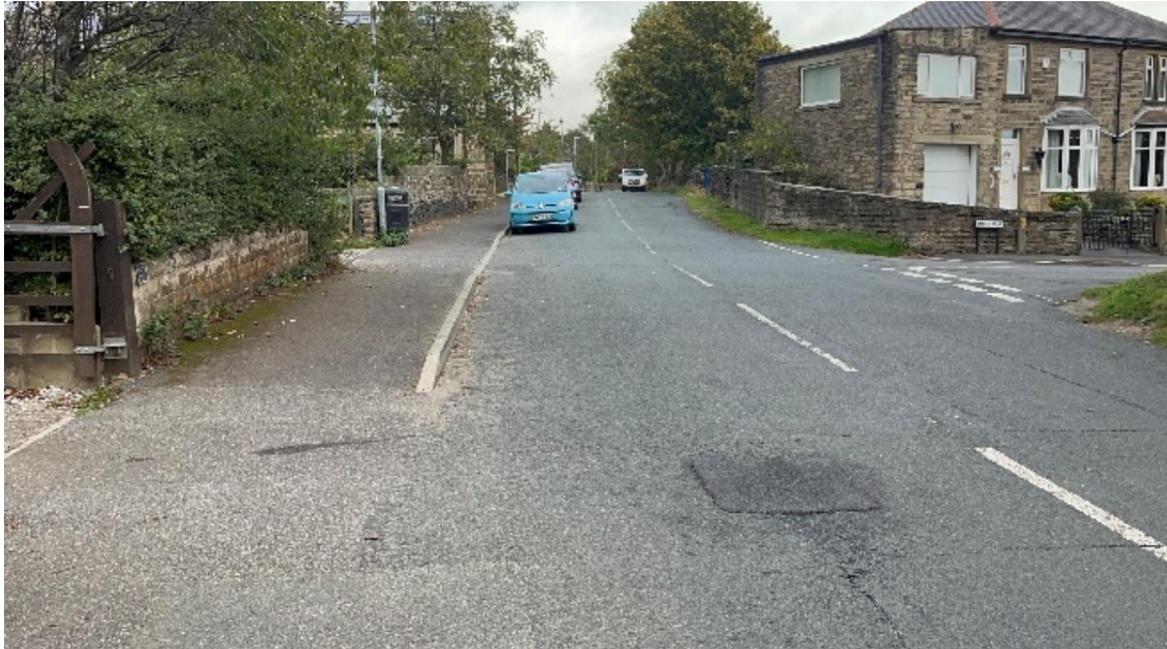
Photograph 7: Chainage 60m – Carriageway repair petruding from existing level

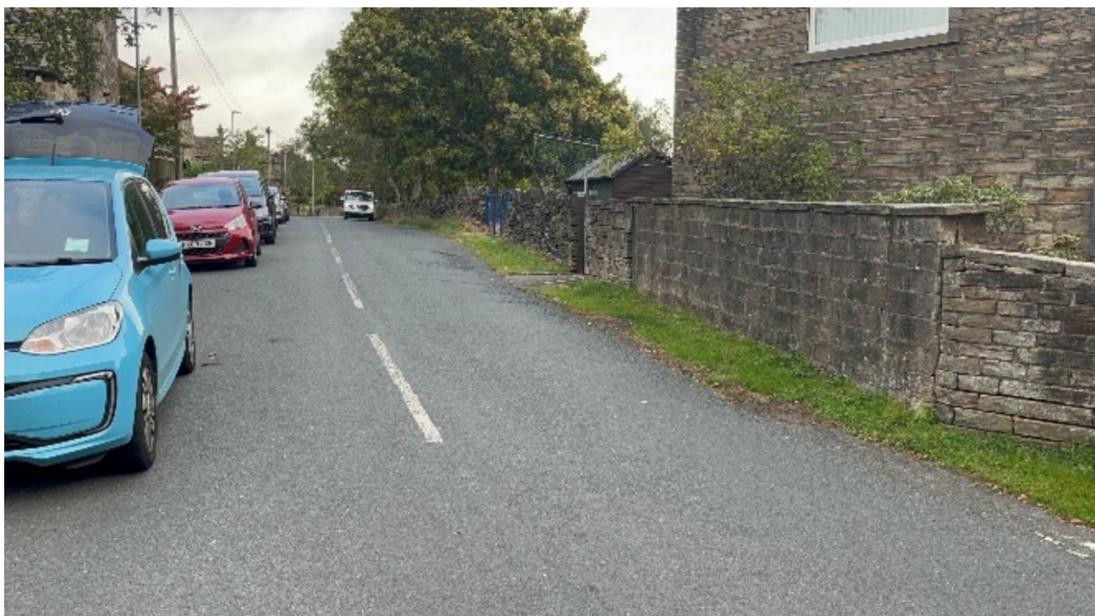
Photograph 8: Chainage 70m – Surface course intact

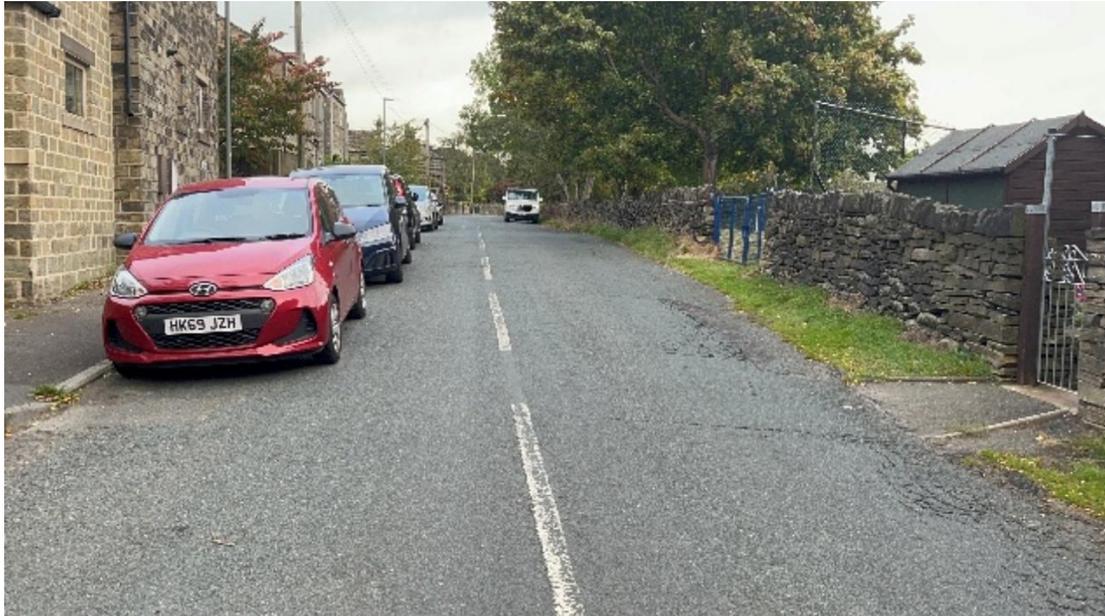
Photograph 9: Chainage 80m – Carriageway deteriorating along the right-hand side. Surface course broke

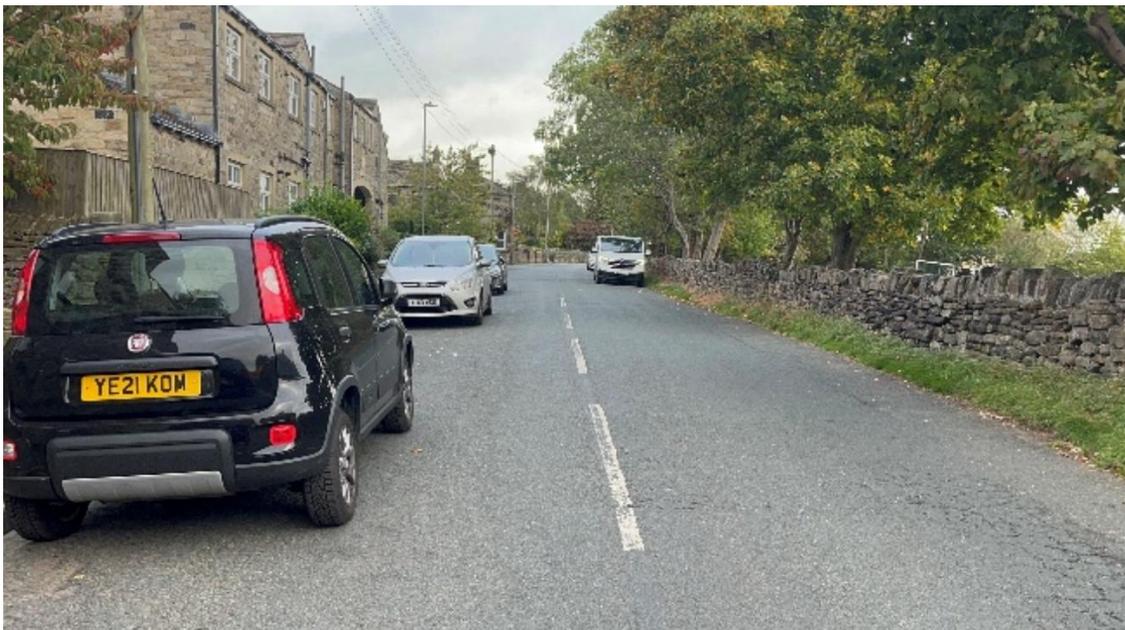
Photograph 10: Chainage 90m – Surface course intact

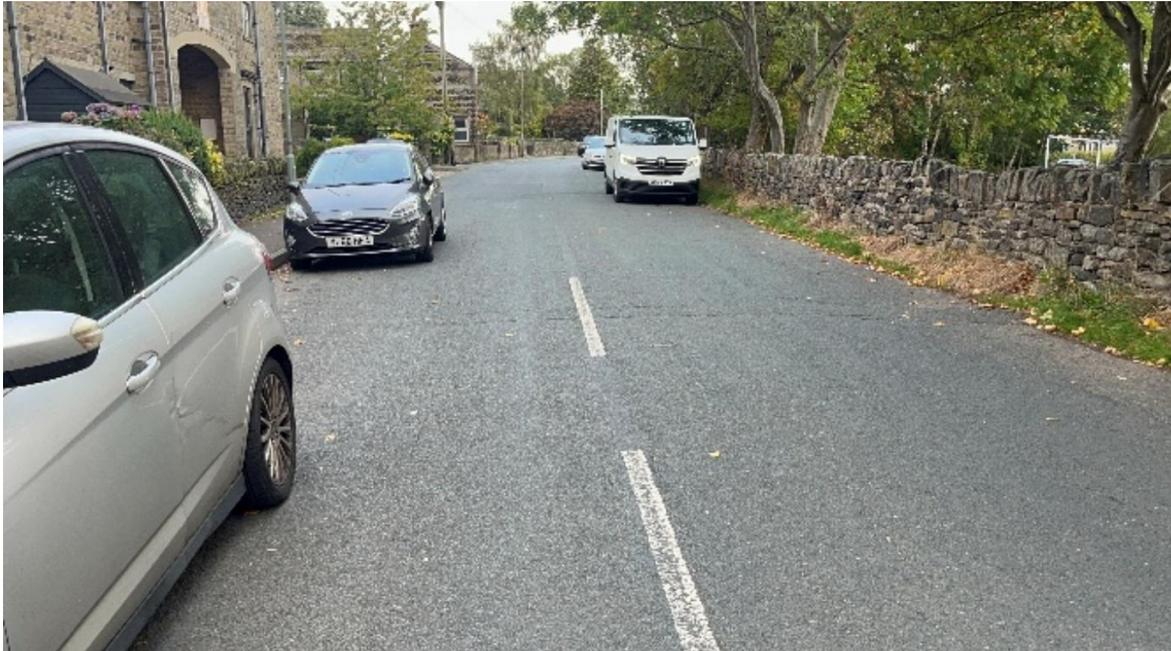
Photograph 11: Chainage 100m – Surface course intact

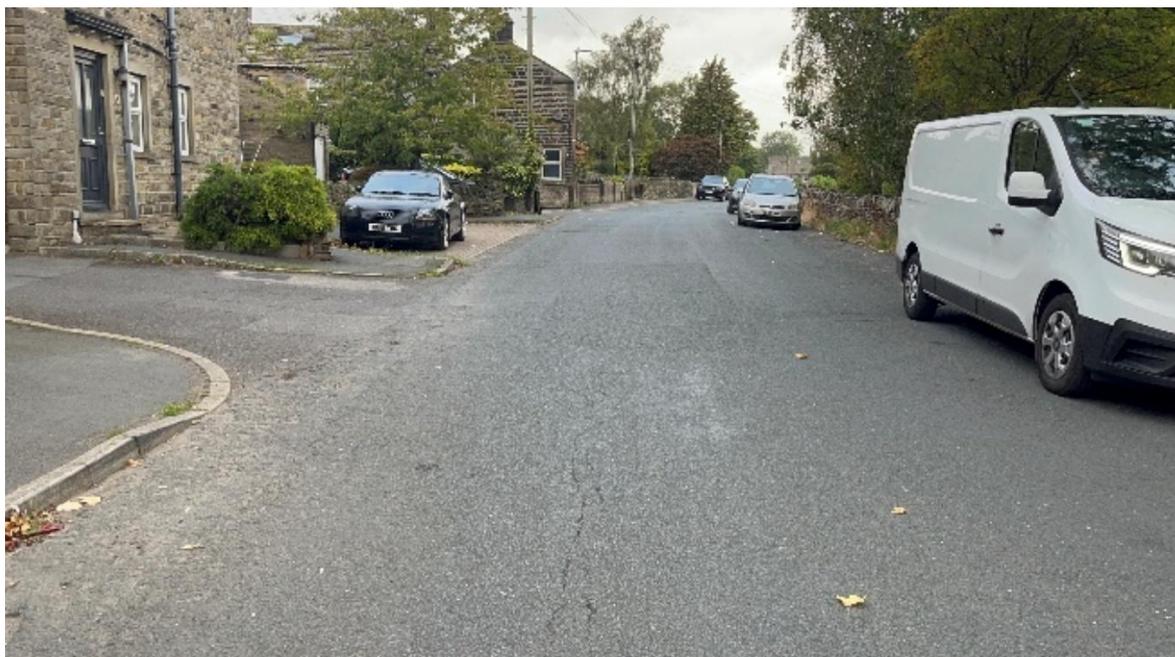
Photograph 12: Chainage 110m – Surface course intact

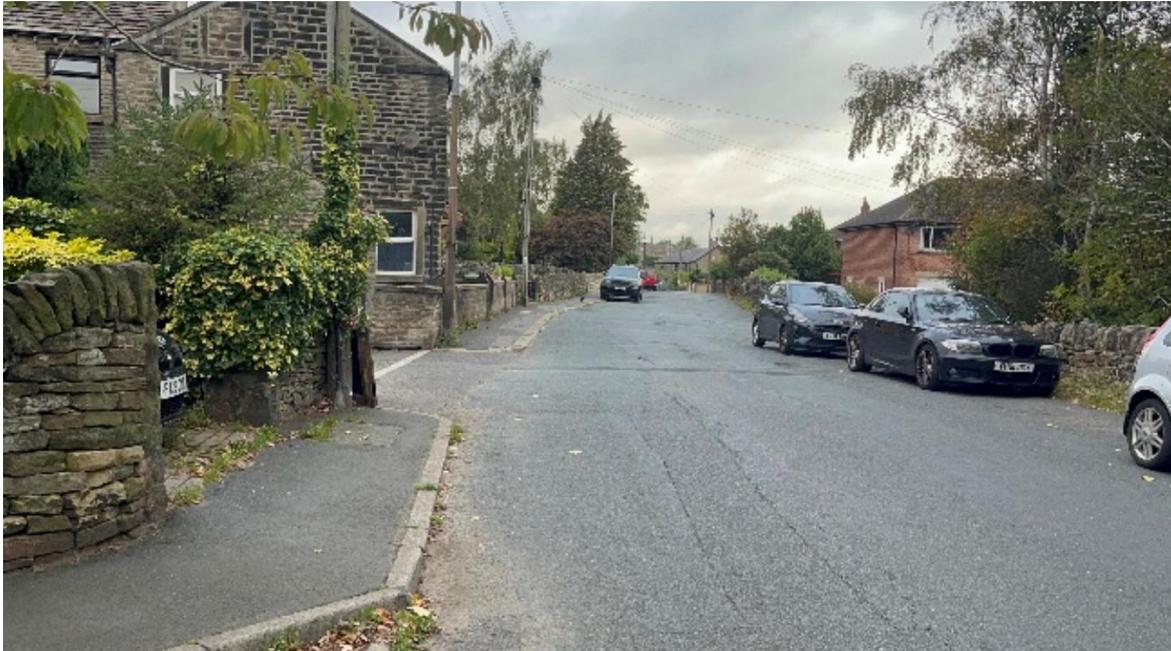
Photograph 13: Chainage 120m – Surface course intact

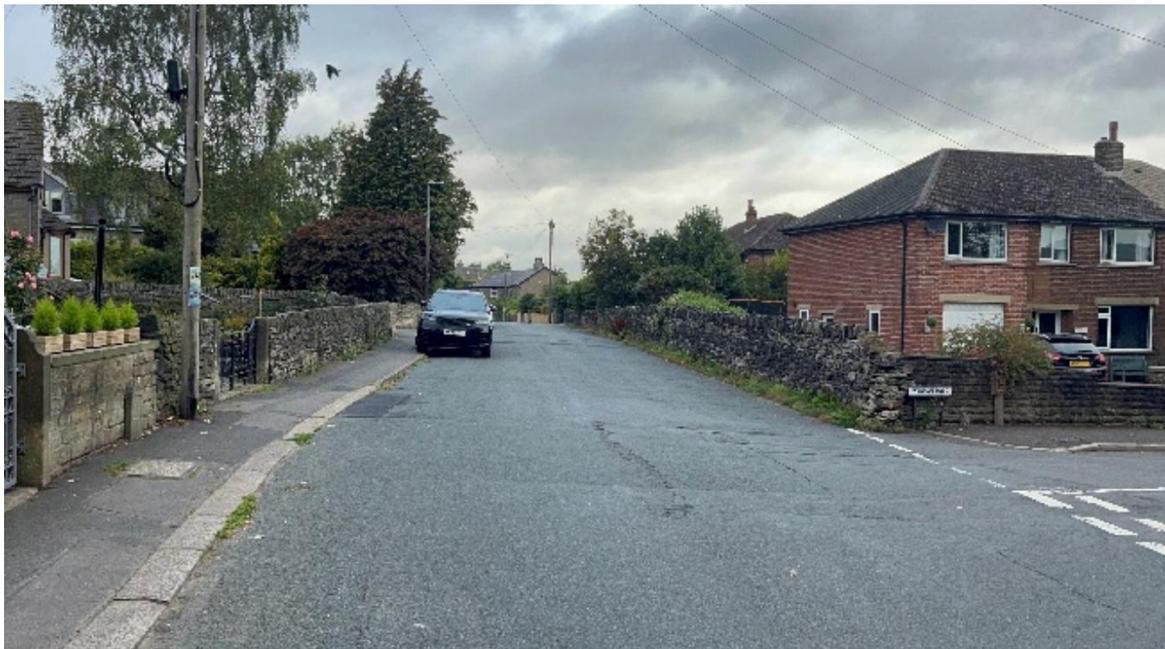
Photograph 14: Chainage 130m – Minor potholes and cracking of the carriageway outside the junction

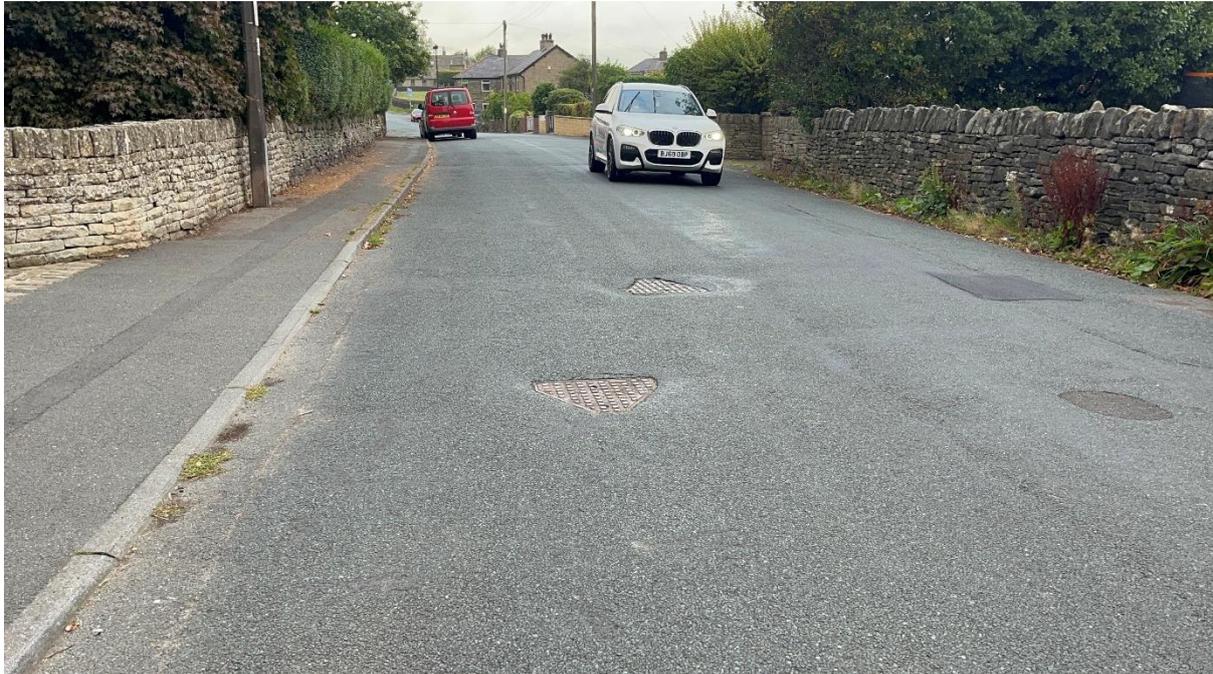
Photograph 15: Chainage 140m – Ironwork sunk into carriageway

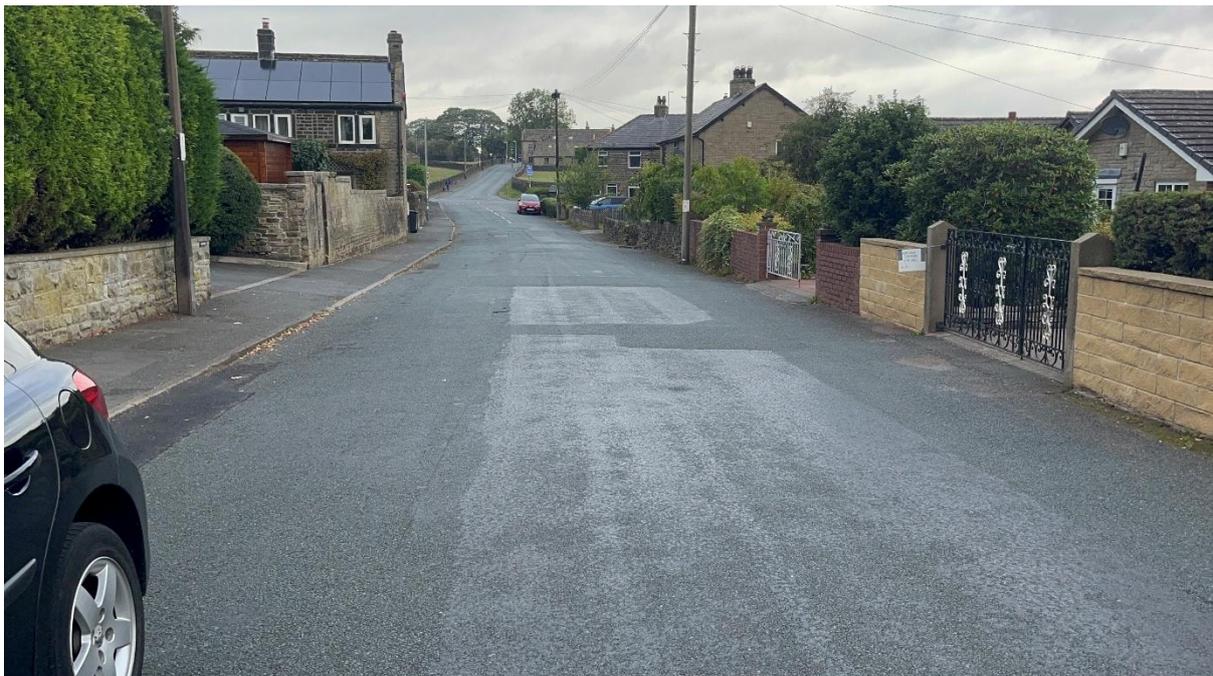
Photograph 16: Chainage 150m – Surface course intact

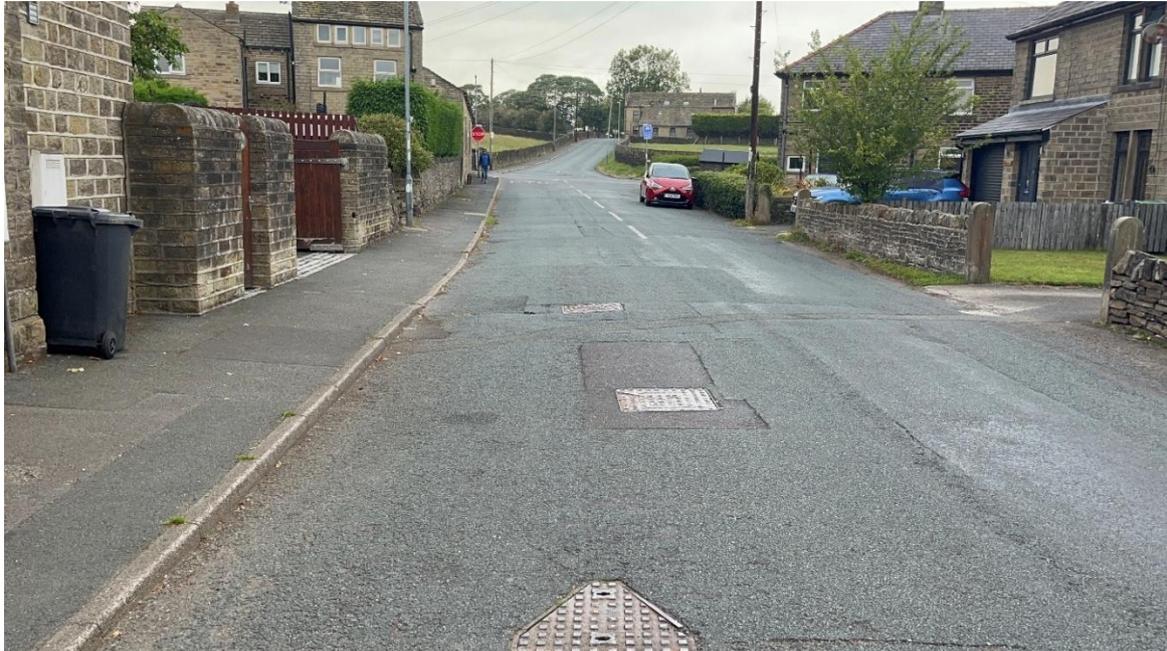
Photograph 17: Chainage 160m – Minor pothole next to ironwork and ironwork beginning to sink into carriageway

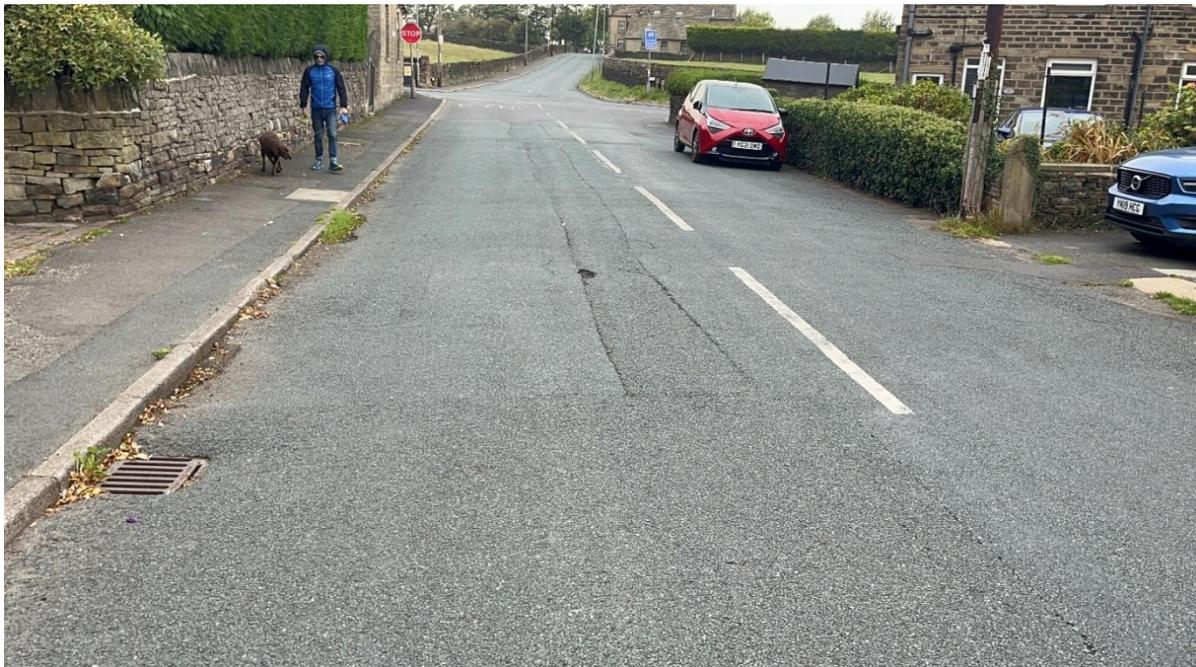
Photograph 18: Chainage 170m – Minor pothole in the middle of the carriageway and carriageway deteriorating adjacent to left-hand kerb

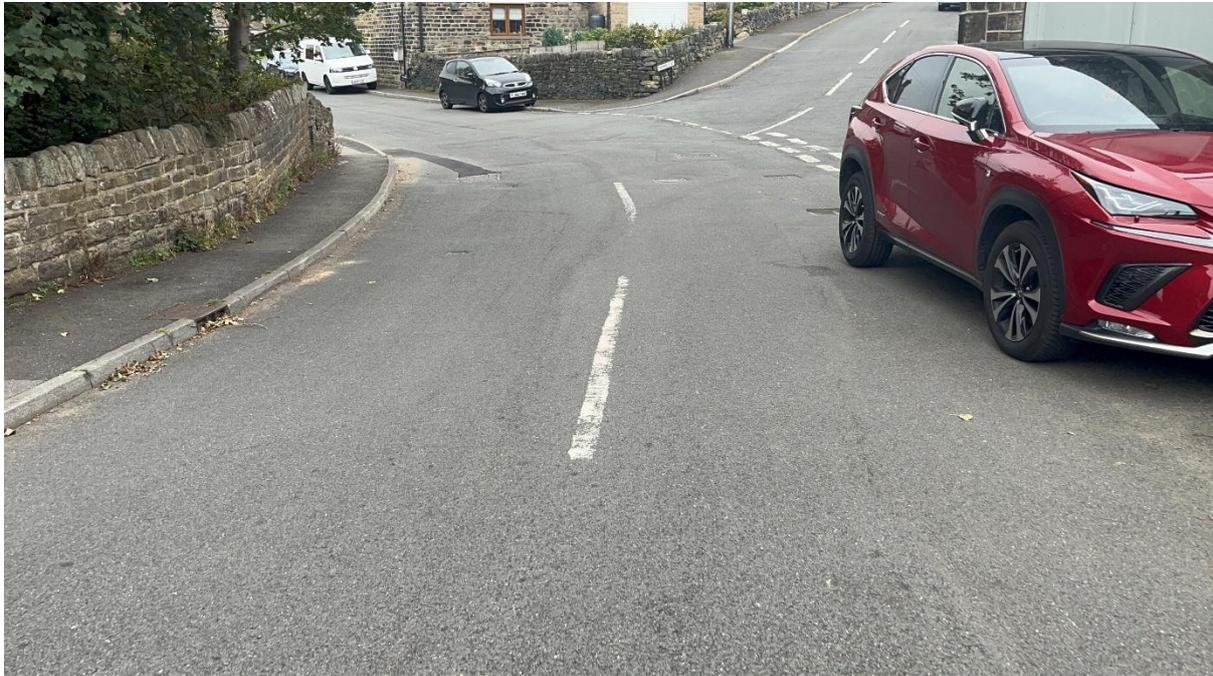
Photograph 1: Chainage 0m – Surface course intact

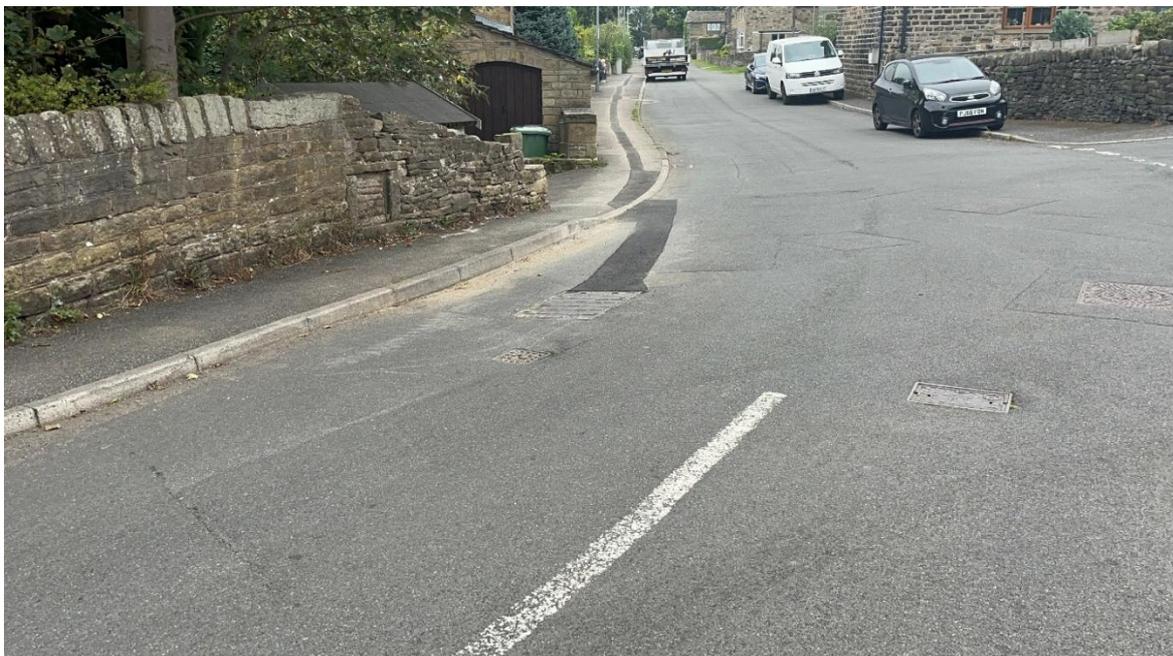
Photograph 2: Chainage 10m – Ironwork sunk into carriageway

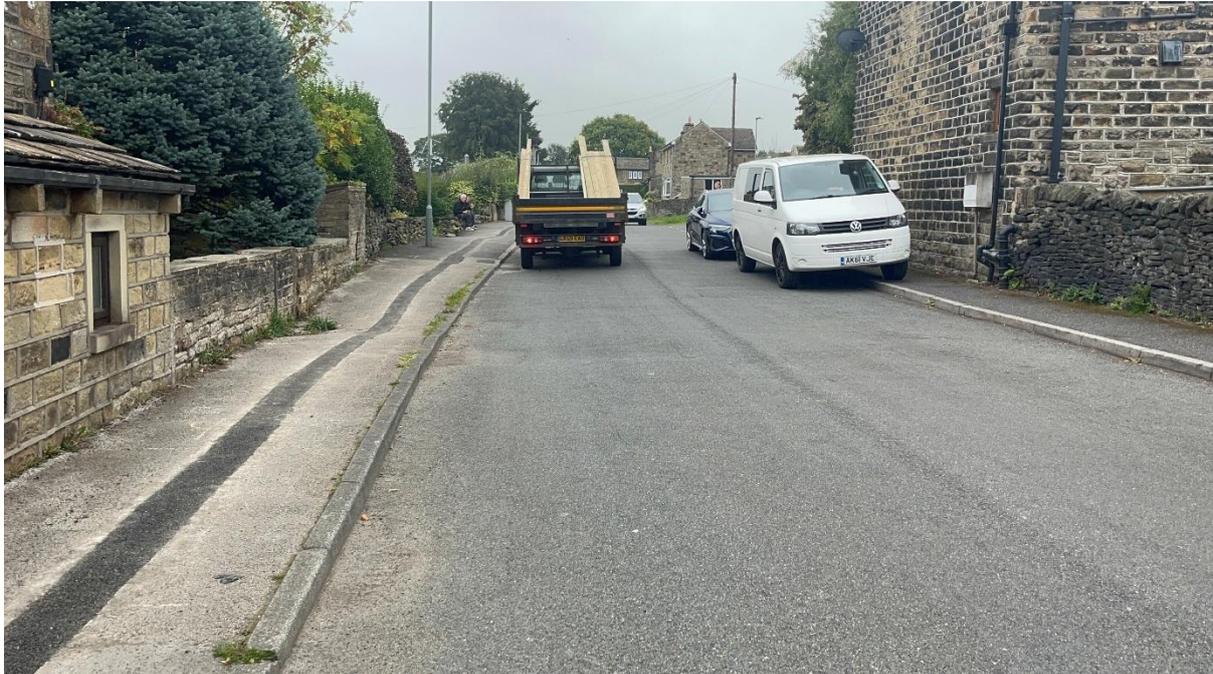
Photograph 3: Chainage 20m – Surface course intact

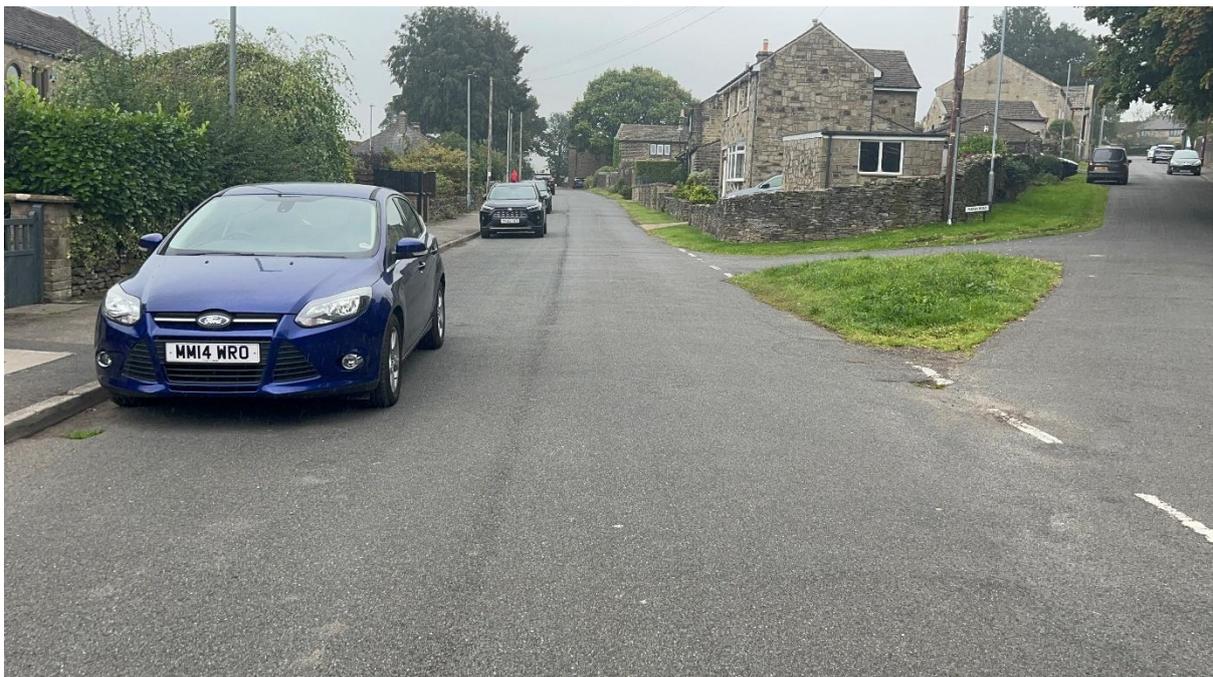
Photograph 4: Chainage 30m – Minor potholes in carriageway on the junction

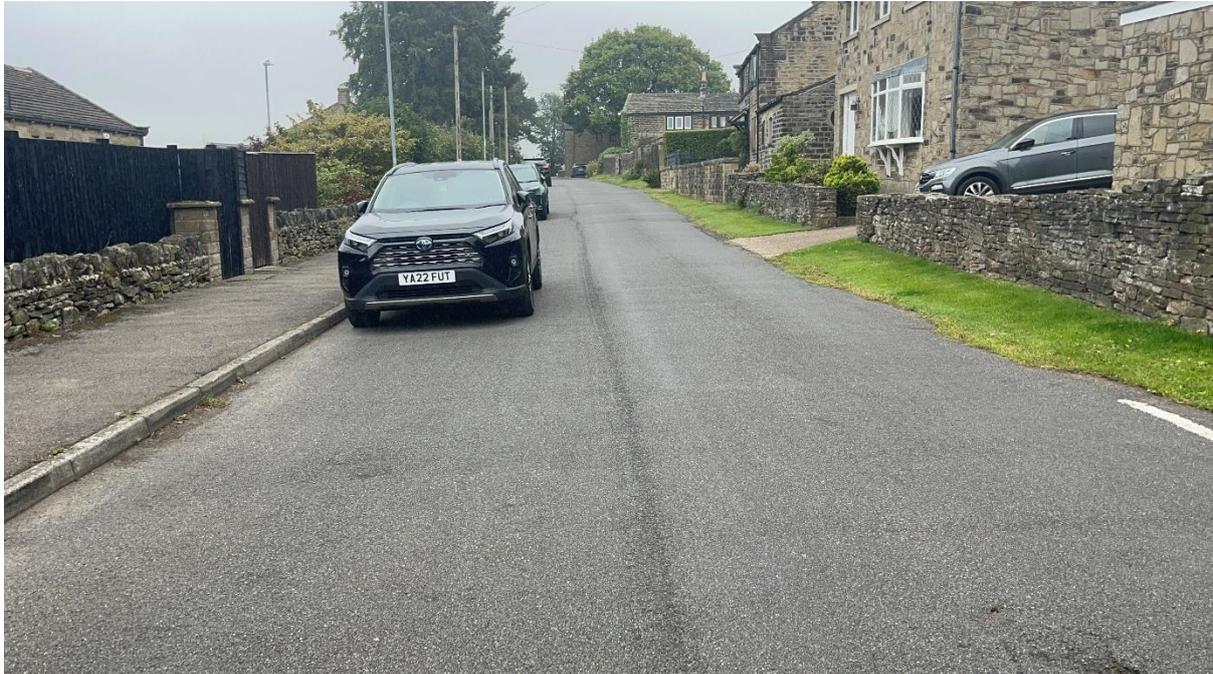
Photograph 5: Chainage 40m – Surface course intact

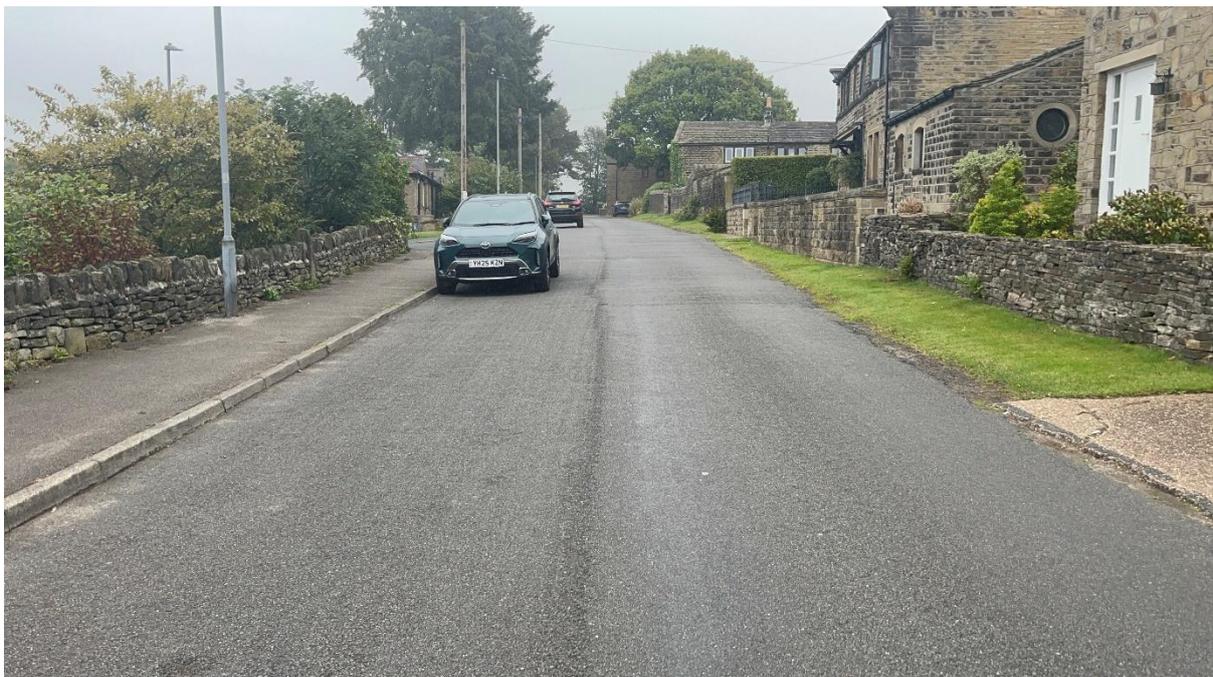
Photograph 6: Chainage 50m – Carriageway deteriorating adjacent to grass verge

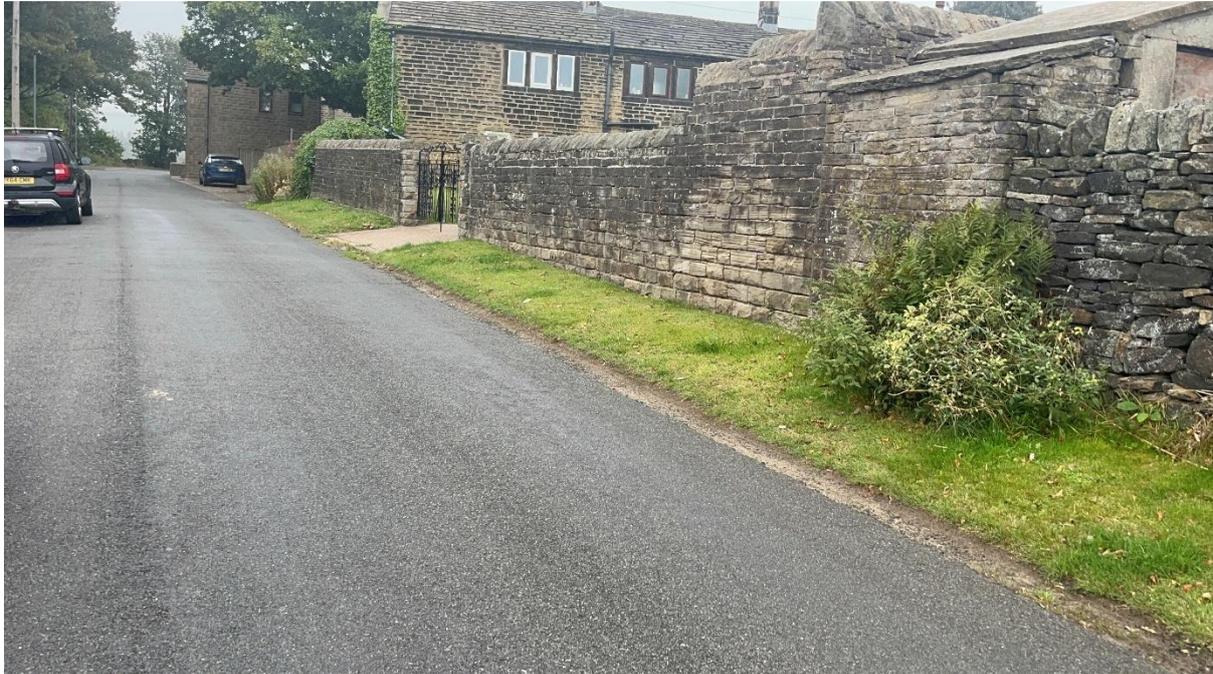
Photograph 7: Chainage 60m – Carriageway deteriorating adjacent to grass verge

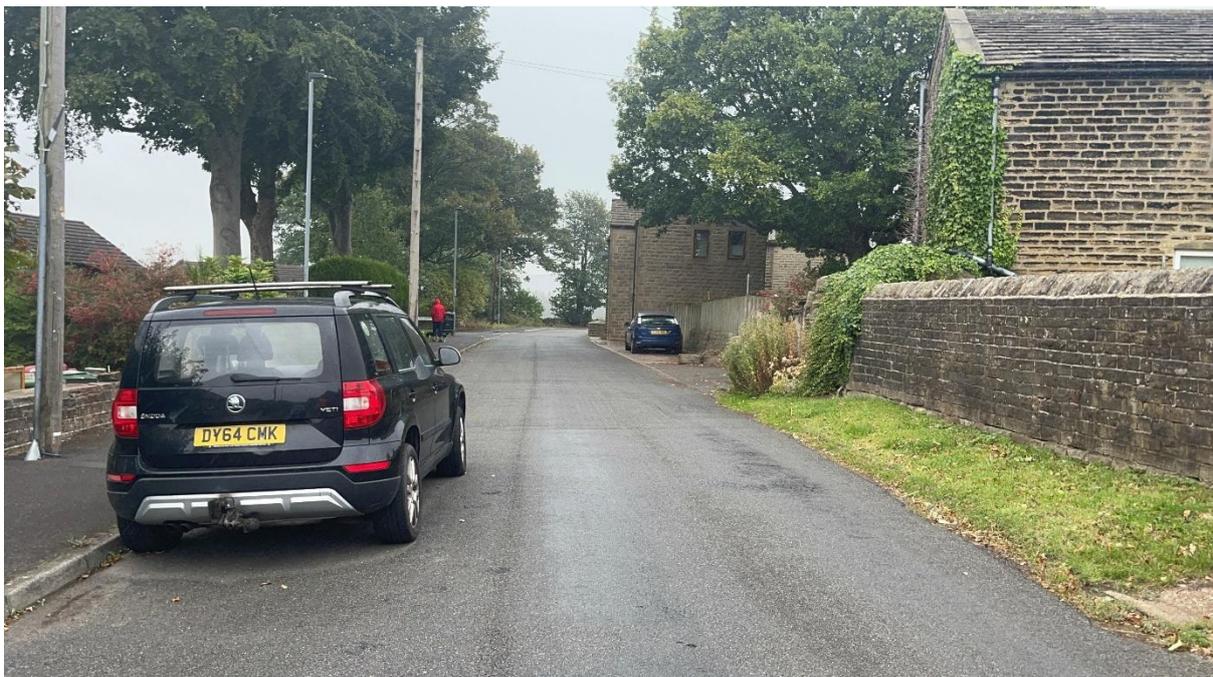
Photograph 8: Chainage 70m – Carriageway deteriorating adjacent to grass verge

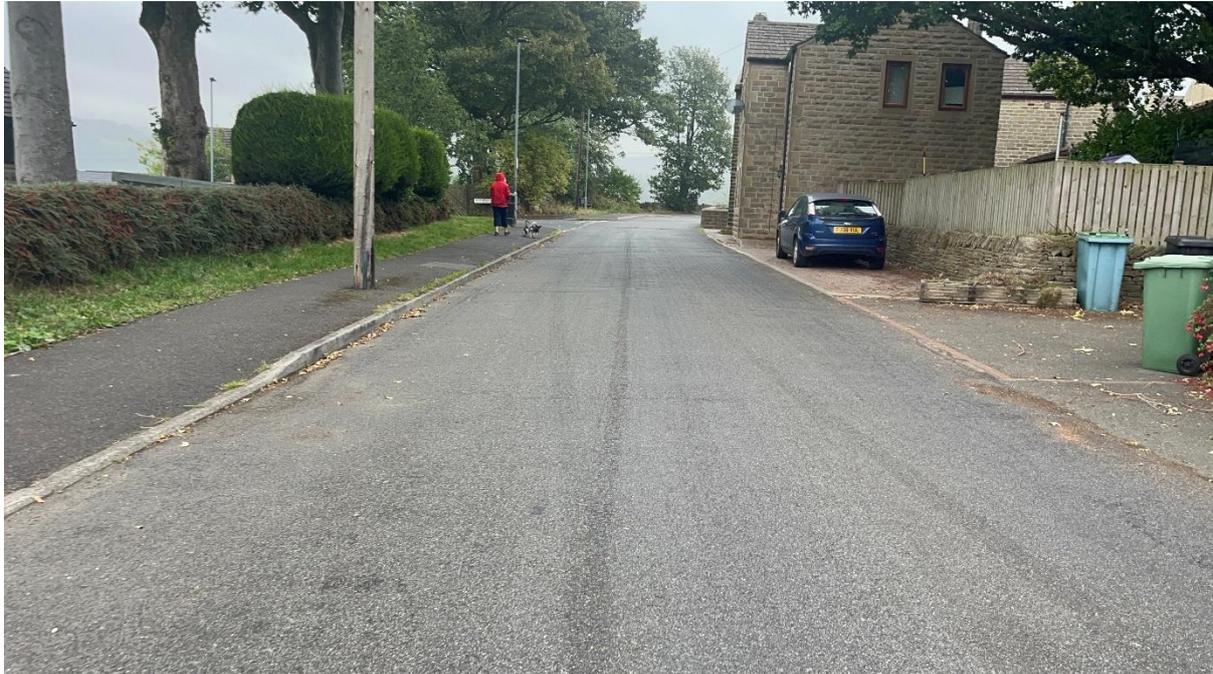
Photograph 9: Chainage 80m – Carriageway deteriorating on right and left sides of the road

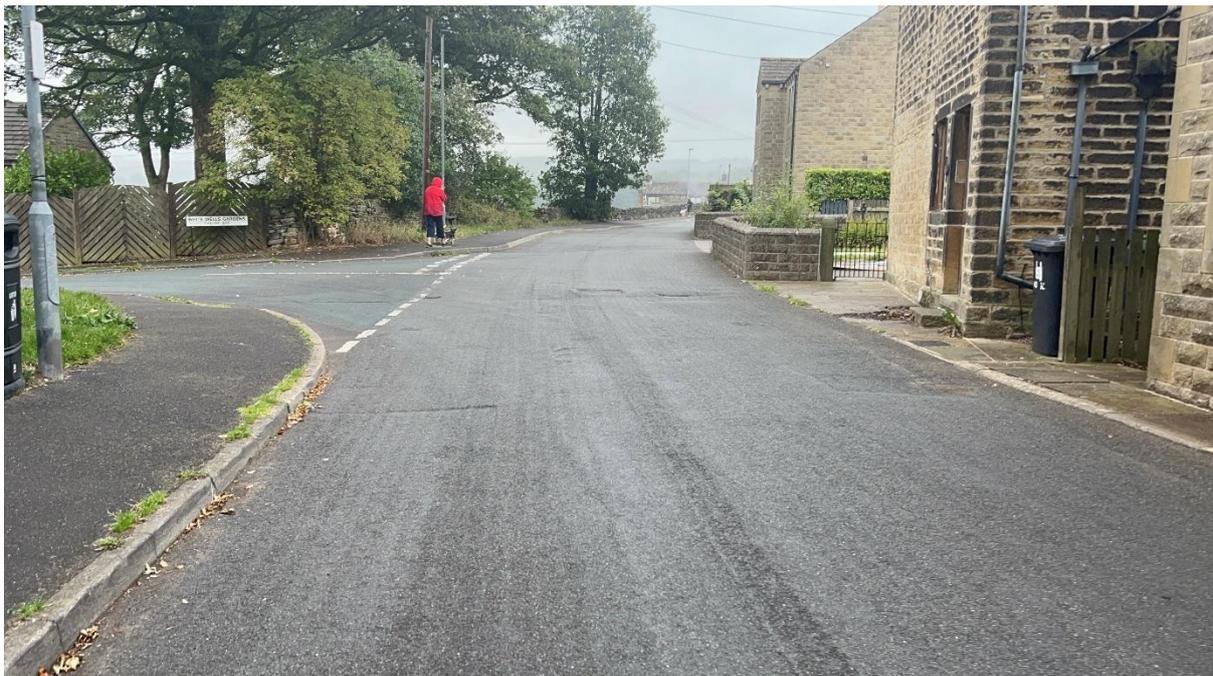
Photograph 10: Chainage 90m – Multiple pieces of ironwork sunk into carriageway

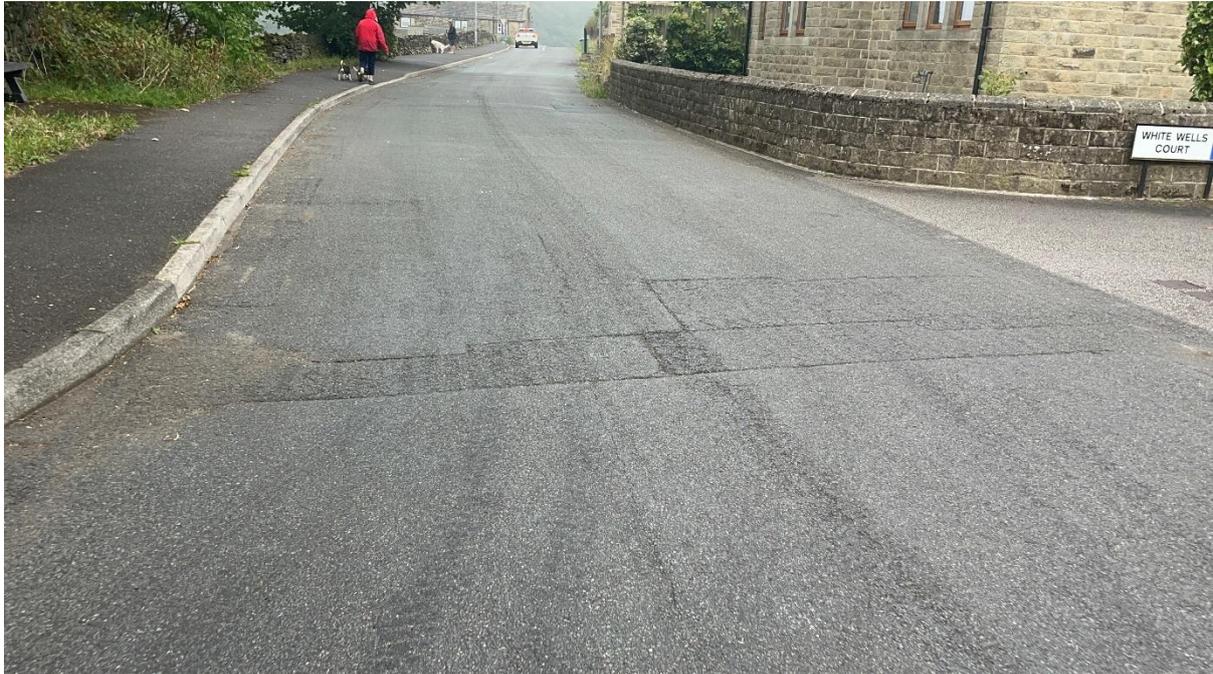
Photograph 11: Chainage 100m – Crack beginning to form in carriageway

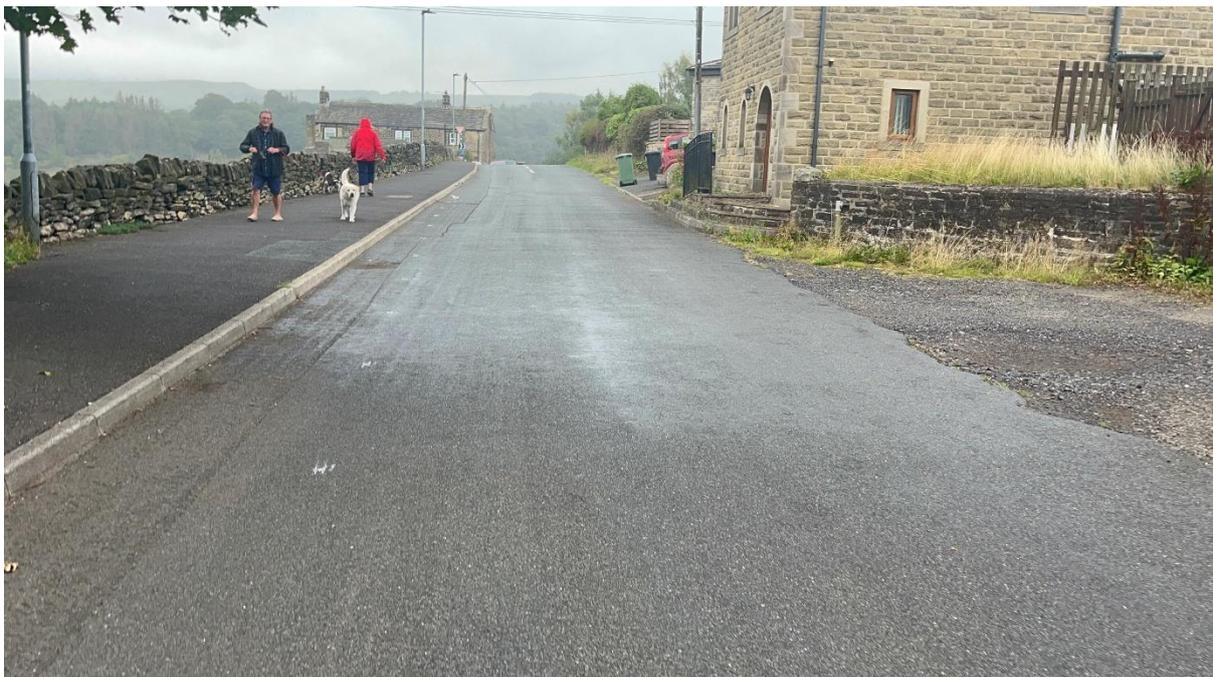
Photograph 12: Chainage 110m – Carriageway deteriorating on the right-hand side edge
