Road Condition Survey Report

Proposed Residential Development

LAND ADJ, 67, CHAPELGATE, SCHOLES (2022/62/92406/W)

September 2025

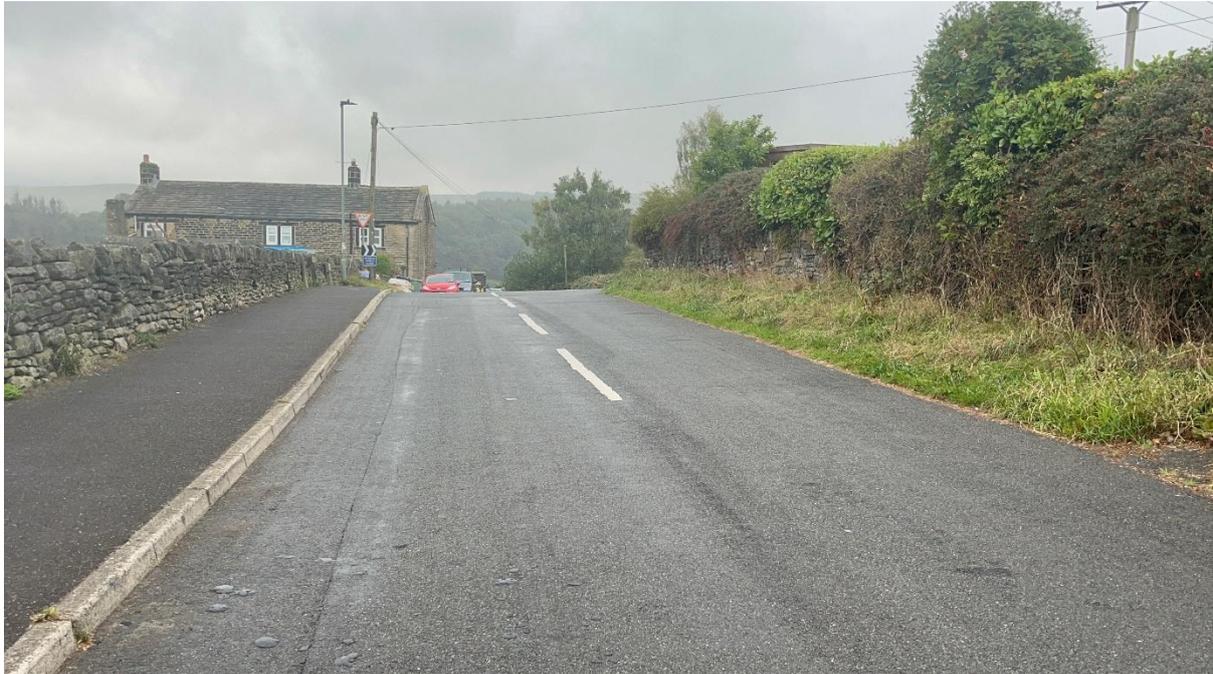
Photograph 13: Chainage 120m – Surface course intact

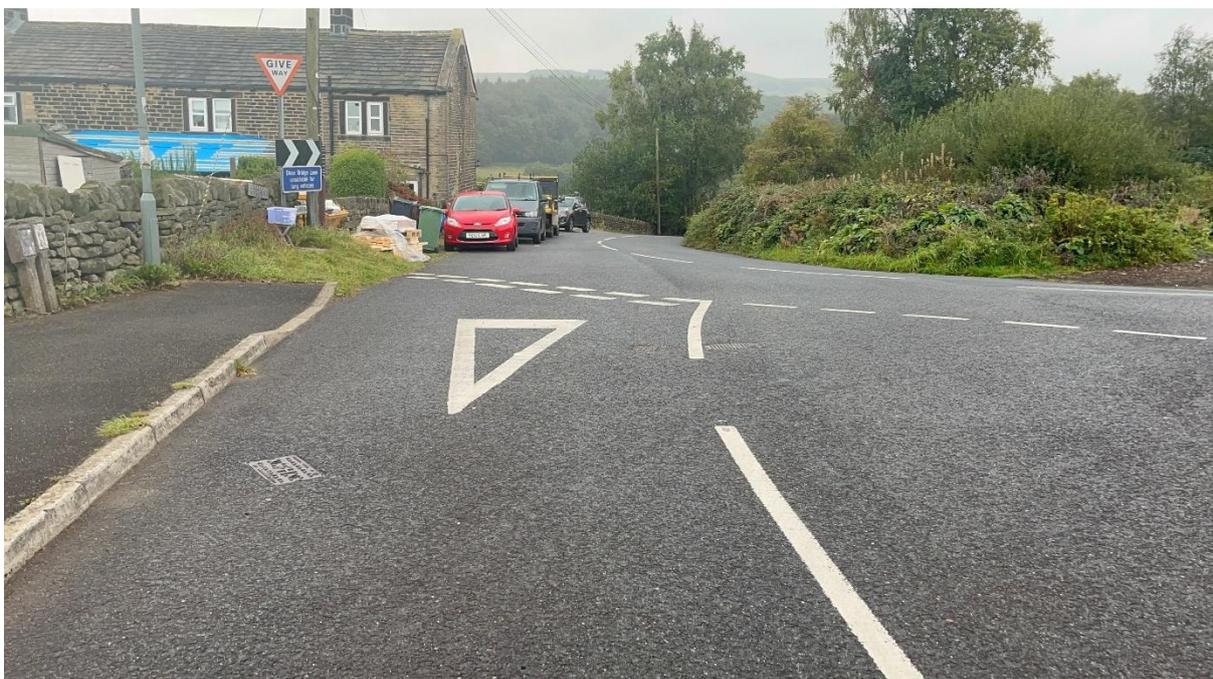
Photograph 14: Chainage 130m – Surface course intact
