**Project Name**  
**5126 - Dean Bridge Lane**  
**CCTV REPORT**

**Project Name**  
5126 - Dean Bridge Lane

**Project Number**  
5126

**Project Date**  
21/01/2026

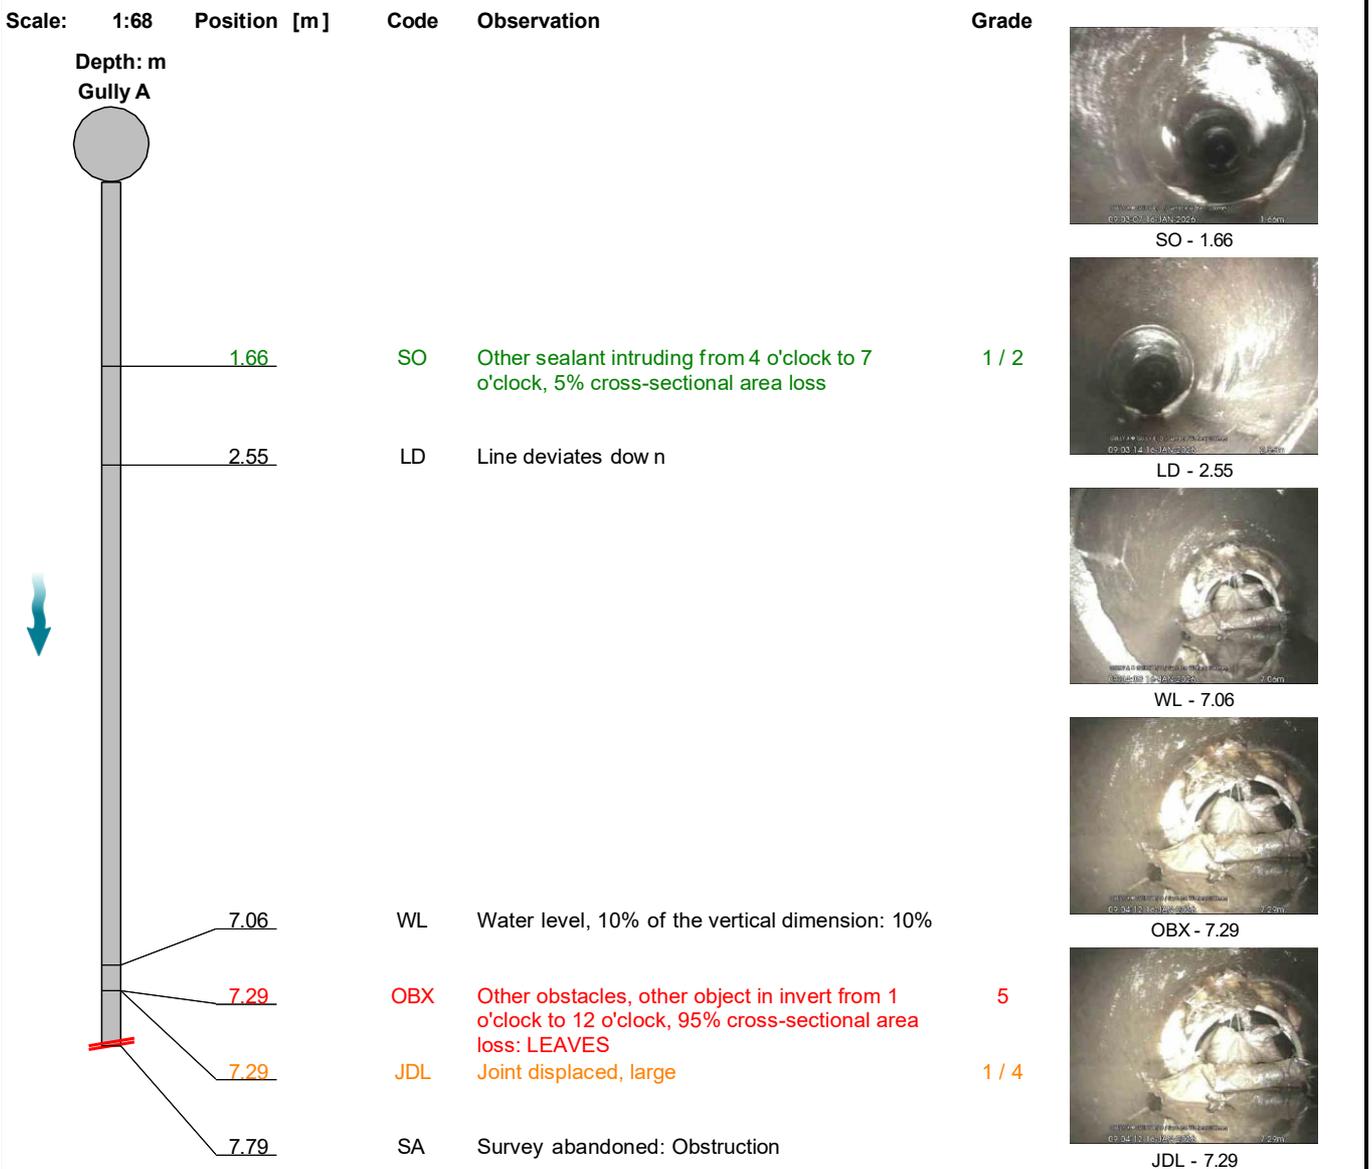
No.	m+	Code	Observation
1	1.66	SO	Other sealant intruding from 4 o'clock to 7 o'clock, 5% cross-sectional area loss
2	2.55	LD	Line deviates down
3	7.06	WL	Water level, 10% of the vertical dimension
4	7.29	OBX	Other obstacles, other object in invert from 1 o'clock to 12 o'clock, 95% cross-sectional area loss
5	7.29	JDL	Joint displaced, large
6	7.79	SA	Survey abandoned

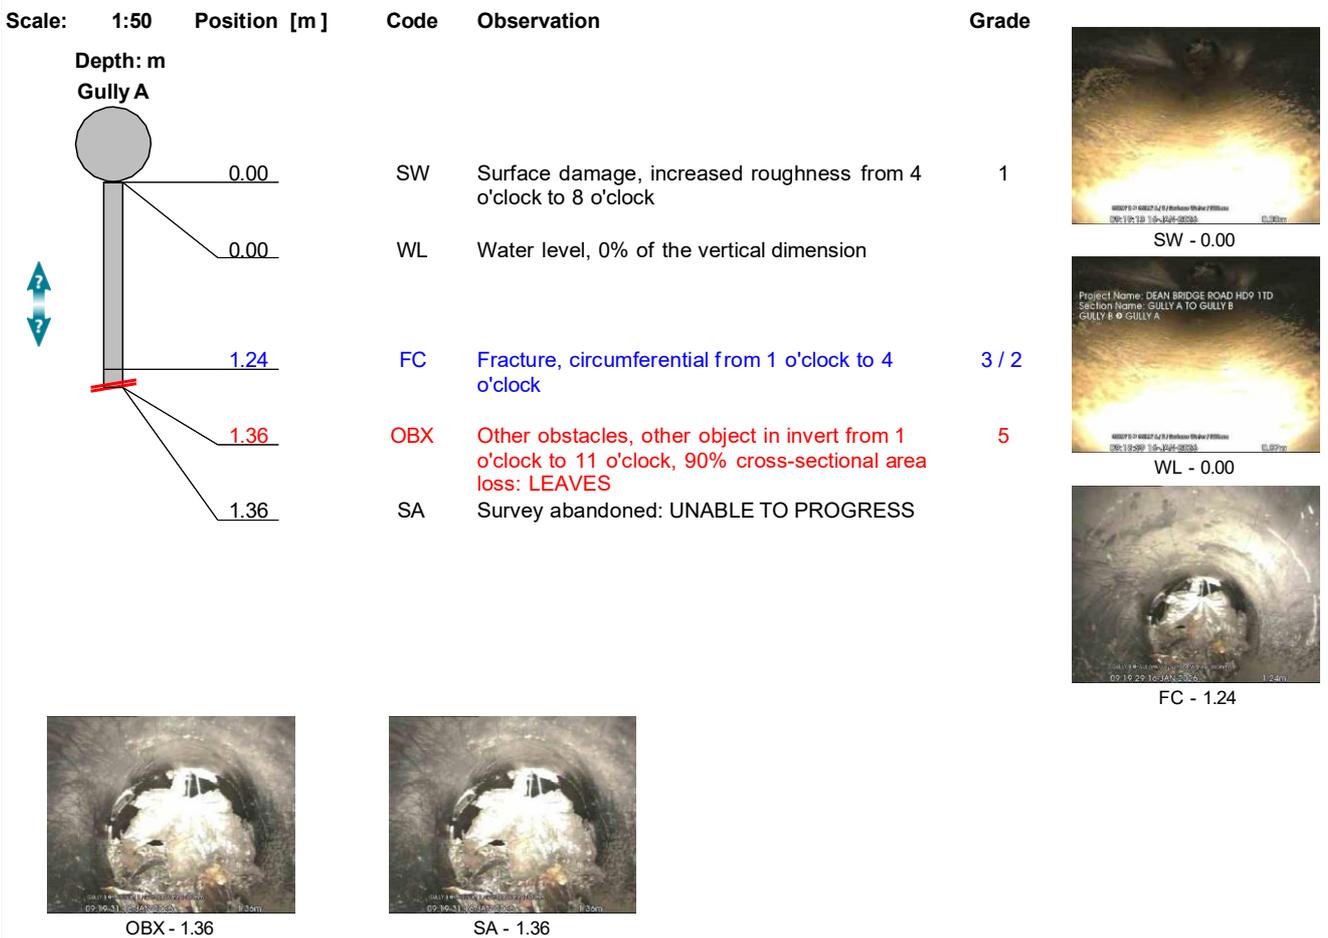
No.	m+	Code	Observation
1	0.00	SW	Surface damage, increased roughness from 4 o'clock to 8 o'clock
2	0.00	WL	Water level, 0% of the vertical dimension
3	1.24	FC	Fracture, circumferential from 1 o'clock to 4 o'clock
4	1.36	OBX	Other obstacles, other object in invert from 1 o'clock to 11 o'clock, 90% cross-sectional area loss
5	1.36	SA	Survey abandoned

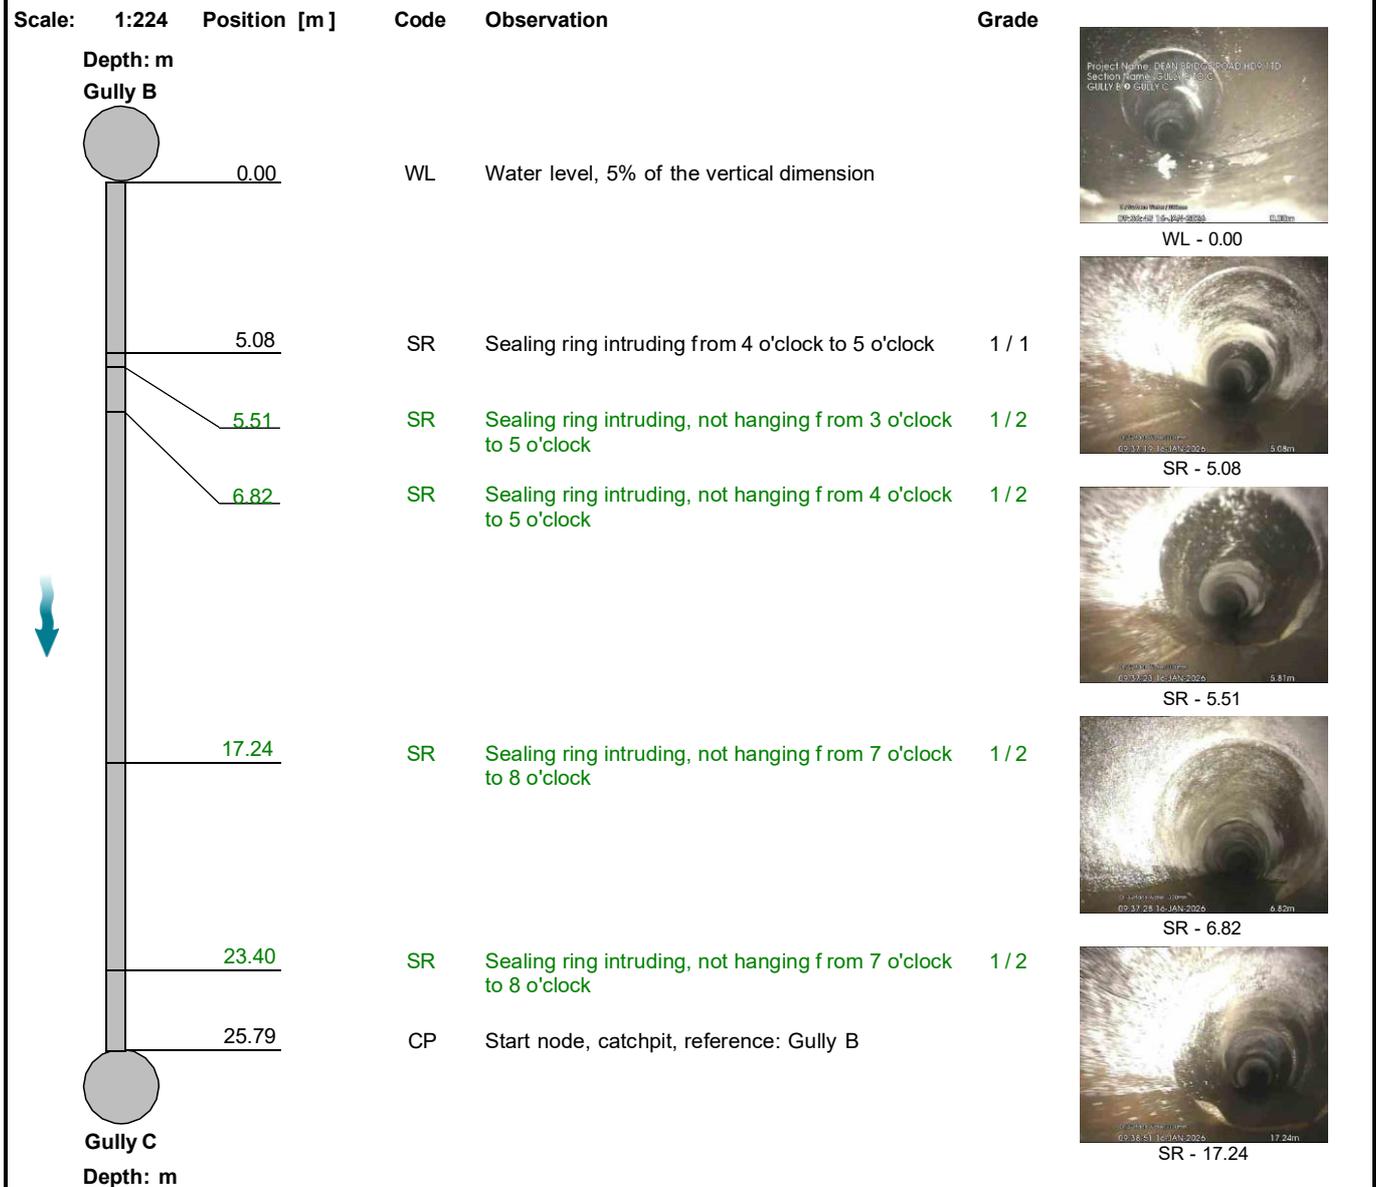
No.	m+	Code	Observation
1	0.00	WL	Water level, 5% of the vertical dimension
2	5.08	SR	Sealing ring intruding from 4 o'clock to 5 o'clock
3	5.51	SR	Sealing ring intruding, not hanging from 3 o'clock to 5 o'clock
4	6.82	SR	Sealing ring intruding, not hanging from 4 o'clock to 5 o'clock
5	17.24	SR	Sealing ring intruding, not hanging from 7 o'clock to 8 o'clock
6	23.40	SR	Sealing ring intruding, not hanging from 7 o'clock to 8 o'clock
7	25.79	CP	Start node, catchpit, reference: Gully B

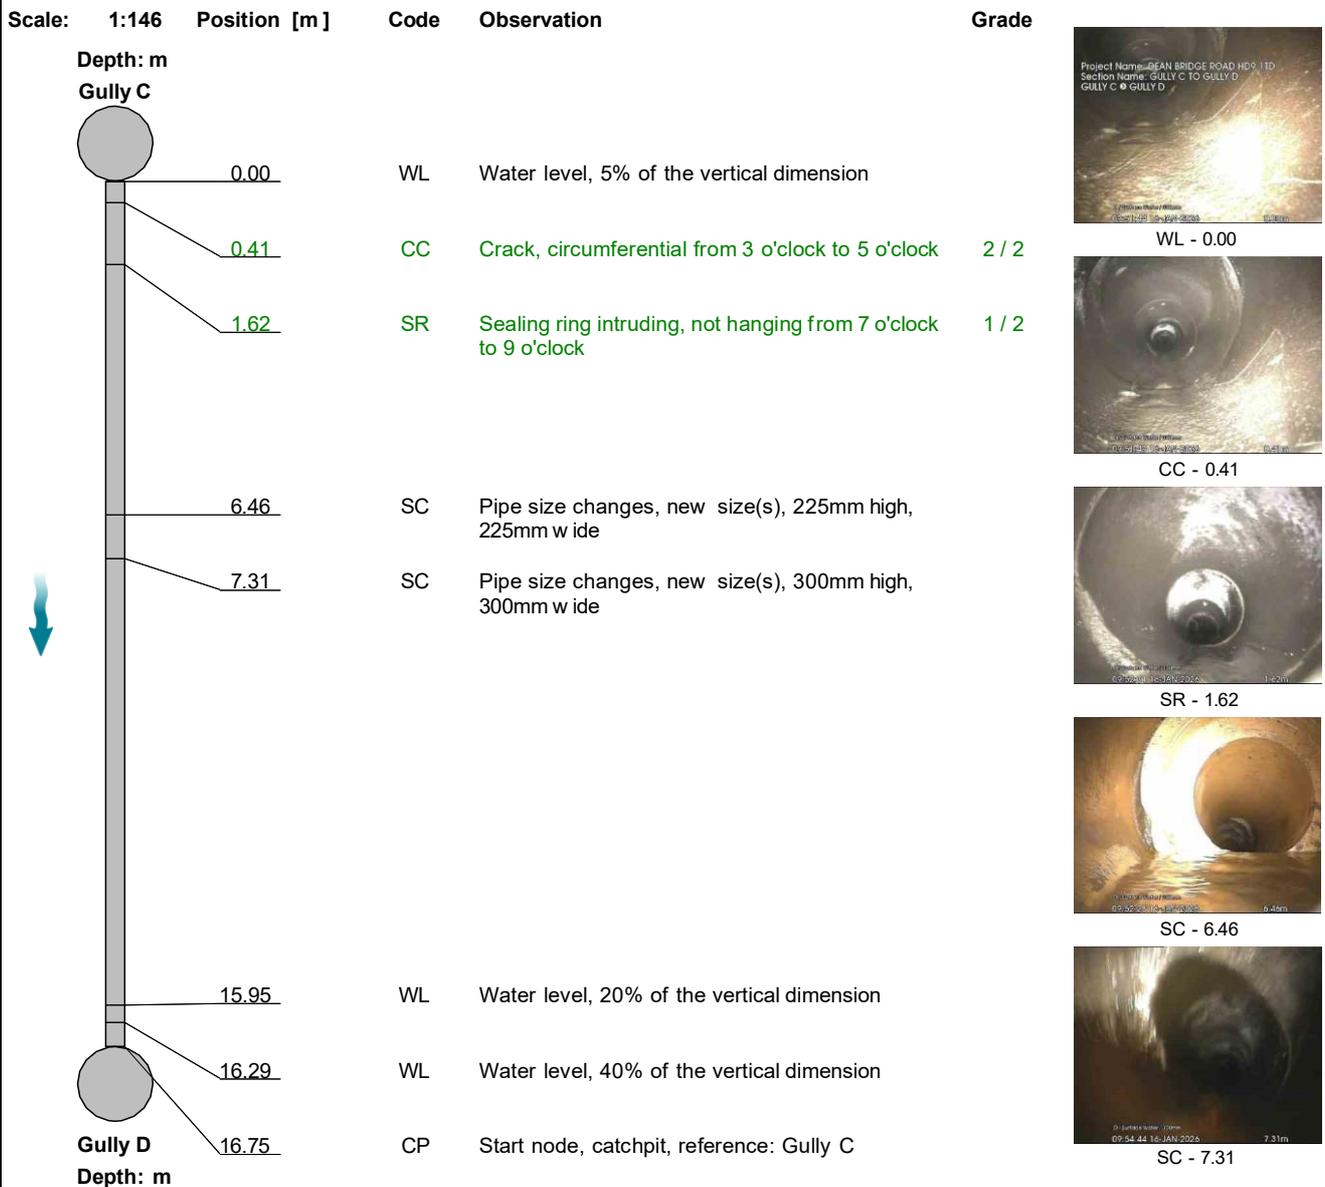
No.	m+	Code	Observation
1	0.00	WL	Water level, 5% of the vertical dimension
2	0.41	CC	Crack, circumferential from 3 o'clock to 5 o'clock
3	1.62	SR	Sealing ring intruding, not hanging from 7 o'clock to 9 o'clock
4	6.46	SC	Pipe size changes, new size(s), 225mm high, 225mm wide
5	7.31	SC	Pipe size changes, new size(s), 300mm high, 300mm wide
6	15.95	WL	Water level, 20% of the vertical dimension
7	16.29	WL	Water level, 40% of the vertical dimension
8	16.75	CP	Start node, catchpit, reference: Gully C

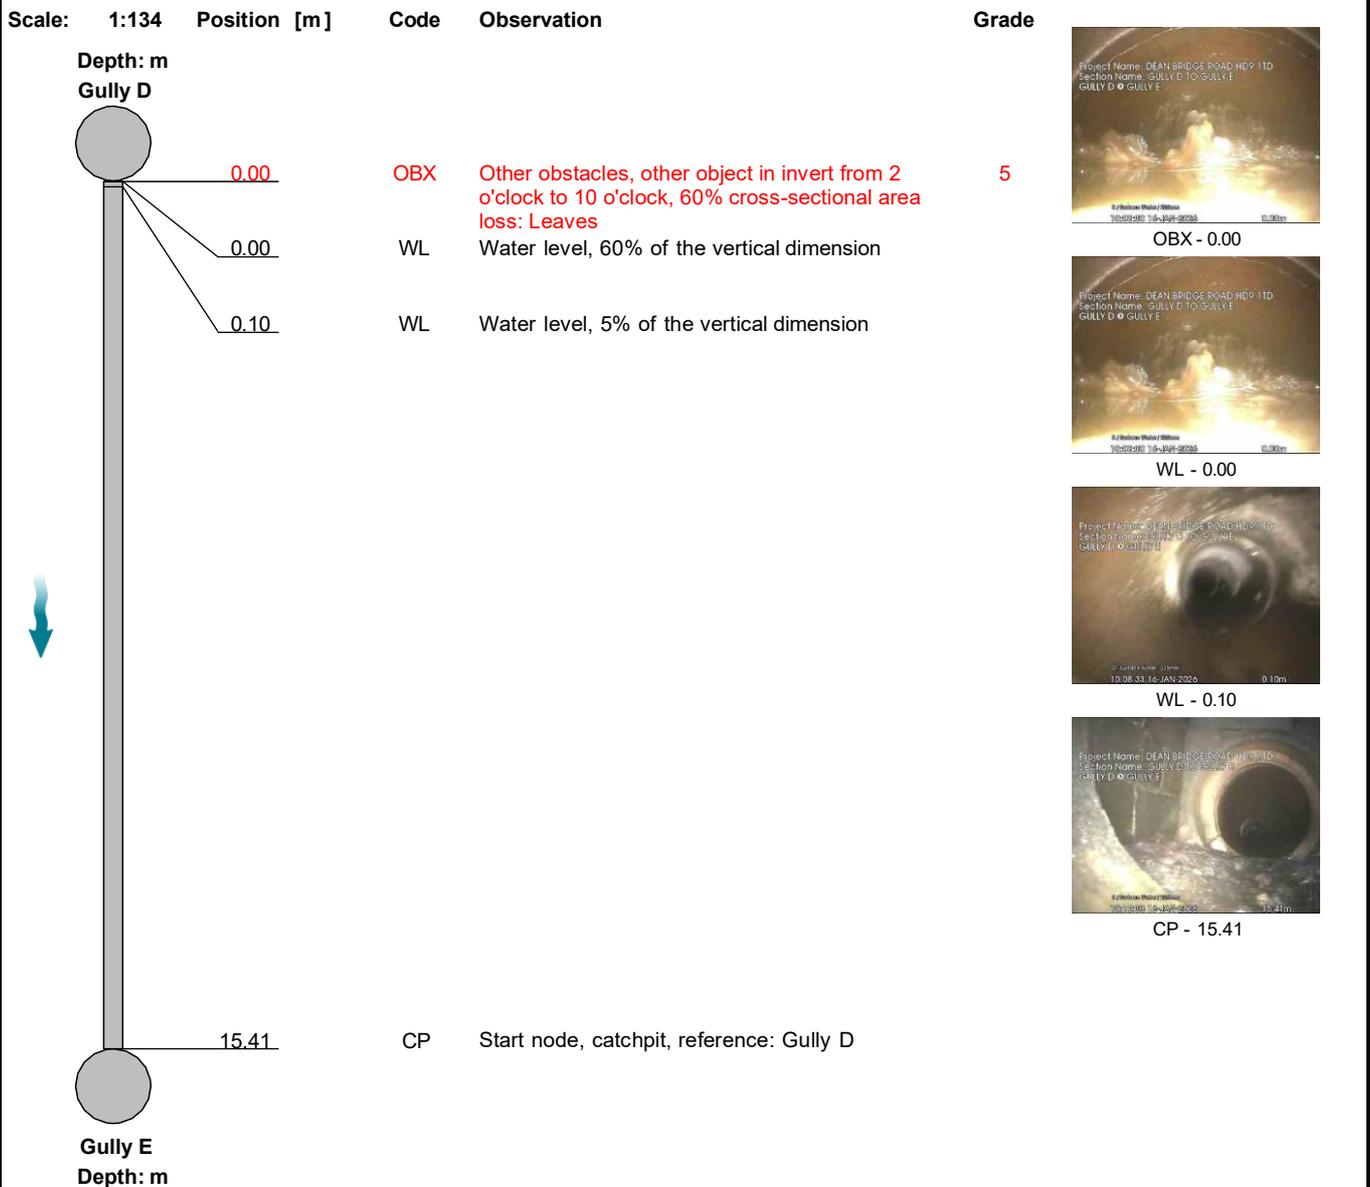
No.	m+	Code	Observation
1	0.00	OBX	Other obstacles, other object in invert from 2 o'clock to 10 o'clock, 60% cross-sectional area loss
2	0.00	WL	Water level, 60% of the vertical dimension
3	0.10	WL	Water level, 5% of the vertical dimension
4	15.41	CP	Start node, catchpit, reference: Gully D

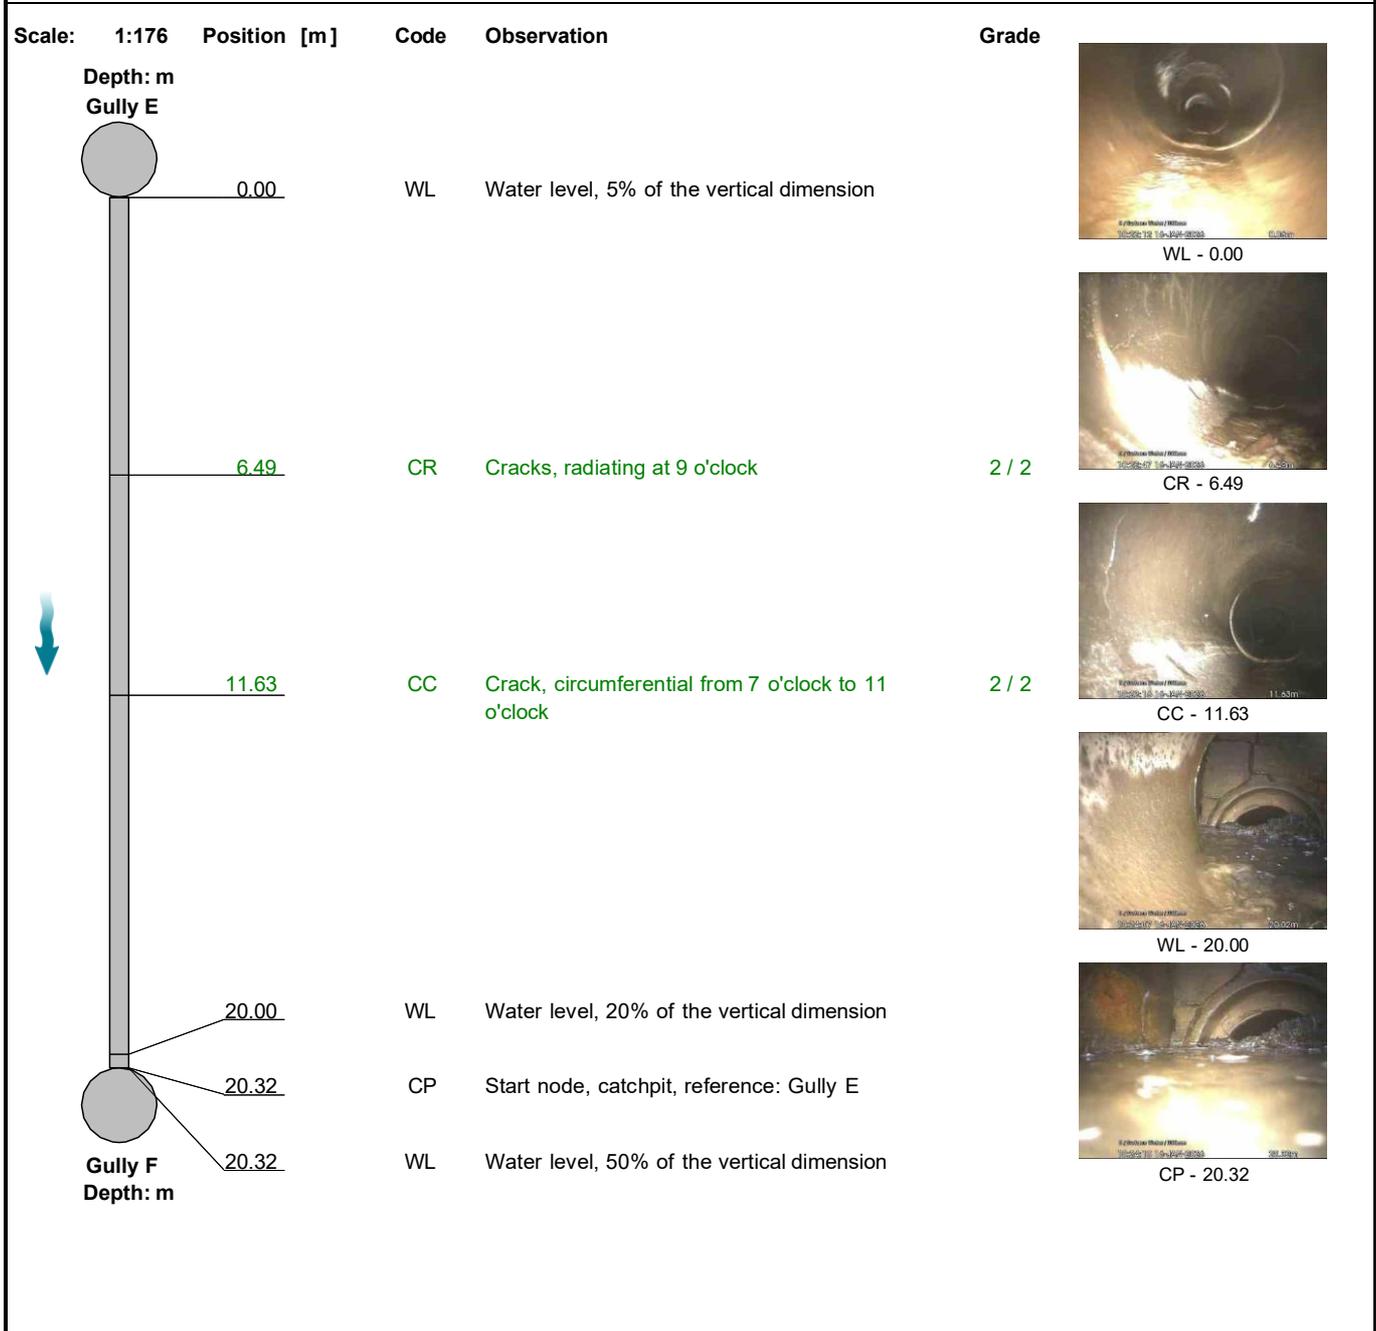
No.	m+	Code	Observation
1	0.00	WL	Water level, 5% of the vertical dimension
2	6.49	CR	Cracks, radiating at 9 o'clock
3	11.63	CC	Crack, circumferential from 7 o'clock to 11 o'clock
4	20.00	WL	Water level, 20% of the vertical dimension
5	20.32	CP	Start node, catchpit, reference: Gully E
6	20.32	WL	Water level, 50% of the vertical dimension

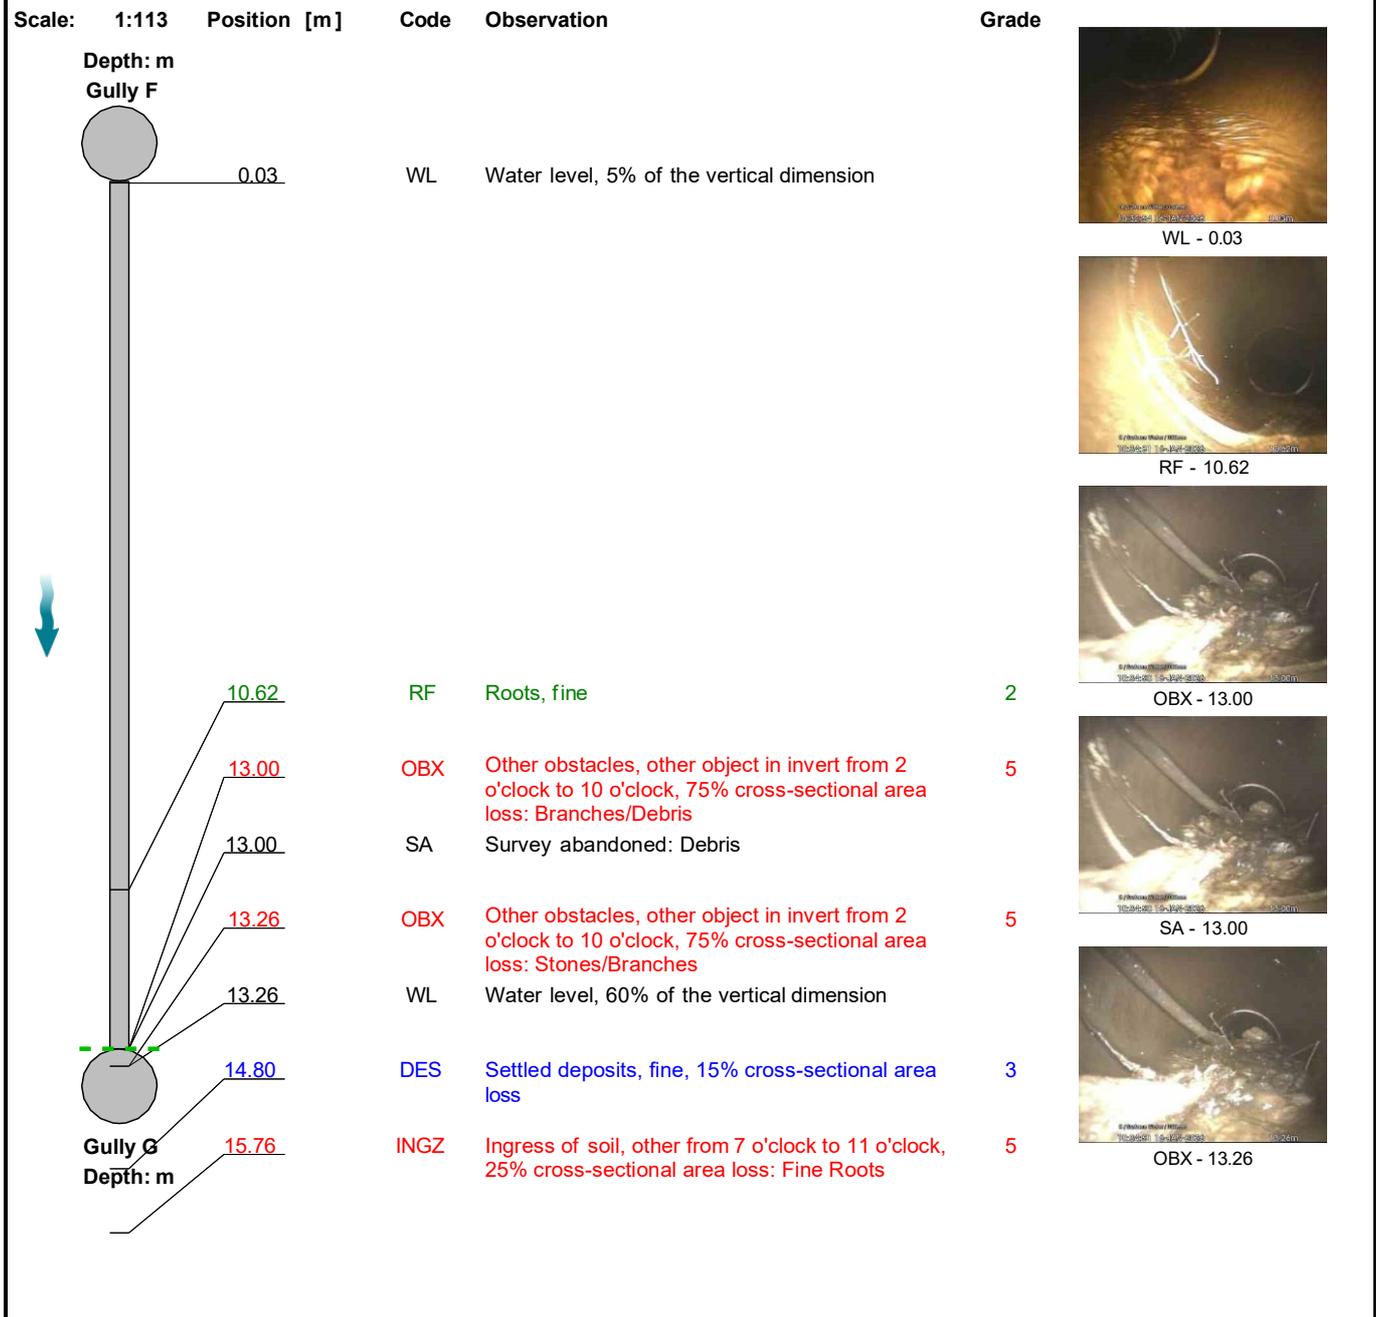
No.	m+	Code	Observation
1	0.03	WL	Water level, 5% of the vertical dimension
2	10.62	RF	Roots, fine
3	13.00	OBX	Other obstacles, other object in invert from 2 o'clock to 10 o'clock, 75% cross-sectional area loss
4	13.00	SA	Survey abandoned
5	13.26	OBX	Other obstacles, other object in invert from 2 o'clock to 10 o'clock, 75% cross-sectional area loss
6	13.26	WL	Water level, 60% of the vertical dimension
7	14.80	DES	Settled deposits, fine, 15% cross-sectional area loss
8	15.76	INGZ	Ingress of soil, other from 7 o'clock to 11 o'clock, 25% cross-sectional area loss

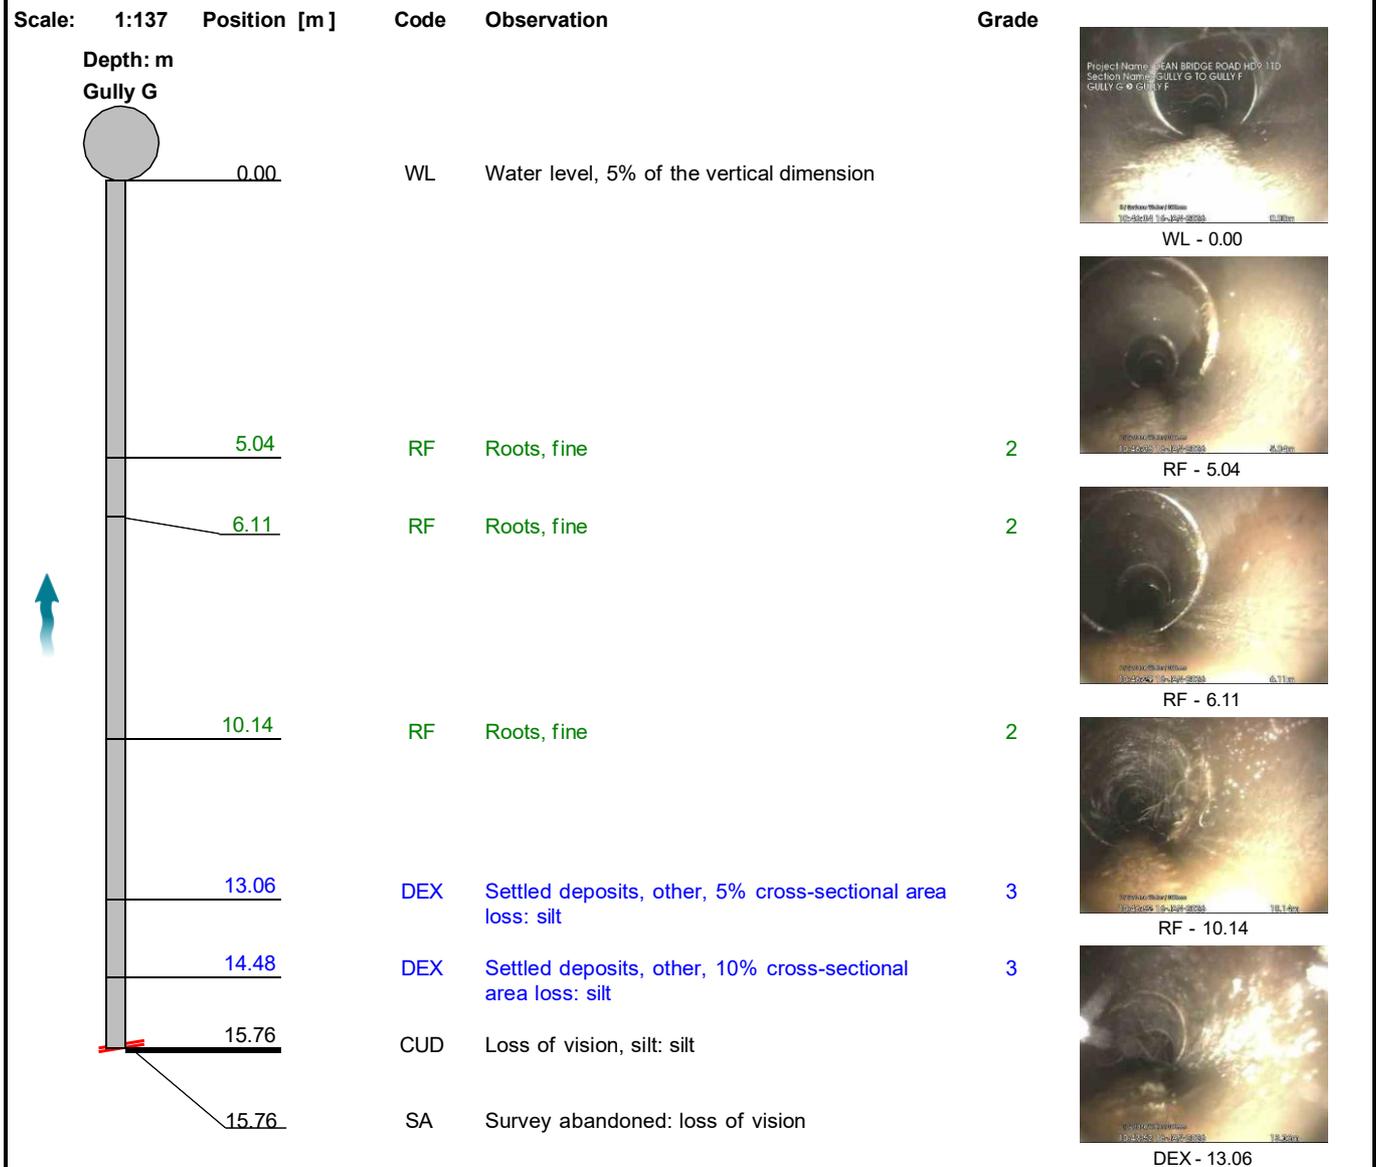
No.	m+	Code	Observation
1	0.00	WL	Water level, 5% of the vertical dimension
2	5.04	RF	Roots, fine
3	6.11	RF	Roots, fine
4	10.14	RF	Roots, fine
5	13.06	DEX	Settled deposits, other, 5% cross-sectional area loss
6	14.48	DEX	Settled deposits, other, 10% cross-sectional area loss
7	15.76	CUD	Loss of vision, silt
8	15.76	SA	Survey abandoned

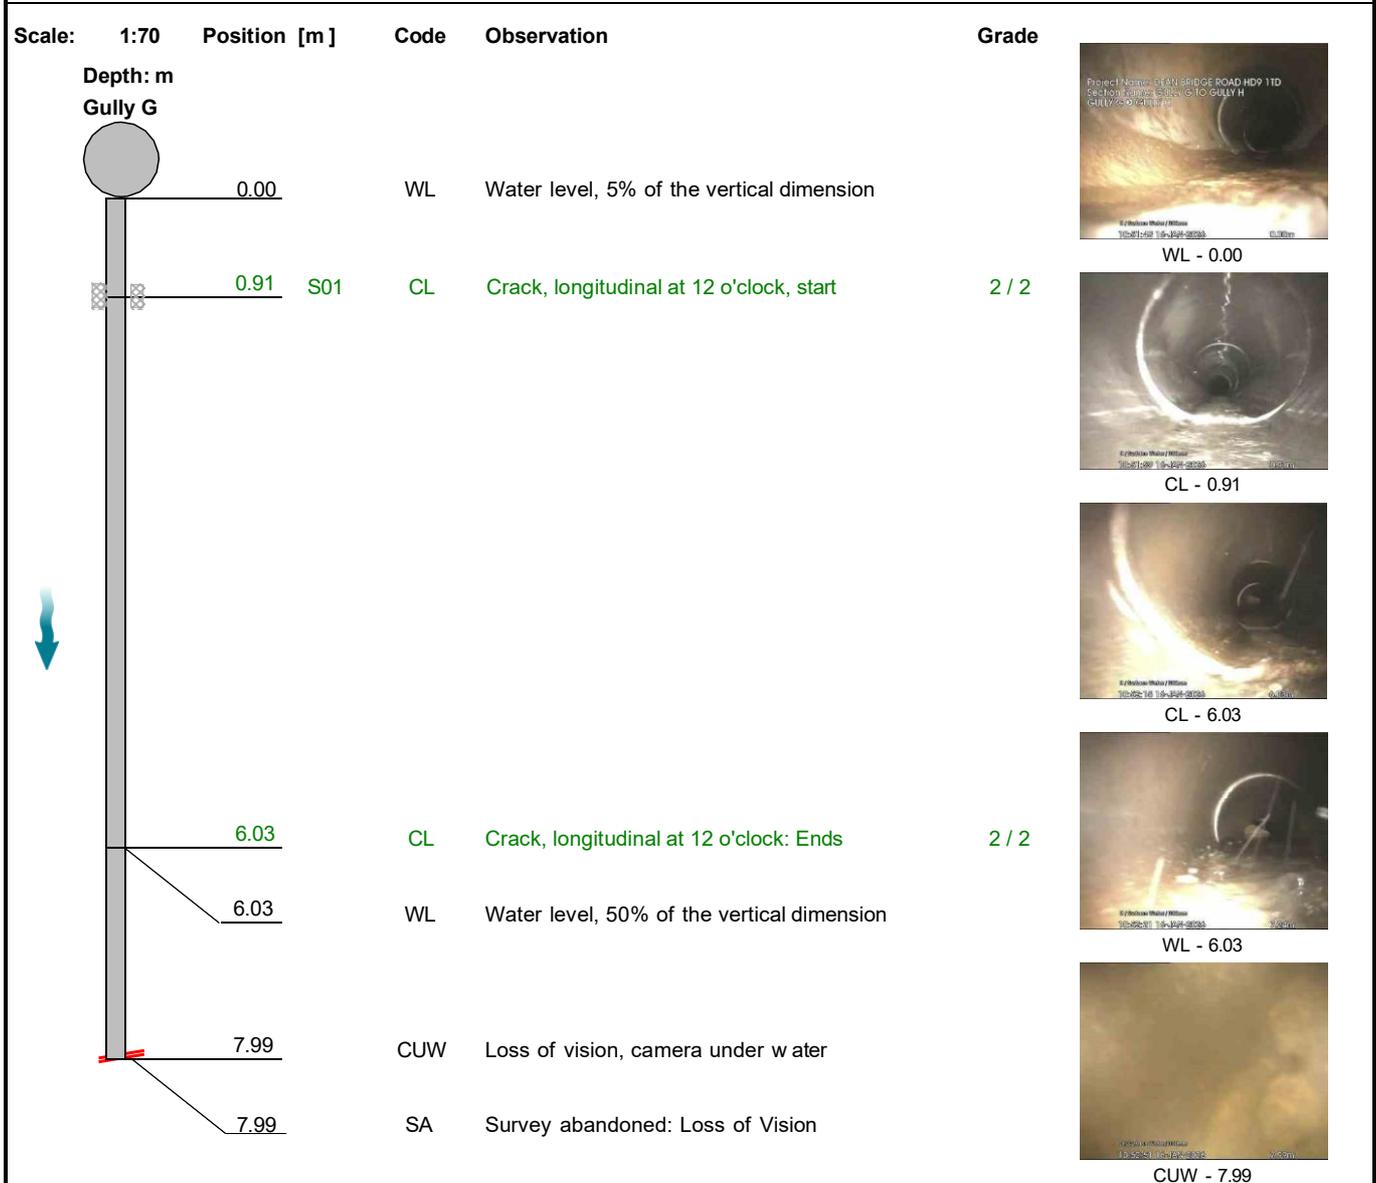
No.	m+	Code	Observation
1	0.00	WL	Water level, 5% of the vertical dimension
2	0.91	CL	Crack, longitudinal at 12 o'clock, start
3	6.03	CL	Crack, longitudinal at 12 o'clock
4	6.03	WL	Water level, 50% of the vertical dimension
5	7.99	CUW	Loss of vision, camera under water
6	7.99	SA	Survey abandoned

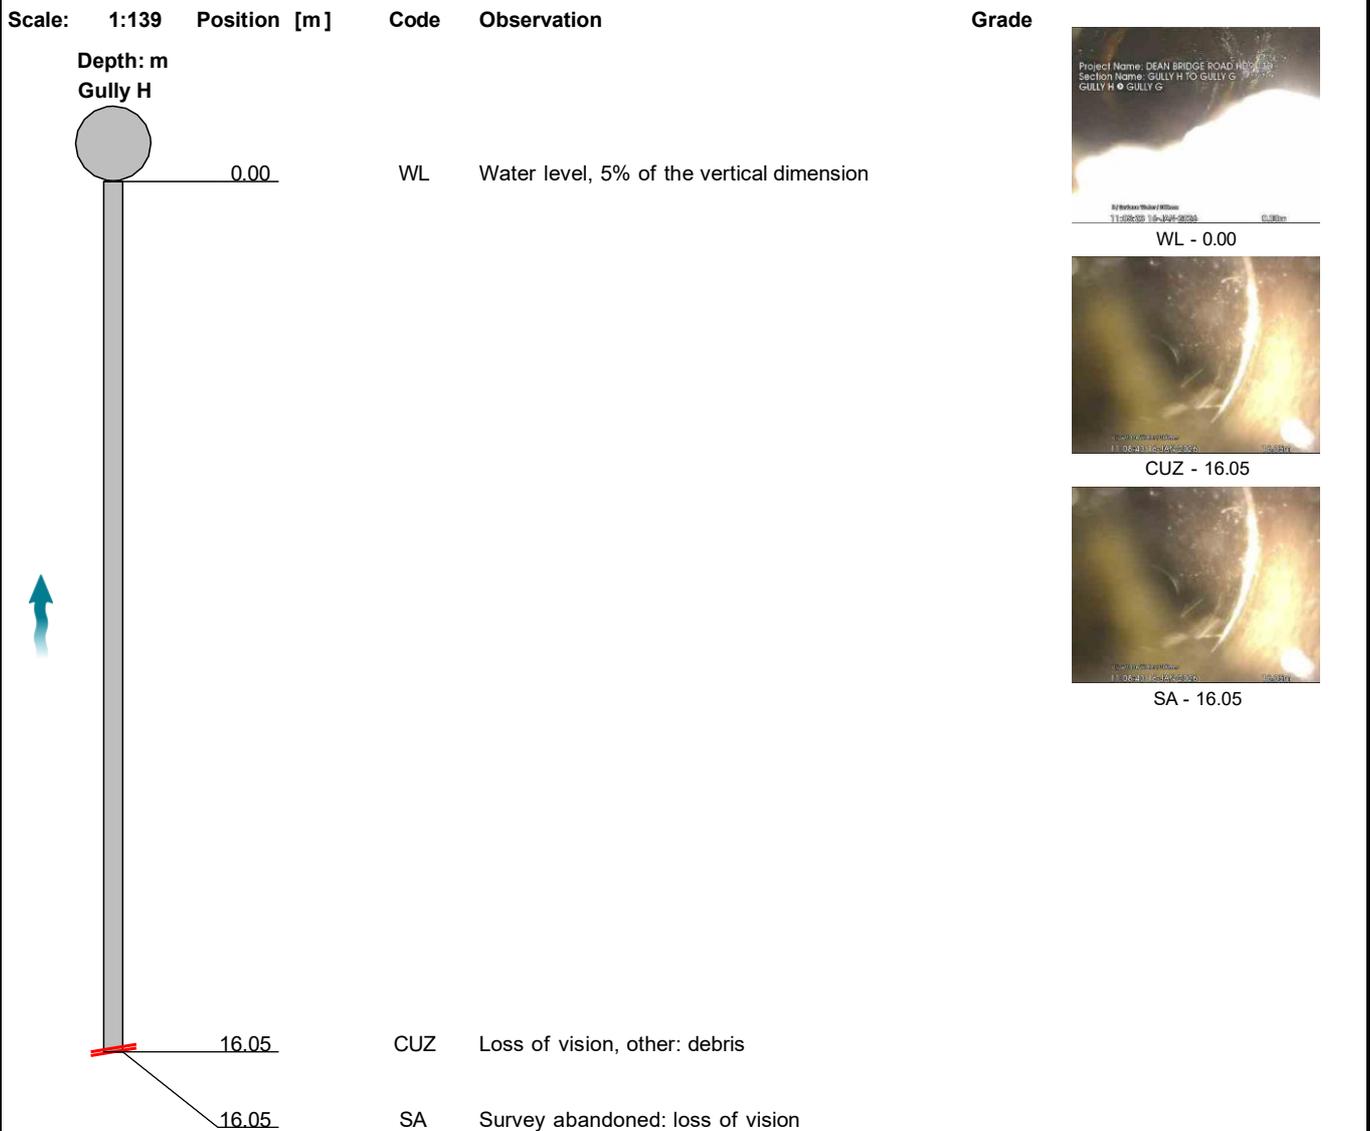
No.	m+	Code	Observation
1	0.00	WL	Water level, 5% of the vertical dimension
2	16.05	CUZ	Loss of vision, other
3	16.05	SA	Survey abandoned

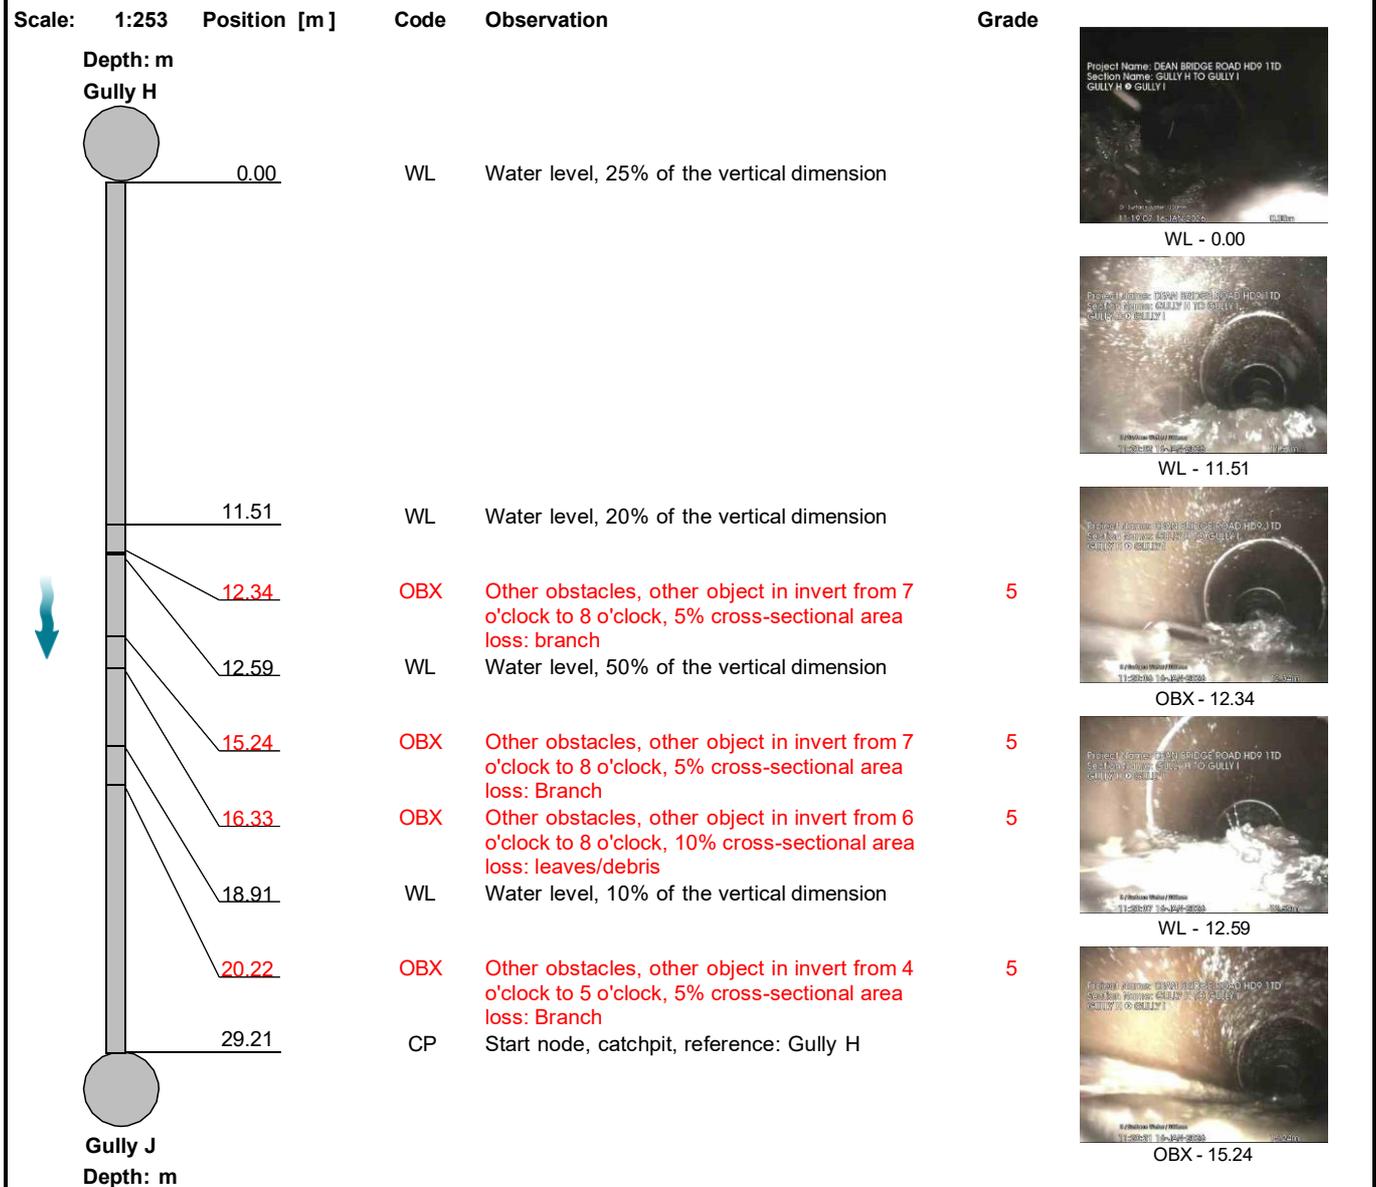
No.	m+	Code	Observation
1	0.00	WL	Water level, 25% of the vertical dimension
2	11.51	WL	Water level, 20% of the vertical dimension
3	12.34	OBX	Other obstacles, other object in invert from 7 o'clock to 8 o'clock, 5% cross-sectional area loss
4	12.59	WL	Water level, 50% of the vertical dimension
5	15.24	OBX	Other obstacles, other object in invert from 7 o'clock to 8 o'clock, 5% cross-sectional area loss
6	16.33	OBX	Other obstacles, other object in invert from 6 o'clock to 8 o'clock, 10% cross-sectional area loss
7	18.91	WL	Water level, 10% of the vertical dimension
8	20.22	OBX	Other obstacles, other object in invert from 4 o'clock to 5 o'clock, 5% cross-sectional area loss
9	29.21	CP	Start node, catchpit, reference: Gully H

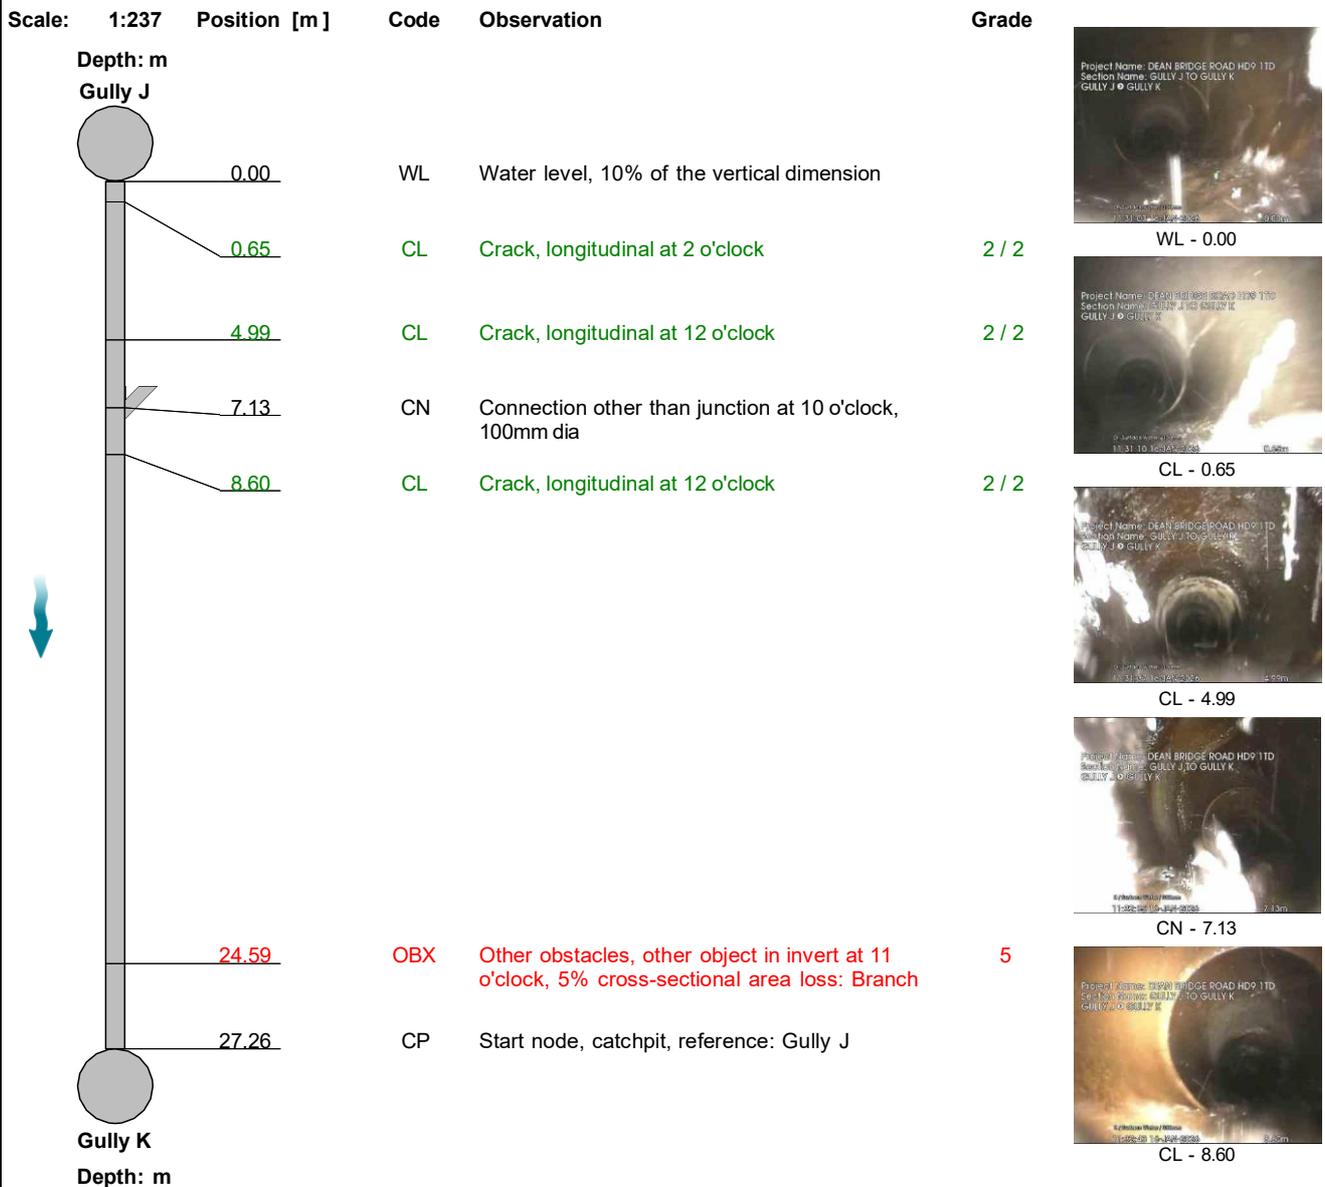
No.	m+	Code	Observation
1	0.00	WL	Water level, 10% of the vertical dimension
2	0.65	CL	Crack, longitudinal at 2 o'clock
3	4.99	CL	Crack, longitudinal at 12 o'clock
4	7.13	CN	Connection other than junction at 10 o'clock, 100mm dia
5	8.60	CL	Crack, longitudinal at 12 o'clock

No.	m+	Code	Observation
6	24.59	OBX	Other obstacles, other object in invert at 11 o'clock, 5% cross-sectional area loss
7	27.26	CP	Start node, catchpit, reference: Gully J

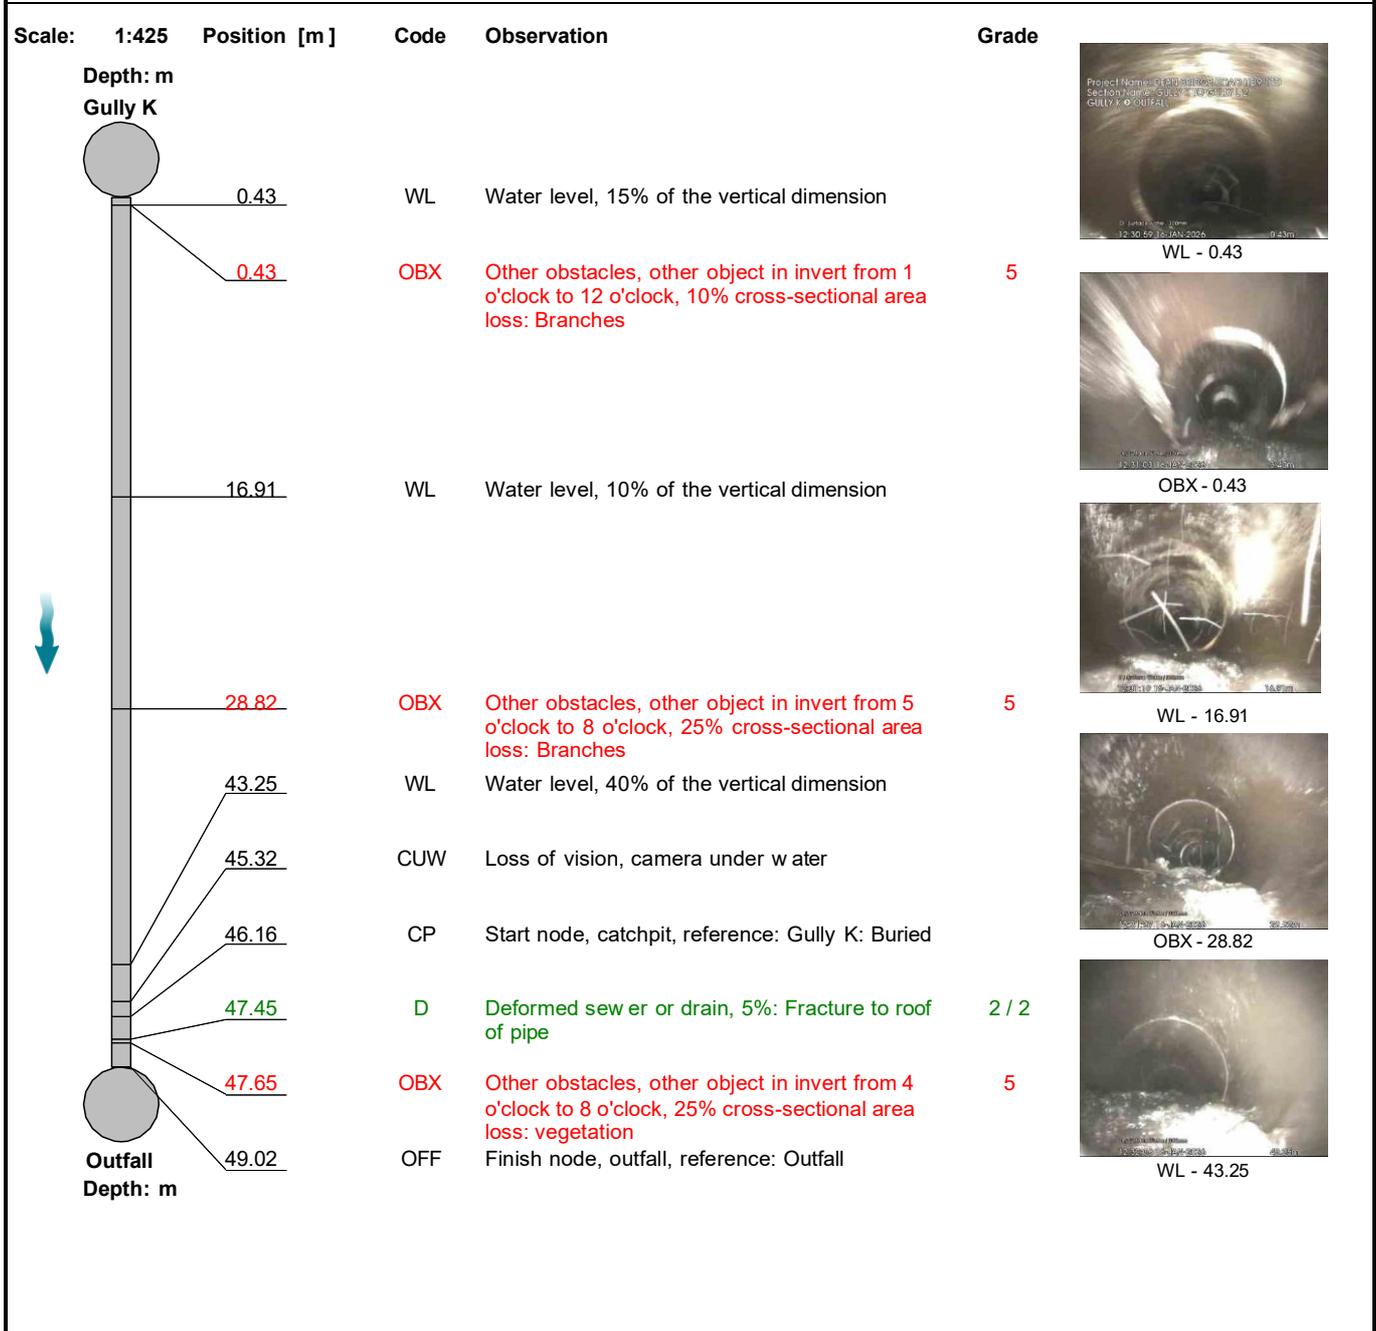
No.	m+	Code	Observation
1	0.43	WL	Water level, 15% of the vertical dimension
2	0.43	OBX	Other obstacles, other object in invert from 1 o'clock to 12 o'clock, 10% cross-sectional area loss
3	16.91	WL	Water level, 10% of the vertical dimension
4	28.82	OBX	Other obstacles, other object in invert from 5 o'clock to 8 o'clock, 25% cross-sectional area loss
5	43.25	WL	Water level, 40% of the vertical dimension
6	45.32	CUW	Loss of vision, camera under water
7	46.16	CP	Start node, catchpit, reference: Gully K
8	47.45	D	Deformed sewer or drain, 5%
9	47.65	OBX	Other obstacles, other object in invert from 4 o'clock to 8 o'clock, 25% cross-sectional area loss
10	49.02	OFF	Finish node, outfall, reference: Outfall
