project Repairs, renovations and alterations
at
Grange Cottage Kirkby Grange Farm,
Clough Rd, Flockton, WF4 4AQ
for
Miss P. McAllister

title As proposed elevations
number GC-04-P01
scale 1:50
size A1

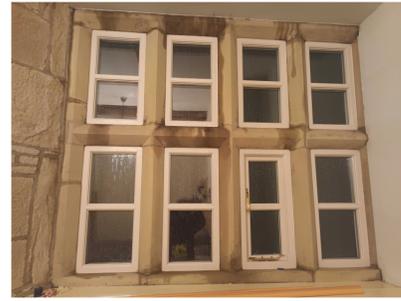
W06 Interior - photograph shows the current problem with excessive ingress of rain water penetrating through the existing ashlar mullions and failed pointing

All existing stone mullions to be re-pointed in Womersley's Ironstone Pre-Mixed Lime Mortar, and treated with Stormdry Masonry Protection Cream to resist rain penetration

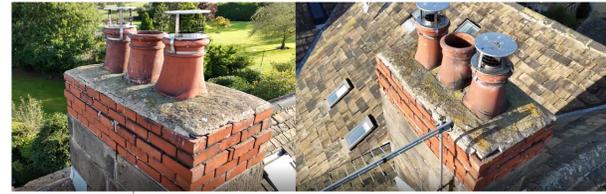
Assessment of repair works required to chimney stack to stop current issue of water ingress down flue.

Due to failed areas of pointing to chimney stack, launching and water table, local repair and repointing is necessary. The extent of which should be reviewed once high level access is available to carry out repair works.

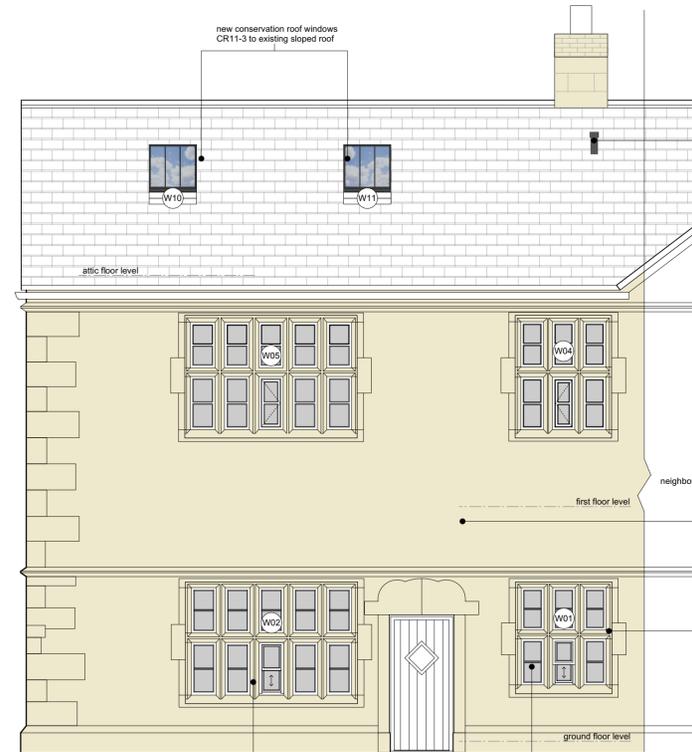
front elevation - south

Large areas of existing natural stonework to exterior walls show failed cement pointing. This is to be carefully raked out and re-pointed in Womersley's Ironstone Pre-Mixed Lime Mortar, colour to be Old White to match existing colour

Areas of existing natural stonework, highlighted in beige, to be carefully raked out and re-pointed in Womersley's Ironstone Pre-Mixed Lime Mortar, colour to be Old White to match existing colour

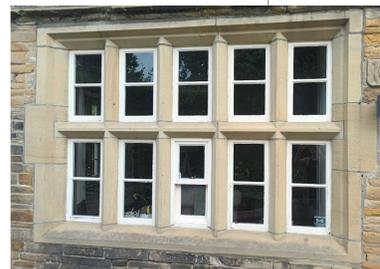
W02 Exterior

Window type: 9 fixed, 1 sash
Location: Lounge, front elevation - south

Condition: Existing windows are not original. They consist of single glazed painted timber windows that are, generally, in a good state of repair due to good upkeep practices. However, their integrity and performance has been degraded over time and the opening sashes are paint fast and currently do not open. The single glazing is thermally inefficient and gathers excessive condensation

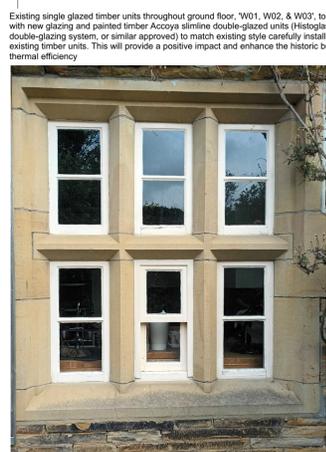
W01

Window type: 5 fixed, 1 sash
Location: kitchen, front elevation - south

Condition: Existing windows are not original. They consist of single glazed painted timber windows that are, generally, in a good state of repair due to good upkeep practices. However, their integrity and performance has been degraded over time and the opening sashes are paint fast and currently do not open. The catch to the sash is broken. The single glazing is thermally inefficient and gathers excessive condensation

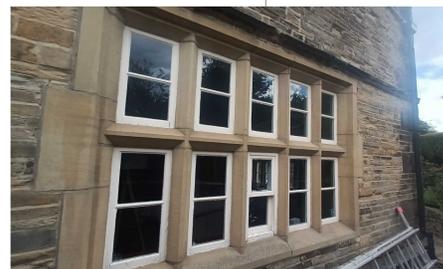
W03 Exterior

Window type: 9 fixed, 1 sash
Location: Lounge, front elevation - west

Condition: Existing windows are not original. They consist of single glazed painted timber windows that are, generally, in a good state of repair due to good upkeep practices. However, their integrity and performance has been degraded over time and the opening sashes are paint fast and currently do not open. The single glazing is thermally inefficient and gathers excessive condensation

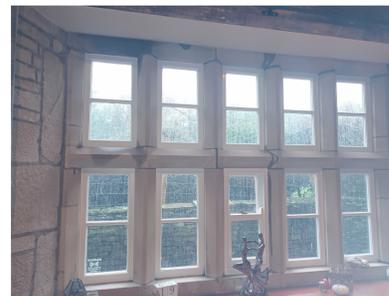
W03 Interior - photograph shows the current problem with ingress of rain water penetrating through the existing ashlar mullions and failed pointing
