Our Ref: PRN/01/L17/WW

13th December 2024

Proposed New Residential Dwellings
Jill Lane, Mirfield
Intrusive Coal Mining Investigation

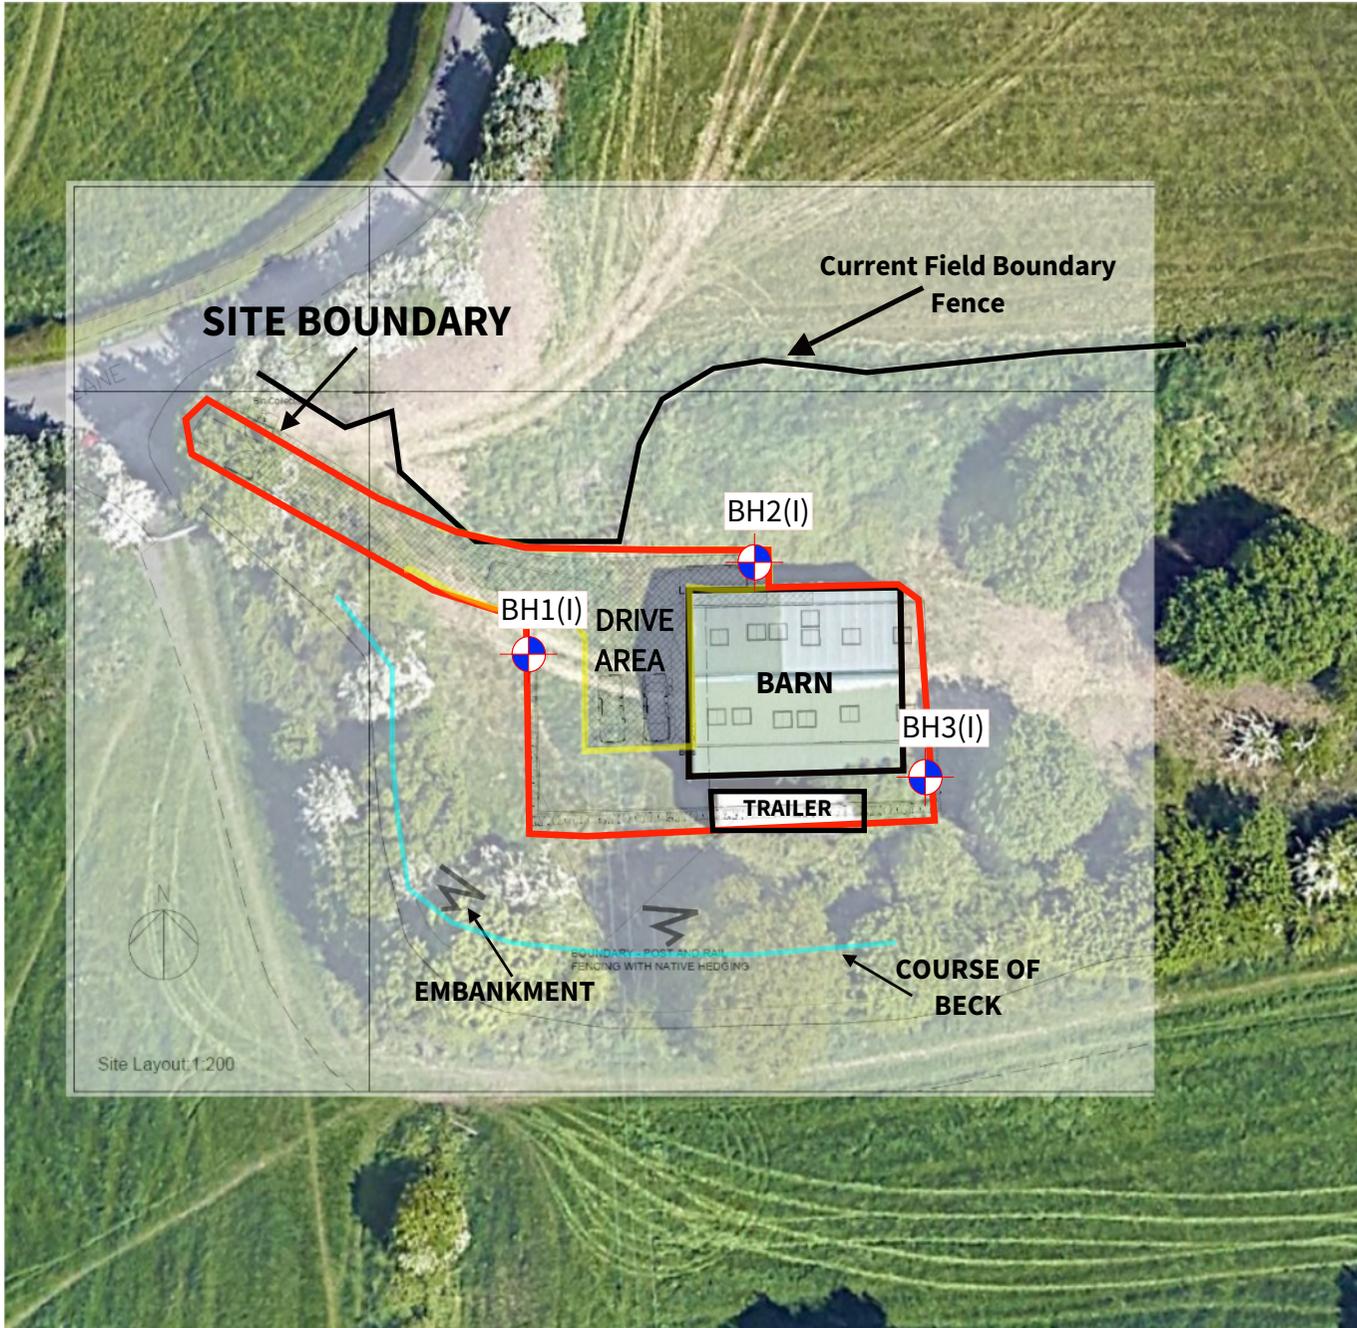
Three boreholes were drilled, using rotary openhole water flush techniques, by Demolition & Geotechnical Ltd between the 28th November to the 3rd of December 2024. The boreholes were numbered BH1, BH2, and BH3 and were drilled to depths of between 12m and 28m, at the locations shown on the attached plan. The investigation was designed, organised, and supervised (on a full-time basis) by ARP Geotechnical Ltd, and boreholes were logged by both the Engineer and the lead driller. The logs are attached.

Broken ground, believed to be at the level of the Middleton 11 Yard Coal, was encountered in BH1 and BH2, at depths of 5.5m-6.0m and 5.8m-6.7m respectively. Soft ground was encountered between 6.0m-6.5m in BH3, again believed to be at the level of the Middleton 11 Yard Coal. No intact coal was encountered at the level of the shallower seam. BH1 and BH2, lost flush from the level of the broken ground. Strata below the workings were recorded as hard strata to the base of each borehole at 12.0m depth. BH3 retained flush through the soft ground and was drilled to a depth of 28m from the surface. A small band of intact coal 0.1m thick, thought to be the Blocking Coal was recorded at 22.5m. With mudstone being recorded throughout the remainder of the borehole.

In the light of the above, coal mine workings identified from the rotary investigation do not have sufficient rock cover, across the whole site, and stabilisation treatment by injection of grout into a grid of boreholes (known as drilling and grouting) will be required. A 3m grid is recommended, continuing 3m beyond the proposed building footprint.
