Mine Entry Interpretive Report

9 RILEY LANE, KIRKBURTON, HUDDERSFIELD, HD8 0RZ

Our reference: 51001424330002
Your reference: FUS11682TBE

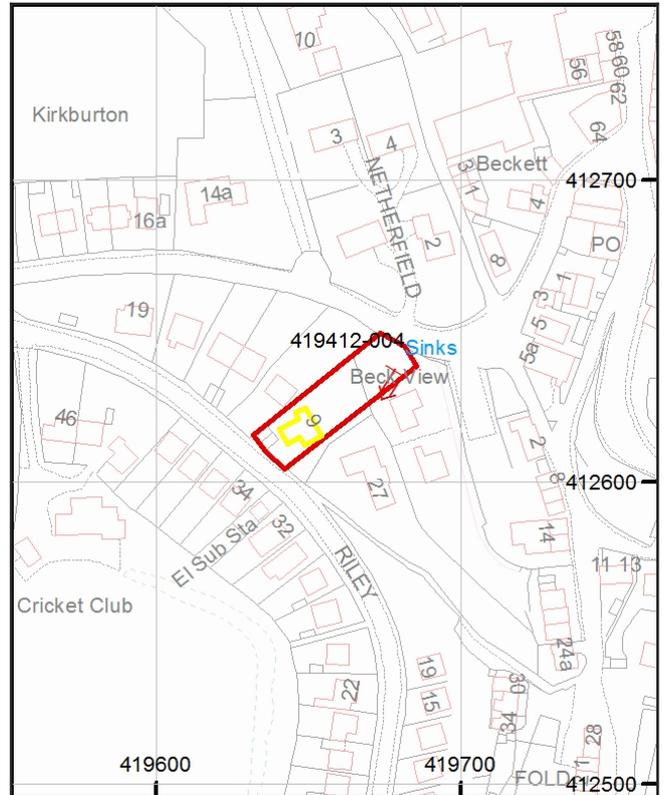
Enquiry boundary

If coal mining subsidence was to occur because of ground movement due to the mine entry, the main building (as shown on the plan) is outside the area likely to be affected. Our opinion takes into account the thickness of the superficial deposits, the potential difference between the actual and the plotted positions of the mine entry and its diameter/maximum width.

The possibility of subsidence damage to the garden areas/other buildings is very small but should not be discounted completely.

In our opinion, the main building (as shown on the plan) is not at risk of coal mining subsidence damage from the subject mine entry. This is because it is not within the area of possible ground movement.
