ARBORICULTURAL REPORT

& Impact Assessment

***23 Barnsley Road,
Flockton,
Wakefield,
WF4 4DP***

Reference: *AWA6298*

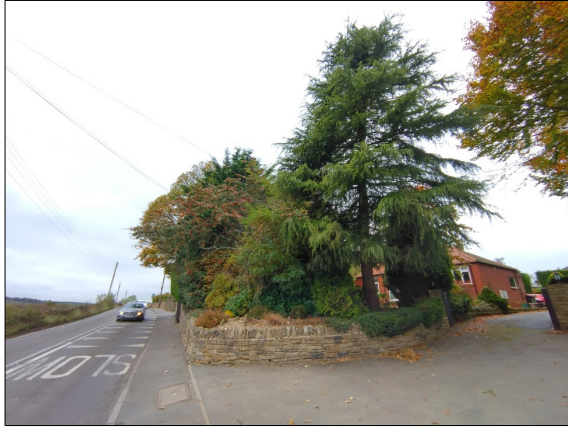
Photo 1: T1 and other woody vegetation along the site's southern boundary, looking west.

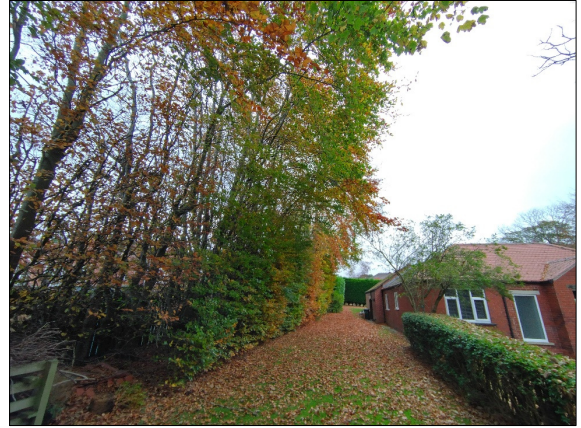
- 3.2.7 G9 is a formally planted row of Beech along the garden's western boundary. The lower crowns have been managed as a hedge, kept pruned back and forming effective screening foliage, while the upper crowns are relatively unmanaged. G9 is moderate value overall and provides effective screening. T11 is a larger tree within G9 and is also of moderate value despite some occasional minor defects.

Photo 2: G9 running along the site's western boundary, looking north.

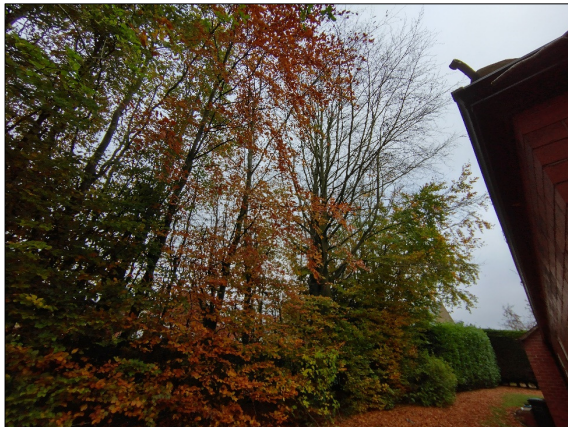
Photo 3: T11 growing within G9, looking northwest.

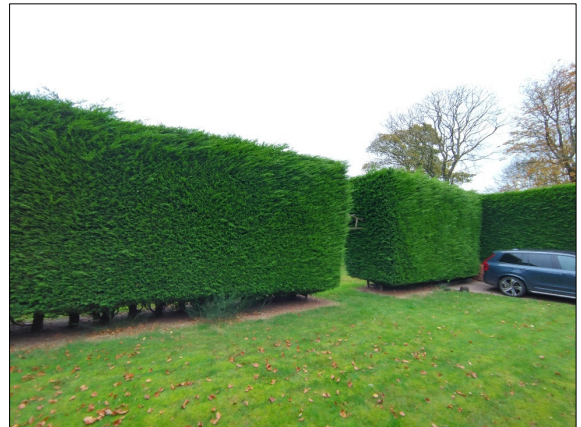
Photo 4: G13, looking northeast.

G13	Leyland Cypress	X <i>Cupressocyparis leylandii</i>	Semi-mature	4	10+	110 avg	Yes	0	See Plan				Managed Cypress hedge. Wooden trellis archway across gap				Good	Good	>40 yrs	Low	C	Partial removal required to facilitate development - Retain western section (see Appendix 6)
G14	Leyland Cypress	X <i>Cupressocyparis leylandii</i>	Semi-mature	2.5	10+	100 avg	Yes	0	See Plan				Managed Cypress hedge				Good	Good	>40 yrs	Low	C	No works required
G15	Laurel	<i>Prunus laurocerasus</i>	Semi-mature	3	10+	100 avg	Yes	0	See Plan				Managed Laurel hedge, fencing to lower southern aspect				Good	Good	20 to 40 yrs	Low	C	Partial removal required to facilitate development - Remove eastern section (see Appendix 6)

4.2.4 The hedges that require partial removal to facilitate the development are G13 and G15.

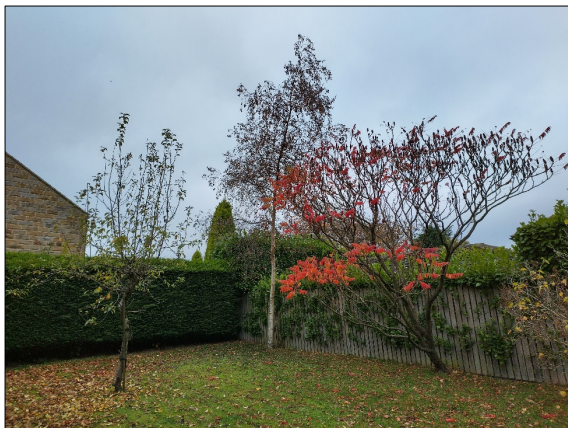
Photo 5: T17, T18 and T19, looking northwest.

T19	Staghorn Sumac	<i>Rhus typhina</i>	Early-mature	5	4	90 80 70 60	No	0.5	1.5	2.5	3	2.5	No visual defects	Multiple stemmed at 1m. Slight lean to south. Tight union. Partially included bark. Minor decay	Minor deadwood. Snapped /hanging branches. Unbalanced to south	Tight unions at base	Good	Fair	20 to 40 yrs	Moderate	C	Pruning works required to facilitate development - Reduce southern crown by 1m, pruning to suitable growth points
T20	Staghorn Sumac	<i>Rhus typhina</i>	Early-mature	6.5	1	160	No	2	2	2	2.5	3.5	No visual defects	Single stemmed. Vertical. Bark damage. Minor cavities	Minor deadwood. Snapped /hanging branches	Lower northern crown suppressed by adjacent Laurel hedge	Good	Fair	20 to 40 yrs	Moderate	C	Removal required to facilitate development

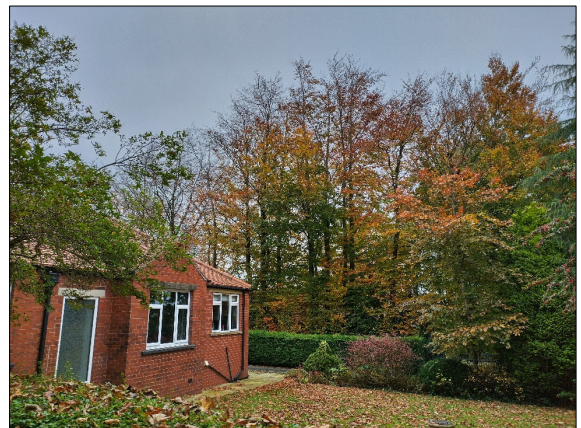
- 3.2.9 The eastern boundary of the survey area is bordered by Beech T21 to T30. These trees are generally moderate value, providing effective screening and amenity within the local landscape.

Photo 6: T21 to T30 along the site's eastern boundary, looking east.
